HISTORIC STRUCTURE  
REPORT:

PHYSICAL FABRIC SECTION

LEISTER BARN

GETTYSBURG NATIONAL MILITARY  
PARK

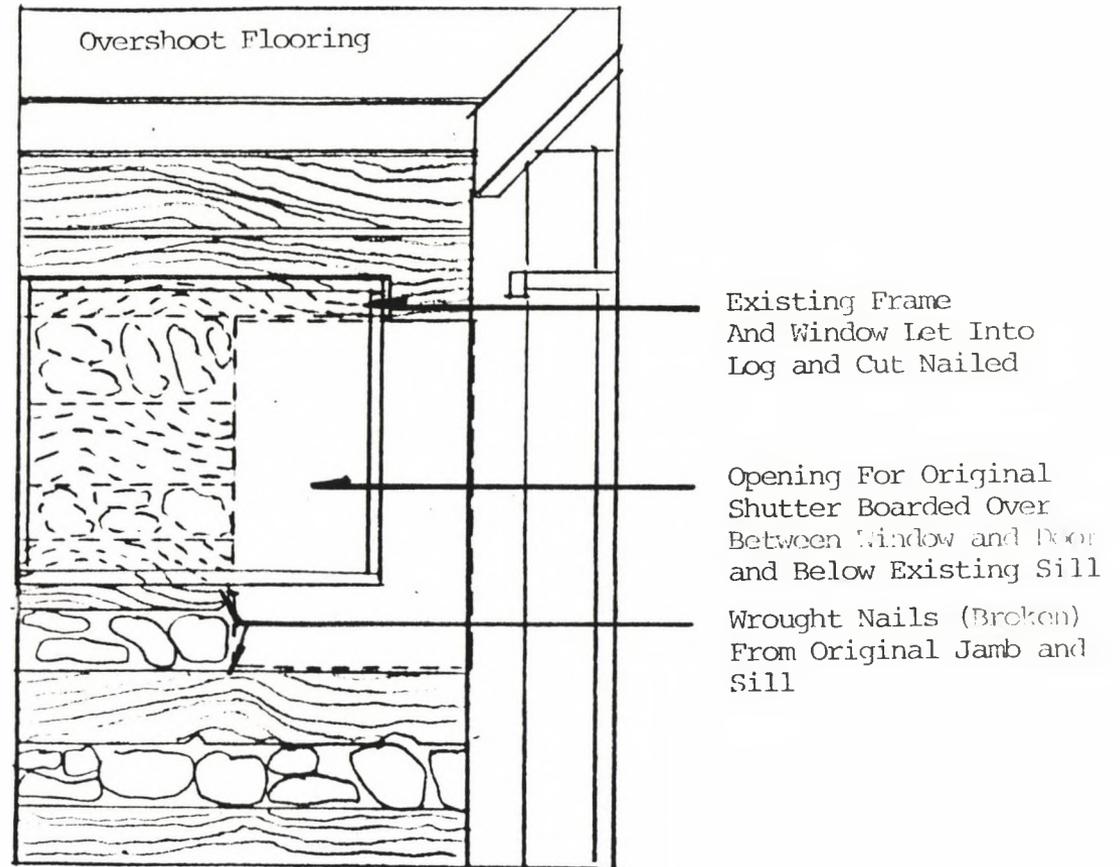
ILLUSTRATION 1

NOTE AREA REVEALED WHEN PLANKS WERE  
REMOVED BETWEEN EXISTING WINDOW AND DOOR.

DETAIL SKETCH OF PHOTOGRAPH AT LEFT.  
THE EXISTING WINDOW AND FRAME WERE  
LET INTO THE LOG SILL AND HEAD AFTER  
1900, REPLACING THE ORIGINAL SHUTTER.

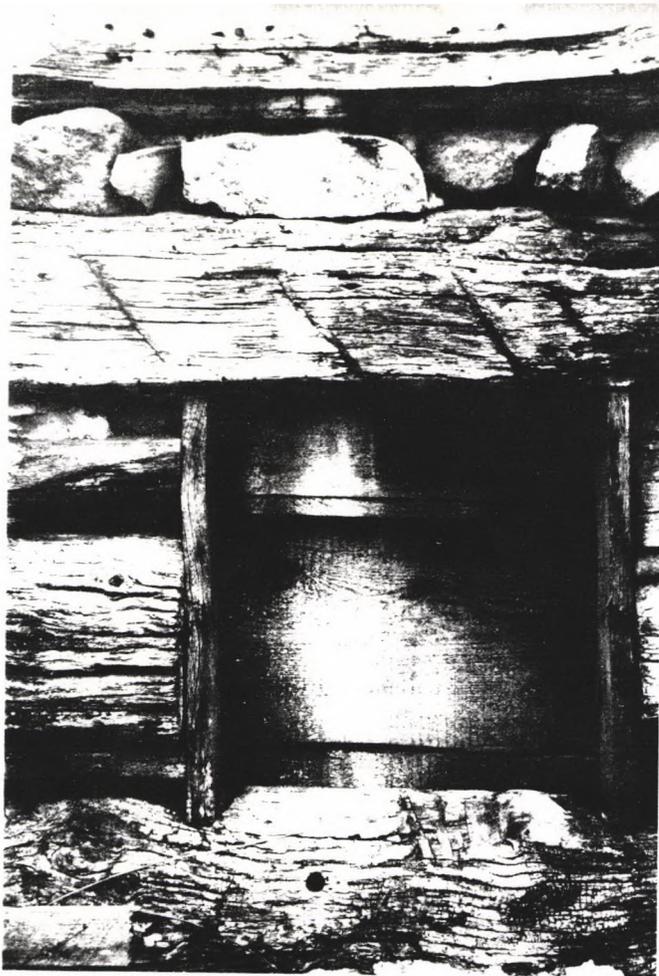
PHOTOGRAPH 22

Removal of some of the siding on the west elevation log exterior revealed another small opening (Photograph 22) covered by the installation of the existing siding and the interior wainscot after 1880. The 20" wide and 19" high opening was notched into the logs forming the head and sill indicating that the aperture was part of original construction. The sides of the opening are now faced with 1 1/8" boards. These served as nailing surfaces for earlier siding as indicated by the broken nails on the exterior edges of the boards. Large nail holes in the cut log ends indicate, however, that the existing boards are replacements of earlier heavier members. The purpose of

WEST ELEVATION OF LOG BAY EXTERIOR AFTER REMOVAL OF SIDING. NOTE THE SMALL DOOR OPENING WHICH HAD BEEN HIDDEN BY THE EXISTING SIDING.

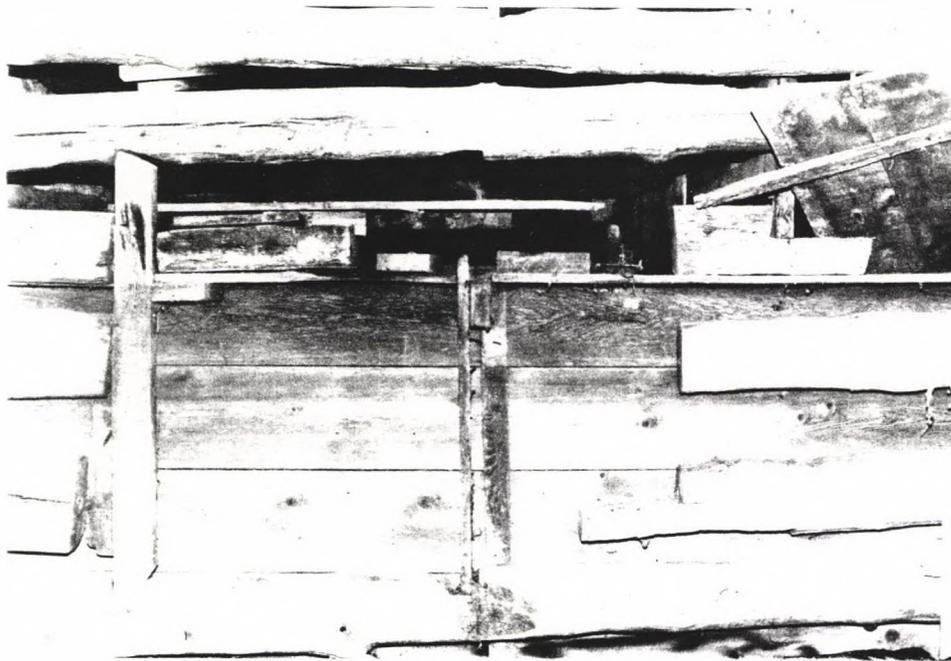
PHOTOGRAPH 23

LOG BAY SOUTH ELEVATION VIEWED FROM THE THRESHING FLOOR AFTER REMOVAL OF THE RANDOM BOARD WAINSCOT. NOTE THE ORIGINAL DOOR OPENING. THE WEST (LEFT) JAMB IS ORIGINAL: THE EAST A LATER REPLACEMENT.

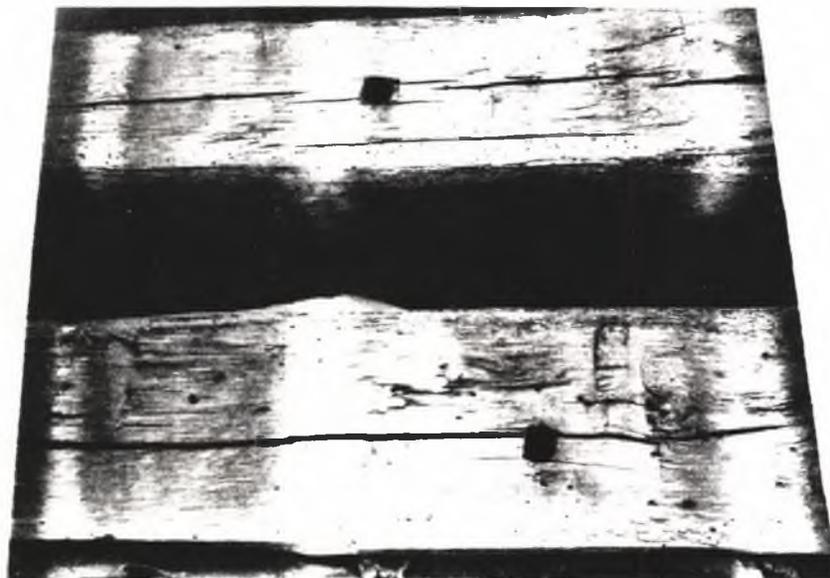
PHOTOGRAPH 24

NOTE THAT THE LOWER LOG HAS MANY BROKEN OR BENT WROUGHT AND CUT NAILS INDICATIVE OF EARLIER SIDING APPLIED DIRECTLY TO THE LOGS. THE UPPER LOG HAS NO EARLIER NAILS OR NAIL HOLES. THE PURPOSE OF THE HOLES AUGERED IN THE LOGS IS UNKNOWN, ALTHOUGH THEY MIGHT HAVE SECURED AN EARLIER LEDGER PLATE FOR A SMALL SHED ADDITION OR WERE REUSED FROM AN EARLIER STRUCTURE.

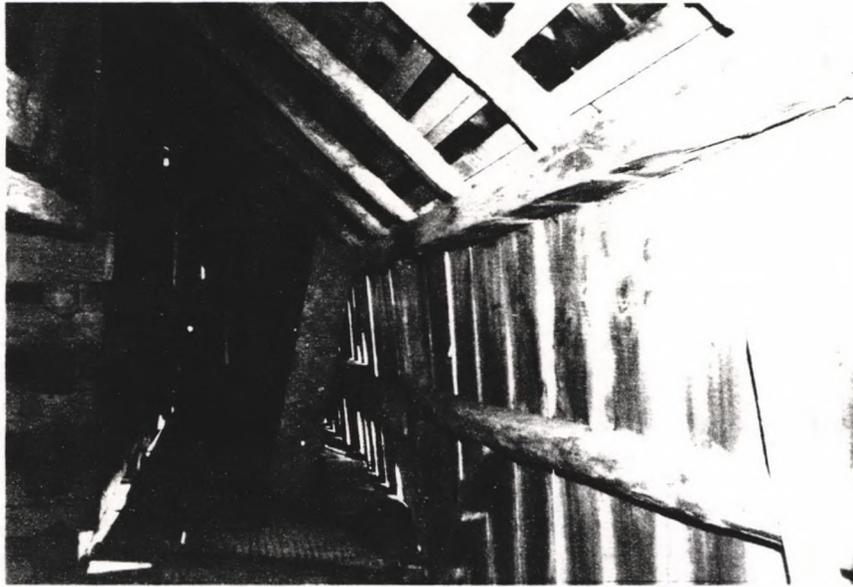
PHOTOGRAPH 26

INTERIOR OF OVERSHOOT LOOKING NORTH. THE LOWER HORIZONTAL GIRT AT RIGHT IS THE ORIGINAL EAST RAFTER PLATE SUPPORTING THE OVERSHOOT AND EAST EXTENSION RAFTERS. THE EXISTING FUNCTIONAL PLATE IS ABOVE IT.

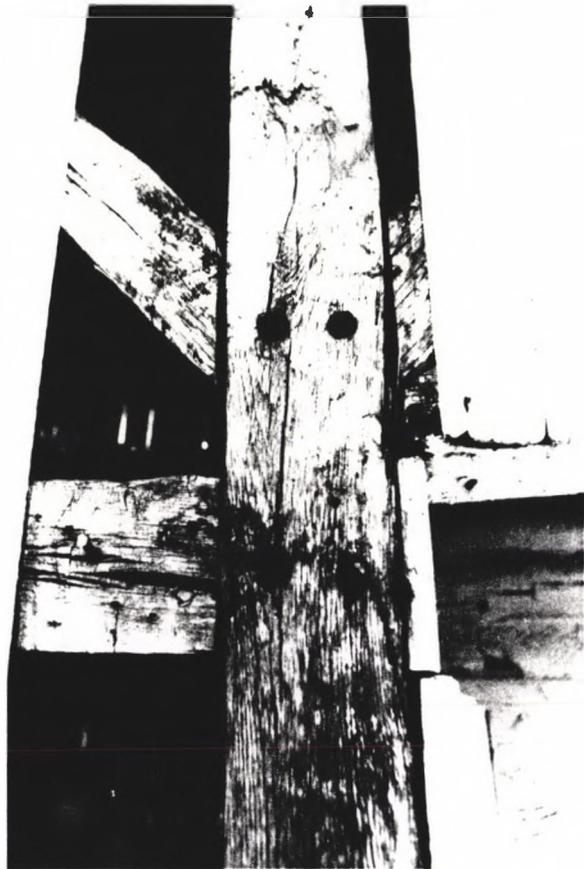
PHOTOGRAPH 27

DETAIL OF EAST EXTERIOR ELEVATION OF THE SOUTH SUPPORT POST OF THE OVERSHOOT AT THE LEVEL OF THE LOWER GIRTS. SIDING HAS BEEN REMOVED FOR INVESTIGATION.

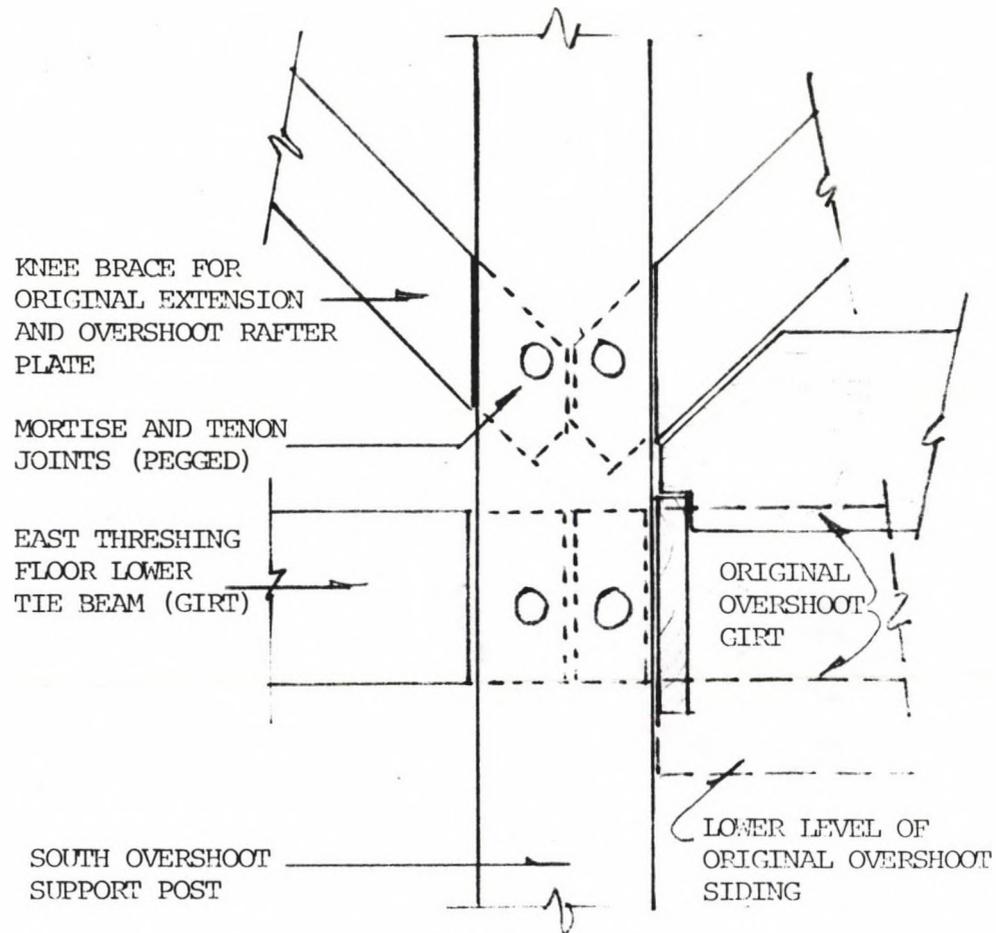
ILLUSTRATION 4

DETAIL SKETCH OF PHOTOGRAPH AT LEFT SHOWING THE MORTISES AND TENONS OF THE ORIGINAL FRAMING. THE EXISTING OVERSHOOT GIRT (SHADED) IS SUPPORTED BY A 4"x6" LEDGER (SHADED) NAILED OVER THE ORIGINAL GIRT TENON.

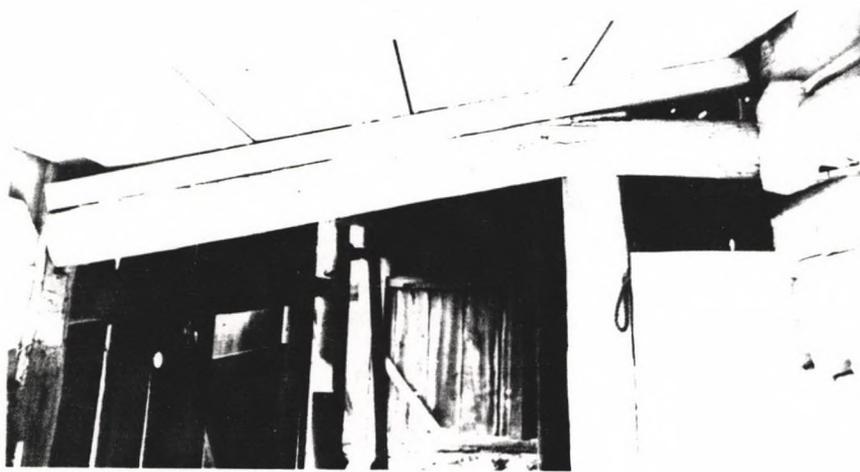
PHOTOGRAPH 29

The overshoot is now in extremely poor condition. The southern end has dropped nearly 5" lower than its original height, and the north end has fallen to the extent that the stall door cannot be opened because of contact with the overshoot floor boards. The failure has been hastened by the rot at the base of both posts and the sill plate on the east side of the threshing floor.

EAST ELEVATION OF LEISTER BARN, SOUTH EXTERIOR ELEVATION OF  
OVERSHOOT SHOWING CONDITION OF ORIGINAL TIE BEAM TO LOG BAY.

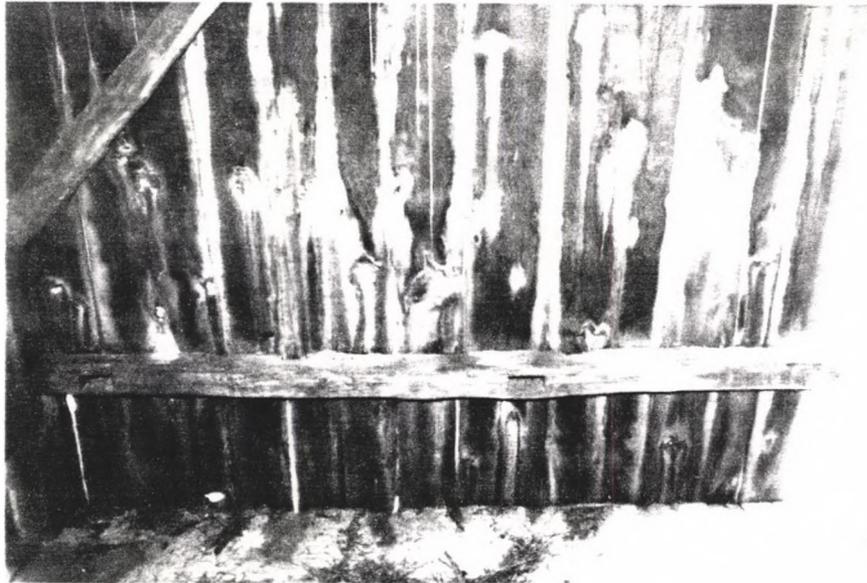
PHOTOGRAPH 35

WEST ELEVATION, SOUTH BAY INTERIOR ABOVE HAY LOFT. THE SOUTH BAY WEST CORNER POST IS SEEN AT PHOTO LEFT. THE HORIZONTAL GIRT HAS FOUR UNUSED BIRD'S MOUTH MORTISES ON ONE FACE AND THREE BLIND MORTISES ON THE OPPOSITE.

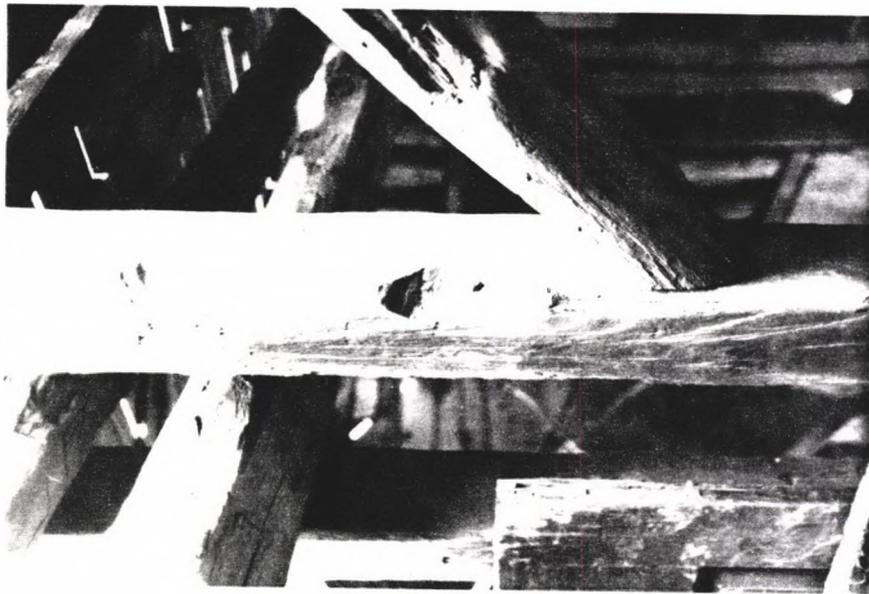
PHOTOGRAPH 36

THRASHING FLOOR BENT UPPER TIE BEAM, WEST SIDE ADJACENT TO WEST POST. THE NOTCH INCLUDES A BROKEN WROUGHT SPIKE; IT ORIGINALLY HOUSED ONE OF THE SOUTH SHED RAFTERS.

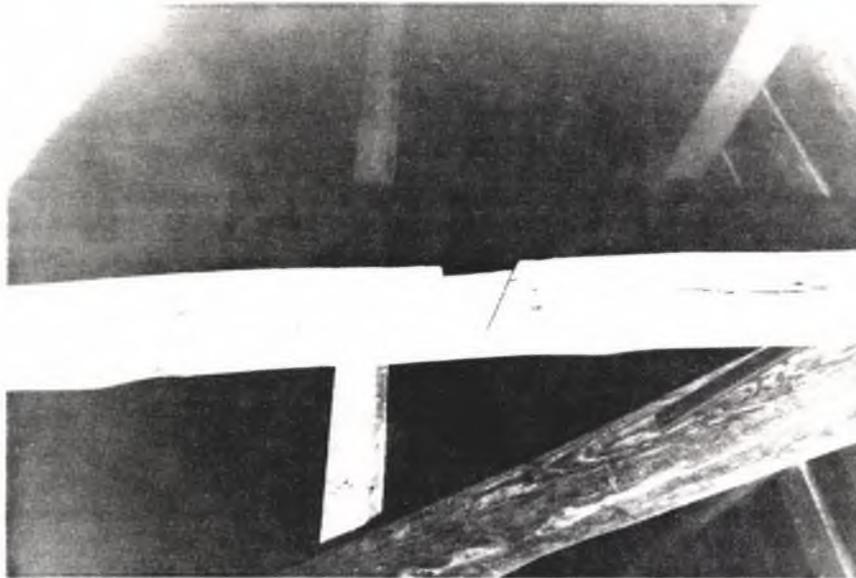
PHOTOGRAPH 37

DETAIL OF UPPER BRACE FOR WEST NON-ORIGINAL RAFTER PLATE SUPPORT POST MOUNTED ON THRESHING FLOOR BENT. POST IS TOENAILLED TO ORIGINAL RAFTER PLATE AND THRESHING FLOOR BENT UPPER TIE BEAM.

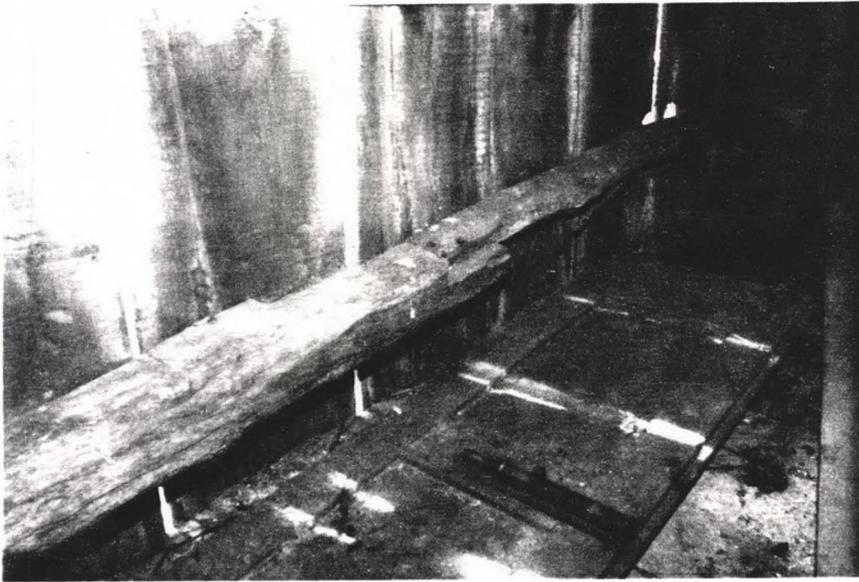
PHOTOGRAPH 38 (ABOVE)

EAST ELEVATION OF SOUTH BAY ABOVE HAY LOFT FLOOR. NOTE THAT THE EXISTING HORIZONTAL GIRT IS HALF-LAPPED; THAT TO THE LEFT (NORTH) IS PART OF THE ORIGINAL SOUTH SHED FRAME.

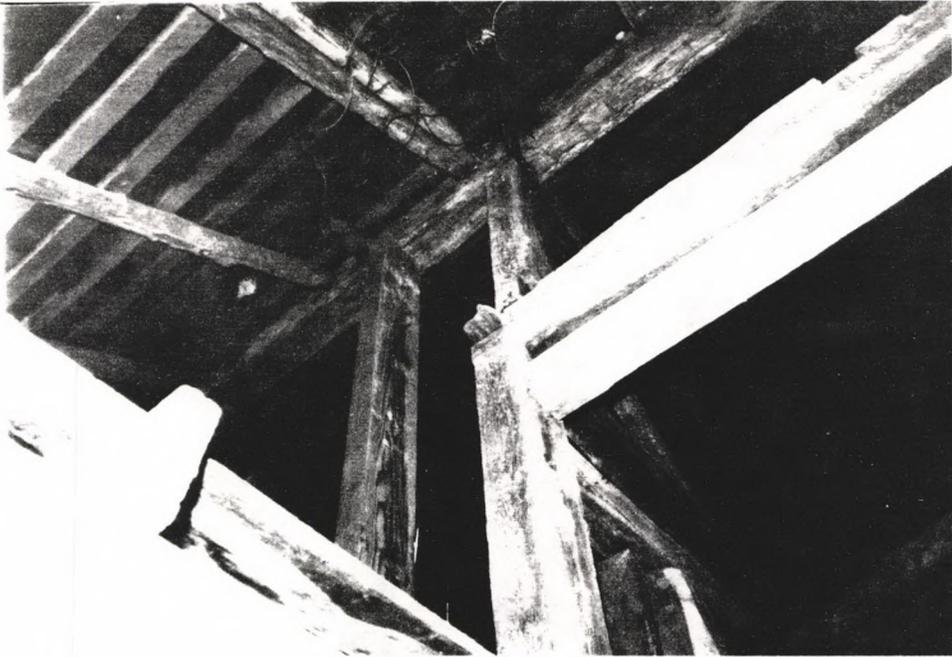
PHOTOGRAPH 40

LOWER SURFACE OF ORIGINAL PRIMARY (EASTERN) RAFTER PLATE AND THRESHING FLOOR BENT CORNER POST SHOWING DETAIL OF ORIGINAL HIP RAFTER SEAT.

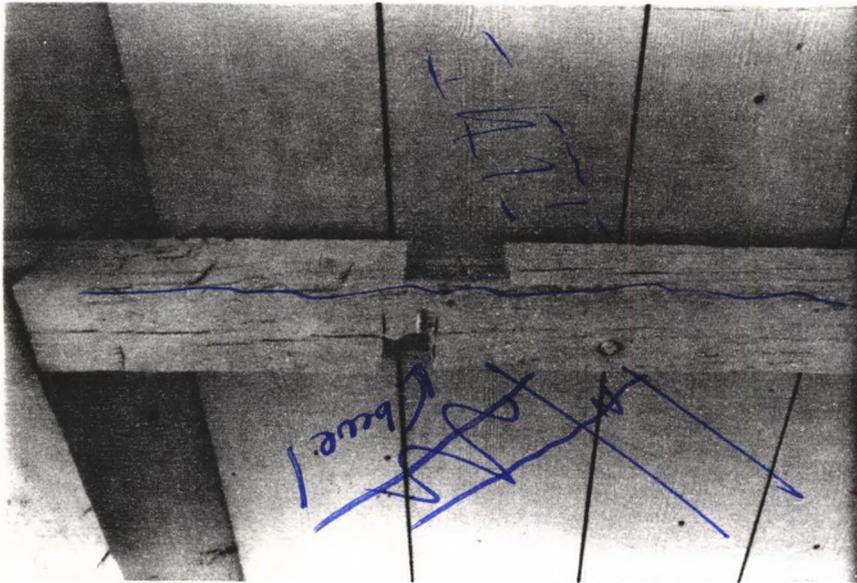
PHOTOGRAPH 45

BOTTOM AND SOUTH ELEVATION OF CENTRAL OVERSHOOT FLOOR JOIST. BEVEL LAP MORTISE AND RABBET ARE VISIBLE AS IS PEG HOLDING CUT TENON IN MORTISE.
