HISTORIC STRUCTURES REPORT - PART I

Gettysburg National Military Park  
Gettysburg, Pennsylvania

J. Snyder Farm Buildings

Historic Farm Building Report  
J. Slyder Farm

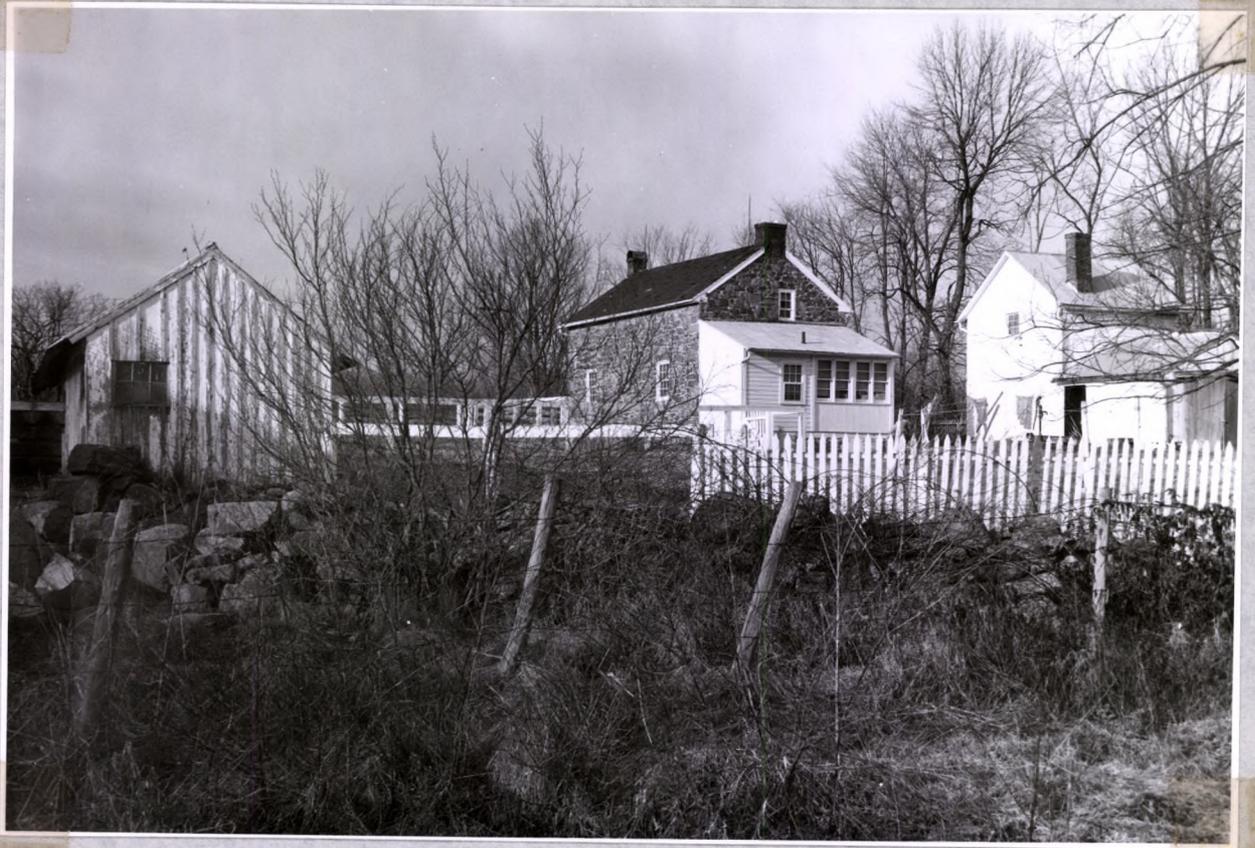
The hog pen, summer kitchen and other structures are in good condition.

View of the Slyder farm building group, excepting the barn. The house is in the center, the washhouse at the right and the hog-house at the left. The barn is located to the left of this view. The view is northwestward.

All other structures are recommended for reroofing with hand-split wood shakes. Minor repairs to siding, window sash, trim, etc., will be accomplished by day labor.

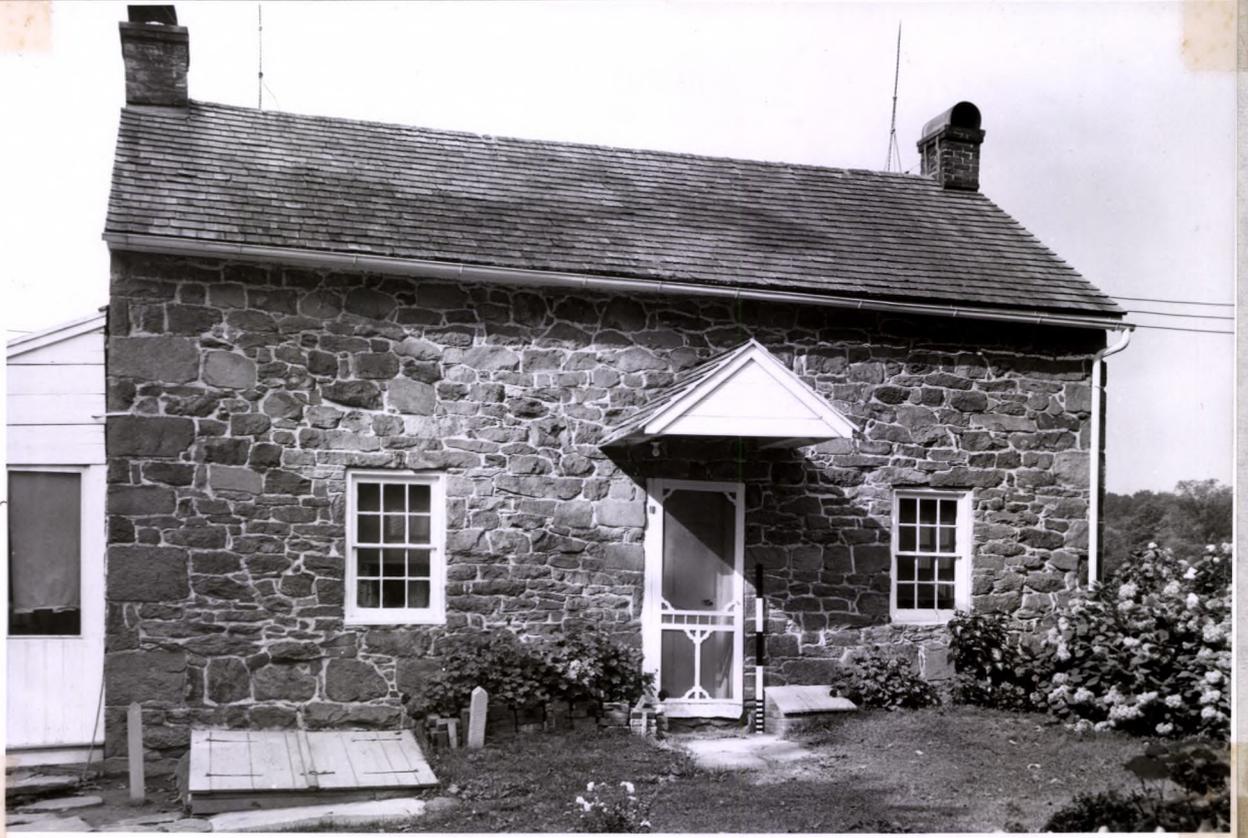
Generally all structures are in a good state of repair except for the barn. The house was modernized on the interior during the 1958 fiscal year by installation of a bathroom, oil-fired forced hot water heating system, first floor framing reinforced and east porch enclosed.

View of the Snyder house from the north. The post-war frame addition is at the left.

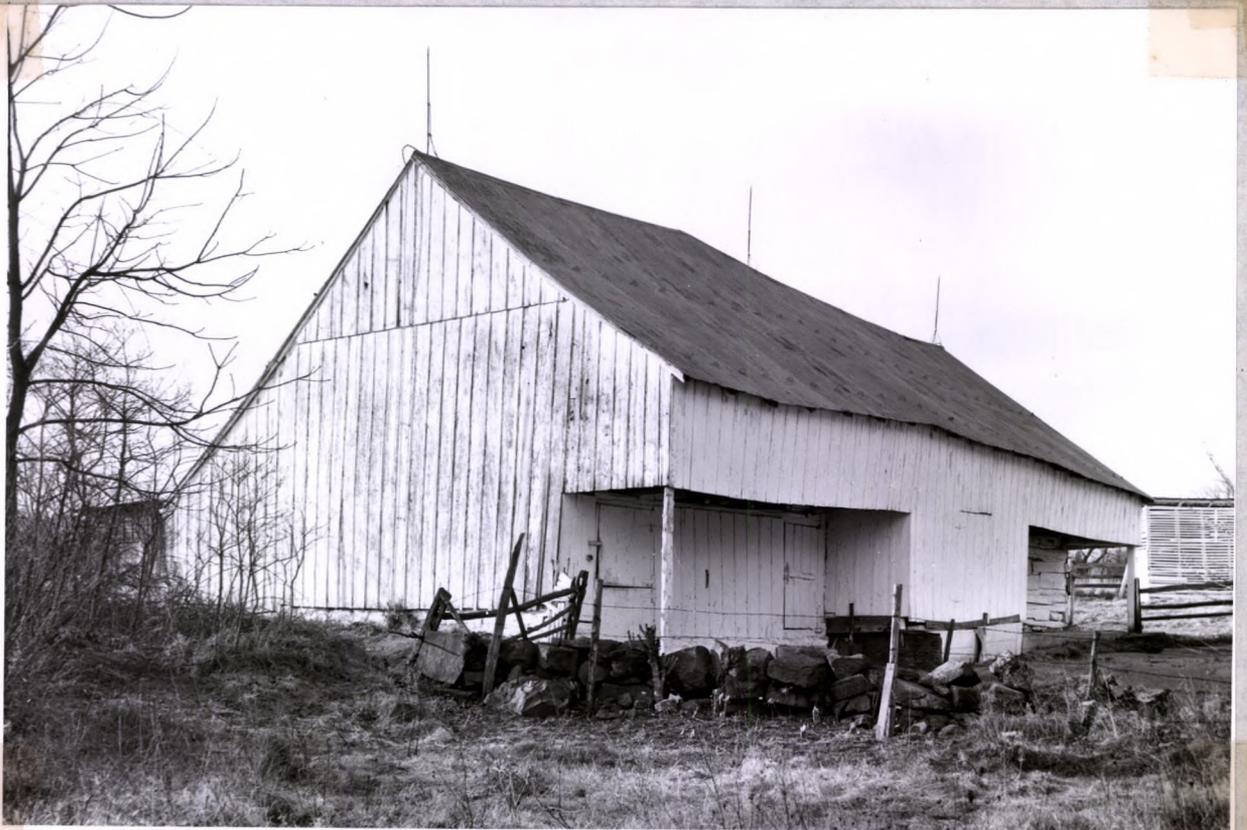
The barn pale rafter roof framing has sagged causing a wavy roof line. This has caused leakage through the present metal roof. Walls of the barn appear to be in good condition.

The Snyder barn as it appears from the northeast. The frame-work is pre-war, the siding entirely post-war. The roof is of galvanized tin.

It is recommended that metal tie rods be installed at plate line of barn walls to preclude further settlement of roof framing. Since a wavy roof line is part of the aging process of the structure, we do not propose a reconstruction to original lines except where necessary to maintain a tight roof.
