## **Tennessee Valley Stables (Cunha/Rapozo Ranch, Ranch A/B)**

### **Cultural Resource Reports and Site Treatment: Cultural Landscape Report Historic Structure Reports Archeological Assessment and Treatment Report**

June 10, 2013  
United States National Park Service,  
Golden Gate National Recreation Area  
Division of Cultural Resources

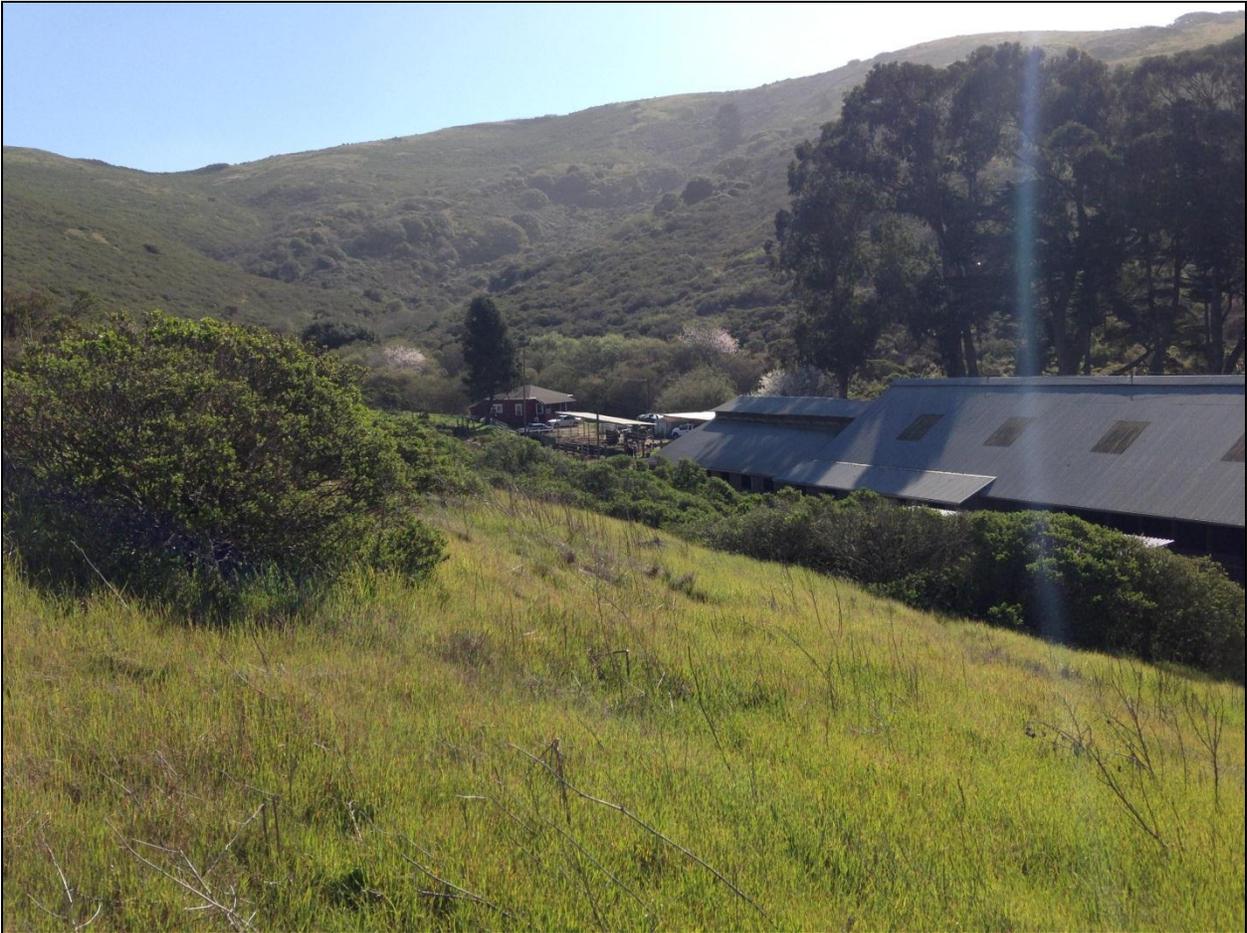
The cessation of grazing has allowed coastal scrub plant communities to outcompete grasslands.

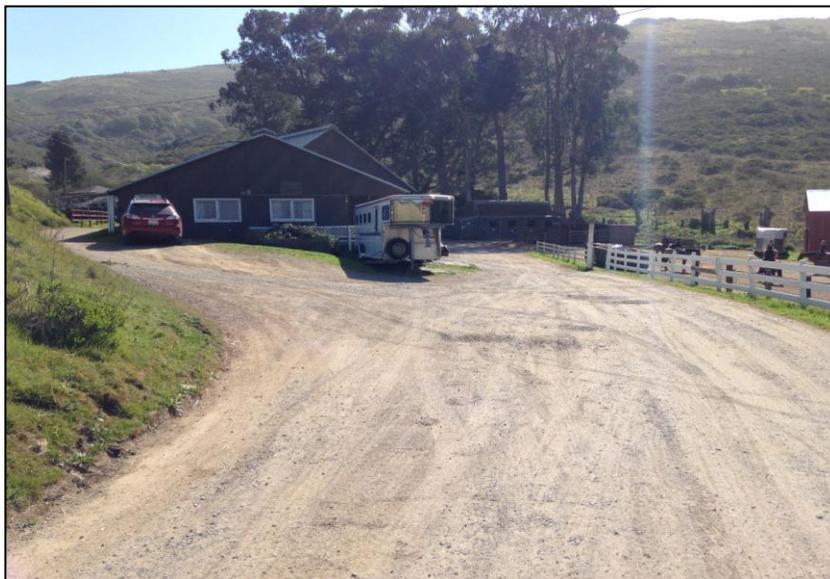
Recommendations to improve the entry sequence include relocating the horse trailer and painting the fence dark brown so it will recede into the landscape.

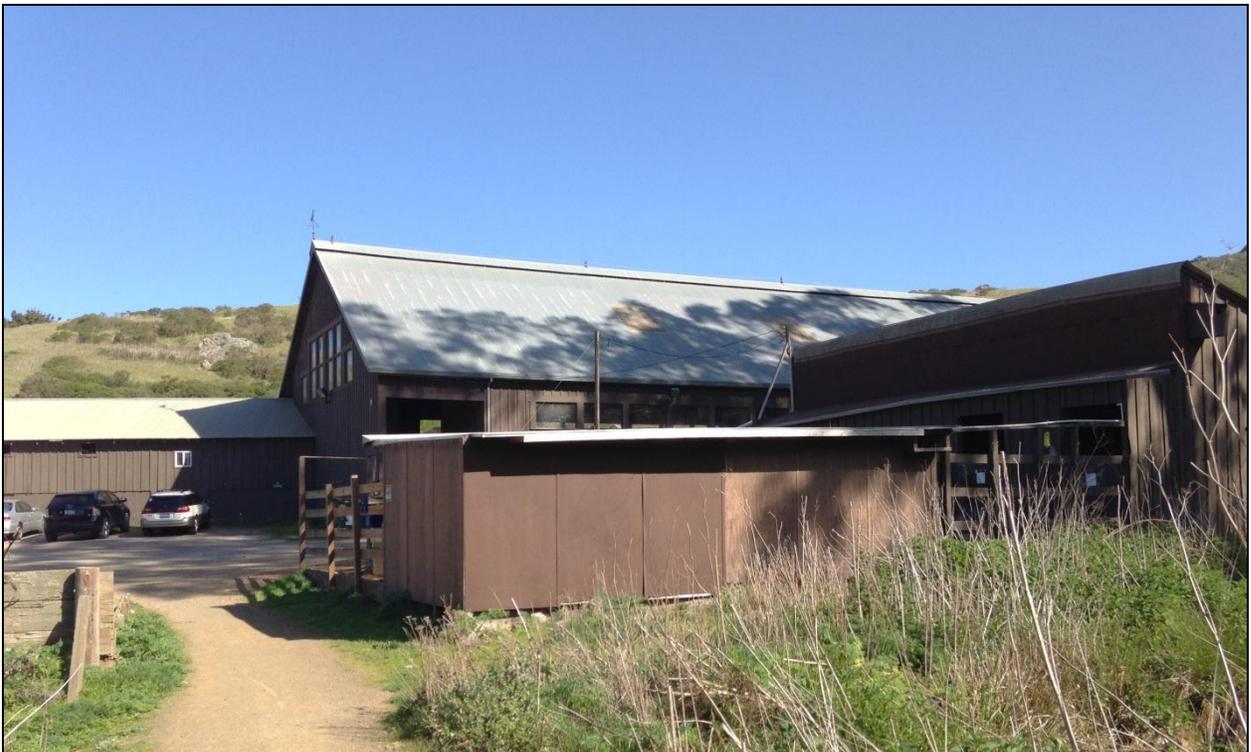
Non-historic addition on the north side of the calf barn is recommended for removal.

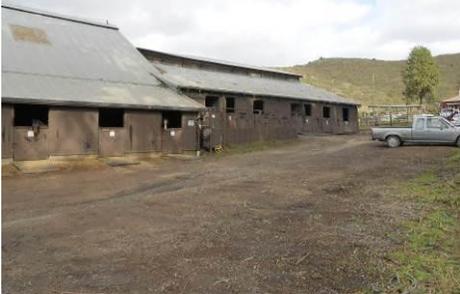
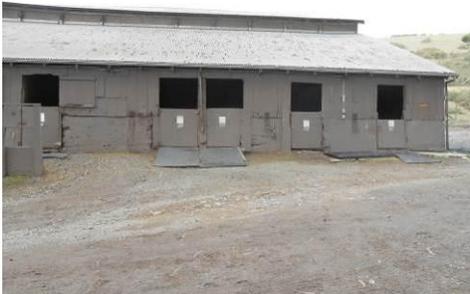
<p>Looking northeast at south wall of Milking Barn (Hay Barn) stables (NPS Photo, 2012)</p>	<p>East end of south wall of Milking Barn (Hay Barn) roof with missing louvers (NPS Photo, 2012)</p>

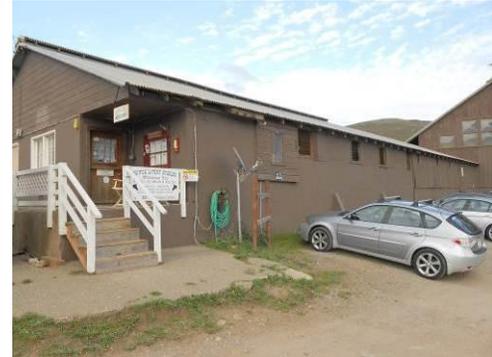
<p>Milk house loading dock with modern Office entry clutter (NPS Photo, 2012)</p>	<p>Looking east at milk house of Main Barn Complex (NPS Photo, 2012)</p>

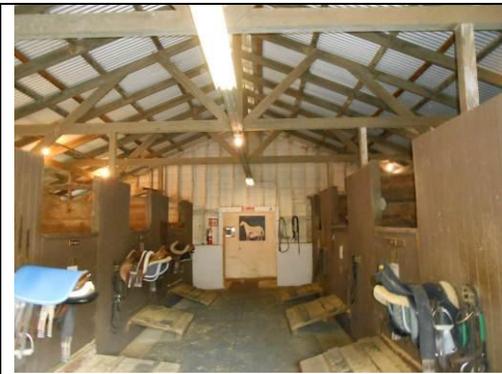
**Milk House Sanitary Barn (Stables) looking southeast to hall. Note open frame gabled partition wall (NPS Photo, 2012)**

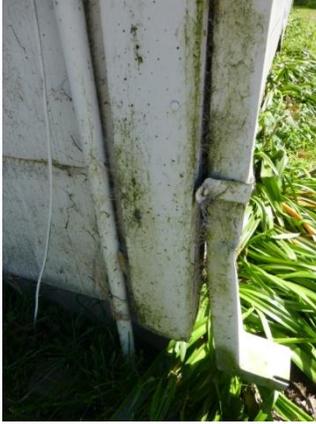
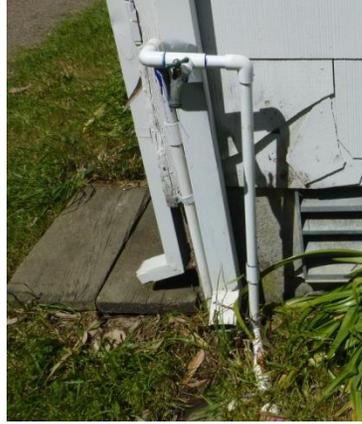
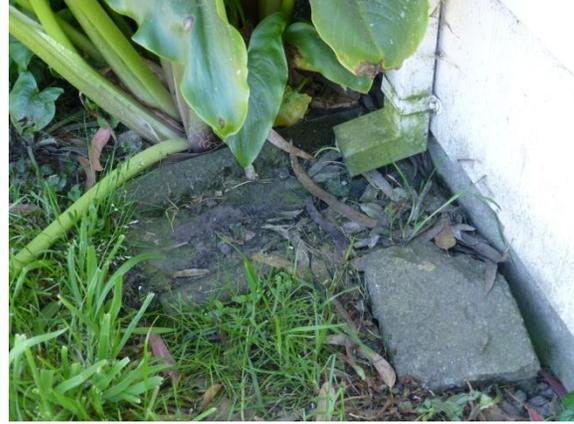
Leader conditions

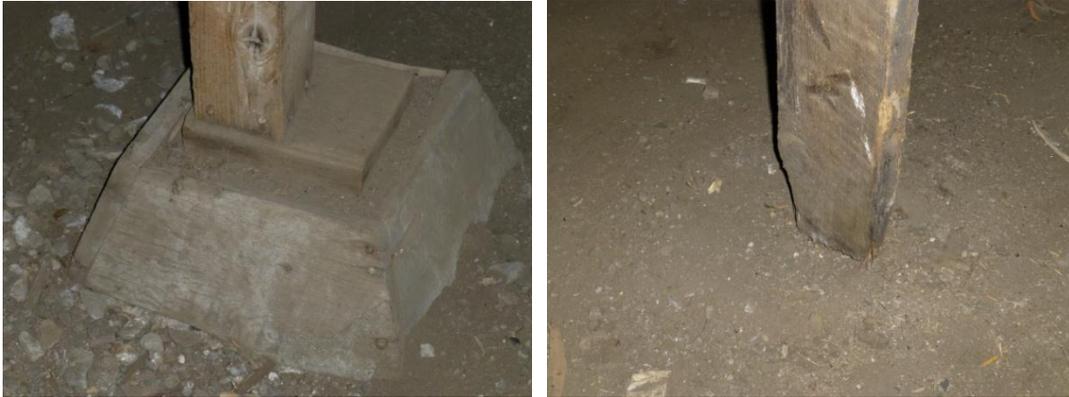
Eccentrically loaded pier footing at centerline of building and column in connection with dirt. (NPS Photos 2013)

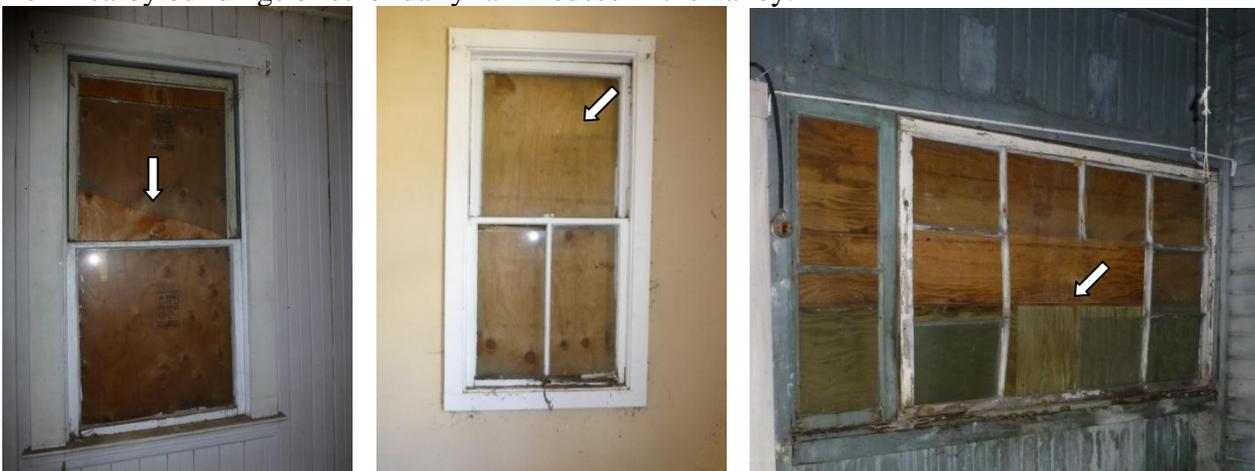
Various conditions of windows – shifted glazing, rotted stile, missing mullions (NPS Photos 2013)

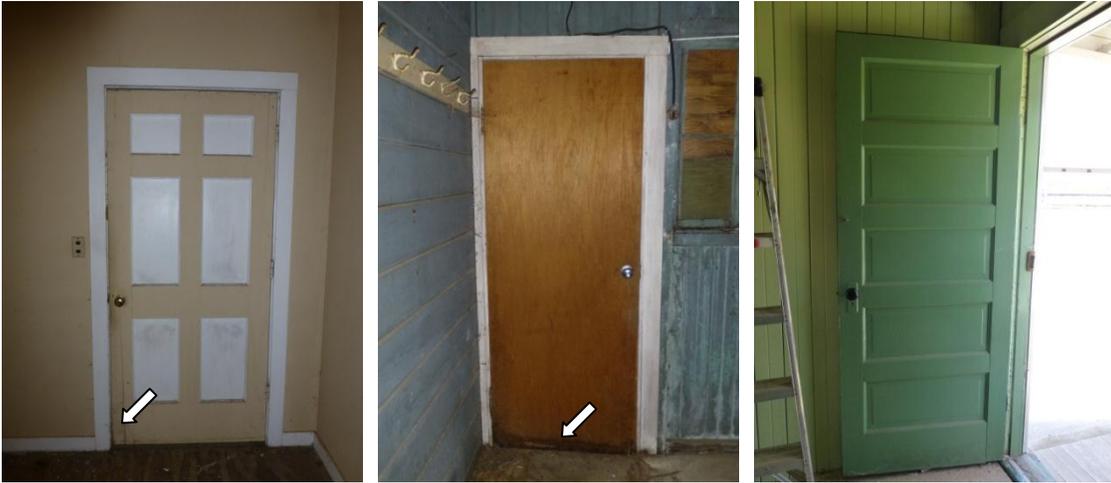
Various conditions of exterior doors- crack at north door, rot at south door, east door in good condition (NPS Photos 2013)

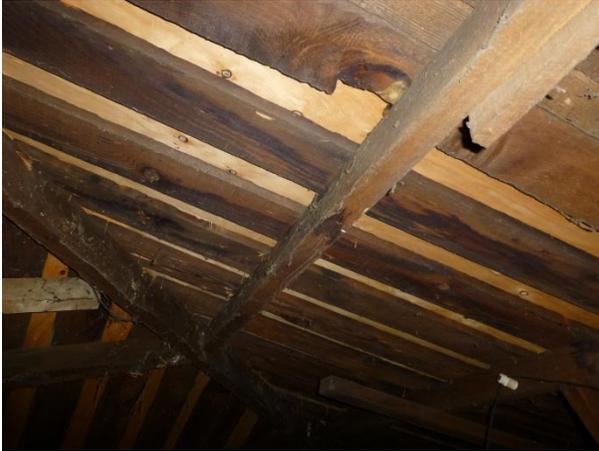
Attic framing conditions

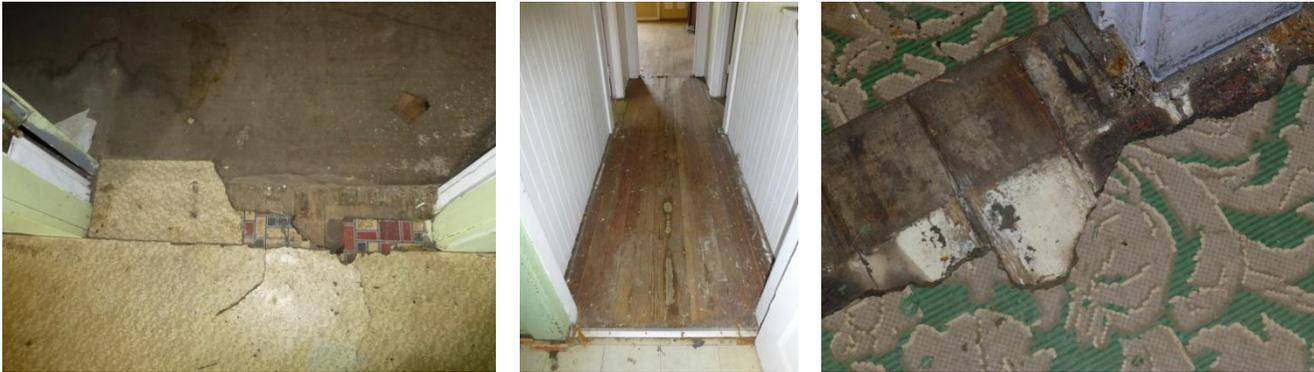
Two layers of laminate (Room 205), wood floor condition (room 211), painted wood floor under laminate (Room 213) (NPS Photos 2013)
