# Fort Barry Balloon Hangar and Motor Vehicle Sheds

## *Abbreviated Historic Structures Report*

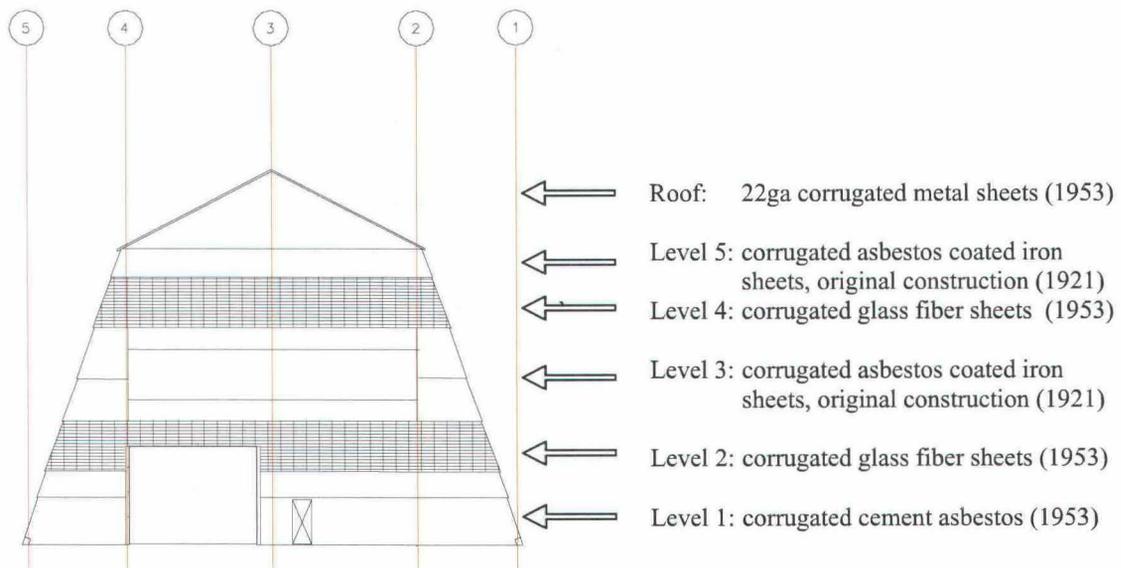
The corrugation radius of the asbestos/iron sheets at the upper levels is similar with that of the glass fiber sheets, but different than the base cement asbestos panels.

A thorough cleaning of the siding throughout is needed, as it appeared covered in rust and moss. (See NPS Hazardous Material Consultants for cleaning of asbestos containing materials).

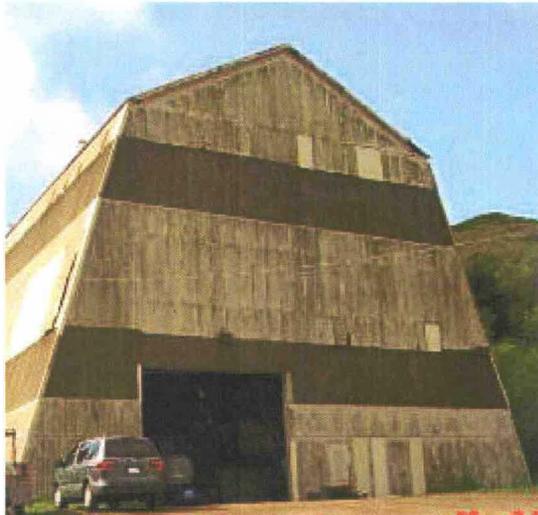
### North Elevation

As illustrated by the photos above, the “window rows” (corrugated glass fiber sheets) at level 2 and 4 appear to be in good condition, with less than 1 percent distress.

There has been relatively recent repairs at level 5 and 3, where painted corrugated sheet metal replaced some corrugated asbestos coated iron sheets. The material is similar in appearance, but the detailing and workmanship was less than adequate. Repairs at level 1 with corrugated sheet metal were also inappropriately constructed

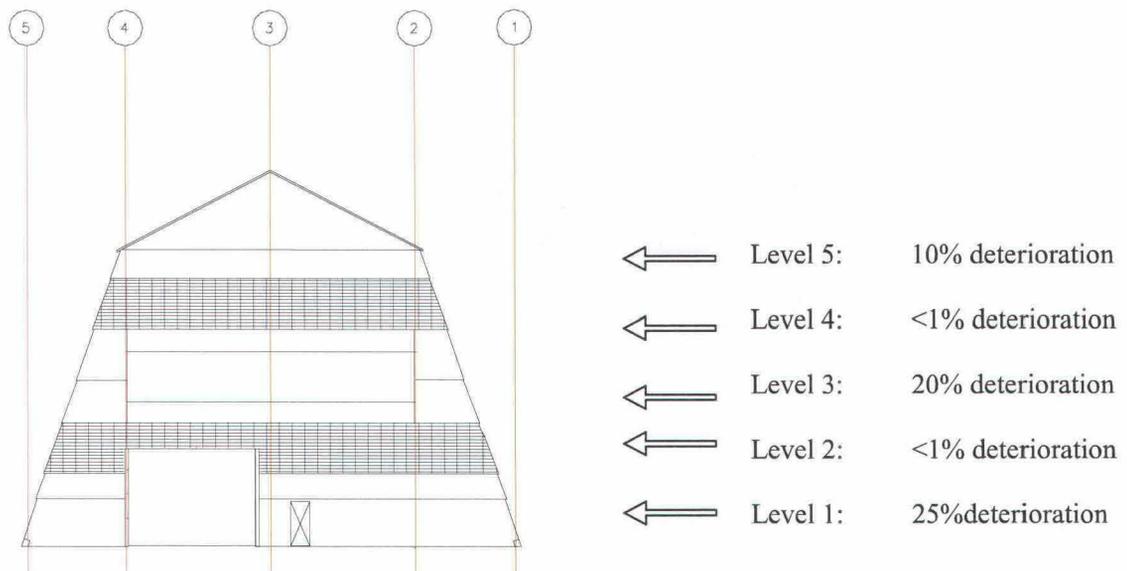
The two 10'x12' warehouse-type hanging doors installed in 1943 are now missing. There is substantial deterioration at the opening frame.

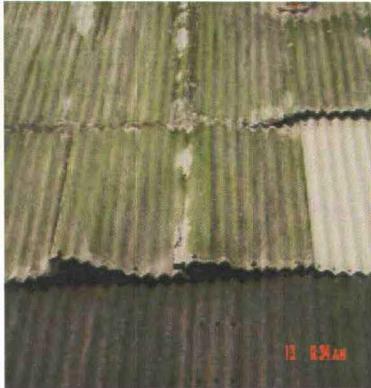
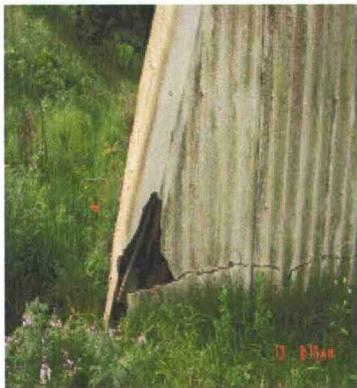
A few sheets at Level 3 became detached from structural brackets and buckled. The most extensive damage occurs at the bottom corners.

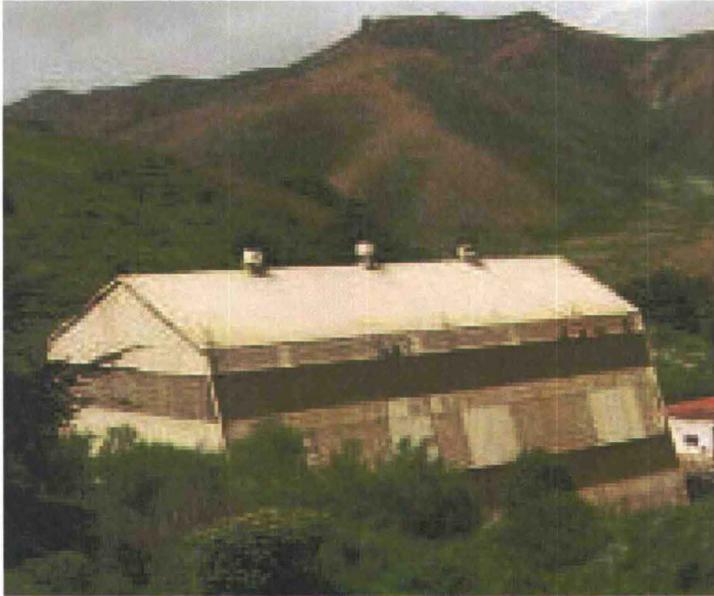
### East Elevation

As illustrated by the photos above, the “window rows” (corrugated glass fiber sheets) at level 2 and 4 appear to be in good condition, with less than 2 percent distress. Most of the distress occurs at the bolthole attachment to structure.

There has been relatively recent repairs at level 5 and 3, where painted corrugated sheet metal replaced some corrugated asbestos coated iron sheets. The material is similar in appearance, but the detailing and workmanship was less than adequate.

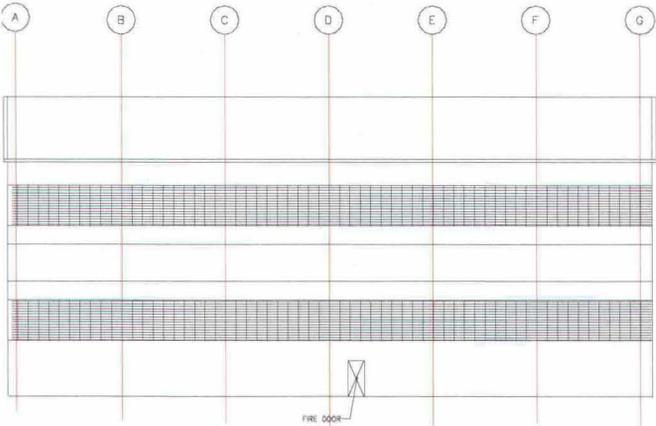
←	Level 5:	40% deterioration
←	Level 4:	<2 % deterioration
←	Level 3:	70 % deterioration
←	Level 2:	<2 % deterioration
←	Level 1:	15% deterioration

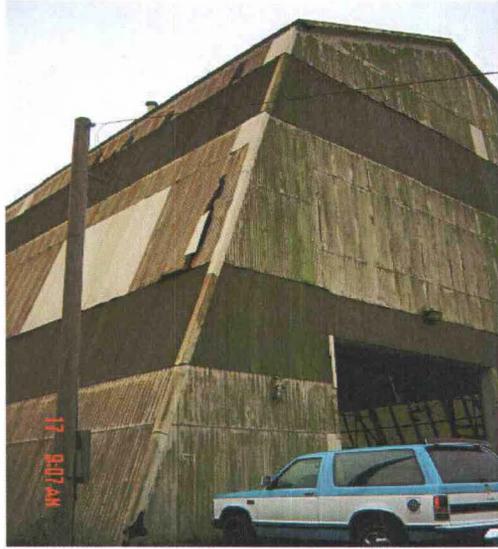
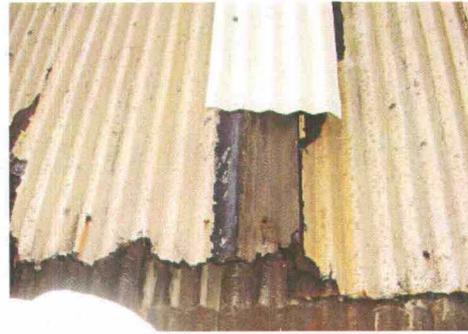
There is substantial deterioration of the asbestos siding mainly at the levels 5: the asbestos layer seems to have been delaminated and rust iron is apparent.

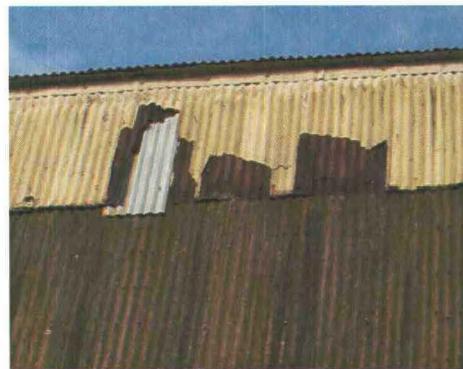
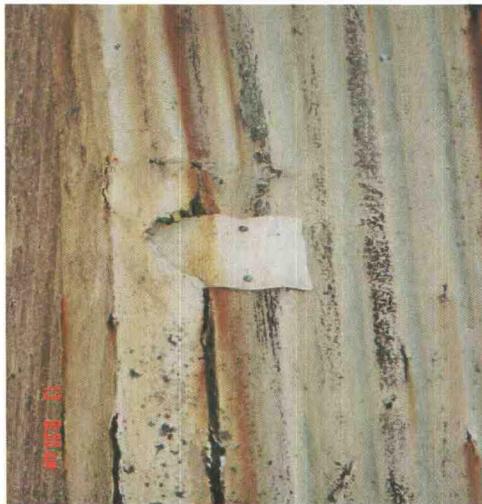
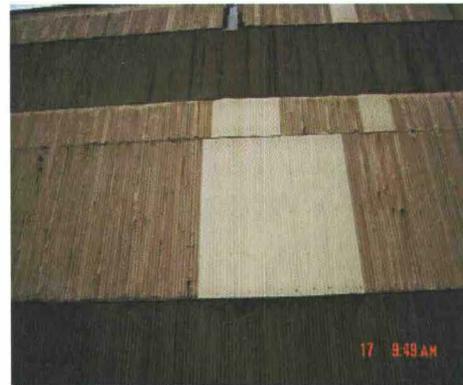
A few sheets at Level 3 became detached from structural brackets and buckled. The most extensive damage occurs at the bottom corners.

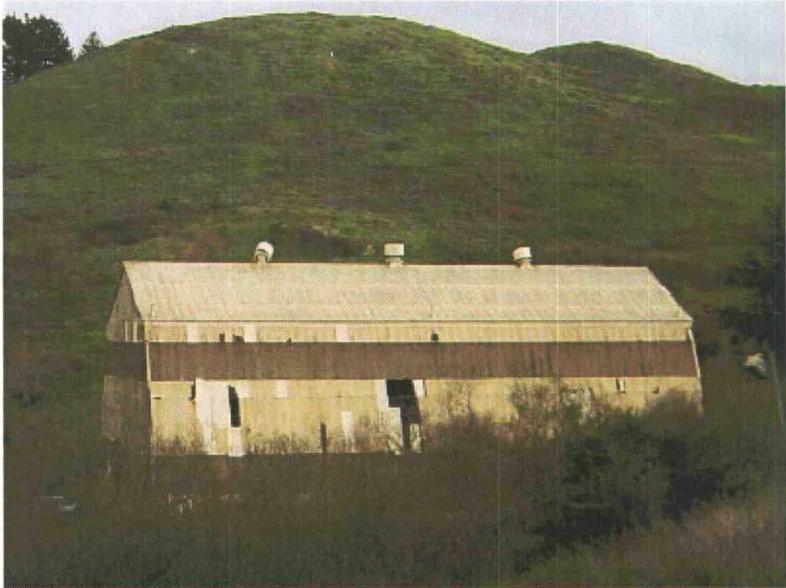
# West Elevation

As illustrated by the photos above, the West Elevation presents the most damage. Even though there has been relatively recent extensive repairs at level 5 and 3, where painted corrugated sheet metal replaced some corrugated asbestos coated iron sheets, the inadequate detailing and installation made them temporary only; currently the replacement sheets have been ripped off and this side of the building is open to the environment in numerous places.

The “window rows” (corrugated glass fiber sheets) at level 2 and 4 appear to be in good condition, with less than 2 percent distress. Most of the distress occurs at the bolthole attachment to structure.

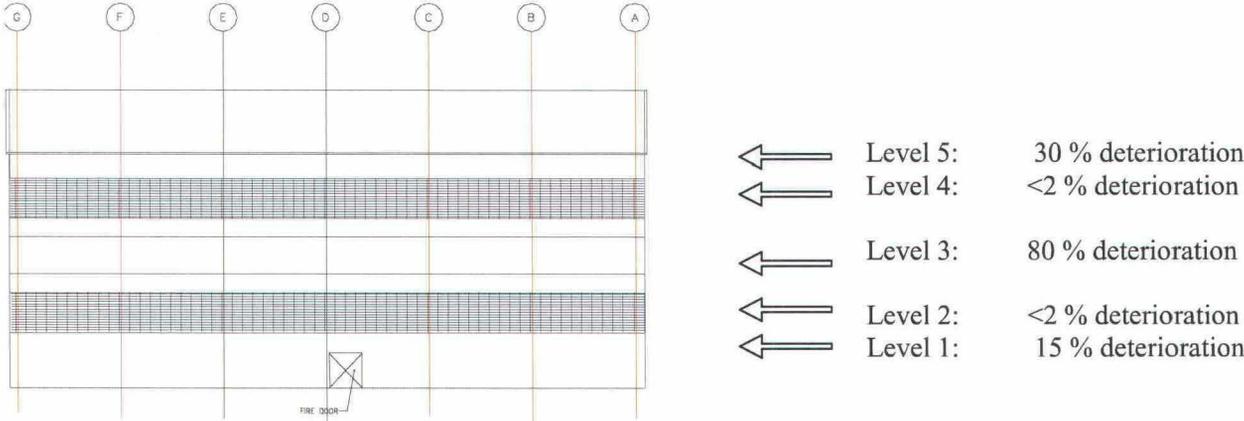
Presently, some remaining replacement panels are unstable and only partially attached to structure, thus constituting a hazardous condition, as they may fall down at any moment.

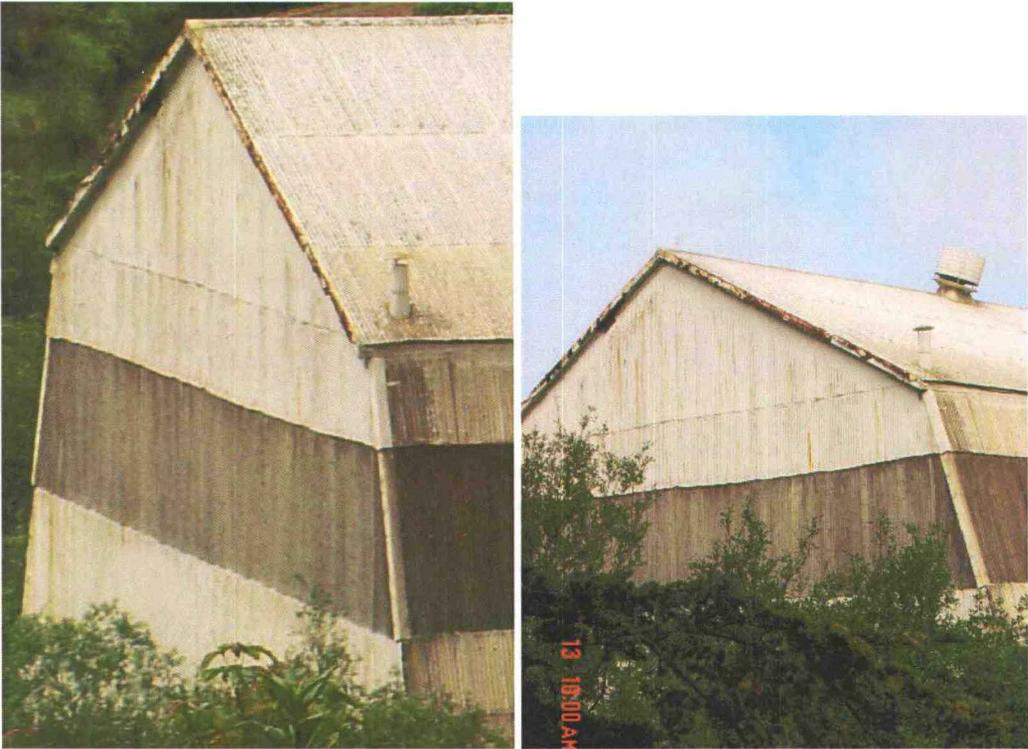
**South Elevation**

As illustrated by the photos above and insofar as the outgrown vegetation permitted full visual observation, the South Elevation presents the least damage.

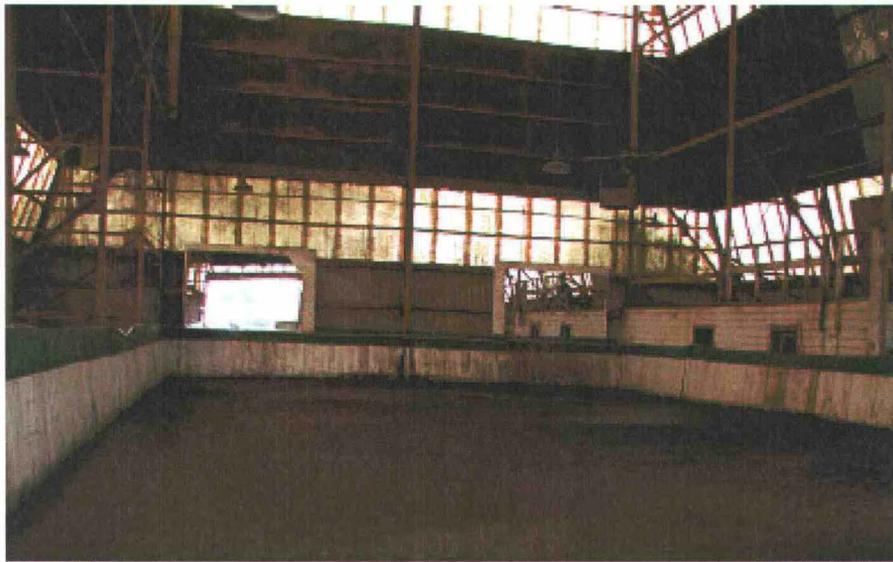
Visual observation from inside out was instrumental in assessing the limited degree of deterioration on this elevation:

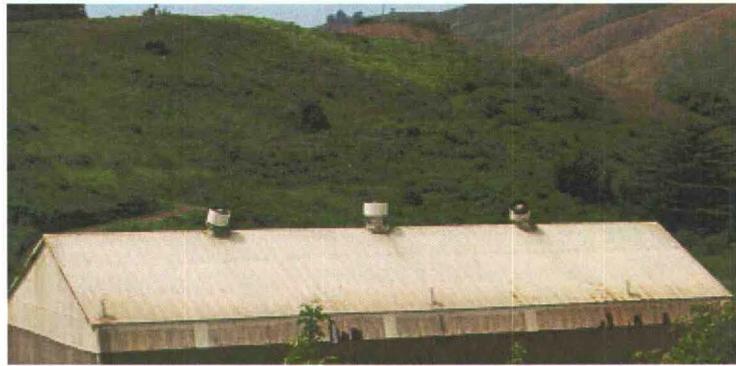
As illustrated by the photo above and insofar as visual observation was possible from the distance, the roof does not present substantial deterioration, despite being over 50 years old. A thorough cleaning of the roof is needed, as moss is present, especially toward the eaves. In addition, rust is present at seams.

The fascias on both South and North Elevation are severely rusted and should be replaced. There are no fascias or gutters on the East and West Elevations, and those should be installed to prevent water penetration. (Historic Photos shows gutters and 3 downspouts on each side).

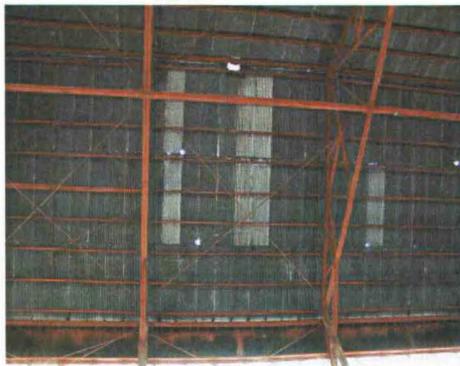
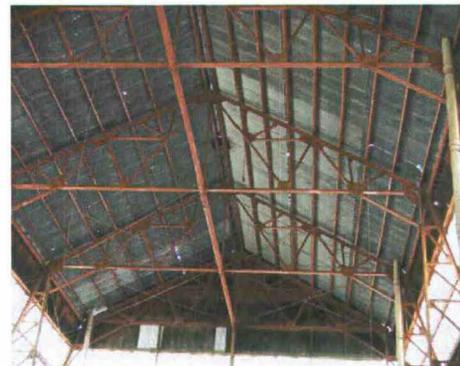
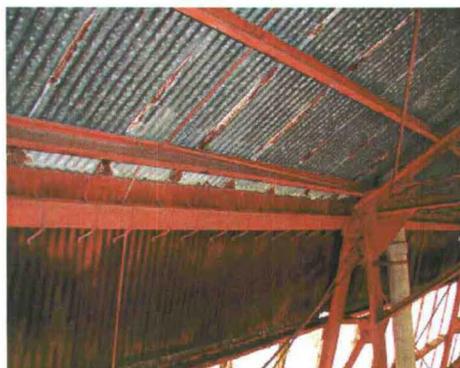
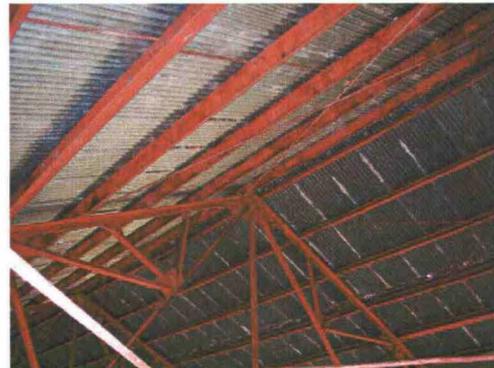
Visual observation from inside out was instrumental in assessing the roof's extent of deterioration: when looked at from inside, various size openings are visible, occurring mostly at seams, allowing water inside the structure. A larger amount of rust is present on the underside, primarily at seams. Past roof repairs are also noticeable.
