**Fiscal Year 2003
Archaeological Site Monitoring and Management
Activities Along the Colorado River in Grand Canyon
National Park.**

2003

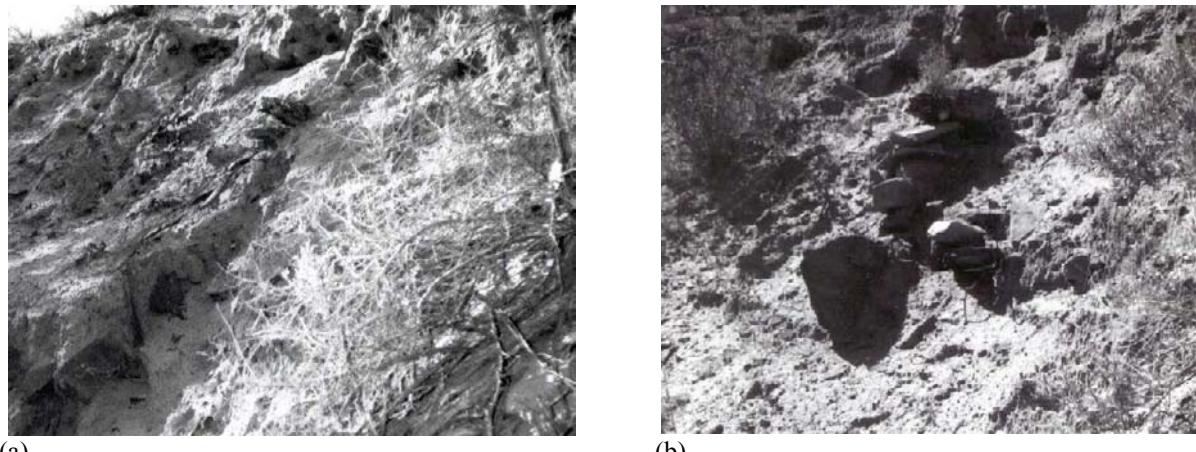
FY03 monitoring staff observed that more sections of the wall are being exposed. In addition to the east-west wall originally recorded, now a wall running north south has been exposed. Approximately two to three courses are exposed on the new portion of the wall as shown in Figure 5. The erosion is caused by slump from the downstream slope of the drainage and undercutting from below in the absence of flood deposits in the mouth of this drainage. The drainage is widening. Excavation continues to be recommended. Annual monitoring will continue.

Figure 5. Site C:13:347, partial wall exposure in 12/1990, (b) the same wall in 3/2003.

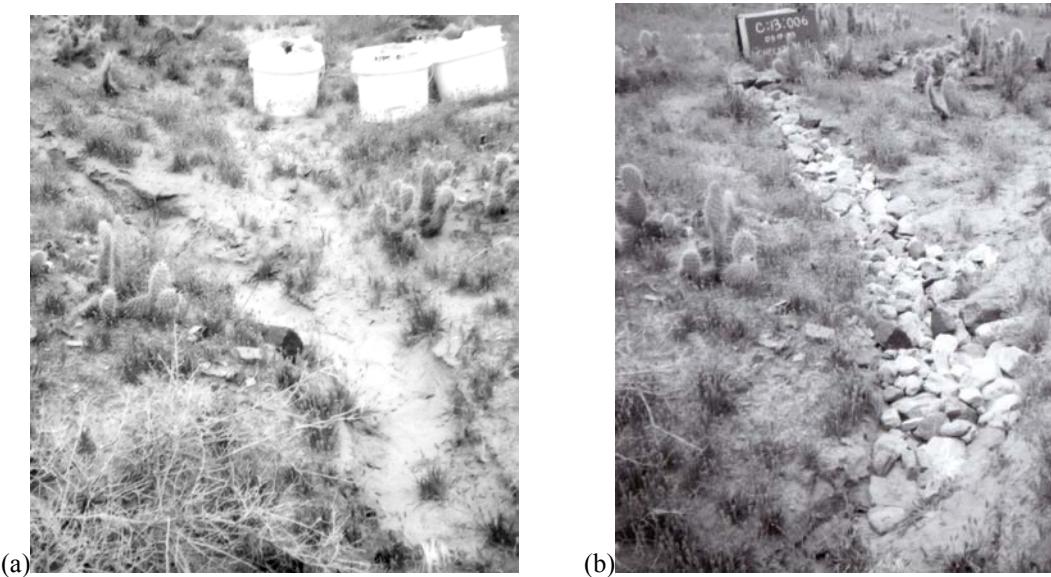
Zuni/RCMP crewmembers constructed 14 checkdams in 1996 in two separate drainages. Minor maintenance was necessary in FY97, FY99, FY00, and FY03. Fine sediments and a large, steep catchment area contribute to the downcutting of the drainages.

Figure 6. Site C:13:006, Checkdam 15: newly developed drainage prior to rock lining (Photo a). Photo b illustrates the drainage after treatment.

GCMRC sponsored a checkdam research project supervised by Joel Pederson (University of Utah). This site was selected and research began in FY00 and the results were drafted in FY03 (Pederson 2001). Nickpoints and plunge pools at Checkdams 3, 4, 7, 8 and 11 required maintenance. Four new checkdams were also constructed. A new drainage has developed this year that merges with the main drainage creating a third arm of this drainage. Figure 6 shows before and after photographs of how this drainage was treated with a rock lining.

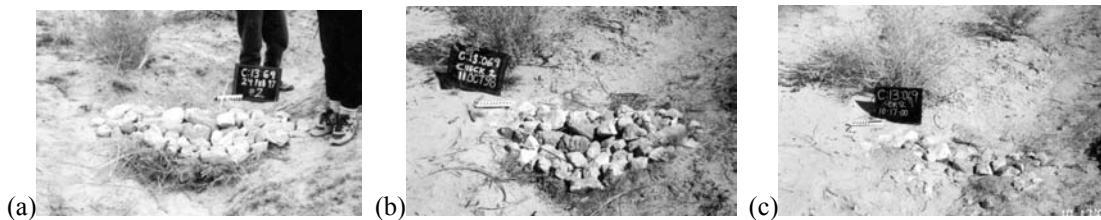
Figure 7. Site C:13:006, Checkdam 2: observed during three separate monitoring and maintenance episodes (Photo a 1997, Photo b 1998, and Photo c 2000). Note extensive sediment accumulation along both the upstream and downstream sides of the checkdam (Photo c).

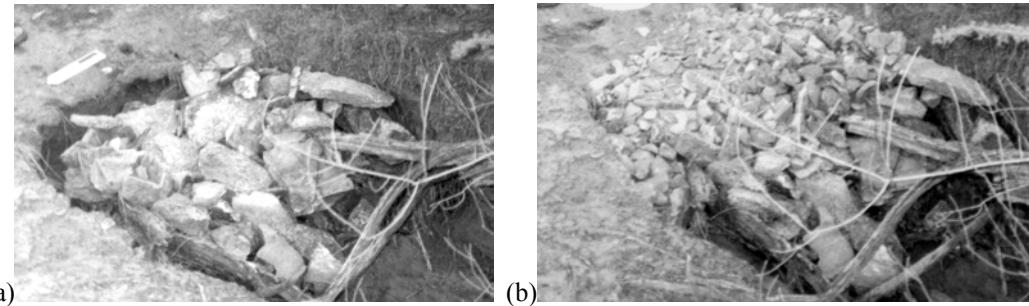
Five checkdams were initially constructed in FY97. In FY00 September rains breached three checkdams. Maintenance work conducted the following February resulted in merging two checkdams into one and constructing two new checkdams. Minor maintenance occurred in FY00 and FY01. Checkdam 2 was blown out in FY02 but not repaired. In FY03, maintenance was required due to the presence of a plunge pool below Checkdam 1. The headcut was filled in with granite rock and brush. The drainage below Checkdam 1 is too deep to fill in. The upper drainage appears to be inactive. Figure 8 shows before and after photographs of treatment to Checkdam 1. Small gravels and brush were used to fill in the spaces between the drainage wall and the checkdam and the spaces between large rocks in the checkdam itself.

Figure 8. Site G:03:002, Checkdam 1: an example of treating headcut advancement (Photo a) with small gravels and brush (Photo b).

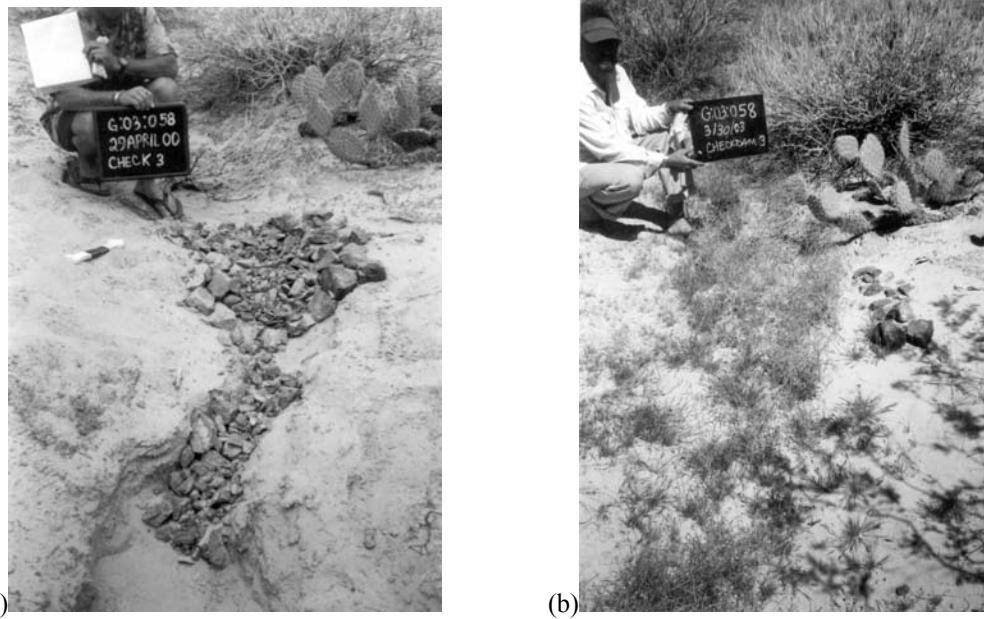
Initial checkdam construction consisted of two rock and brush checkdams in one drainage in FY97. In FY99, several new nickpoints appeared in the drainage resulting in the construction of four new checkdams. The drainage continued to be extremely active with all checkdams obliterated and reconstructed and two new checkdams constructed. The drainages were inactive for the next two years. In FY03 the checkdams were covered in sediments and vegetation as shown in Figure 9. The drainages have completely filled in with sediment and vegetation is growing throughout the drainage. The checkdams have been successful and are barely visible on the surface. No work was necessary.

Figure 9. Site G:03:058, Checkdams 8 and 9 in 2000 (Photo a) and again in 2003 (Photo b).

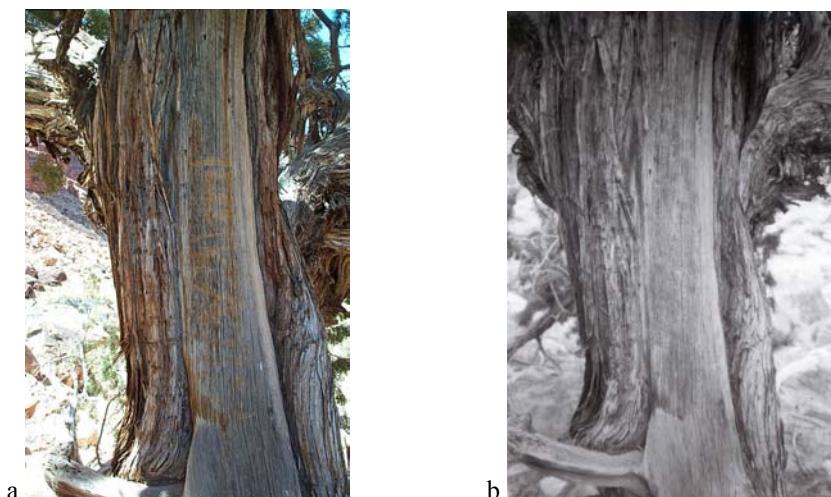
On May 10 this information was given to NPS archaeologists. Fortunately there was an NPS river patrol trip leaving a few days after receipt of this information. An NPS archaeologist went on the river trip to complete a more detailed assessment. The archaeologists noted that the incised, scratched graffiti was not as deep or clean as a knife cut, but it looked like the vandal used a rock or stick. It extended above the H. McD inscription and was not decipherable (see Figure 12a). There was also incised graffiti noted on a nearby boulder ["TLS 2000" AND "RYAN SWEENEY"].

Figure 12. Graffiti recorded by NPS archaeologists at site C:05:007 in May 2002 (Photo a). On 3-18-03 base Park archaeologists (Jan Balsom and Grace Ellis) removed the graffiti with sandpaper (Photo b).

On the FY03 BOR sponsored trip base funded Park archaeologists used sandpaper to remove the vandalism on the tree (see Figure 12b) and the rock. Additional work on the boulder with graffiti included mixing clay and water and covering the rock to mask the incised lettering. Because this is only a mask, it is imperative to revisit the site to determine if additional removal is necessary. The San Juan BLM was contacted regarding the removal of graffiti on desert varnish. We anticipate applying their methods to this site if necessary. The NPS ARPA officer, Joe Sumner is investigating the case.
