Archaeological Site Monitoring and Management Activities along  
the Colorado River in Grand Canyon National Park

Jennifer L. Dierker and Lisa M. Leap  
Grand Canyon National Park

RCMP REPORT No. 91  
Flagstaff, Arizona

OCTOBER 2006

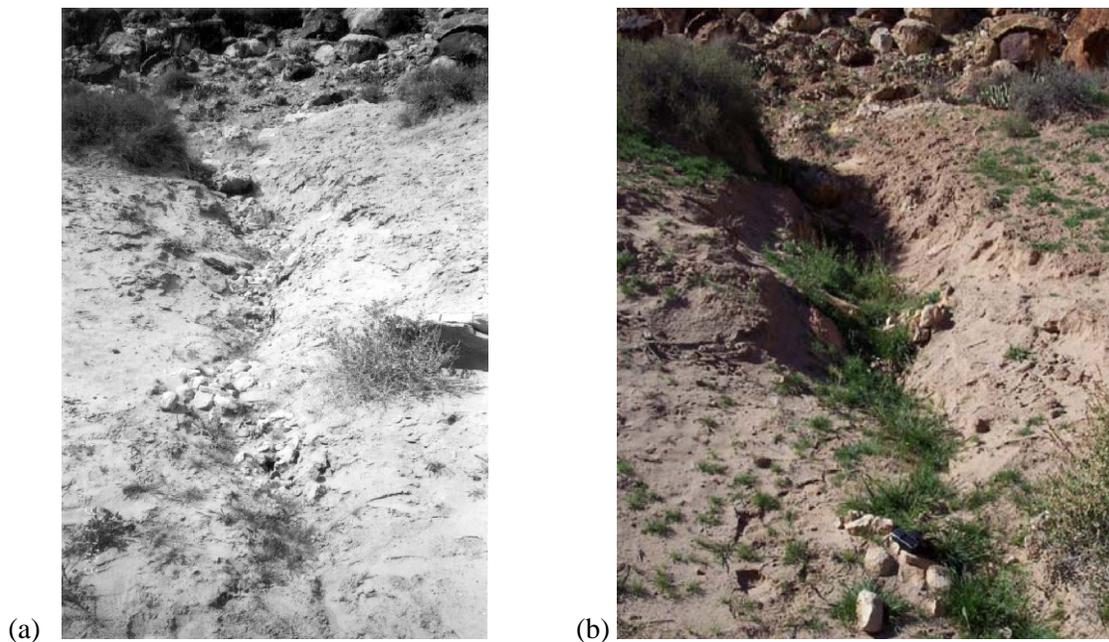
Figure 10. C:02:101 Checkdams 3, 4 and 5 upon completion of construction (a) and during the FY2005 monitoring visit (b). The drainage has filled with sediment and contains abundant vegetation growth.

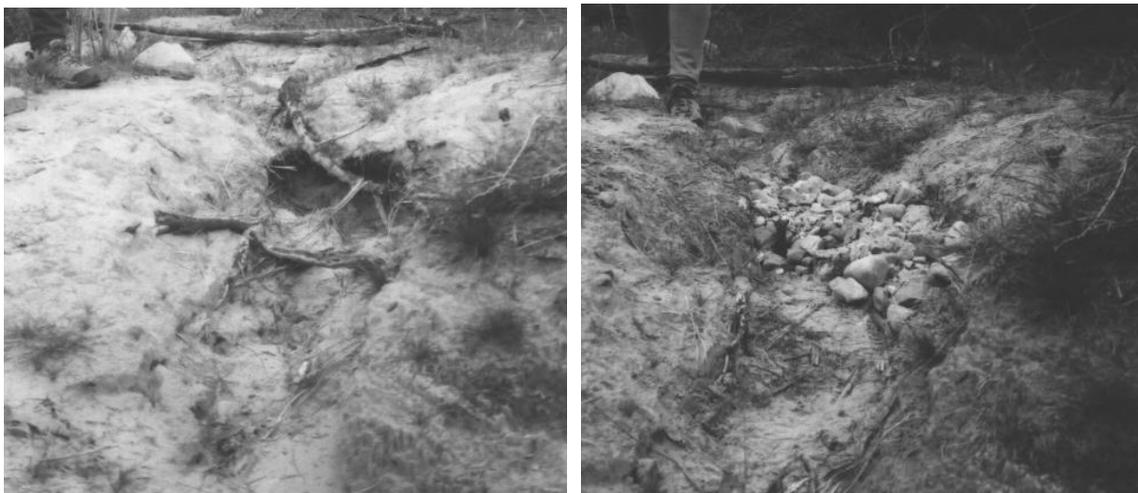
(A) Knickpoint advancement at C:13:100 and a knickpoint treatment constructed in FY2005.

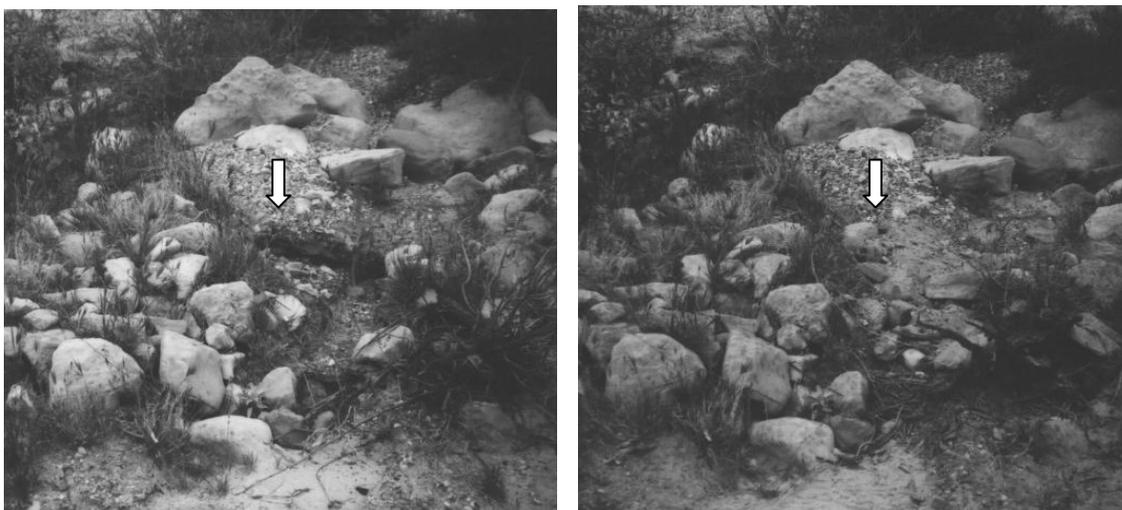
(B) Headward advancement at C:13:099 and a headcut treatment constructing in FY2005.
