HISTORIC STRUCTURE REPORT

HERMIT'S REST

GRAND CANYON NATIONAL PARK

December 2007

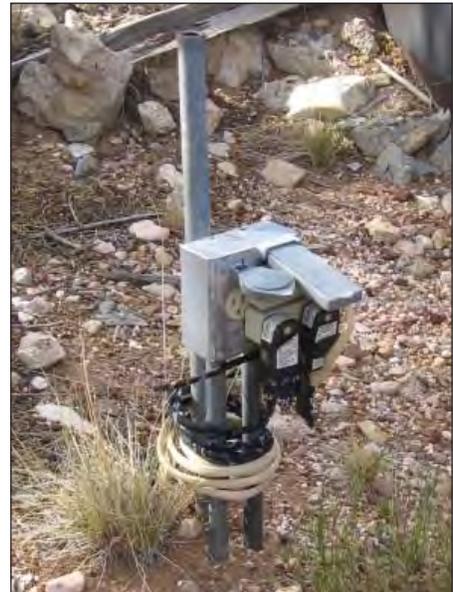
FIG. S24: Potentially hazardous outlet at the septic tank, 2007.

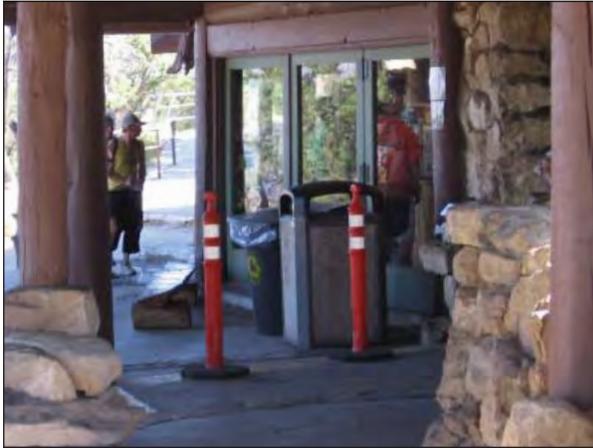
FIG. S25: Trash receptacles and safety bollards impair the view of the Hermit's Rest, 2007.

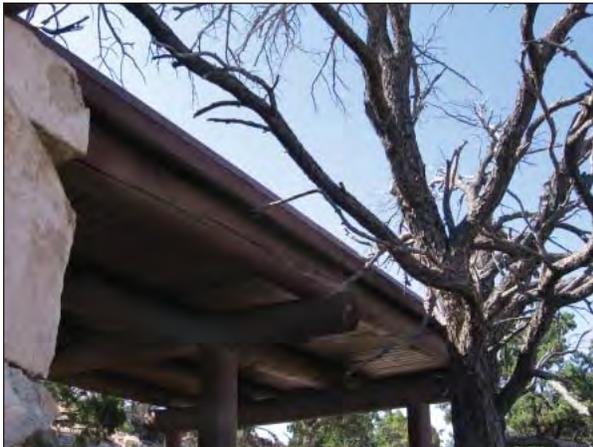
FIG. S27: Tree in contact with the porch addition roof creating a potential fire hazard, 2007.

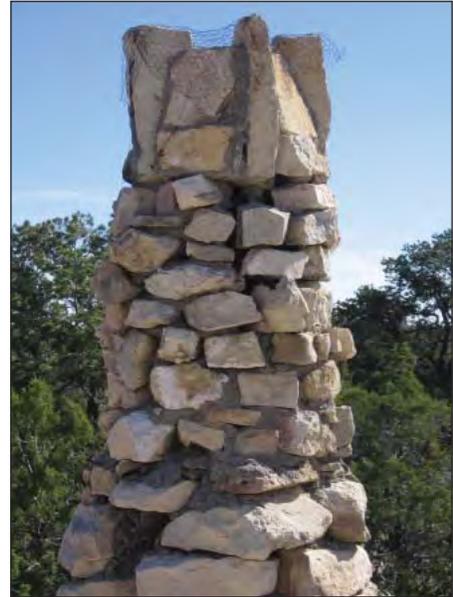
FIG. E10: Missing stones and mortar creating holes in the in Secondary Room chimney. Note unsecured wire mesh, 2007.

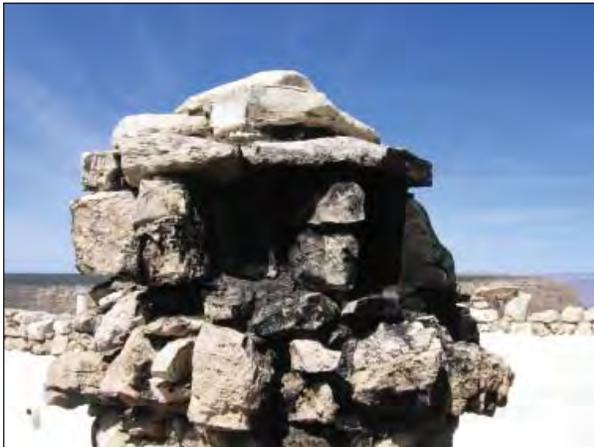
FIG. E11: View of the Great Room chimney facing north showing blocked exhaust holes, 2007.

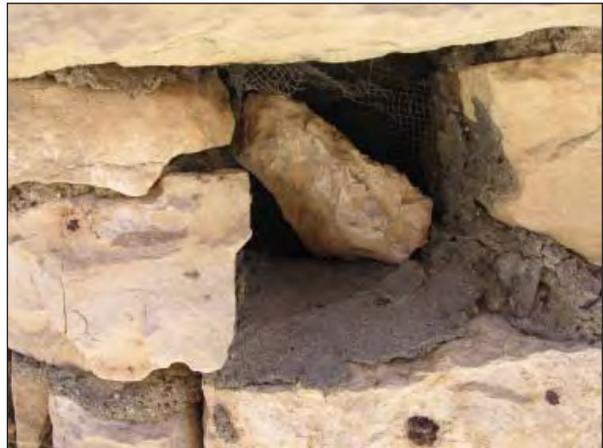
FIG. E14: Missing stone on the west elevation allowing rodent access to the building interior, 2007.

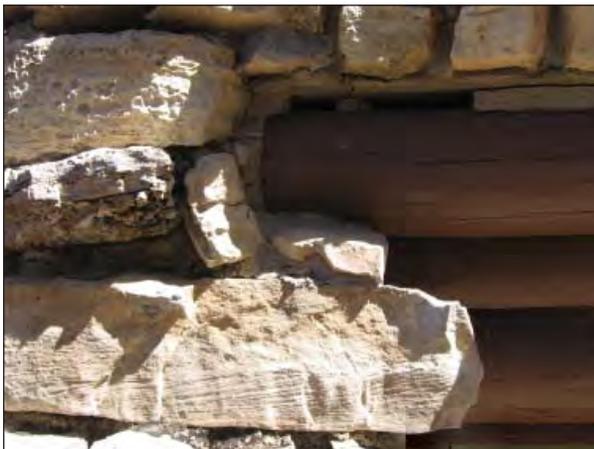
FIG. E15: Gap between a lintel and stone allowing rodent access to the building interior, 2007.

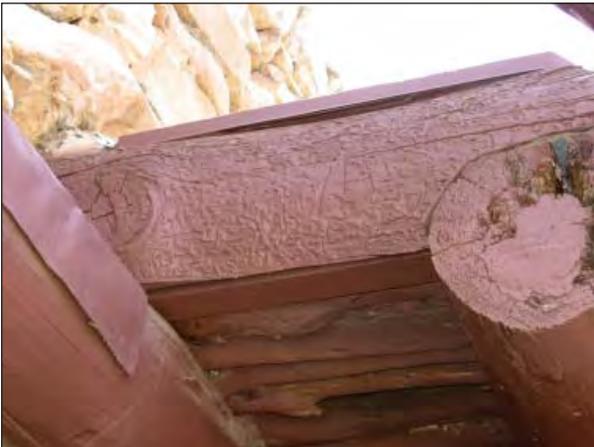
FIG. E23: Historic bark beetle damage on the porch fascia and epoxy on the log end at right, 2007.

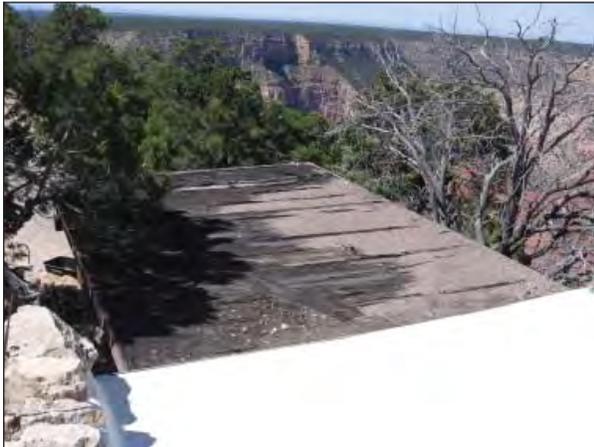
FIG. E35: View of the porch roof facing northwest showing the treatment of the historic roof in the foreground and the damaged addition roof at center, 2007.

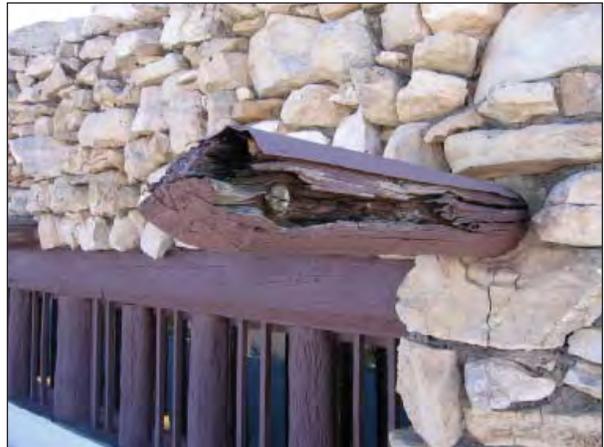
FIG. E36: Decayed vigas covered with sheet metal at the north elevation clerestory, 2007.

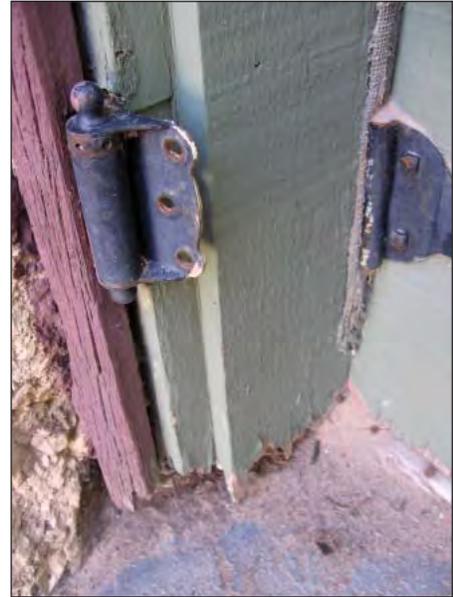
FIG. E38: Decayed door jamb and trim on the Secondary Room entrance, 2007.

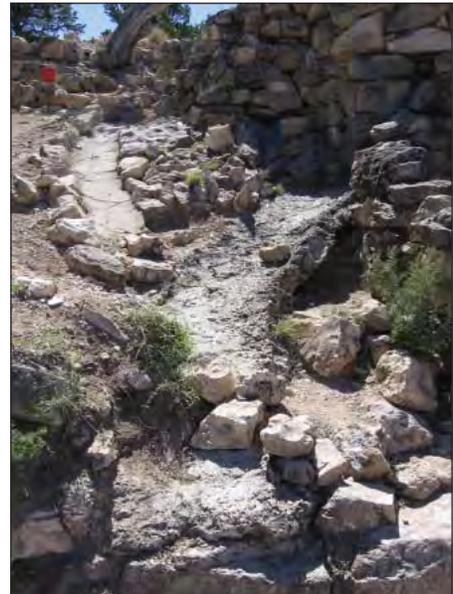
FIG. E52: Improper drainage channels to the east of the building, 2007.

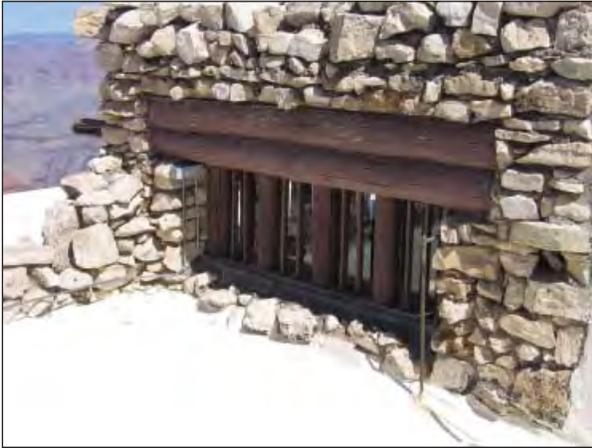
FIG. E53: West clerestory showing the electrical conduit through the window frame at bottom right, and propane conduit through mortar adjacent to window frame at center, 2007.

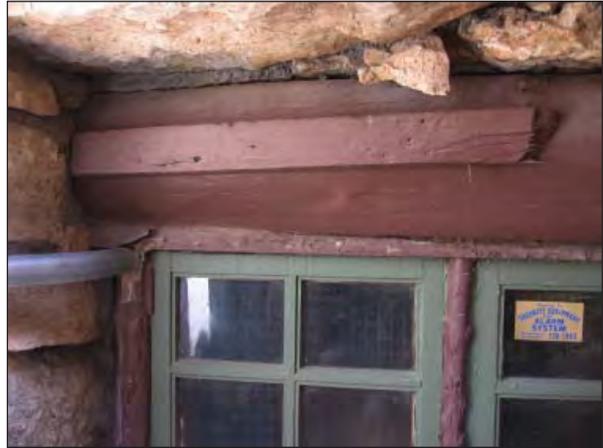
FIG. E58: Damaged 2 x 4 applied on the lintel above the Office window on the west elevation. Note electrical conduit entering the building through the window trim at left, 2007.

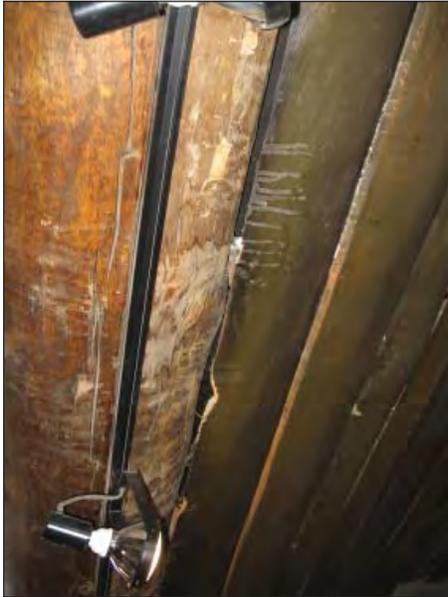
FIG. GR9: View of the modern log slab ceiling at the entrance showing the track lighting and damage caused by rodents, 2007.

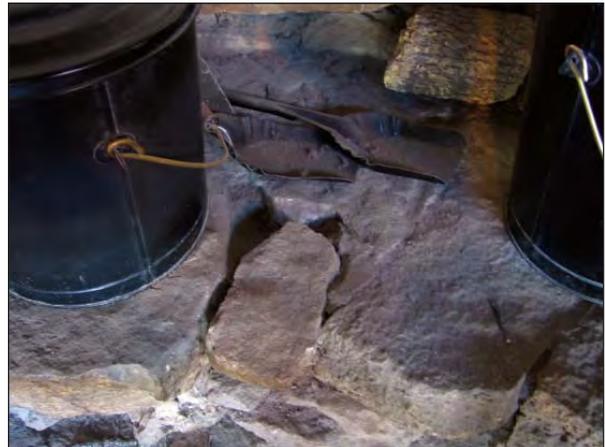
FIG. GR12: Loose stone in the fireplace area bench, 2007.

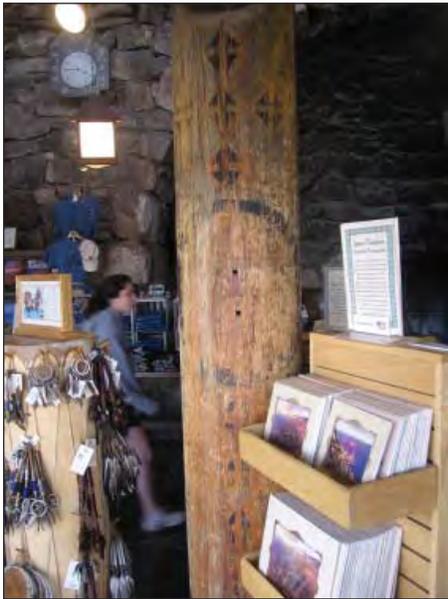
FIG. GR13: View of a log post showing the faded paint and adjacent merchandise displays, 2007.

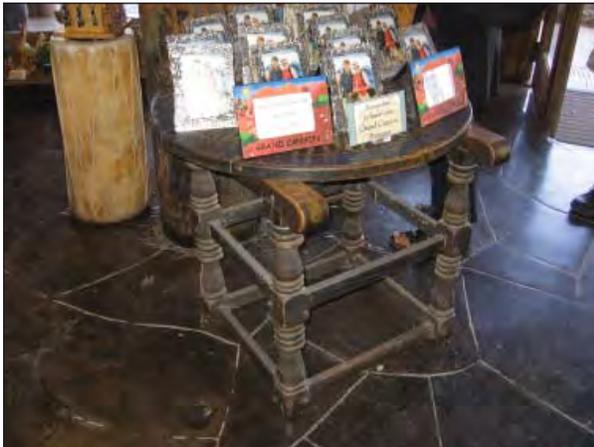
FIG. GR19: Missing seat on the painted wood table that converts into chair. Note scored concrete floor treated with wax, 2007.

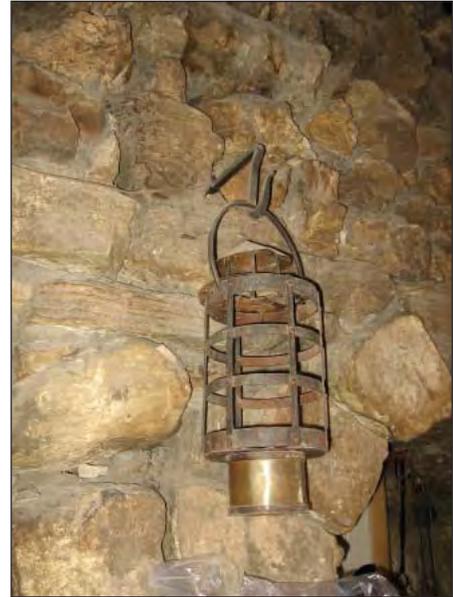
FIG. GR26: Lamp fixture on an iron hanger missing translucent screen, 2007.

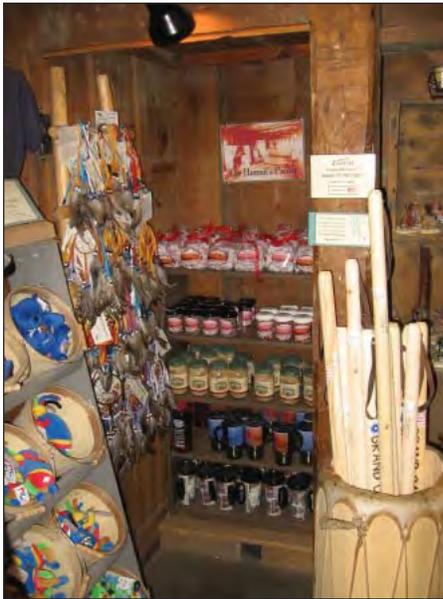
FIG. SR5: Southeast corner of the Secondary Room showing the missing closet door and modern merchandise display, 2007.

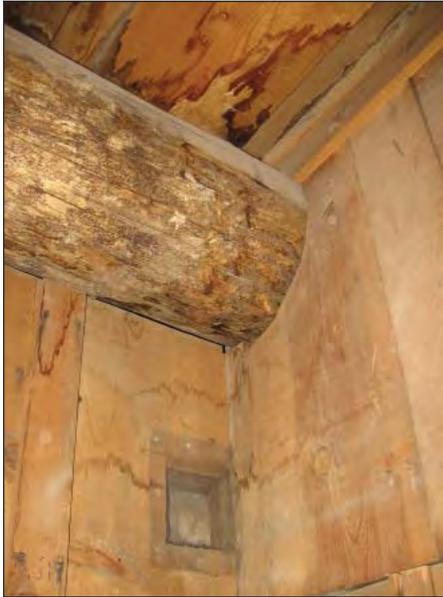
FIG. SR13: Water damage on the closet ceiling and a screen over a hole in the wall, 2007.

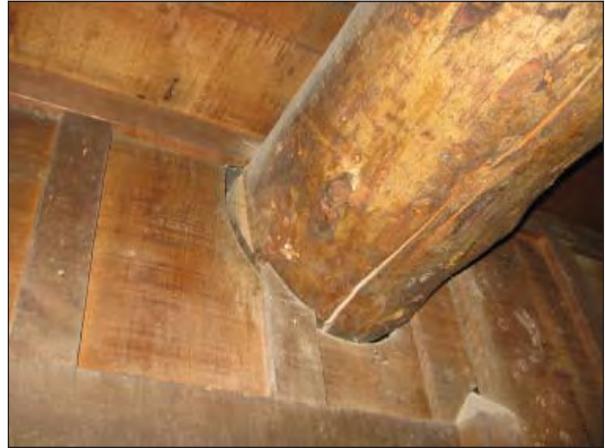
FIG. SR14: Gap between a ceiling beam and wall, 2007.

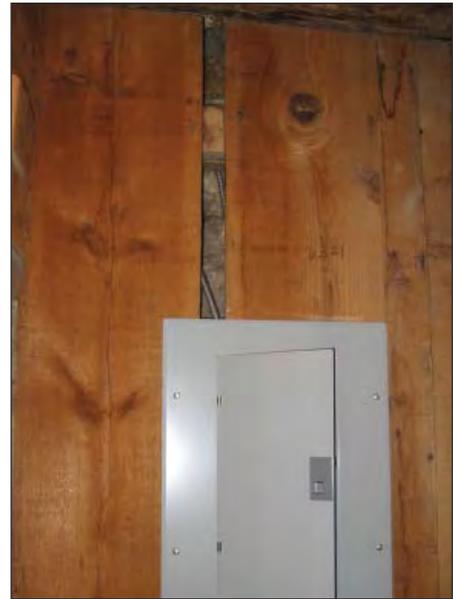
FIG. SR18: Missing batten in the storage closet, 2007.

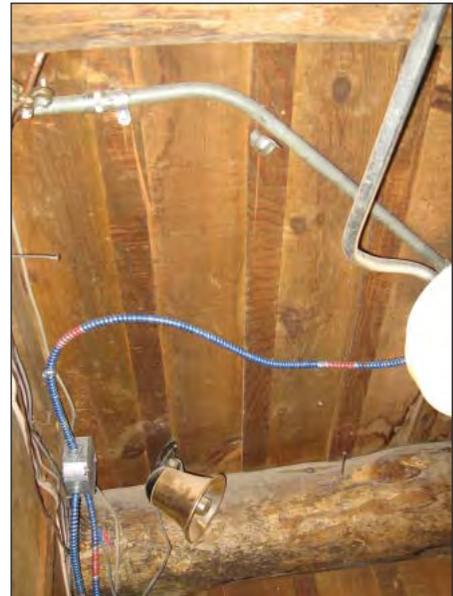
FIG. H4: Ceiling treatment on the south side of the Hall. Notice water damage behind light fixture at right, 2007.

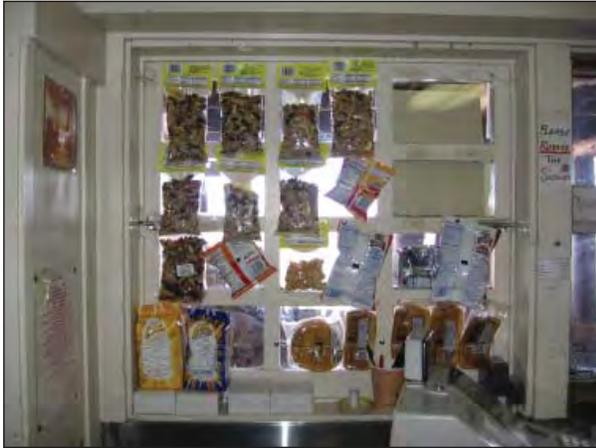
FIG. K1: North window covered with product display, 2007.

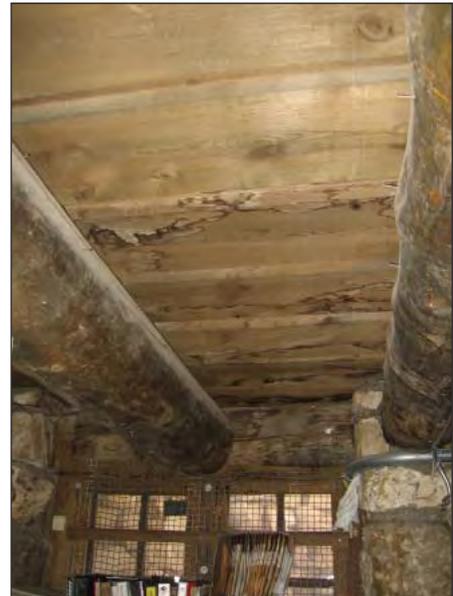
FIG. O8: View facing west showing water damage on the ceiling and wire over the windows, 2007.

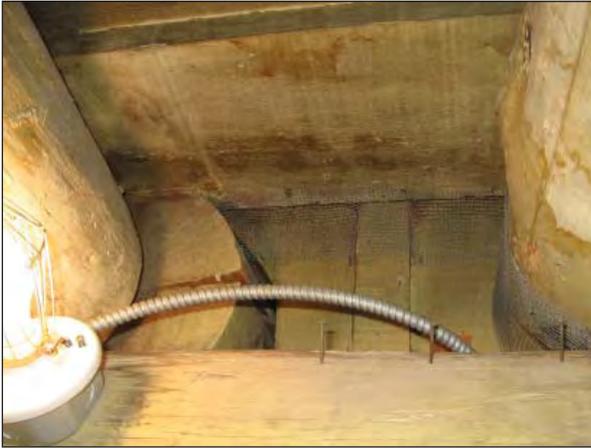
FIG. O9: Gaps between a ceiling member and the wall covered with a screen, 2007.
