# North Rim Entrance Station

Historic Structure Report

North Rim Entrance Station  
Historic Structure Report

*prepared by*  
Architectural Resources Group  
Architects, Planners & Conservators, Inc.  
San Francisco

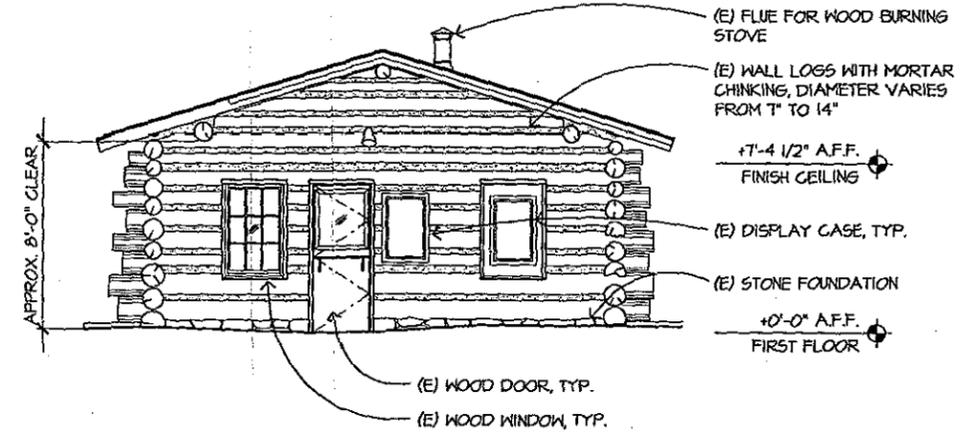
EXISTING CONDITIONS - WEST ELEVATION ③

This elevation receives greater exposure to sun and the elements, consequently, larger amounts of chinking are missing than other elevations; peeling of the painted surface of logs is more severe, particularly at the lower level. On the south side of the west elevation at the upper level, gaps and missing chinking have left three distinct openings around the purlin log into the attic, though this condition does not appear to be problematic. There is no sign of water infiltration and the openings may be beneficial for attic ventilation.

A piece of the roof sheathing and fascia is missing at the northwest corner of the roof where cars have hit the building. The remaining material is damaged; corrugated metal is crumbled.

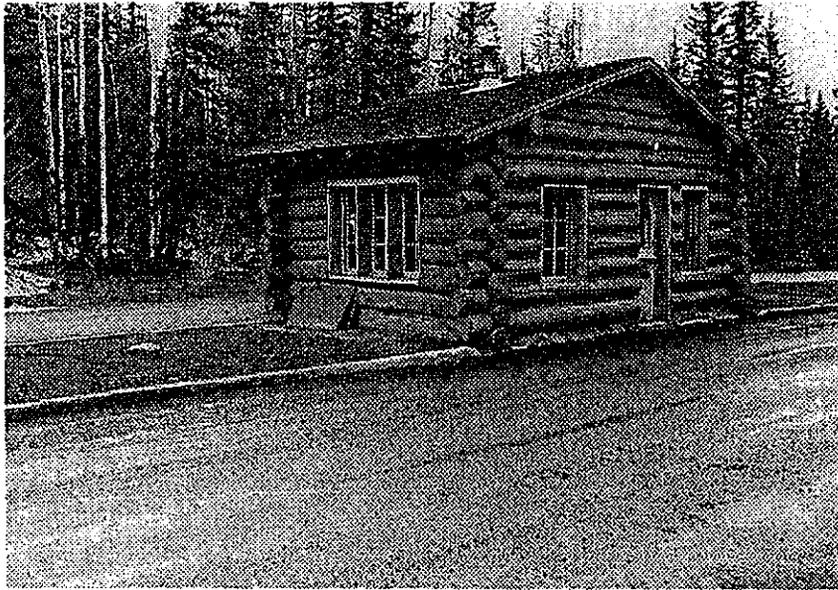
*Figure 14. The image illustrates the North Rim Entrance Station after removal of the canopies that covered the roadway. The works significantly altered the architectural expression of the building. Photo is dated 1973. GCNPA Number 10018.*

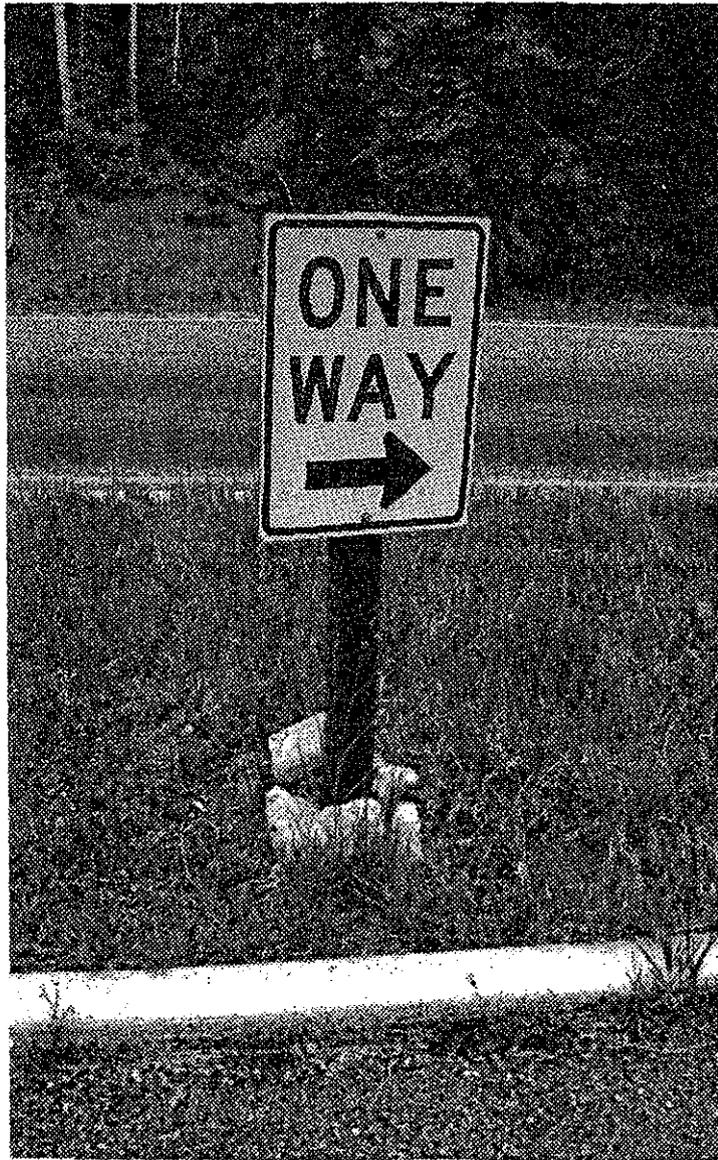
*Figure 3. The image illustrates the type of piecemeal signage that clutters the site. ARG Photo dated June, 2000.*

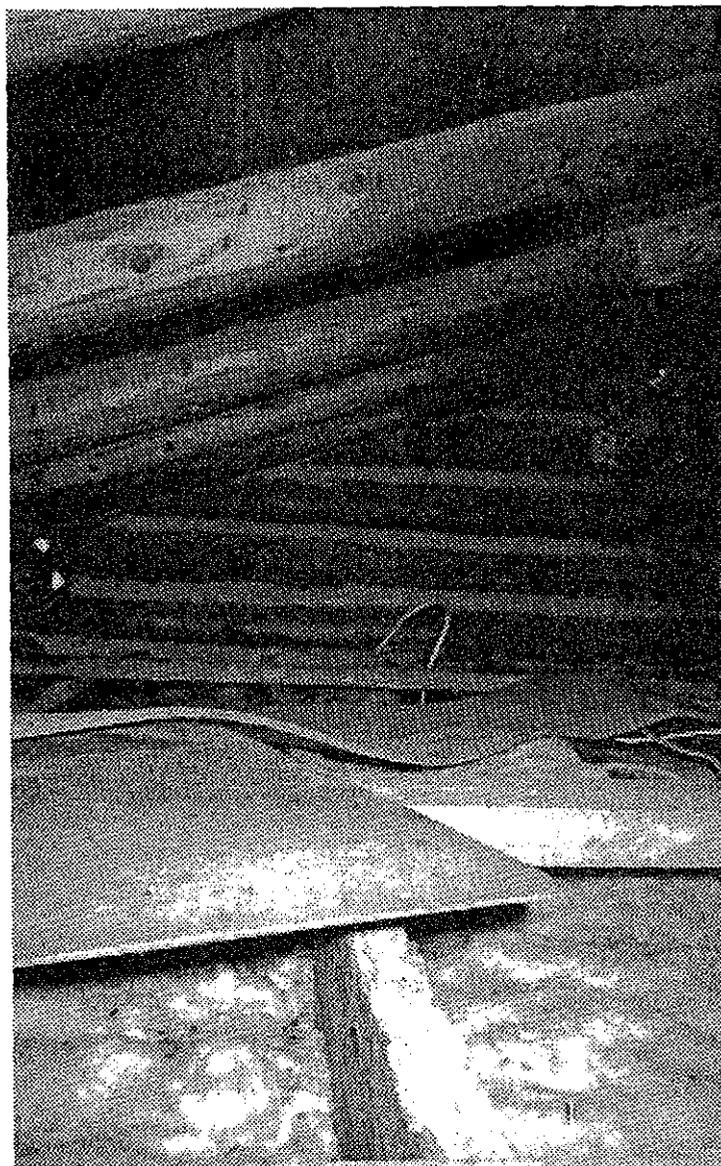
*Figure 8. The image illustrates the interior of the attic showing the original color of the chinking and framing members. Note three openings around purlin log on left indicating log shrinkage. ARG Photo dated June, 2000.*

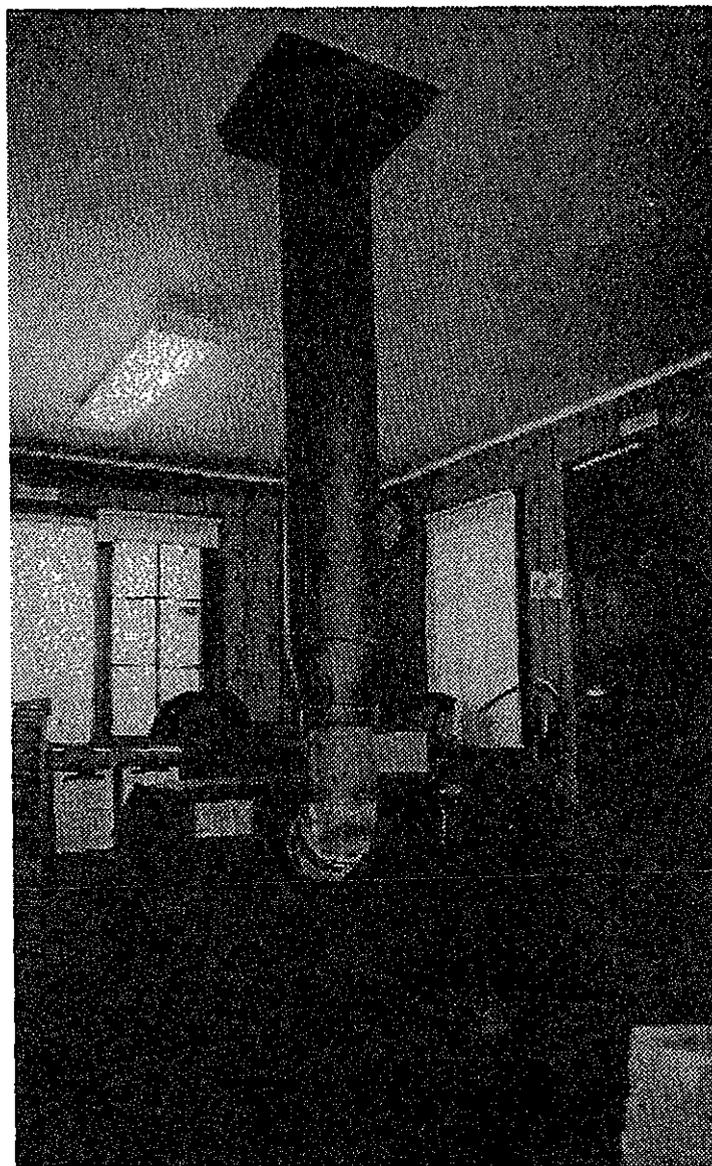
*Figure 10. The image illustrates the wood-burning stove in the center of the interior of the North Rim Entrance Station. The stove replaced a stone chimney and fireplace that was removed in the 1950s. ARG Photo dated June, 2000.*

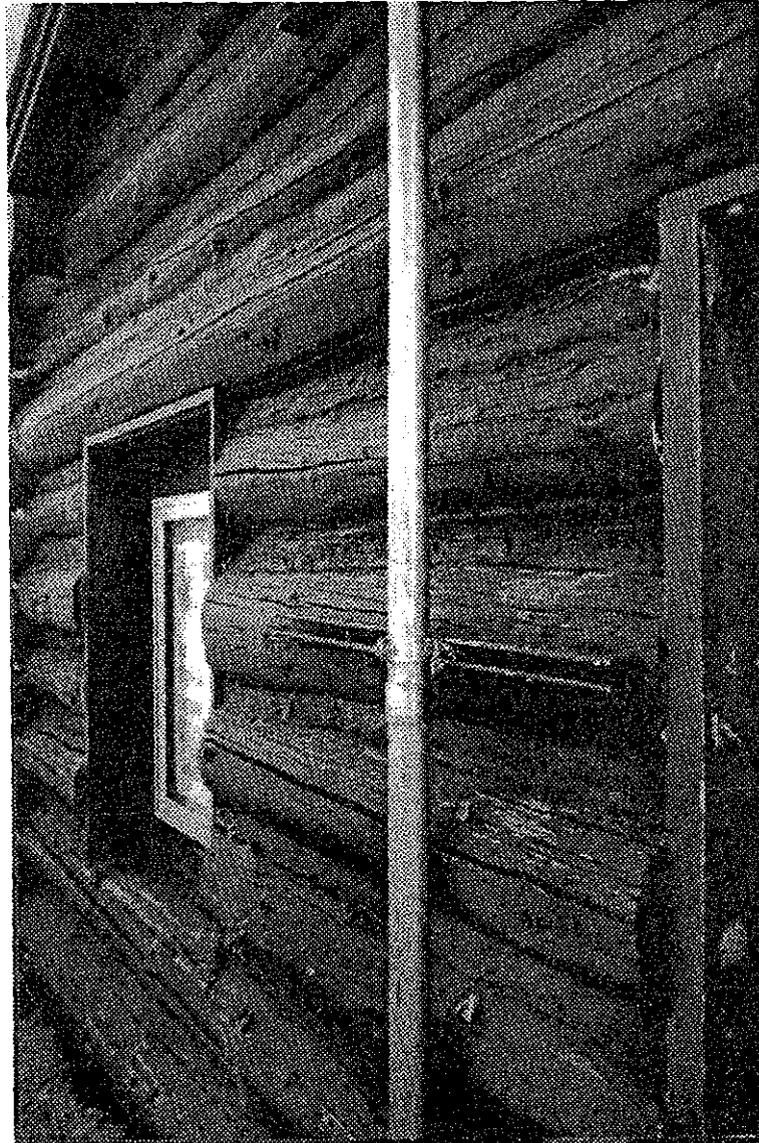
*Figure 11. The image illustrates the east elevation of the entrance station. Typical conditions are splitting and cracking of the logs, peeling paint on the log surfaces, antenna support pole, and moth cocoons. ARG Photo dated June, 2000.*

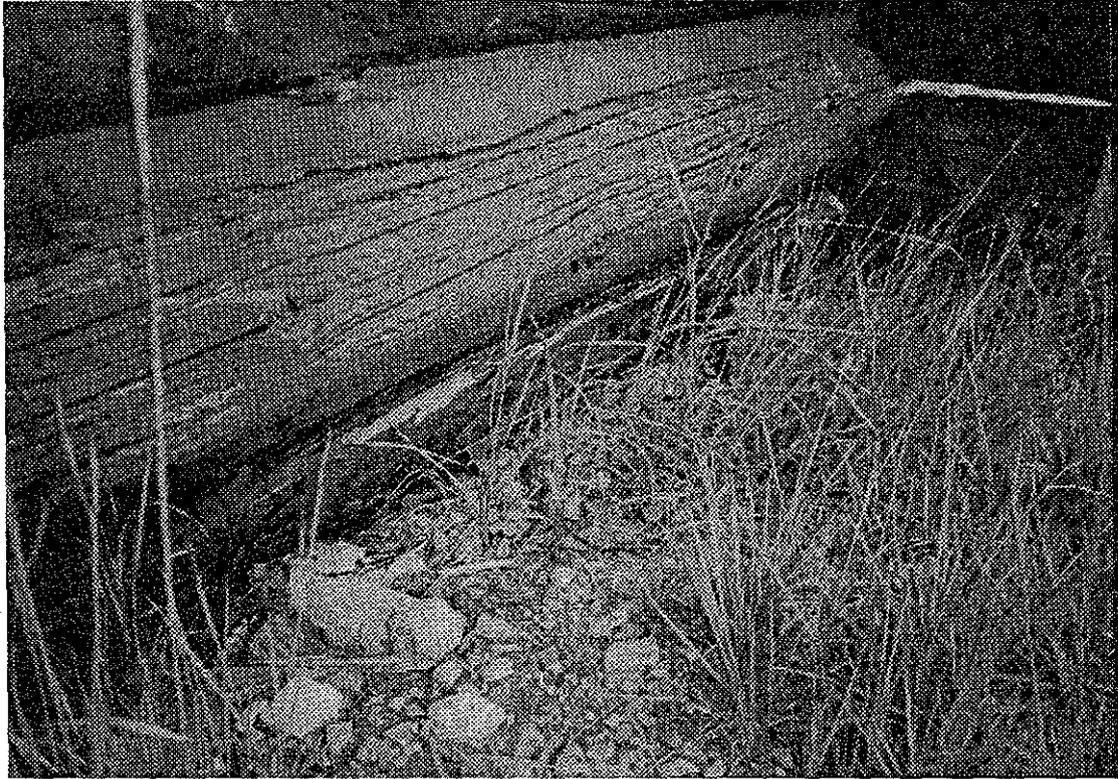
*Figure 12. The image illustrates log deterioration at the North Rim Entrance Station. Deterioration on the lower level of the south elevation is particularly severe due to sun exposure and snow drifts in winter. ARG Photo dated June, 2000.*

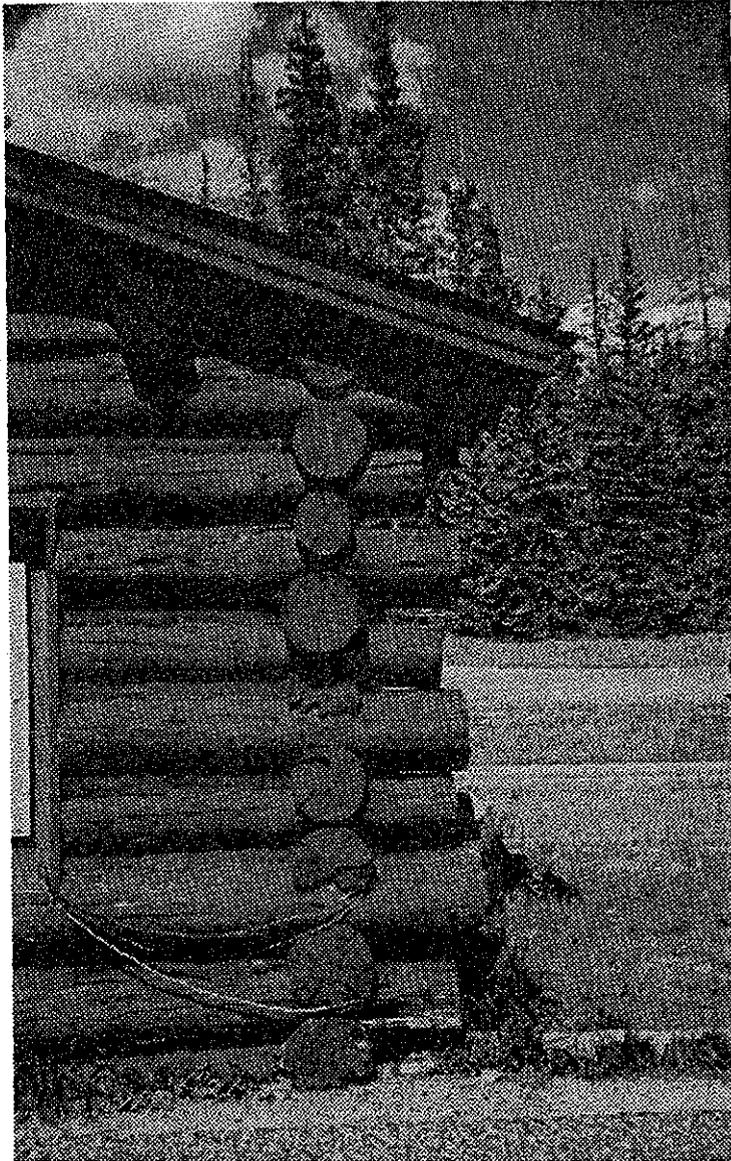
*Figure 13. Staggered log ends are a character-defining feature of the North Rim Entrance Station. The north-south running logs retain their original configuration. The east-west running logs (ends facing viewer) have been altered to form an even vertical line to accommodate vehicles that pass closely by the structure. ARG Photo dated June, 2000.*

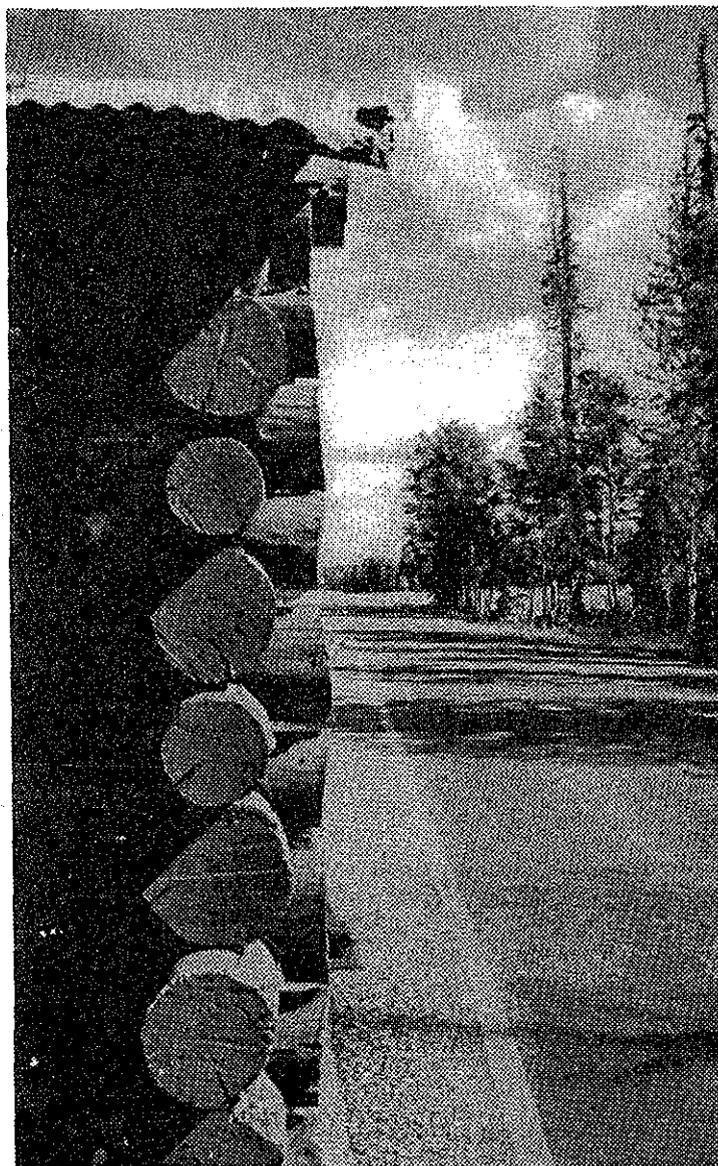
*Figure 14. The east-west running logs have been altered to form an even vertical line to pull the log ends back from the roadway to accommodate vehicles. ARG Photo dated June, 2000.*

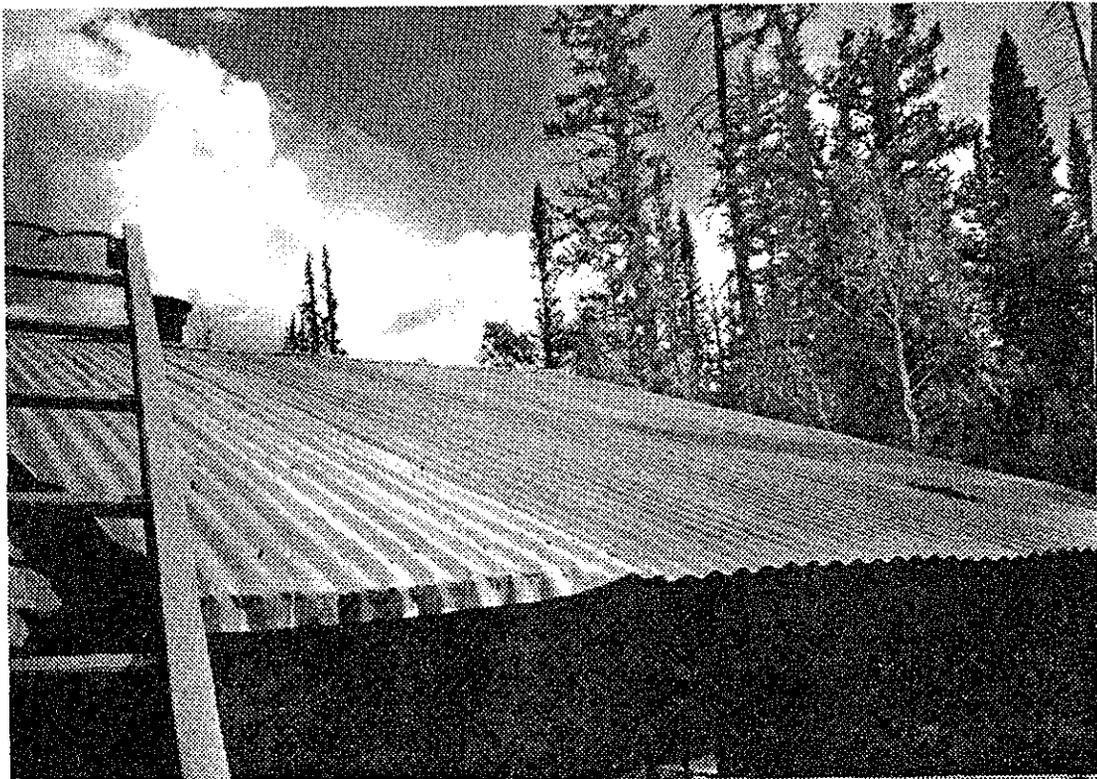
*Figure 15. The image illustrates the weathered corrugated metal roof of the building. Characteristics of the roof are: peeling brown paint exposing the metal; curling seams of the sheathing; rusted nails; splitting and curling wood shingle ends of irregular lengths below the metal sheathing; gaps and openings in the seams of the sheathing; and crinkled metal sheathing with holes. ARG Photo dated June, 2000.*
