South Rim Ranger Operations Building  
Historic Structure Report

Grand Canyon National Park, Arizona

## I. EXECUTIVE SUMMARY

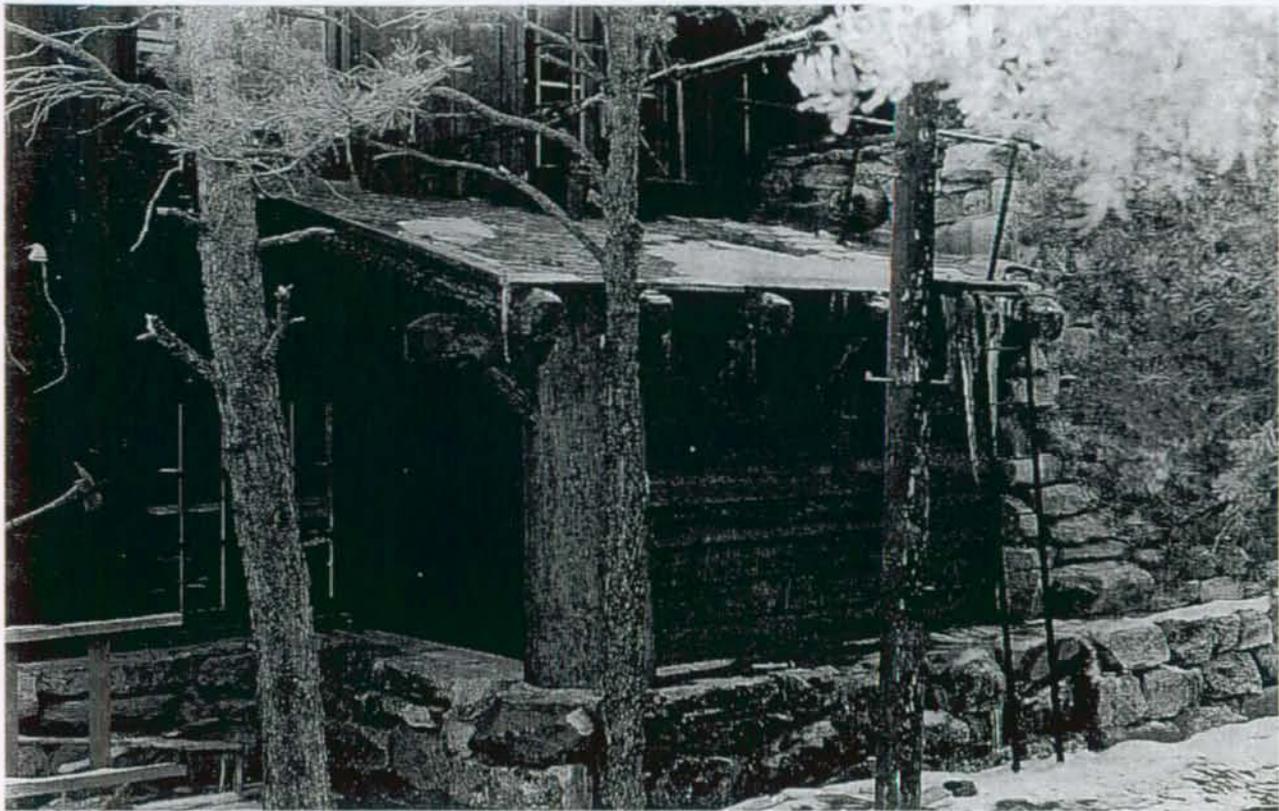
GCNPA Photograph Number 9250.

Figure 15: Completed vault at east elevation of Headquarters' Building, February 1936. Note stone foundation and emergency exit ladder.

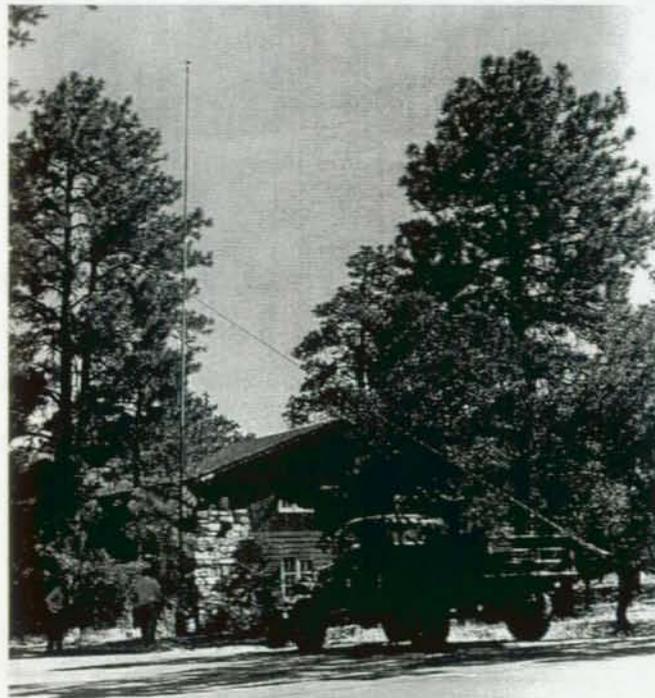
GCNPA Photograph Number 2310.

Figure 16: Erecting flagpole after repairs, June 1952.

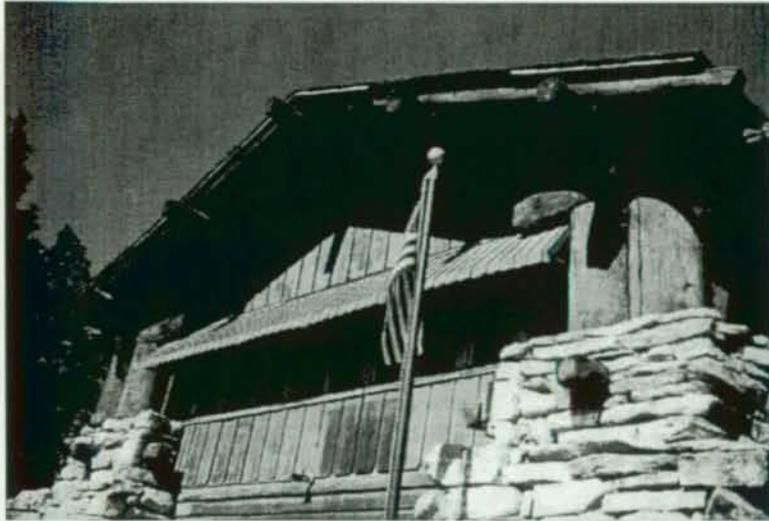
Figure 17: Metal awning at west elevation.

(Figure 17) It is likely that this occurred when the new awning was installed as the original casements would not have been operable with the awning in place. Due to the condition and construction of the double-hung sash, it is assumed that both the awning and double-hung windows were added soon after the building's initial construction date, perhaps when the 1935 alterations occurred to the structure.

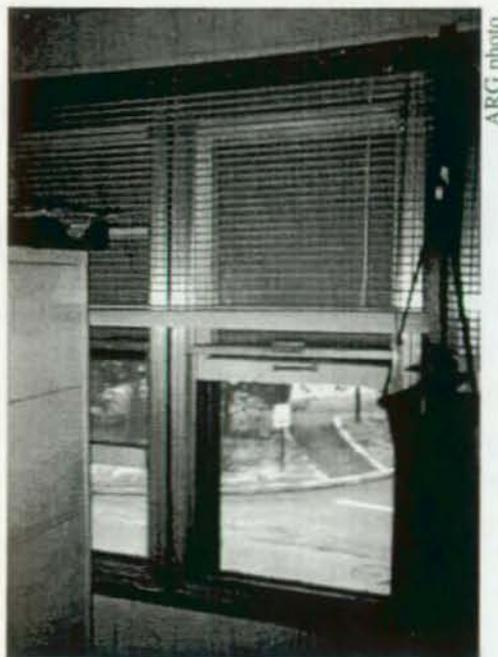
The metal awning at the second floor of the west facade is a non-contributing feature. (Figure 27)

Figure 27: Double-hung wood sash window at Room 201. Note underside of awning outside window.

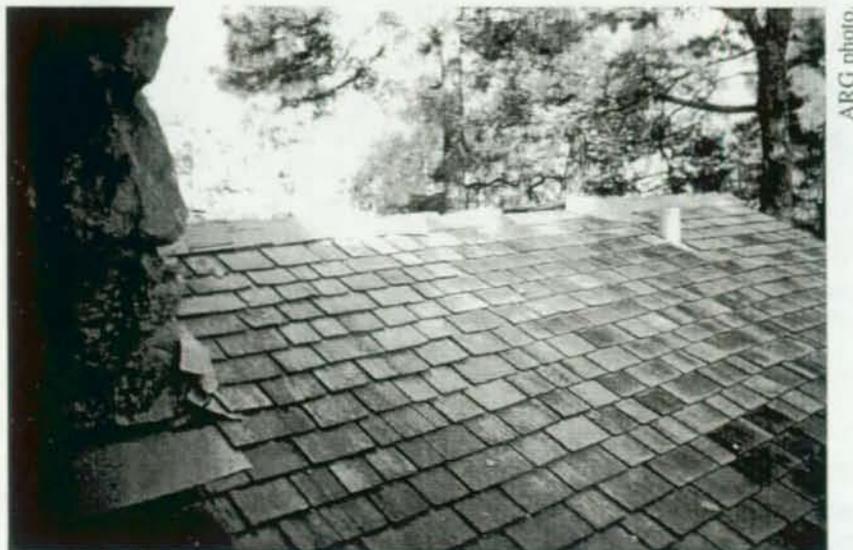
Figure 28: Roofing over toilet room addition. Some wood shingles are slipping at ridge line.
