113/D-SS3
Grand Canyon

Yavapai Observation Station

Historic Structure Report

Yavapai Observation Station
Historic Structure Report

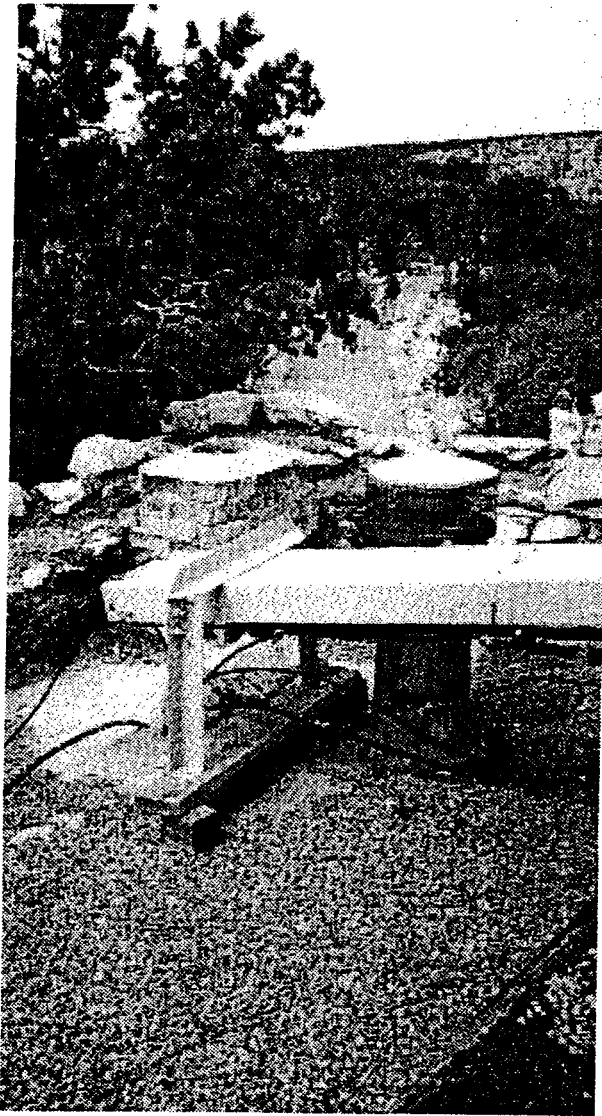
Figure 9. This image illustrates typical conditions on the flat tar and gravel roof. In the foreground is the brick chimney below the parapet. View is looking to the southwest corner. Long view is looking southwest. Note paved rim trail and boulders along the walk. Photo dated May, 2000.

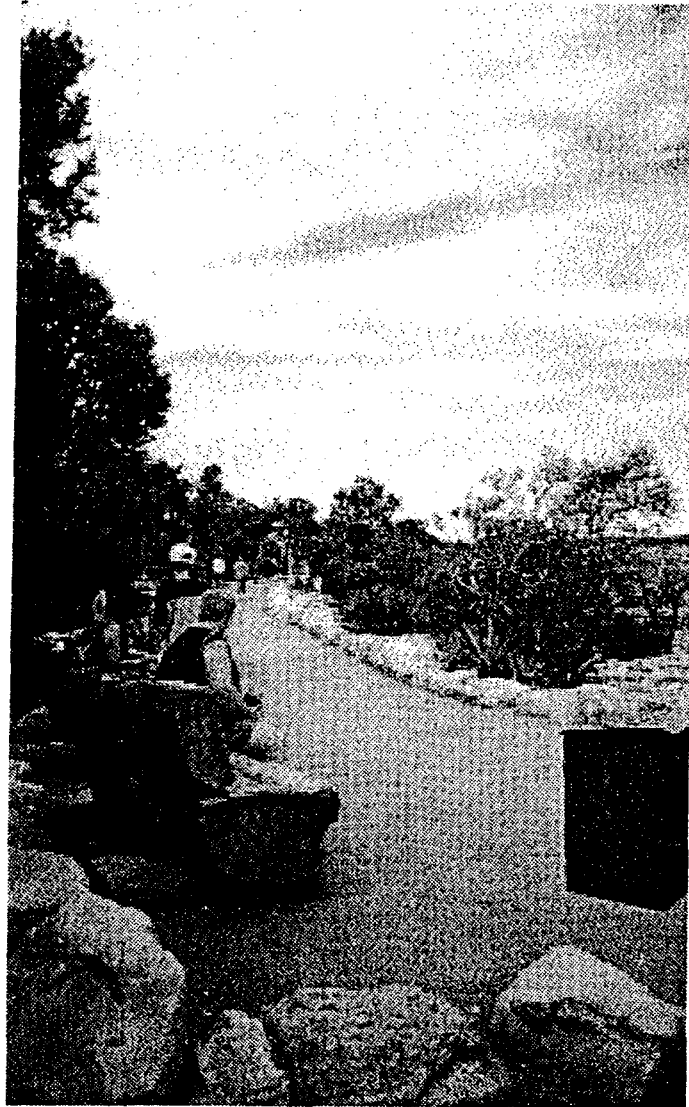
Figure 13. This image illustrates the landscaping and paving leading to the west side of the building. Benches are in poor condition. Photo dated May, 2000.

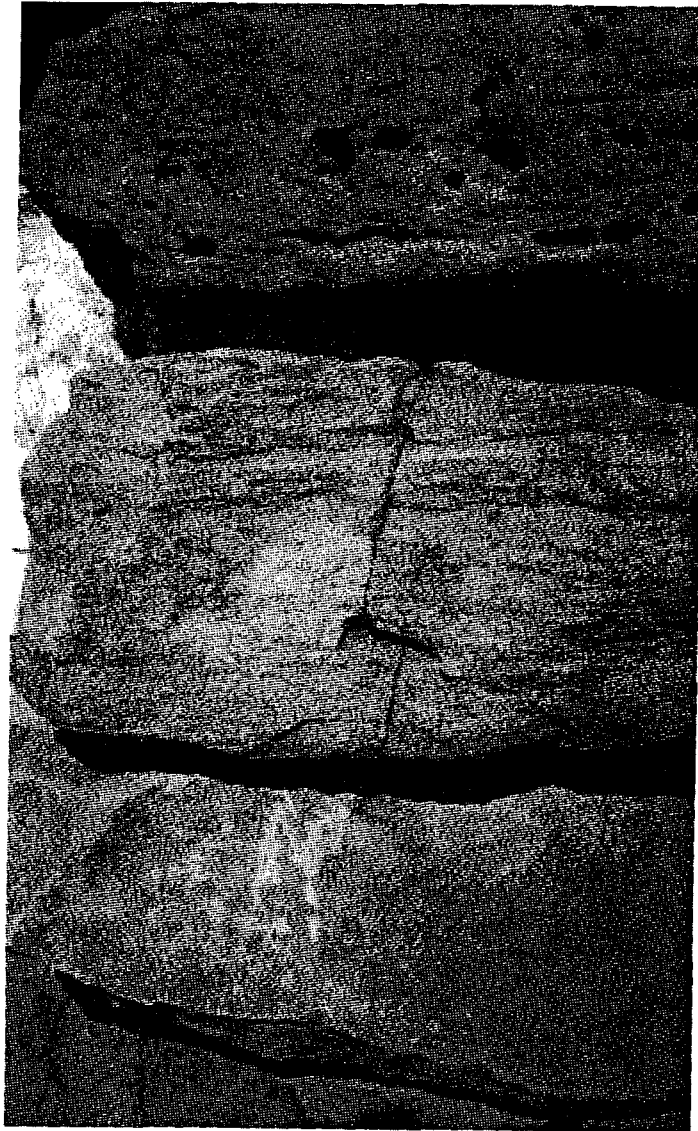
Figure 15. This detail image illustrates a fracture that runs the length of a boulder near a small window opening on the east elevation. The fracture may be the result of a natural cleft in the stone or it may be due to stresses on the rock. View is looking toward the north. Photo dated May, 2000.

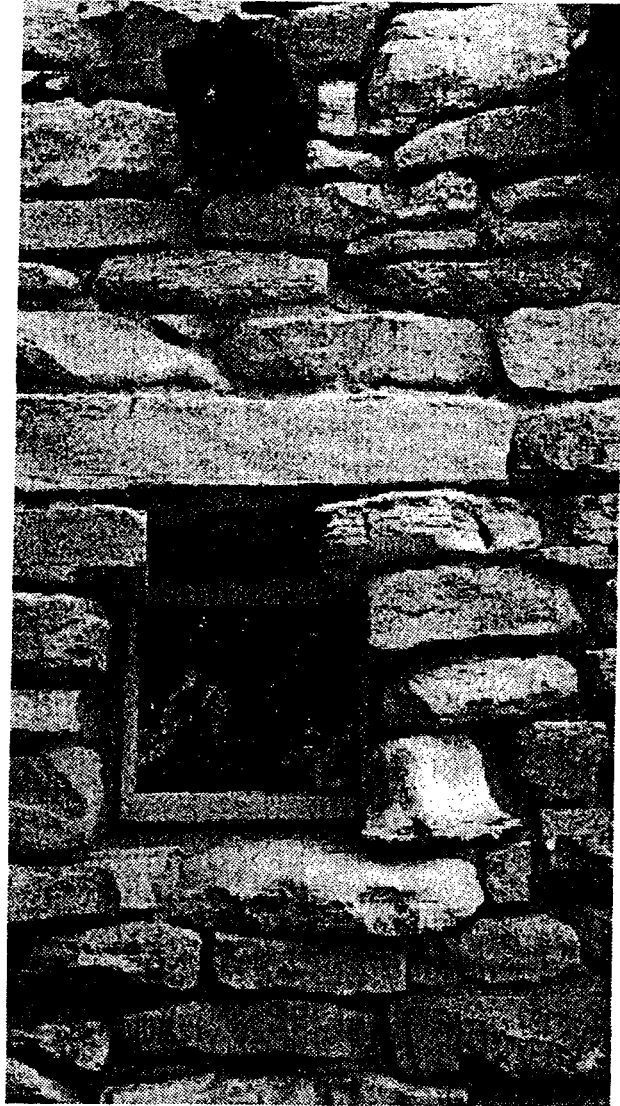
Figure 17. Detail shows window on the west elevation of the Yavapai exterior. Wood log end exhibits deterioration. Photo dated May, 2000.

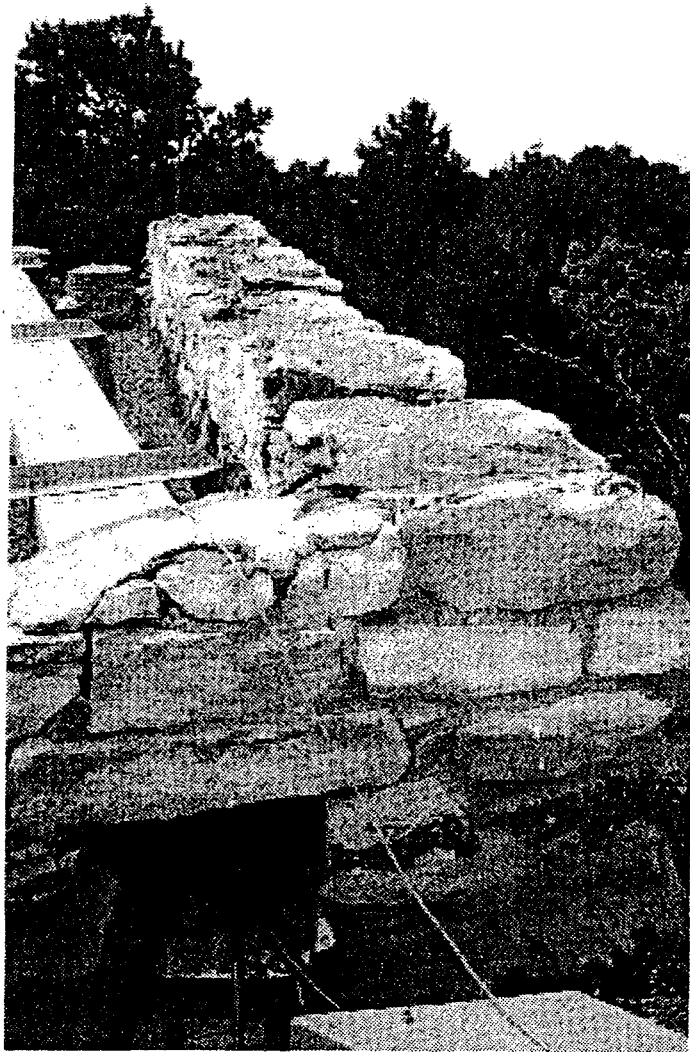
Figure 19. This image illustrates the parapet above the flat roof. Evidence of mastic repairs. View is looking south. Photo dated May, 2000.

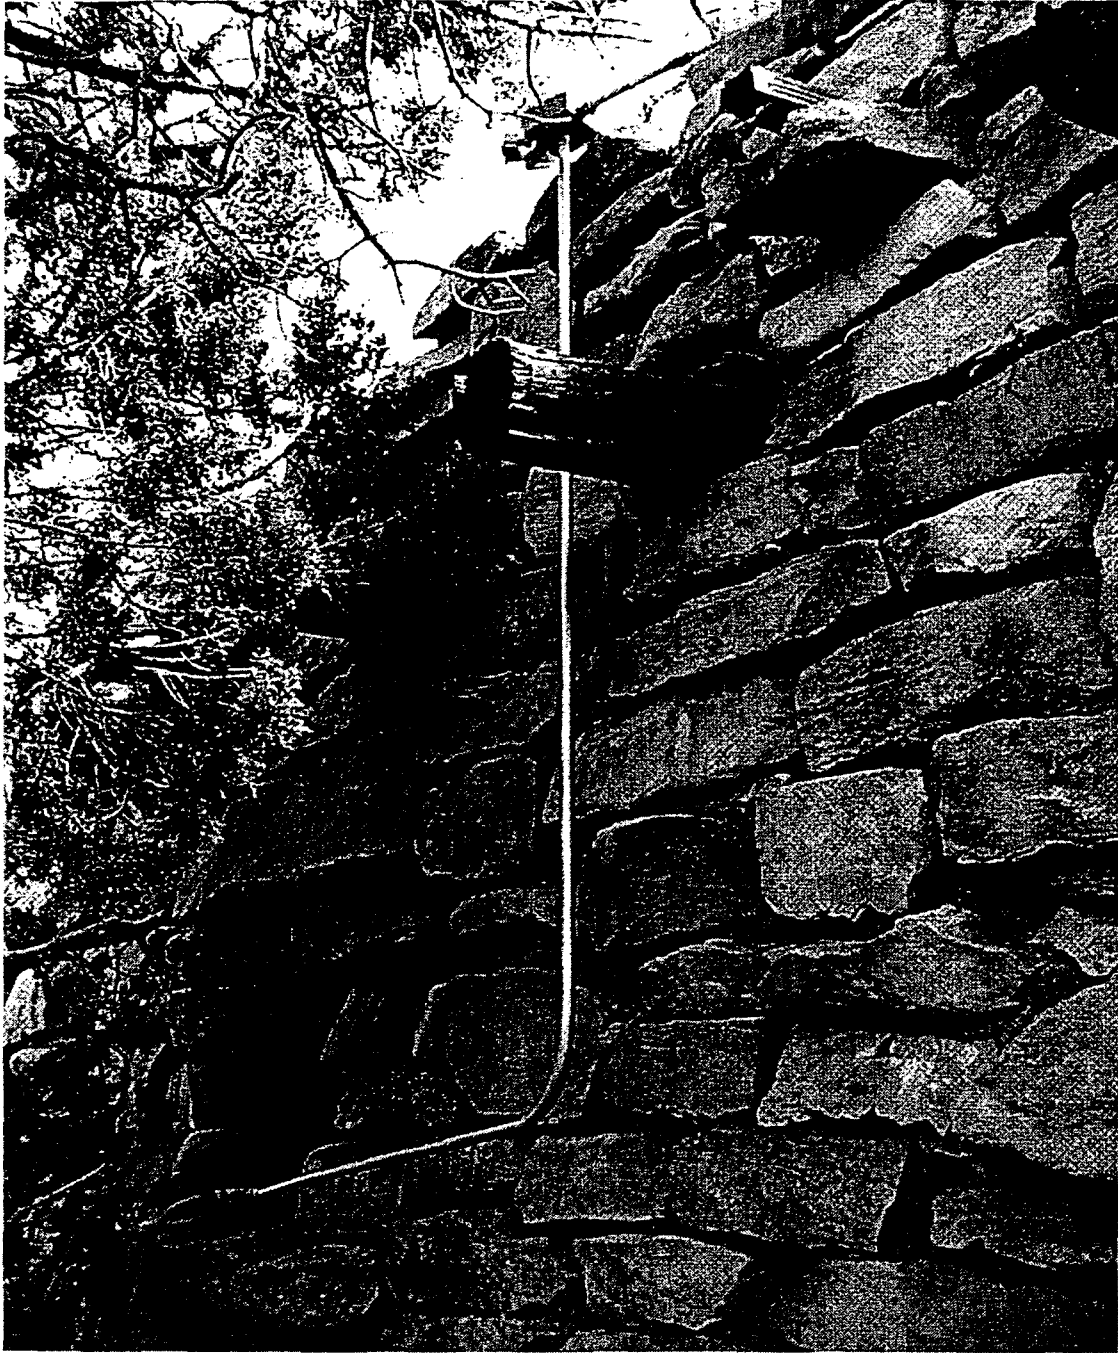
1: Conduit on Exterior Wall and Scupper

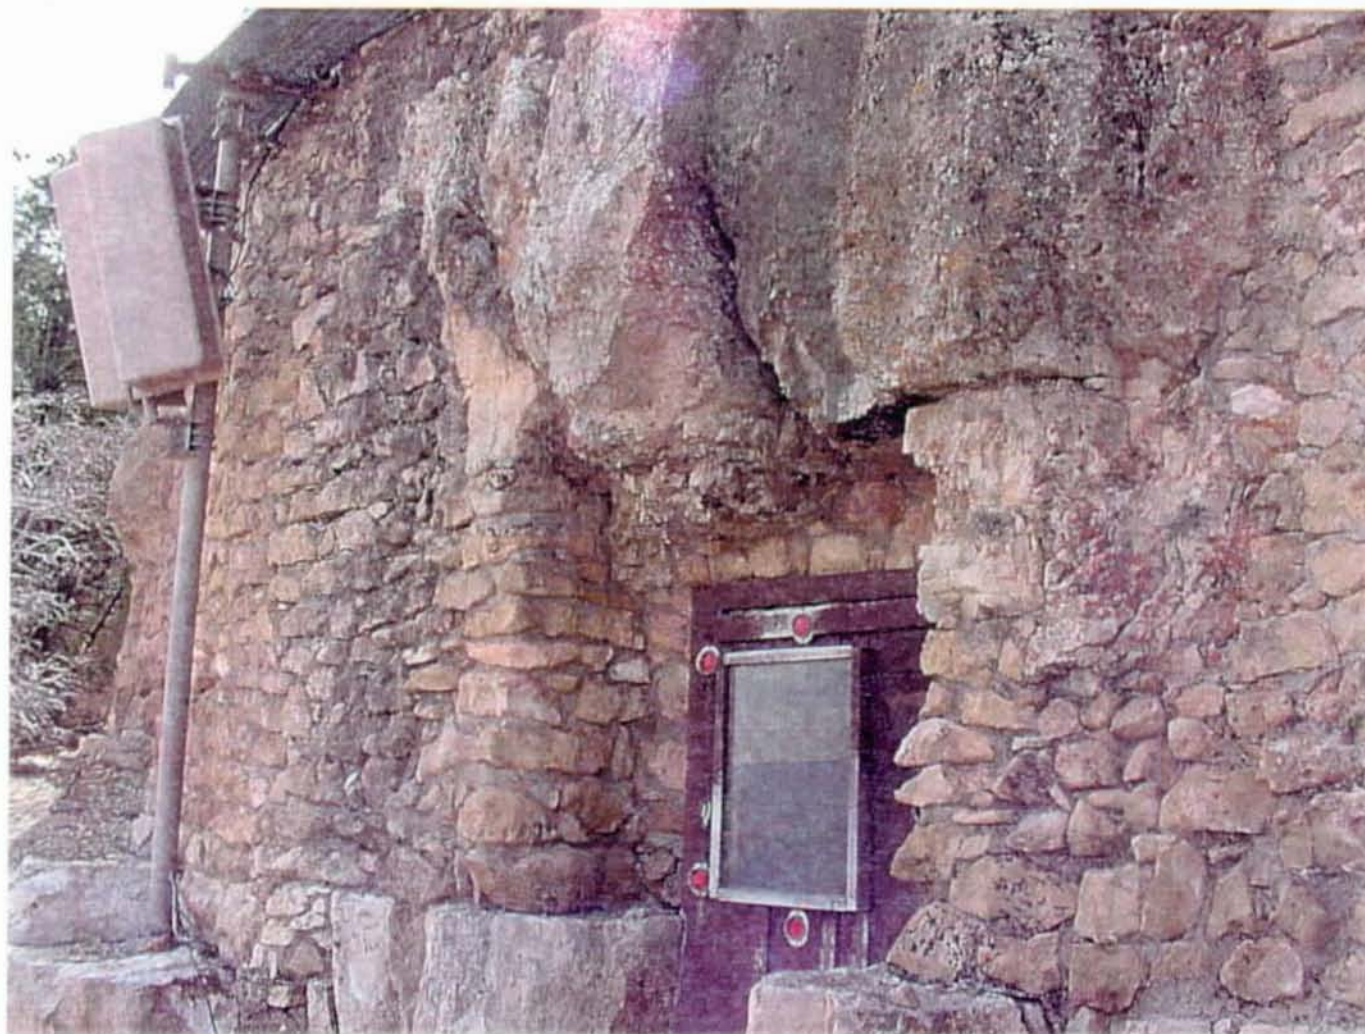
BASEMENT, SHOWING CRACK AND MASONRY REPAIRS TO CANYON WALL

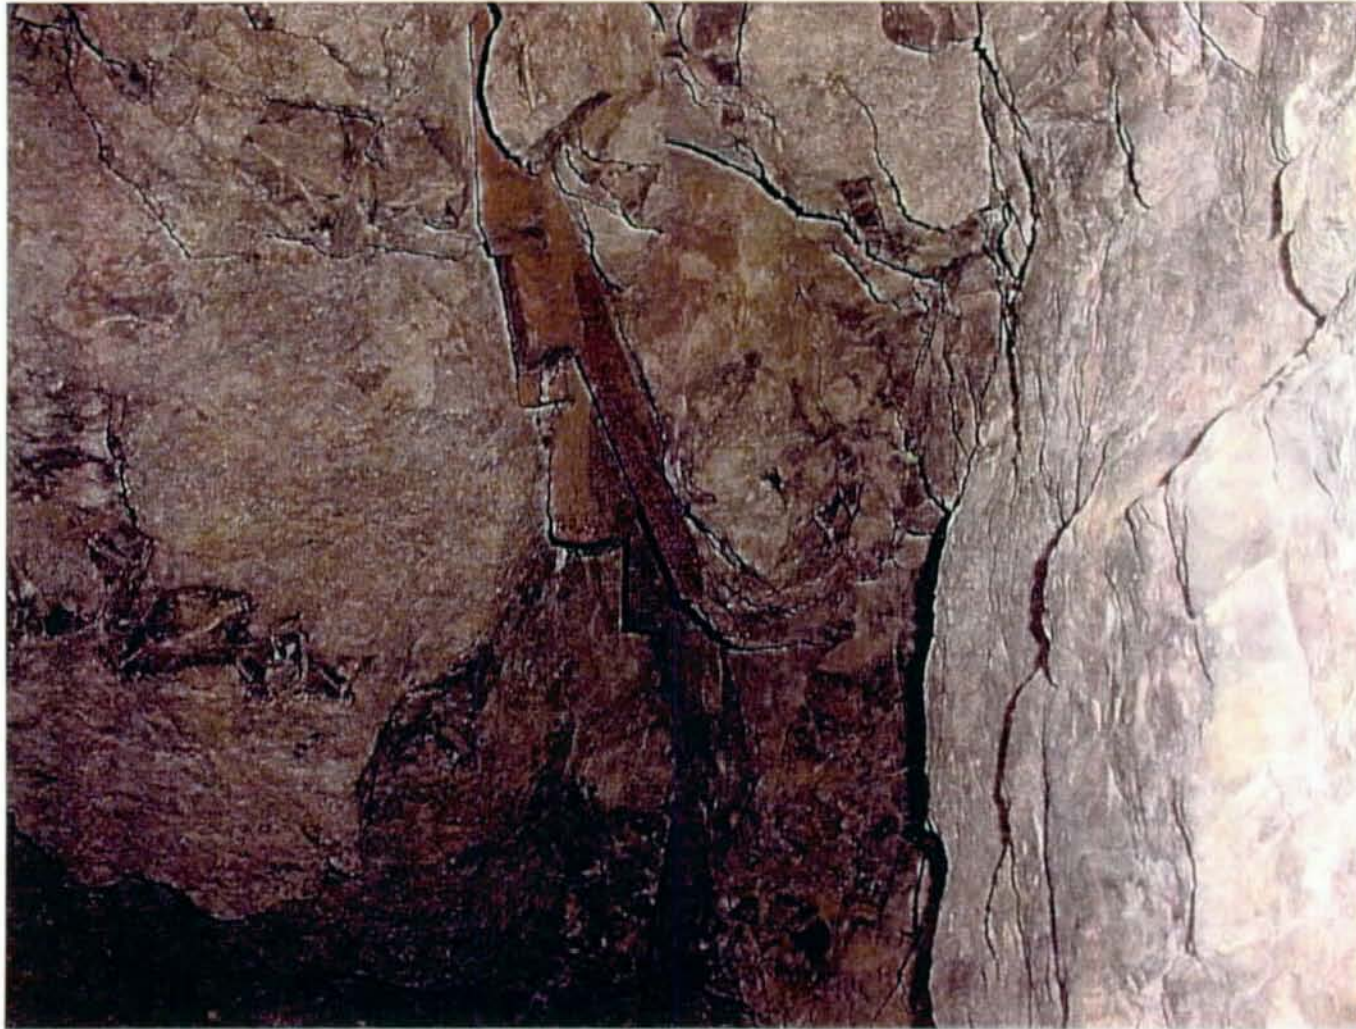
BASEMENT, SHOWING CONTINUING CRACK AND WOODEN WEDGES

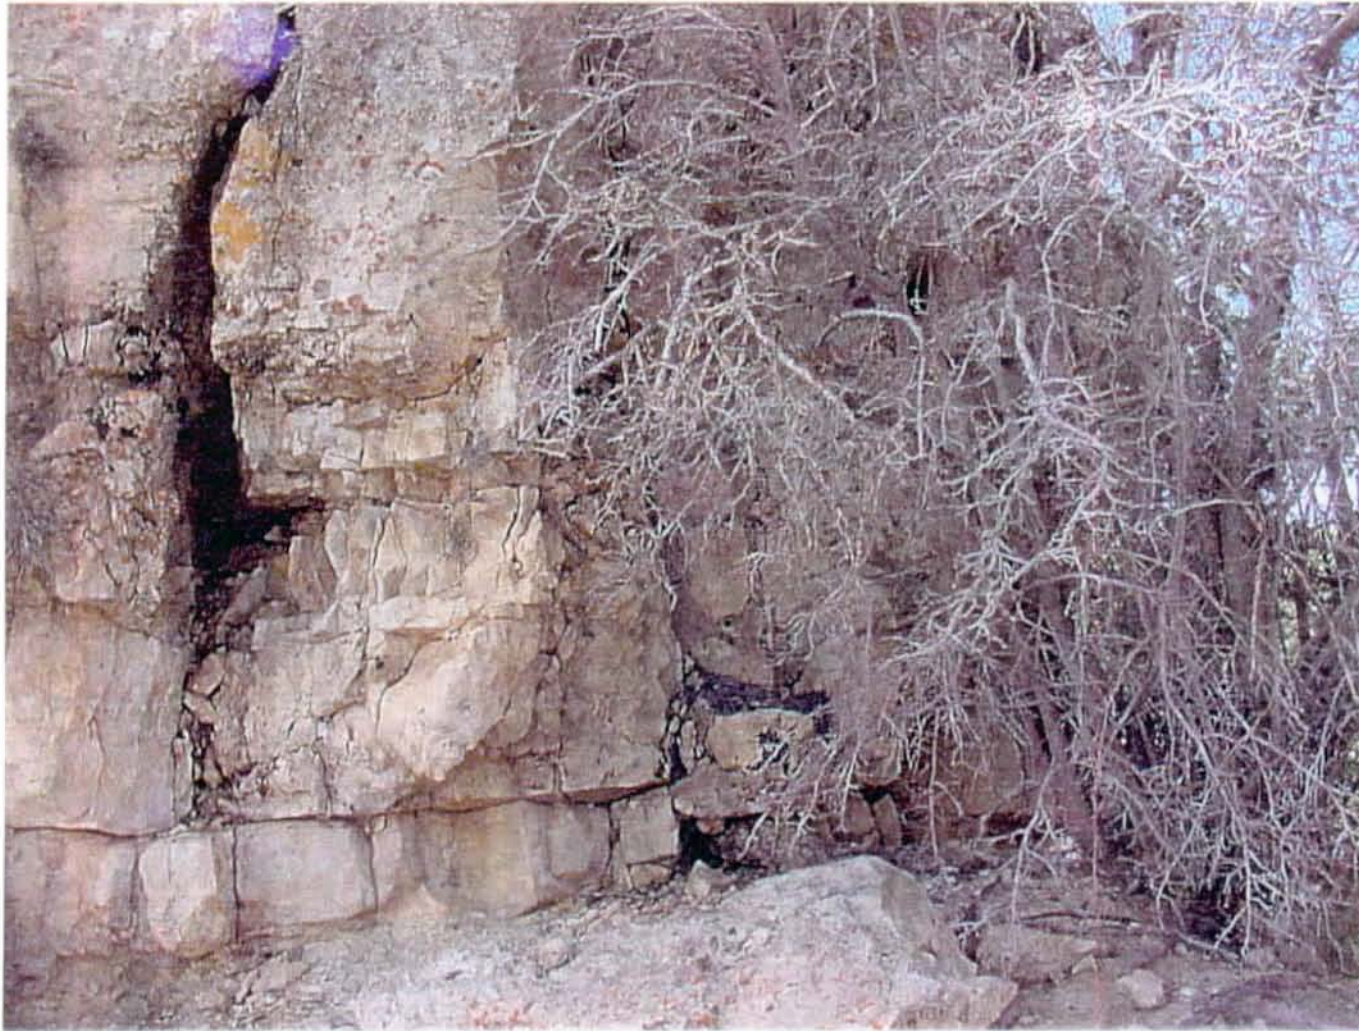
LARGE CRACK IN STRATA BELOW STRUCTURE

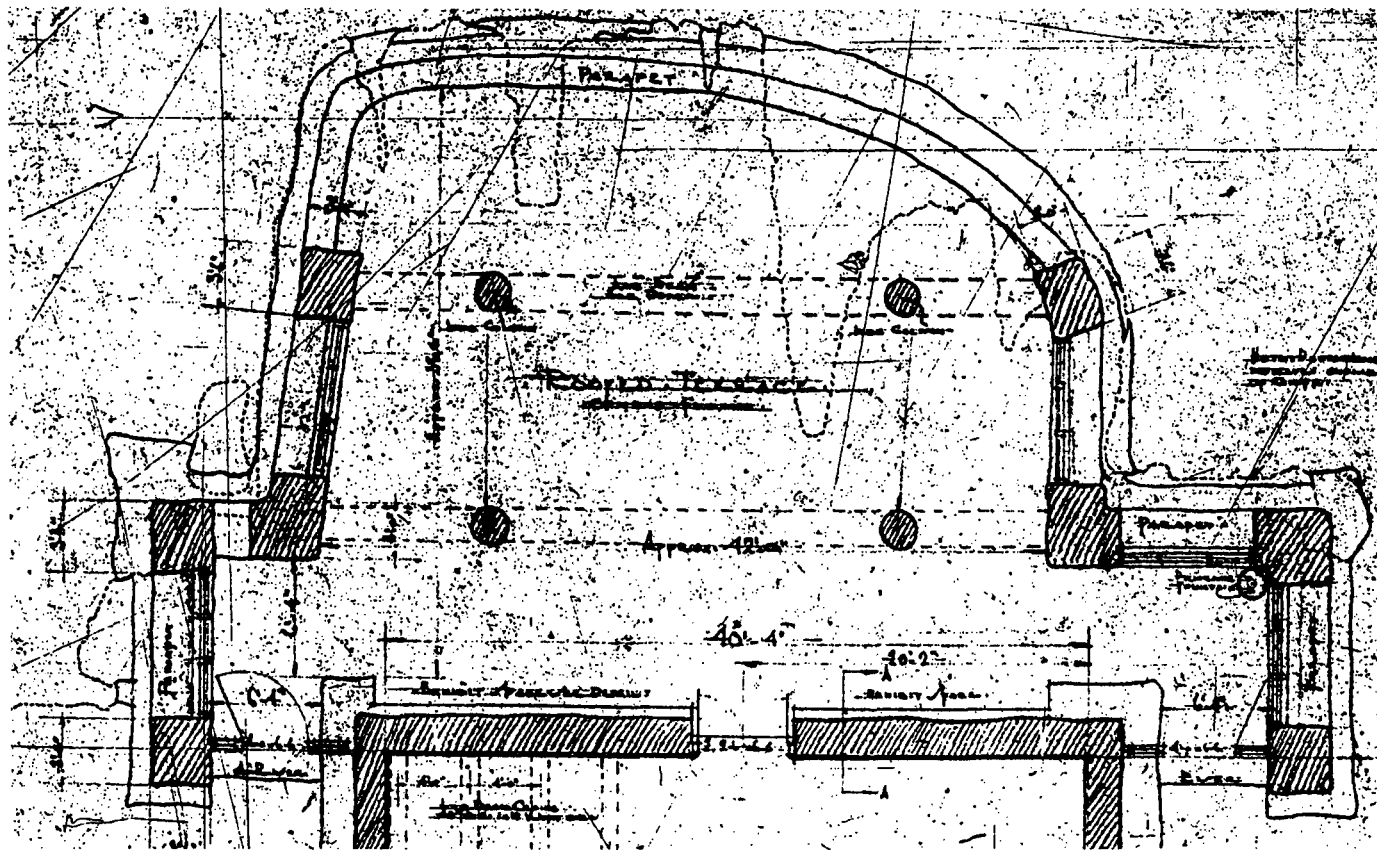
PORTION OF ORIGINAL FLOORPLAN SHOWING VOIDS BELOW STRUCTURE
