APPALACHIAN CLUBHOUSE

Great Smoky Mountains National Park
Elkmont Historic District
Sevier County, TN

HISTORIC STRUCTURE REPORT

February 17, 2009

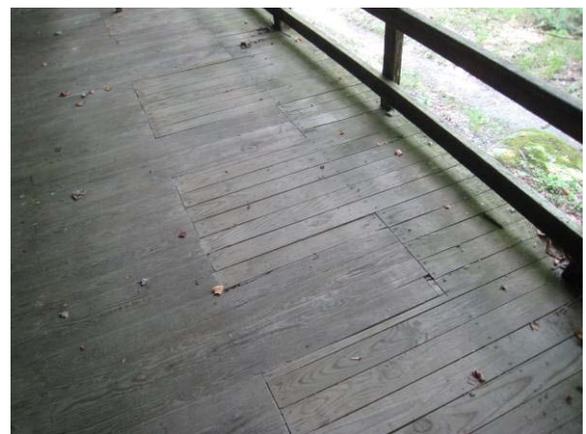
boards have been replaced along the front edge of the porch. The new and old boards create a seam with a distinctive dentil pattern. Another location with replacement material is at the roof deck in approximately the exterior, middle, side of the porch. Here the deck boards measure 1" x 5¼" and are stained. The earlier decking consists of 1" x 8" plank-boards.

Figure B- 4. Replacement deck boards at east porch.

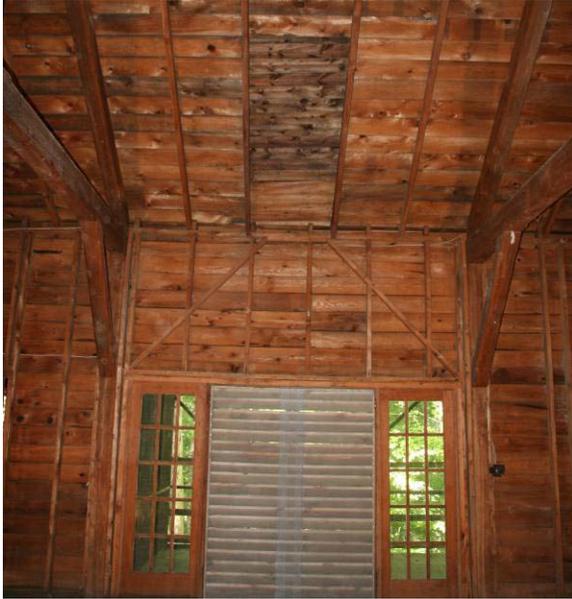
In between Room 101's roof trusses, some of the deck boards along the east and west slopes of the gable roof have been replaced. The location and size of the replacement areas suggests that these boards may have enclosed previous dormer windows.

Figure B- 5. Replacement roof deck boards are darker than the originals.

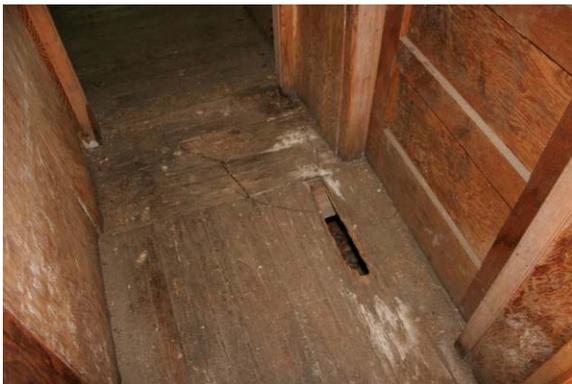
In the far southwest corridor and room (104D and 111 respectively) there is a conspicuous change in direction and size of the floor boards. The resulting seam indicate previous changes to the room configuration.

Figure B- 6. Change in floor board direction and width at south end of Room 104D.

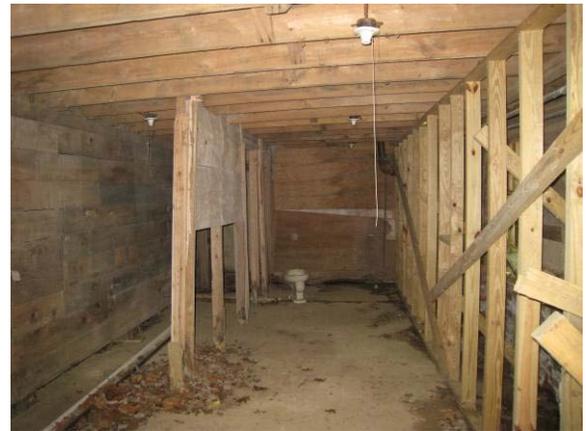
In the long rectangular basement room (Room 002B), wood framing remains from previous partition walls and later reinforcing. The wall covering has been mostly removed on the older framing.

Figure B- 7. Stud framing in Room 002B. The framing to the left (east) appears older than that on the right (west).

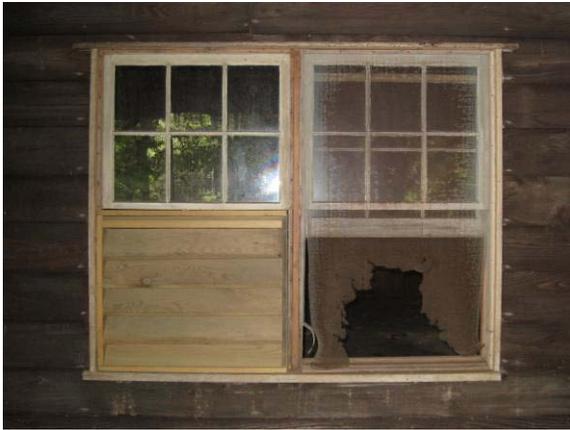
A 1998 condition assessment conducted by the NPS Historic Preservation Training Center helps date later alterations. The Park has carried out several stabilization and mothballing projects since late 1998, including the securing of doors and windows; installation of window vents and louvers; installation of brick and stone caps at the two chimneys; and installation of a few support posts beneath the main floor of the building.³

Figure B- 8. Louvers were installed in some door and window openings as part of the 1998 stabilization and mothballing project.

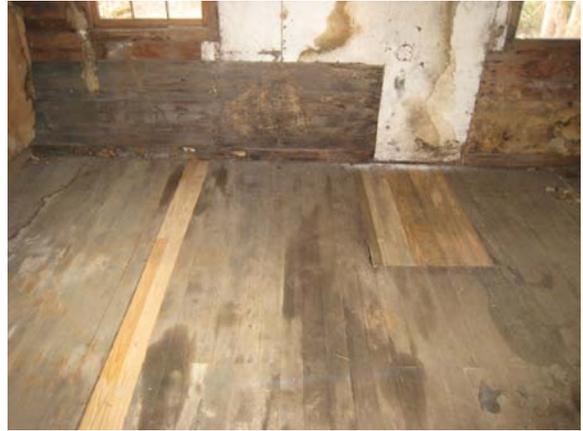
During the Fall of 2008, some additional repairs have been made on the interior. The repairs consist primarily of replacing damaged or rotted floor deck boards in the southwest corner of the Clubhouse (Rooms 110, 111 and 112).

Figure B- 9. Replacement floor deck boards in Room 111.

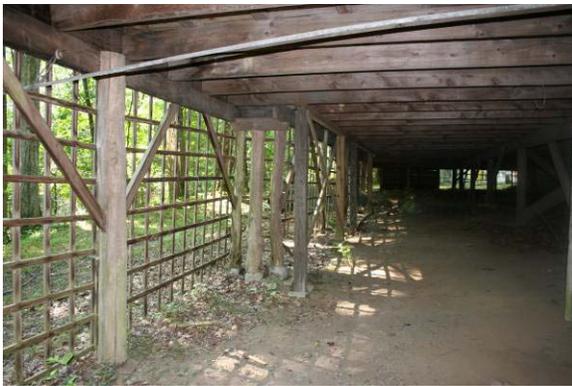
Along the exterior perimeter of the east porch, which runs along the entire, long, east elevation of the building, the piers are un-hewn, bark-covered, locust posts of various diameters. Each post rests on a river stone at grade, has two 2" x 4" diagonal braces and supports the 2" x 8" floor plate. These posts and braces appear to be the originals and there is some localized rot, primarily at the bottom ends of the posts. Shoring of treated lumber has been recently added as supplemental support.

Figure C- 3. Log posts on river stone. East edge of East porch.

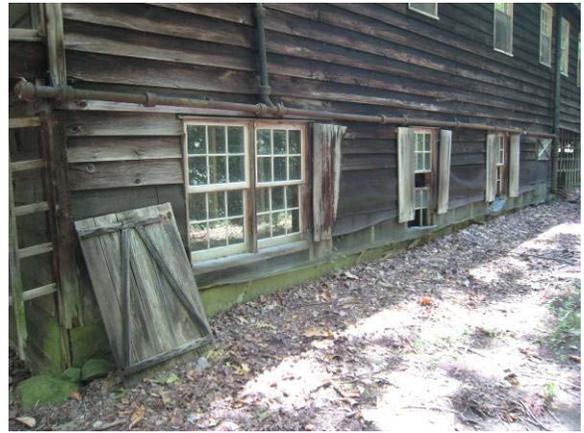
Figure C- 4. Damaged siding, windows and shutters along west wall.

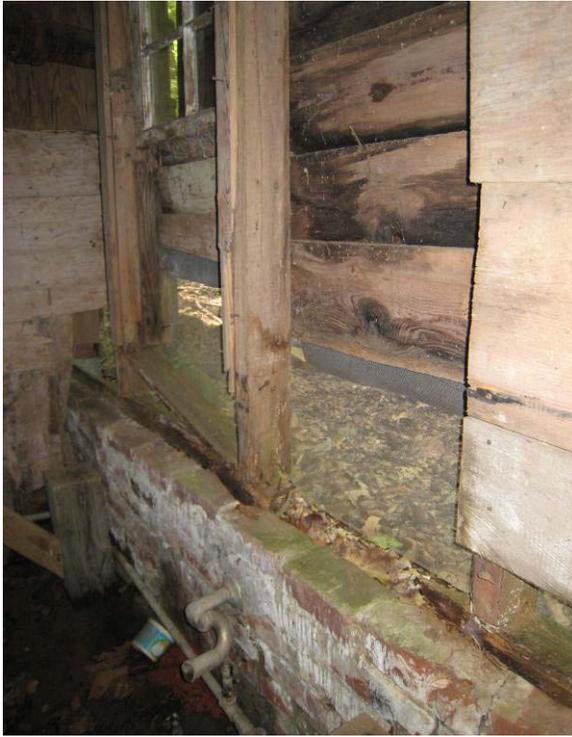
Along the north section of the west elevation, at the rooms enclosed at grade, there is a low, one-wythe deep, stuccoed-brick wall, apparently original, that supports the wall posts. This area of the building has suffered from long- term water damage. Perhaps slow evaporation of rainwater runoff along the shady exterior, or the dampness of the interior baths, or both contributed to the damage. Whatever the reasons, both the brick wall and the adjoining wood elements have extensive deterioration. See *Figure C- 30*.

Figure C- 5. Interior view of brick wall at west elevation.

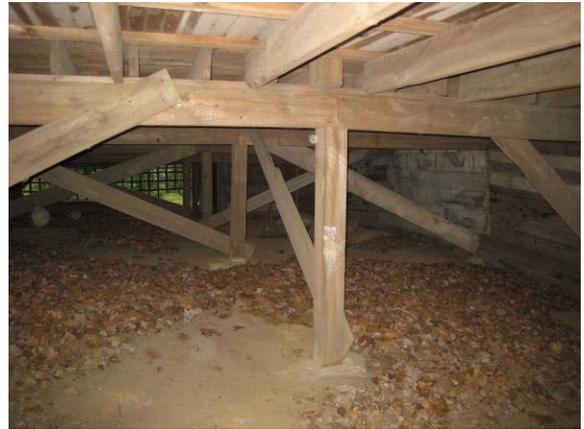
Girders beneath the club's internal spaces run north-south. Each girder is made up of three sections of 2" x 8s". Atop the girders are floor joists measuring 2" x 8" at 16" o.c. running east-west. These floor framing components appear to be original and, except for water damage along the

building's exterior and localized roof leaks, appear to be generally sound.

Figure C- 6. Floor framing.

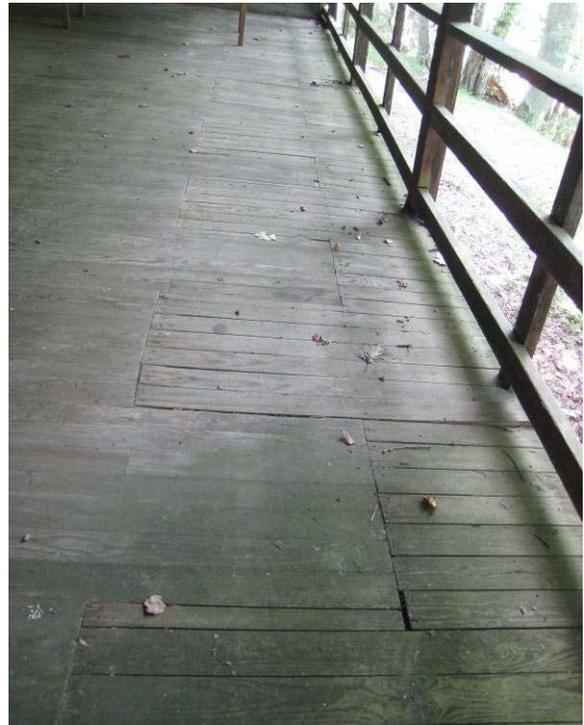
The porch flooring is constructed of tongue-and-groove boards that run east-to-west. A dentil shaped seam at the south end of the porch denotes where the floorboards change in width from one side of the seam to the other. This seam runs approximately north-to-south and corresponds to where floorboards were replaced. To the north and west of the seam, the boards appear to be older, if not original, and are 3¾" x 7/8". To the south and east of the seam, the boards measure 3½" x 7/8".

Figure C- 25. Seam at floor showing where replacement boards have been added.

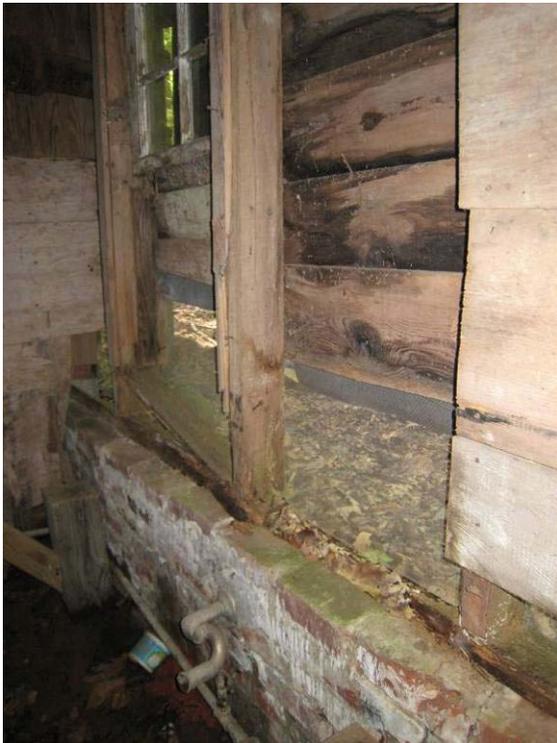
Figure C- 41. Missing bottom sash and modified upper sash at far south window along west wall or Room 002B.

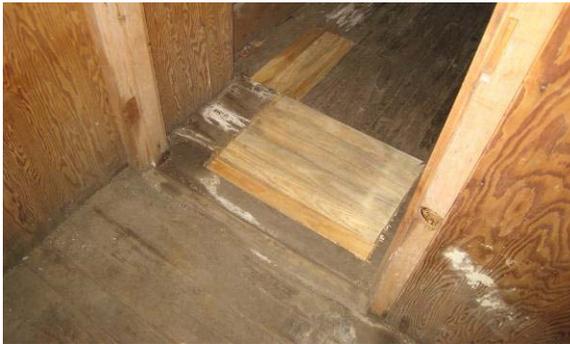
Figure C- 66. Floor at south end of Room 104D showing change in floorboards as well as damage to floor as a result of water infiltration.

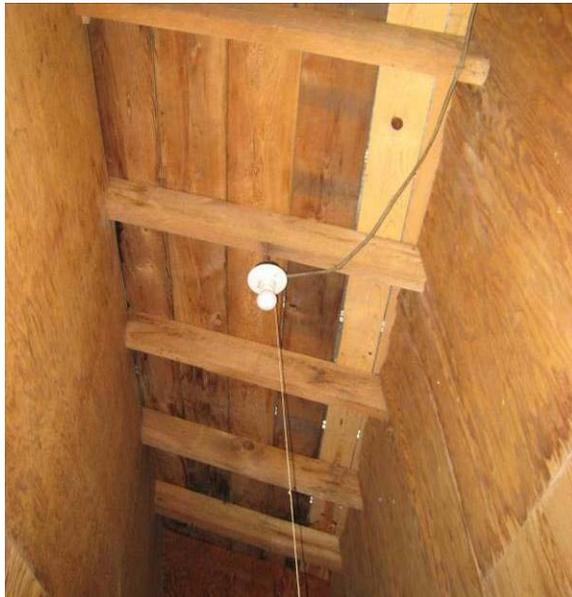
Figure C- 68. Exposed roof framing in Room 104D. Note replacement deck-board at the far right.

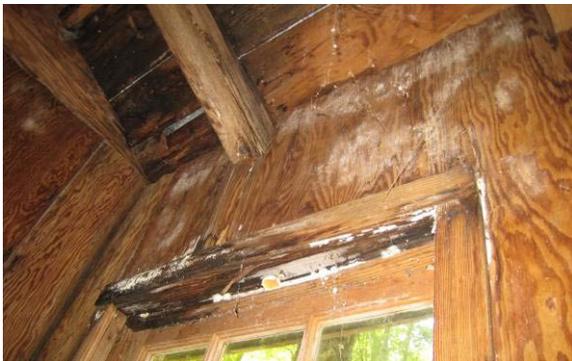
Figure C- 80. Rot and water staining at top of west wall and underside of roof.

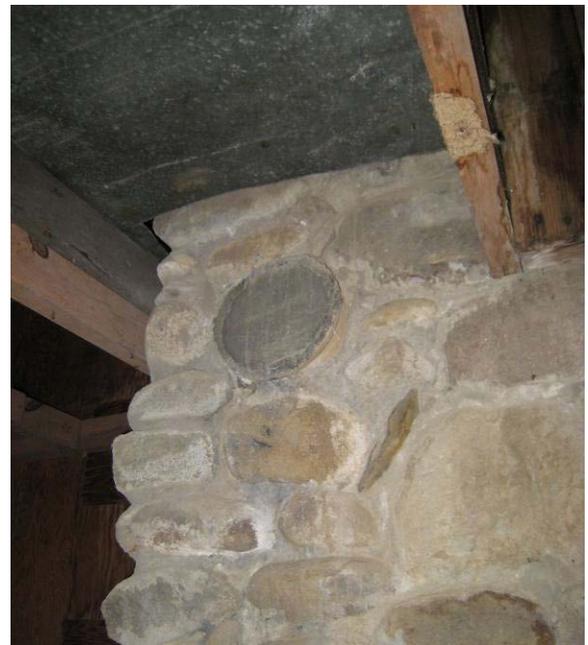
Figure C- 88. Patched flue in chimney along north wall.
