Creekmore Cabin
Elkmont Historic District
Great Smoky Mountains National Park
Historic Structure Report

September 2014

Historic Structure Report

Creekmore Cabin
LCS#: 264273

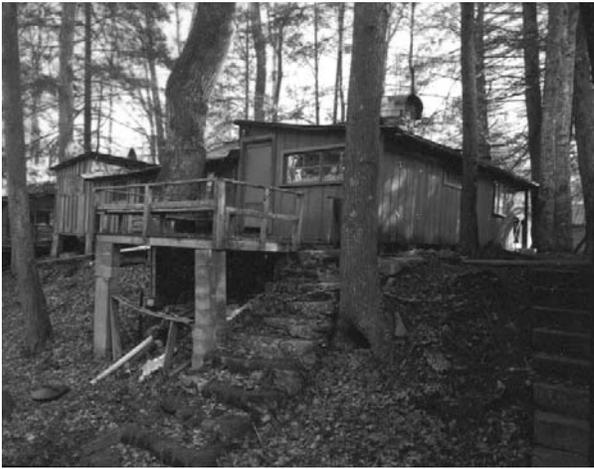
Figure 25. Raised deck at kitchen door seen in 2001, when the tall CMU piers are near collapse. (HABS-250-G-8)

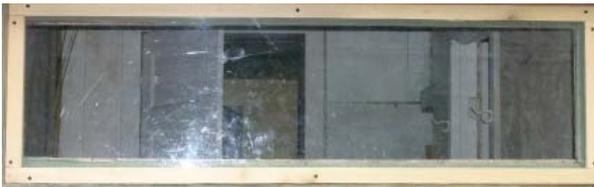
Figure 26b. A clear sheet of replacement glass was installed after the Van Gilder leaded window was stolen from the cabin in 2014. Interior features of the bathroom are visible through the glass in this image. (Oppermann, June 2014)

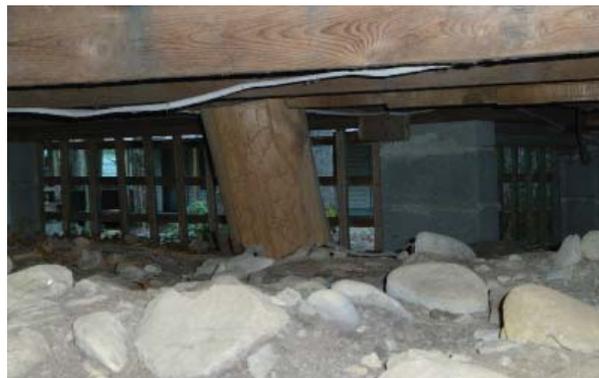
Figure 45. Typical unmilled foundation post and modern CMU pier.

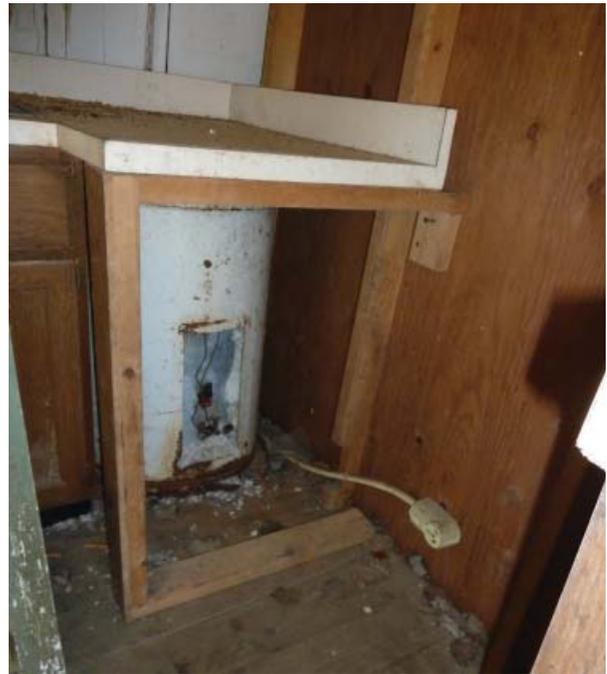
Figure 52. Inoperable hot water heater in the Kitchen (Room 108).

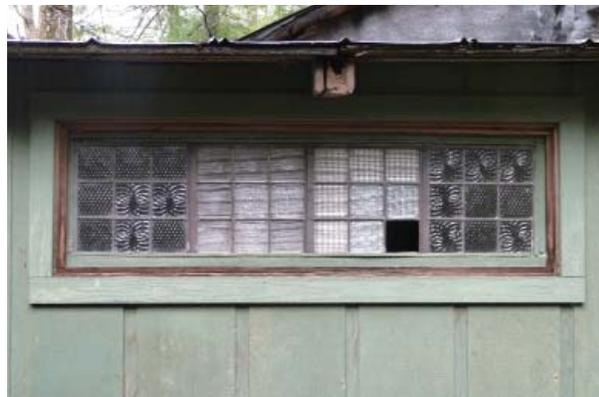
Figure 65. 36-light window on the south elevation, now missing.

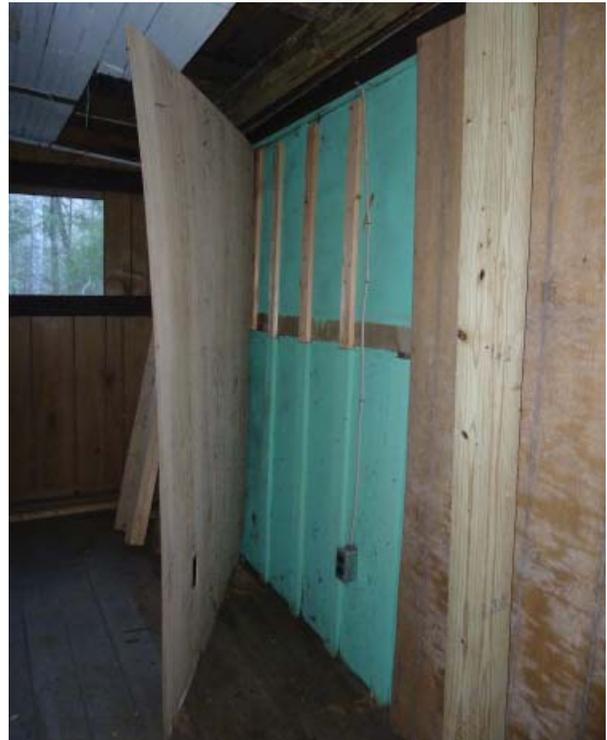
Figure 82. Paneling delaminating from wall of Northwest Bedroom (Room 105).

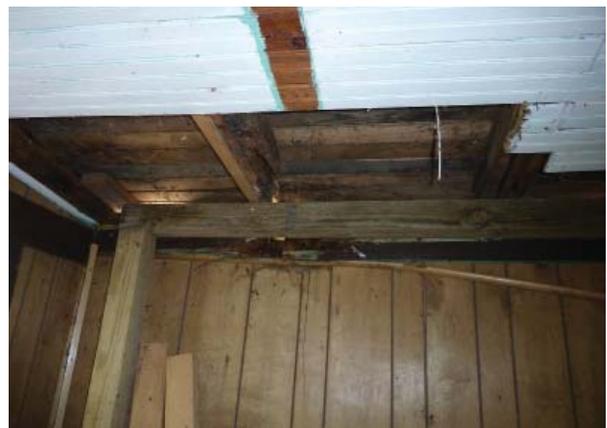
Figure 83. Poor condition of ceiling in Northwest Bedroom (Room 105).

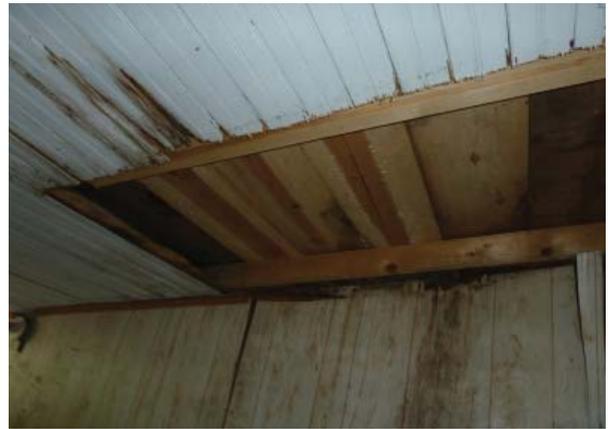
Figure 98. Patch in northwest corner of the ceiling.
