# Hale Cabin Elkmont Historic District Great Smoky Mountains National Park Historic Structure Report

# Historic Structure Report

March 2016

The Jaeger Company

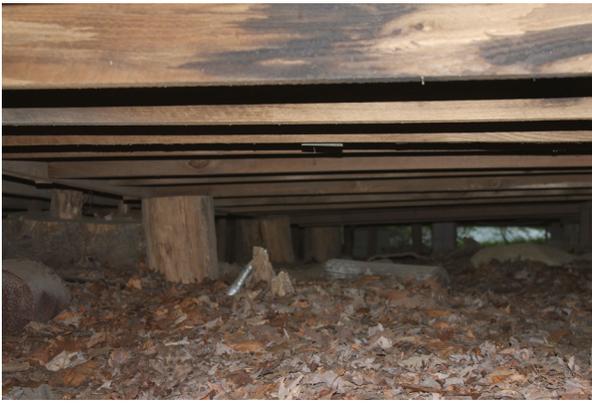
**Figure 15:** Log foundation piers under the main core.

The house's post-and-beam foundation features unmilled log piers under the main core and CMU piers under most of the rest of the house; some sawn timbers are also present. (Figure 15) The northeast corner of Room 111 rests on a large in-situ stone boulder that serves as the foundation pier. A number of the piers also use in-situ boulders as bases. (Figure 16)

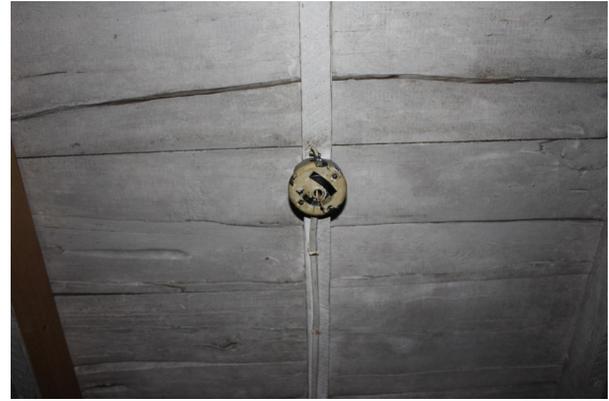
**Figure 21:** Ceramic light with hanging socket on rear

Electrical outlets and light sockets remain intact throughout the house although many of the electrical wires are missing. The electrical wiring that remains is cloth-wrapped insulated wiring. A few remnants of earlier ceramic knob and tube wiring are intact. Outlets are steel boxes mounted on exposed wall studs. A 240-volt outlet for a refrigerator is in the kitchen. Overhead ceramic light sockets, some with hanging sockets, are on the front porch, in the enclosed porch, and in rooms with ceilings. (Figure 21) The main core has no ceilings and, therefore, no overhead light sockets. No electrical service currently exists at the house.

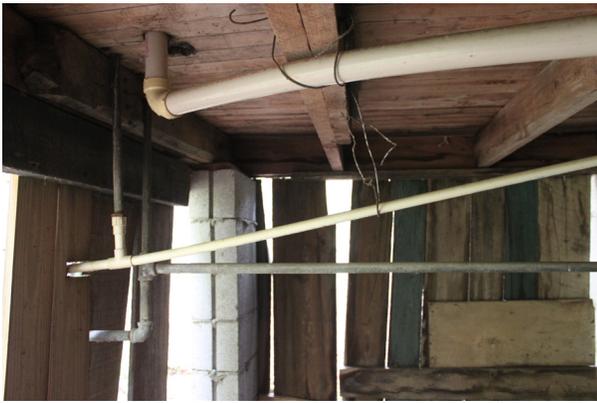
**Figure 22:** Water supply and drain lines to the kitchen sink.

front steps at the west front elevation. The house currently has no water supply. (Figure 22)
