# **ALFRED REAGAN HOUSE AND TUB MILL**

**HISTORIC STRUCTURES REPORT**

**GREAT SMOKY MOUNTAINS NATIONAL PARK  
TENNESSEE-NORTH CAROLINA**

**OCTOBER 12, 1969**

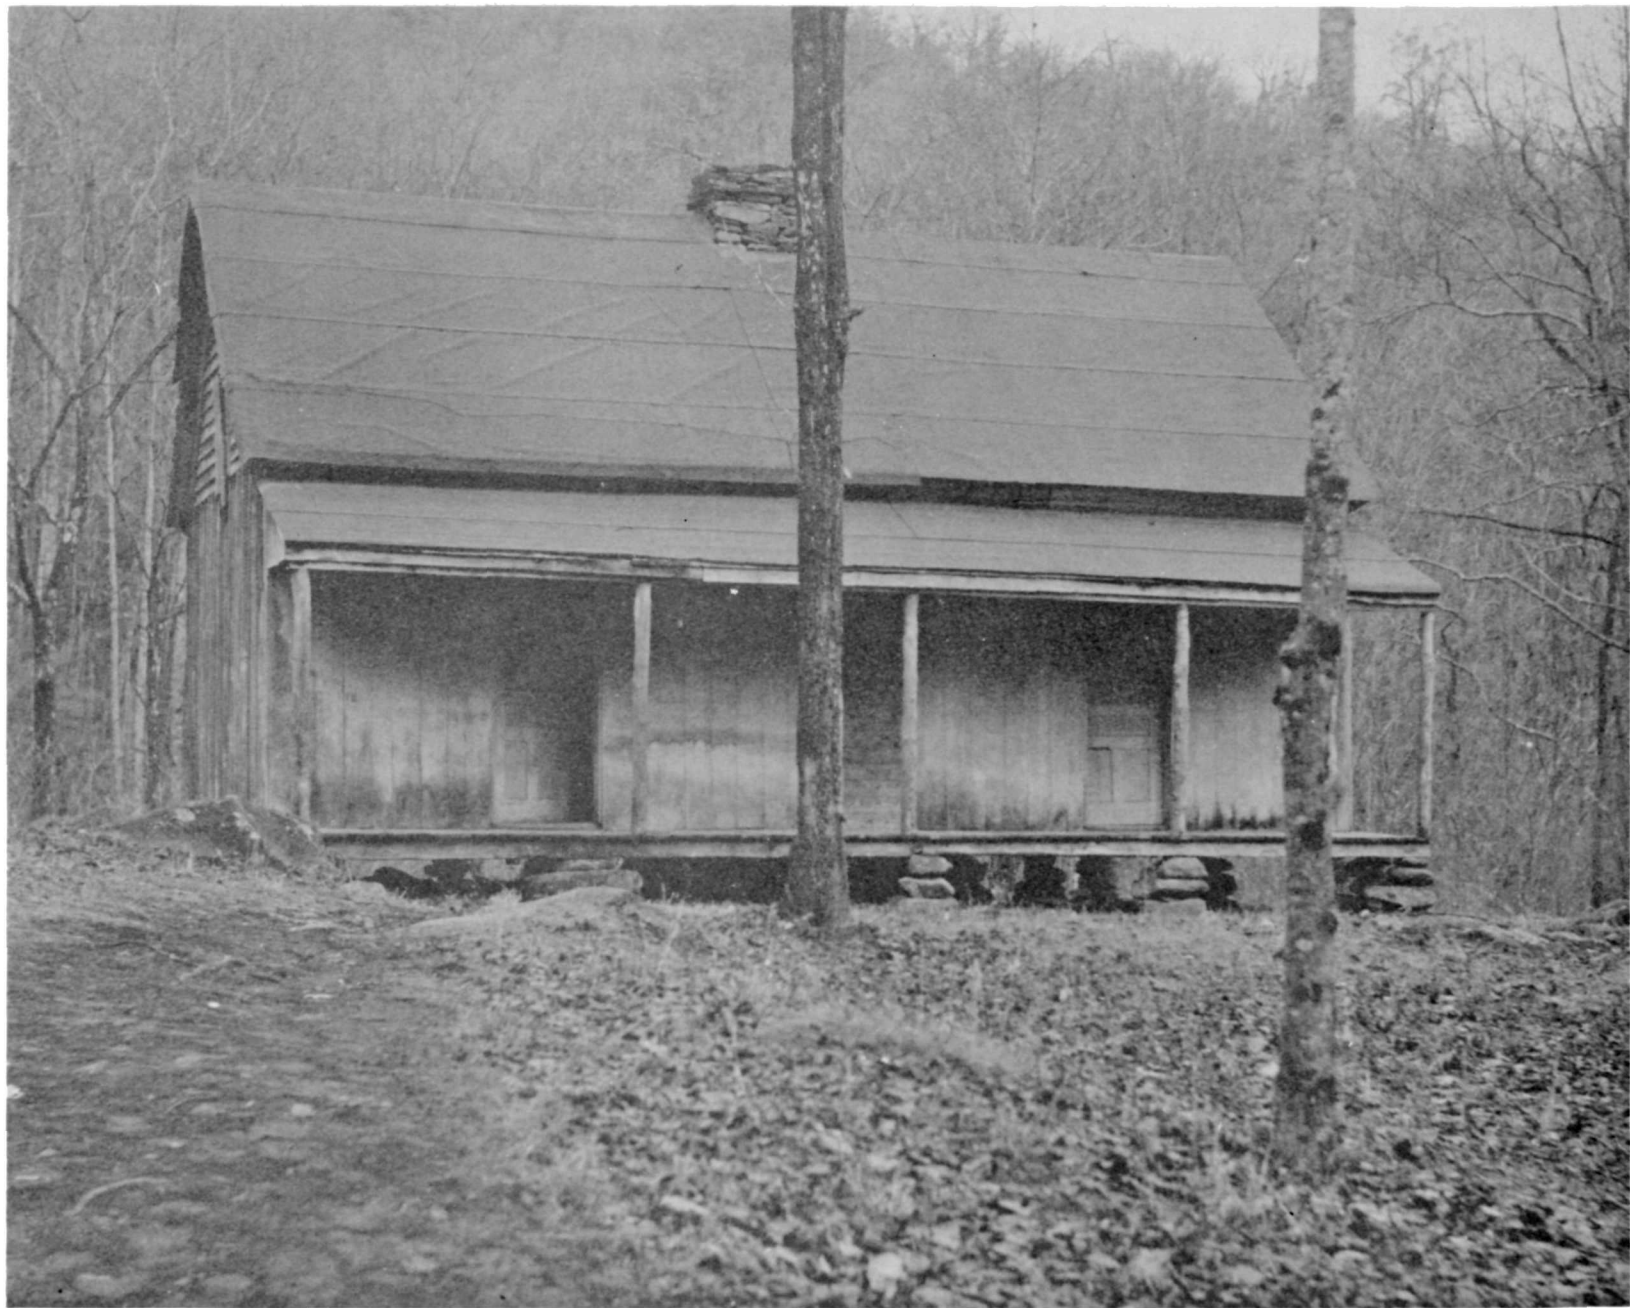
PLATE VI

General view of Alfred Reagan house. Note modern roof installed by the Park Service to protect the building.

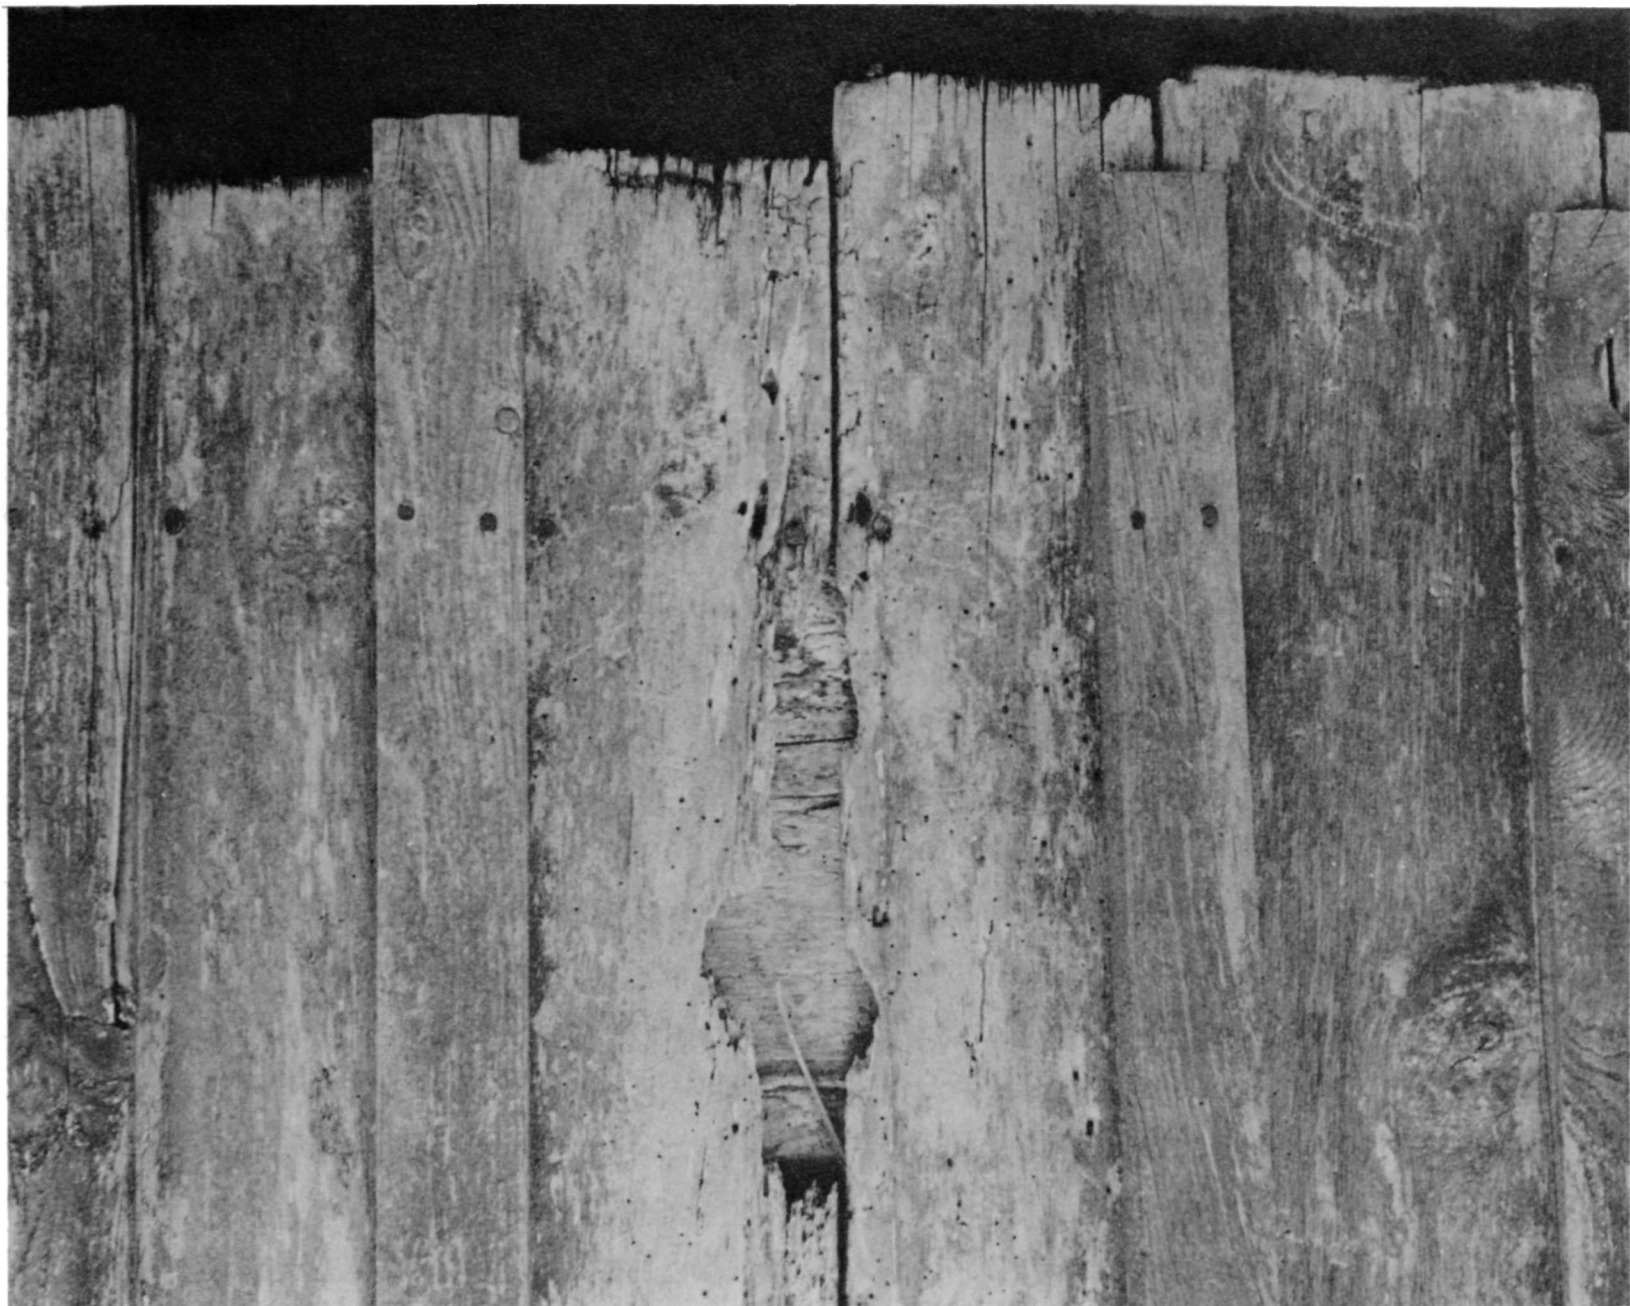
PLATE VII

This photograph shows the deterioration of the  
vertical board and batten siding.

Exterior Walls - Replace all rot infected siding boards and battens. Renail loose boards and battens.

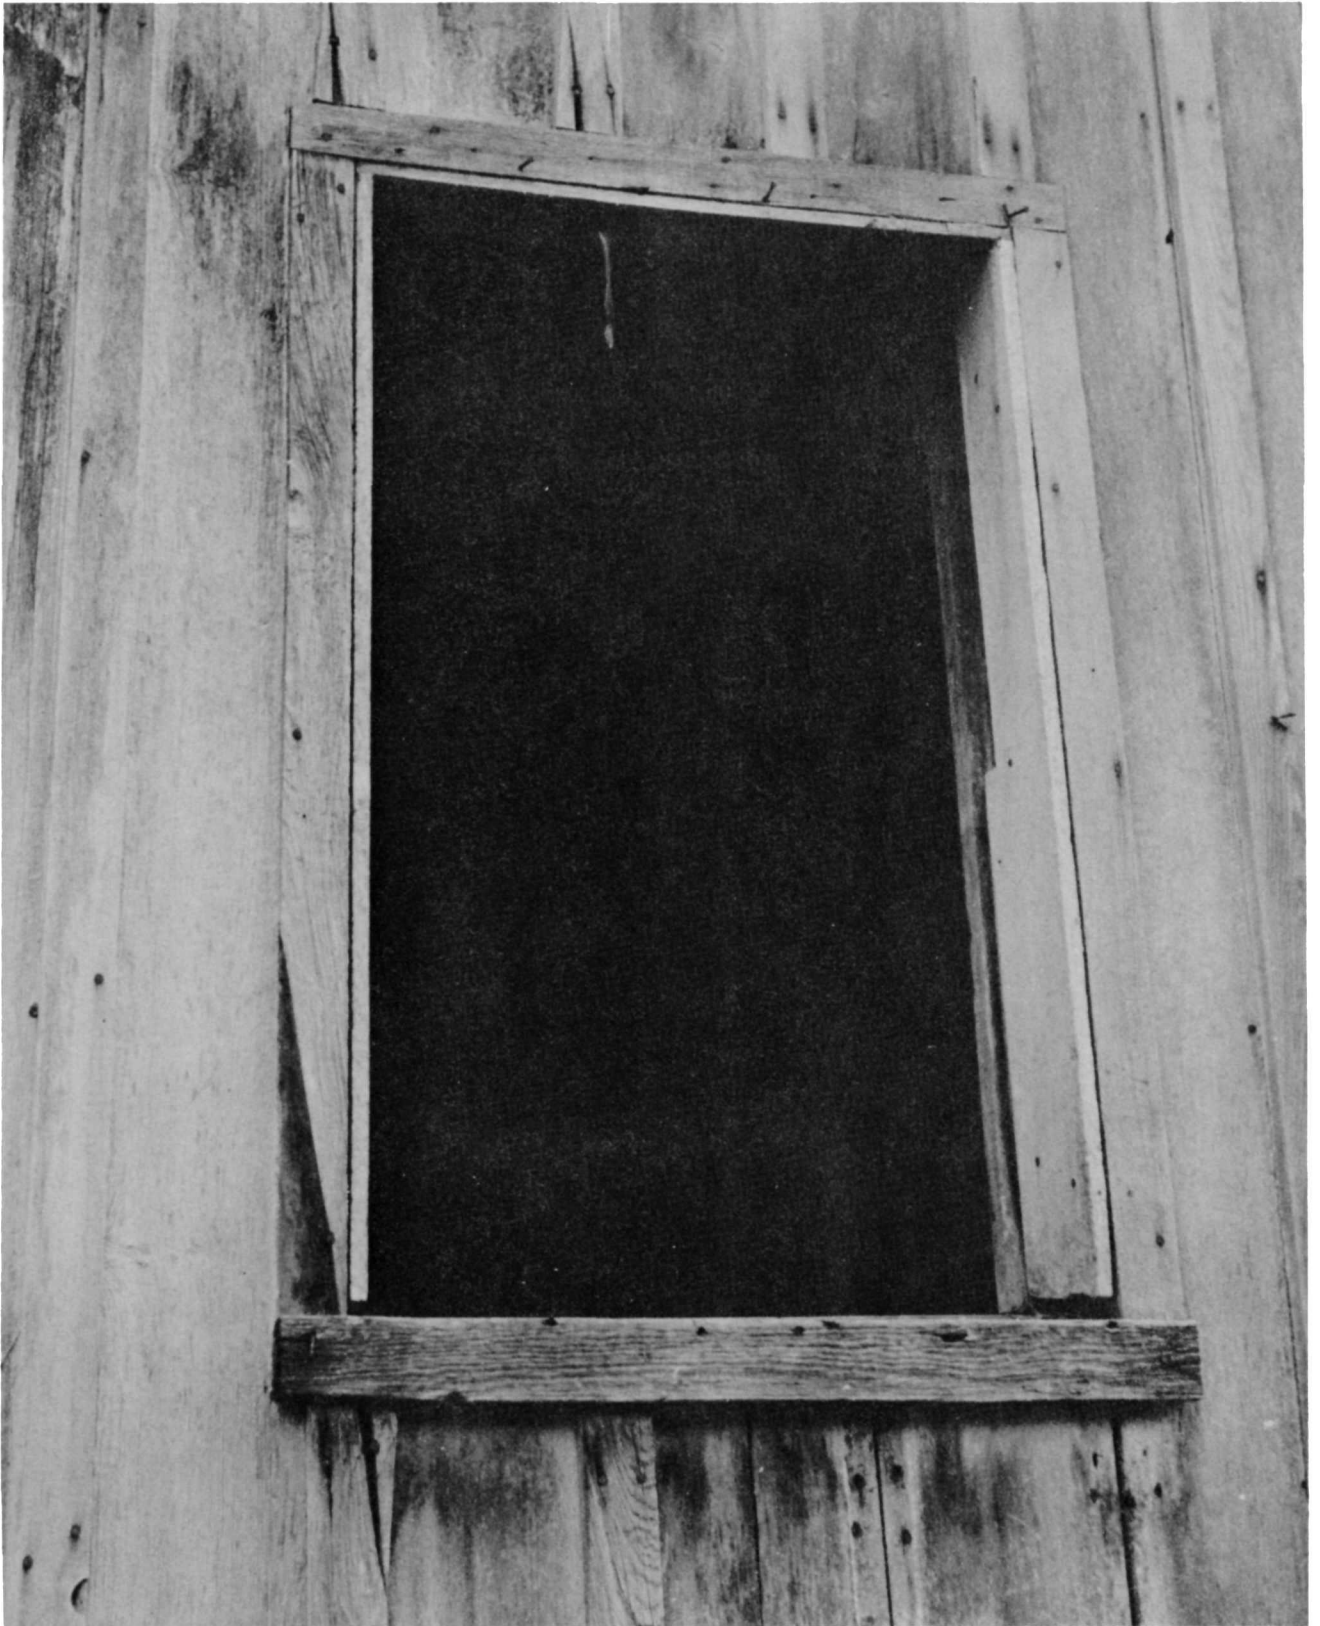
PLATE IX

All sash are missing. The frames and trim are infected with rot. Note splitting of the trim and missing battens.

Windows - Repair or replace frames. Install sash of the historic period. Install necessary hardware of the historic period.

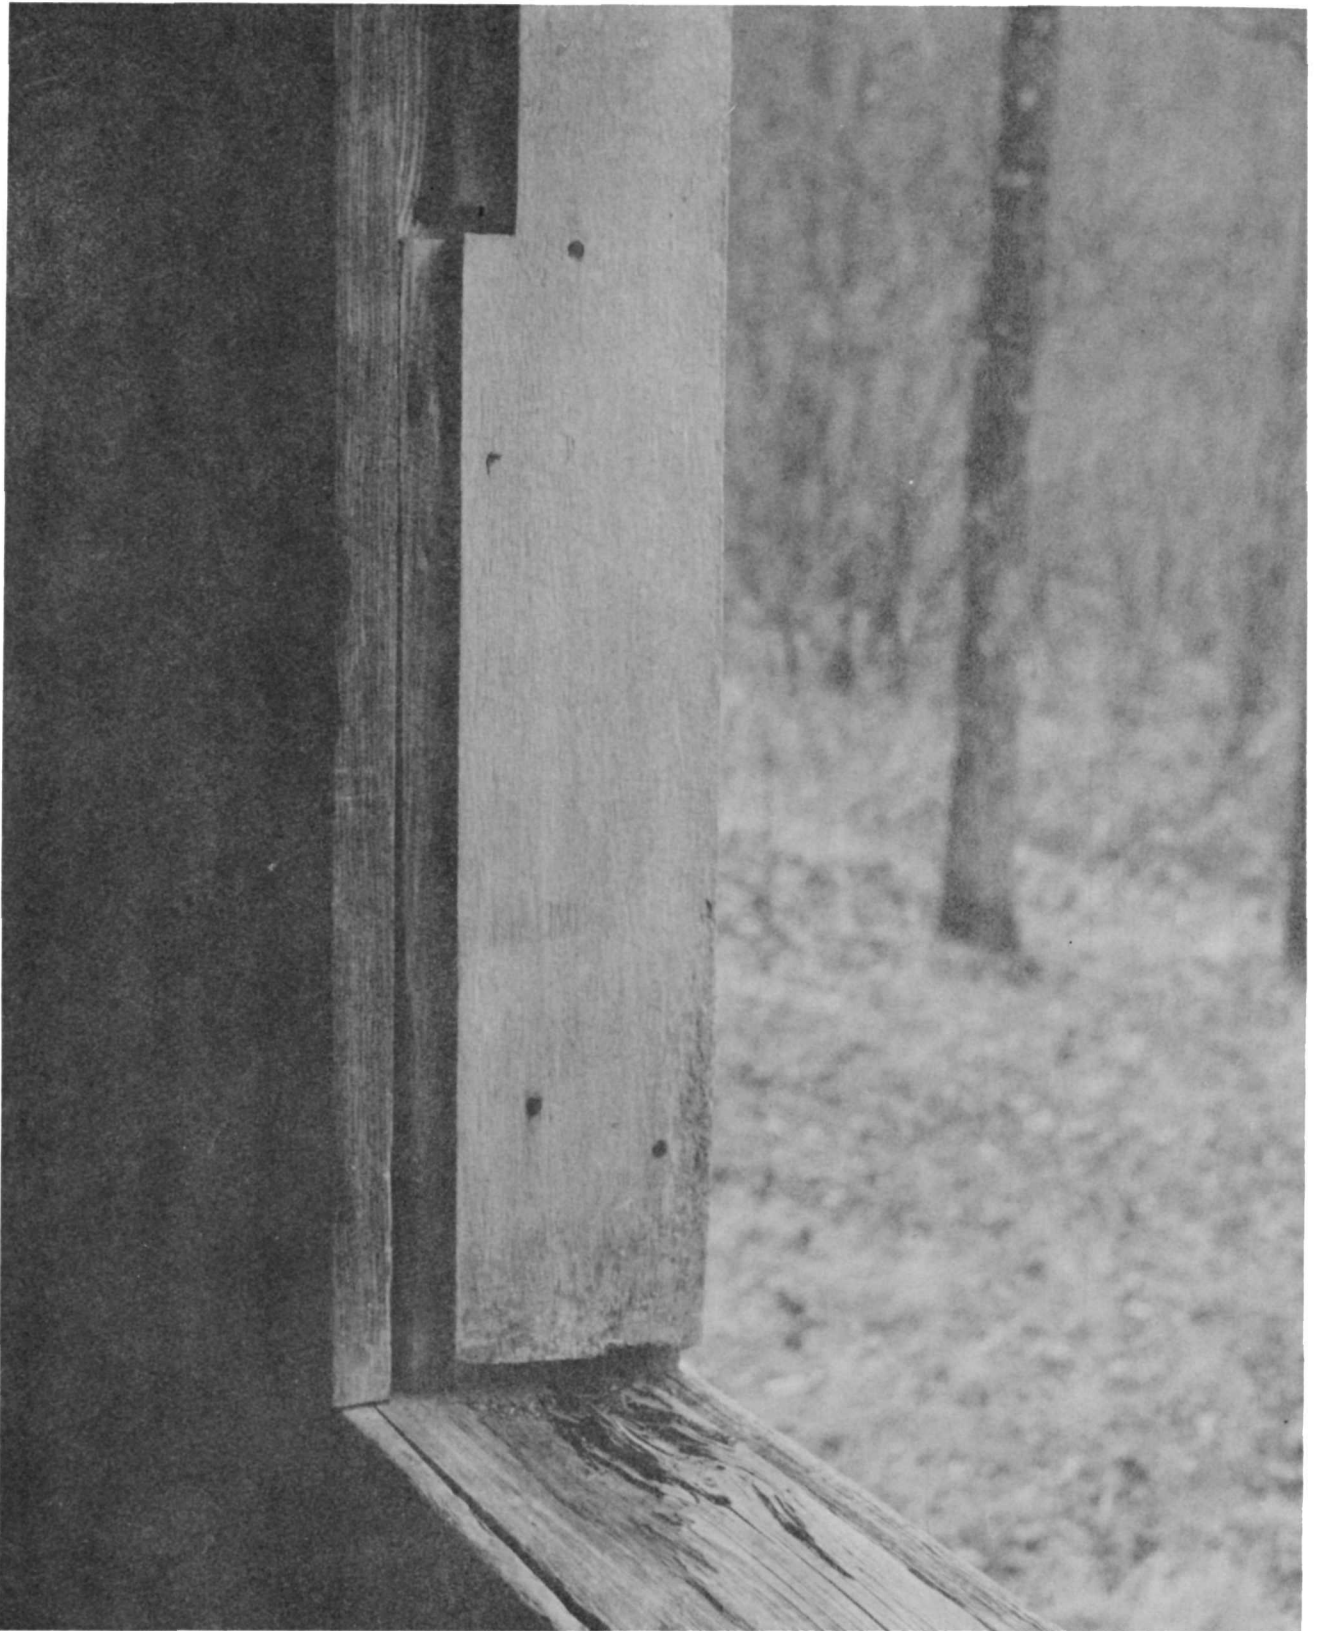
PLATE X

The top sash in all the windows was fixed.

The sill is infected with rot.

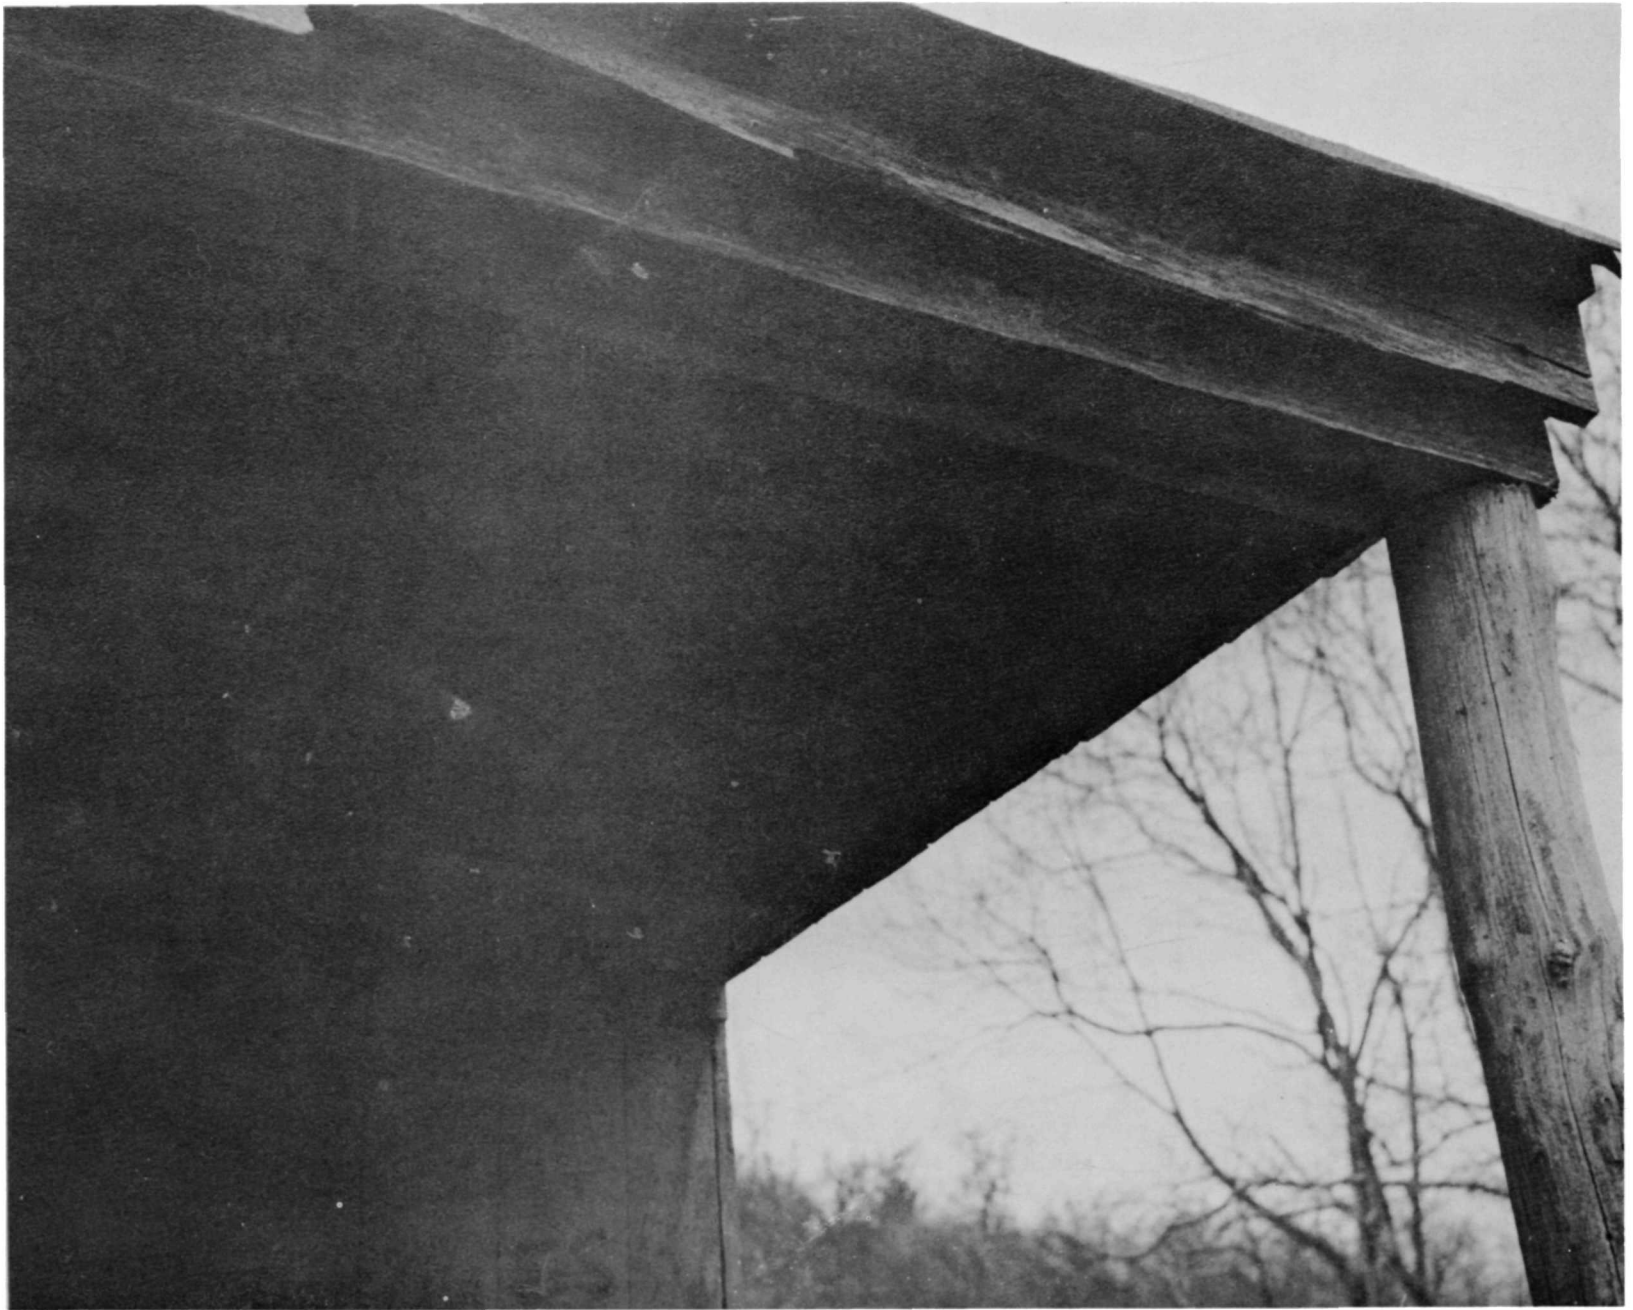
PLATE XI

The porch beam and fascia is infected with rot.

Porch - Inspect floor framing and replace all timbers infected with termites and rot. Replace flooring. Remove log posts and install sawn posts. Replace porch roof beam, ceiling joist, rafters and fascia. Remove modern sheathing and roll roofing and replace with wood shingles and shingle laths.

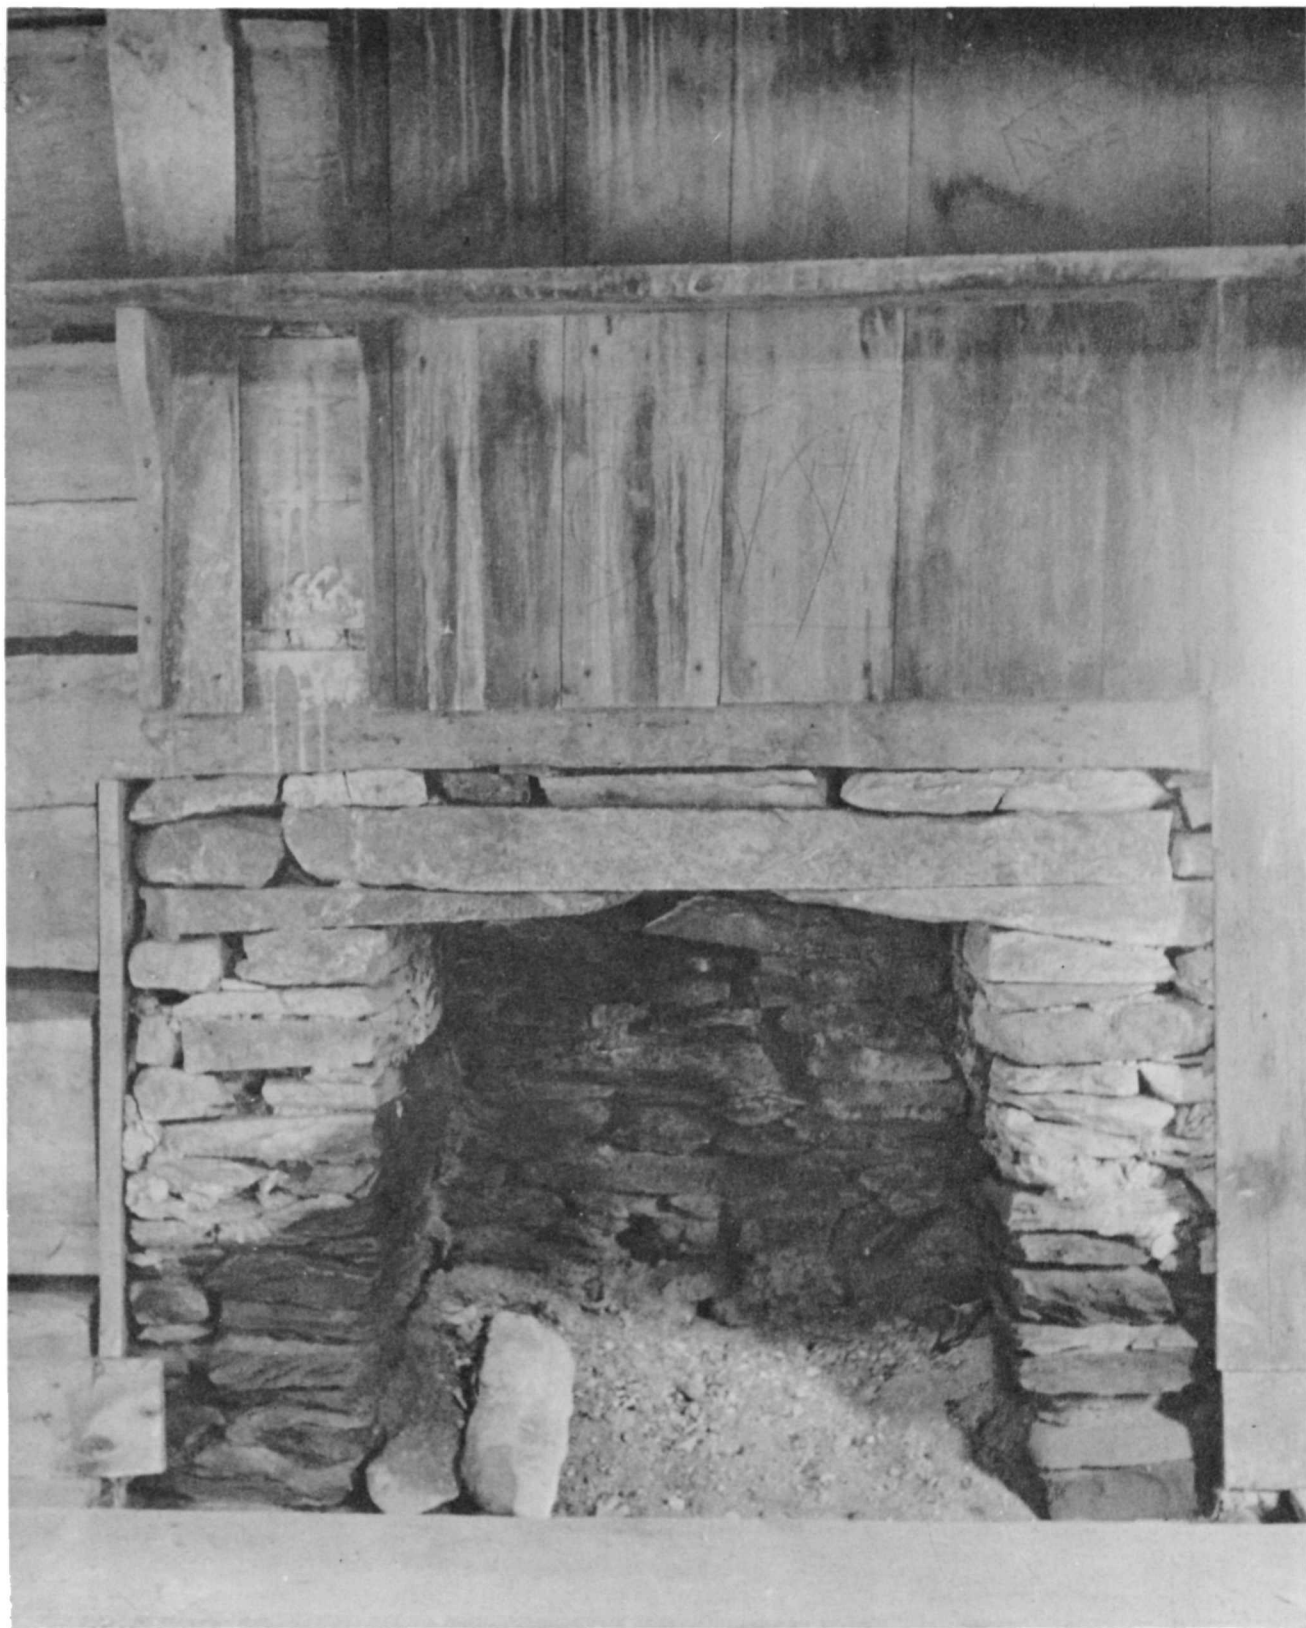
PLATE XII

Much of the interior paneling is missing.

The fireplace and hearth must be repaired  
and repointed.

Chimney and Fireplaces - Inspect foundation and reinforce as needed. Repoint with mud mortar where protected from the weather. Repoint with cement mortar where exposed to weathering. Cement mortar to be colored to match mud mortar. Rebuild fireplaces and hearths. Repair mantel in bedroom and replace mantel in living room.

First-Floor Interior Walls and Partitions - Replace any interior board paneling seriously affected with termites or rot. Renail loose boards. Replace missing base in living room.

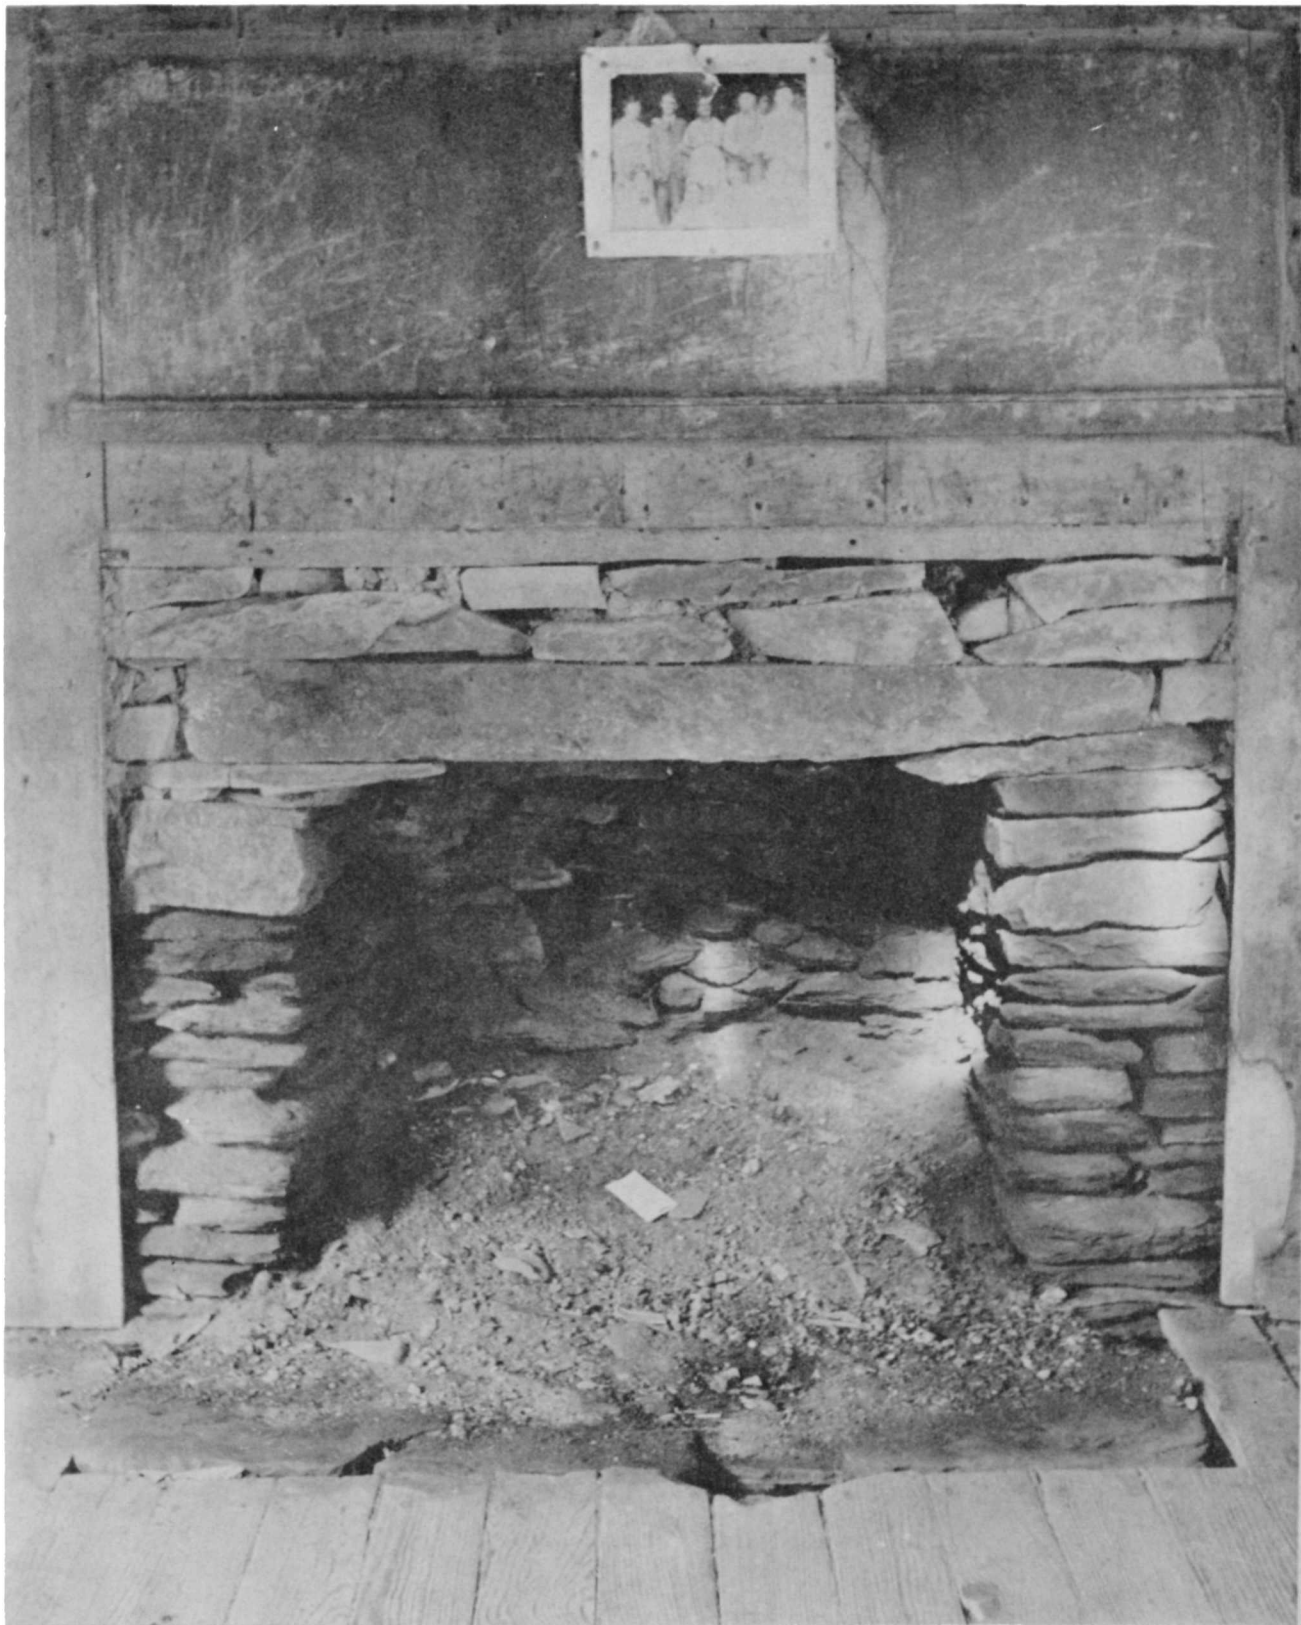
PLATE XIII

The mantel in the living room is missing.

The fireplace, hearth and chimney will require  
repair and repointing.

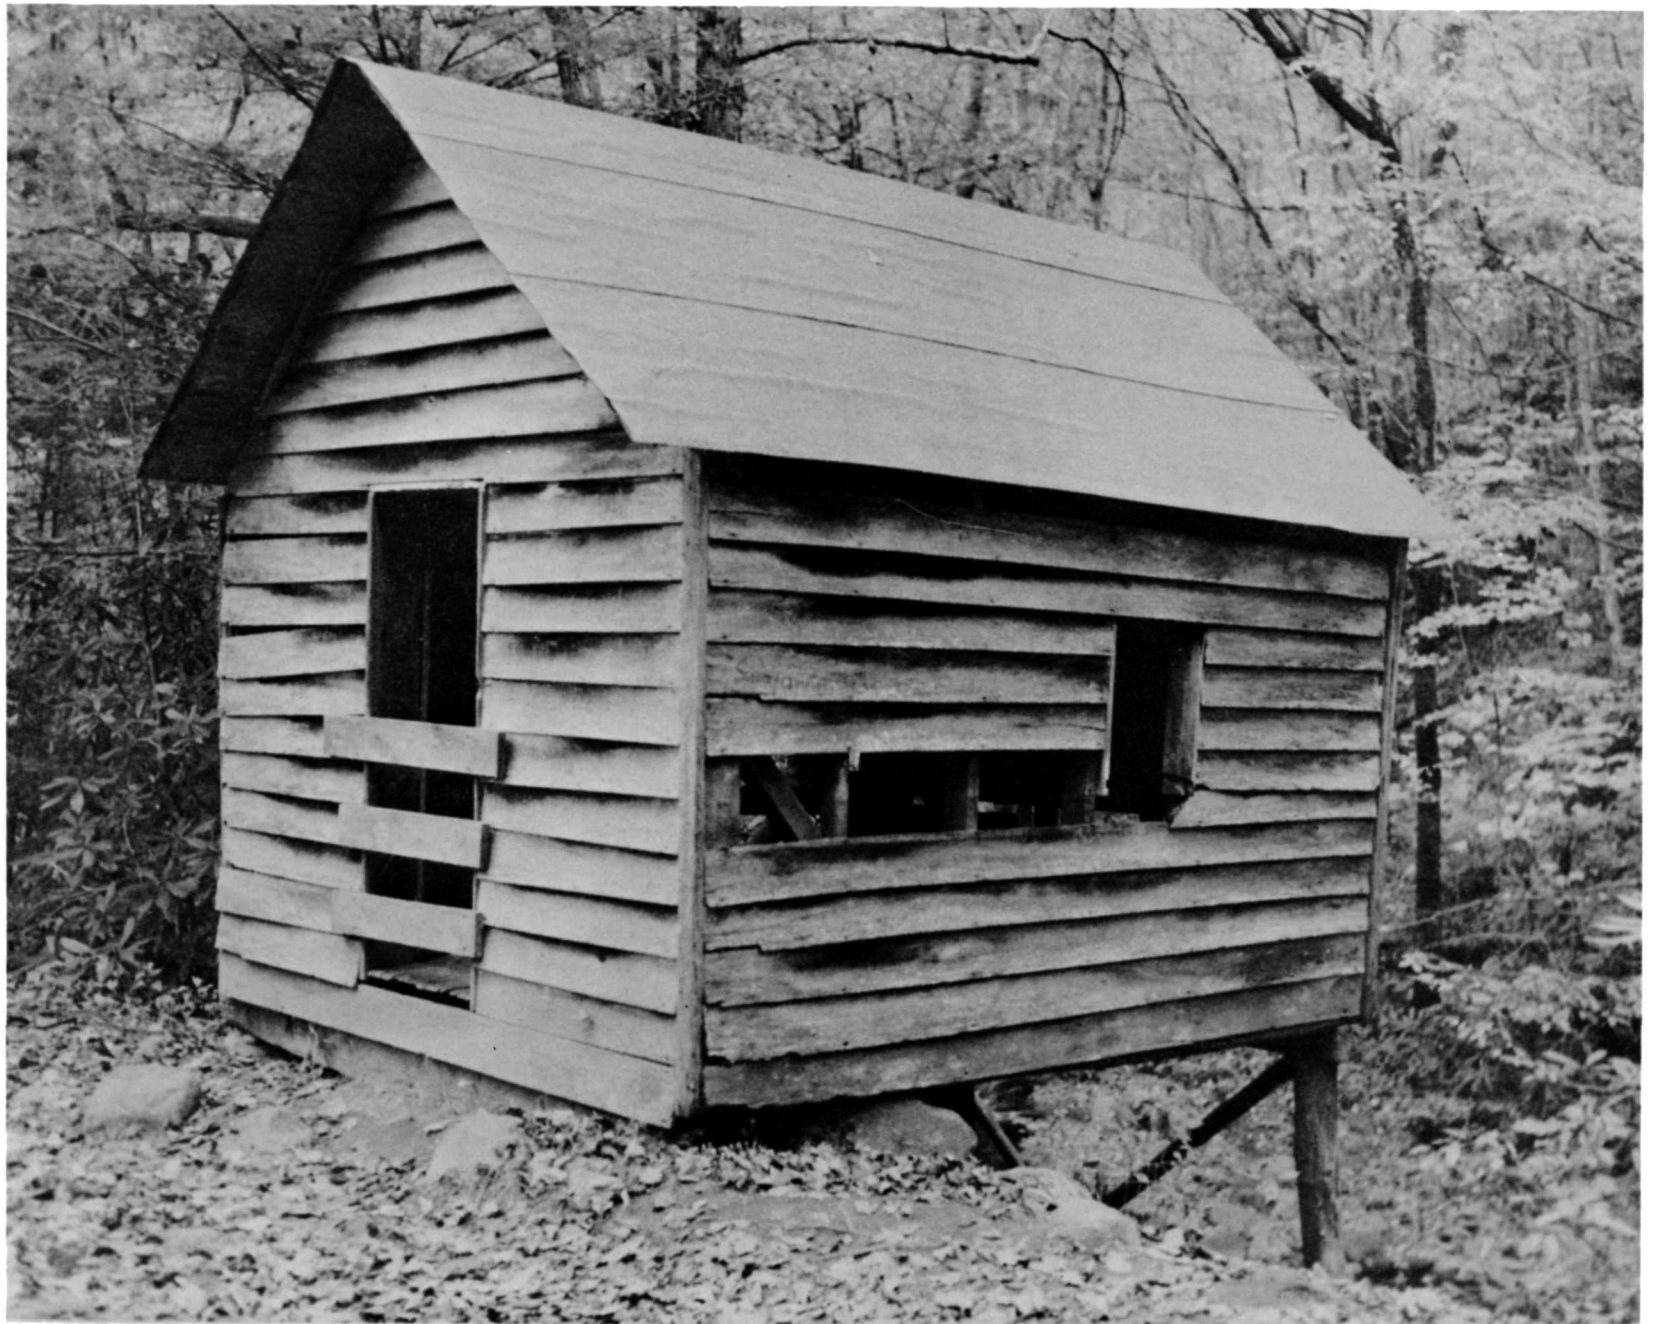
PLATE XIV

General view of Alfred Reagan Tub Mill. Much of the lap siding is missing and most of the remaining boards are infected with rot and termites. Modern roof was installed by the Park Service to protect the building.

Exterior Walls - Replace sills, corner posts, studs, plates and bracing. Reuse existing timbers where practical. Replace rotted siding. Salvage existing siding for reuse where practical. Replacement lumber shall match the existing members in size, material and tool marks. Replace rotted and missing corner boards.

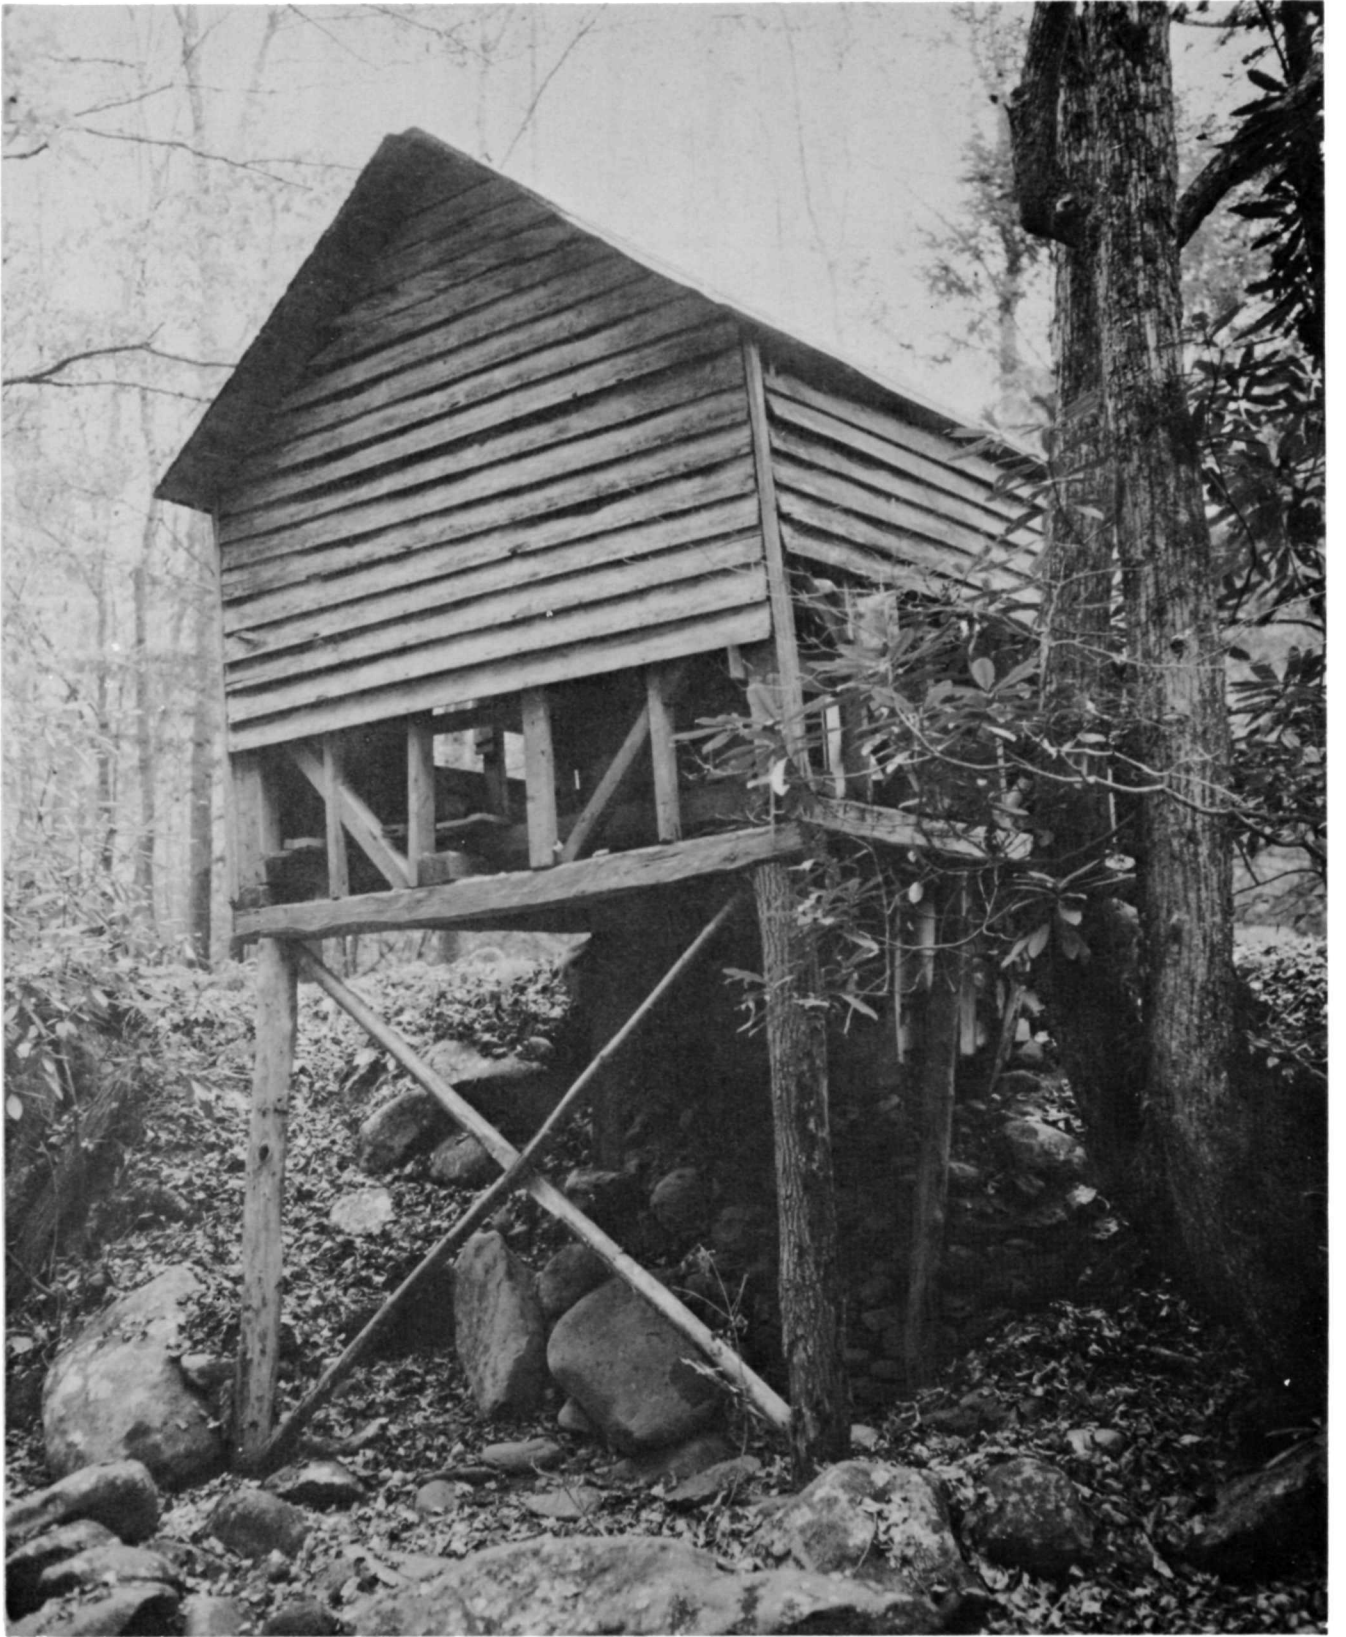
PLATE XV

Foundation - The front sill rests on loose stones. The rear of the building is carried on peeled log posts or underpinnings, which are undoubtedly replacements of the original timbers. There is rot in the lower ends of the posts.

Log post supporting the rear of the mill  
are infected with rot.

Foundation - Install concrete footings under stone piers and log posts. Replace any rot or termite infected post and bracing.

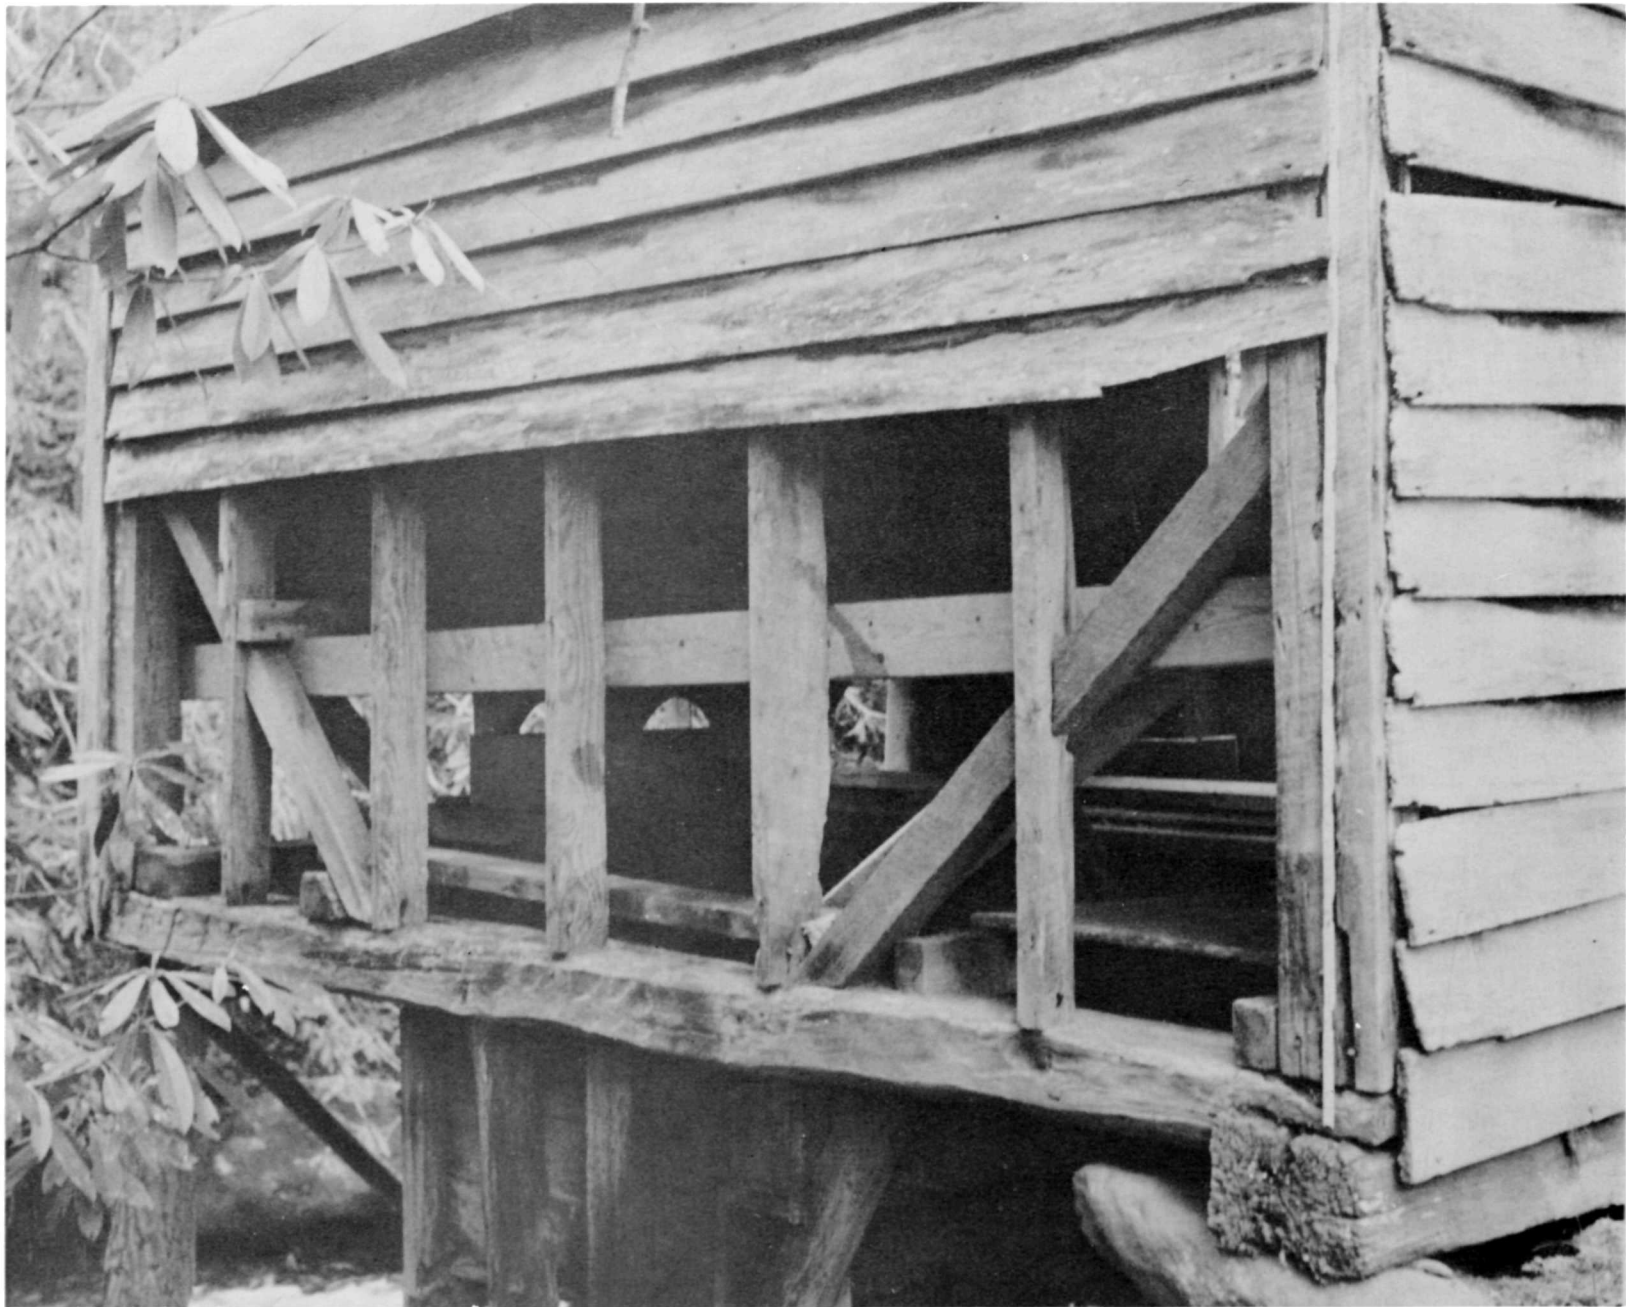
PLATE XVI

The sills and wall framing are in very bad condition. About 25% of the siding is missing and most of the remaining is not infected.

Sills, corner post and studs are infected with rot and termites. Corner boards are missing. Note condition of siding.
