# **ALFRED REAGAN HOUSE AND TUB MILL**

**HISTORIC STRUCTURES REPORT**

**GREAT SMOKY MOUNTAINS NATIONAL PARK  
TENNESSEE-NORTH CAROLINA**

**OCTOBER 12, 1969**

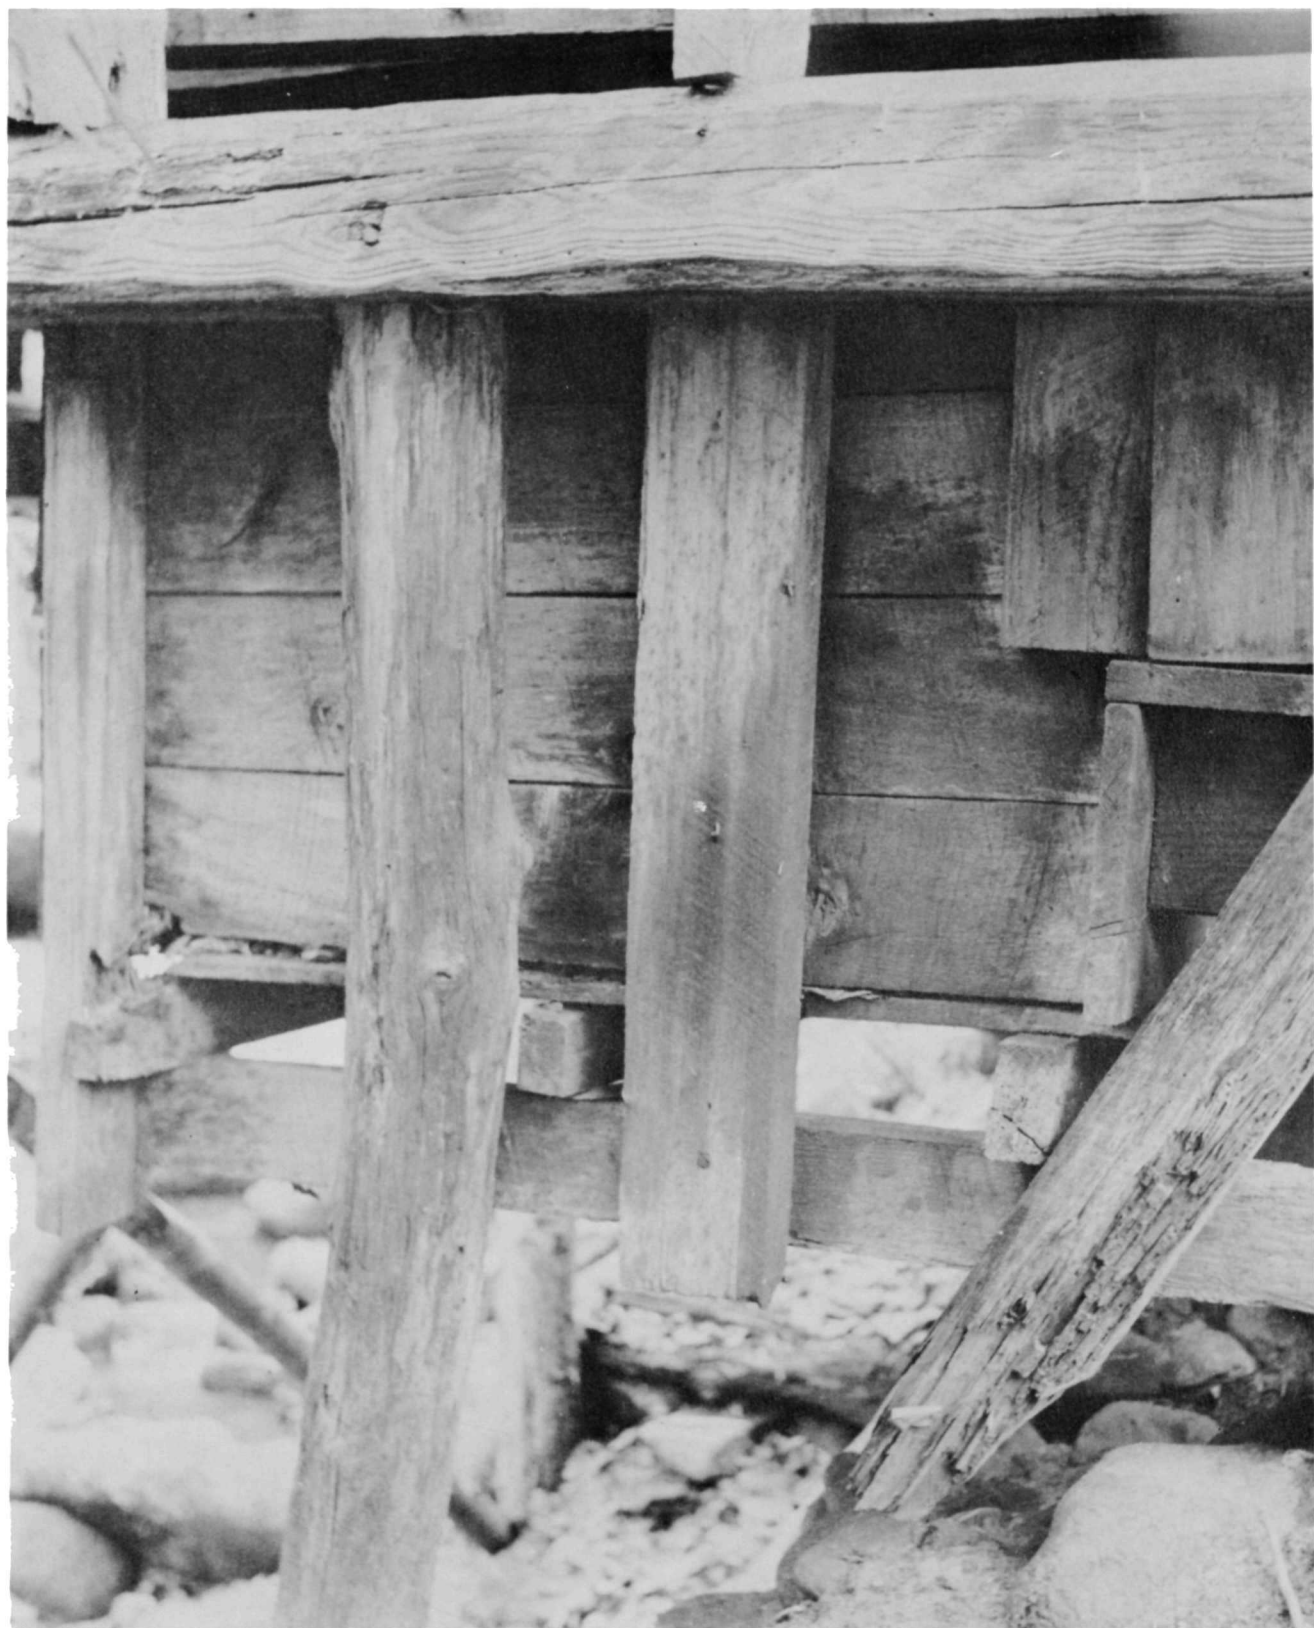
PLATE XVII

The floor and pit framing is infected with rot.

Interior - Replace floor framing and flooring. Replacement timbers shall match the original in regard to size and tool marks. Replace machinery supporting structure.

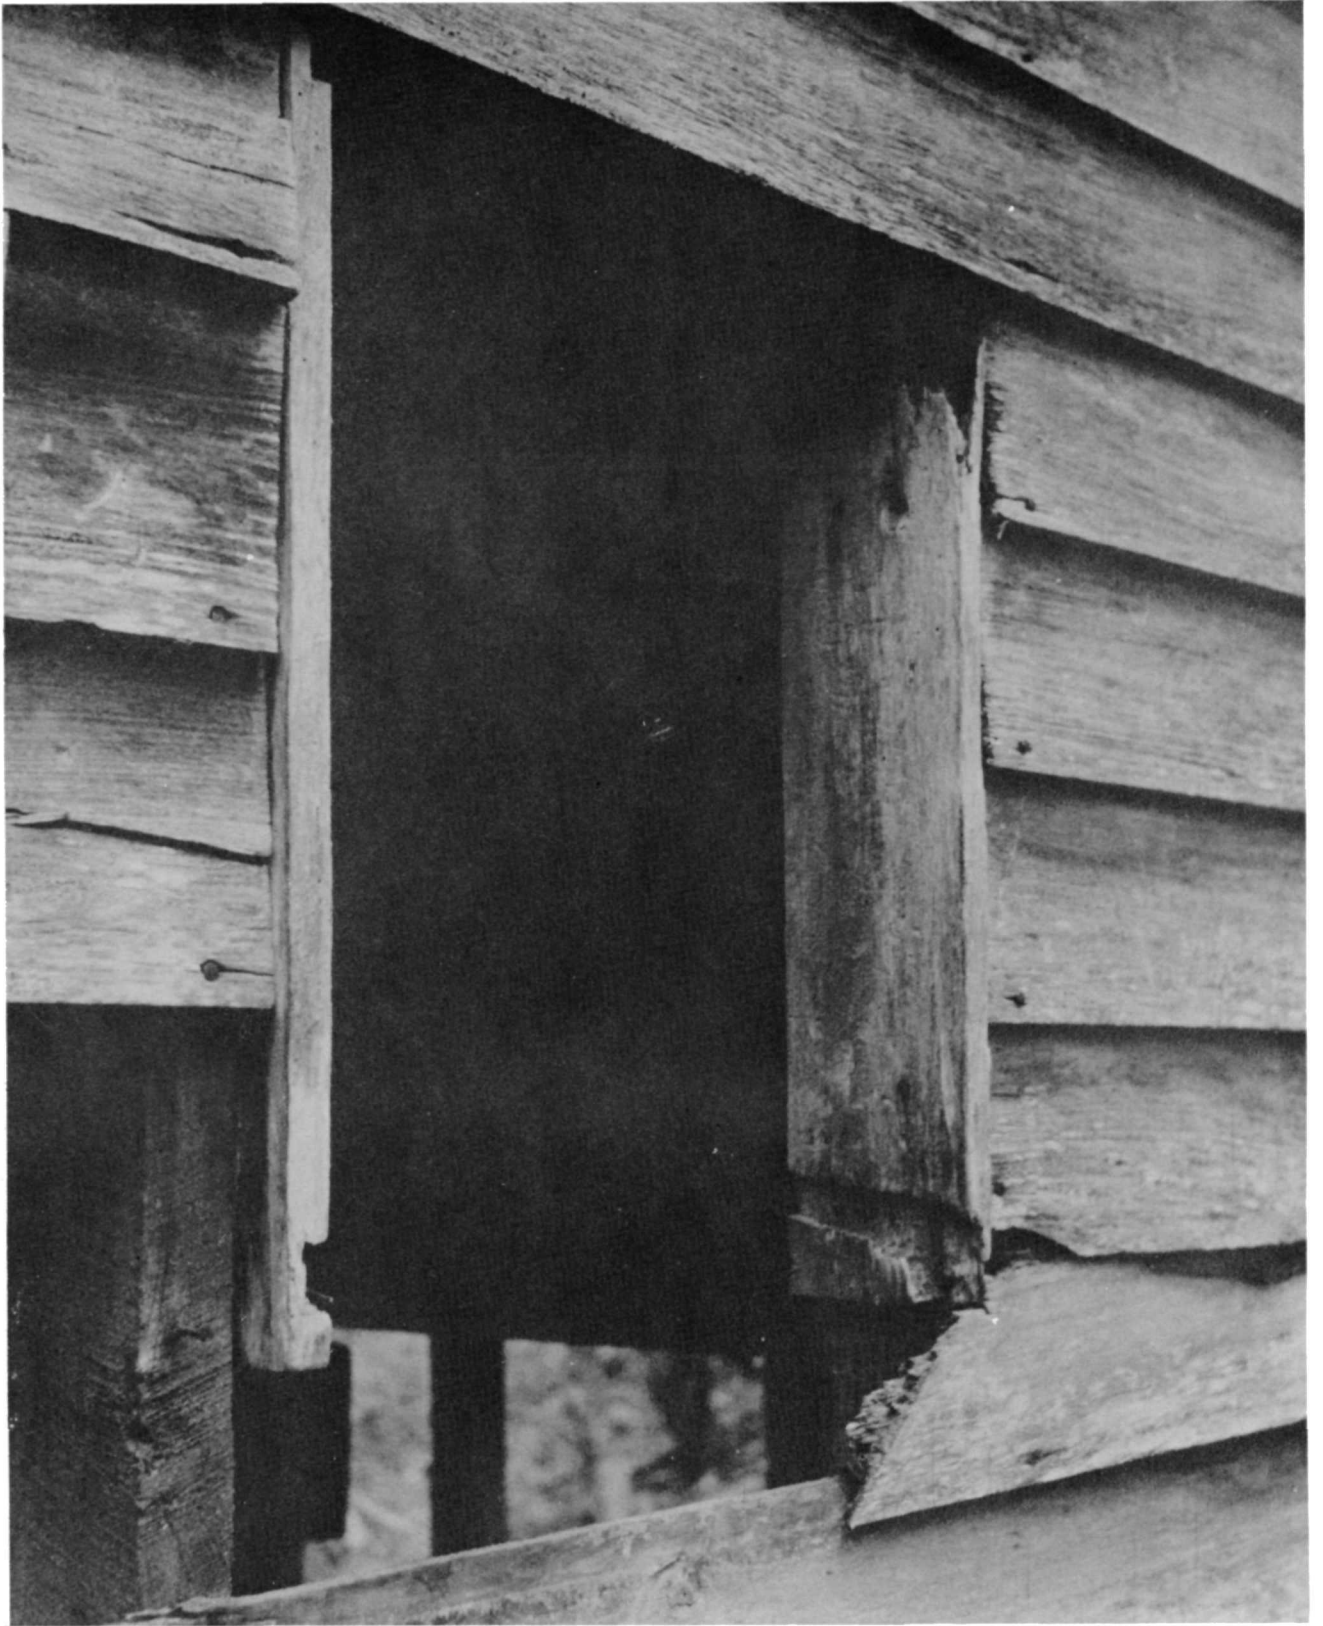
PLATE XVIII

The window frame must be replaced. There is no evidence that the window was ever fitted with a sash.

Door and Window - Repair door and frame. Reconstruct window frame.

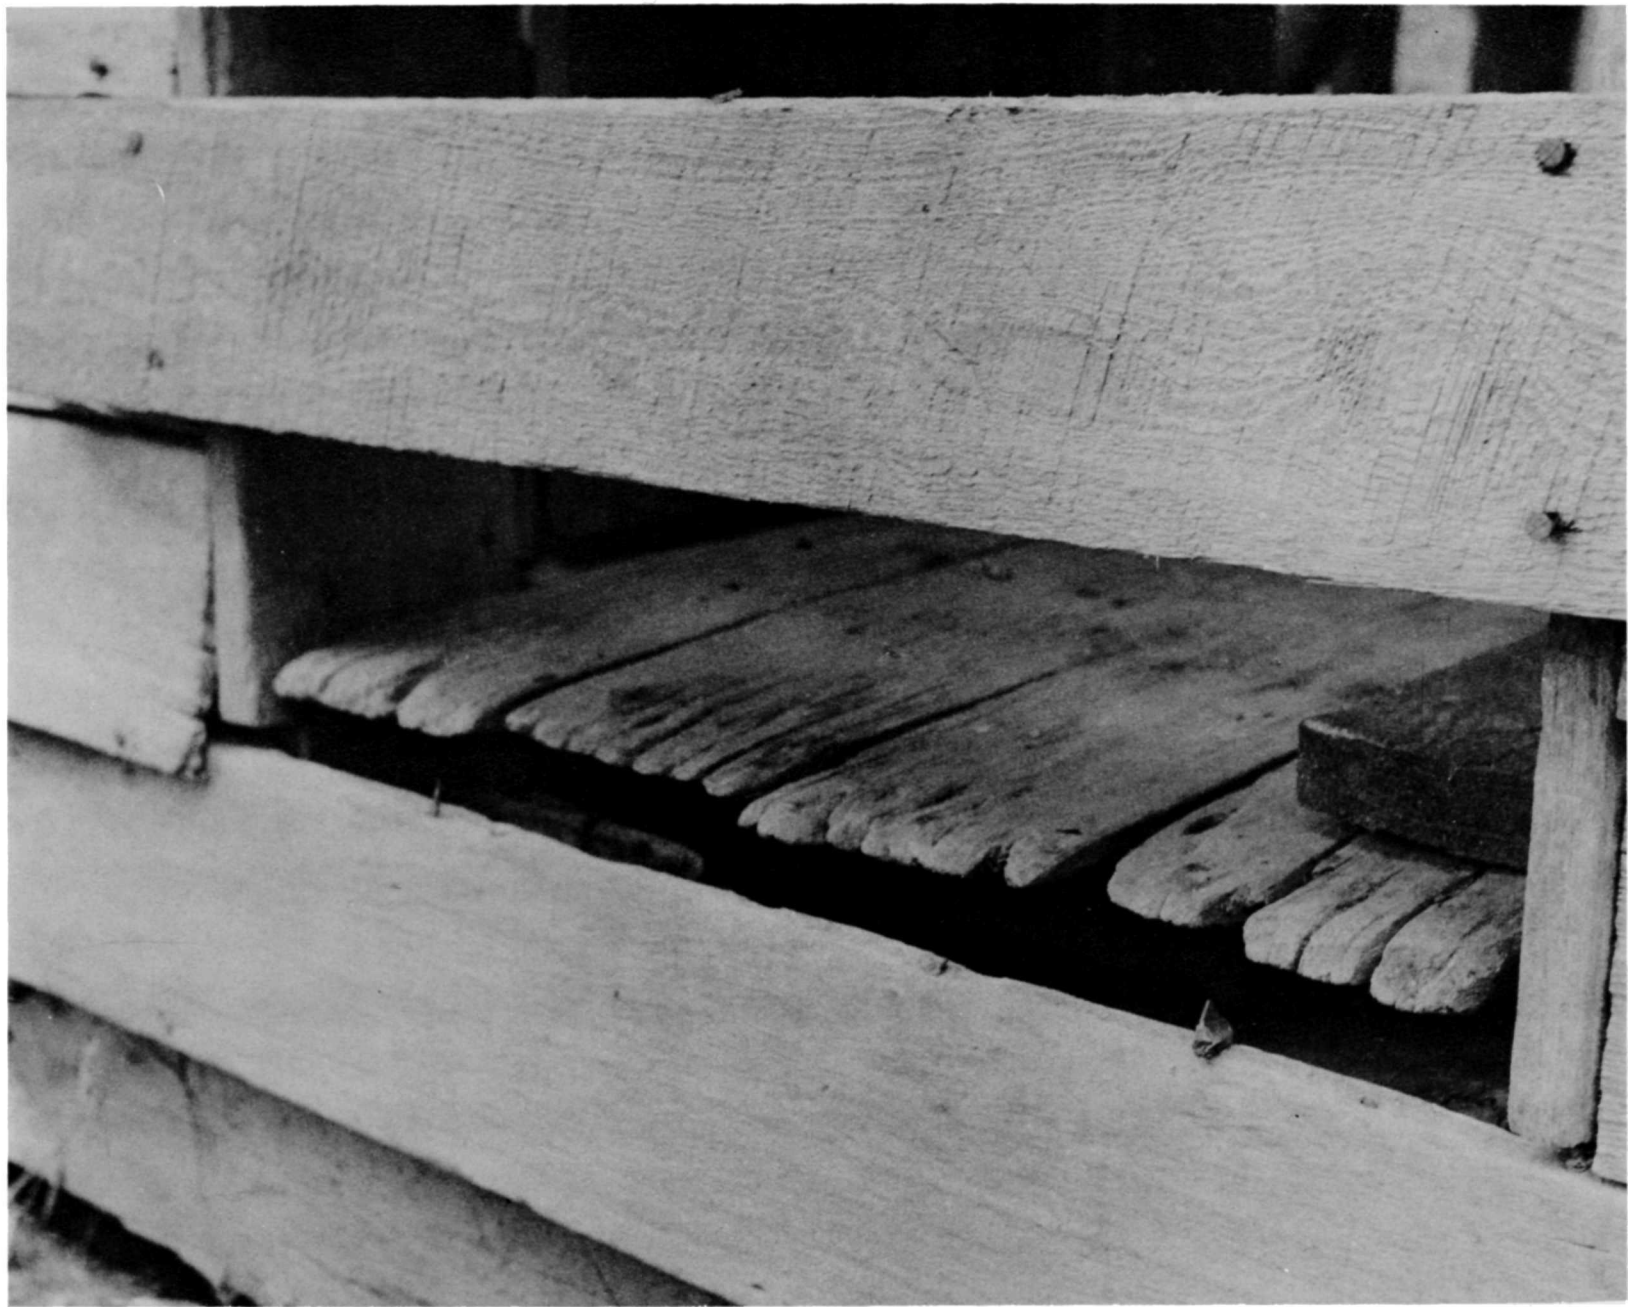
PLATE XIX

The mill floor is very worn and should be replaced.

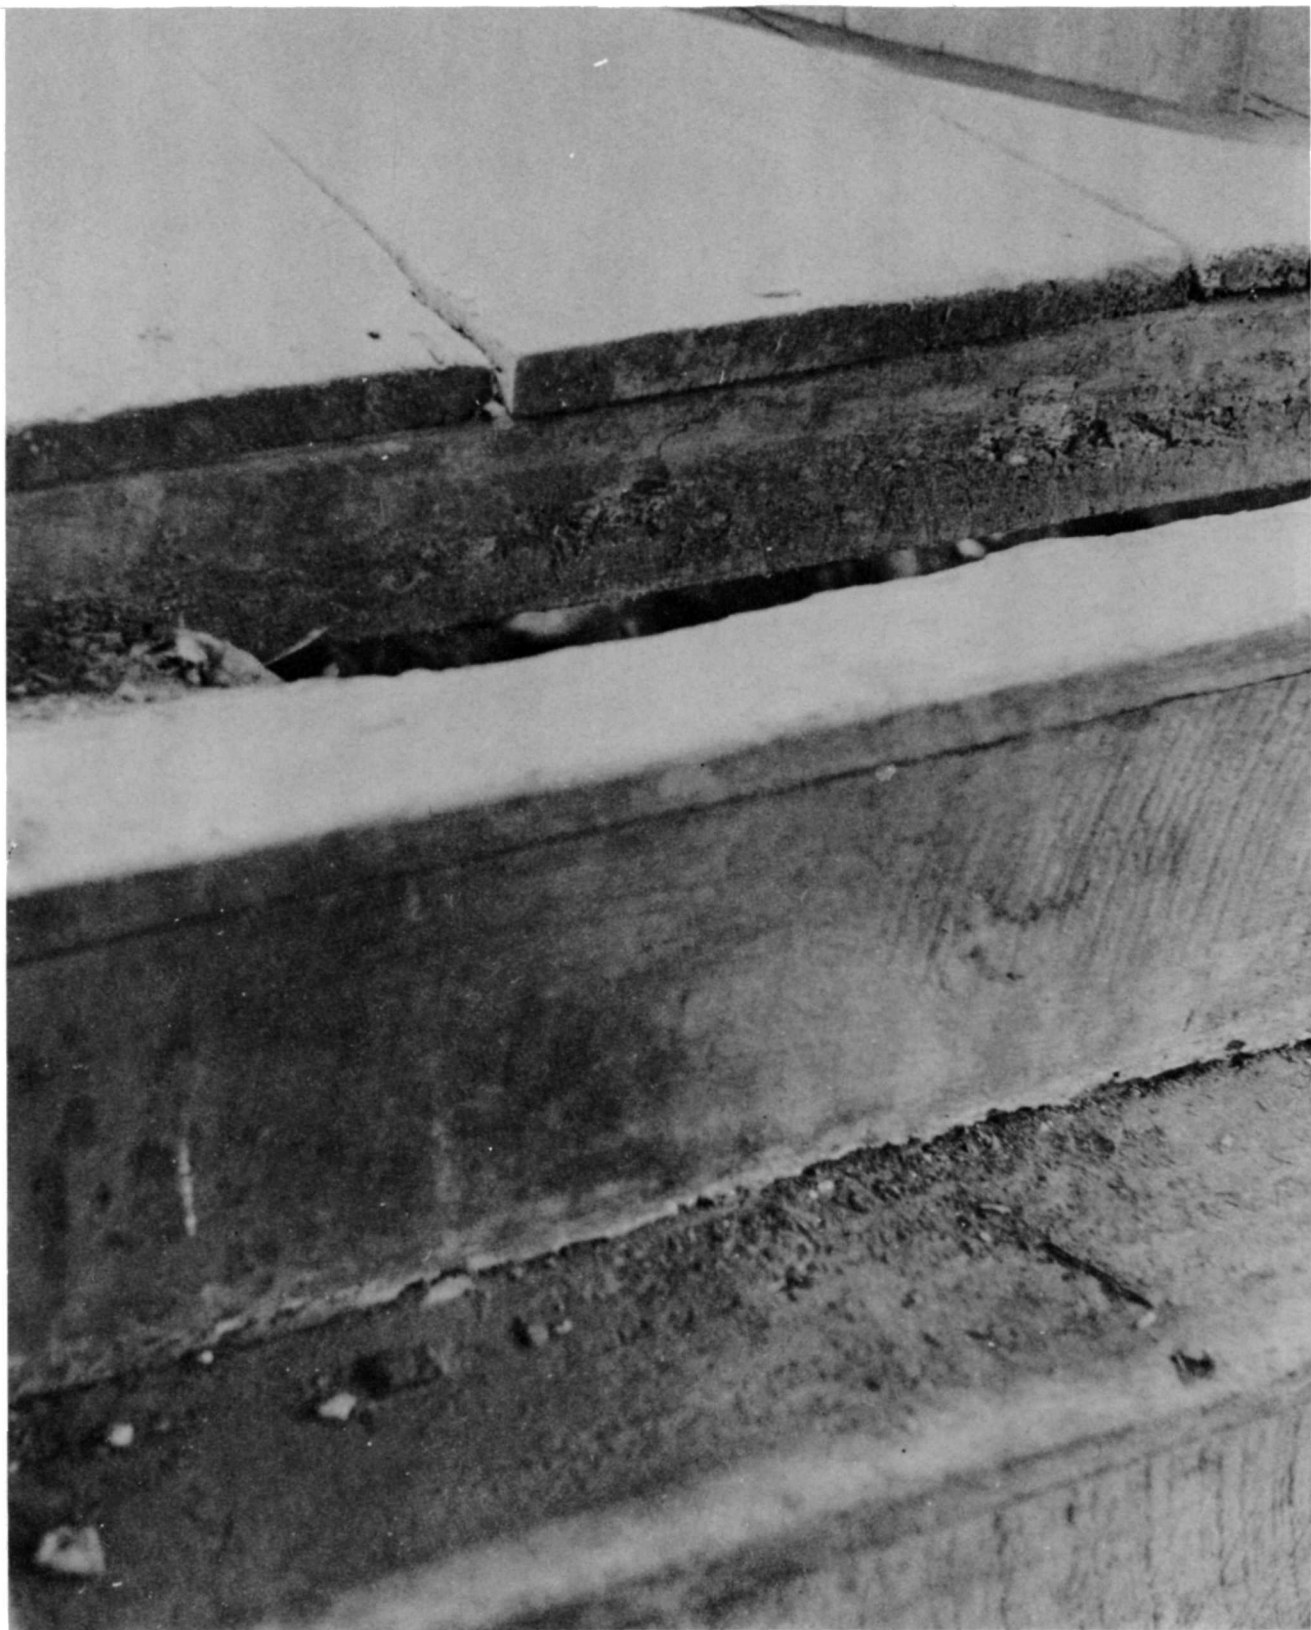
PLATE XX

View showing rot in floor framing and pit risers.

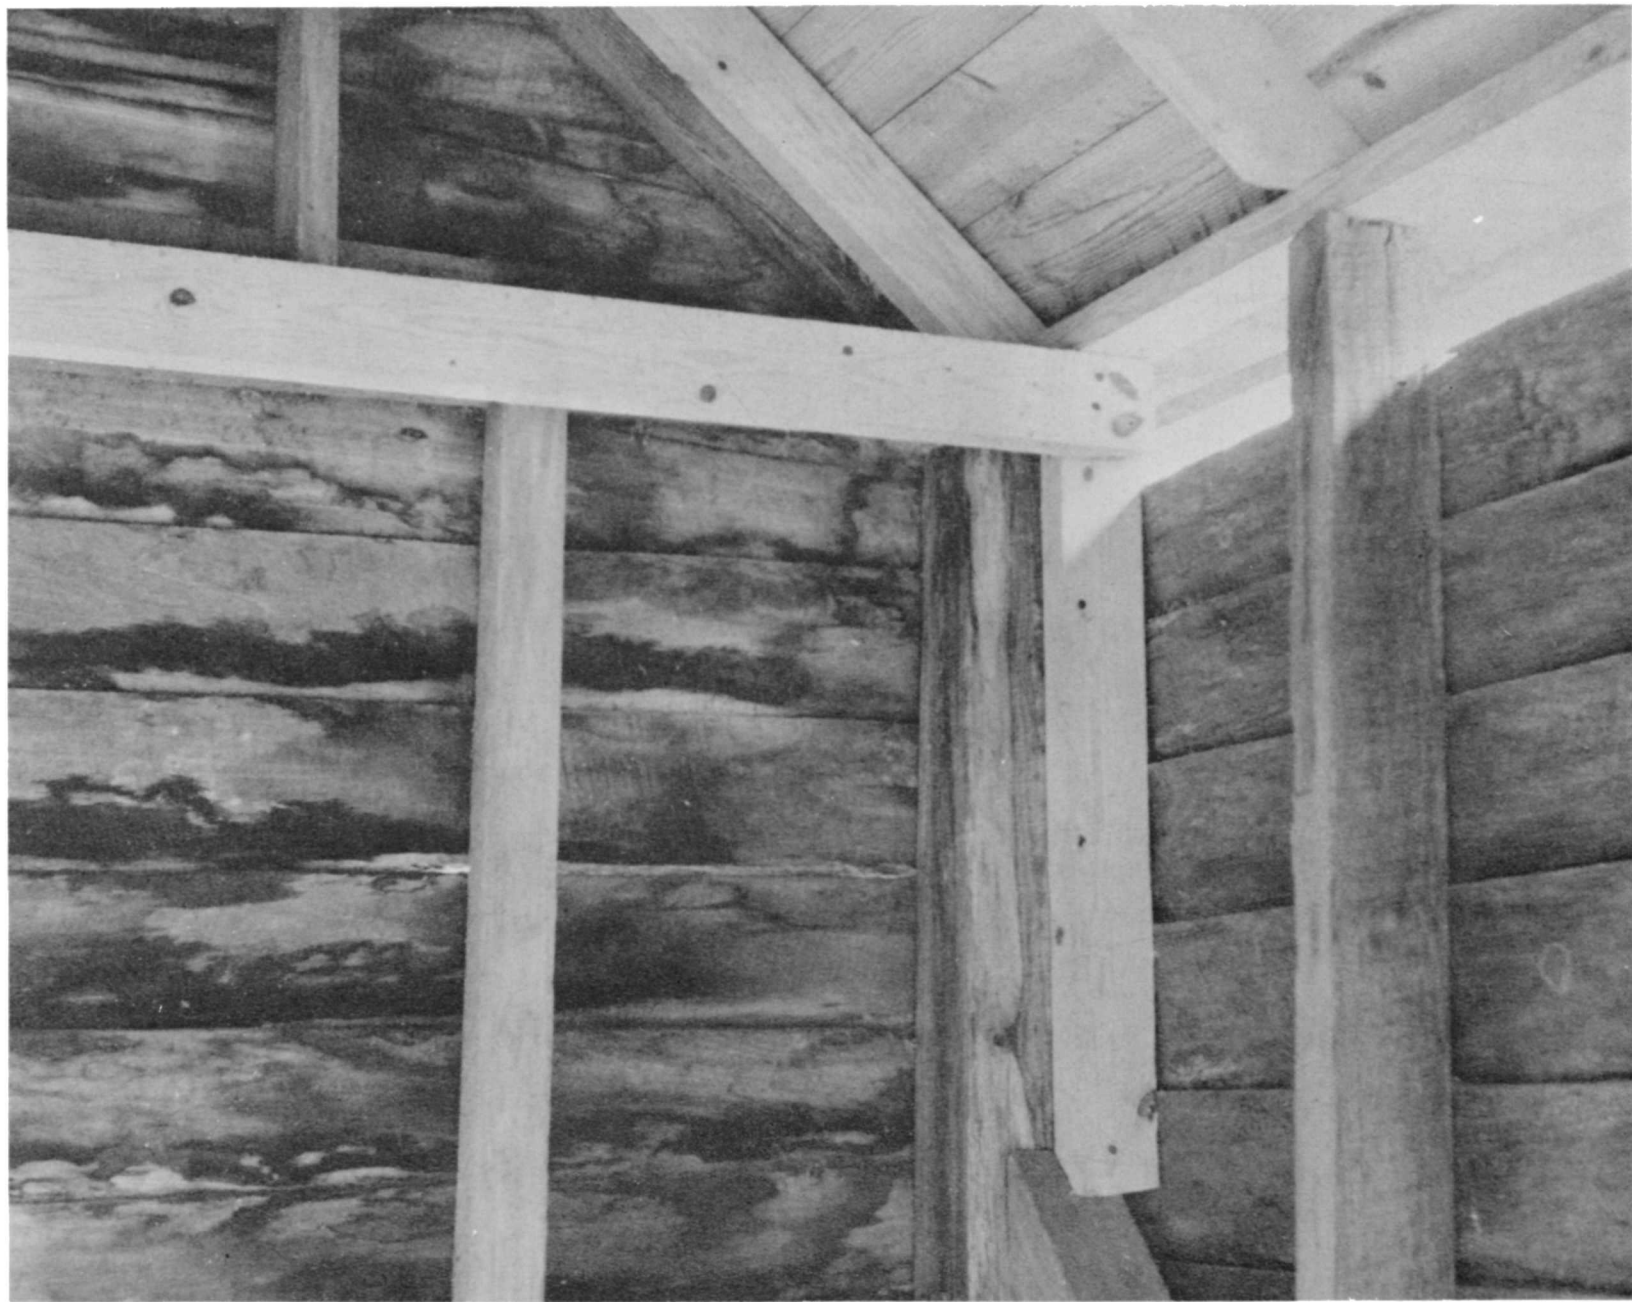
PLATE XXI

Modern roof installed by Park Service to protect the building.

Some of the studs have been replaced also.

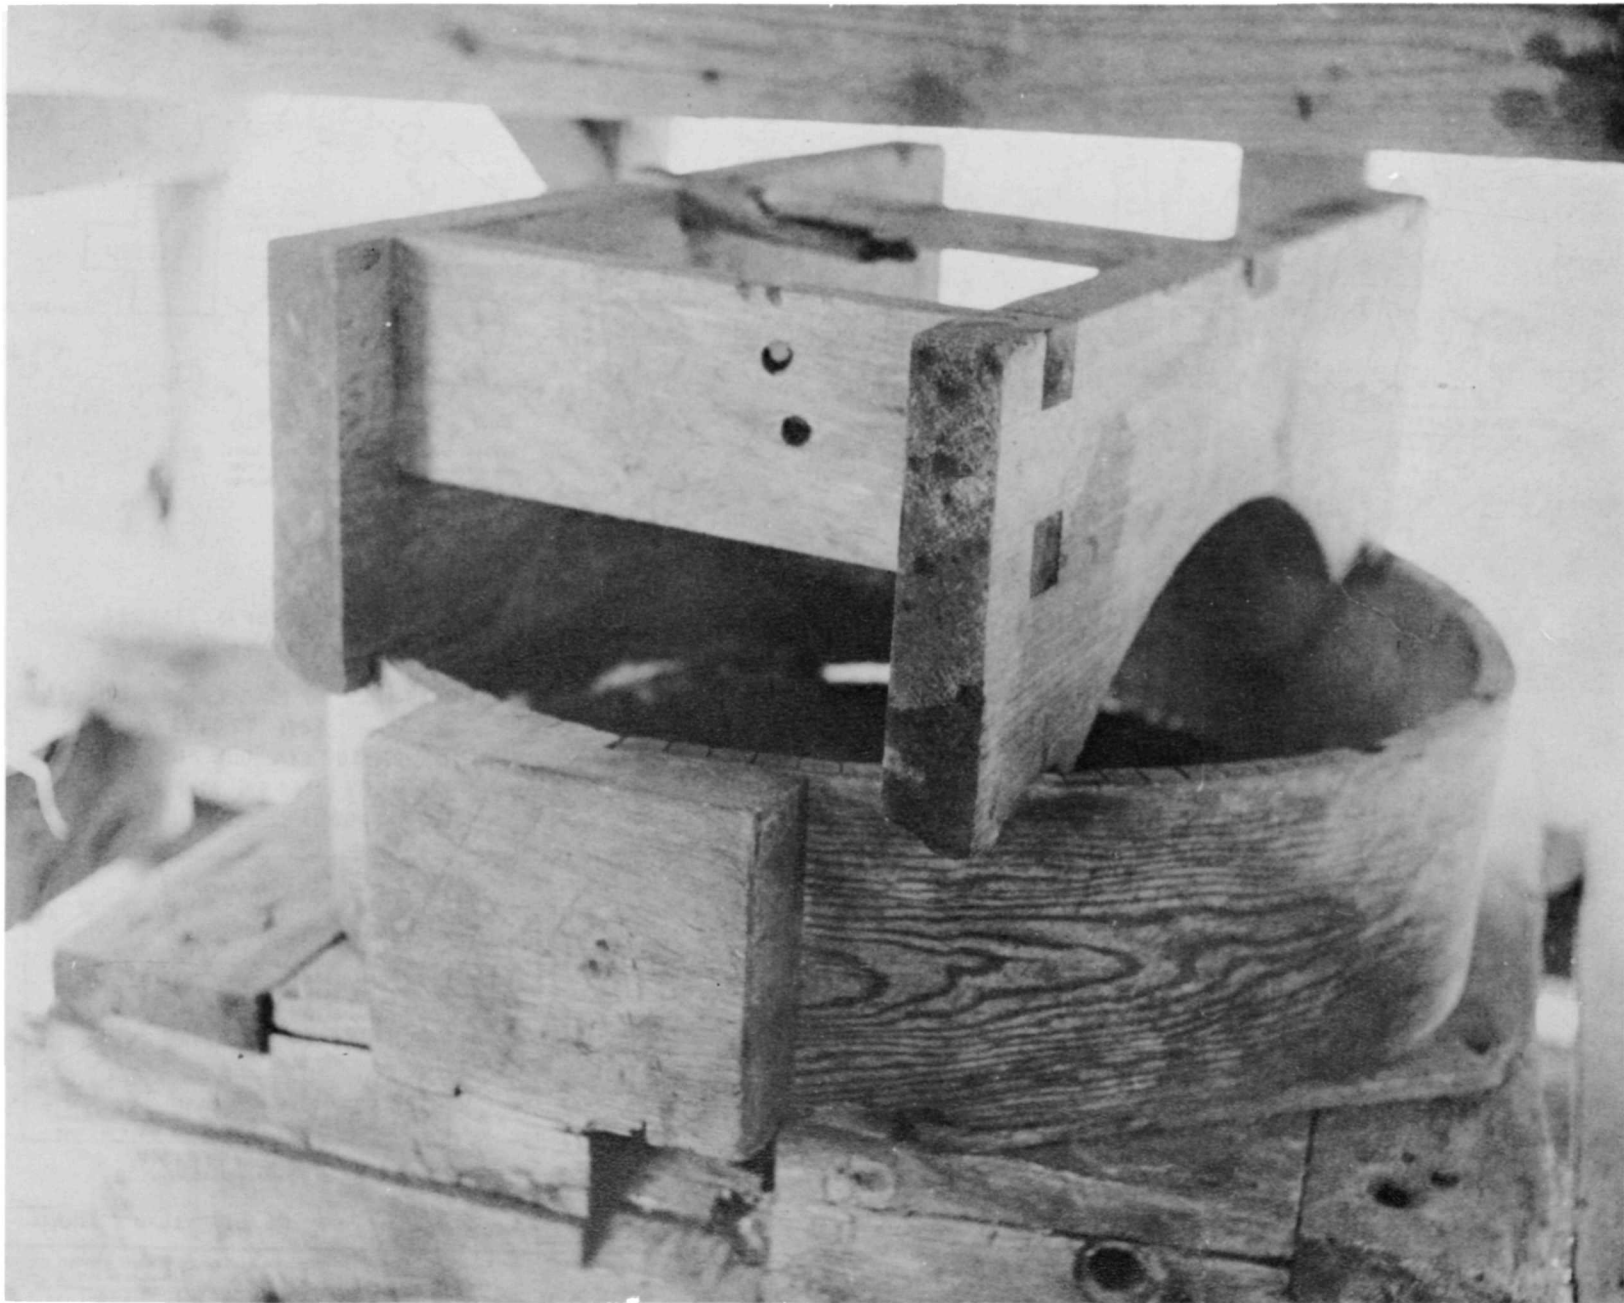
PLATE XXII

All of the mill machinery that remains in place is the cradle,  
hood and stone seat.

Gristmill Machinery - Inspect the parts of the machinery now in storage. Reconstruct damaged and missing parts to make operational.

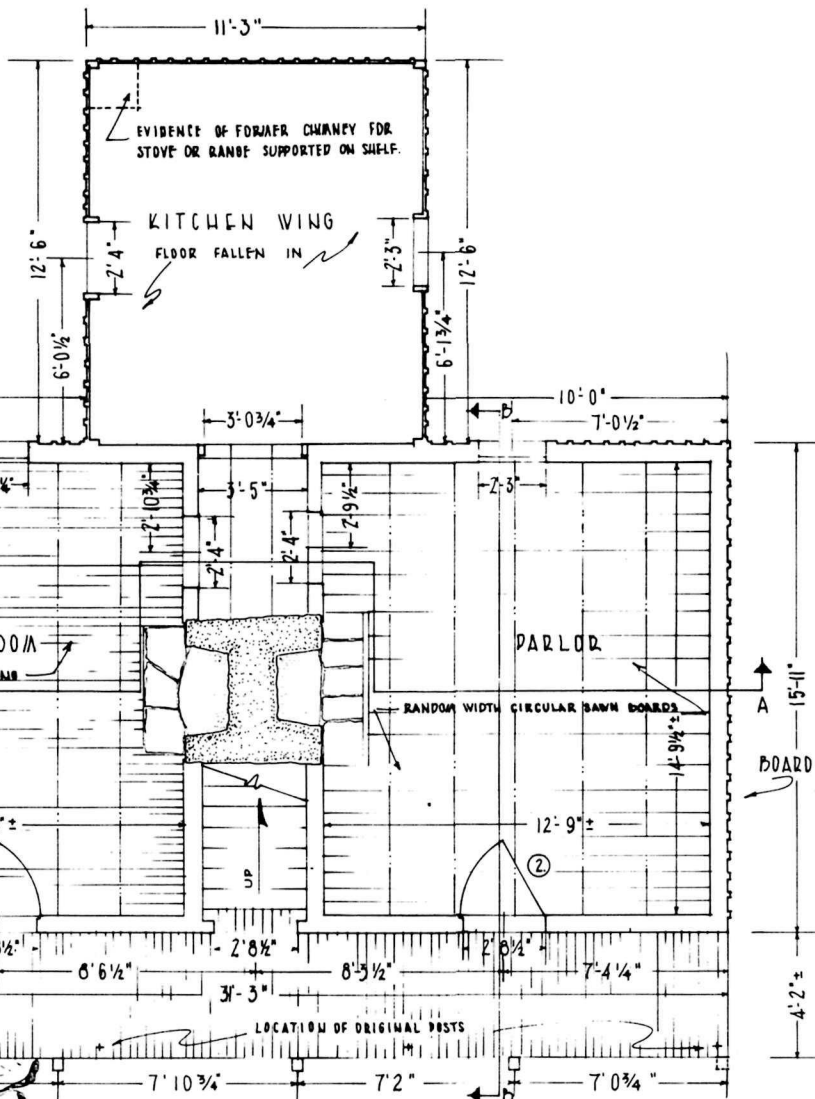
ALL WINDOW SASH MISSING

PORCH IS NOW IN EXTREMELY  
DILAPIDATED CONDITION.  
ORIGINAL PORCH POSTS MISSING.  
TEMPORARY POSTS INSTALLED IN 1948

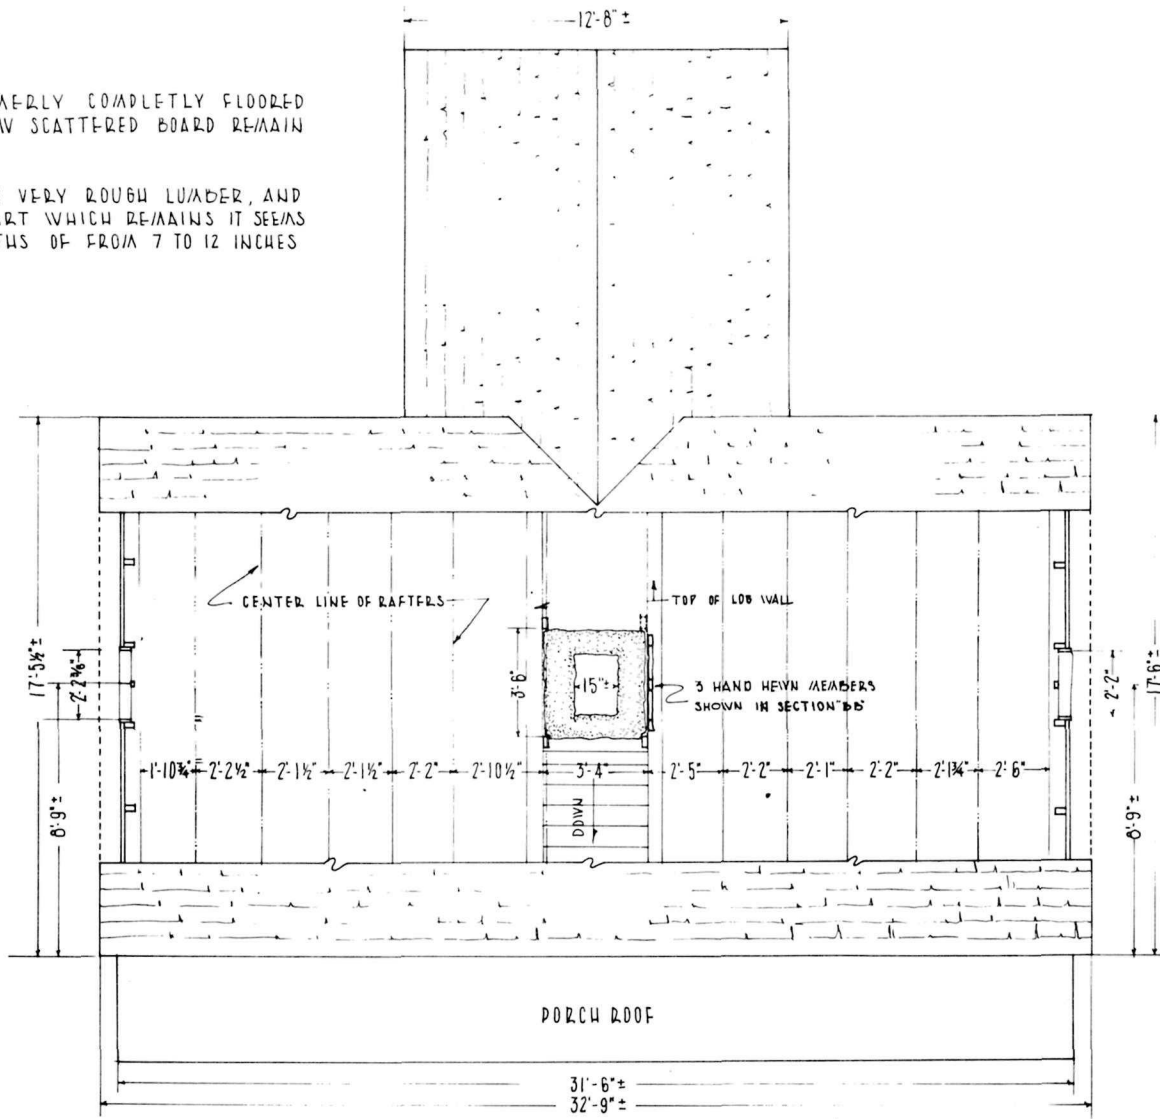
LOFT FLOOR PLAN

NOTE:  
LOFT WAS FORMERLY COMPLETELY FLOORED  
BUT ONLY A FEW SCATTERED BOARD REMAIN  
IN PLACE

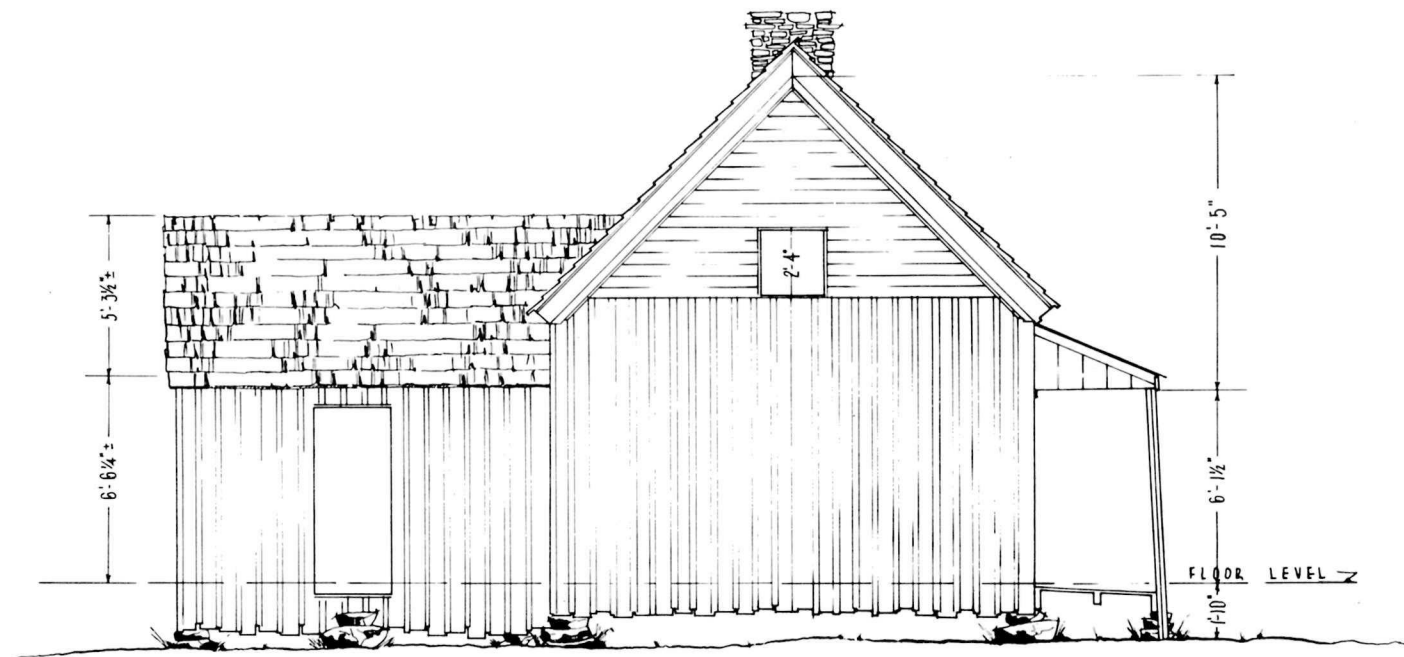
SOUTH ELEVATION

AT THE PRESENT TIME THE LATER ADDITION WHICH WAS MADE ON THE WEST SIDE OF THE HOUSE (THE KITCHEN) IS IN ALMOST COMPLETE RUIN; THEREFORE, THE DIMENSIONS GIVEN IN THESE DRAWINGS CAN ONLY BE ACCEPTED AS APPROXIMATE.

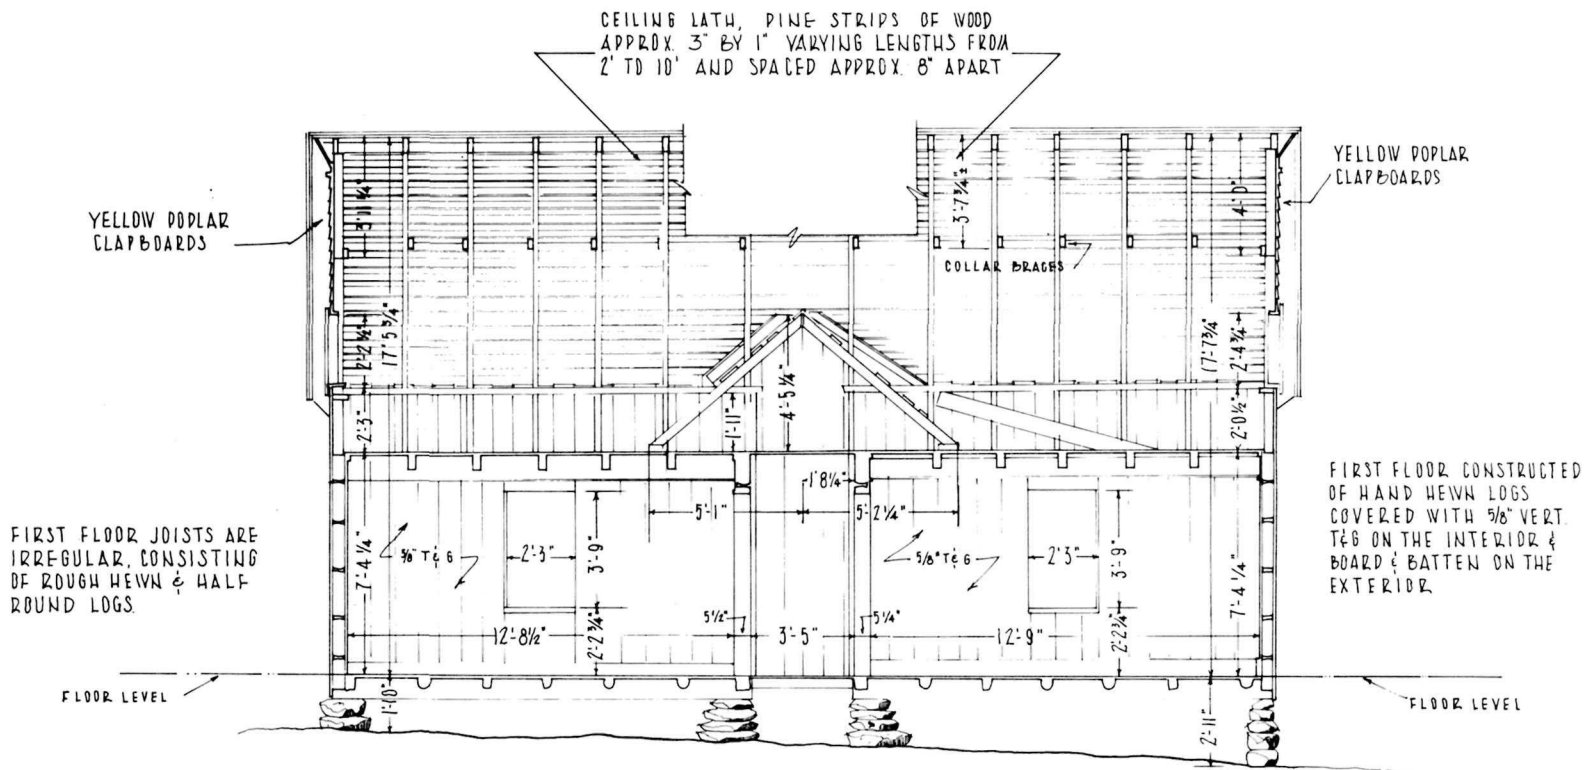
SECTION AA  
SCALE 3/8" = 1'-0"

TRACE OF ATTIC FLOOR CLEARLY DEFINED, BUT MOST BOARDS ARE MISSING.
