**Mayo Cabin and Mayo Servants' Quarters
Elkmont Historic District
Great Smoky Mountains National Park
Historic Structure Report**

Historic Structure Report

Mayo Cabin
LCS#: 264293

Mayo Servants' Quarters
LCS#: 264321

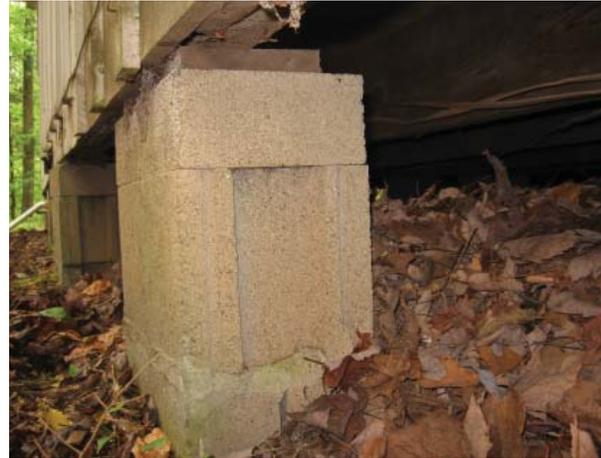
The one-story cabin is of wood frame construction supported on masonry piers. The cabin's foundation system now consists of 8" by 16" by 8" hollow concrete block piers around the perimeter and at interior bearing points, replacements for

Figure 10, Typical concrete block foundation pier, north wall. Some of the piers are capped with solid 4" blocks.

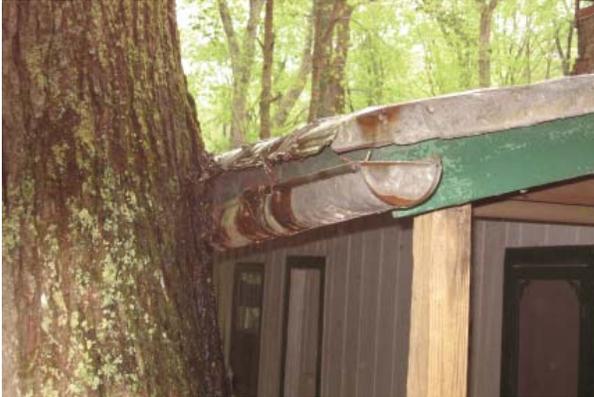
traditional rolled ridge. The modern 5-V pattern indicates that the roofing material is a mid-twentieth century or later replacement. The only extant gutters are located over the center steps to the front porch and against the hemlock tree which has grown into the southwest corner of the porch. The gutters are 5" diameter half-round galvanized steel and are not connected to downspouts, but serve only as diverters.

Figure 15, Half-round gutter section at south end of Front Porch.

- Repoint chimney.
- Replace in-kind the 5-V metal roof, install new gutters and downspouts and coordinate rainwater dispersal with site drainage.
- Modify grade along the south exterior

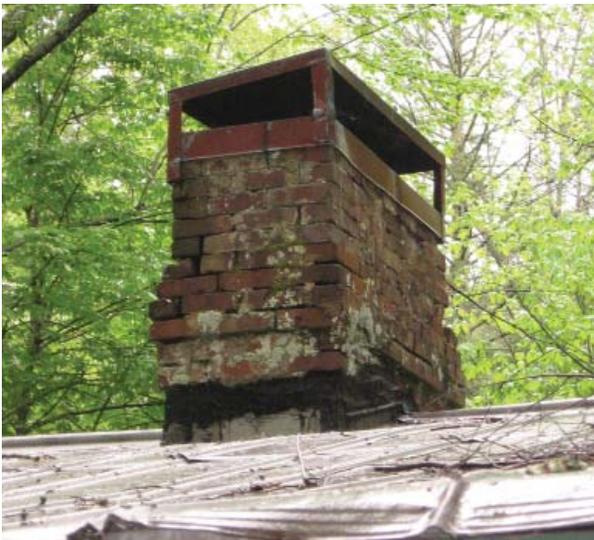
The chimney, probably original as indicated by surrounding wall framing, is brick masonry, approximately 21" by 42" (based on assumed brick dimensions). The chimney extends 12 courses above the ridge, the brick corbelling out and then stepping back in. The double flue is covered with a raised galvanized metal cap which has a broken strut at the northwest corner. Flashing appears to be galvanized, and a thick coating of asphalt roofing mastic has been applied along the joint to the brick.

Figure 16, Brick chimney at ridge.

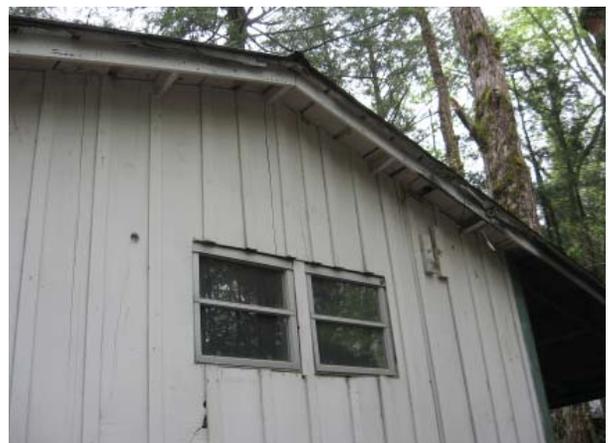
Three late-twentieth century vintage windows constructed of mill-finish aluminum are located high on the north wall for privacy. In Room 102, a pair of awning windows measure 25½" wide by 35½" high. The opening was roughly cut into the board-and-batten wall and left untrimmed, creating a water infiltration issue.

Figure 23, Aluminum replacement windows at north wall of Room 102.

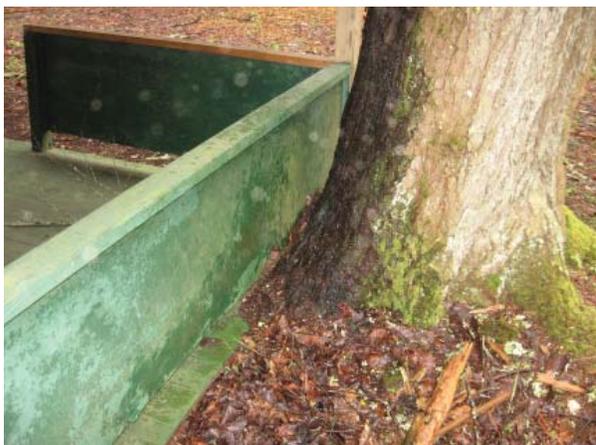
Today, the Mayo Cabin is in fair to poor condition. Water infiltration is the major culprit. Deterioration occurs all along the south elevation where the wall siding is virtually at grade and a large hemlock intrudes into the front porch floor and roof framing. Site drainage immediately adjacent to the cabin is inadequate. Water damages extend well into the southeast corner room, with deterioration apparent in the floor boards, wall boards and exterior door. The roof appears secure though flashing appears suspect; the chimney is in dire need of repointing. All the exterior walls need minor repair and repainting. Exterior doors and windows need maintenance, suffering from broken muntins, missing glass and damaged rails.

Figure 45, South end of Front Porch where hemlock has grown into floor structure.

- Remove large hemlock. Repair damages to front porch.
- Make repairs to water-damaged floors and walls in southeast room.
- Perform routine repairs to building envelope and repaint.
- Install emergency lighting, security and fire detection systems.

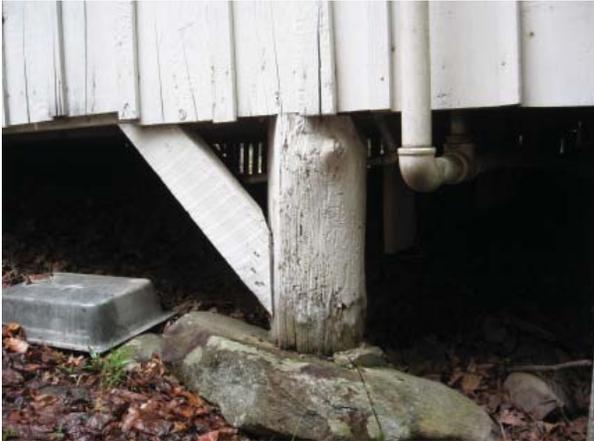
Figure 49, Detail of locust pier bearing on rock at south wall.

- Repair, replace in-kind or supplement the damaged piers.
- Install emergency lighting, security and fire detection systems.

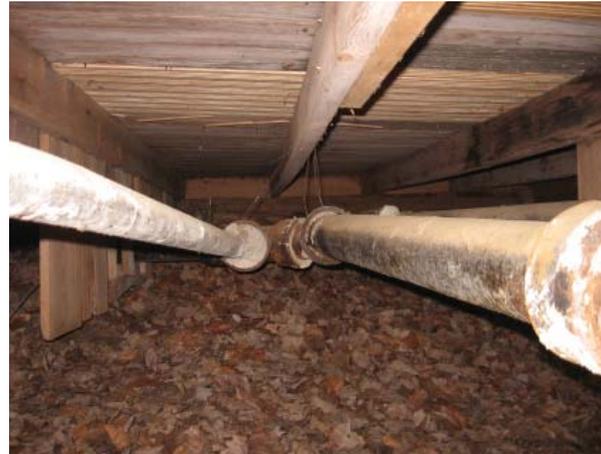
Figure 54, Galvanized (left) and cast-iron (right) waste lines leading from the bathroom, view toward north. Note the replacement flooring in Room 103, beyond, due to water damage. The band joist for the addition is attached to the original Servants' Quarters at left.

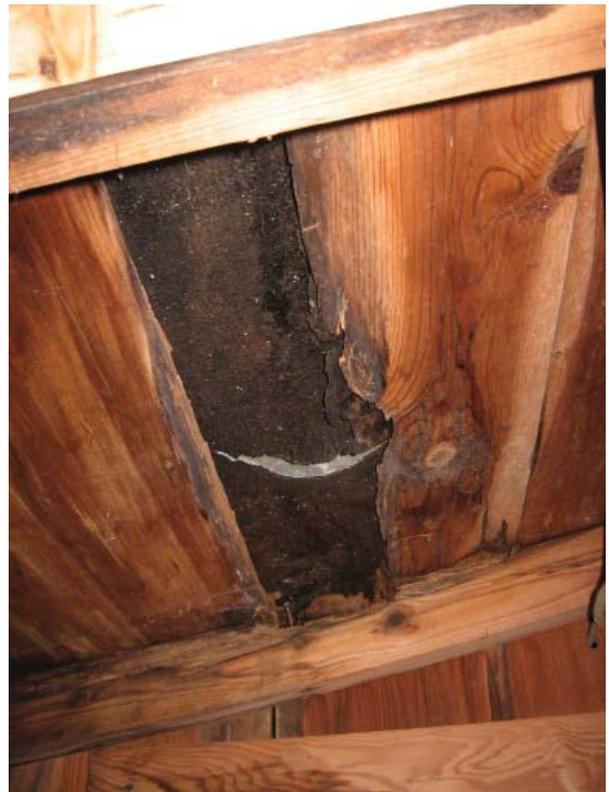
The Mayo Servants Quarters is in fair condition. Set on piers and on an incline of site grade, drainage is less a threat than at the Mayo Cabin. However, several piers show deterioration and need attention. All exterior envelope of walls, doors and windows are in need of minor repair and repainting as a protective measure. The metal roof has been damaged by falling branches and is in need of repair.

Figure 68, Damage to roof sheathing over partition between Room 102 and Room 103.

- Replace in-kind the 5-V roofing and repair damaged deck boards.
- Perform routine repairs to building envelope
