# Scruggs-Briscoe Cabin Elkmont Historic District Great Smoky Mountains National Park Historic Structure Report

# Historic Structure Report

March 2016

The Jaeger Company

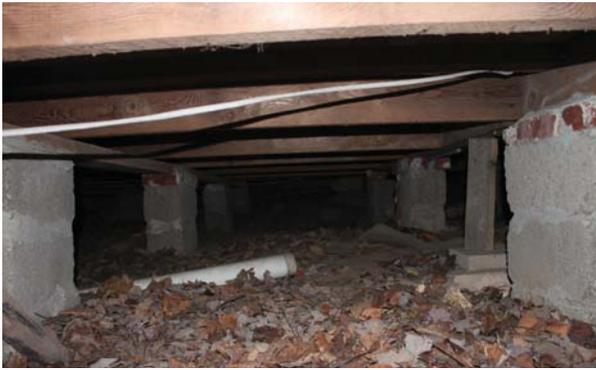
**Figure 13:** Foundation CMU piers and floor framing under Room 103.

with 2" by 6 ½" joists running north-south. The northwest corner of the front porch foundation is infilled with fieldstones along the west front wall and with CMU blocks along the north wall. (Figure 13)

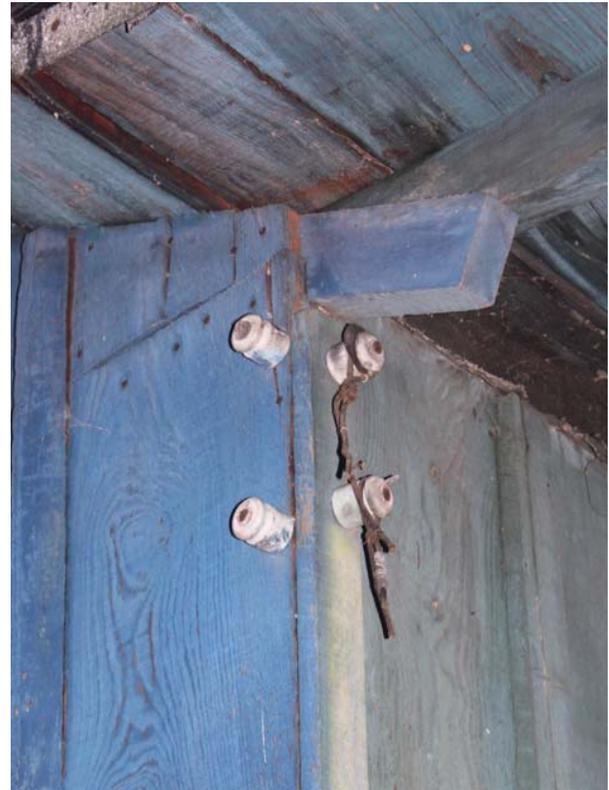
**Figure 16:** Remnants of ceramic knob-and-tube wiring system.

Several components remain from an early knob-and-tube wiring system. These include ceramic knobs and braided insulated cables. (Figure 16) A modern electrical system replaced the house's previous electrical system. Wiring is generally vinyl-wrapped insulated cable. Electrical service entered the house at the north side elevation under Room 108. The electrical service box is visible in the 1992 and 2001 photographs and cut cables and a ground wire remain at this location.

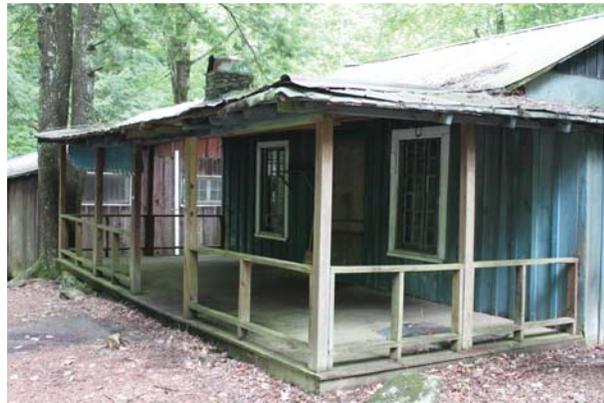
Figure 17: Front porch on west front elevation.

The front porch extends across the west front elevation of the house. (Figure 17) The shed roof is supported with replacement 3 ½” by 3 ½” wood posts with a 2” by 4” railing between each post except at the front entrance. The railing has a top and bottom rail and a middle support post. On the north side of the porch, a scalloped fabric awning is attached with nails to the plate that supports the roof rafters. A second awning on the south side visible in earlier photos is now gone. The porch flooring is 3 ½” wide boards extending east-west with a ¼” space between each board. The flooring and perimeter sills are replacements.

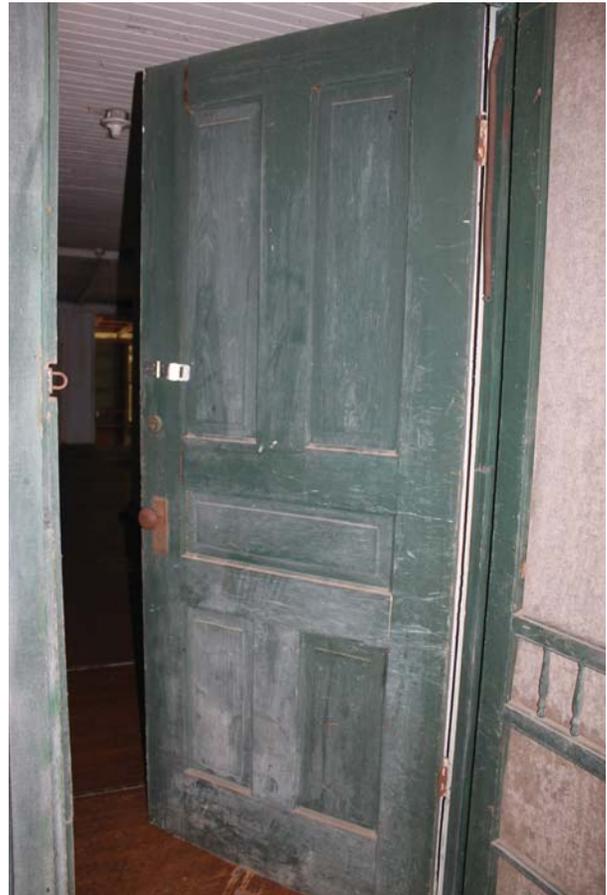
**Figure 21:** Front entrance door.

screened door at the front entrance has upper and lower screen mesh panels and a middle panel with wood spindles. The screened door has a metal pull handle, a wire spring that is no longer connected to the door, and a hook with the eye missing. This door is attached with 3 ¼" hinges.

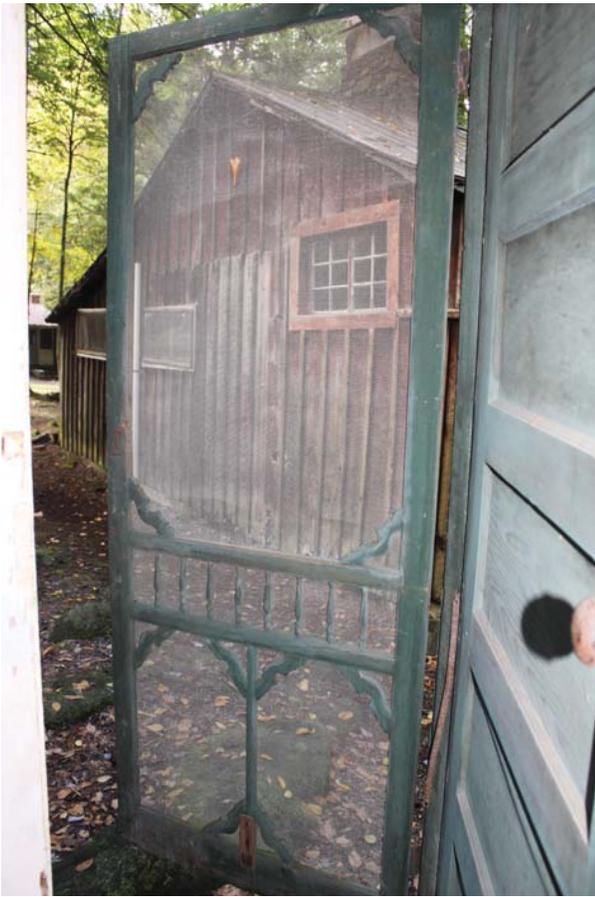
**Figure 22:** Screened door at rear entrance stoop at north side elevation.

screened door has upper, middle, and lower screened panels. The middle panel has wood spindles and the upper and lower panels have decorative brackets (same design as Room 109). (Figure 22) The screened door has a hook closure but the eye is missing, and a wire spring that is no longer connected to the door.

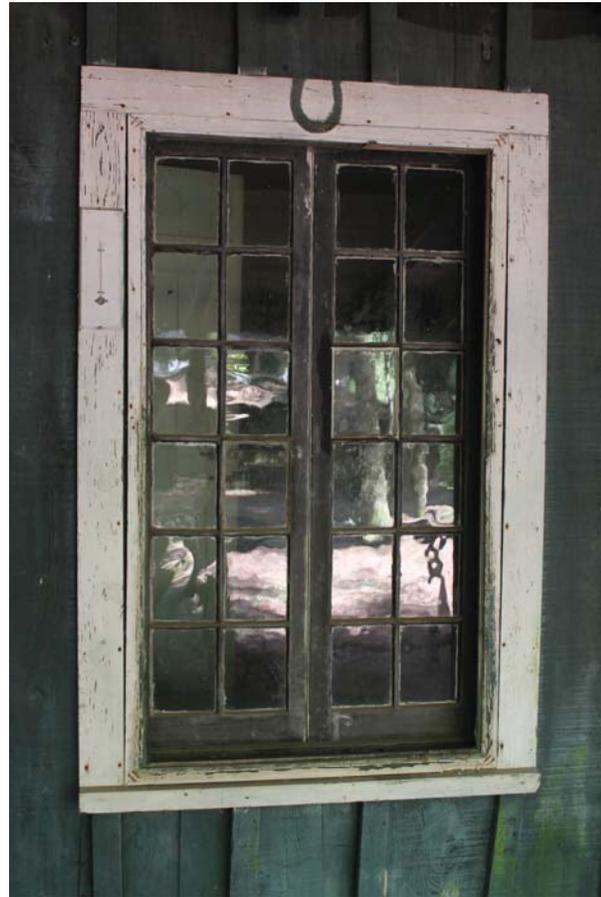
**Figure 23:** Casement window on west front elevation.

The west front elevation has two pairs of casement windows, one pair in Room 102 and one pair in Room 103. (Figure 23) These window openings measure 2'-9" wide by 4'-7" tall; the exterior surrounds are 3 3/4" wide with a 1 7/8" deep sill. The top surround of the south window in Room 102 has a paint outline of a horseshoe that until recently hung above the window; the horseshoe is now missing. Hinges measuring 2" attach the wood casement sash, which each have twelve panes; the north window sash in Room 103 is attached with two 2" hinges and two 2 7/8" hinges. A 1 1/2" wood screen frame is attached on the exterior of the window openings but the screen mesh is no longer

intact; one-half of the screen frame is missing on the window in Room 103.

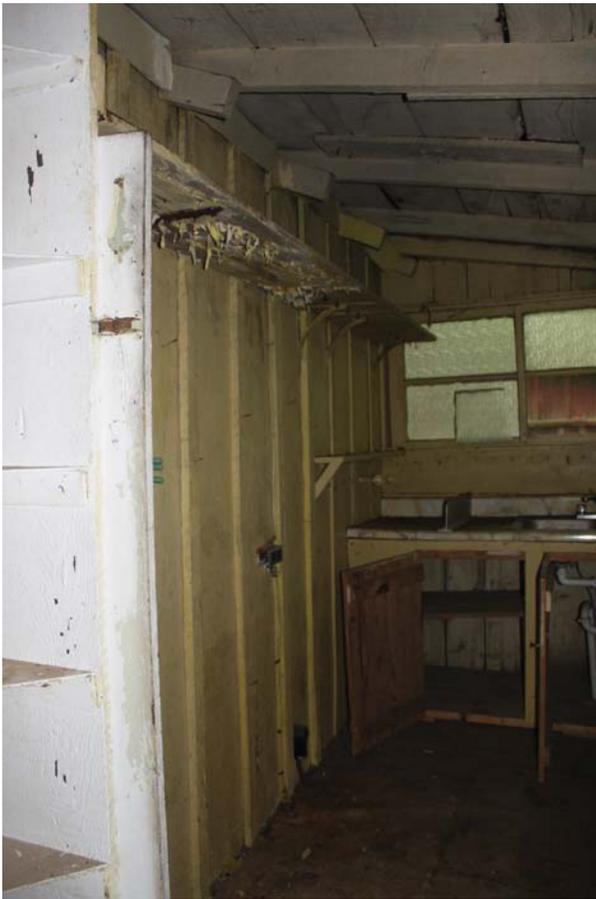
**Figure 48:** Room 108, rear board-and-batten wall of main core and gabled roof rafter ends.

*Walls*—The west wall is finished with board-and-batten siding. This wall is the east rear wall of the main core and may have been an exterior wall. (Figure 48) The north wall consists of a flat 2" by 4" stud at the northeast corner and the back side of the exterior board-and-batten siding nailed to the top plate. The south wall consists of the back side of the wide boards in Room 107. The east wall is
