Sneed Cabin

Elkmont Historic District
Great Smoky Mountains National Park

Historic Structure Report

August 2015

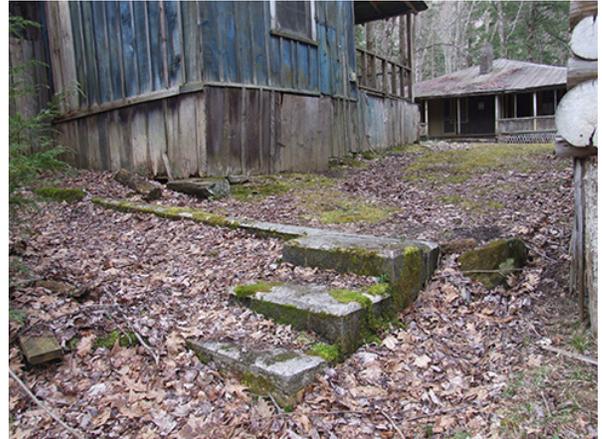
Figure 49. View of concrete steps near the southeast corner of the Sneed Cabin and the contemporaneous concrete curb extending south behind the Higdon Cabin.

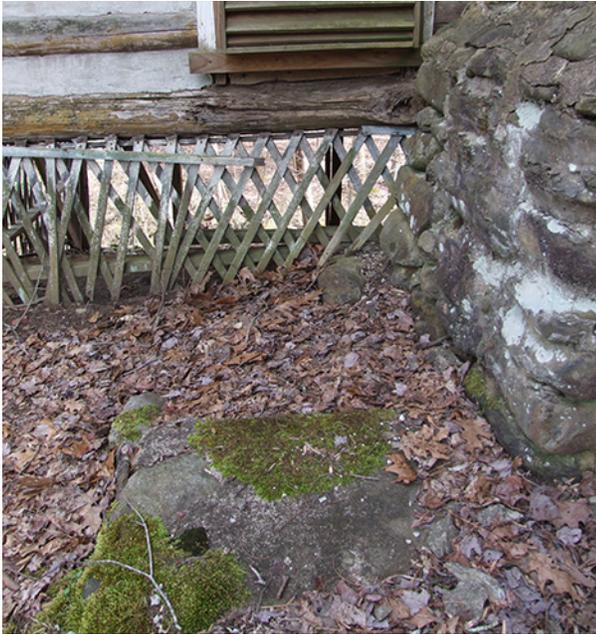
Figure 50. View of rock landing for missing stairs at the outside door on the west wall of the kitchen.

- whenever site work requires ground disturbance, secure clearance from an archaeologist before commencing work;
- repair grade around the cabin to ensure positive drainage away from the foundation, especially on the south side;
- ensure that there is no wood-to-ground contact under and around the cabin;
- reconstruct wooden steps to front porch, back porch, and kitchen;
- repair front walkway, steps, and retaining wall.

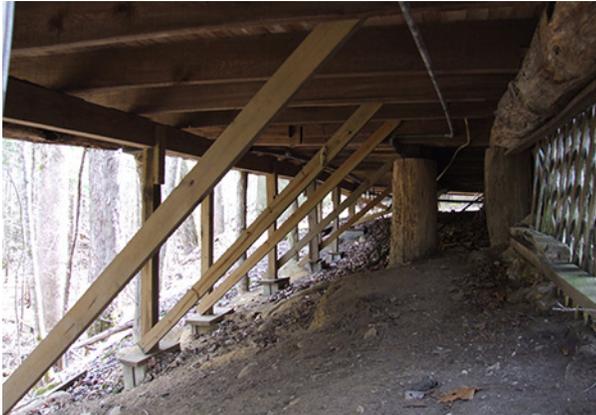
Figure 56. Looking south beneath kitchen showing diagonal braces recently installed under the back porch and kitchen.

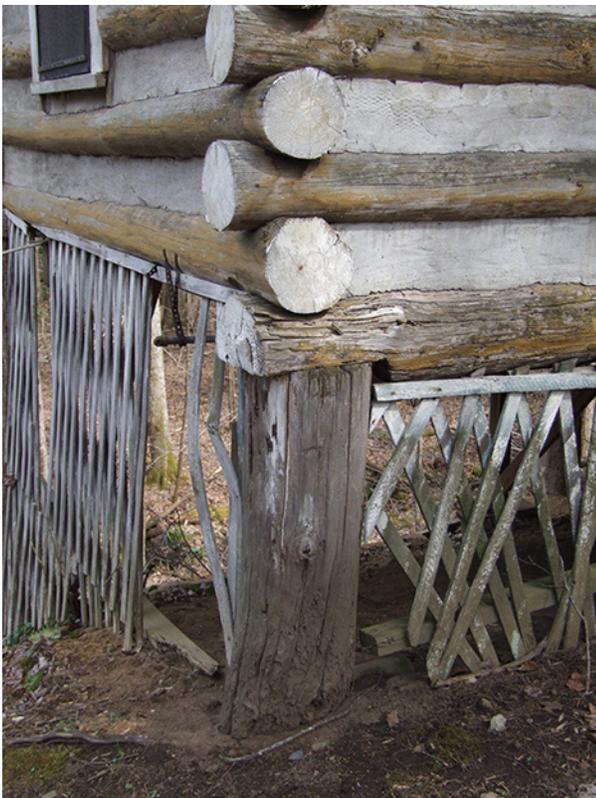
Figure 57. View of diamond-patterned lattice that originally concealed the entire foundation.

- eliminate wood-to-ground contact under and around the cabin and/or install metal termite shields;
- recreate diamond-patterned lattice foundation enclosure.

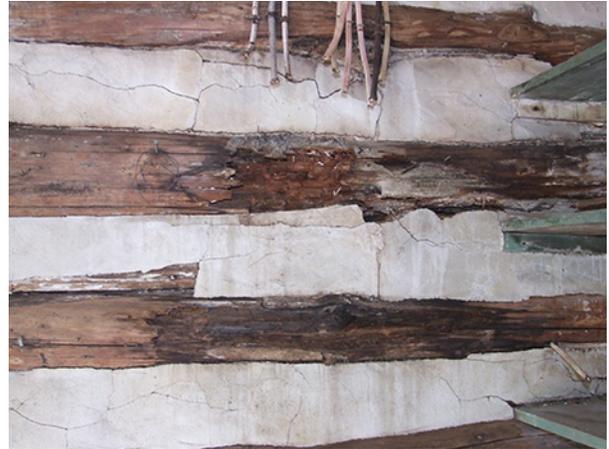
Figure 64. View of water-damaged logs at south end of back porch.

- repair damaged collar ties and gable trusses, replacing missing features in kind;
- repair rotted log ends at south end of back porch;
- repair and repaint exposed log ends;
- maintain added beams supporting floor joists.

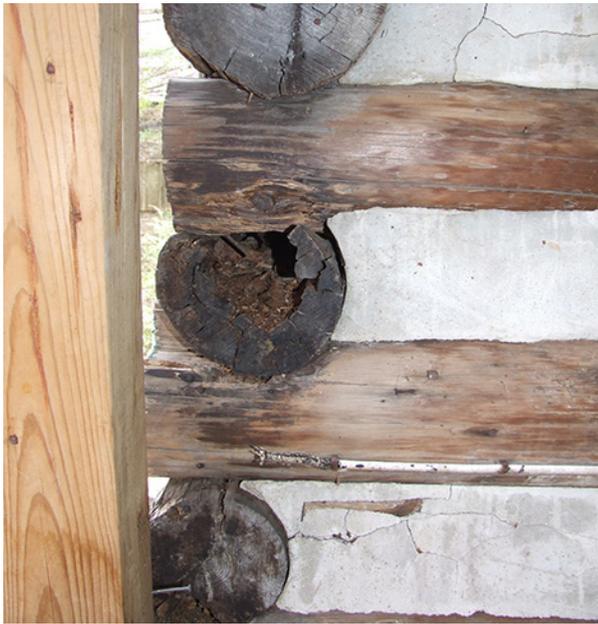
Figure 65. View of damaged logs at southeast corner of the back porch, probably caused by uncontrolled run-off of rainwater from the roof.

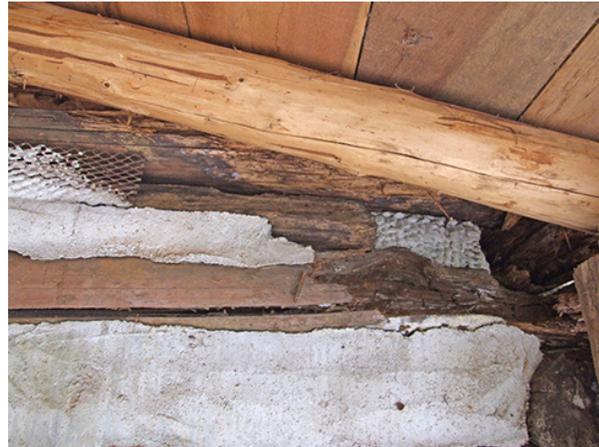
Figure 66. View of expanded metal lath used in repair of chinking at south end of front porch.

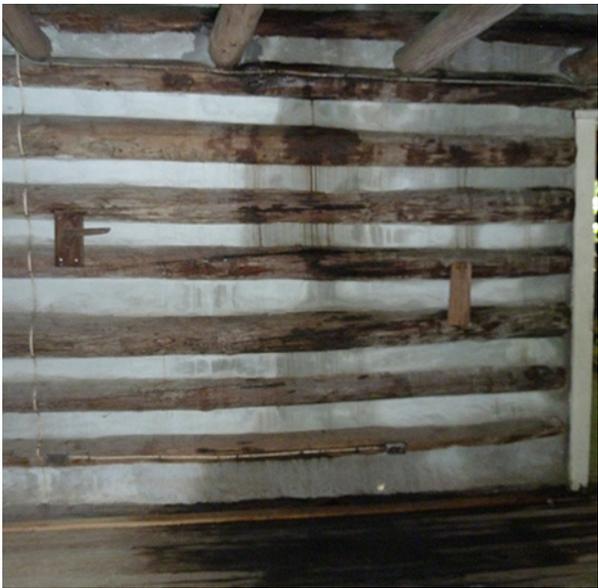
Figure 71. View of east wall of Room 101, showing water stained wall from roof leaks around the east dormer.

There is a major active leak around the dormer on the east side of the house. The entire roof covering is in very poor condition. There are no gutters on the cabin and ground drainage is uncontrolled, keeping areas of the

- remove all existing roofing, repair decking as necessary, and install green asphalt roll roofing;
- install full system of unpainted, galvanized, half-round gutters and round downspouts on all sides of the house.

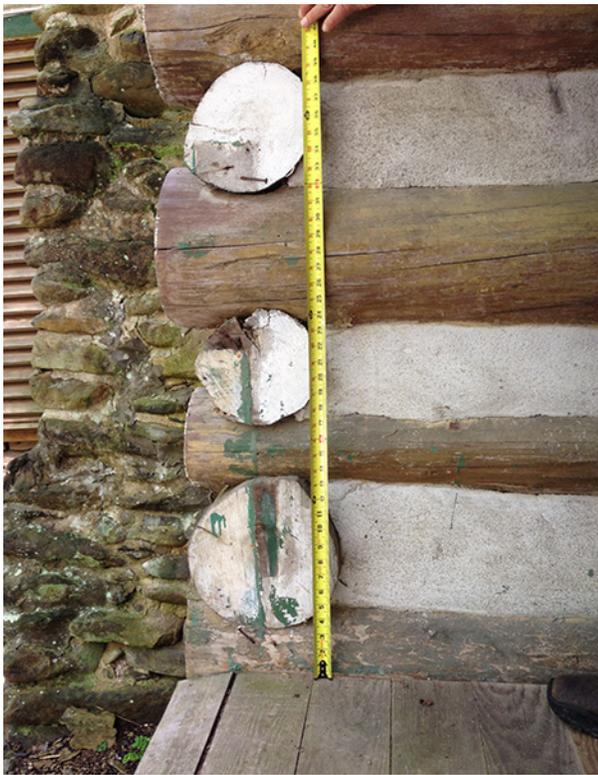
Figure 83. View of "ghost" of front porch railing at the northeast corner of the porch.

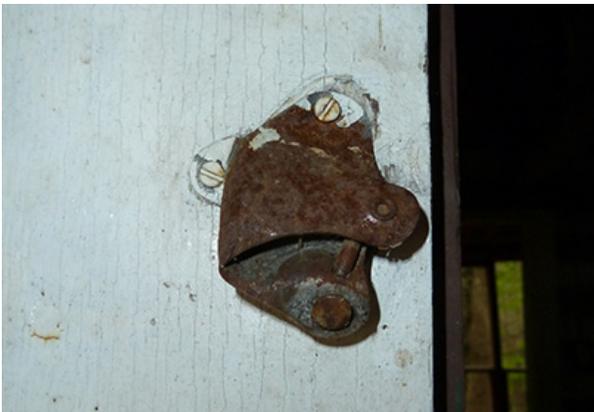
Figure 93. View of the unidentified, damaged metal object fixed to the exterior face of the front door casing.

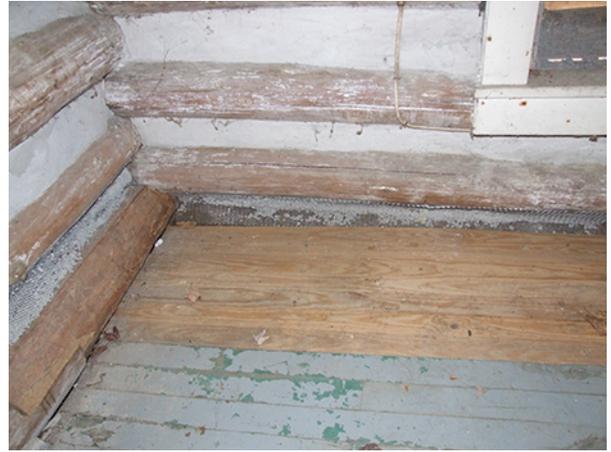
Figure 115. View of recent repairs to southwest corner of Room 102.

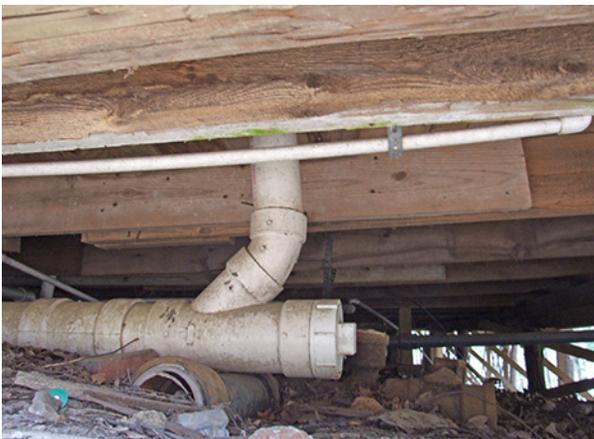
Figure 128. View of PVC waste line for bathroom. It is resting on an earlier cast-iron waste line.

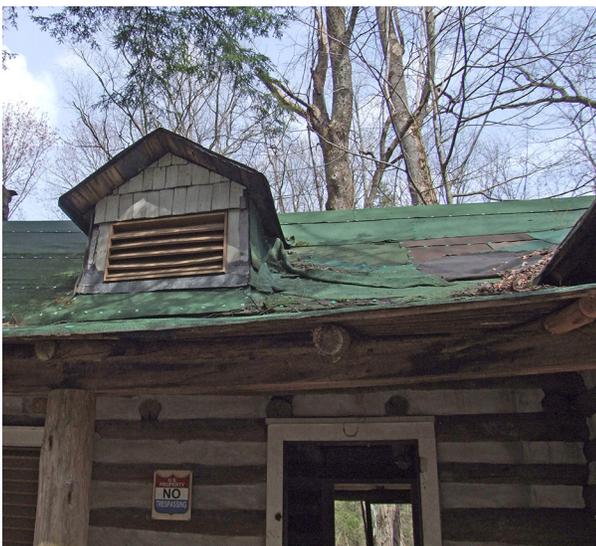
Figure 141. View of typical roofing.
