## Battery 234 CRF/BCS Tower

# Historic Structure Report

May 2015

Prepared by:  
Wiss, Janney, Elstner Associates, Inc.  
330 Pfingsten Road  
Northbrook, Illinois 60062

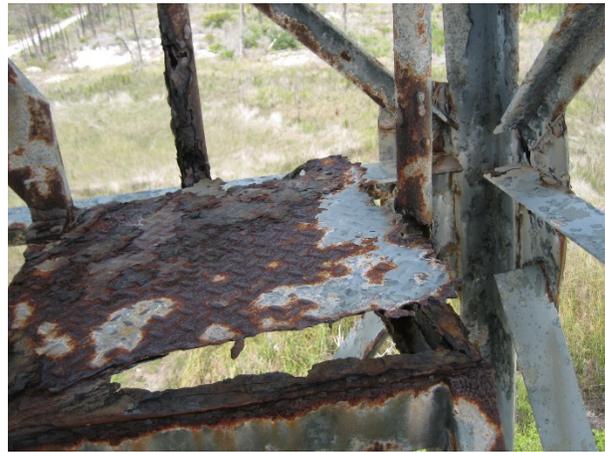
**FIGURE 17.** Deterioration of the upper stair landing, 2008. Source: Gulf Islands National Seashore.

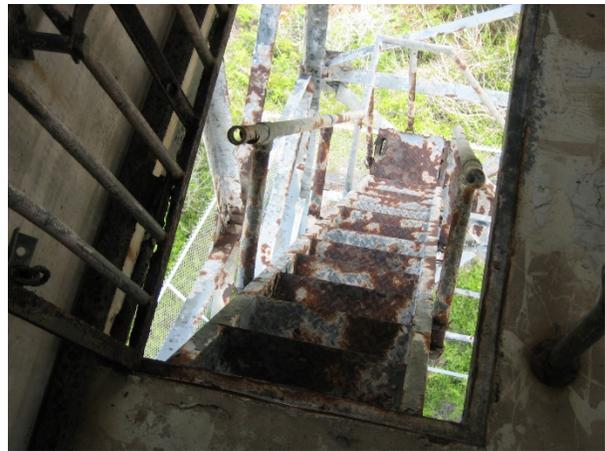
**FIGURE 18.** Deterioration of the stairs, 2008. Source: Gulf Islands National Seashore.

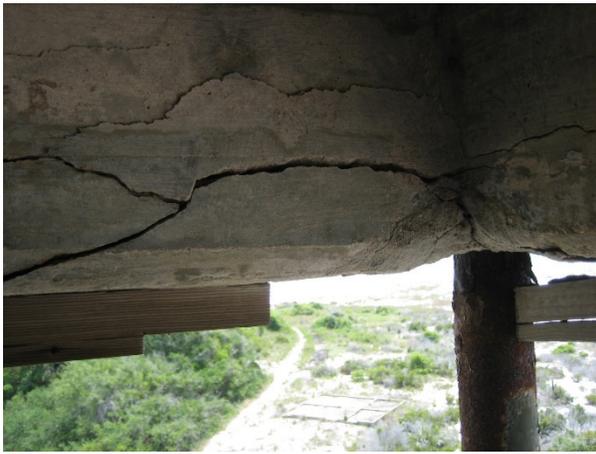
**FIGURE 20.** Corrosion of the southwest corner column and cracking and spalling of concrete at the lower observation level, 2008. Source: Gulf Islands National Seashore.

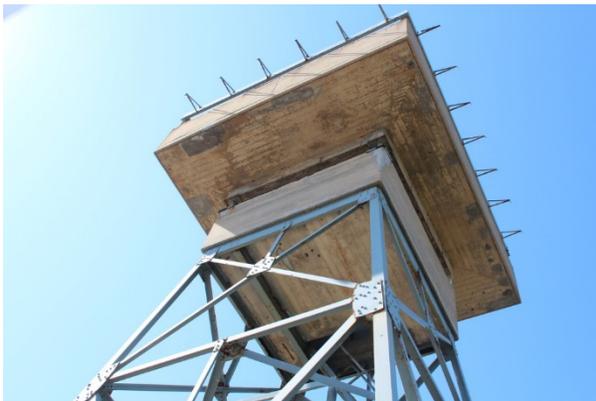
**FIGURE 22.** View of the underside of the concrete structure, August 2014. The gray-colored mortar patches were installed as part of the 2009 work. Photo by the authors.

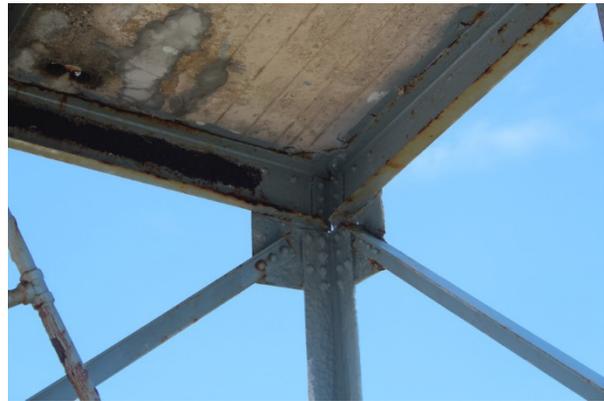
**FIGURE 37.** View of the top frame of the steel structure, formed by 10-inch channels. At left, where the 1980 web reinforcing plate is missing, the surface of the channel is uncoated and has extensive corrosion.

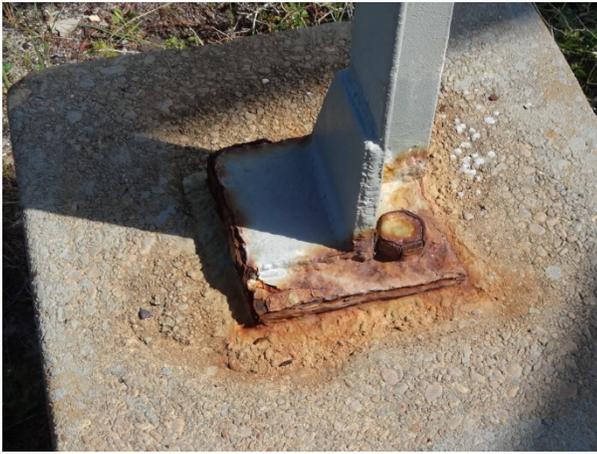
**FIGURE 48.** Anchor bolt at base of stair structure; note corrosion on bolt and base plate.

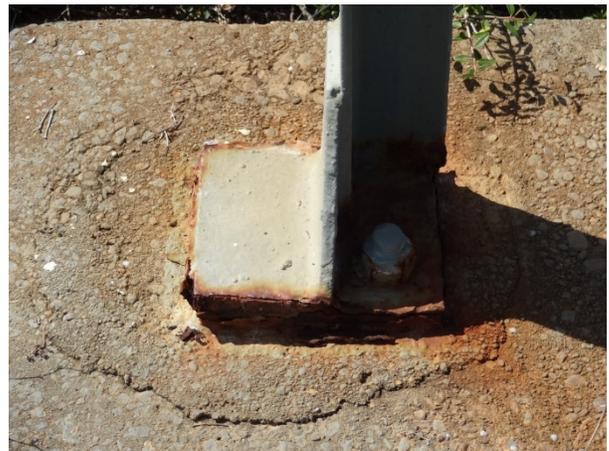
- Previously installed concrete patches were observed at the stair structure footing (Figure 68). The patches were approximately 10 inches square and surrounded the anchor plates for the stair structure. Patch material is distinguished by eroded joints that separate the patch from the original concrete, and a finer standard aggregate size than the original concrete. The patches were most likely installed when the stair support tower was replaced in 1980.
- Mild paste erosion was observed throughout the concrete foundation (Figure 69). Areas of paste erosion were characterized by pronounced aggregate exposed on multiple sides.
- Small spalls were observed at the corners of the footing but did not appear to impact the structural integrity of the foundation.

**FIGURE 68.** Previously installed concrete patch at the stair structure footing.

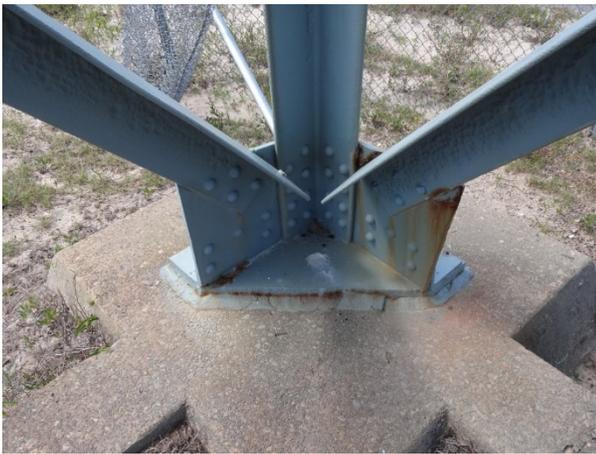
**FIGURE 69.** Paste erosion of the concrete foundation.

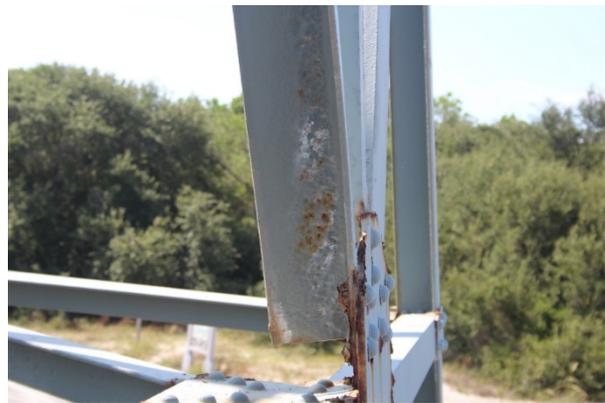
- Areas of white-colored surface staining were observed on many of the steel framing members throughout the structure (Figure 70). Each surface stain was typically a few inches in area and associated with breaches in the surface coating.
- Pitting, or localized corrosion resulting in cavities of varying size and depth, was observed on the underside of many of the steel angles, particularly at the top half of corner columns and at diagonal bracing members (Figure 71). Pitting was more prevalent on structural members at the west and south elevations. The depth of pitting was typically 1/8 inch. Advanced pitting, resulting in complete section loss of the steel, was observed at the diagonal bracing members at mid-height of the tower on the south and west elevations (Figure 72).

**FIGURE 70.** White-colored surface staining associated with breaches in the coating.

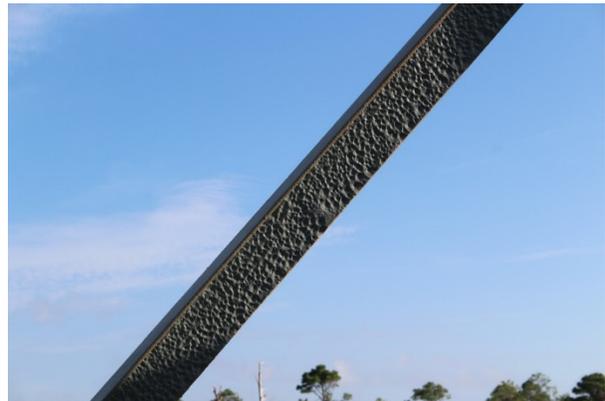
**FIGURE 71.** Pitting of steel elements.

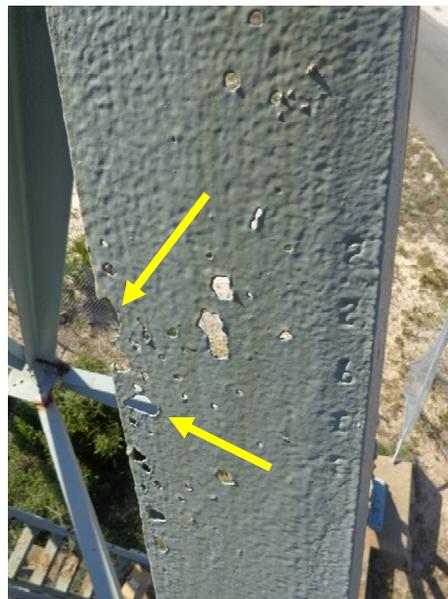
**FIGURE 72.** Corrosion and pitting resulting in section loss at steel elements. The location shown is at element H (refer to Figure 31).

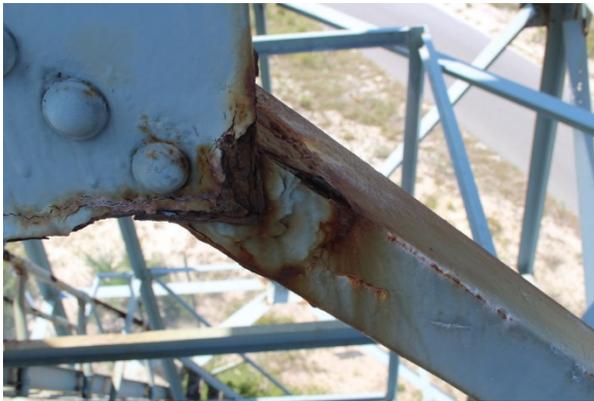
corrosion, especially where pack rust (layers of corrosion product in a contained location, such as between steel plates) has occurred. Rust jacking was observed at numerous locations, specifically at the lap joints between steel angles and gusset plates and above the channel frame at the top of the steel-framed tower (Figure 73). Displacement at gusset plates was typically 3/8 inch. Upward displacement due to rust jacking was observed at the top flange of the steel channel members and was most pronounced above steel channels at the north end of the structure (Figure 74).

**FIGURE 73.** Rust jacking and section loss at the joint between a steel element and gusset plate.

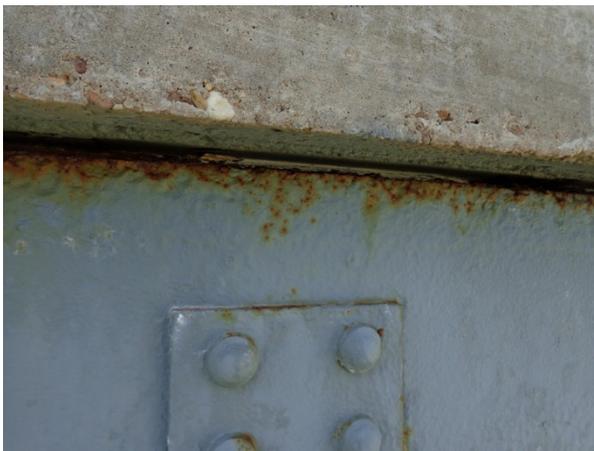
**FIGURE 74.** Upward displacement of the concrete observation booth due to corrosion of the top flange of the channel members at the top of the steel frame.

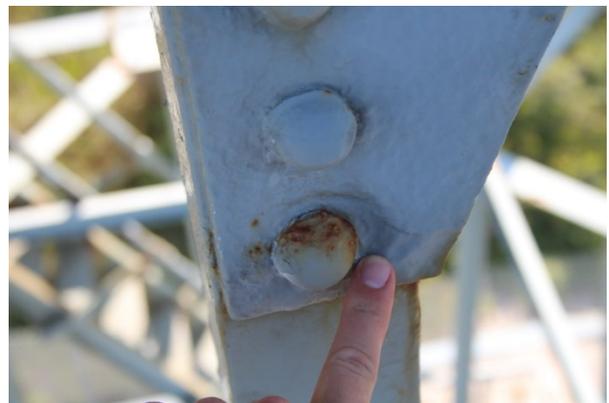
**FIGURE 75.** Corrosion of gusset plate around a rivet head.

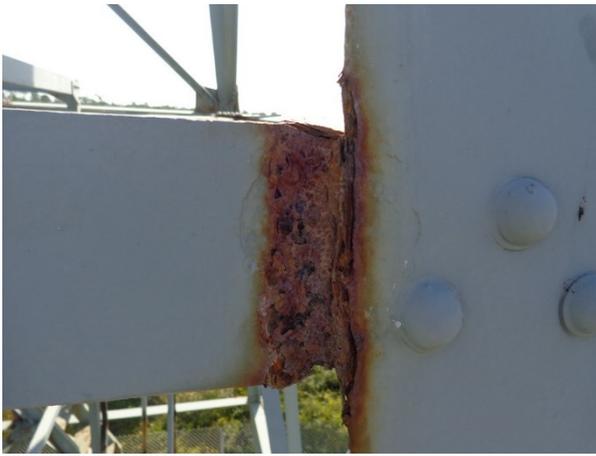
**FIGURE 76.** Corrosion of steel framing member and gusset plate at lap joint.

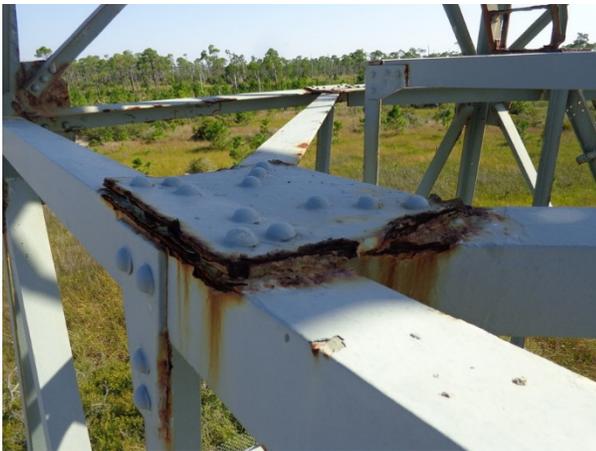
- Observed corrosion typically had a striated or layered appearance where observed along the edges of horizontal and vertical gusset plates (Figure 77). The corrosion was concentrated at areas adjacent to connections with other framing members. Corrosion staining and peeling paint were present at the framing members adjacent to areas of corrosion on the gusset plate, and areas of crevice corrosion and rust jacking at lap joints.

**FIGURE 77.** Layers of corrosion product at a gusset plate.

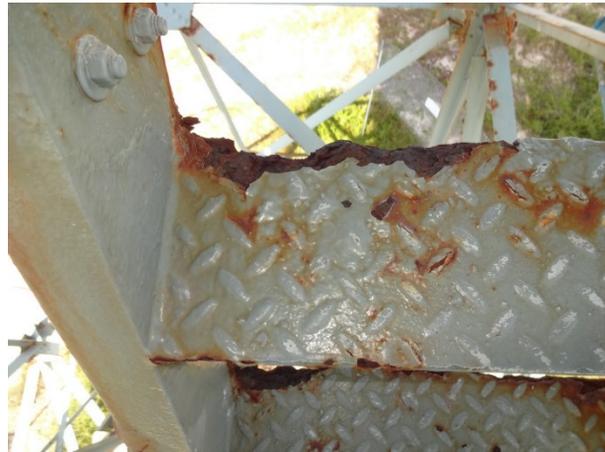
**FIGURE 78.** Severe corrosion and section loss at stair treads.

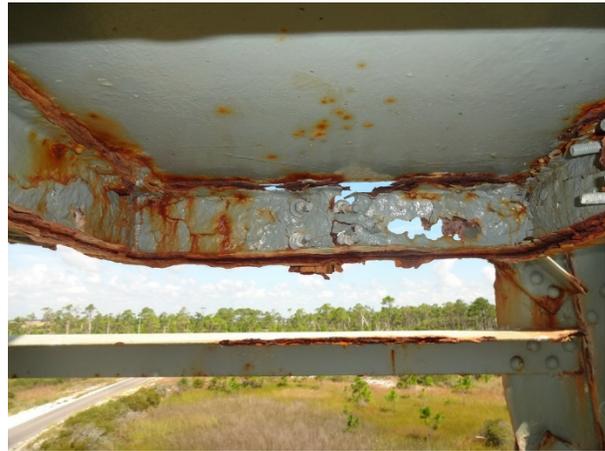
**FIGURE 79.** Severe corrosion and section loss at framing members for a stair landing.

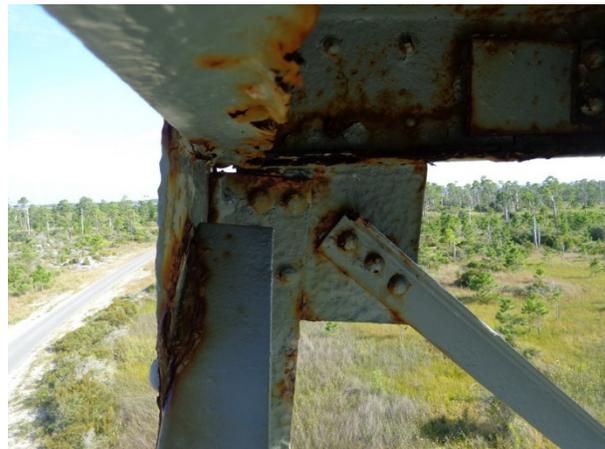
**FIGURE 80.** Widespread surface corrosion near the top of the steel structure.

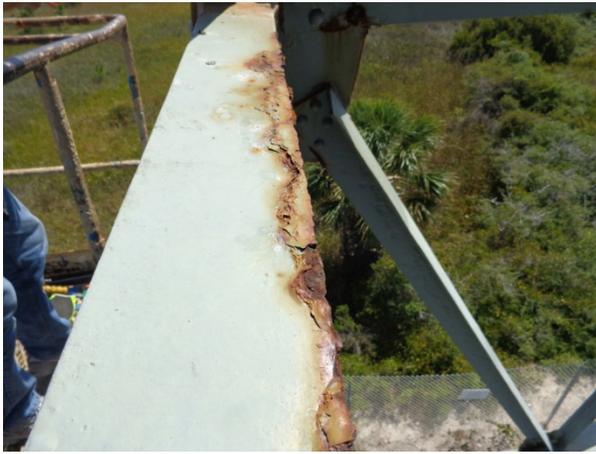
**FIGURE 81.** Corrosion along the toe of one angle framing member.

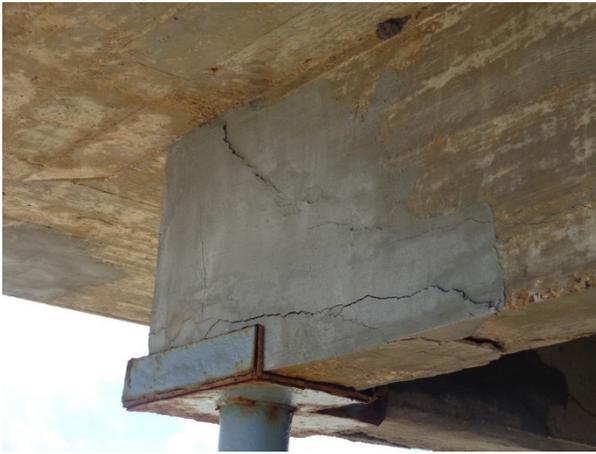
**FIGURE 83.** Previous patching of spalls and subsequent cracking at the corner of the lower level, above the window opening.

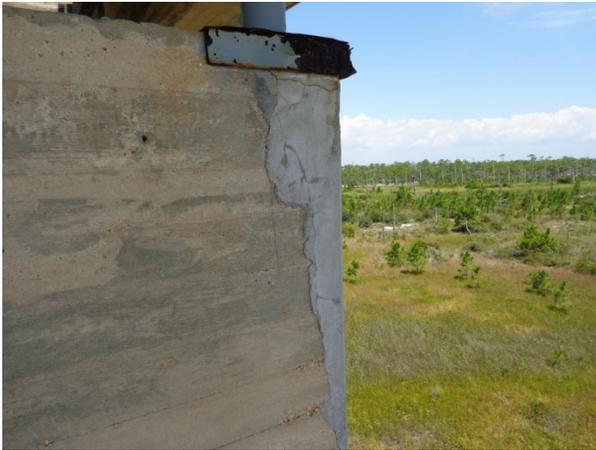
**FIGURE 84.** Previous patching of spalls and subsequent cracking at the corner of the lower level, below the window opening.

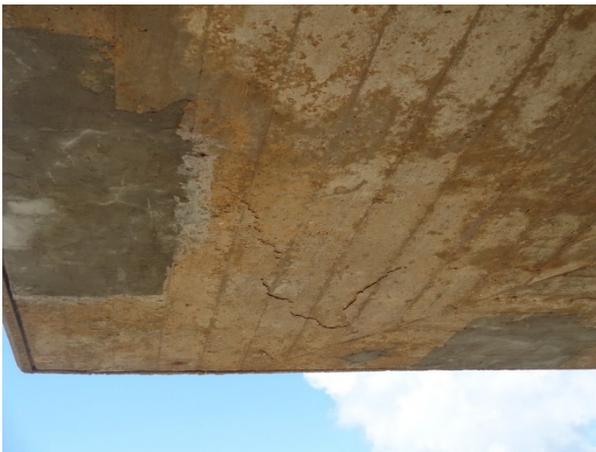
**FIGURE 85.** Previously installed patches, as well as cracks and incipient spalls, at the underside of the upper level cantilever.

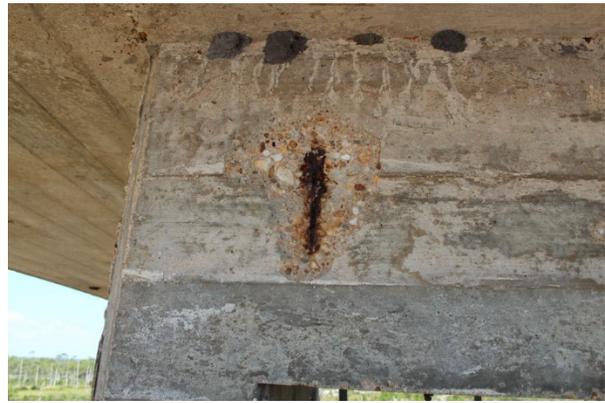
**FIGURE 86.** Spalled concrete with exposed reinforcing steel.

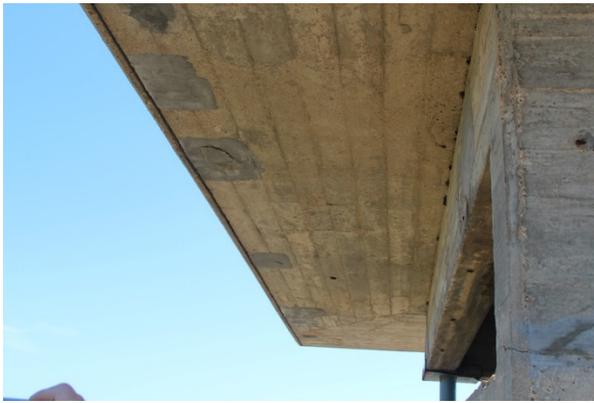
**FIGURE 87.** Previously installed patches at the underside of the upper level.

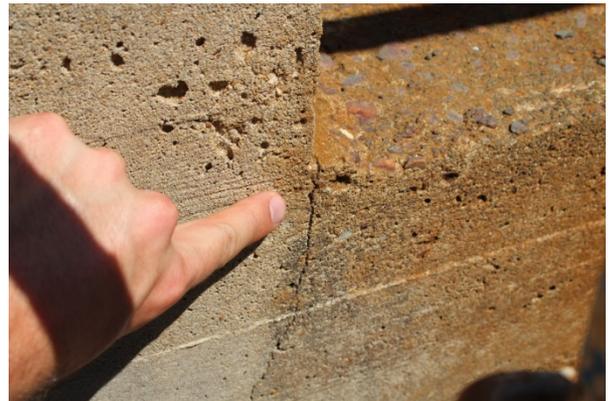
**FIGURE 91.** Vertical crack in concrete.

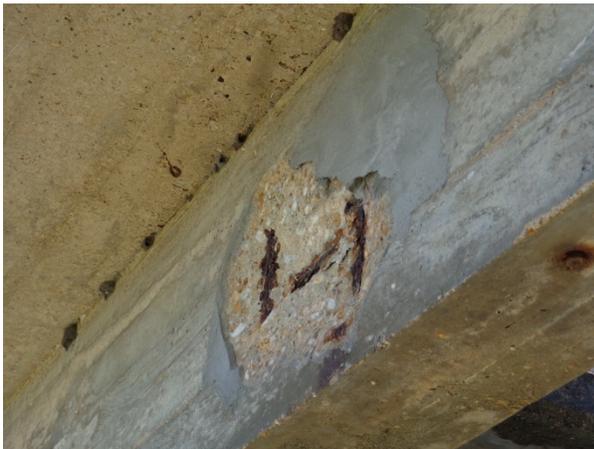
**FIGURE 89.** Corroding reinforcing steel at spalled patch.

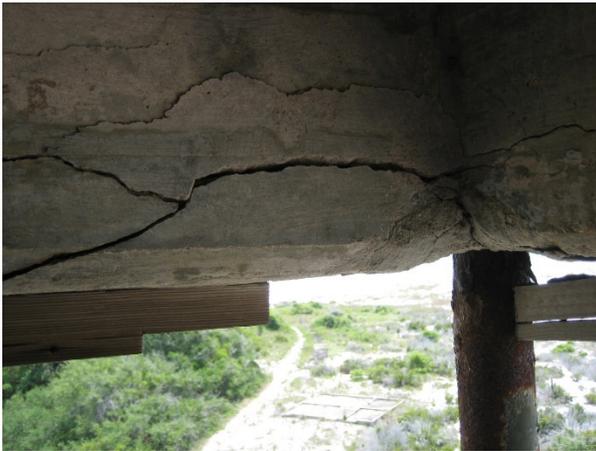
**FIGURE 95.** Cracking and spalling of concrete at the southwest corner of the lower observation level, 2008. Source: Gulf Islands National Seashore.

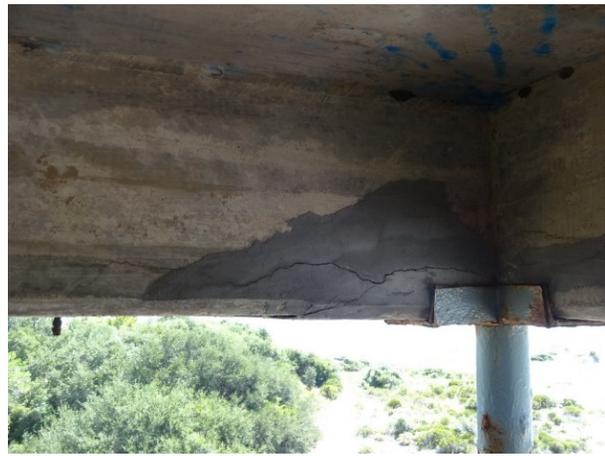
**FIGURE 96.** Cracking of repair mortar at the same location, August 2014. Note that the repair mortar has cracked in an almost identical pattern to the previous concrete distress. Photo by the authors.

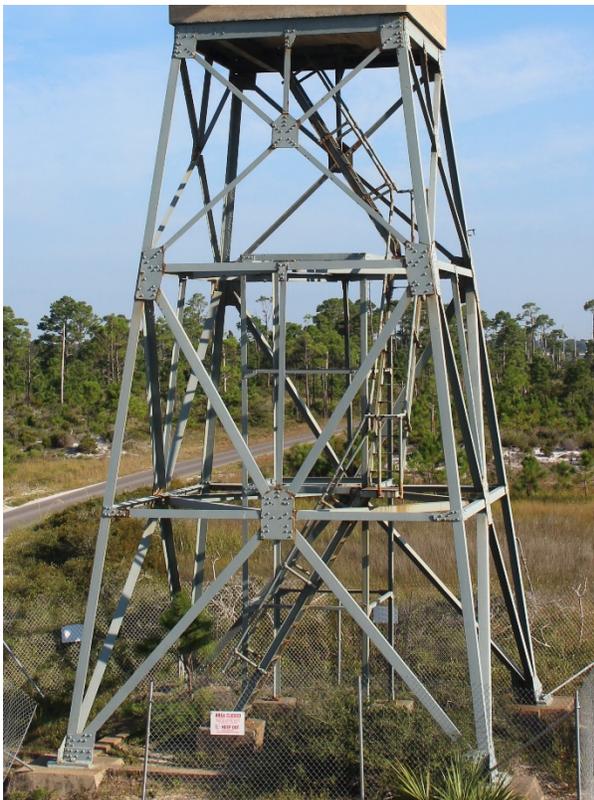
**FIGURE 98.** A similar view, August 27, 2014. Note the development of corrosion and staining.
