HISTORIC STRUCTURE REPORT

WILLIAMS RANCH

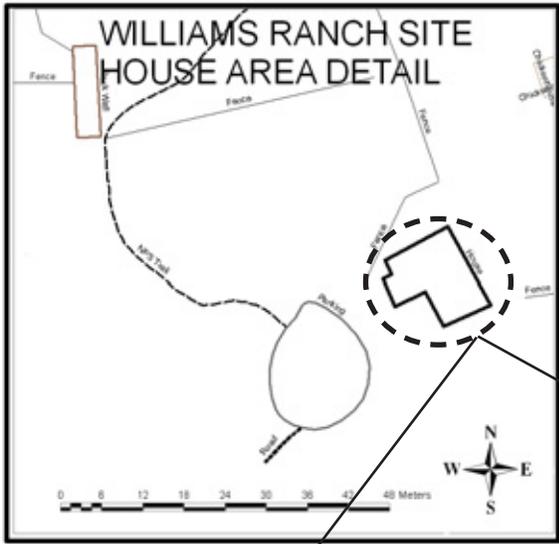
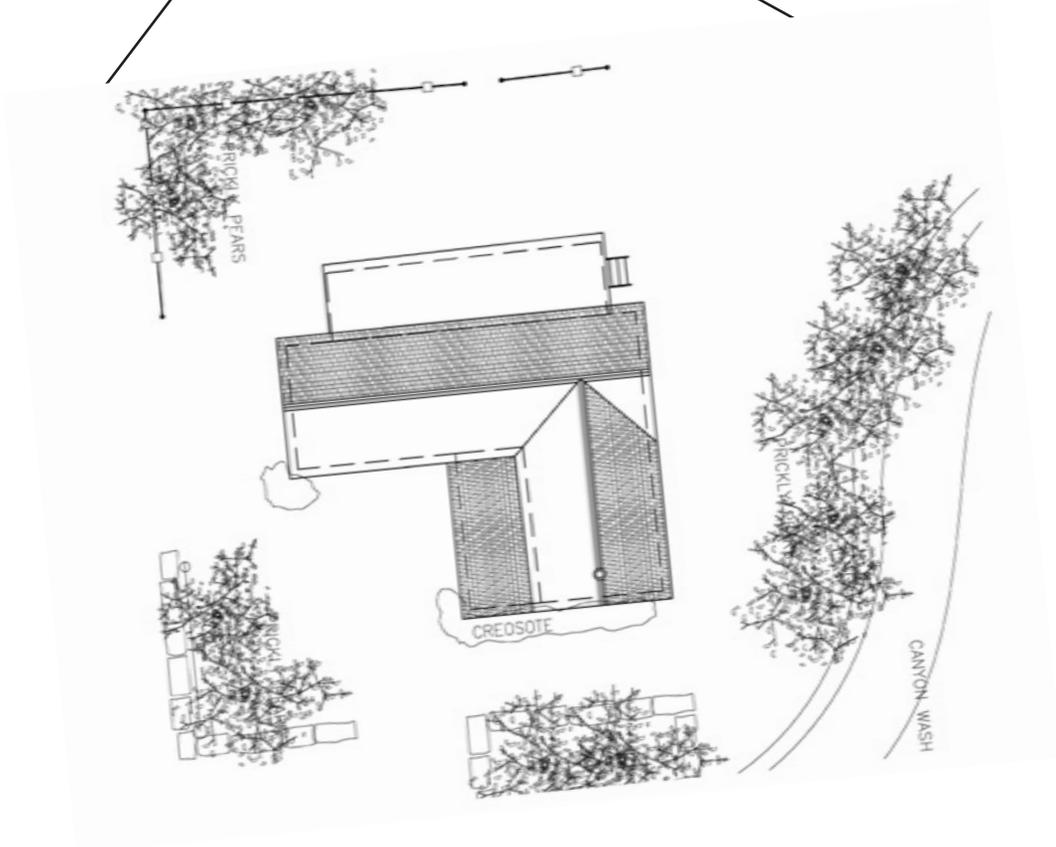
The park's LCS classifies the ranch house as being in Good Condition, indicating that it is structurally sound and that the deficiencies are primarily Low to Moderate. The major structural deficiencies include wood deterioration from water, wind and sun exposure. A major non-structural issue includes stained, deteriorating and detaching wallpaper.

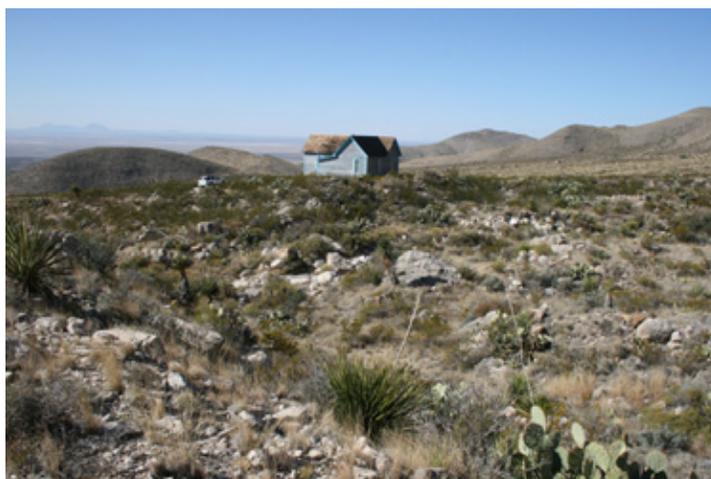
Fig. Setting_3: Looking southeast toward the house from the rock wall corral, one of the major features of the ranch complex. This photo was taken before the wall was repaired in 2010 in accordance with the *UA Rock Wall Report*.

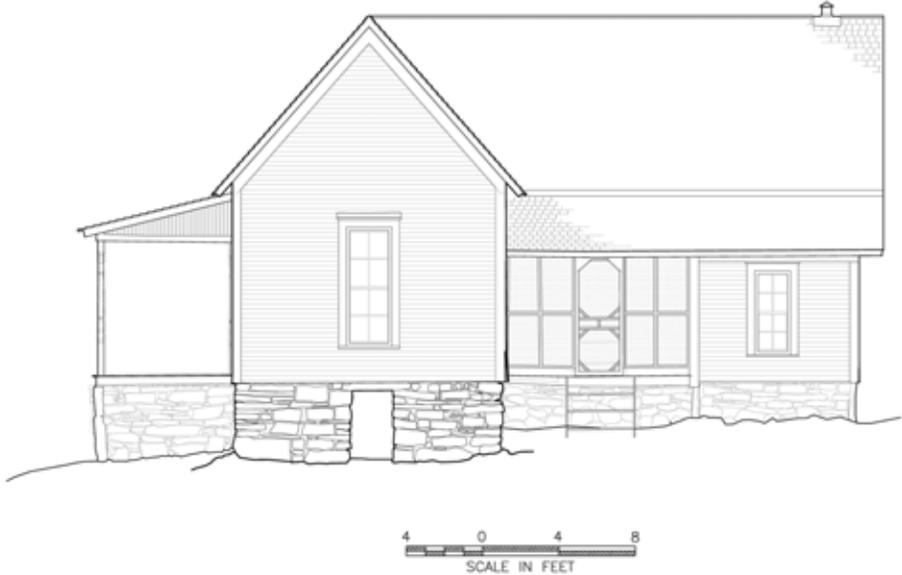
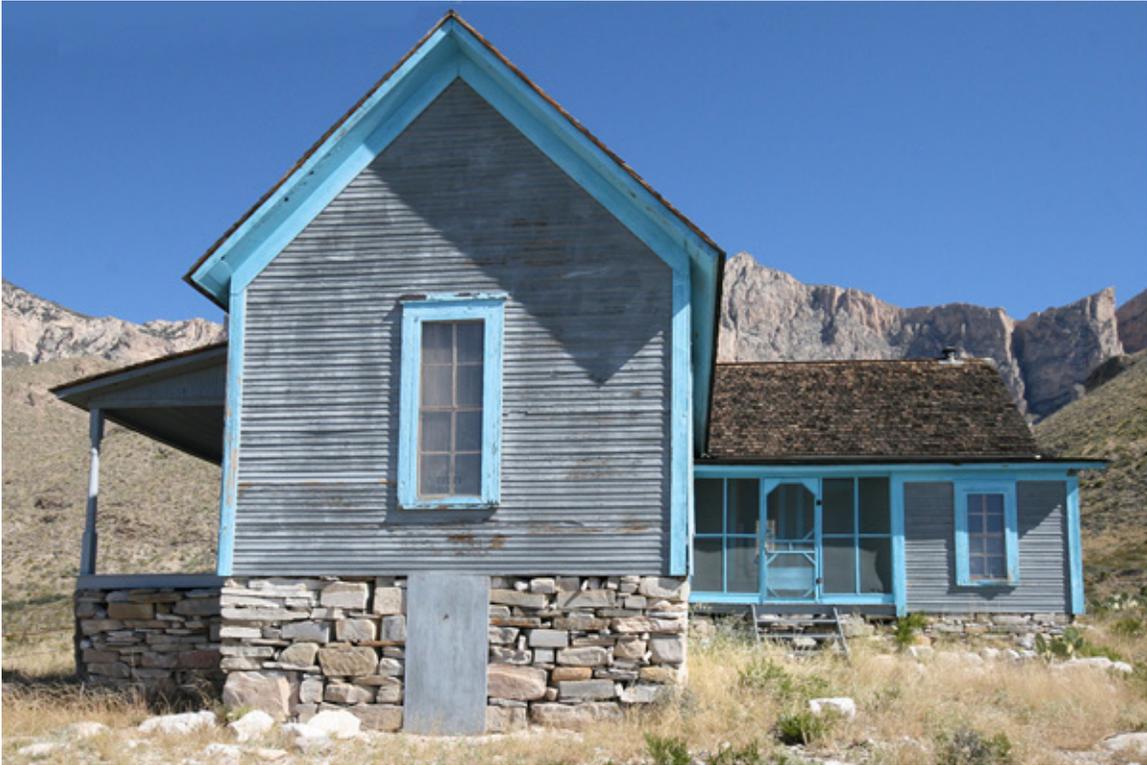
Foundation and Crawl Space

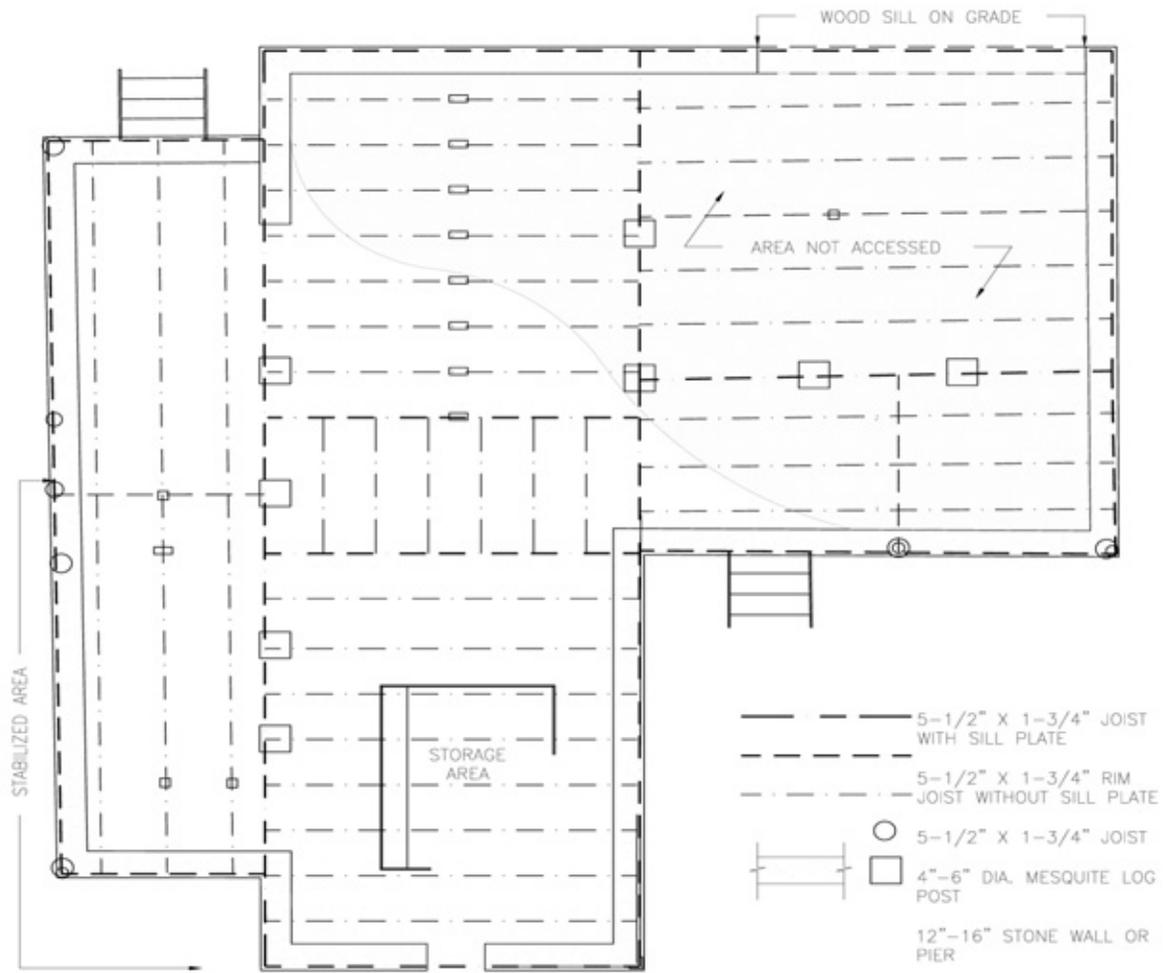
Fig. Foundation/Crawl Space_1: Post not seated properly under northwest corner of north porch.

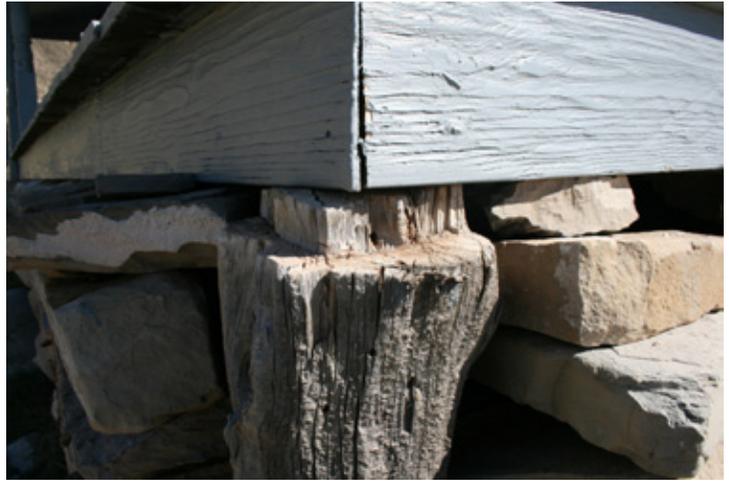
Fig. Foundation/Crawl Space_2: Post under north porch too short. Replacement will require moving and resetting foundation stones to accommodate burying post below grade.

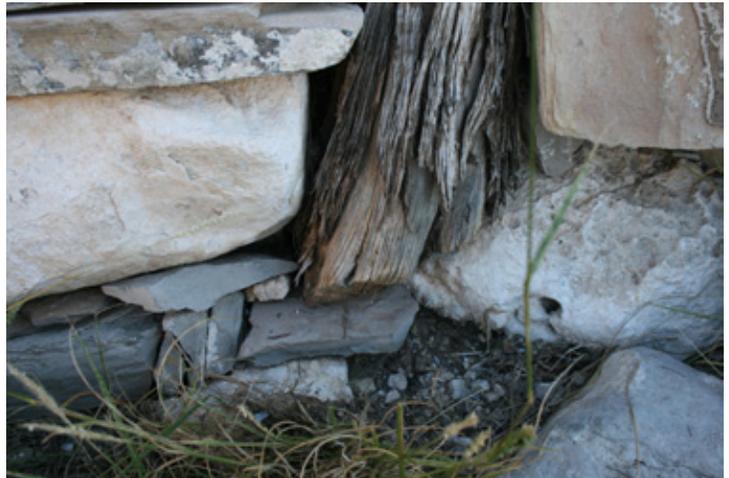
Fig. Foundation/Crawl Space_3: Note architectural detail. Posts rest inside corners of the house, directly under the vertical 1x12 box construction that forms the interior walls of the house.

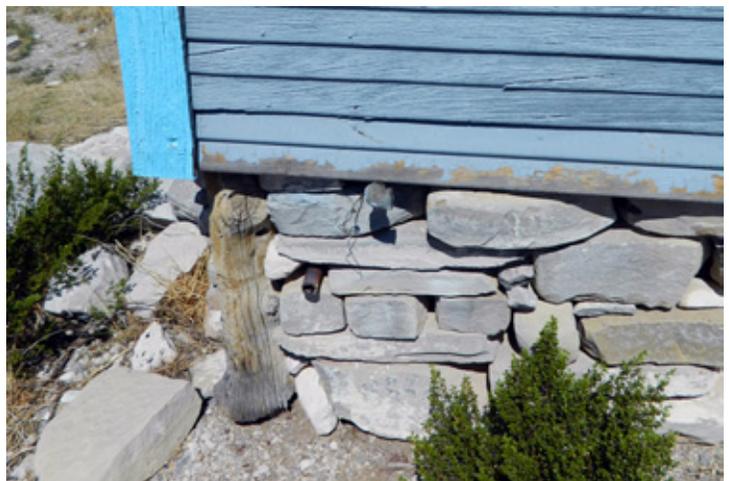
Fig. Foundation/Crawl Space_4: Western stone foundation wall and post of north porch leaning to the west. All walls of the foundation should be monitored and corrected as needed.

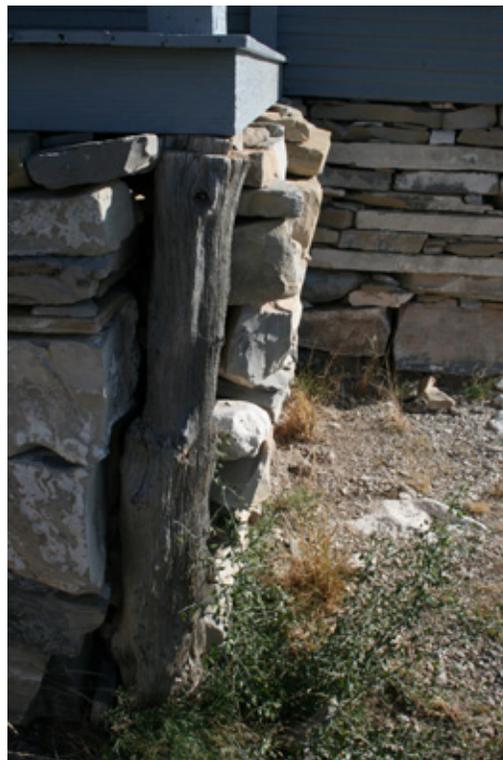
Fig. Foundation/Crawl Space_5: Missing foundation stones.

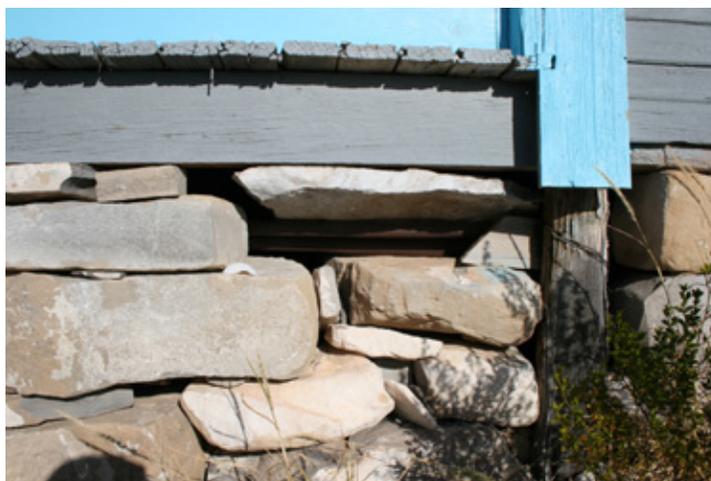
Fig. Foundation/Crawl Space_6: Debris, some historic, in crawl space.

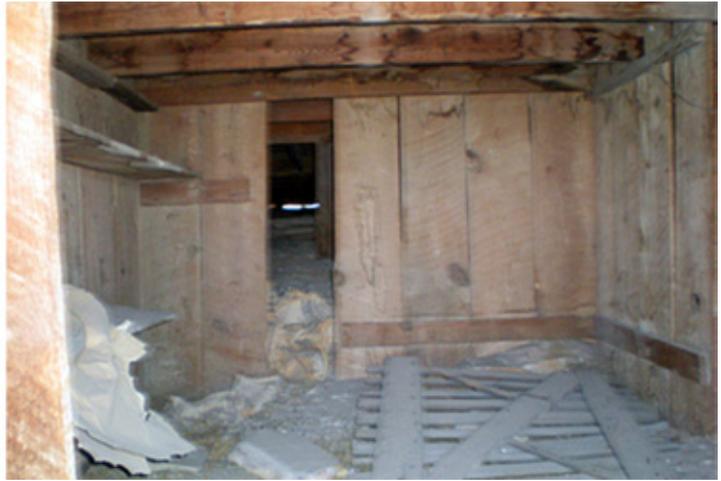
Fig. Foundation/Crawl Space_7: Varied shoring under floor joists.

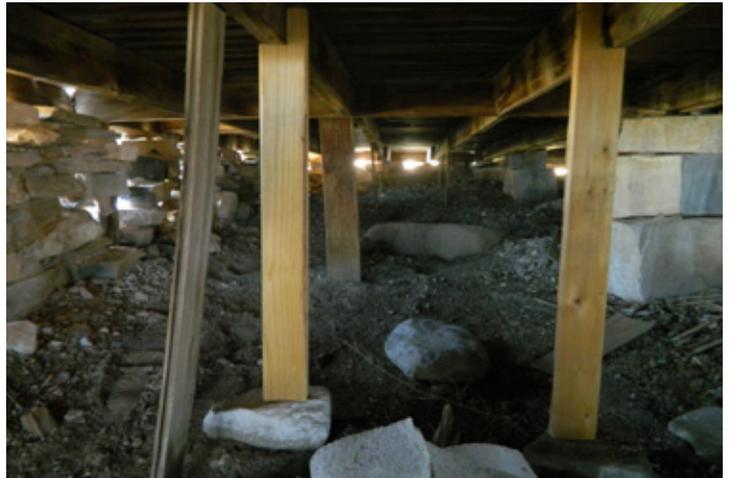
Fig. Foundation/Crawl Space_8: Evidence of pests (pack rat).

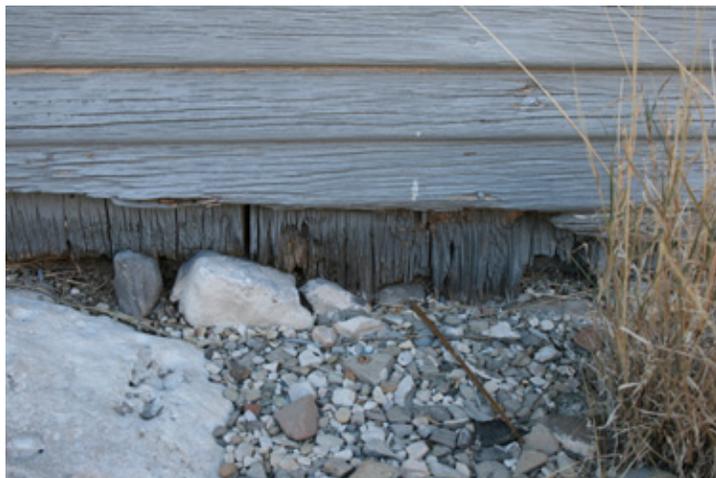
Fig. Exterior Cladding_2: Slight settling has caused deformation of siding at the base of the easter wall.

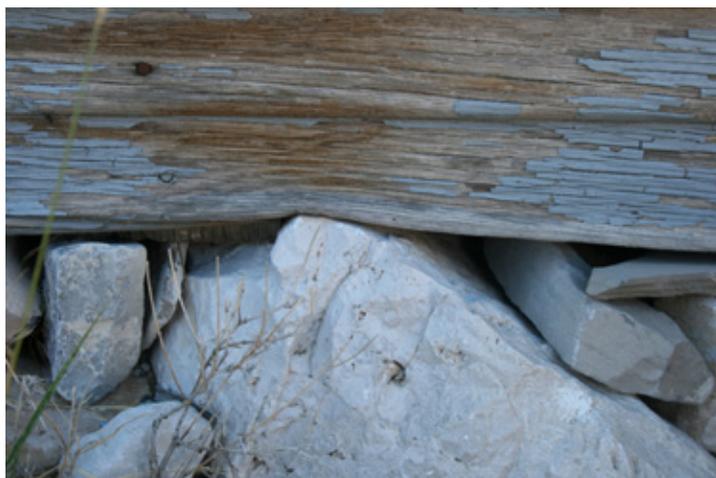
Fig. Exterior Cladding_3: Deterioration of siding in places includes cracking, splitting, and UV degradation.

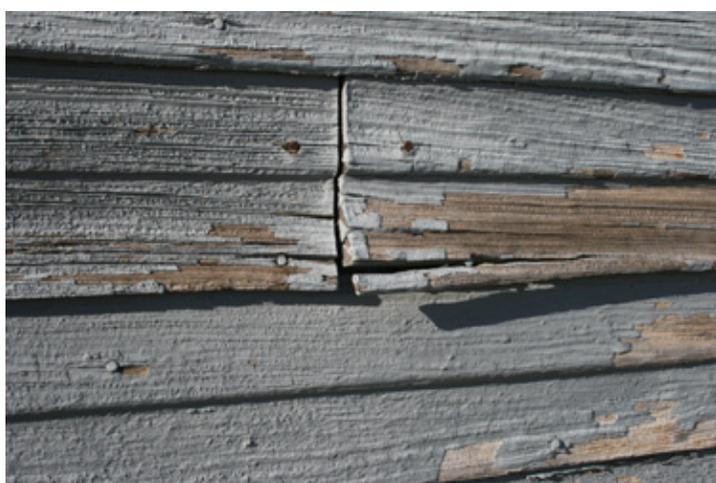
Fig. Exterior Cladding_4: Replacement siding is highly noticeable due to differences in appearance and how it accepts the paint.

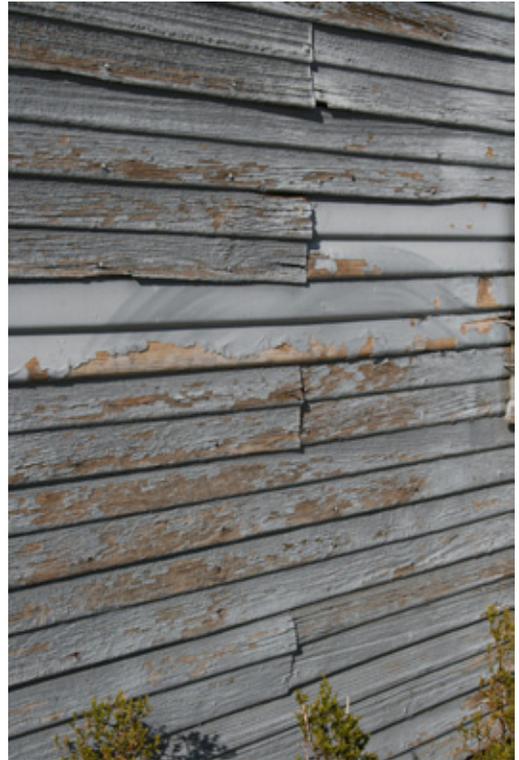
Fig. Exterior Cladding_5: Trim boards at corners are warped and detached. Note deformation of siding where settling has caused it to push against the stone foundation at the base of the wall.

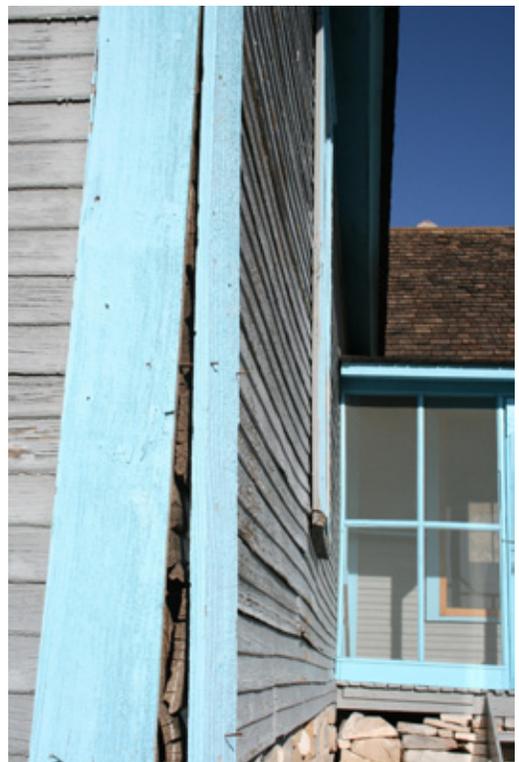
Fig. Exterior Cladding_6: Chipped and flaking paint on the siding.

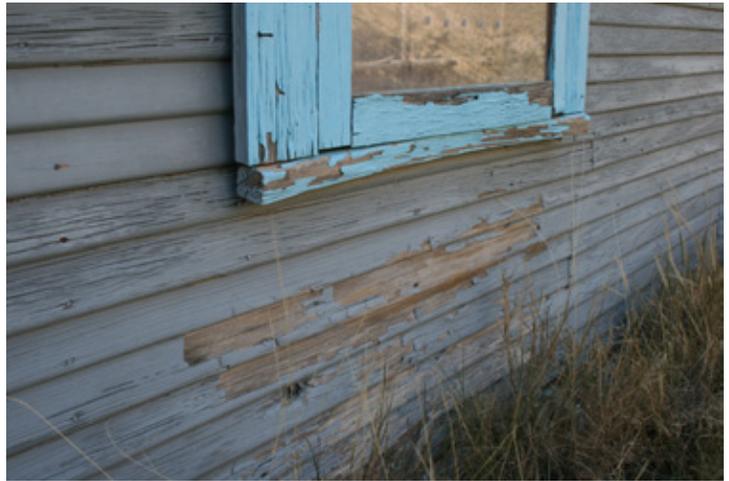
Fig. Windows and Doors_2: North window on eastern elevation exhibits slippage of the still and cracking of the frame.

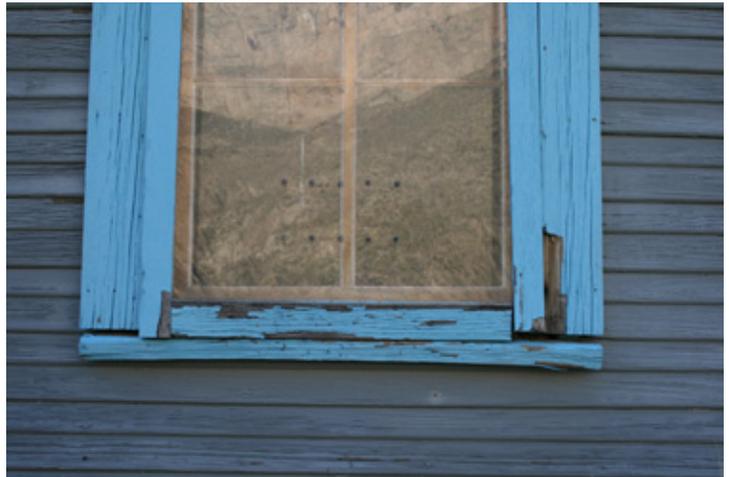
Fig. Windows and Doors_3: North window on eastern elevation shows wear to the flashing and sash has slipped.

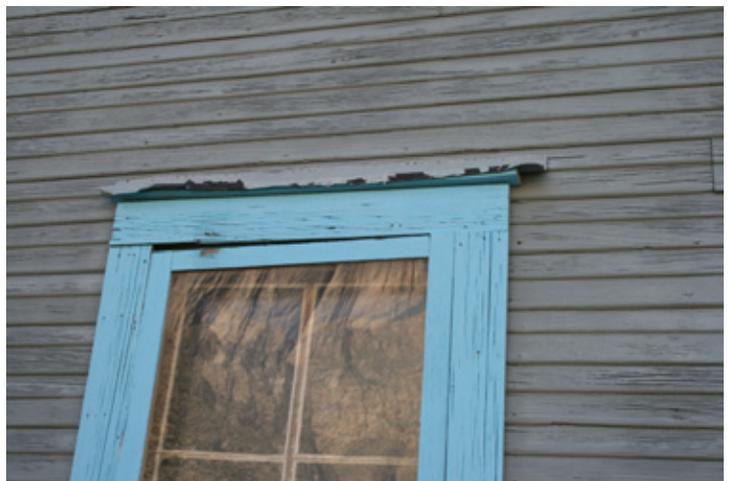
Fig. Windows and Doors_4: South elevation window with damaged flashing and warped sill.

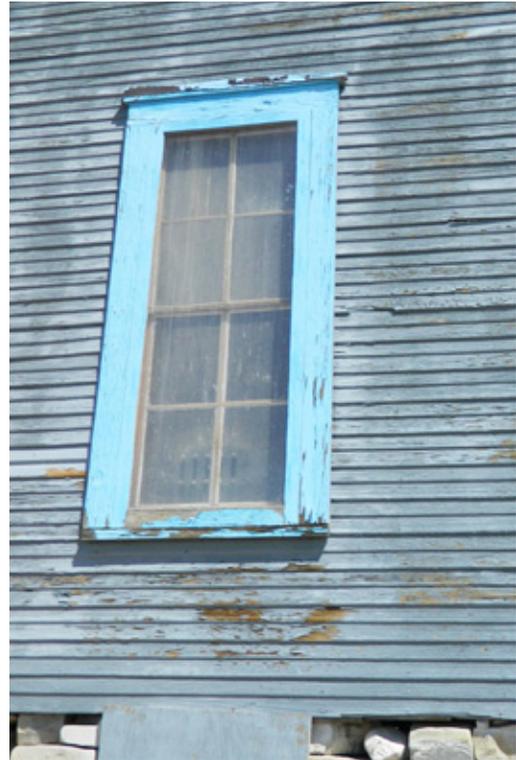
Fig. Windows and Doors_5: West elevation window with sash protruding out of frame.

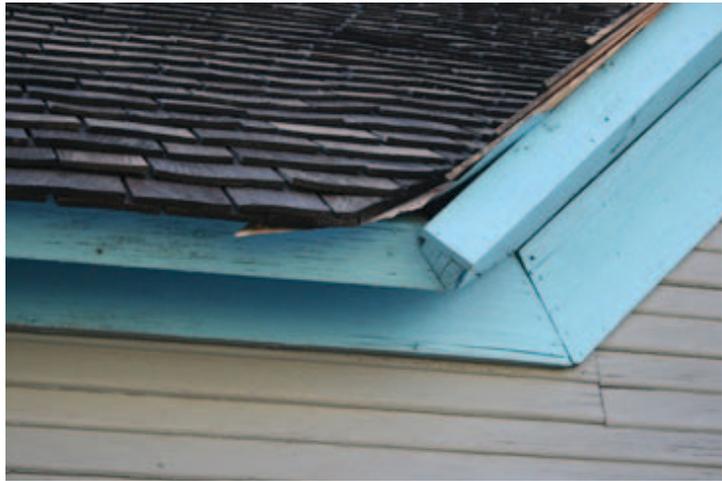
Fig. Roof_2: Fascia board warped on west façade.

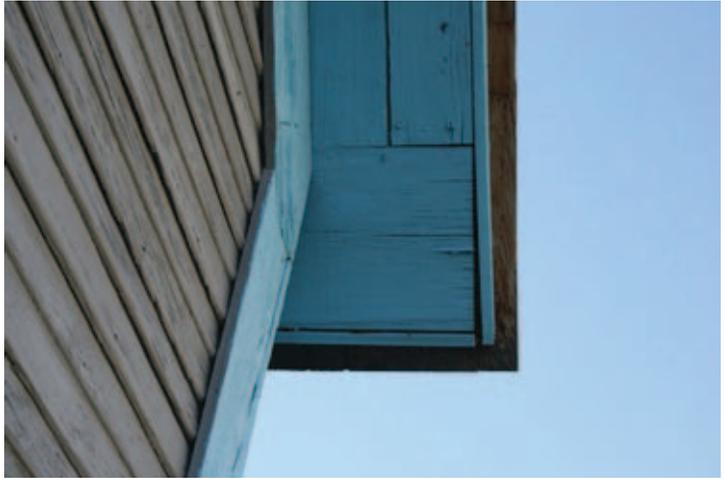
Fig. Roof_5: Holes in soffit all around the house due to woodpecker damage.

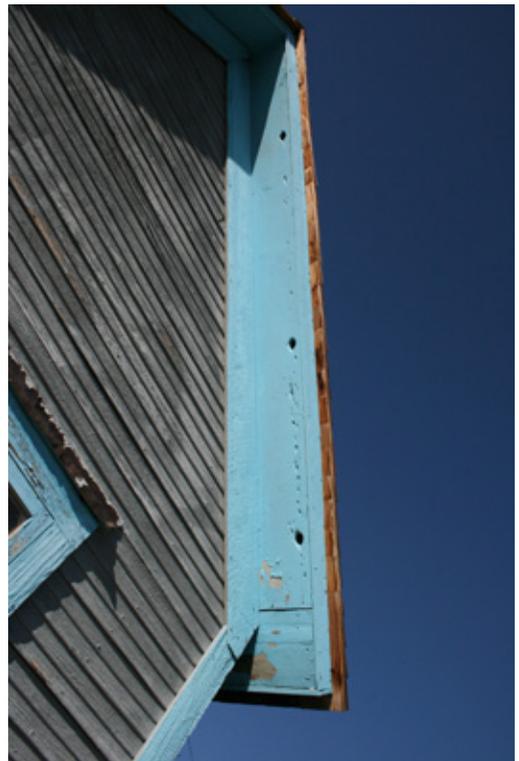
Fig. Roof_6: Trim warped at gable on south façade.

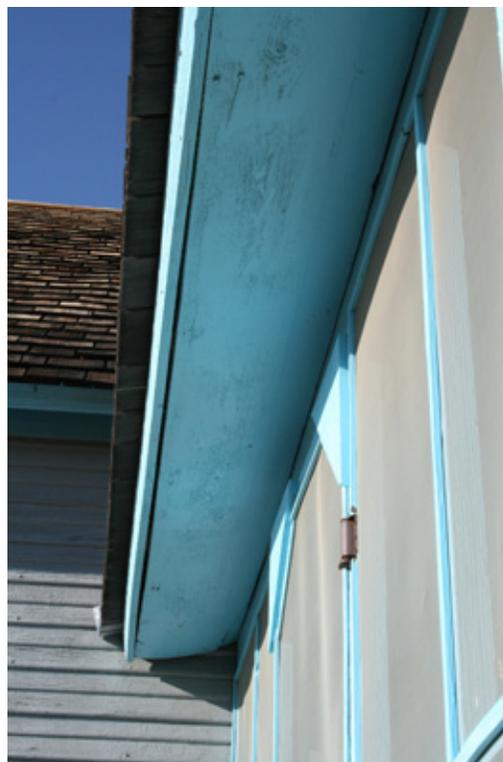
Fig. Roof_8: The roof condition was assessed in 2010 and found to be good. Previous repairs to the roof are holding well, with no missing shakes and tight joints with flashing and chimney.

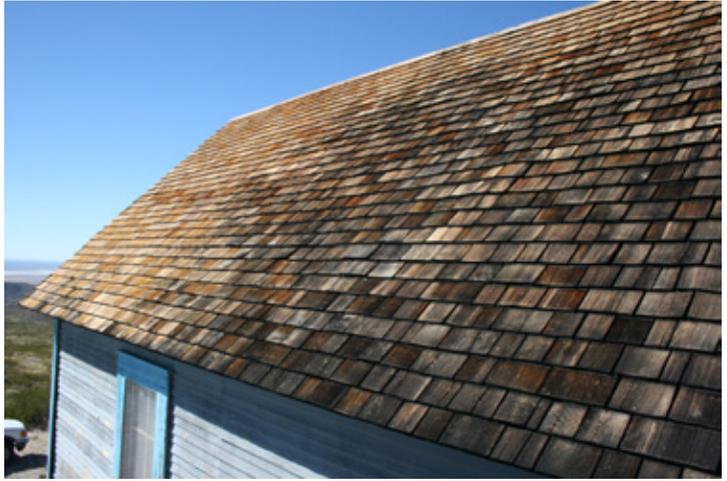
Fig. Roof_9: Image of gutter at ell of house. Note shed roof on west porch; may support idea that this was added by Williams after original construction.

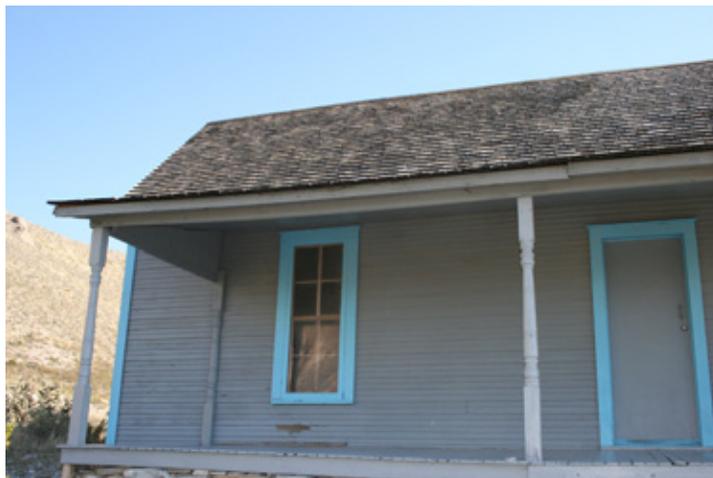
Fig. North Porch_2: Separation of butt joints near center post on north porch. Woodpecker damage to soffit.

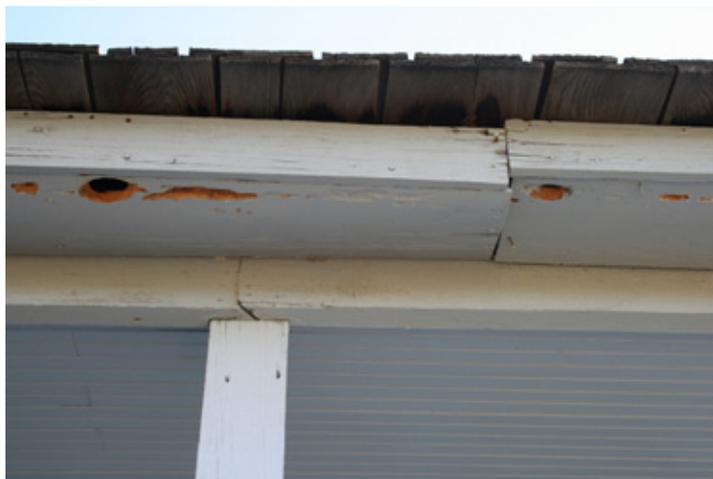
Fig. North Porch_3: Separation of soffit at northeast corner of porch due to warping of board. Note missing piece of decorative beadboard.

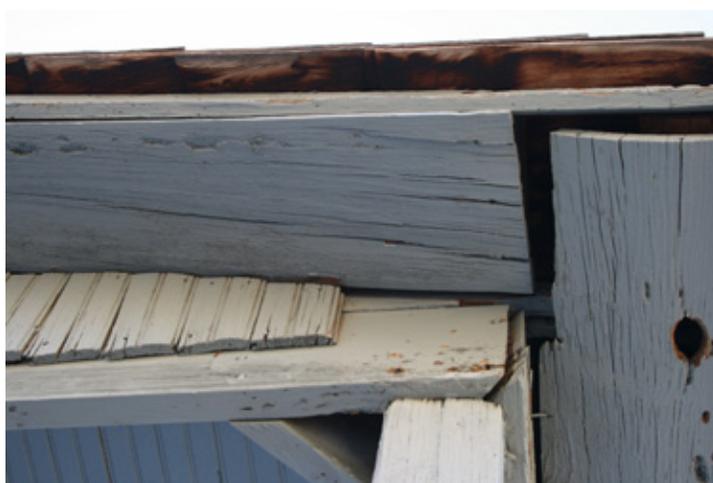
Fig. North Porch_4: Architectural feature: support posts against the house are flat and attached directly to the siding.

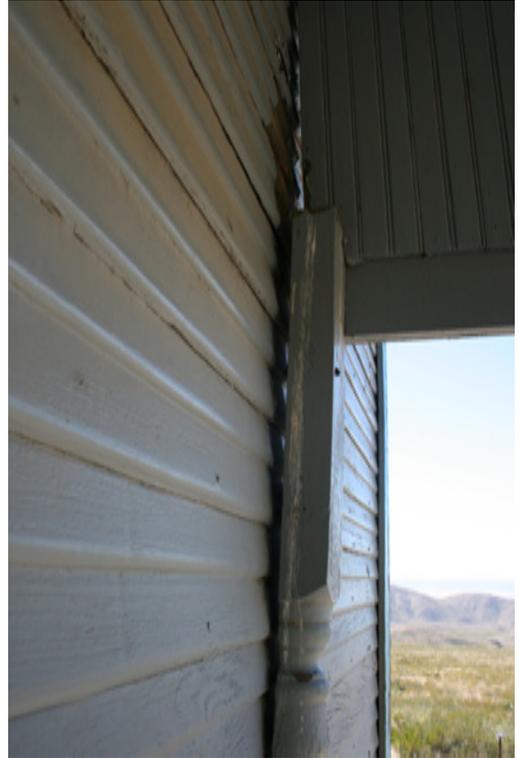
Fig. North Porch_5: Evidence of bird nesting on engaged post at southwest corner of porch, damaged paint on siding.

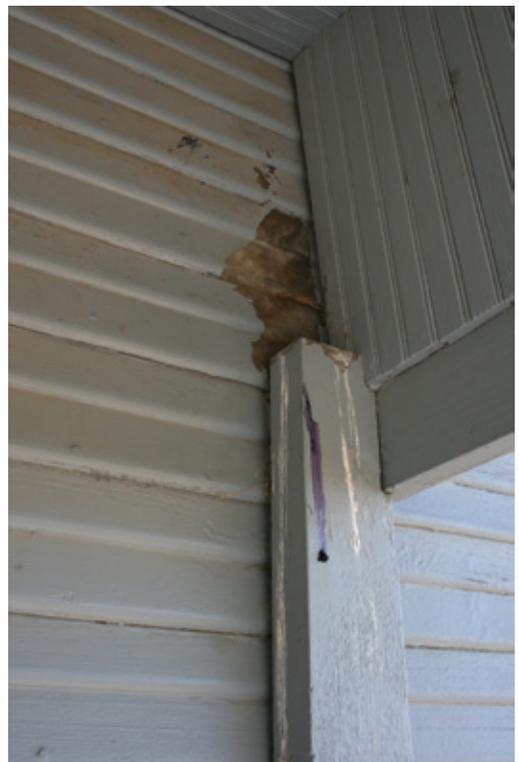
Fig. North Porch_6: Previous stabilization measure which consolidated the bottom of a historic post using epoxy. Note face plate at front of porch. For further details see Bigelow 2009 “Williams Ranch Porch Restoration Report”.

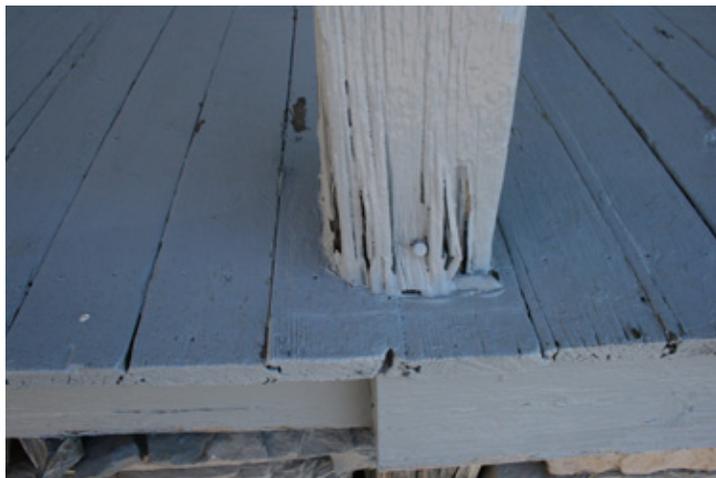
Fig. North Porch_7: Foundation posts under porch; note western post is not sitting directly under post it should be supporting. Some floorboards are loose and should be nailed down.

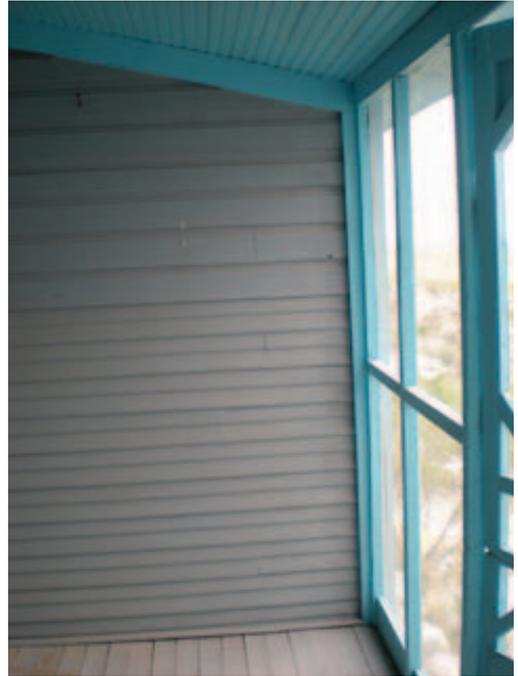
Fig. West Porch_2: Hole in floor adjacent to standing pipe in northwest corner of porch.

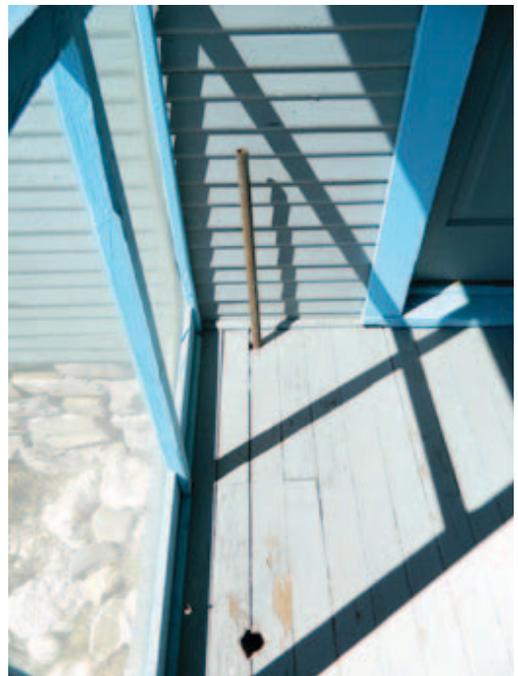
Fig. West Porch_3: Porch floor uneven. Floor boards warped with some deterioration on the exterior ends; note warped end of screen frame in lower left corner

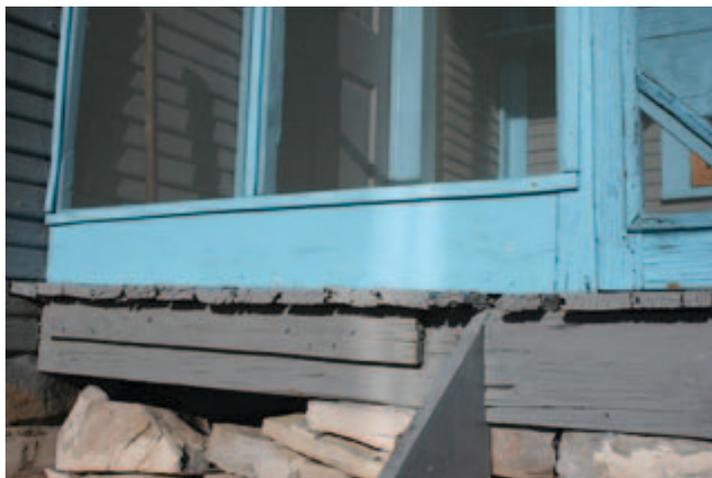
Fig. West Porch_4: Hip joint of shed roof over west porch and interior storage room and main gabled roof is not very tight; may allow water to enter.

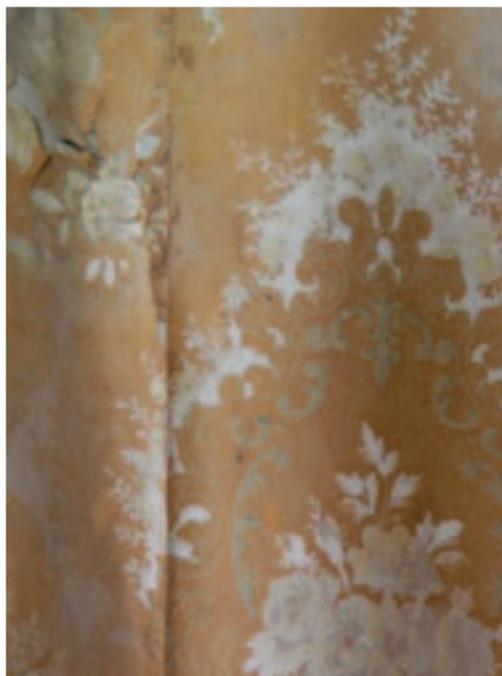
Fig. Bedroom_2: Remaining wallpaper on ceiling faded and stained.

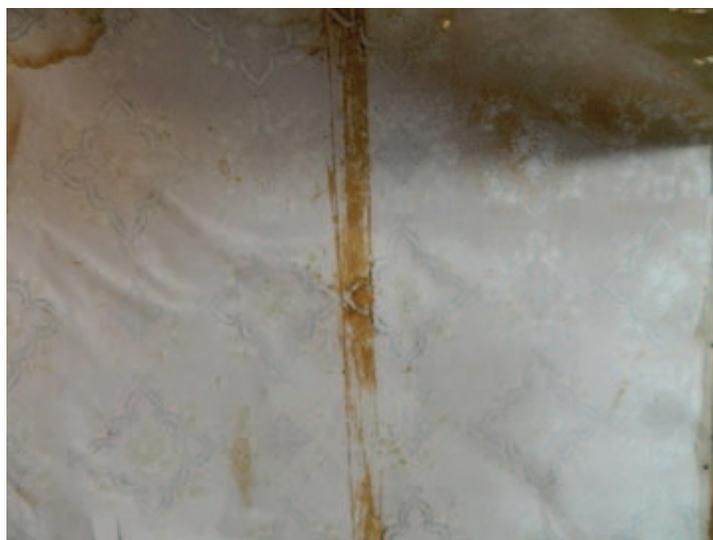
Fig. Bedroom_3: Overview of bedroom; note wallpaper detaching from walls, storage of extra wood siding, lumber, and debris on floor, and door, and debris on floor.

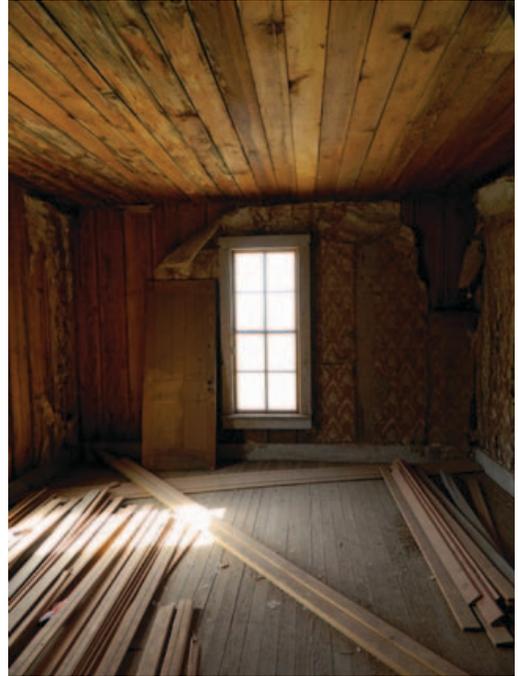
Fig. Bedroom_4: Water staining on suspended wood ceiling; note water damage to wallpaper at bottom of photograph. It is likely this occurred before roof repair was undertaken, though not recorded. Monitor area for further damage.

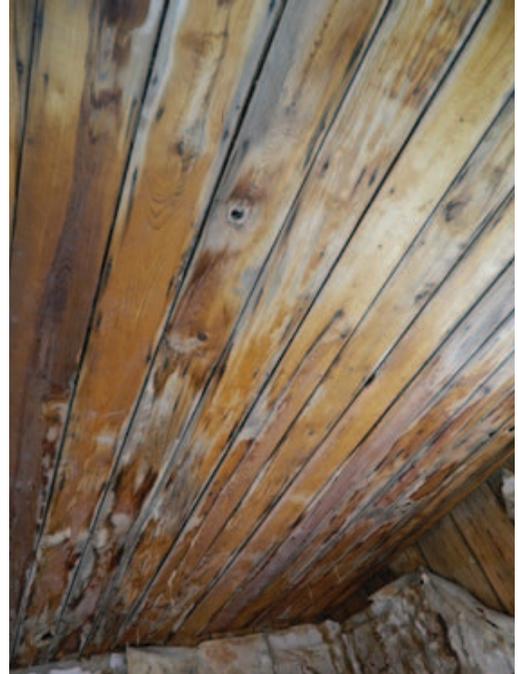
Fig. Bedroom_5: Gaps in framing and siding expose interior to exterior conditions, water and pests. Note backs of routed dimensional lumber used to replace exterior shiplap siding.

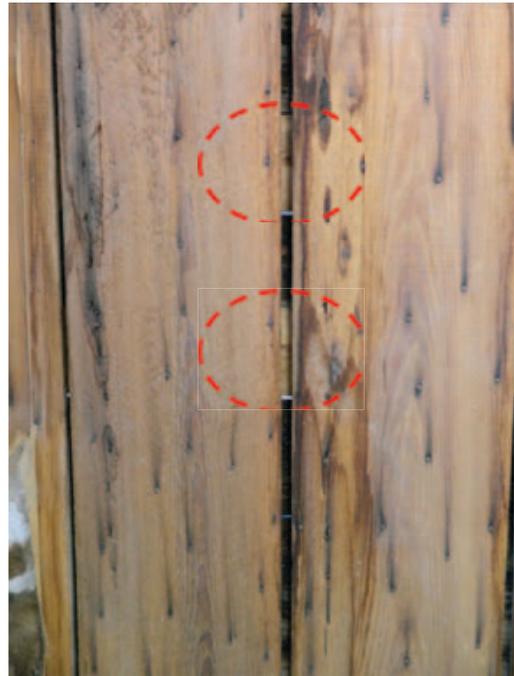
Fig. Bedroom_6: Bedroom closet; tarp and wood siding stored in closet.

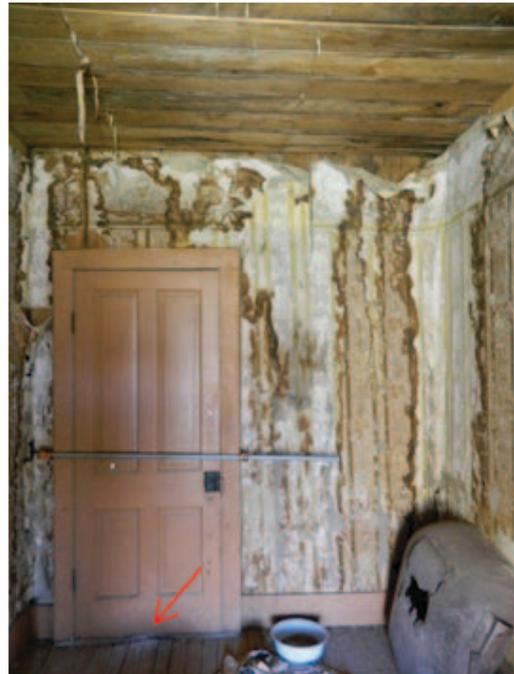
Fig. Foyer_2: Foyer shelves, facing southeast; note debris on floor.

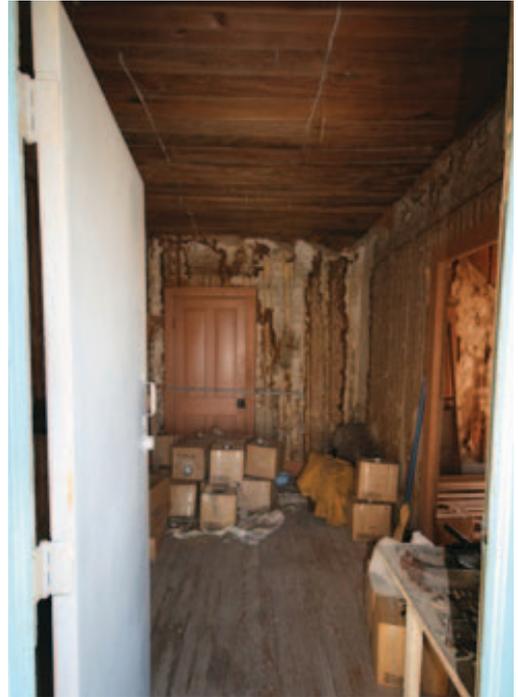
Fig. Foyer_1: Foyer, facing south; note debris and maintenance items on floor.

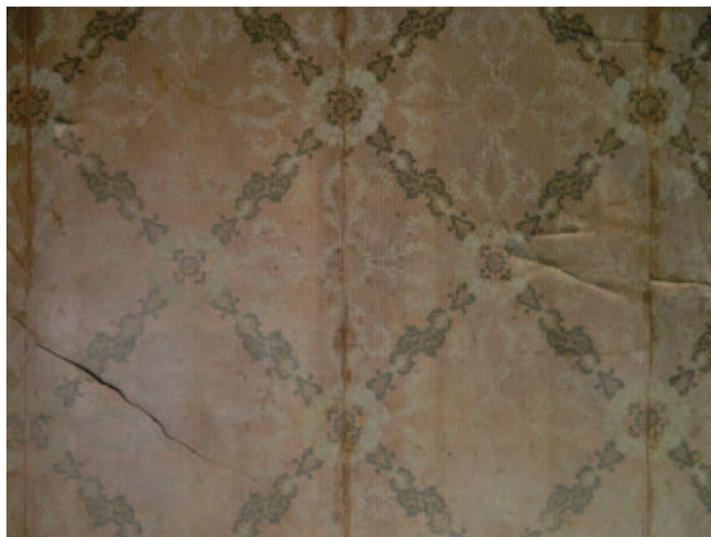
Fig. Parlor_2: Wallpaper on bedroom walls.

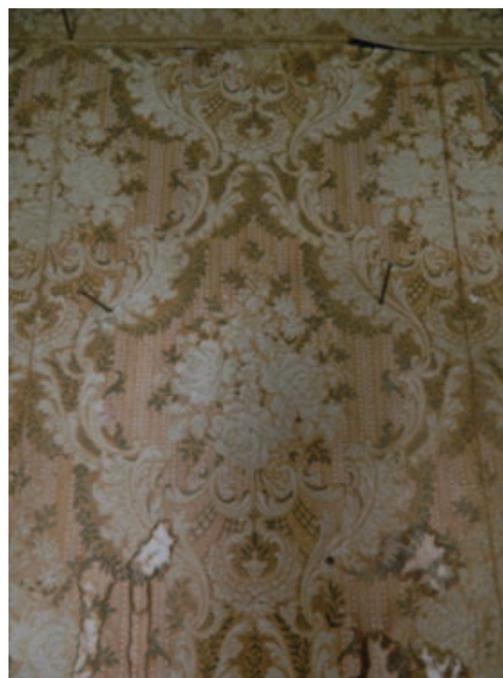
Fig. Parlor_3: Water staining and damage on ceiling and down west parlor wall. It is likely this occurred before roof repair was undertaken, though not recorded. Monitor area for further damage.

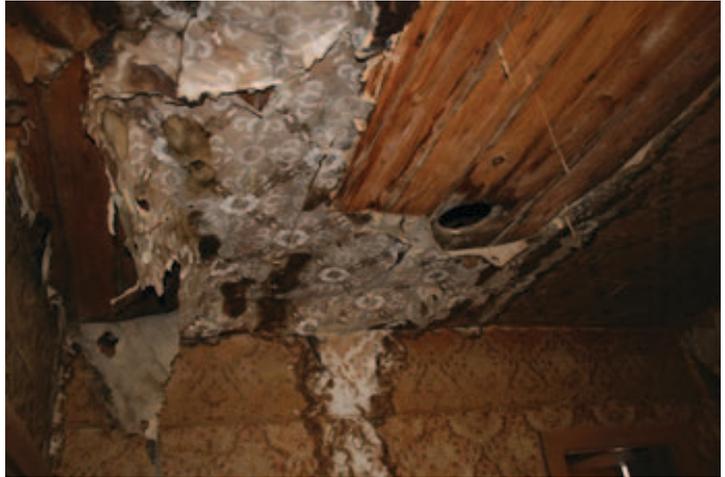
Fig. Parlor_4: Wallpaper water stained and detaching; note gaps in studs and siding at top right corner.

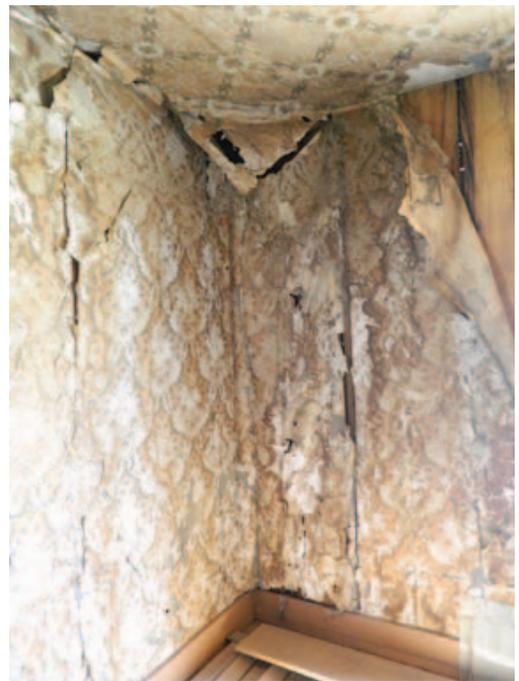
Fig. Parlor_5: Extra siding stored on floor; debris accumulating on floor.

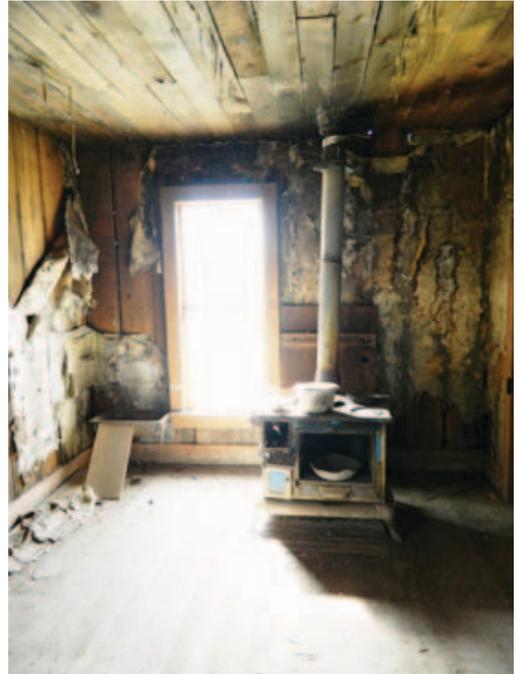
Fig. Kitchen_2: Kitchen facing northeast; note water staining and detachment of wallpaper.

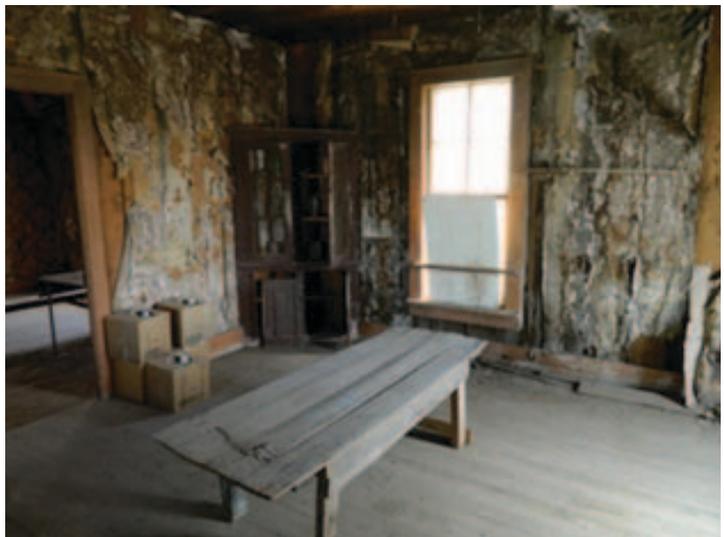
Fig. Kitchen_3: Fallen wallpaper on east wall; white residue on baseboard; deterioration of baseboard.

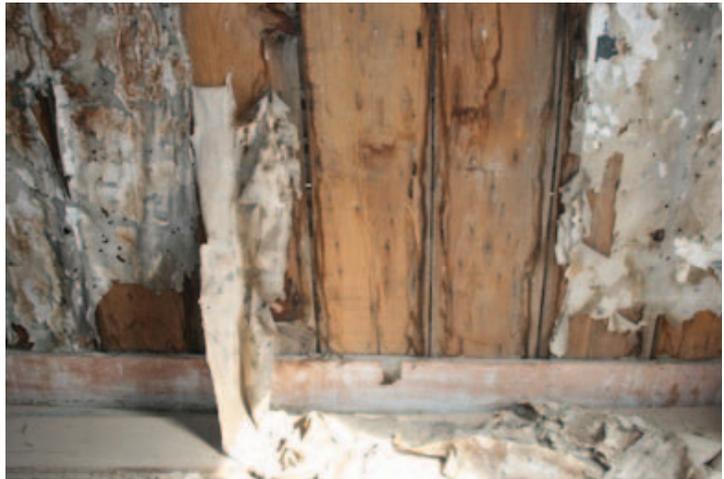
Fig. Kitchen_4: Kitchen sink; note plywood supporting sink due to missing legs and debris in sink basin.

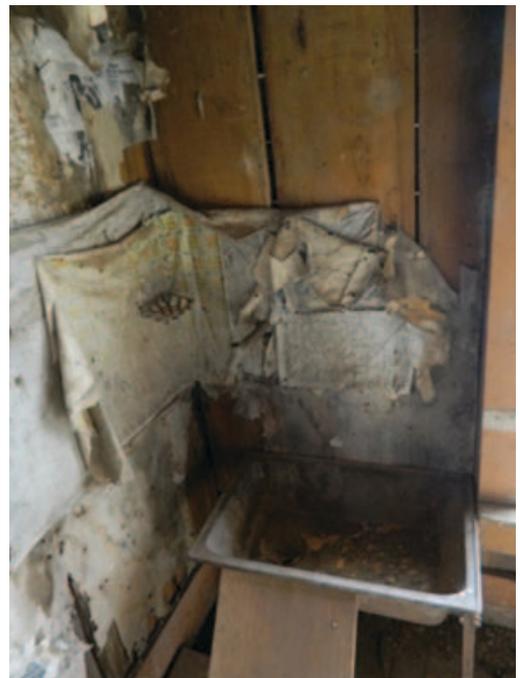
Fig. Kitchen_5: Wooden rod added across window to support interpretive sign; sign, sill and floor beneath window covered in bird droppings.

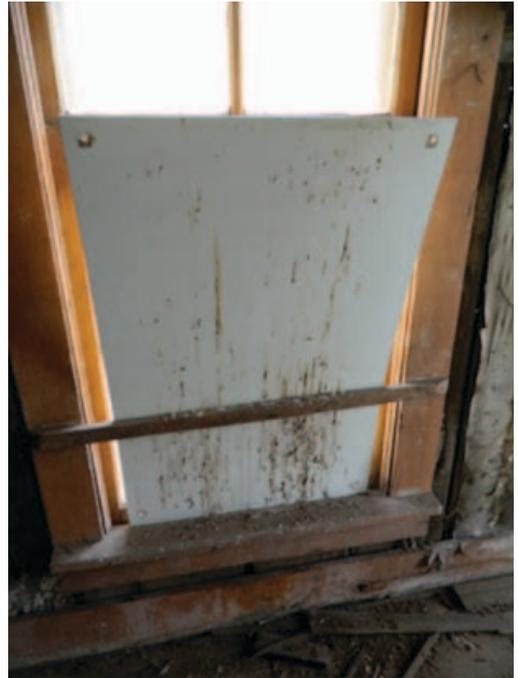
Fig. Kitchen_6: Joint of stove pipe and wooden drop ceiling; note water staining. It is likely this occurred before roof repair was undertaken, though not recorded. Monitor area for further damage.

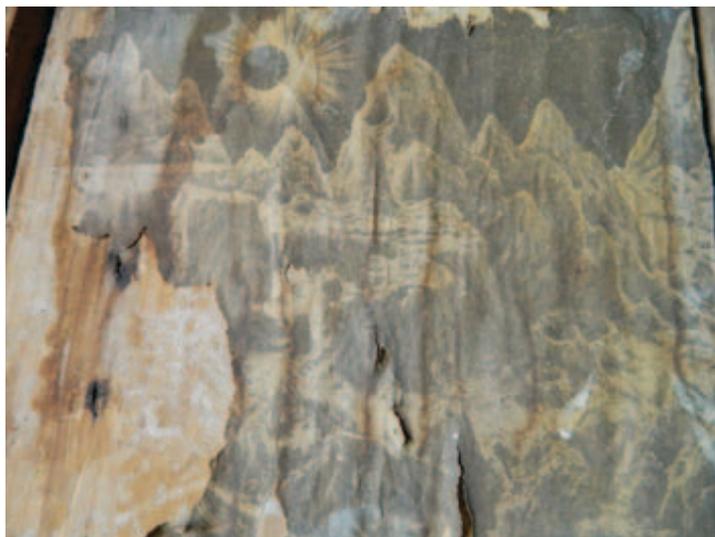
Fig. Pantry/Washroom_2: Additional view of newspaper on interior wall.

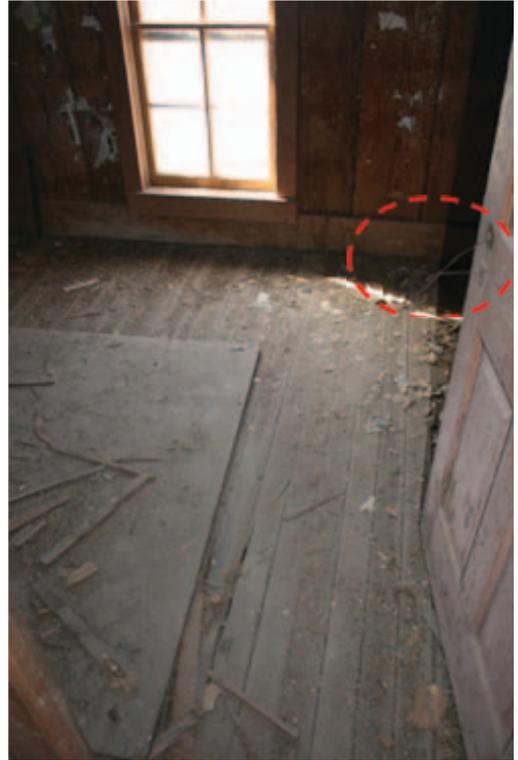
Fig. Pantry/Washroom_4: Water-stained and rotting studs on south wall of storage room; note debris on shelves.
