HISTORIC STRUCTURE REPORT

WILLIAMS RANCH

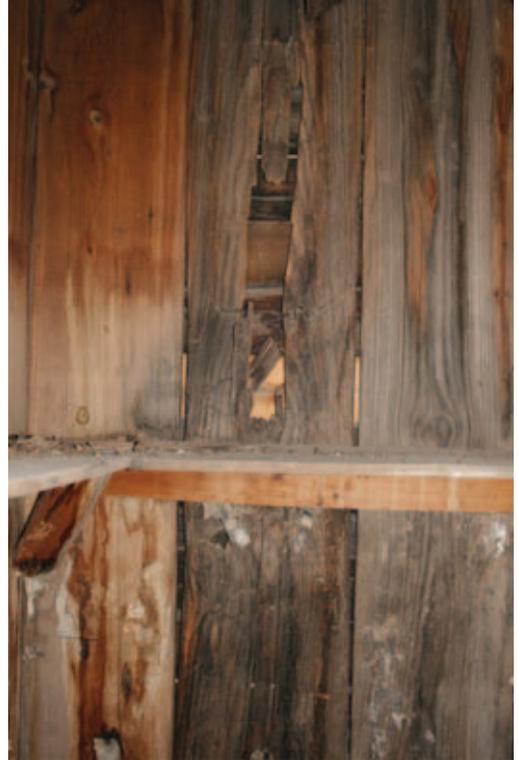
Fig. Pantry/Washroom_5: Water staining and splash line on vertical planks in south and east walls; it is possible that this resulted from use of the room.

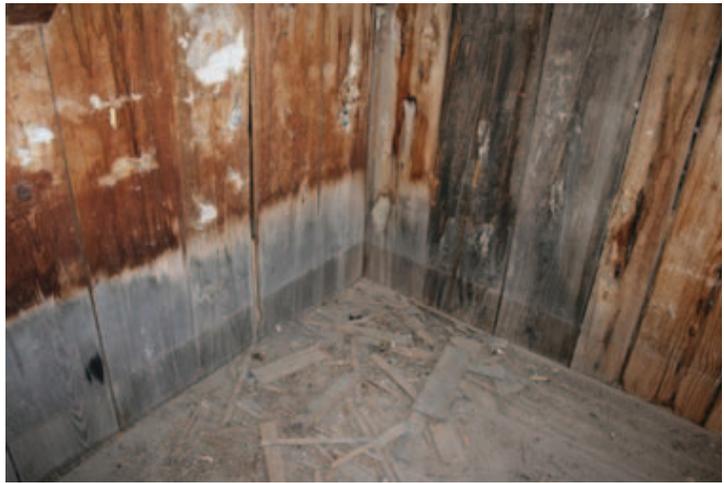
Fig. Pantry/Washroom_6: Wood ceiling has extensive water damage, causing it to buckle and partially collapse.

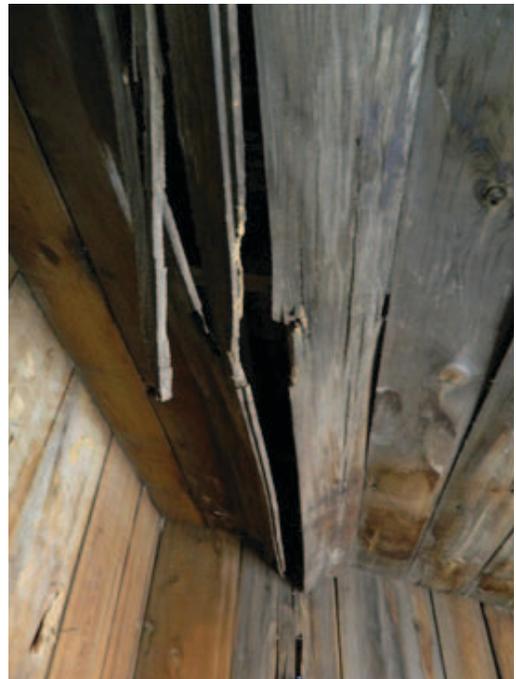
TREATMENT AND *W*ORK

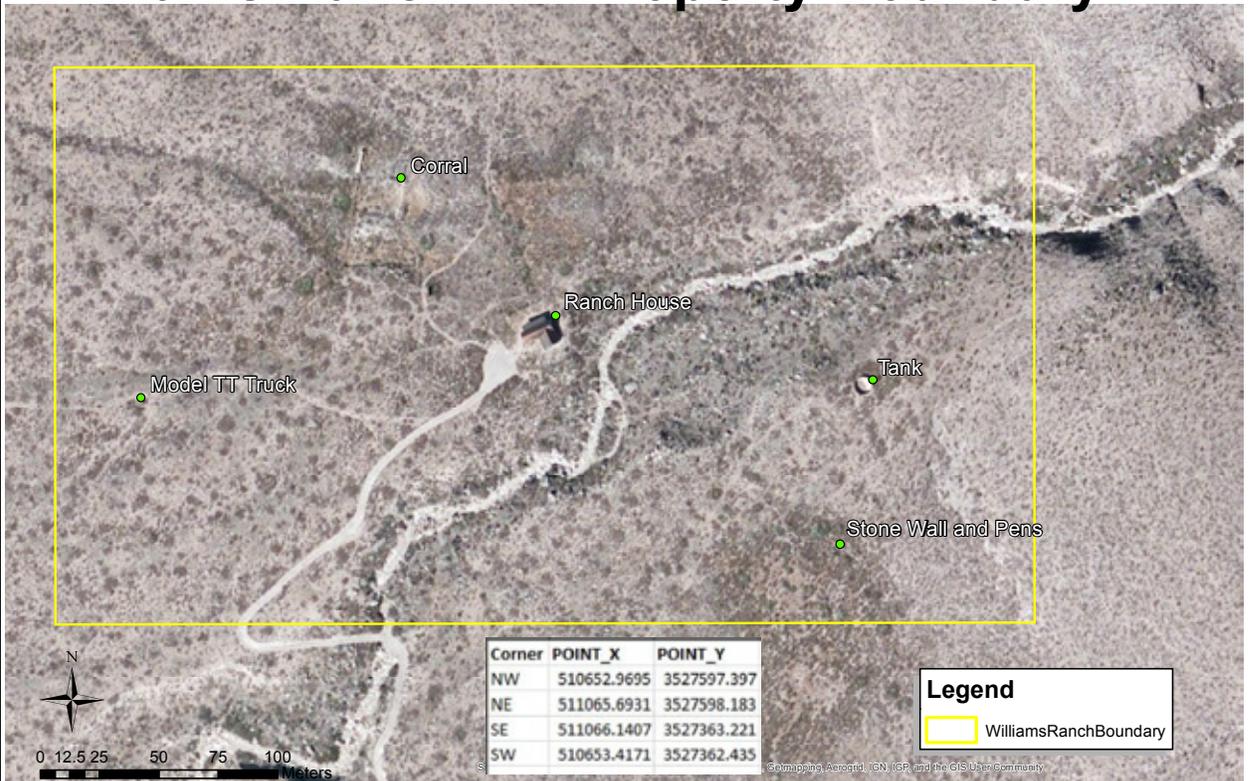
Williams Ranch NR Property Boundary
