John Brown's Fort Building 63

Harpers Ferry National Historical Park Flood / Storm Recovery Project

Condition Assessment Report and Preservation Repairs

February 1998

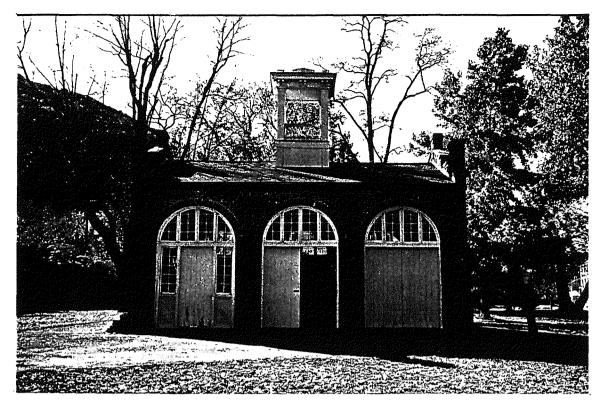
measures 3'-10" by 8'-3" and it is centered between two glass side lights which are approximately 1'-10" by 5'- 0"; the bottom portions of the side lights being a flush wood panel. While the large pair of double doors have minimal damage at the bottom portions of each leaf, the single door and frame with its associated side lights has seen more drastic decay from both moisture and insect infestation. It should be noted that the interface between all of the door and window frames and the masonry openings are/were filled in with mortar which has failed and allowed moisture to get behind the frames and rot the wood out from behind. Another issue that was noted is the glazing at the window sash; over the years the glazing compound between the glass and the wood has become brittle and cracked; this creates another place for water intrusion and eventual decay of the window components. It appeared that approximately 50% of the glazing compound is in this condition.

Figure 1 - John Brown's Fort, north elevation.

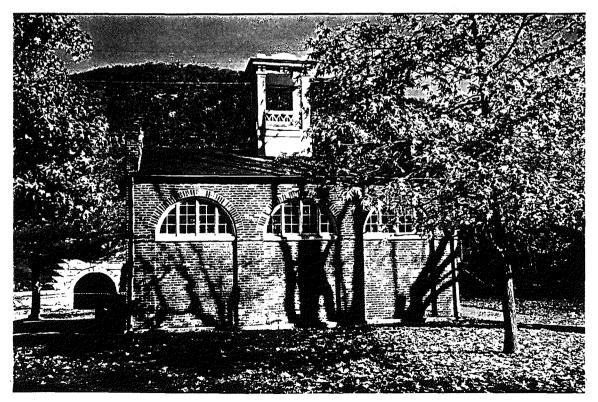
The south elevation is a mirror image of the north except that the lower portions of each bay do not have doors but are filled with recessed brick masonry. The same issues exist relative to the masonry. The mortar at the joints in the stone water table is missing and the fifteen courses of brick masonry above the water table have extremely soft mortar joints that can be attributed to high water levels during flooding events and possibly rising damp. In addition to the soft mortar the lower five courses of brick have moss and lichen growth which is contributing to the deterioration of both brick and mortar.

Figure 2 - John Brown's Fort, south elevation.

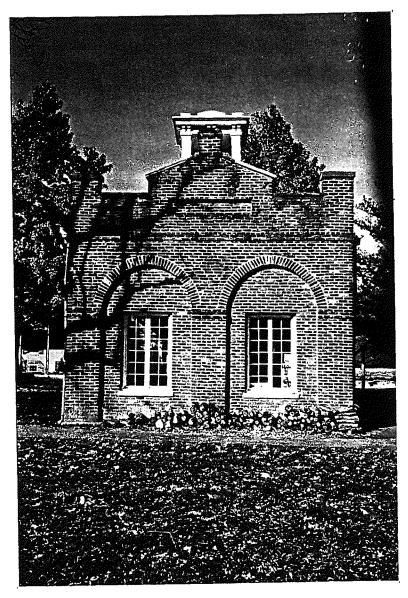
The east elevation measures 22'-3" in length, and is divided into two bays. An inswinging casement window is located in the center of each recessed bay. The windows are divided into two sash with each sash having twelve lights which are 9/11. The window sill on the north end (W110) has a combination of rot and insect damage at the right end. The end returns of both window sills have separated from the brick and have left gaps for water to penetrate into the end grain and accelerate deterioration and rotting. The window on the south end (W109) has rotted at the bottom rail and it is suspected that the rot has also effected the bottom of the side rails and the pins holding the sash together. The pins holding the bottom and side rails together on the north window are also loose ; a closer look at this sash may also reveal deterioration that will require additional replacement. As was also noted on the window sills of the south elevation, the sills do not have a drip edge cut into the underneath side which would help prevent water from rolling under the sills and to the wall.

Figure 3 - John Brown's Fort, east elevation.

The casement windows on the east elevation (W109/W110) should both be removed and repaired . The most serious work is the replacement of the wood sill on the north end of this elevation. The sash itself , on both windows, needs repair to the bottom rails, and all pin joints should be verified and reglued or replaced as necessary. As with the semi-circular windows , the casement window sills need to have a drip edge cut on the underneath side. It is also recommended that approximately 30% of the window panes be reset with new glazing compound.

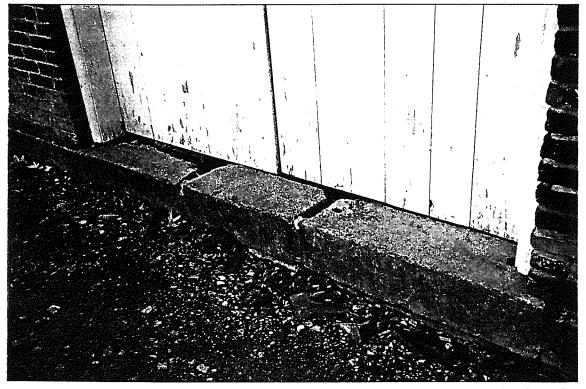
The top of the dressed stone water table, at grade level, varies from five to ten inches above the surrounding grade. The mortar joints for the stone have deteriorated over time and for the most part the mortar is non existent. The brick masonry above the water table was laid in a common bond pattern, but the header courses vary from every seventh to eighth course, and in some areas there are no header courses but just running bond. The damage to the lower fifteen courses of brick focuses around the deteriorated mortar and can be attributed to the severe flooding that has inundated the building over the last several years, and to a possible rising damp situation.

Figure 5 - John Brown's Fort , dressed stone water table at north elevation. Note deteriorated mortar joints.

The dressed stone water table, at grade level, should be excavated to the bottom of the stone and the joints raked out and repointed. The 1976 construction drawings indicate that the water table was built on top of a concrete block foundation wall that should be just below the existing grade level. The stone itself appears to be approximately one foot in depth and the existing grade should be approximately 6" to 1'-0" above the bottom of the stone.

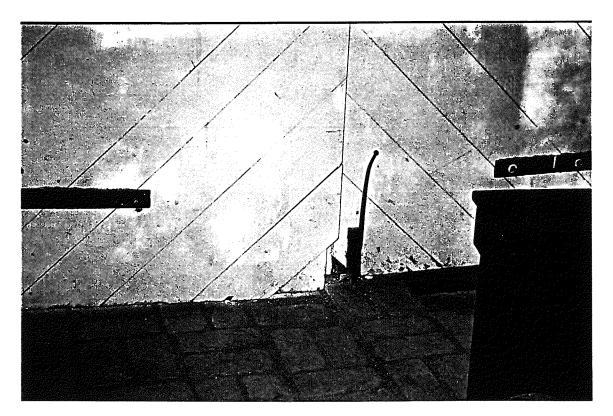
Figure 6 - John Brown's Fort, double sheave doors at center bay of north elevation.

The two pairs of double sheave doors at the center (D102) and west (D103) bays are in relatively good condition. The center doors are missing two small diagonal boards at the lower corners where the doors intersect when in a closed position. It is recommended that these boards be replaced. While not noted on the field notes it would be wise to run some additional material for similar replacement on the other door. A nailing block , which is located the left hand side of the interior, for this center door, has pulled loose from the brick and needs to be reset. The left hand leaf of the door will need to be removed to relieve the pressure on the frame while this work is accomplished.

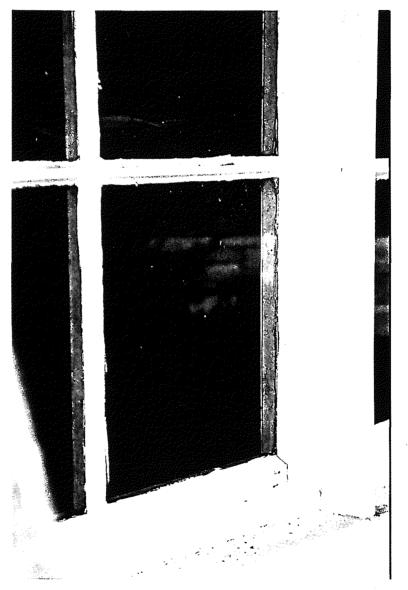
Figure 7 - John Brown's Fort , typical detail of bottom rail at semi-circular window

It is estimated that this repair work is needed over 30% - 40% of the existing window area. The western most half of the bottom rail at the east window on the south elevation (WT108) is rotted and needs repair. If this cannot be removed easily, it is recommended that epoxy repairs be done in place. A similar condition exists on the two end bottom rails of the center window on the north elevation (WT102); this may also be a window to repair in place. It is also recommended that the wood sills of all semi-circular windows on the south and west elevations have a drip edge cut into the underneath side of the sill (kerf cut).

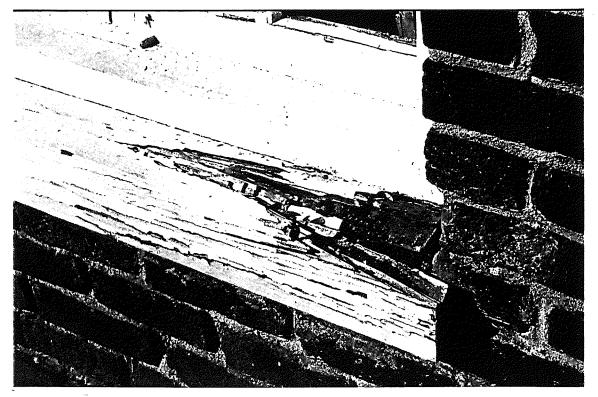
Figure 8 - John Brown's Fort, rot at window sill of northern most window at east elevation.

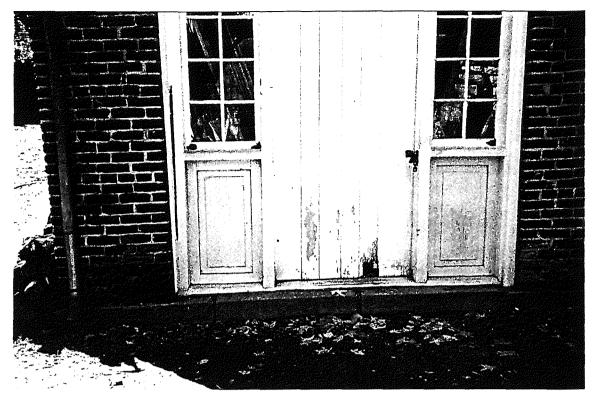
Figure 9 - John Brown's Fort, door and sidelights at eastern bay of north elevation. Note gutter discharges at base of building.

The single door (D101) and sidelights (DSL1/DSL2) are in poor condition. It is recommended that the entire unit be removed for repairs. This recommendation is based on the fact that the

frame on the east end of this opening is rotted up to a height of 8'-2" and repairs need to be made to the door frame, door, flat panels below the lights, the bottom rails of the sidelights, and the window stops.

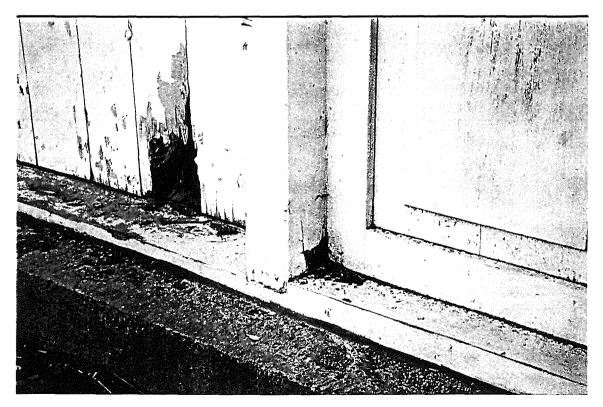
Figure 10 - John Brown's Fort , detail at bottom of door and sidelight showing rot.

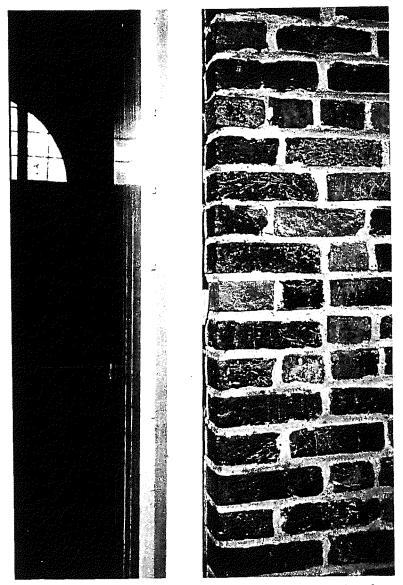
Figure 11 - John Brown's Fort, wood jamb of double doors at center bay. Note gap between wood and masonry.

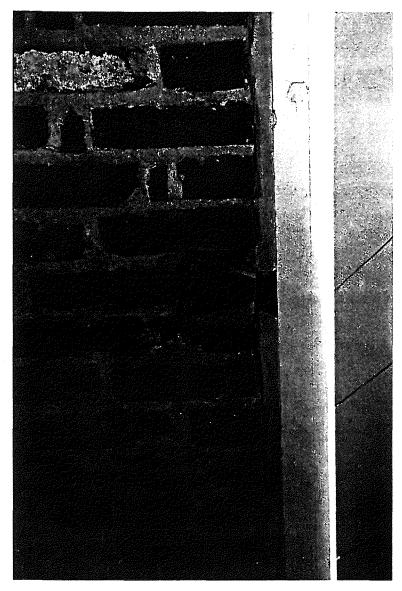
The two pairs of doors into the large space are missing small diagonal pieces at the base of the doors. The wood nailing block on the west end of the brick pier to the center bay has pulled away from the masonry. The single door and sidelights have not withstood the flooding and insect infestation as well, and the lower portion of the door and frames are in poor condition, as are portions of the frame and stops for the sidelights.

Figure 12 - John Brown's Fort , interior elevation of jamb at center bay doors. Note wood nailing block pulling away from masonry.

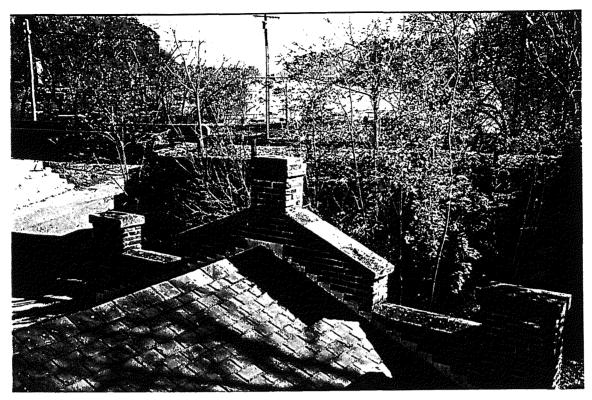
The mortar joints of the stone water table have deteriorated as have the fifteen course of brick masonry above the water table. Here again water from past flooding has taken its toll. The end walls of this elevation extend up above the roof line and form a crenelated gable wall that is capped by stone. The corbeled brick at the eave line of the north and south elevation carry around this elevation in a brick band which falls about four courses above the brick arches. The area above the band to the stone cap acts , for the most part, as a parapet wall and the mortar is in very poor condition. The joints for the stone cap are also in poor condition, and the cap stone itself may need to be removed and reset.

Figure 13 - John Brown's Fort, interior of east end wall above roof. Note stone caps and lack of mortar wash on chimney features.

The stone forming the cap of the walls on the east and west elevations should be removed and reset. It is also recommended that the center chimney feature on these elevations be provided with a mortar wash that is slightly sloped, as not to be seen from the ground, to help facilitate water run off at these areas. Another approach would be to cap the chimneys with a sheet metal hood.

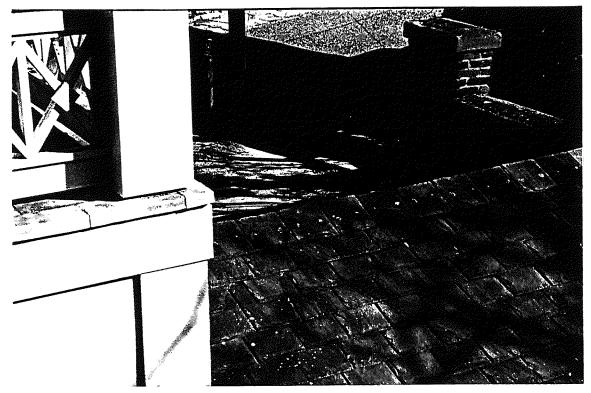
The roof is covered with slate and is a uniform 9" width with an exposure of 6" - 6-1/2" to the weather. Due to the uniform gray coloration it is possible that the source of the slate may be from the Buckingham-Virginia Slate Corporation in Arvonia, Virginia. The schedule of their standard roofing sizes indicates that with a 6 1/2" exposure and a 9" width, the length of the slate would be 16". The standard thickness of 3/16" also conforms to that which is on the building. The ridge is overlapped to the north approximately 2". There are several broken or split slate but the overall condition of this roof is very good.

Figure 15 - John Brown's Fort , roof as viewed from south looking northeast. Note cap slate overhangs to the north.

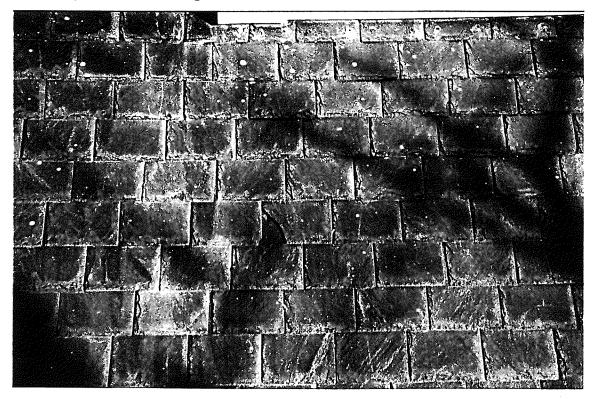
Figure 16 - John Brown's Fort, plan view of slate roof with one broken slate shown in center. Note trim at base of cupola is tight to slate.

The slate roof is in very good condition. It appears that there are less than a dozen broken slate that will need to be replaced. It is recommended that the broken slate be removed and replaced. Further investigation is necessary to determine the flashing details at the intersection of the slate roof and the base of the cupola. The flat metal seam roof that covers the cupola could not be accessed but if the floor deck of the cupola is an indicator of condition, it is probably in good condition. The flat metal seam roof that covers the floor deck may have one small seam in the center that needs to be cleaned and resoldered.

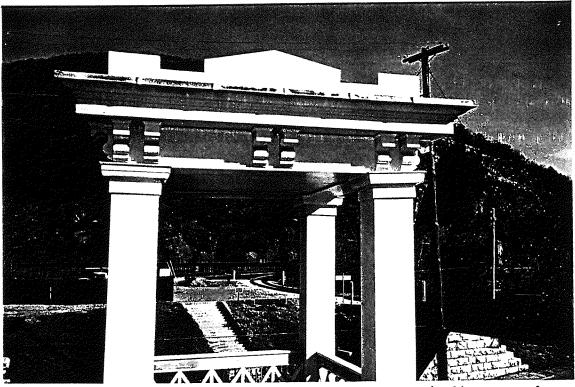
The woodwork on the cupola shows the most signs of distress. The most noticable locations for rot are highlighted with a black fungal mold; this includes the crenelated trim at the upper roof and the railings at the lower portion of the cupola. At some point in the last twenty years it appears that the 1" x trim boards which cover the corner posts were cut approximately 2' above the metal deck and replaced on all four columns. The joints have opened up and it now presents a place for water to be caught. The trim at the top of the column on the south east corner was either built with a slight slope or it has settled. The joints on the majority of trim have opened and allow for moisture penetration and eventual rot. The flat seam roof at the lower deck appears to be in good condition except for a small separation at one seam towards the center. The upper roof could not be accessed with the lift and was not investigated at this time. The tongue and groove siding that forms the base of the cupola is rotting through at the bottom boards that are adjacent to the roof surface; it appears that there may not be enough space between the roof slate and the bottom boards and when snow and ice builds up at this point it gets trapped and wicks into the wood. It will also be necessary to look at the flashing details at this area to ensure that it is properly flashed.

Figure 17 - John Brown's Fort, south elevation of cupola. Note top of column capital at front right slopes inward.

The appearance of the cupola, from ground level, would lead one to beleive that this feature is in relatively good condition, but a closer inspection indicates that 75%-80% of the millwork needs to be replaced. The railings on all the elevations need to removed and replaced. The trim boards facing the columns have been repaired and all the joints have opened at the repairs; it is recommended that all of the 1" x trim boards on all four columns be removed and replaced for the full length of the columns. The horizontal siding boards , between the floor and roof, have started to rot at the bottom; it is recommended that all of these boards as well as the corner boards at this area be removed and replaced. The crenelated wood trim at the roof level could not be accessed , but signs of mold on the surface indicates that these features need attention; it is recommended that the crenelated trim boards be removed and replaced.

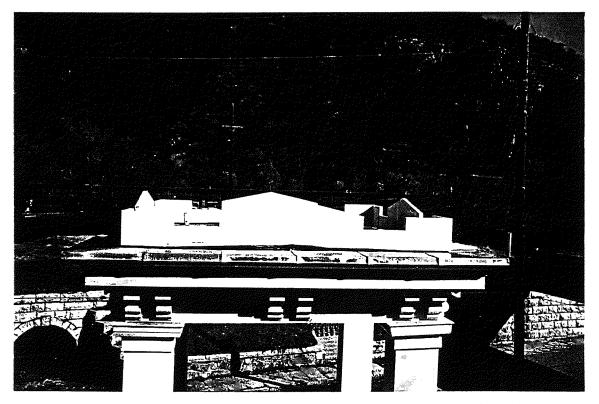
Figure 18 - John Brown's Fort, south elevation of cupola showing crenelated trim boards attached to roof by metal "L" brackets.

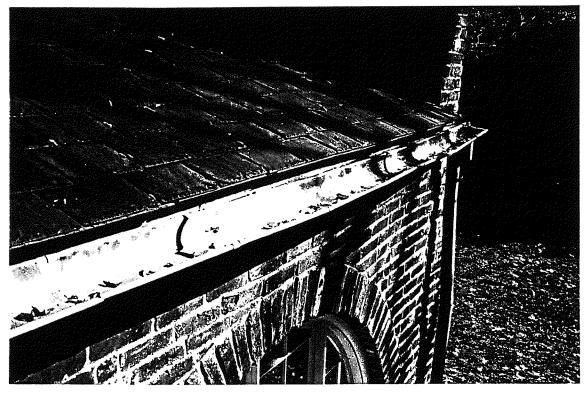
The sheet metal gutters and downspouts have been damaged over the years by severe snow and ice storms. The gutters and down spouts were both constructed of very short sections of lead coated copper which provides the potential for leaks at each joint. While it is assumed that the short sections were used to simulate that which may have been historically correct it does create a maintenance problem. It is recommended that the gutters and downspouts be replaced, and that additional gutter and downspout brackets be fabricated and installed to provide additional support in the event of future heavy snows and ice.

Figure 19 - John Brown's Fort , half round gutter on south elevation. Note how shape has flattened out and is wavy.

It is recommended that the 6" half round gutters on both the north and south elevations be replaced with lead coated copper that is fabricated in longer sections. It is also recommended that additional gutter brackets be placed on both elevations to provide additional support to the gutter. The 3" diameter downspouts should also be replaced with lead coated copper in longer lengths.
