Historic Structure Report
Architectural Data Section

Buildings 11 and 11A
William Anderson Buildings

Harpers Ferry National Historical Park

July 1975

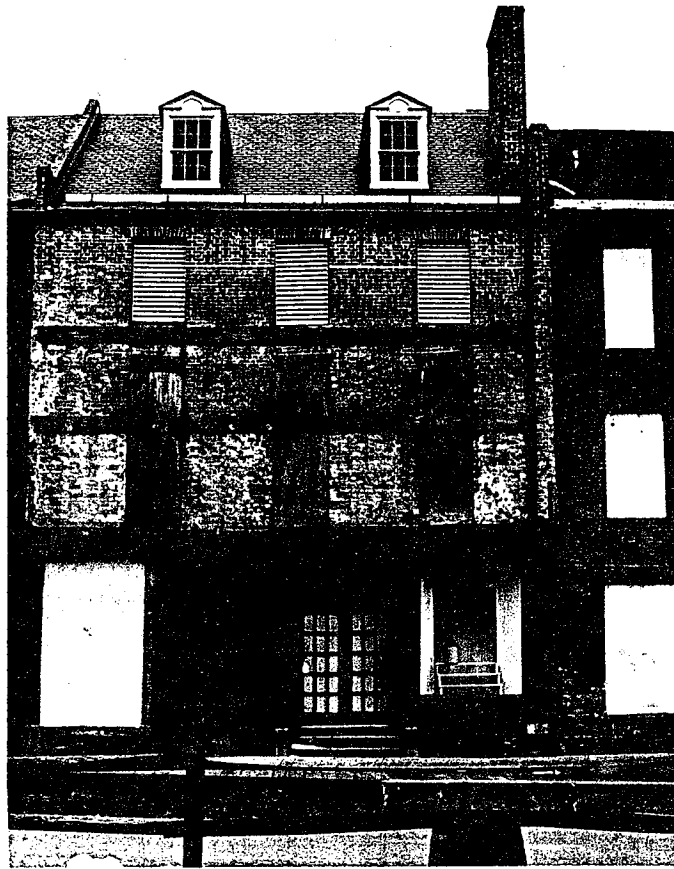
Existing Rear Elevations - Buildings 11 and 11A

(Building 10 to left, Building 12A to right)

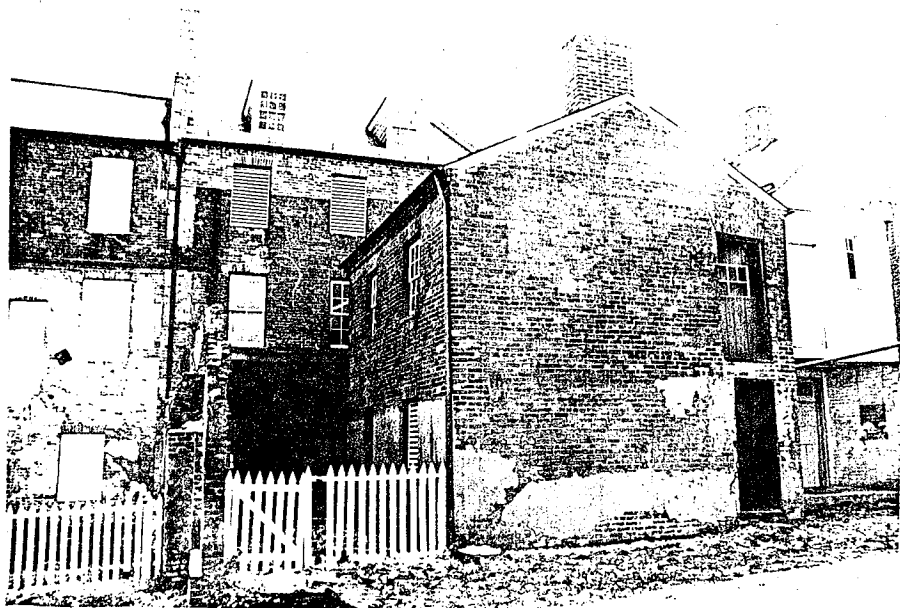
2. West (Rear) Wall of Building 11 and South Wall of Building 11A with one story wood porch at rear of Building 11

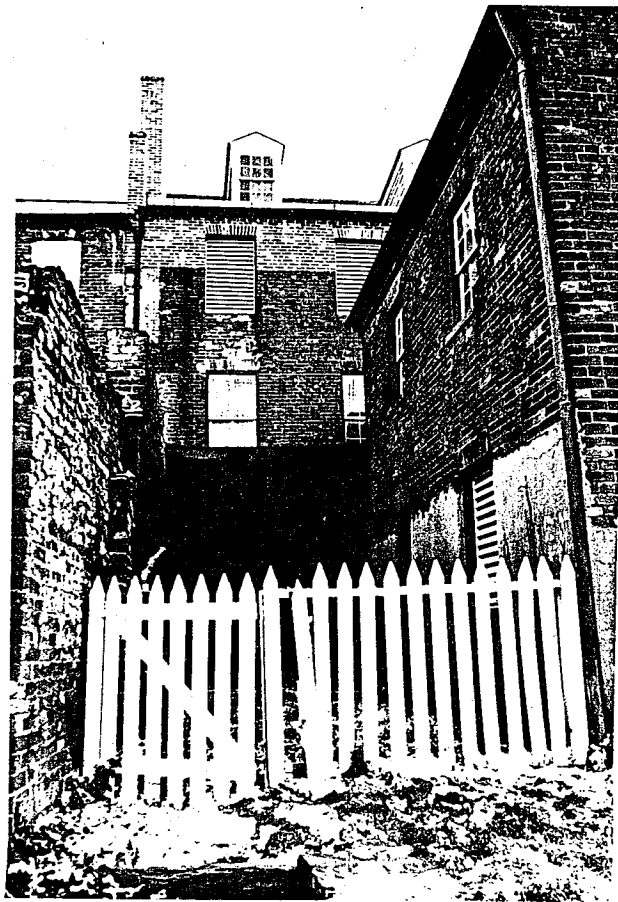
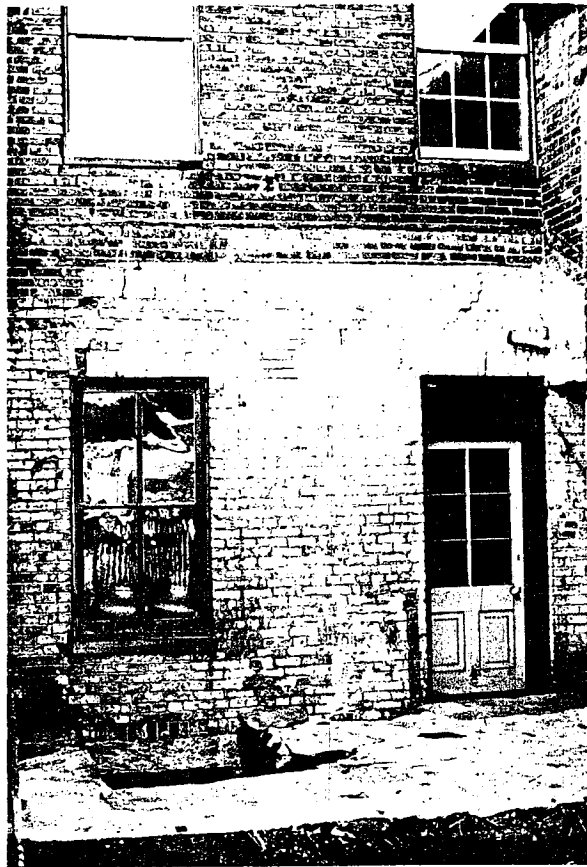
When the roof was removed, the cast iron pipe was found set into the brick at the intersection of buildings 11 and 11A just above the first floor openings. The pipe leads from the exterior wall, through the brick, and into the interior of one of the first floor storerooms in building 11A. The construction appears original and may have been a collecting point from exterior rain gutters to a former cistern in the storeroom.

Area of rear wall of Building 11 formerly covered by wood porch (after porch removed). Note pipe in brick above 1st floor door.

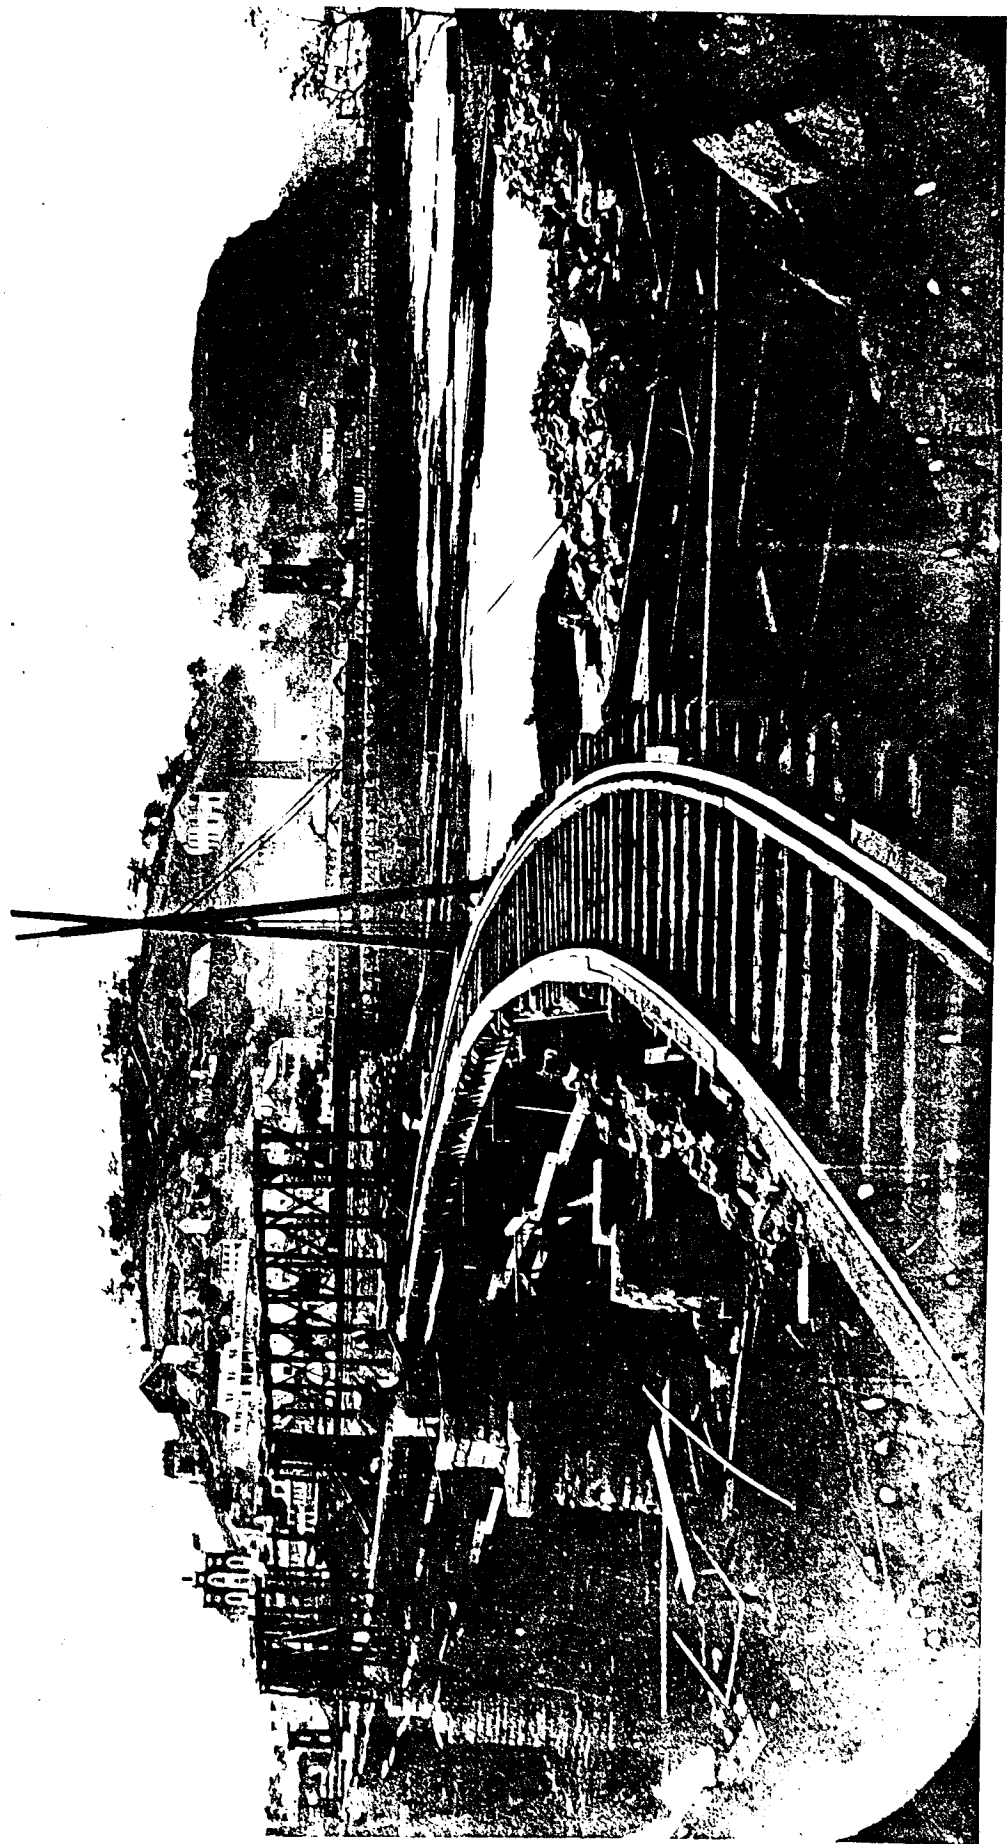
Photograph HF-11 from 1862 and HF-66 from 1859 show the top portions of the front and rear facades, with the south gable end brick parapet wall and chimneys. The existing south parapet wall as rebuilt by the NPS matches that in the photographs (which matches the north gable end parapet wall of building 12). The present roof slope and dormers also match those in the historic photographs (HF-11 shows the front, and HF-66 the rear).

Photograph HF-11 also shows the third floor of the front (east) facade, but the openings do not show clearly. Most of this level of the wall was rebuilt, as evidenced by the change from Flemish to American bond at the sill of the third floor windows. The top portion of the wall, including the flat brick arches over the windows, has been rebuilt by the NPS in the original Flemish bond. These three window openings appear to be in their original locations, however, as they line up with the second floor openings, and sections of the original Flemish bond brickwork remain at the gable ends on either side of the openings. They are also probably their original size, as they match original masonry openings in building 12 which can be assumed to be very similar (refer to documentary information). Details of missing sash and frames can also be assumed to be similar to originals still existing in building 12.

The historic photographs show at the second floor level of the front wall of building 11 a porch, which no longer exists. Details of the porch are not visible in the photograph, but it most likely had a cast iron balcony railing matching that shown in slightly later historic photographs of the second floor balcony of building 12. And there also must have been cast iron balcony supports, as archeology uncovered no foundations for post supports. There appears to be a roof on the porch

in photograph HF-11, but no support posts for the roof are visible, and no evidence of any roof has shown up at this level on either building 11 or 12.

3. HF-11 Front of Building 11 in 1862 (through break in bridge)

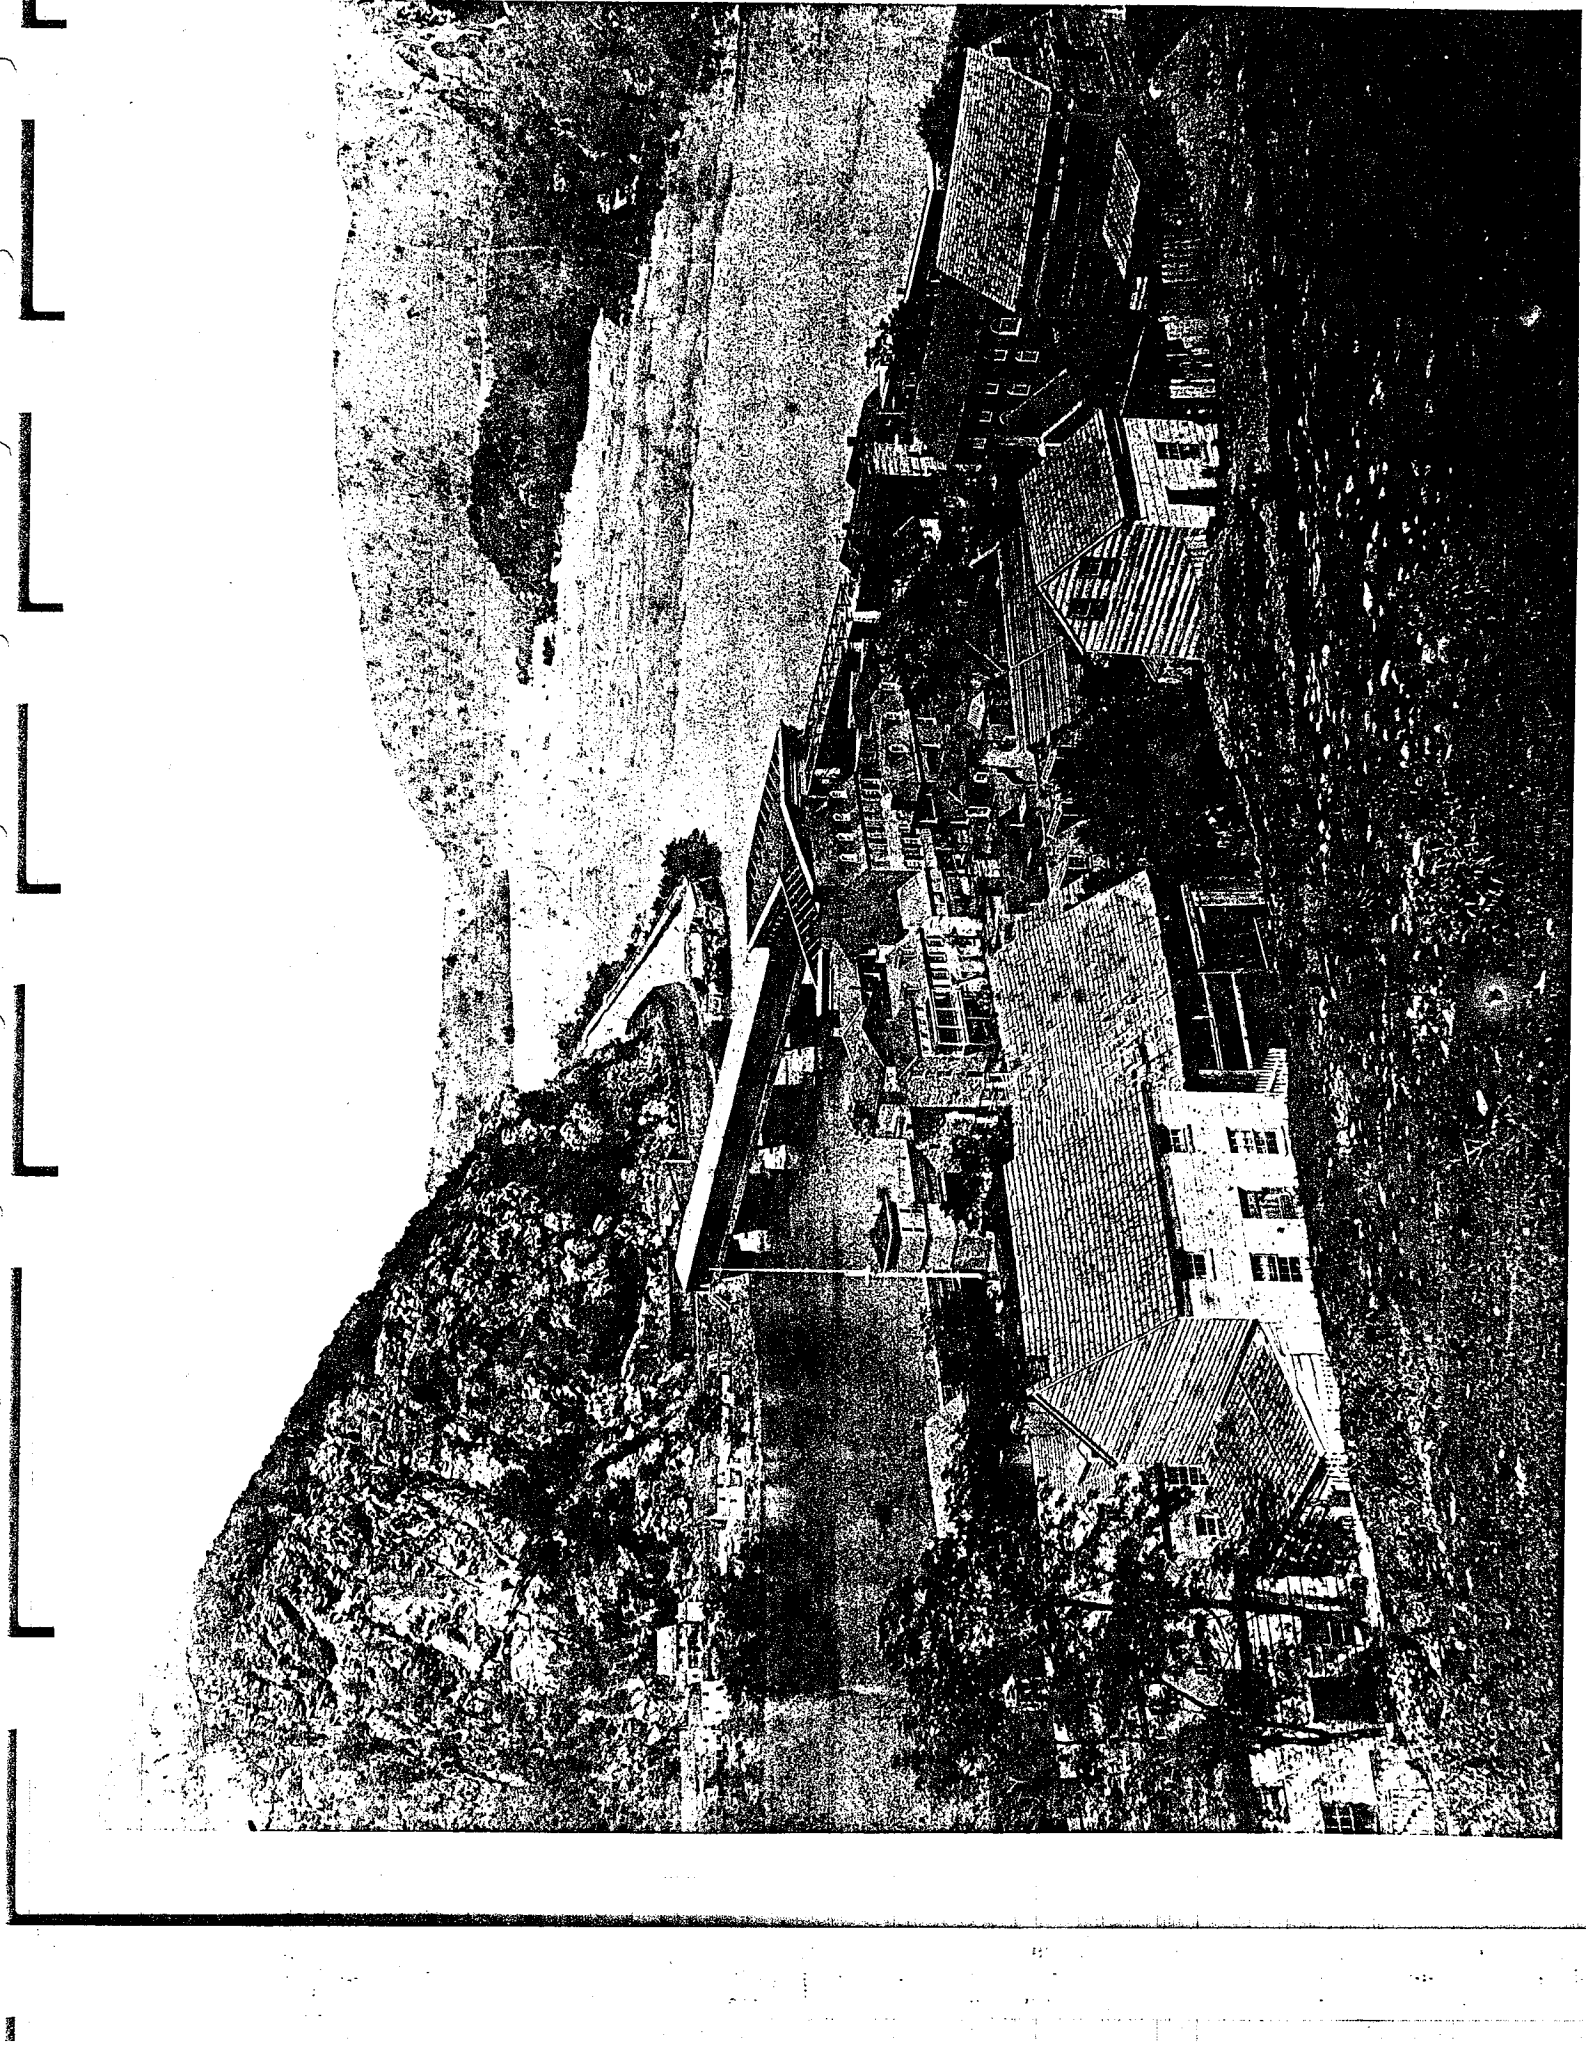
4. HF-66 Rear of Building 11 in 1859

(Roof only, near center right of photograph)
