REPAIR DAMAGED STUCCO ON BUILDING #33

HARPERS FERRY NATIONAL HISTORICAL PARK

HISTORIC STRUCTURE TREATMENT REPORT

**REPAIR DAMAGED STUCCO ON BUILDING #33
HAPRERS FERRY NATIONAL HISTORICAL PARK**

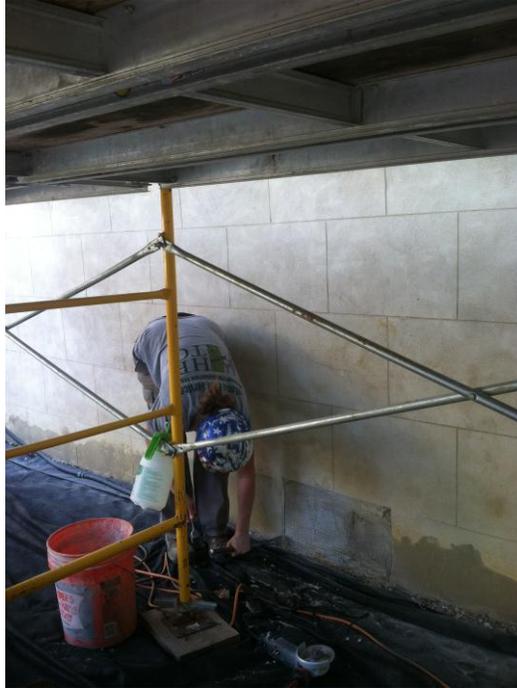
Photo 1: During training with Cathedral Stone large areas of hollow sounding stucco were removed.

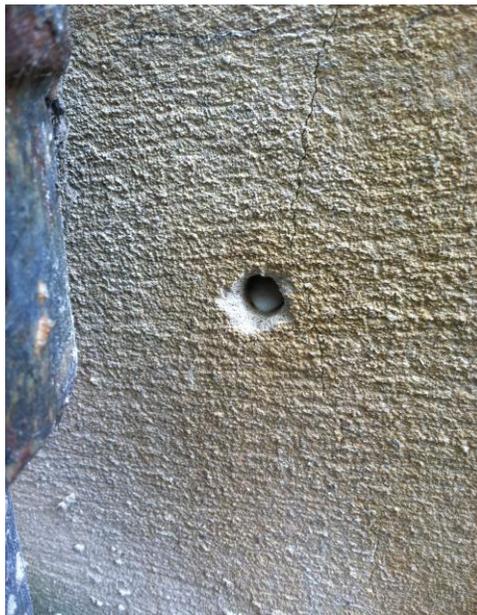
Photo 2: An alternative treatment during training included the drilling of holes and the injection of grout.

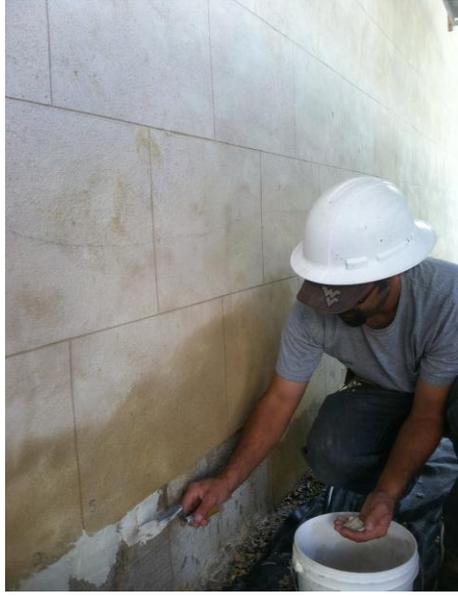
Photo 3: Craftsman applies different samples of Jahn Restorative Mortar to pick a color match during training.

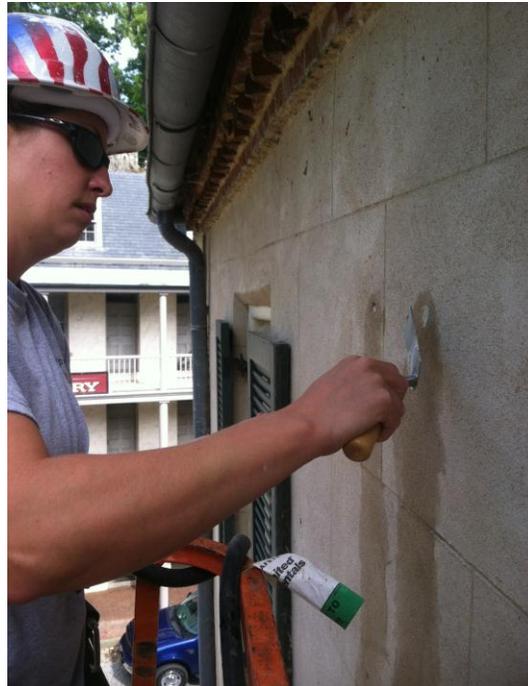
Photo 4: HPTC craftsman patches holes with Jahn M60 restorative mortars after Jahn M30 injection grout application

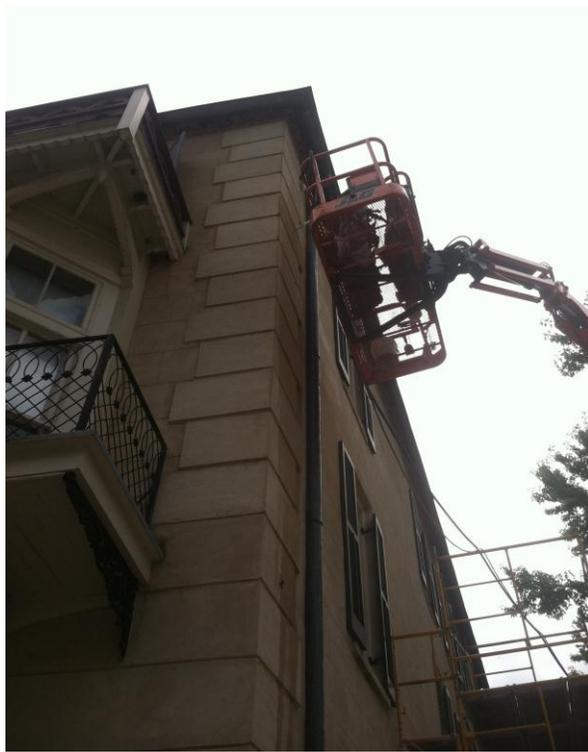
Photo 5: HPTC craftsman performs grout injections to all the hollow quoins of Building #33.

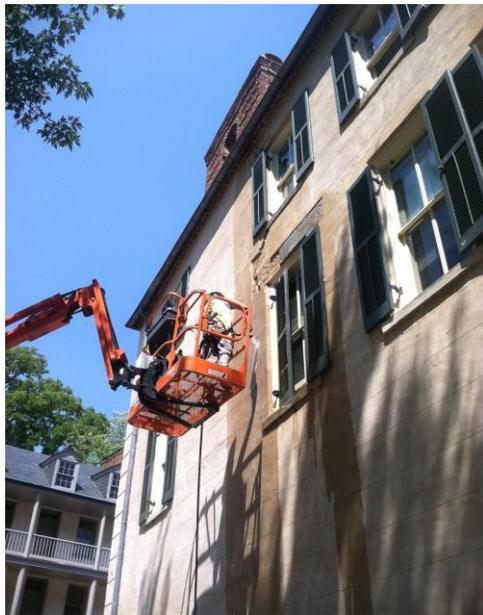
Photo 6: All blocks exhibiting depreciation of stucco, large cracks and hollow areas were sounded and loose stucco removed.

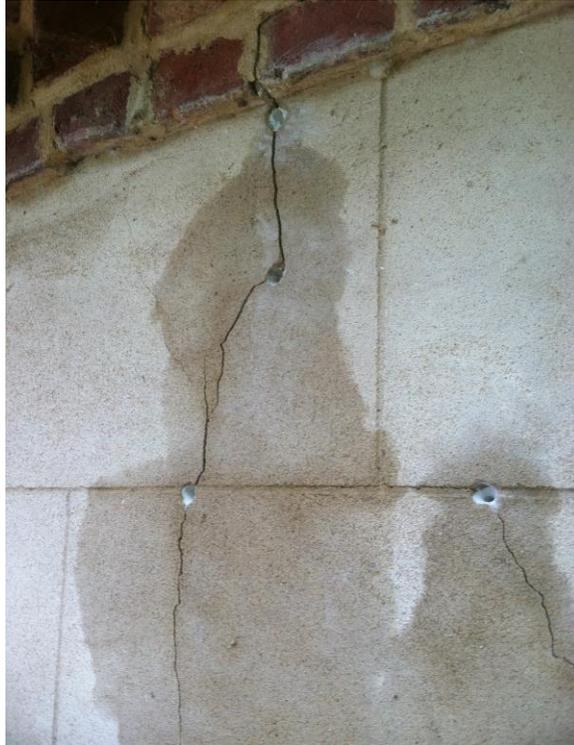
Photo 7: Injection grout application performed in the areas of large cracks.

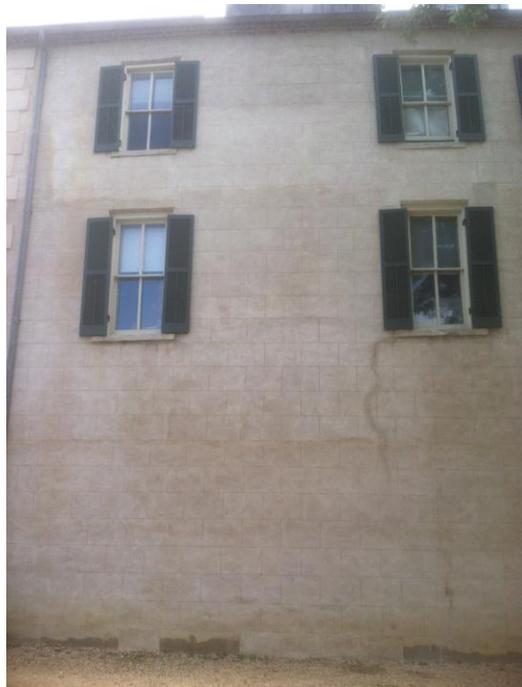
Photo 8: All patched areas, panels and cracks were tinted with Cathedral Stone Stain Kit.

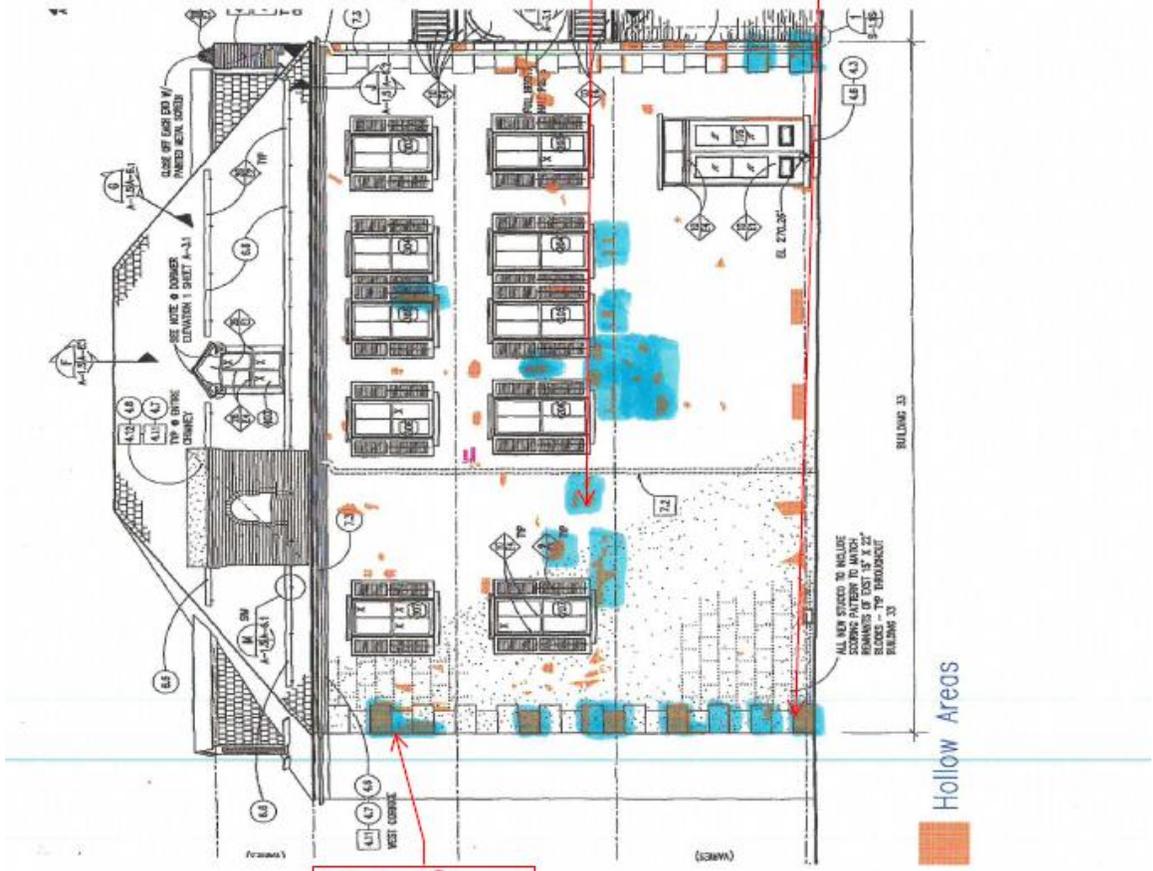
Hollow Areas

Numerous holes were drilled in this area during class to exhibit grouting techniques

Numerous holes were drilled for the training class to demonstrate grouting. HPTC found the holes hard to to patch and color match. Grouting was ineffective in reducing the hollow sound and in permeating all the hollow areas of the quoin.

HPTC drilled a minimum amount of holes in all marked quoin and other highlighted areas to minimize patching appearance

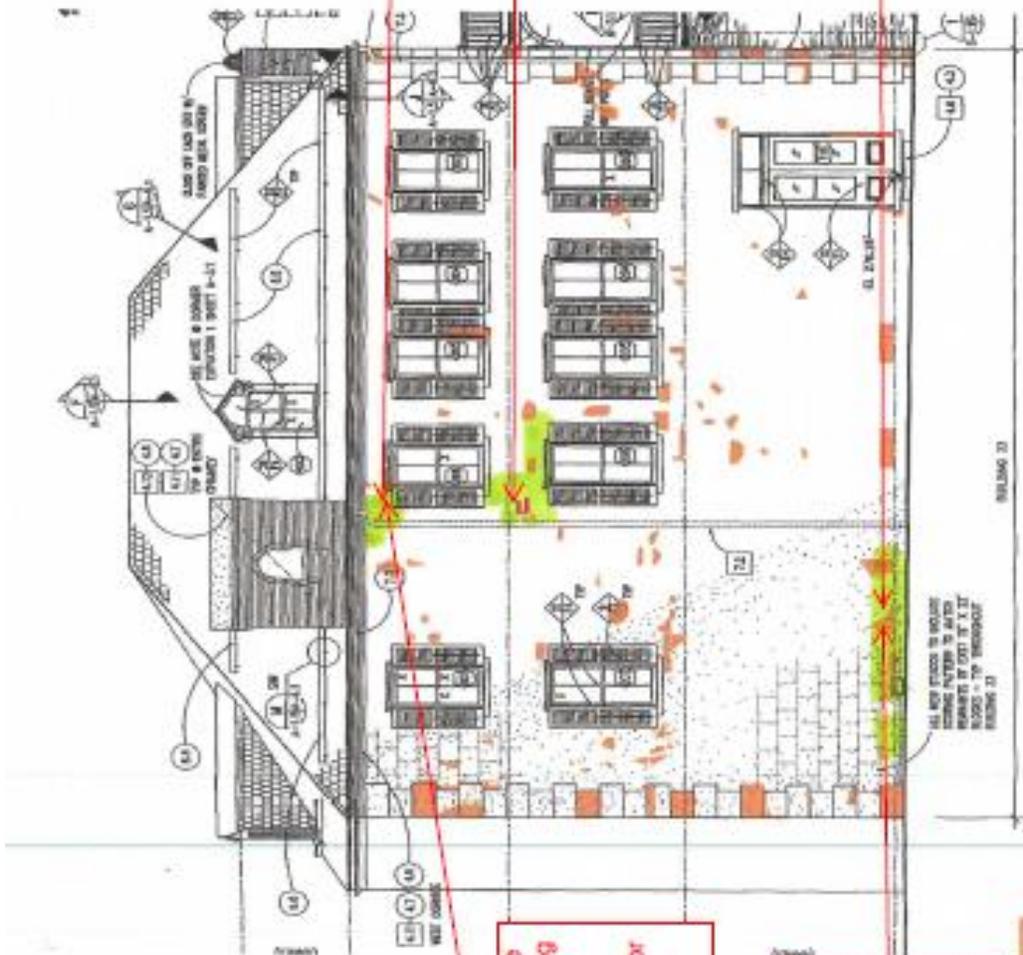
PANELS

HPTC found the crack to permeate all layers of stucco and through the stone.

panels were replaced with M-60 Stucco/plaster color matched to #11. The size, texture and scoring were performed to match existing.

Color match for stucco was performed in this area for color match, #11 best match

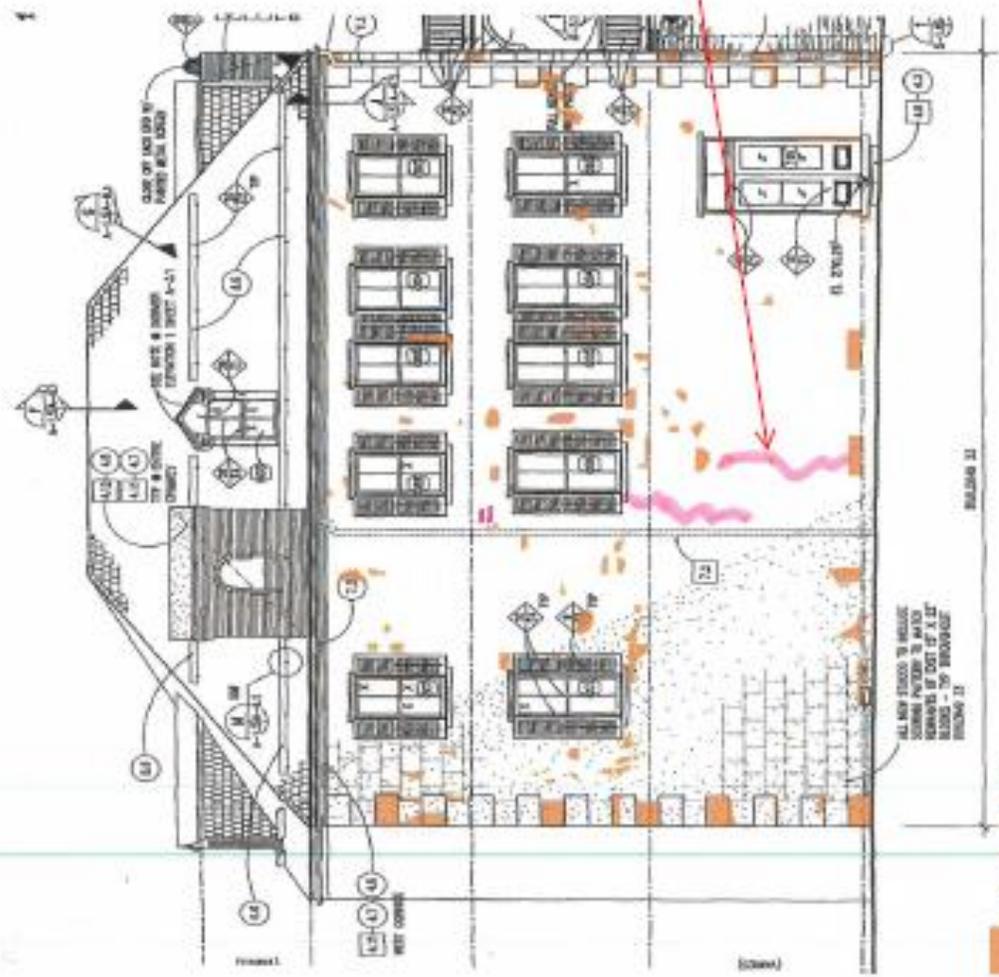
CRACKS

Cracks were chased during class for the application of repair stucco

Cracks were the final condition addressed on the façade. M60 restorative mortar was mixed and applied to all the cracks that had been chased with the grinder during the training session. (See drawing Cracks)

Cracks were chased with masonry grinder blades to the depth of the cracks. These did not permeate all layers of stucco and were patched with M-50 Stucco/Plaster color match #11

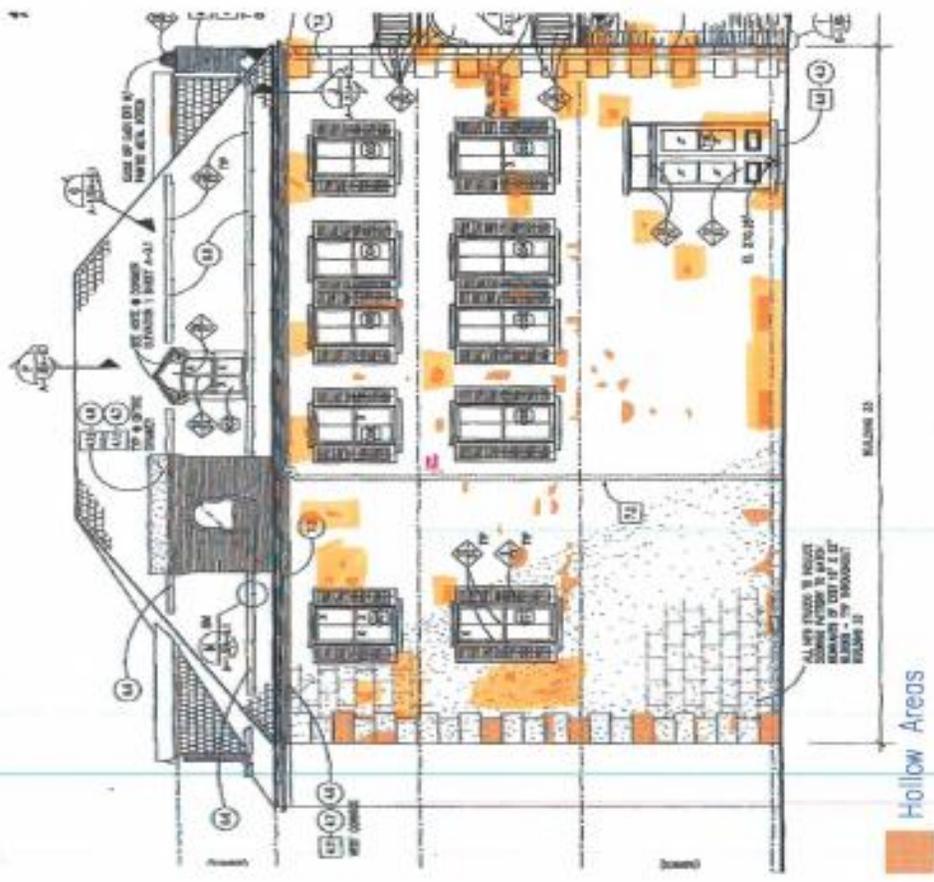
NO TREATMENT

HPTC assessed all the hollow areas found in the original report. Some areas were found to sound hollow but exhibited no cracks or failure. HPTC recommends no treatment required at this time. Treatments may cause more problems than exist.

Work began on the west side of the top elevation and progressed down the quoins. The area was accessed with a forty-five foot man lift. Holes were drilled and attempts were made to flush water out of lower drilled holes. Grout was mixed and injected in all holes. M60 restorative mortar was used to plug all holes after grout injection. Work continued from west to east, roof to foundation on the façade. Attempts were made to drill, flush and inject on major hollow sounding and cracked areas. (See drawing Grout) Some areas would not flush. M30 grout was injected in all drilled holes regardless and it would act as a key in the stucco. It was determined that the drilling and grouting of some hollow sounding areas would be more detrimental to the substrate than the hollow area itself. In areas where there was minimal hollow sounding and no signs of deterioration a no treatment approach was taken. (See drawing No Treatment)
