Condition Assessment and Treatment Plan for Libbey Memorial Physical Medicine Center

P R E - D E S I G N S E R V I C E S

June 30, 2022
NPS PMIS # 318915
NPS TIC #128-180181

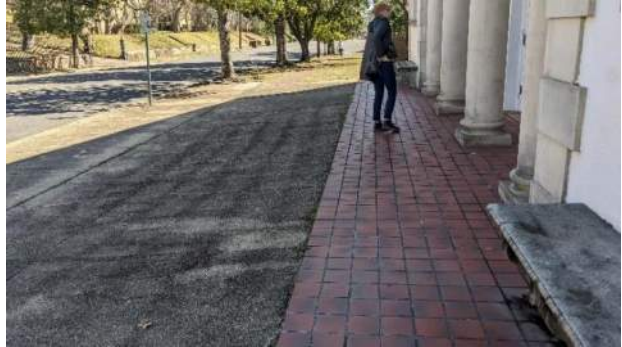
XC.5– Exterior at North. Quarry tile and damaged concrete at plaza.

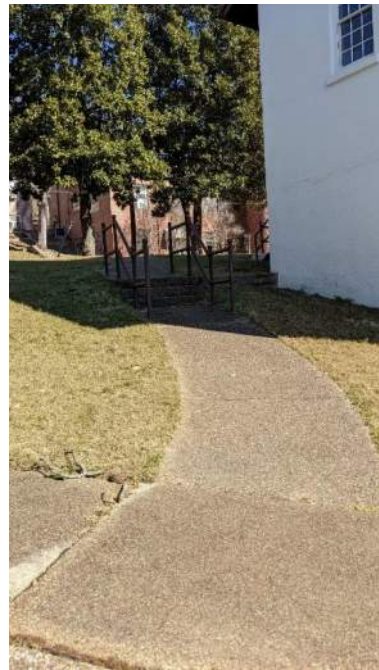
XC.6 – Exterior at West. Damaged sidewalk, railing at stair.

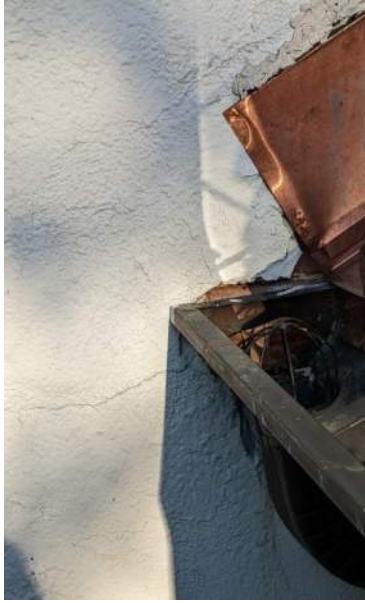
XAE.9 – Damaged stucco wall, around gutter.

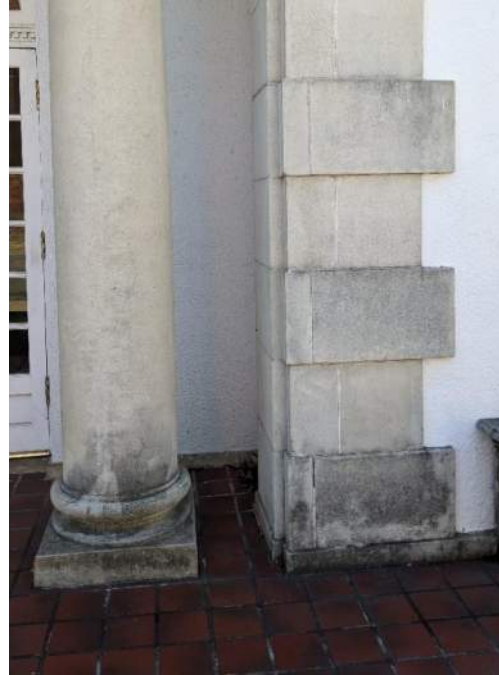
XAE.12 – Atmospheric staining, open joints, and cracking at cast stone column and quoin.

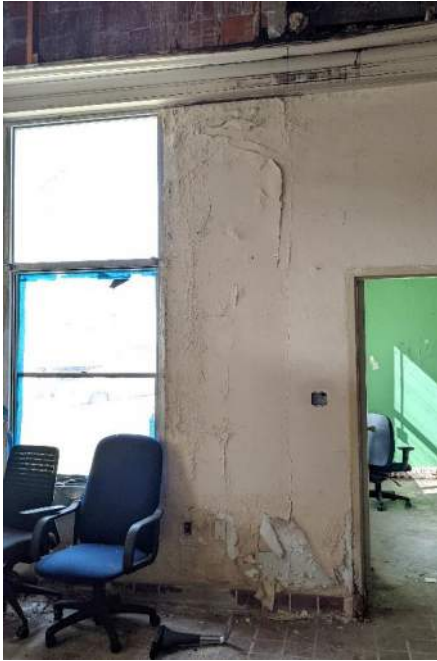
XAI.1 – Lobby 100. Damaged plaster and trim.

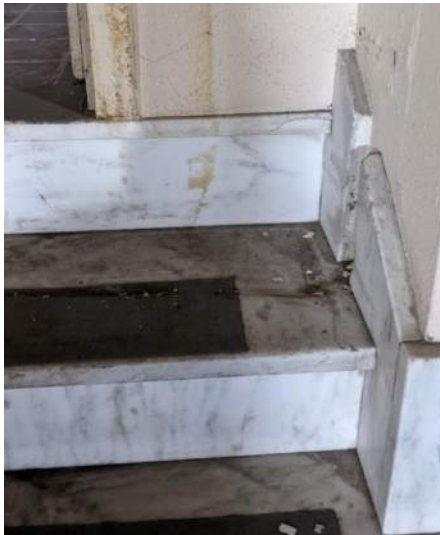
XAI.2 – Stair 100. Damaged marble stair and trim.

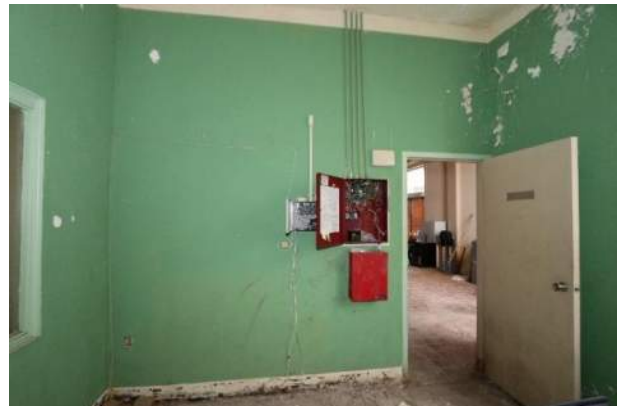
XAI.4 – Office 101. Existing alarm and damaged plaster.

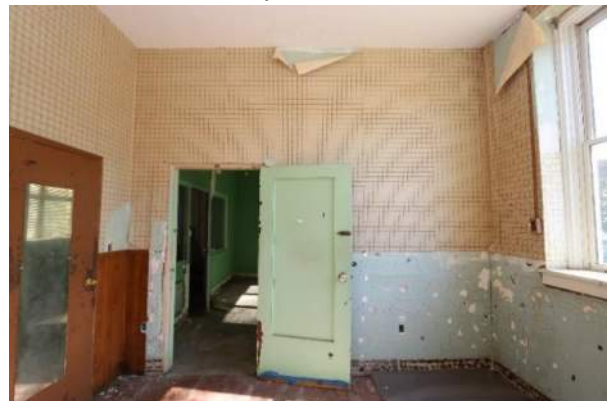
XAI.5 – Office 102. Damaged plaster and peeling wallpaper.

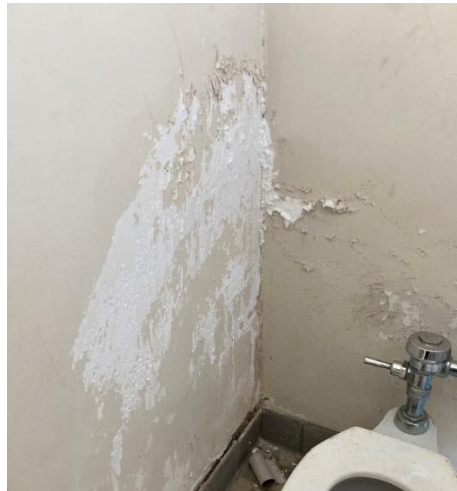
XAI.10 – Toilet 104. Damaged wall plaster.

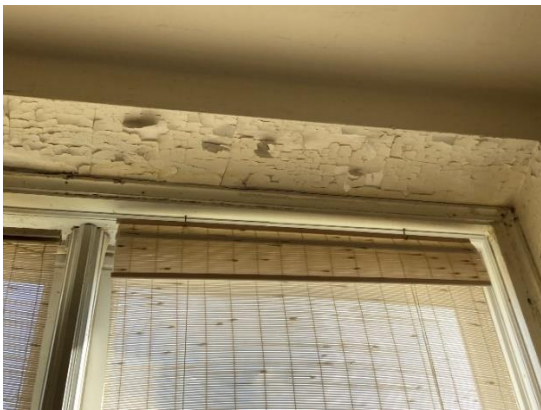
XAI.8 – Office 103. Damaged at window header.

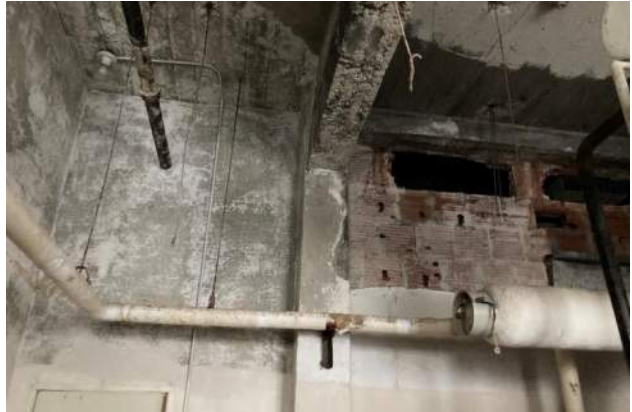
XAI.16 – Mechanical 107. Damaged plaster and holes cut into clay tile walls.

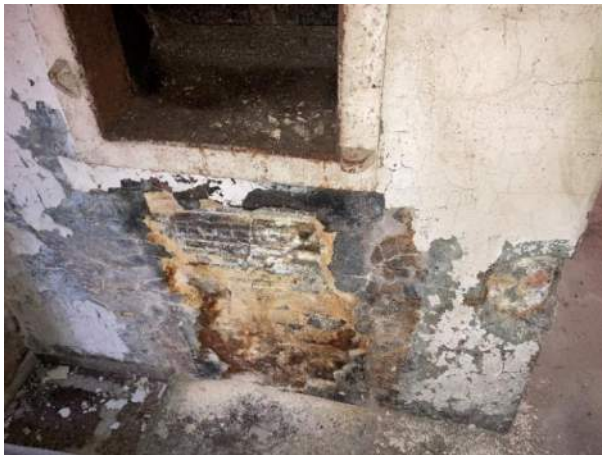
XAI.13 – Mechanical 106. Damaged wall plaster.

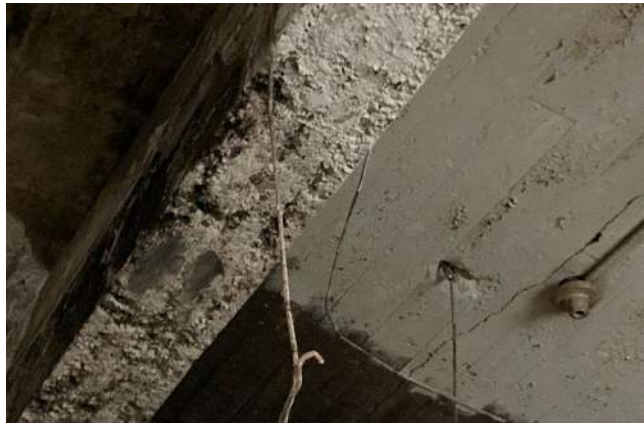
XAI.17 – Mechanical 107. Deterioration at concrete beam.

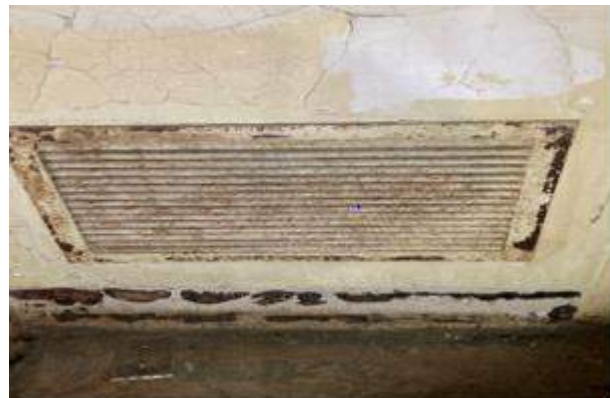
XAI.18 – Office 108. Wall grill and missing wall base.

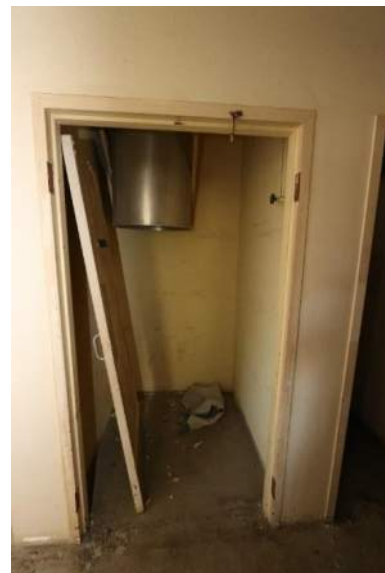
XAI.24 – Laundry 112. Damaged door frame and removed door.

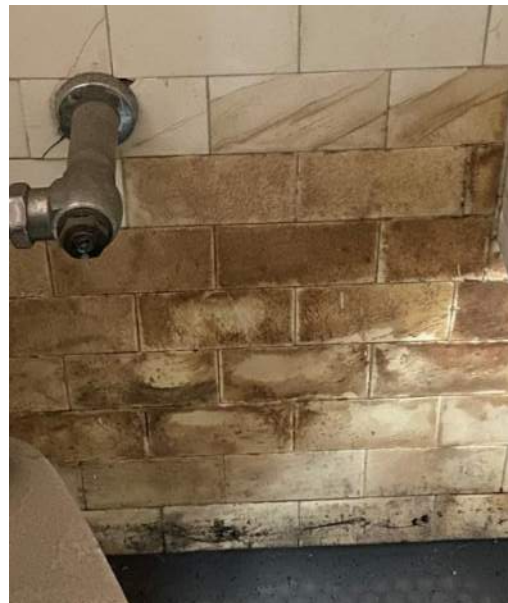
XAI.31 – Toilet 116. Damaged tiles.

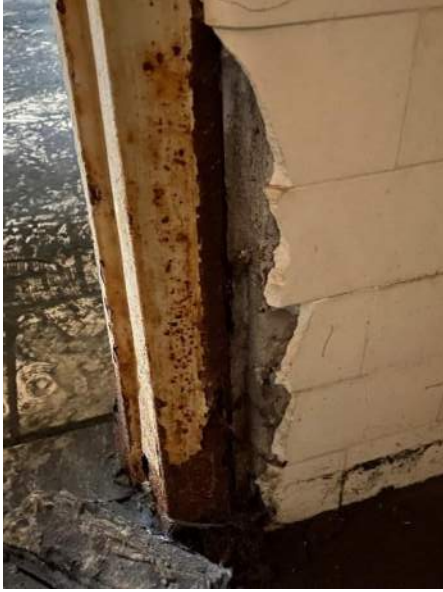
XAI.32 – Toilet 116. Damaged tiles and deteriorated door frame.

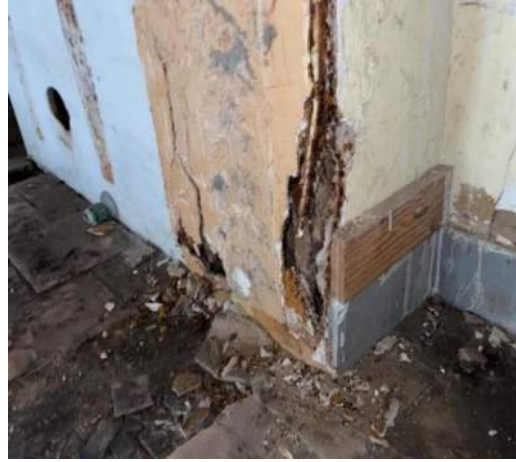
XAI.35 – Pool Room 117. Damaged wall plaster.

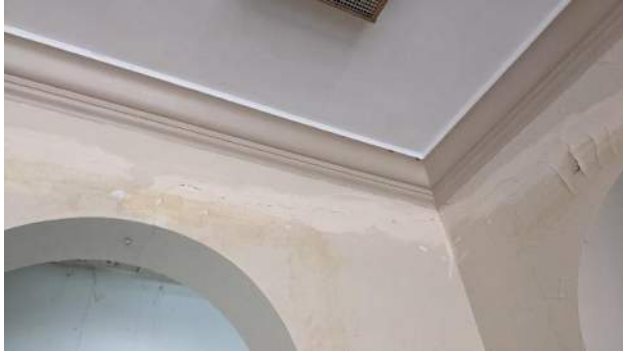
XAI.44 – Lobby 200. Cracked wall plaster.

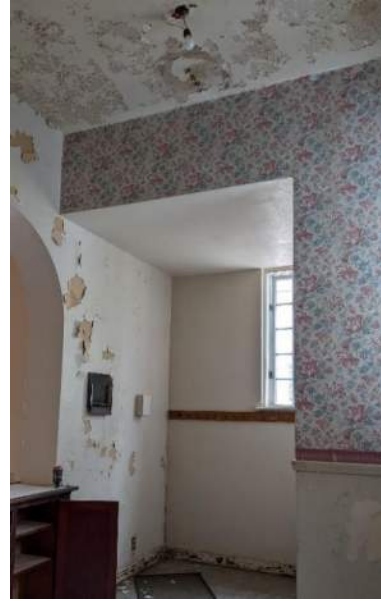
XAI.47 – Office 201. Damaged walls, ceiling, and wallpaper.

4. Office 201: Repairs are needed for the original wood cabinets in the office and countertop. Wallpaper is to be removed, walls and ceilings restored, and new flooring and lighting installed.
5. Stairs between Lobby 100 and Lobby 200: The central stair will be preserved and repaired. The laylight above will be cleaned and repaired. A new ABA-compliant handrail will be installed, and the non-compliant fire door at the bottom landing will be removed.

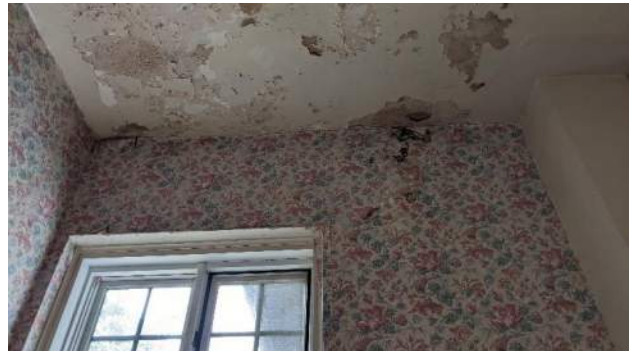
XAI.48 – Office 201. Damaged wallpaper and ceiling.

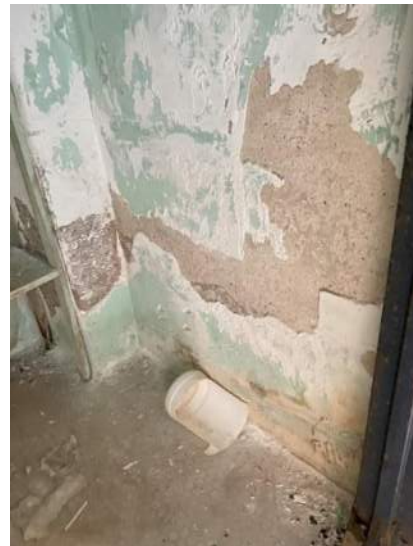
XAI.55 – Closet 204. Damaged plaster.

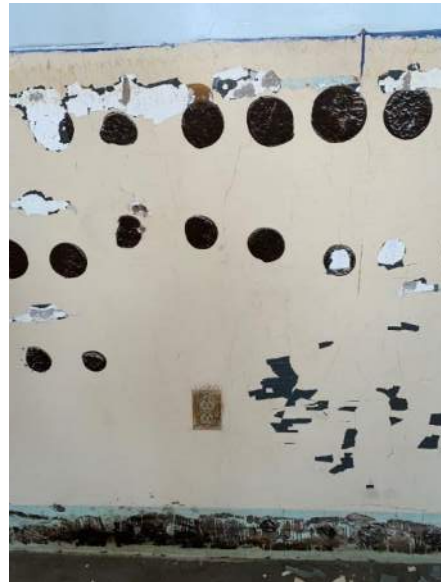
XAI.61 – Room 207. Damaged plaster wall and abandoned adhesive.

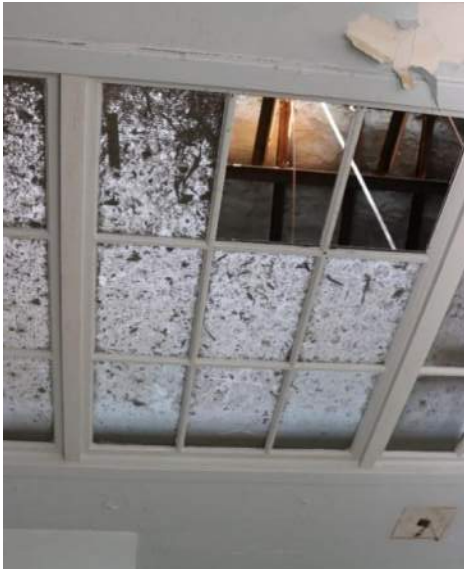
XAI.63 – Hallway 209. Damaged laylight.

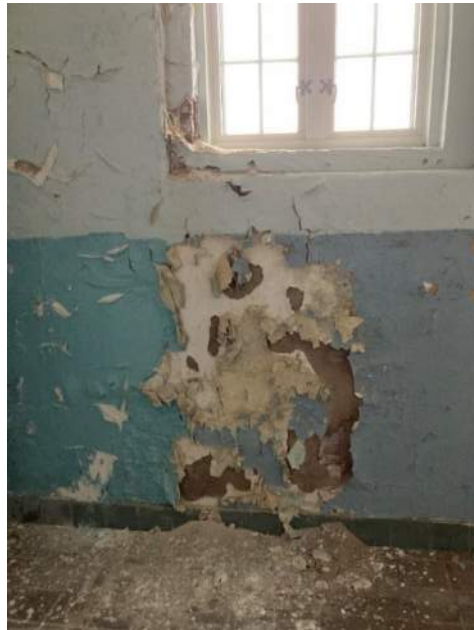
XAI.73 – Room 216. Damaged plaster, south wall.

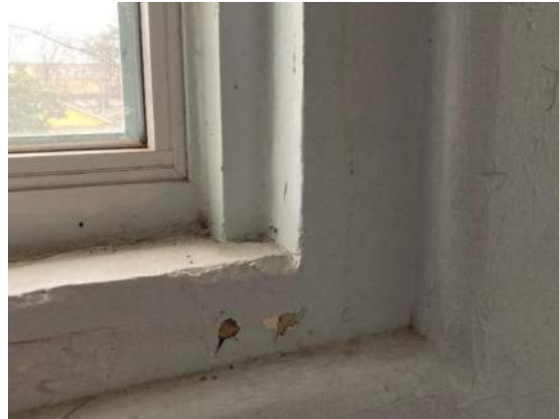
XAI.74 – Room 216. Damaged plaster at window.

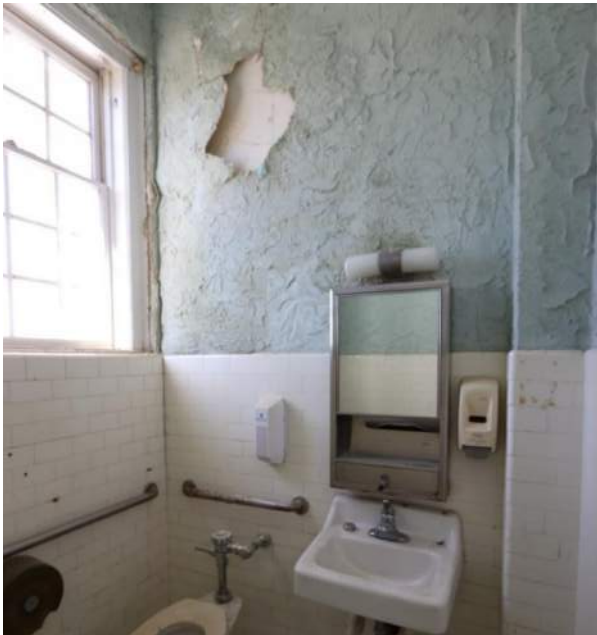
XAI.72 – Toilet 214. Damaged plaster, north wall.

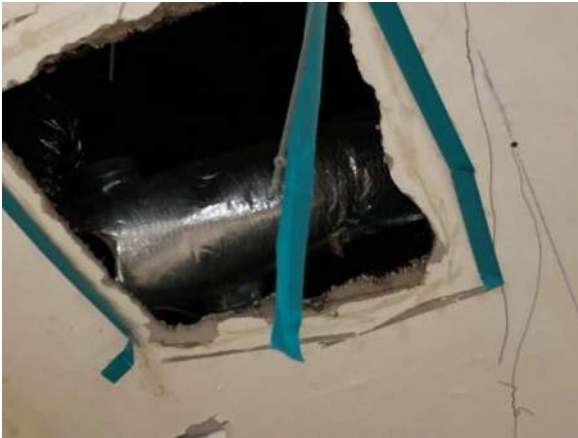
XAI.76 – Room 217. Damaged plaster at ceiling.

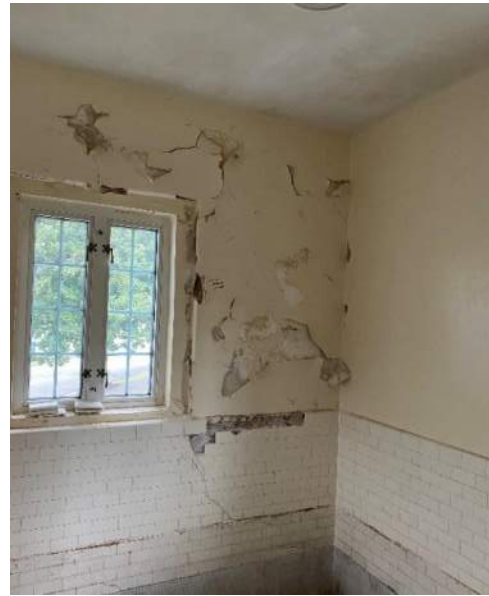
XAI.79 – Men's Bath 218. Damaged plaster wall and tile.

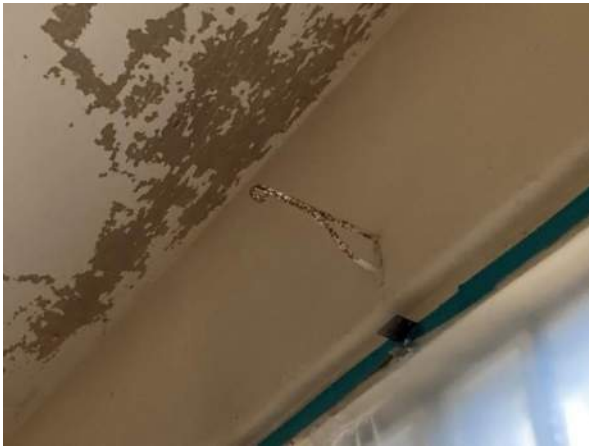
XAI.77 – Room 217. Damaged plaster at ceiling and wall hook above window.

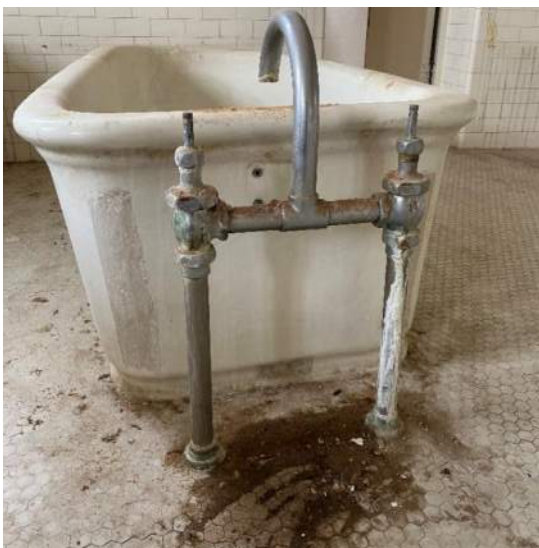
XAI.78 – Men's Bath 218. Damaged flooring, plumbing, and wall tiles.

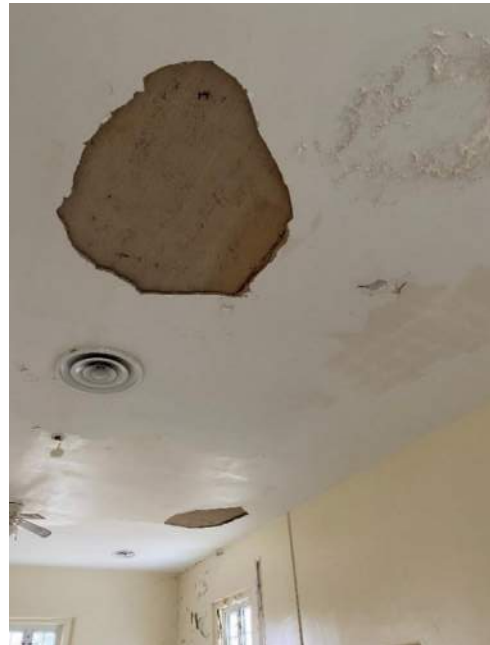
XAI.80 – Men's Bath 218. Damaged plaster in ceiling.

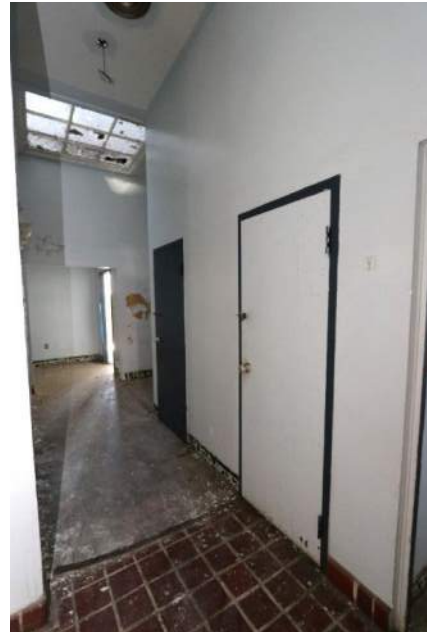
XAI.85 – Hallway 222. Looking southwest.

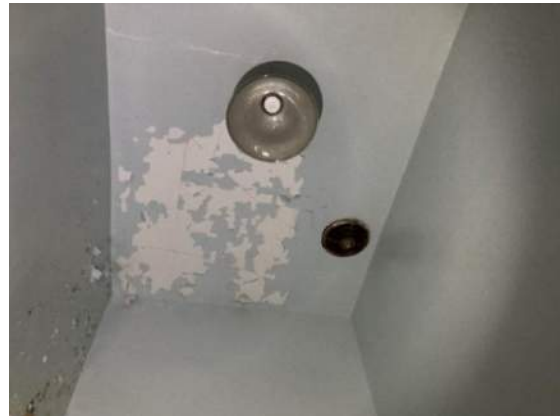
XAI.86 – Toilet 223. Damaged ceiling plaster.

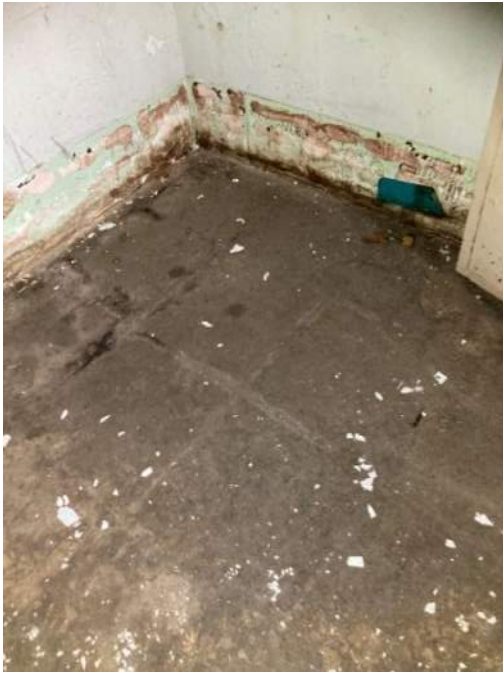
XAI.87 – Toilet 223. Damaged plaster at base of wall.

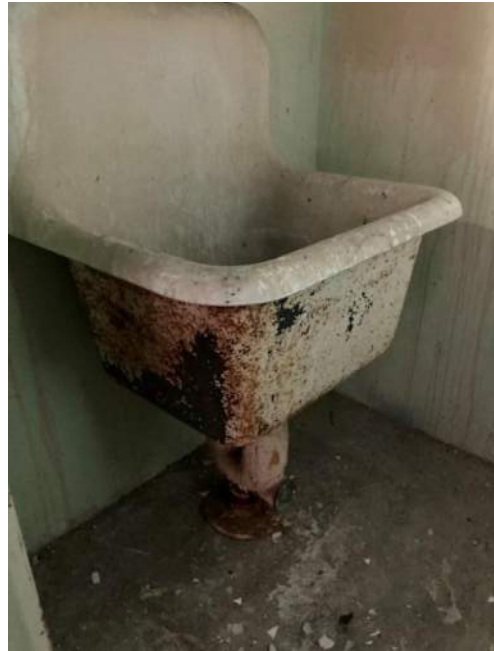
XAI.89 – Janitorial Closet 224. Damaged sink.

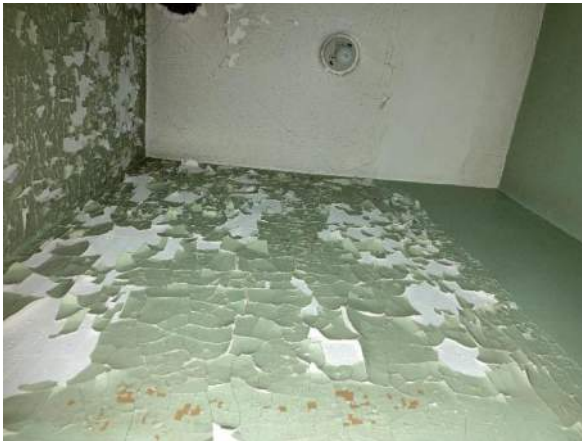
XAI.88 – Janitorial Closet 224. Damaged wall plaster.

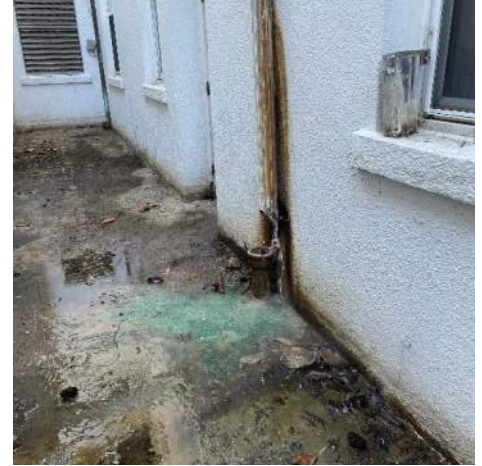
XP.7 Missing Section of Downspout Leader

8. EXTEND COLD, HOT, HOT CIRCULATING PIPING & WASTE & VENT PIPING TO WET LAB.
9. REPLACE MISSING SECTION OF MISSING SHEET METAL DOWNSPOUT LEADER.
10. PROVIDE NEW OIL MINDER TYPE SUMP PUMP IN SUMP IN ELEVATOR PIT. PUMP DISCHARGE TO SANITARY WASTE W/GALVANIZED IRON PIPING.
