Condition Assessment and Treatment Plan for Maurice Bathhouse

PRE-DESIGN SERVICES

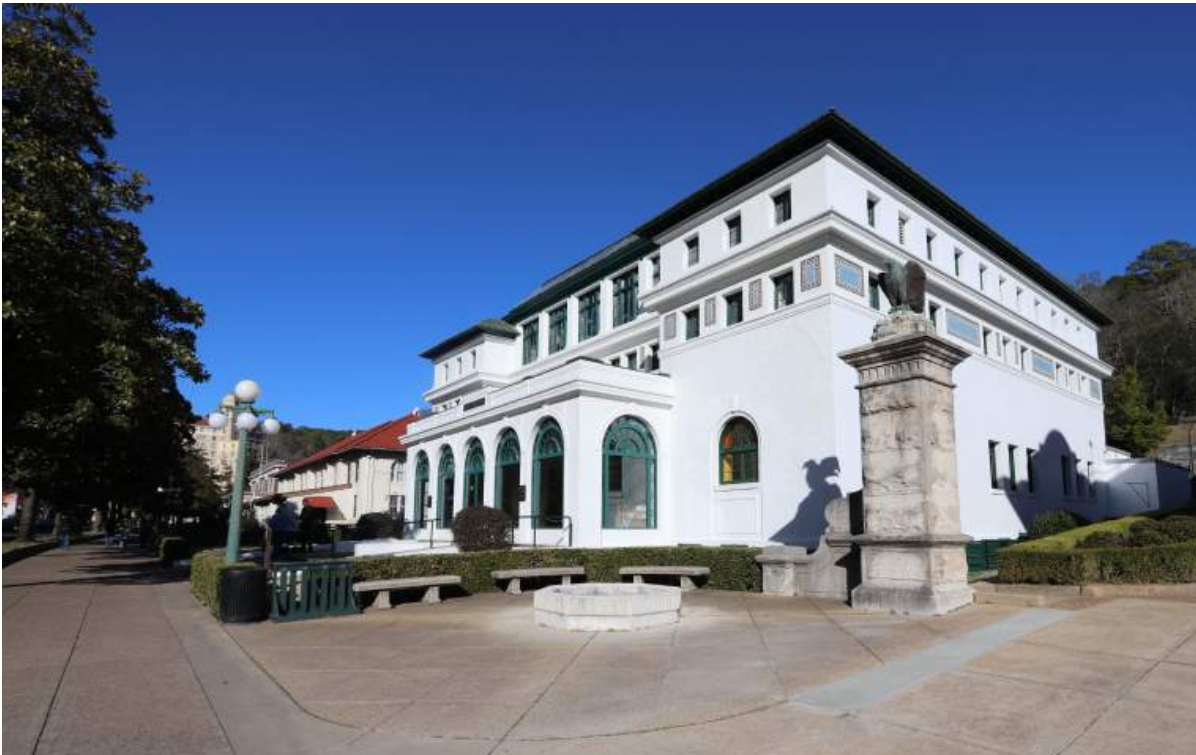
Maurice Bathhouse, Exterior Southwest Corner (STRATA, 2022)

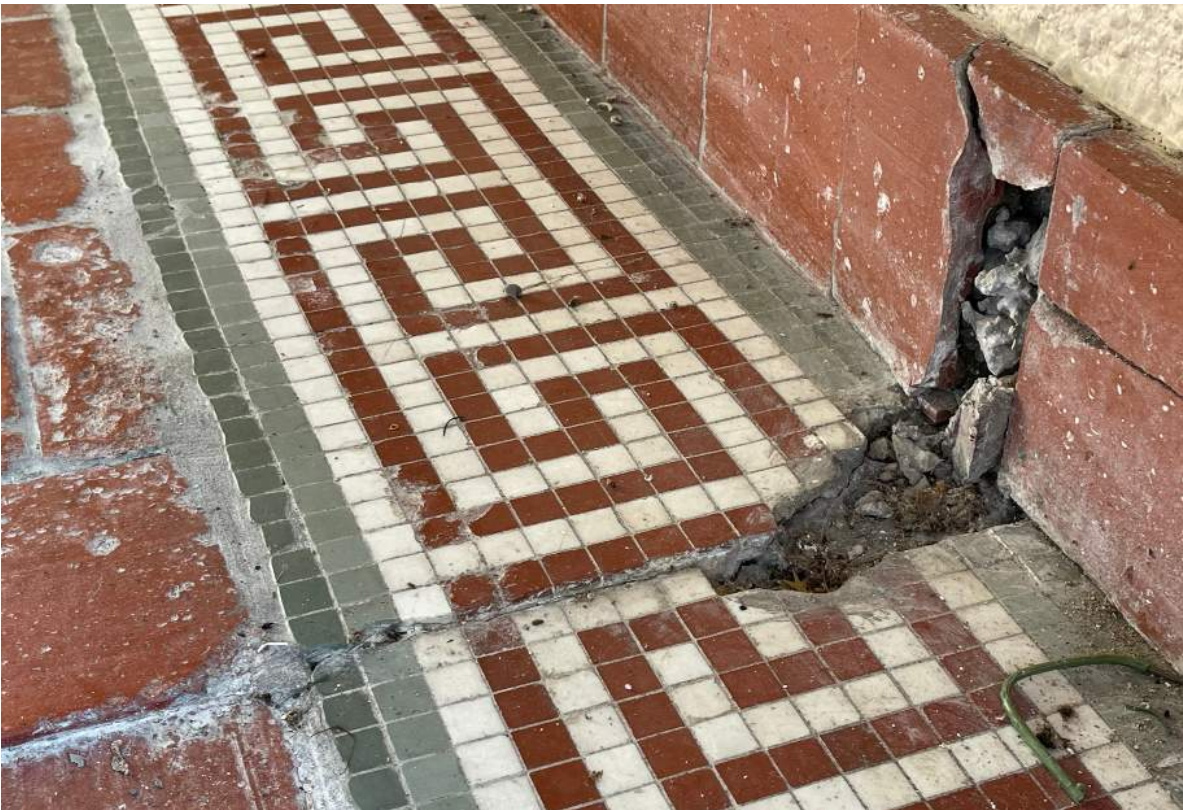
Maurice Bathhouse, Sun Porch Tile Detail (STRATA, 2022)

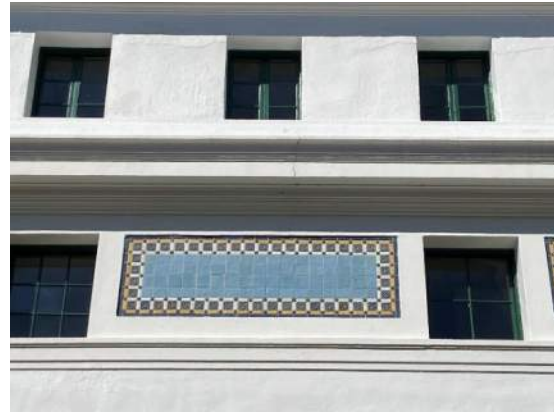
XAE.8 – Exterior. Damaged tile, cornice, and wall.

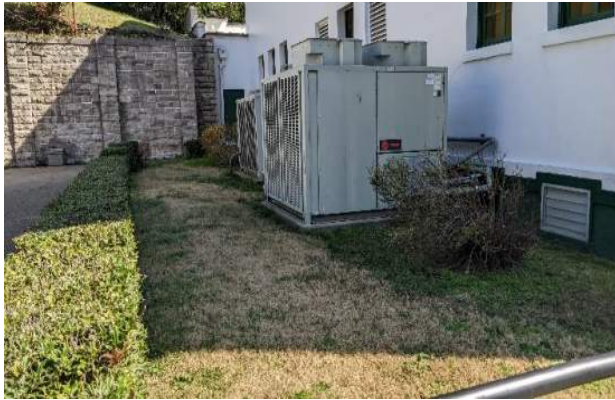
XAE.6 – Exterior. North equipment yard, looking east.

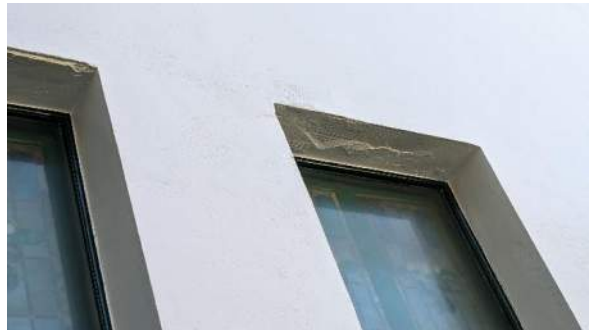
XAE.9 – Windows. Damaged plaster.

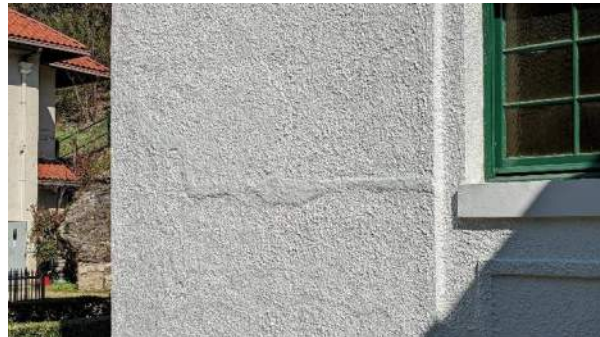
XAE.7 – Exterior. Patched stucco where previously cracked.

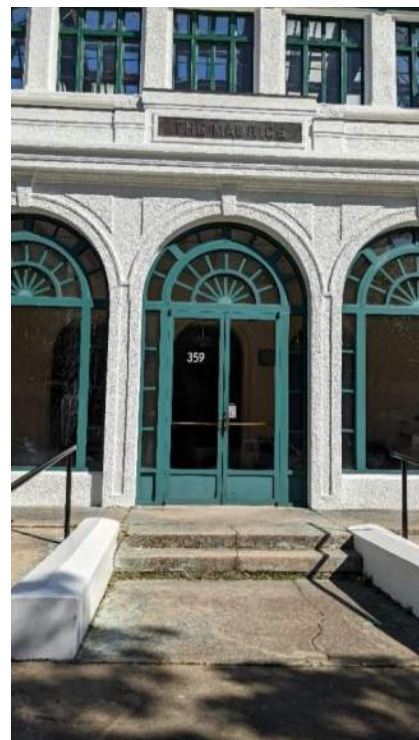
XAE.10 – Sunporch. Damaged stair, window, door.

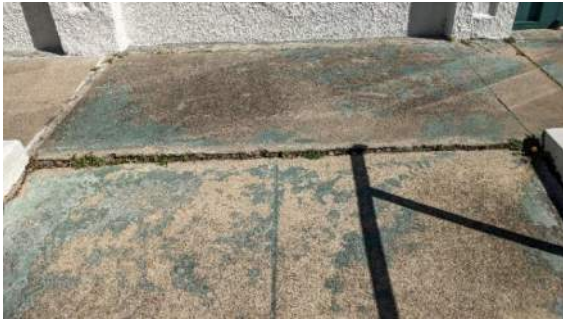
XAE.11– Exterior at West. Damaged ramp and landing at entrance.

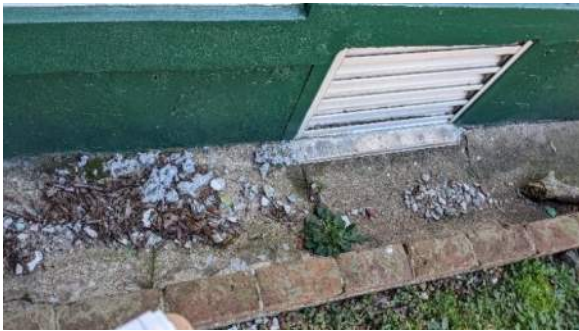
XAE.12– Exterior at North. Damaged runnel and louver.

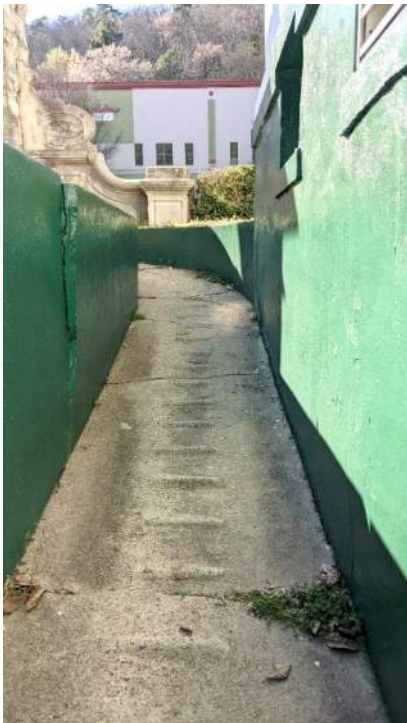
XAE.13 - Exterior at South. Deteriorated concrete ramp to basement and concrete retaining wall.

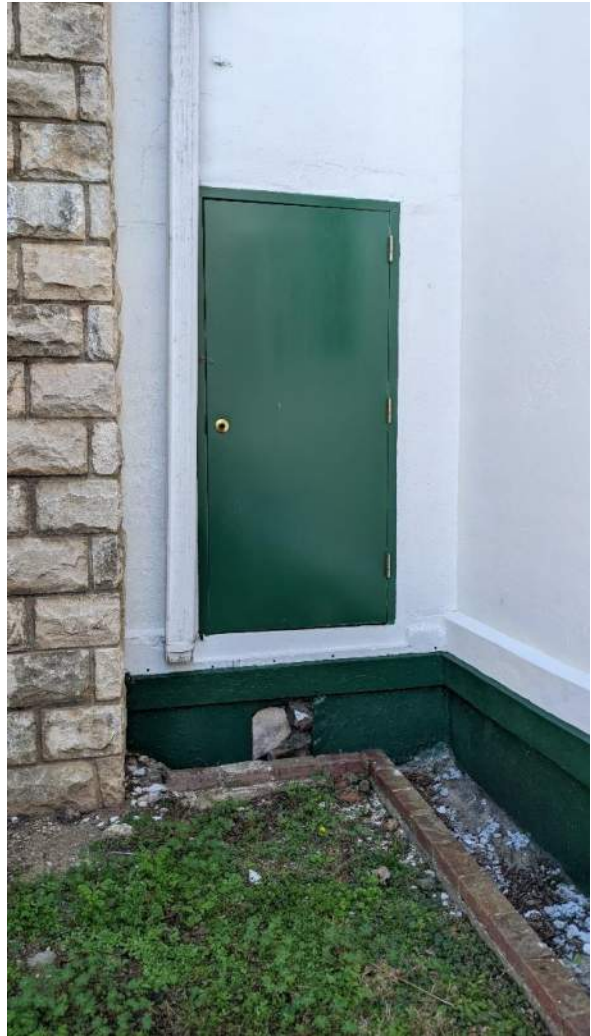
XAE.14– Exterior at North. Exit with no stair to grade.

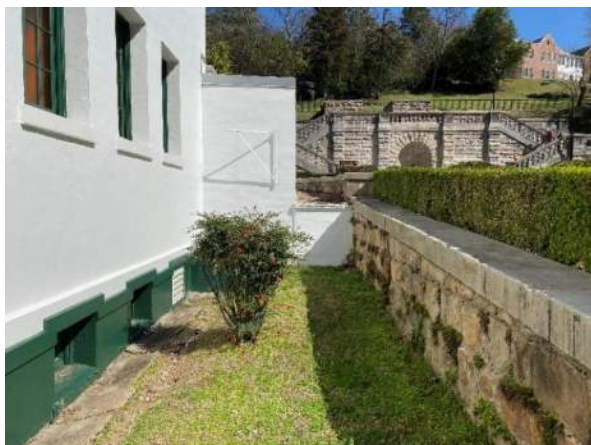
XAE.15 – Exterior at South. Deteriorated stone retaining wall and concrete runnel.

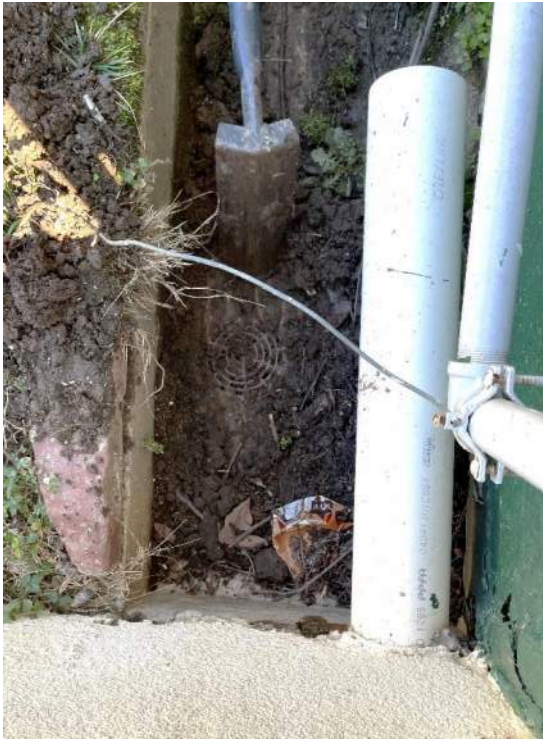
XAE.16 – Clogged drain in north side runnel. Note, the drainage (large white pipe) from the north side of the Sunporch roof also drains into this runnel.

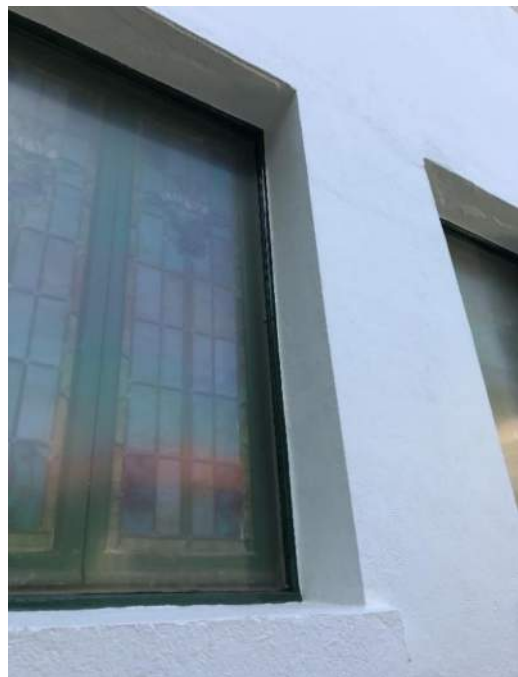
XAE.19 – Yellowed plexiglass coverings over historic stained glass windows. Coverings are not properly vented.

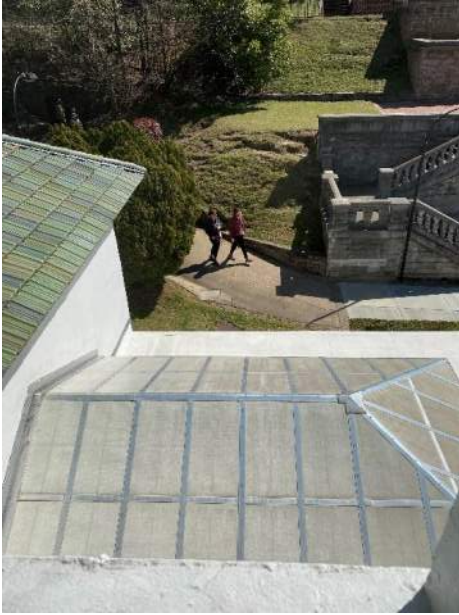
XAE.20 – Skylight. Deteriorated to be replaced.

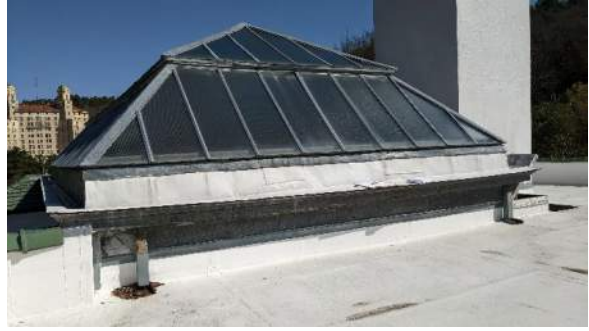
XAE.23 – Skylight. Deteriorated to be replaced.

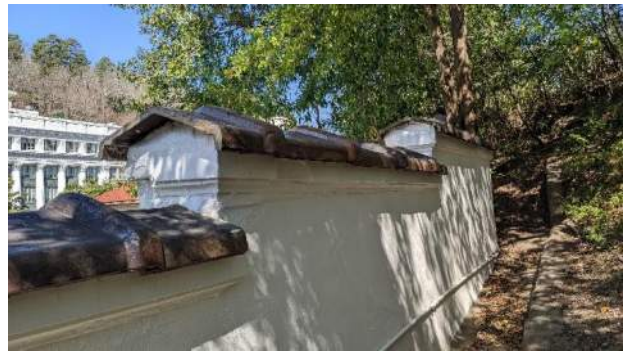
XAE.24 – Roof parapet with clay tiles at east wall, northeast roof.

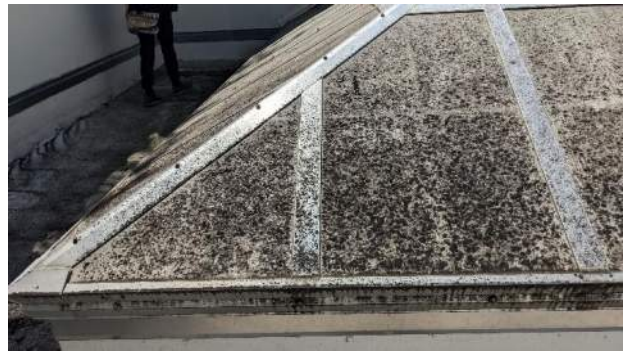
XAE.25 – Northeast skylight staining from berries from tree above roof.

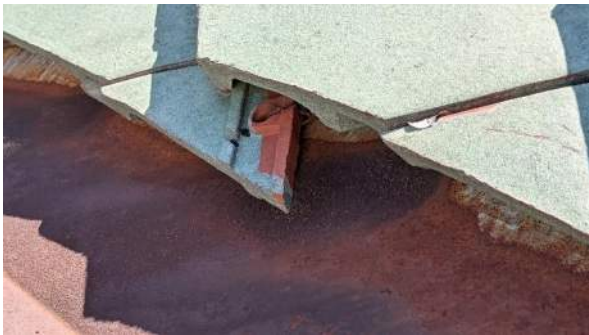
XAE.22 – Roof. Damaged green glazed vitrified clay roof tiles and copper flashing.

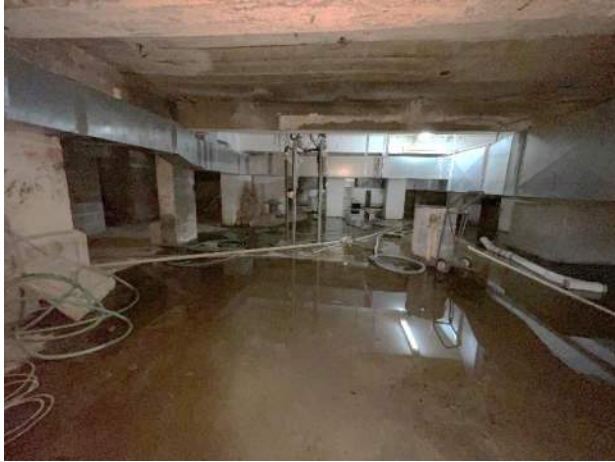
XA.1 – Basement B01 – Typical Conditions.

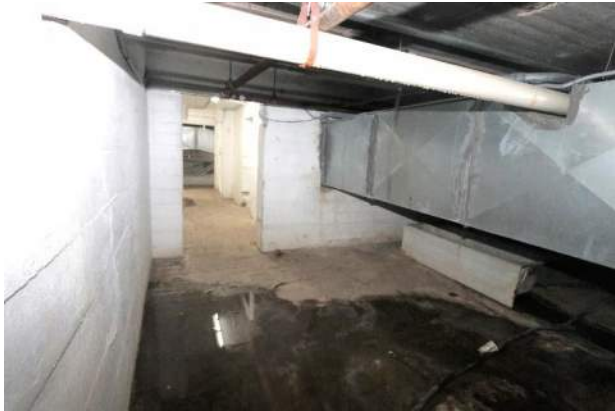
XA.2 – Basement B01 – Typical Conditions in east rooms with standing water and low head-height at ductwork in basement.

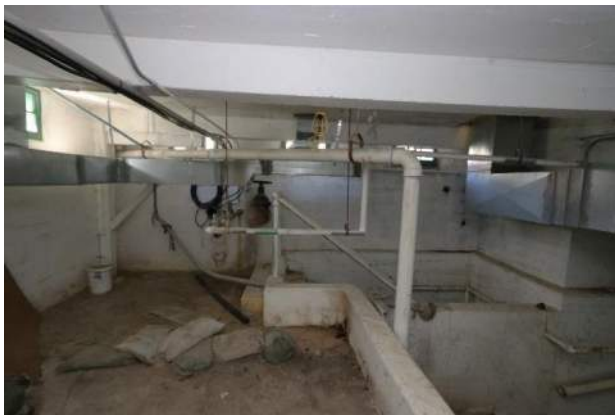
XA.3 – B10 Pool. Typical conditions at south end of pool with utilities, structural stabilization steel, and low ductwork.

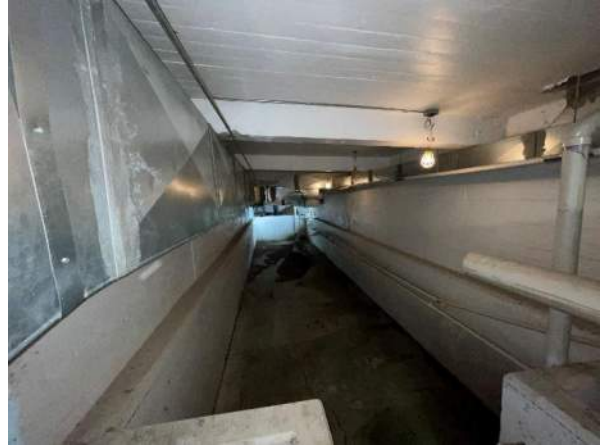
XA.4 – B10 Pool – Typical conditions at pool with roof drains into pool and ductwork overhead.

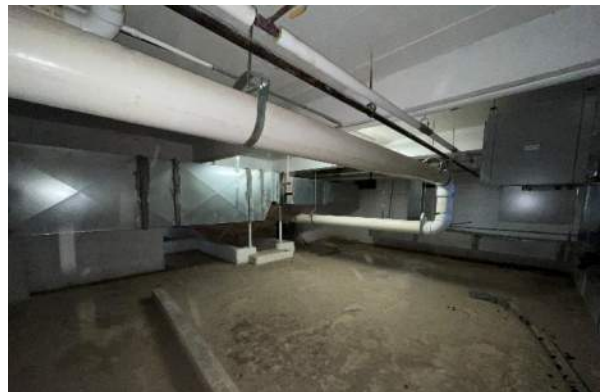
XA.5 – B10 Pool Deck – Typical conditions at pool deck with low ductwork, piping, and equipment. Note, the ductwork is over the entrance stairs into the pool.

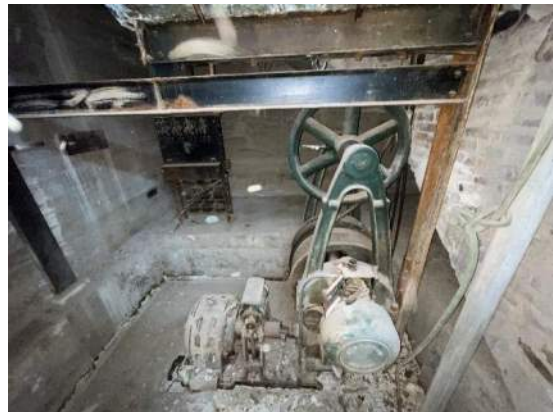
XA.6 – Elevator Pit. Typical historic elevator pit.

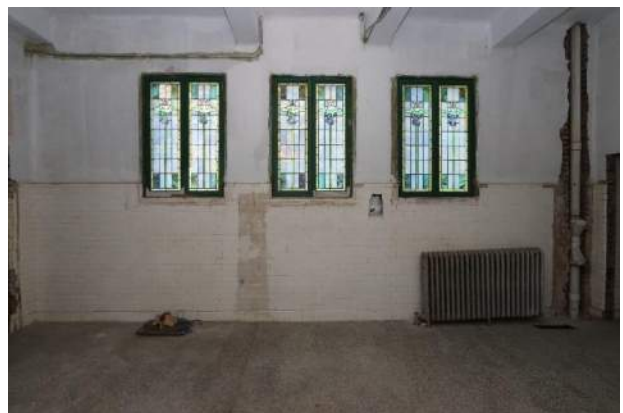
XA.17 – Women's Pack Room 101. Looking north at stained glass windows.

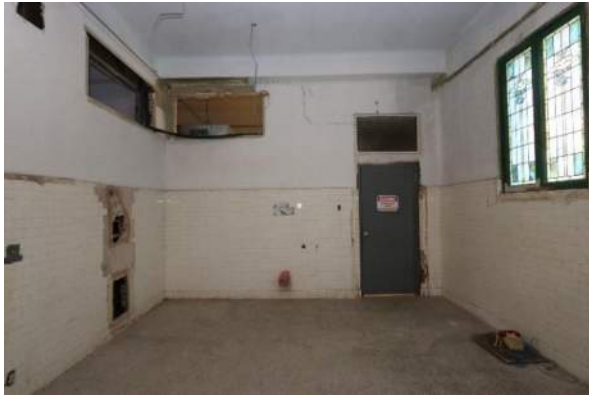
XA.18 – Women's Pack Room 101. Looking west.

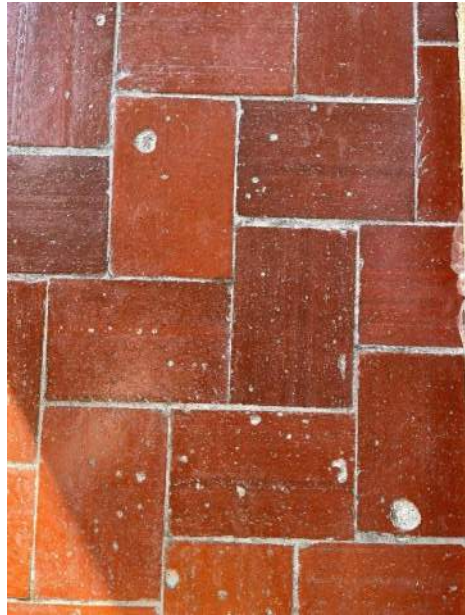
XA.33 – Sunporch 109. Damaged mosaic border and base to be replaced.

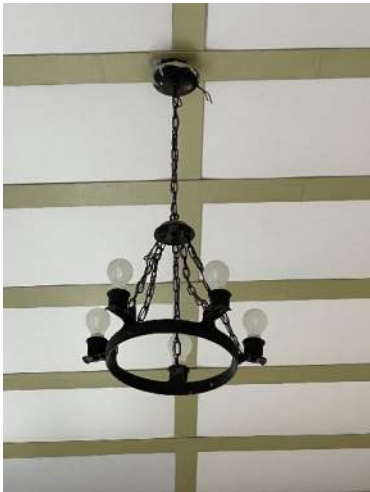
XA.31 – Sunporch 109. Detail of light fixture and ceiling.

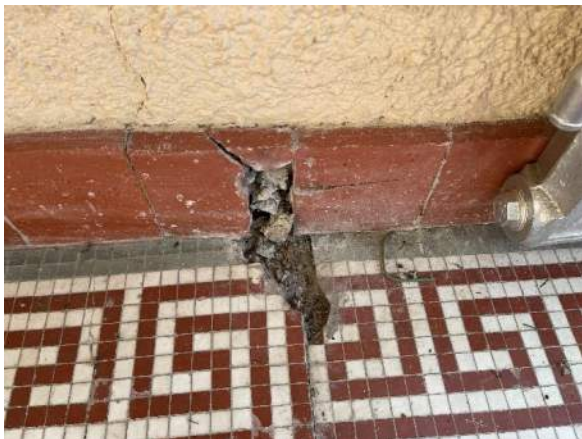
XA.32 – Sunporch 109. Damaged mosaic border and base to be replaced.

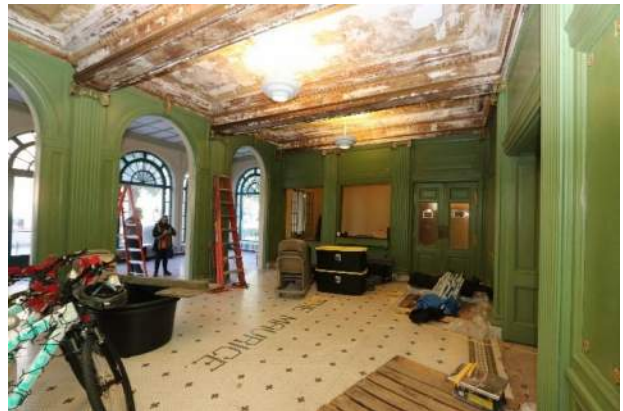
XA.35 – Lobby 110. Lobby, looking northwest.

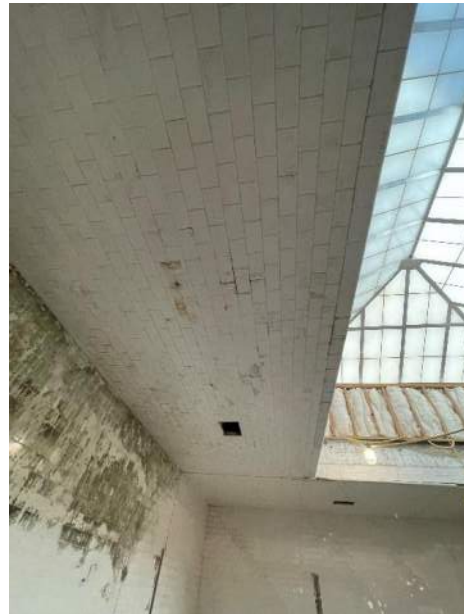
XA.50 – Men's Bath Hall 113. Detail of stained wall tiles and tiled ceiling.

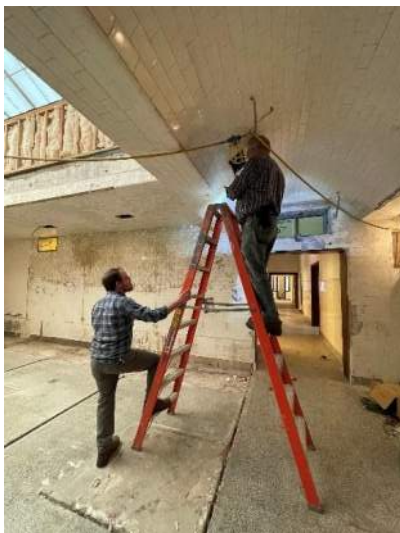
XA.48 – Men's Bath Hall 113. Detail of tiles barrel vaults.

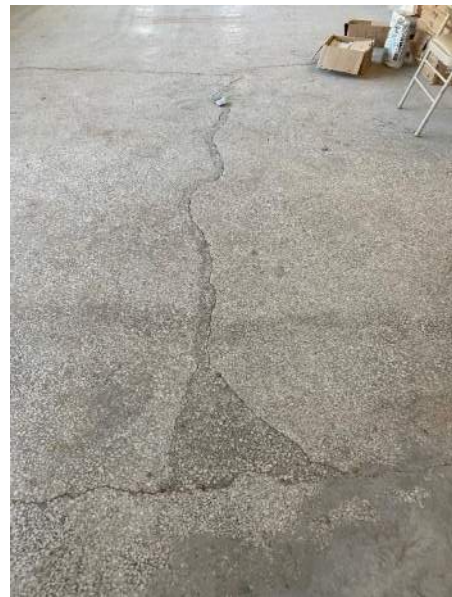
XA.74 – Men's Dressing 205. Detail of cracks in floor.

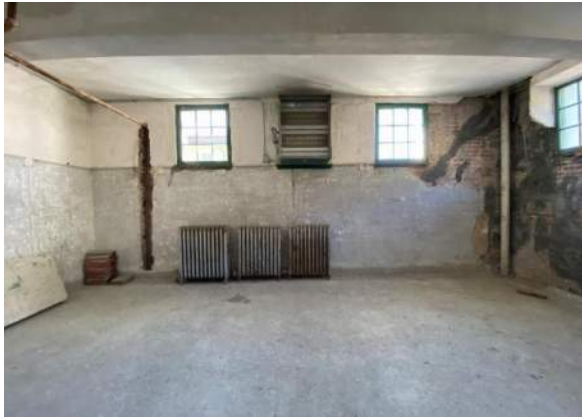
XA.75 – Men's Dressing 205. Looking south.

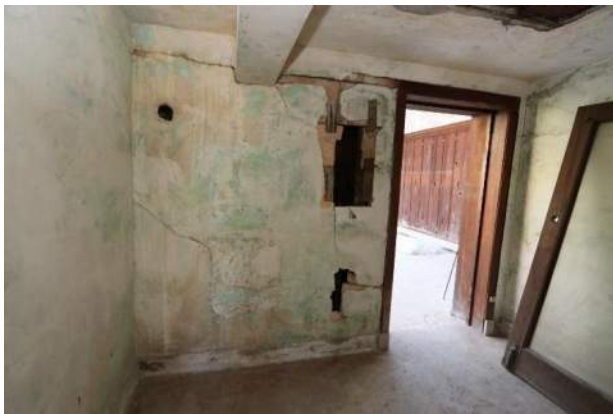
XA.113 – Maurice Office 311. Looking north.

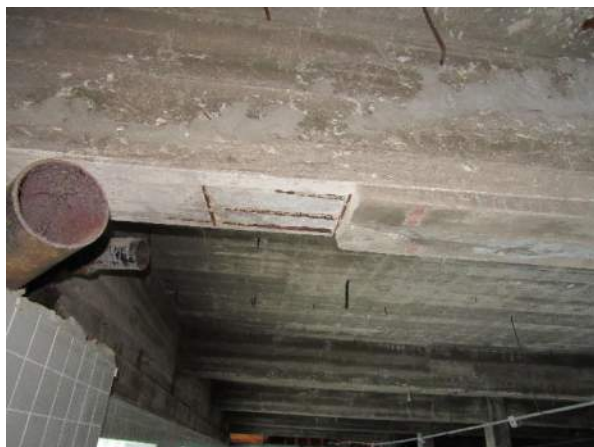
S.1 – Typical overhead beam repair due to original construction.

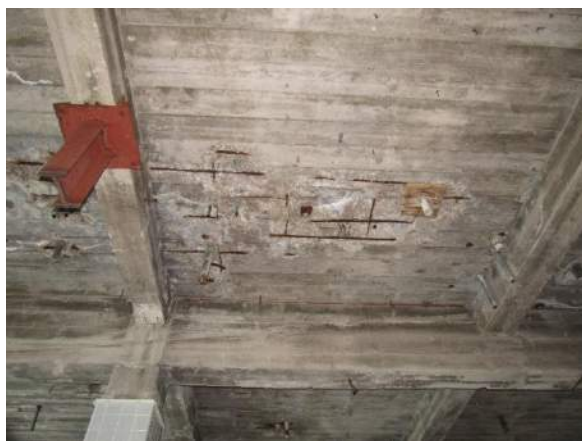
S.2 – Typical overhead slab repair area due to corrosion of reinforcing steel.

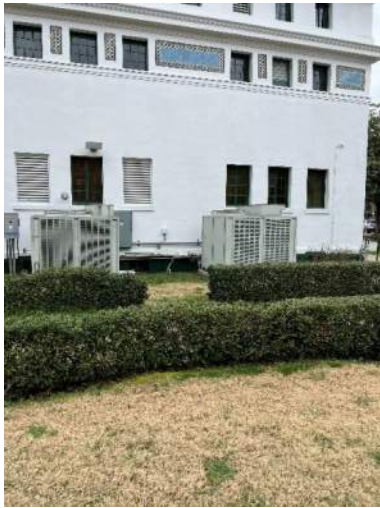
XM.1 Hale and Maurice
Condensing Units

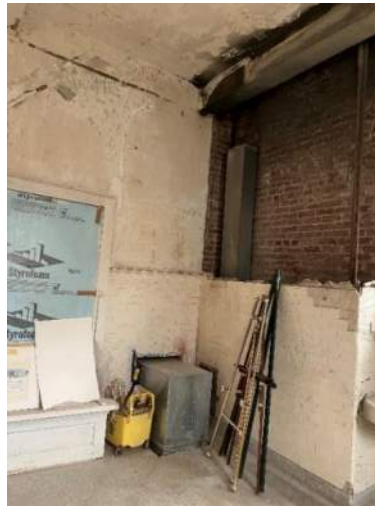
XM.10 Abandoned Ductwork

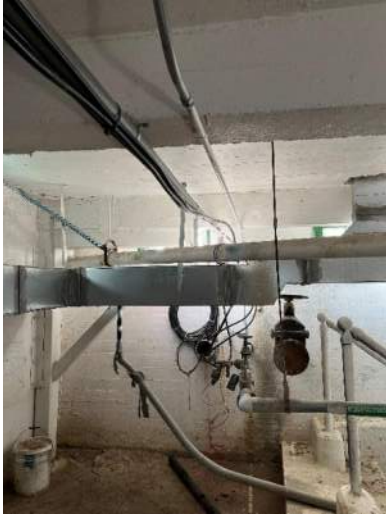
XP.1 Fire and Water Service

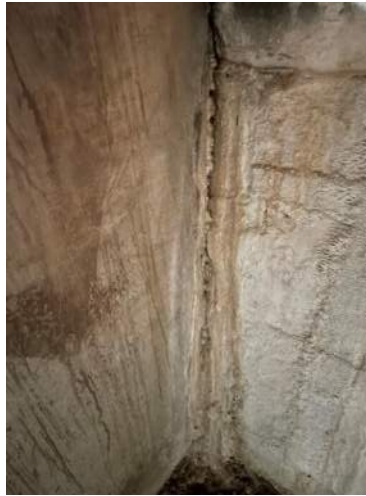
XP.11 Springs Collection Basin Leak

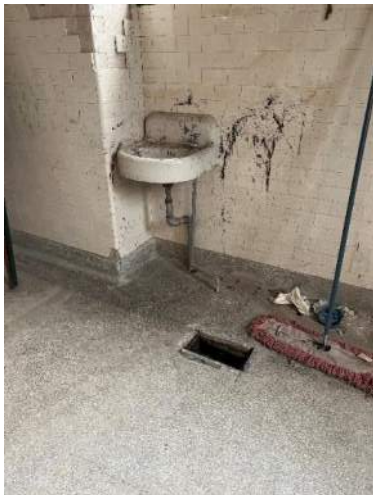
XP.9 Existing Plumbing Fixture

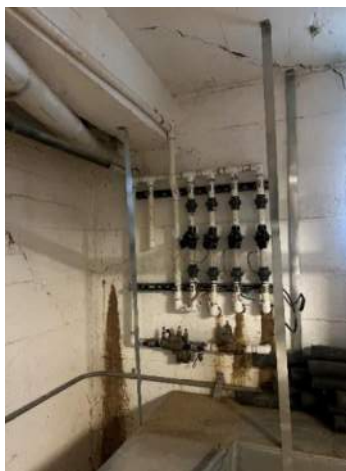
XP.12 Existing Irrigation System

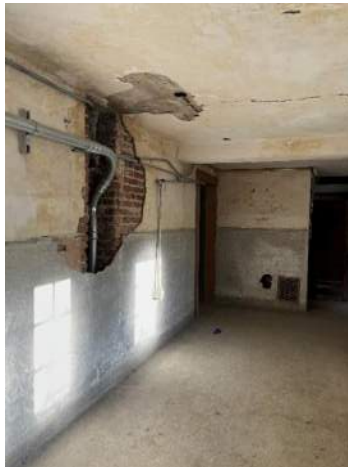
XE.10 Existing Damaged Conduit

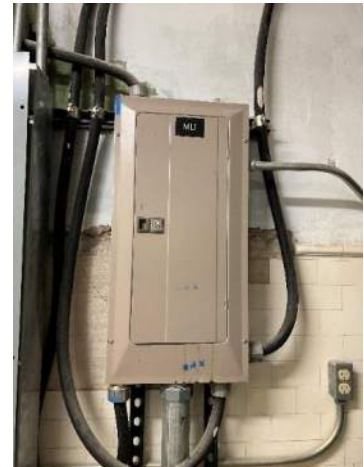
XE.13 Panel for Temporary Service

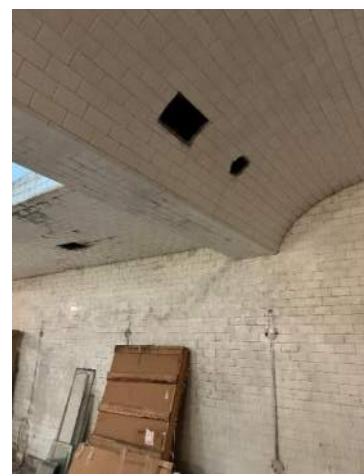
XE.14 Missing Light Fixture Openings

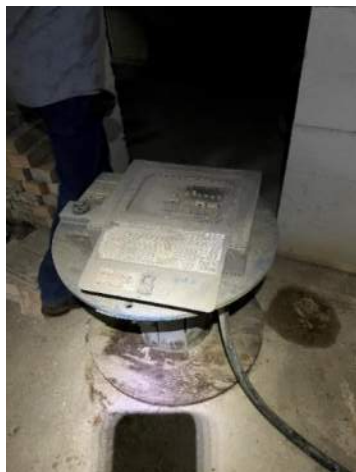
XE.9 Temporary Wiring and Distribution

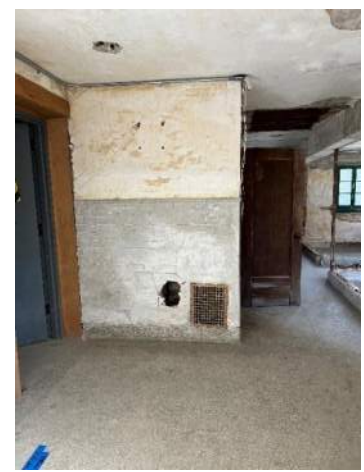
XE.15 Junction Box with Missing Cover Plate

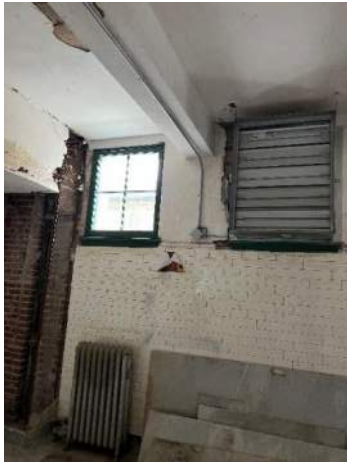
XE.16 Junction Box with Partial Cover Plate

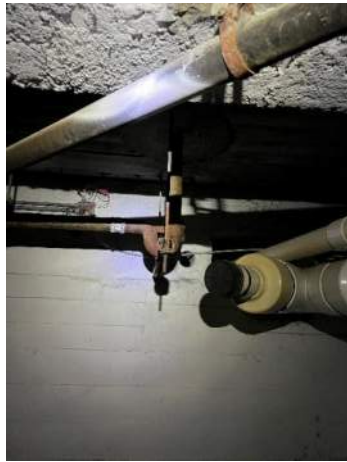
XE.17 Junction Box with Missing Cover Plate

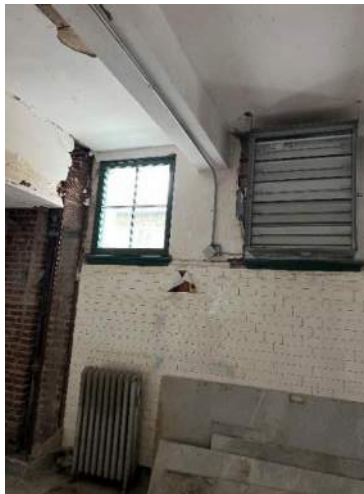
XE.20 Junction Box with Partial Cover Plate

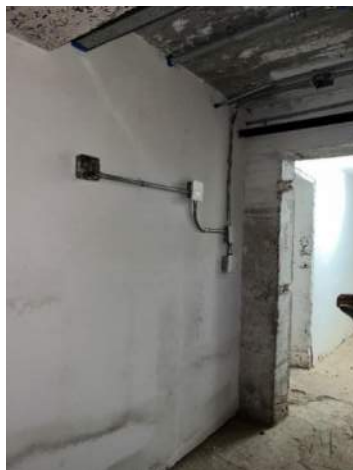
XE.18 Junction Box with Missing Cover Plate

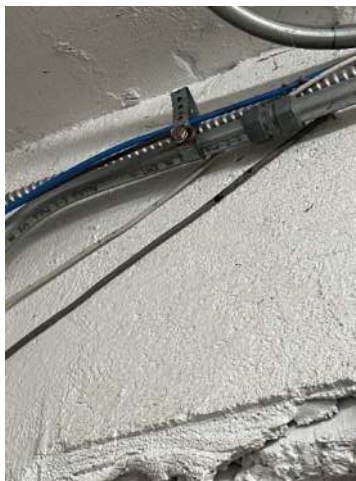
XE.21 Ground Connection

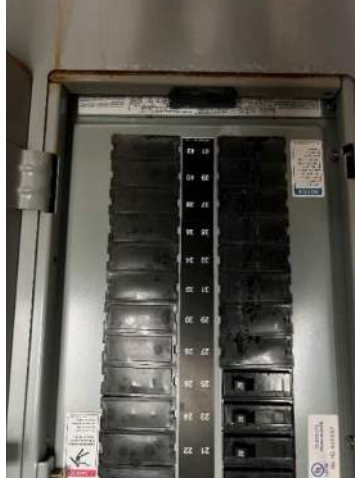
XE.28 Rust on Electrical
Equipment

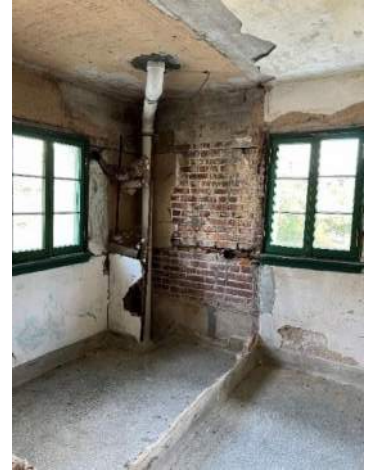
XE.31 Rusted Conduit

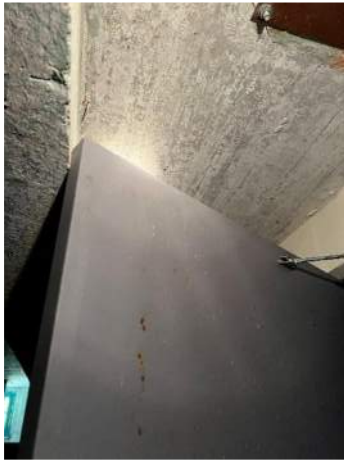
XE.26 Elevator Equipment
Entry Door

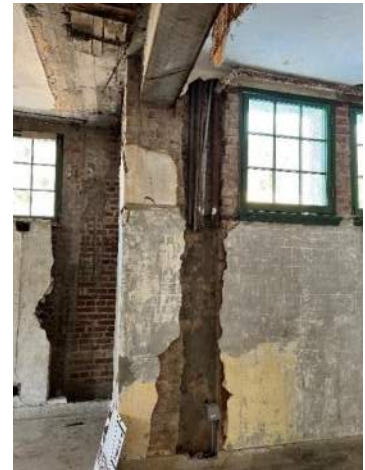
XE.32 Rusted Conduit

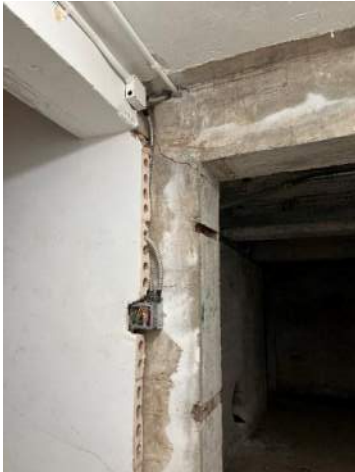
XE.34 Missing Cover Plates

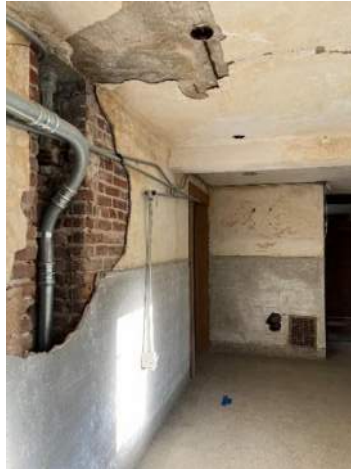
XE.37 Broken
Conduit/Grounding System

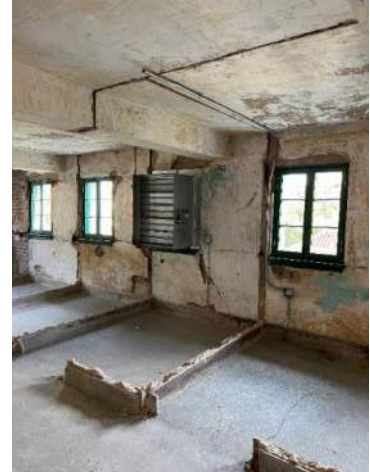
XE.40 Broken
Conduit/Grounding System

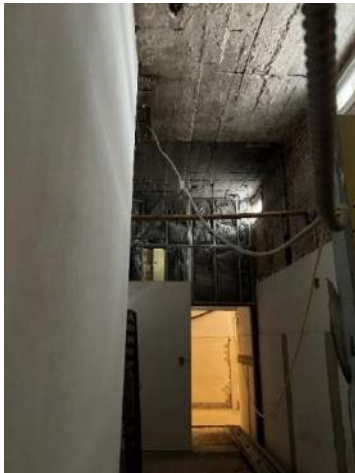
XE.35 Support Wiring

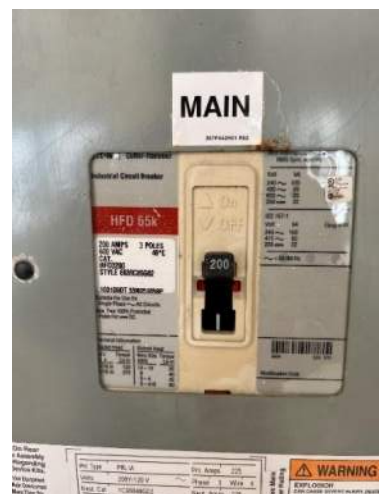
XE.41 Rust on Electrical
Equipment

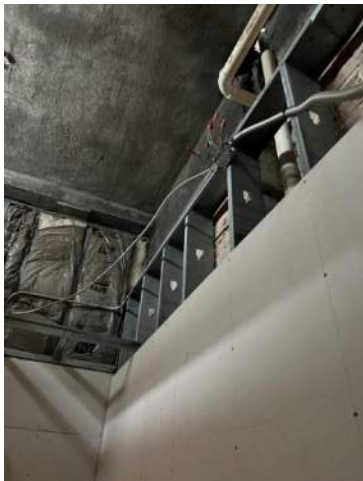
XE.36 Incomplete Open
Wiring

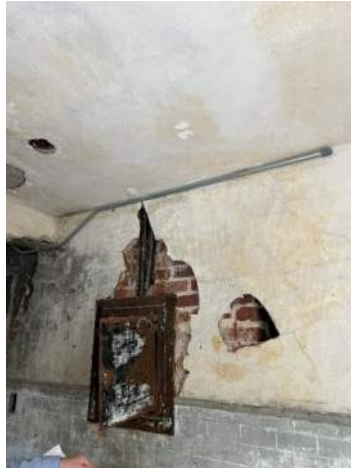
XE.39 Broken
Conduit/Grounding System

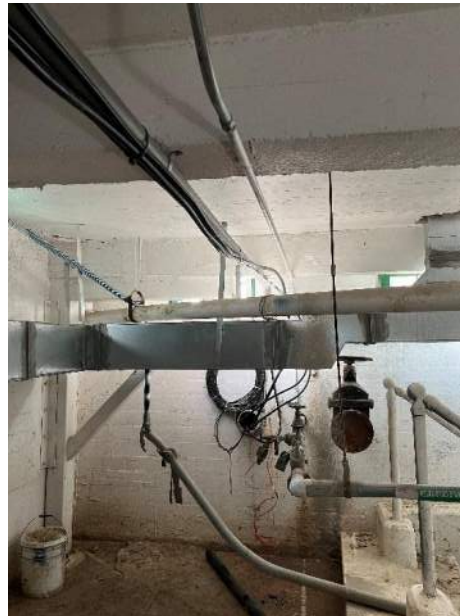
XF.1 Fire and Water Service

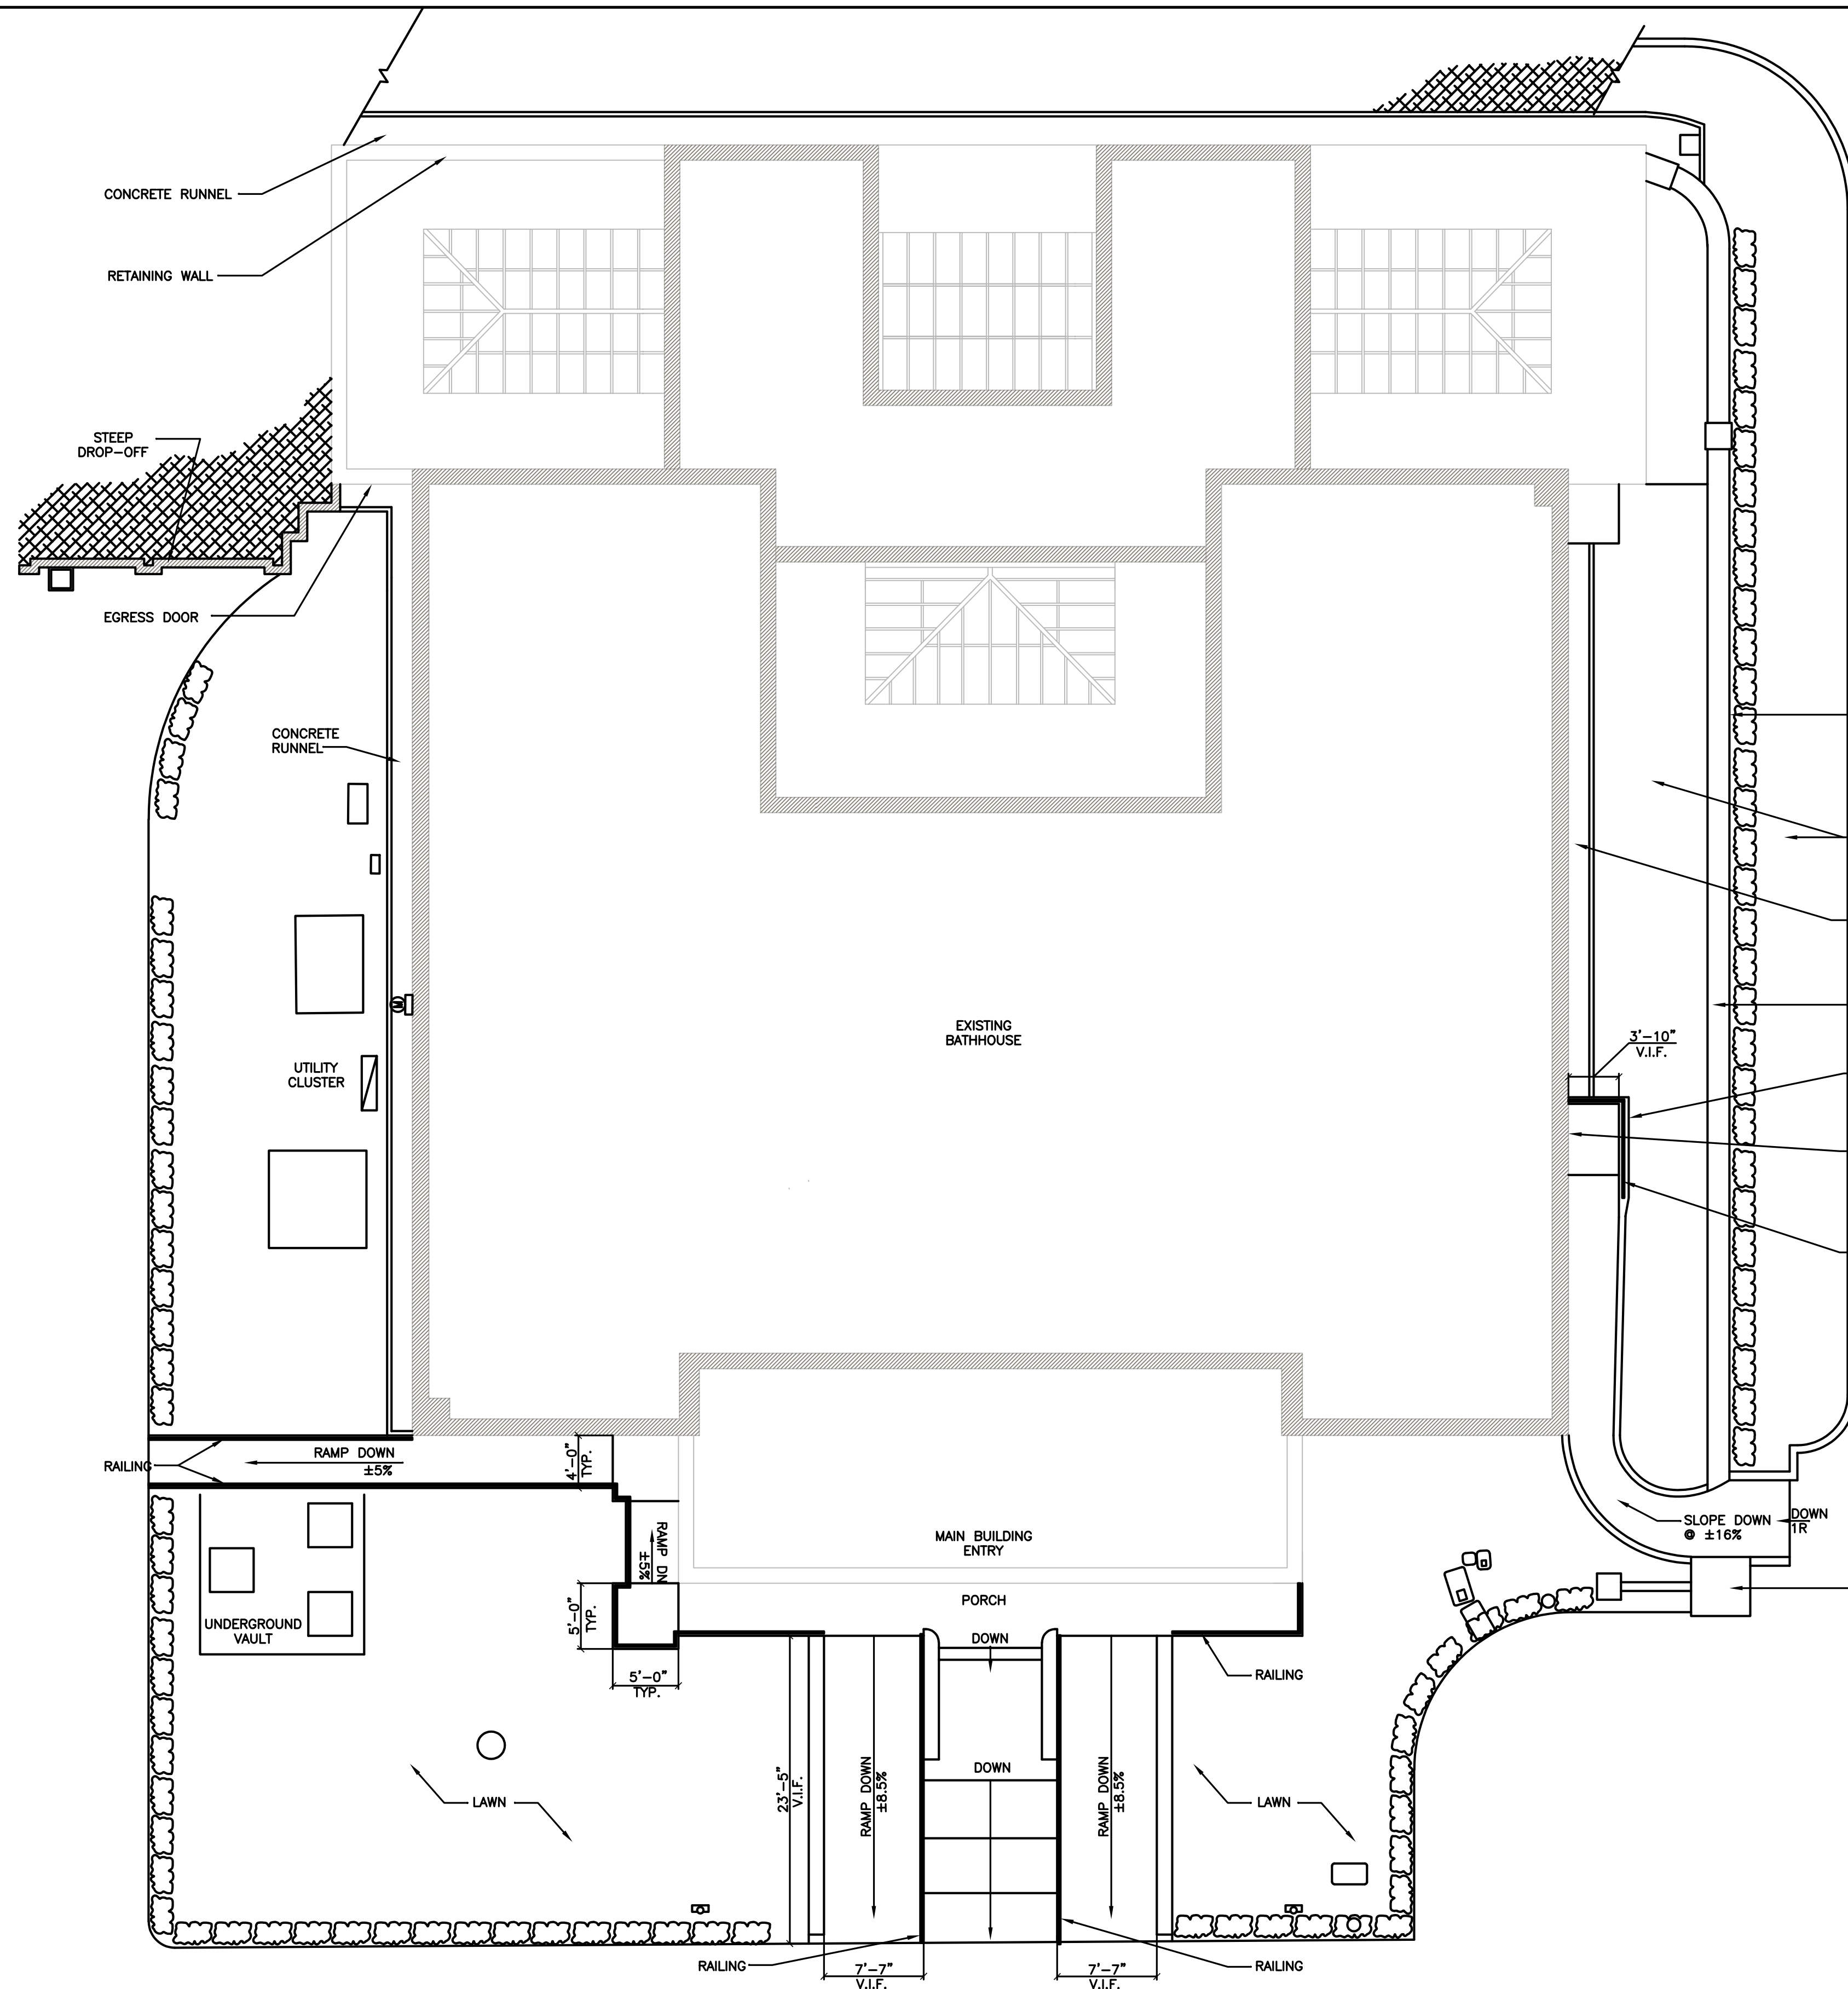
EXISTING CONDITIONS DRAWINGS
