Condition Assessment and Treatment Plan for Maurice Bathhouse

PRE-DESIGN SERVICES

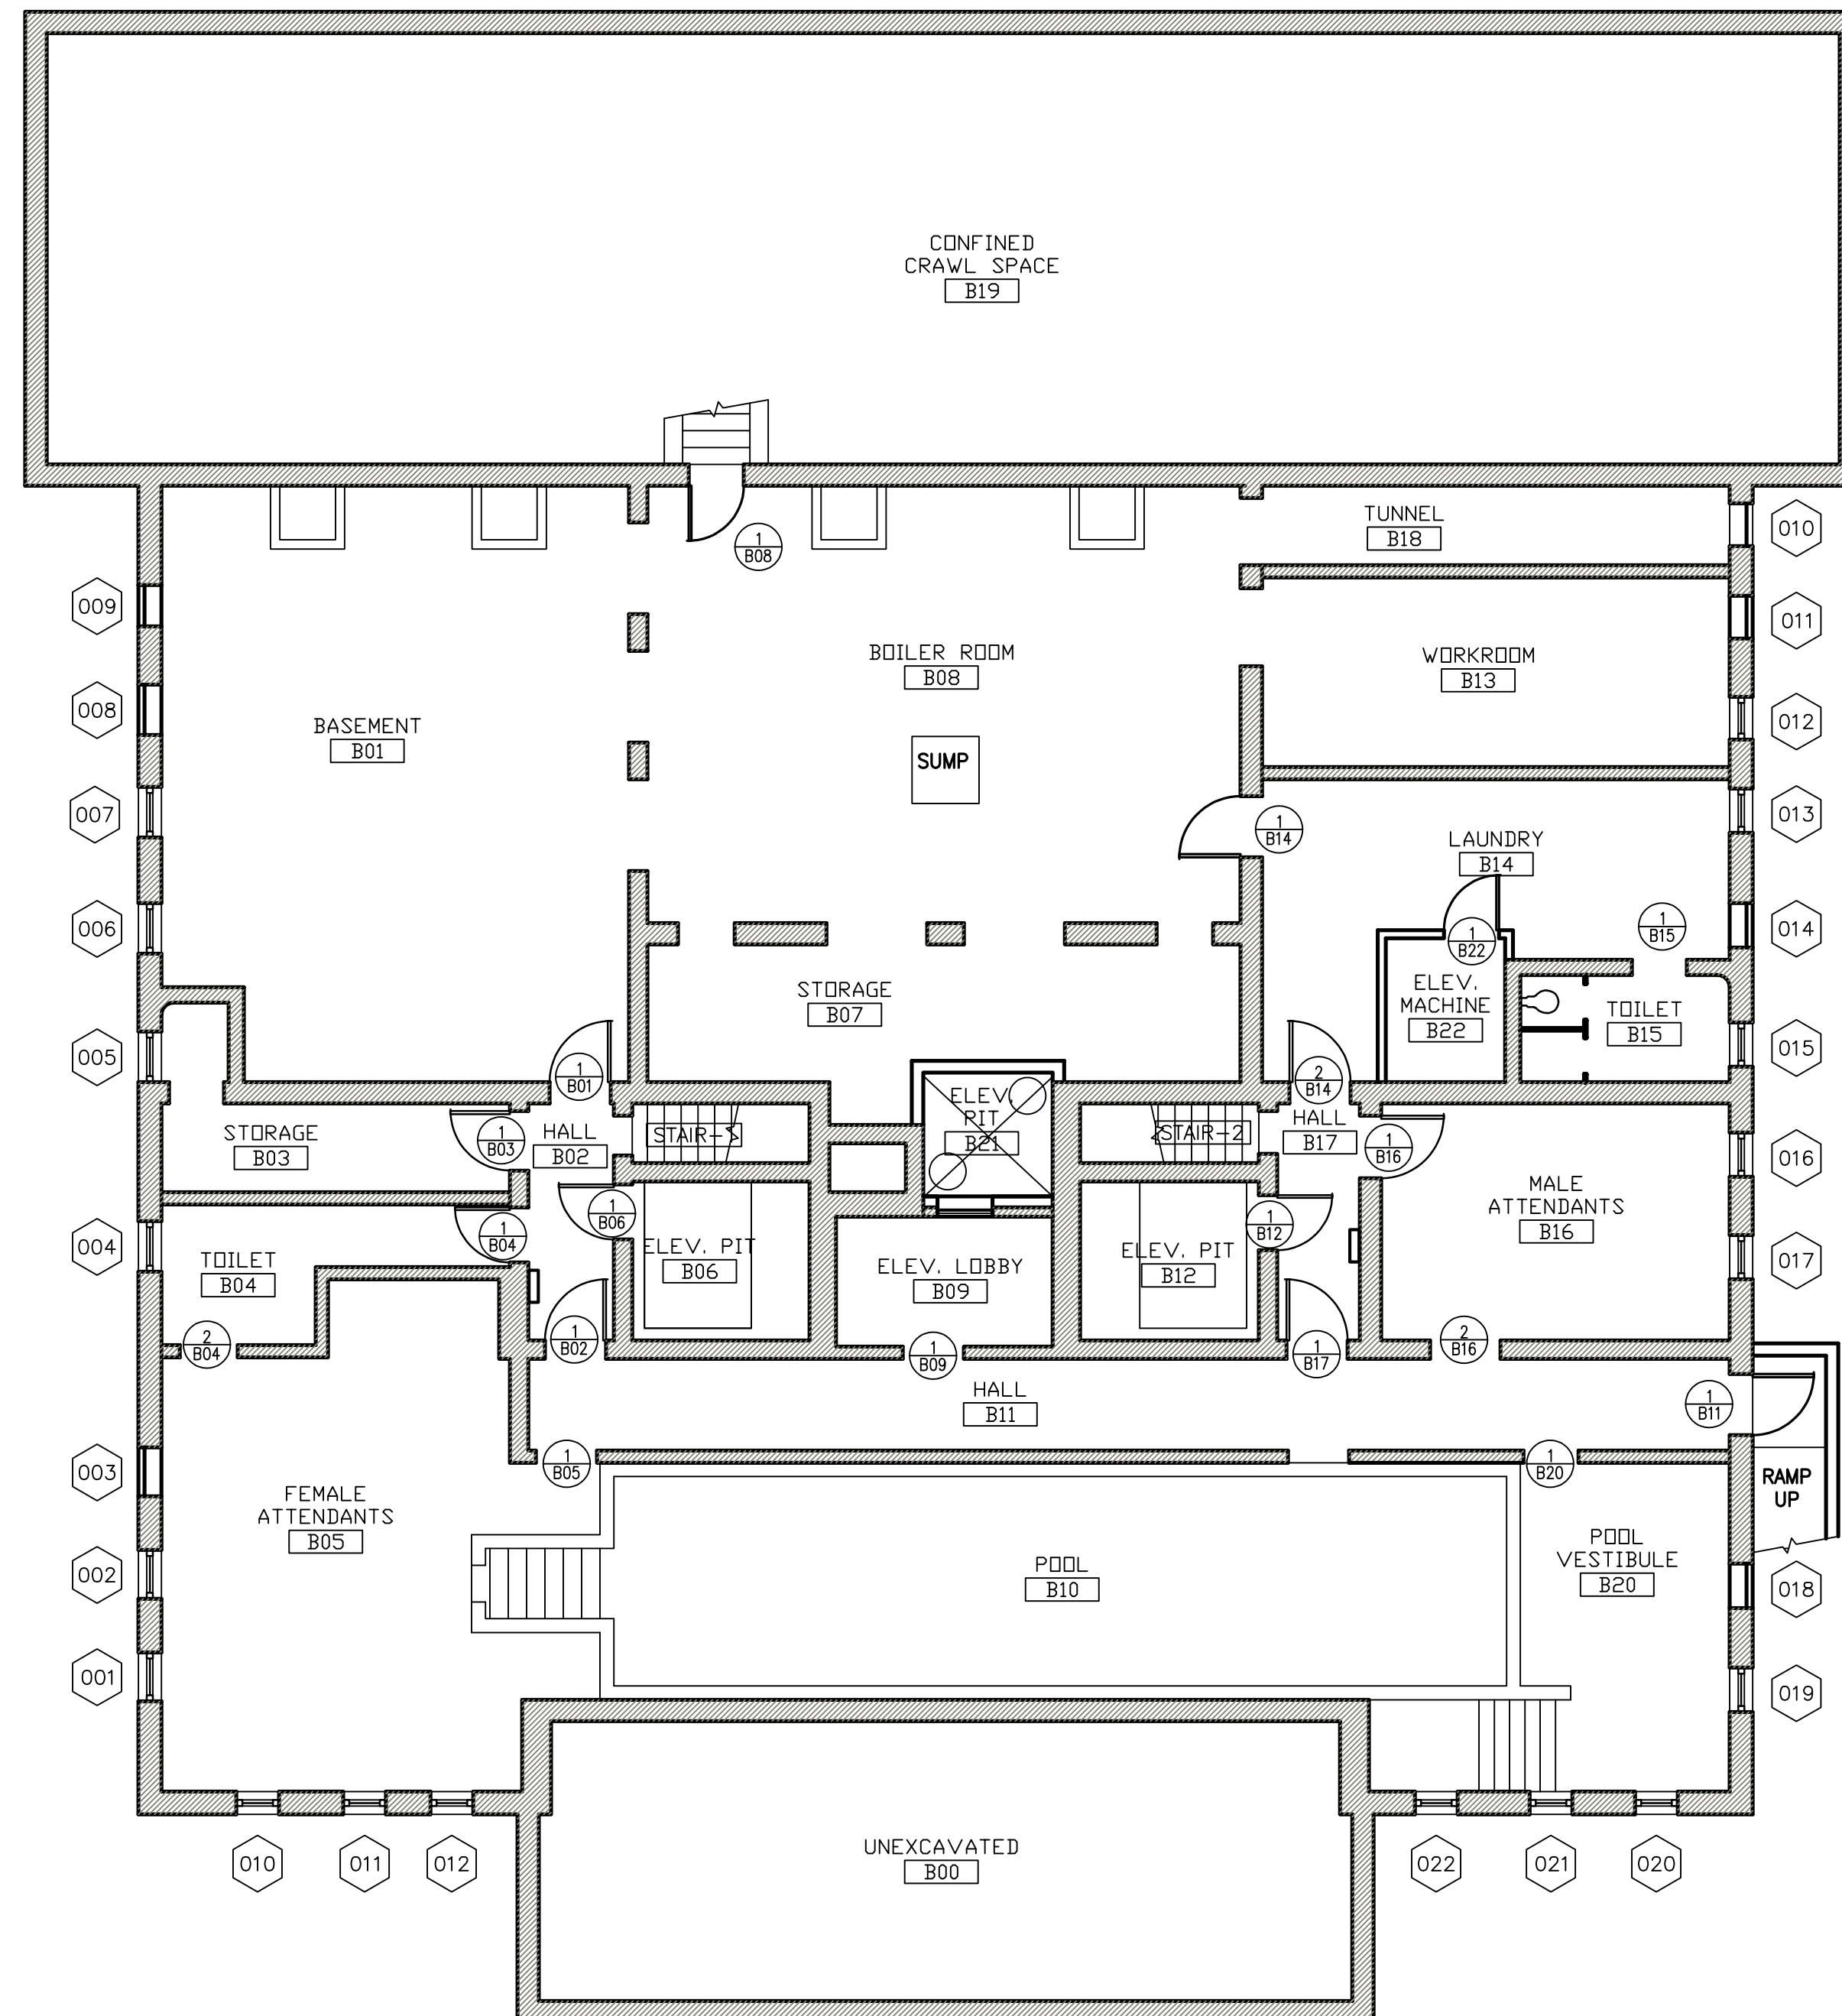
1 MAURICE EXISTING BASEMENT FLOOR PLAN
 AO 1/8" = 1'-0"

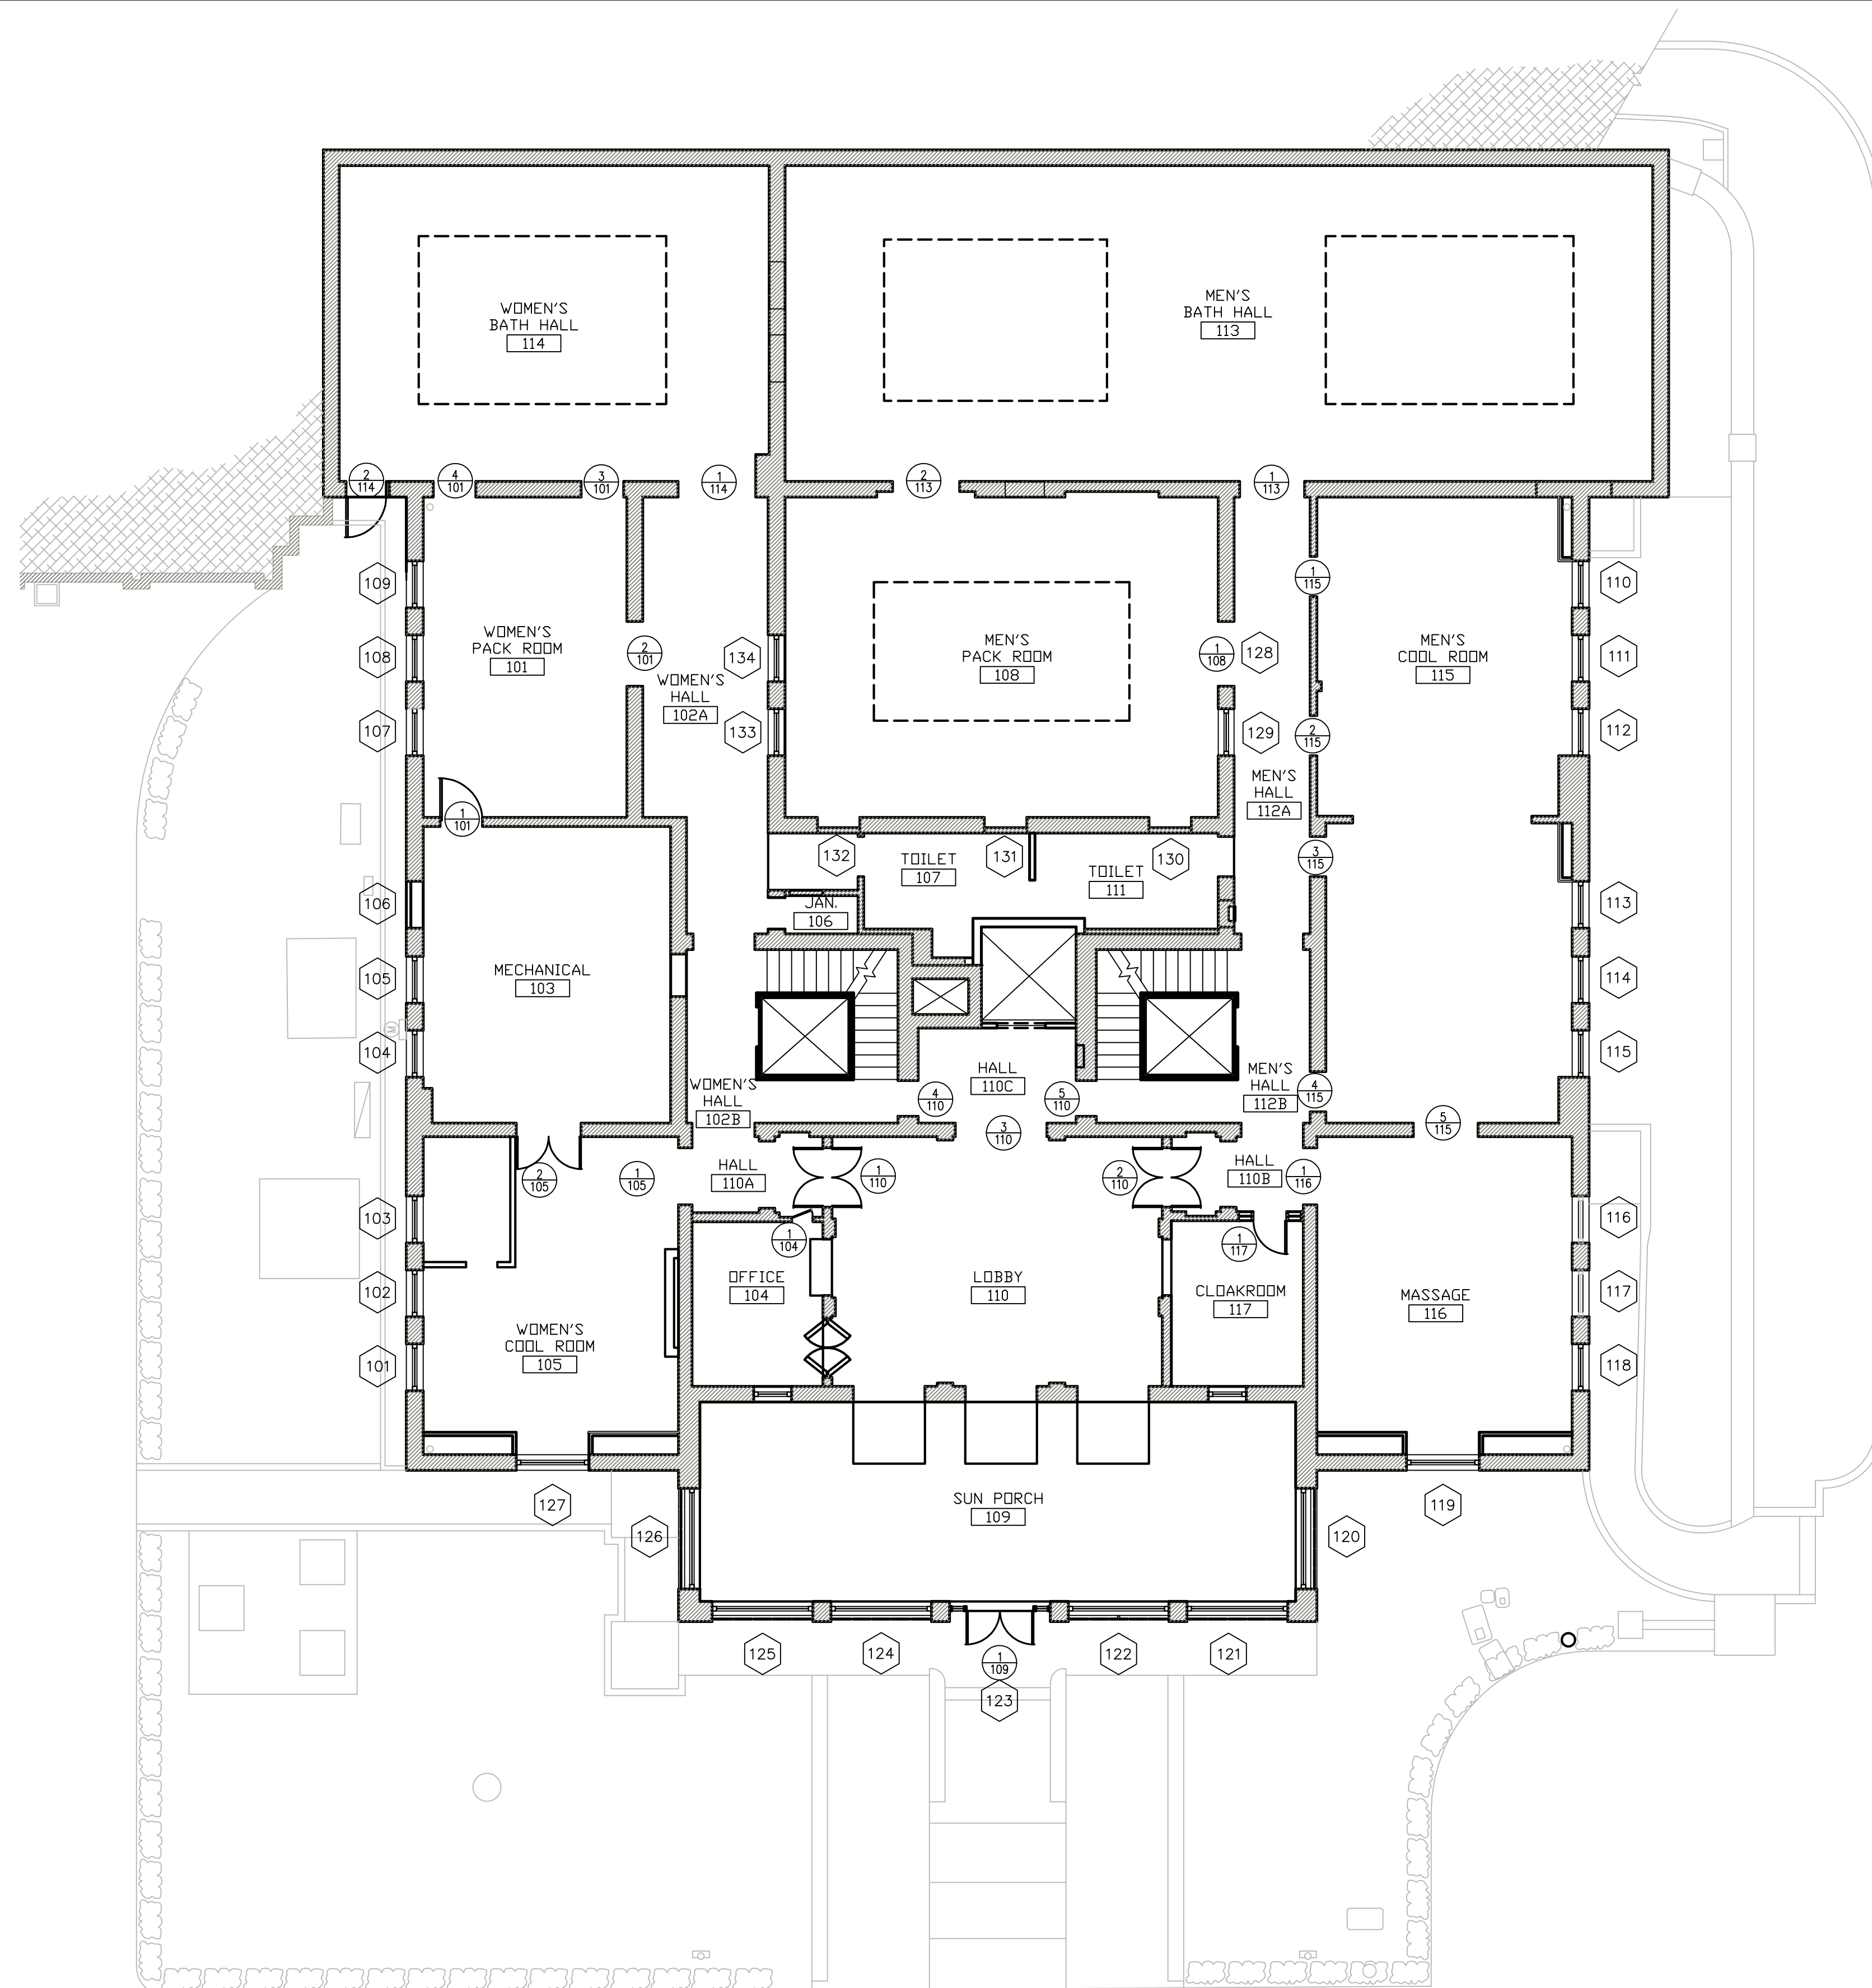
1 MAURICE EXISTING FIRST FLOOR PLAN
 A1 1/8" = 1'-0"

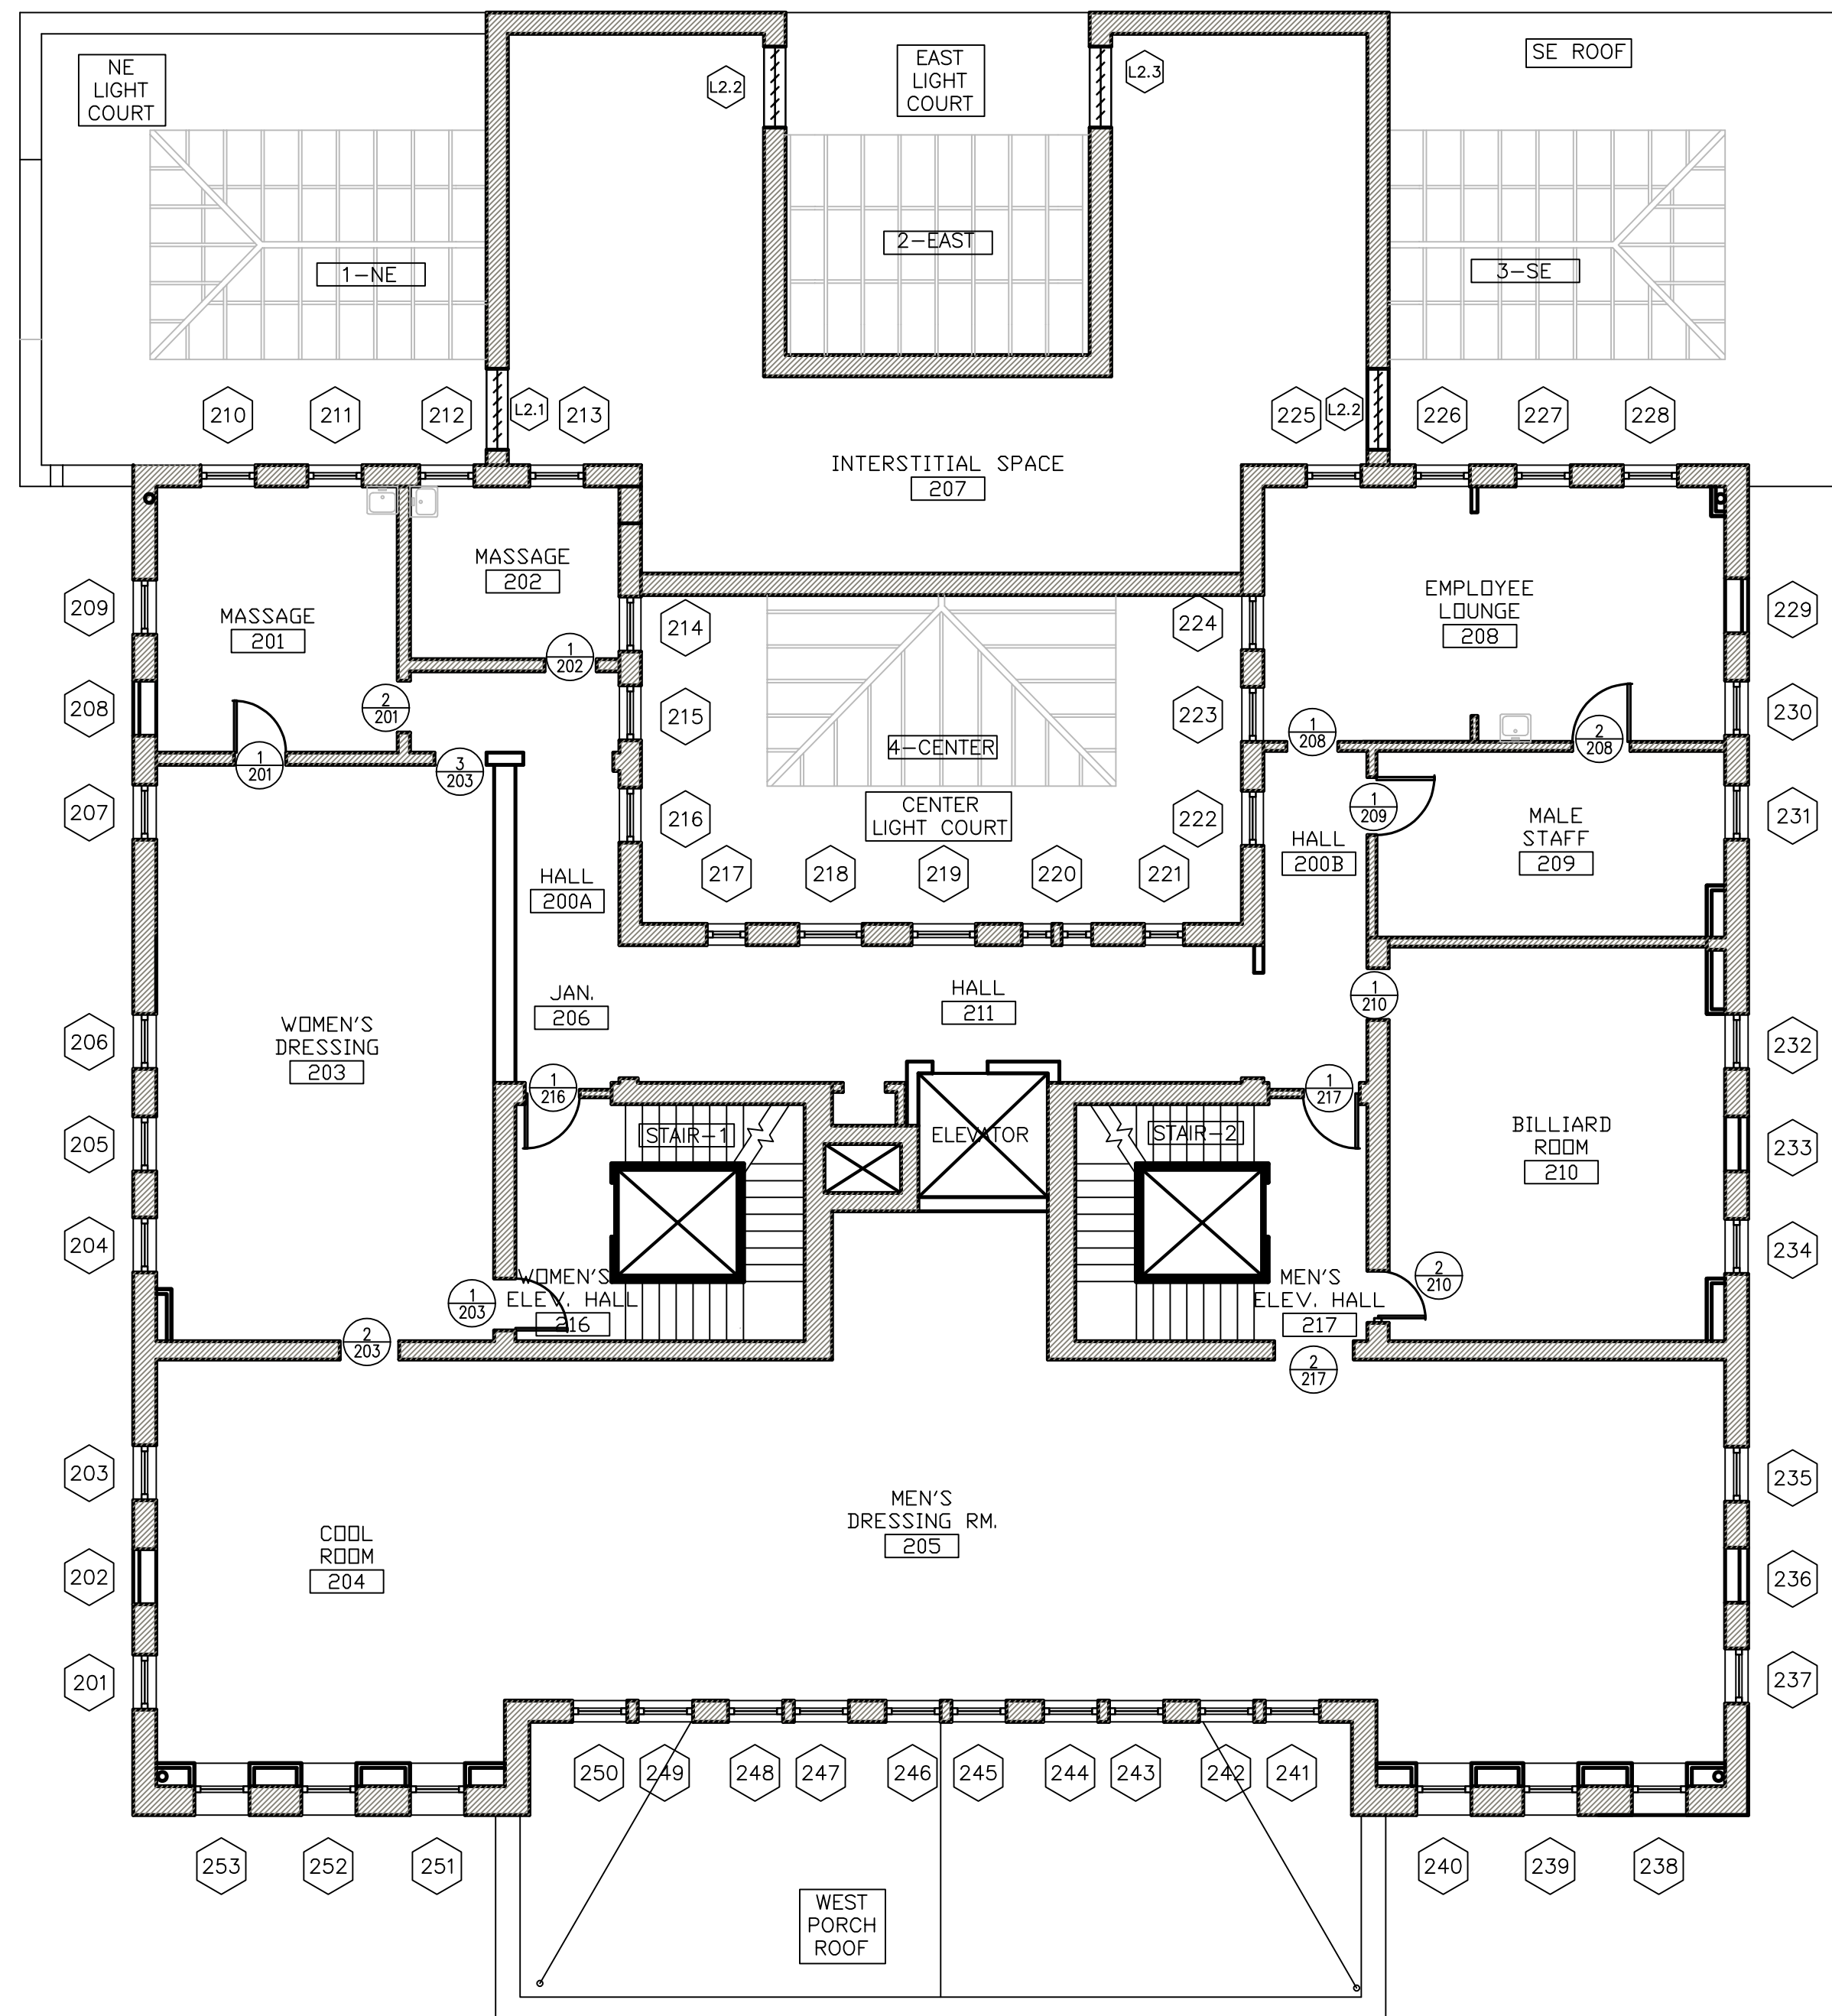
1 MAURICE EXISTING SECOND FLOOR PLAN
 A2 1/8" = 1'-0"

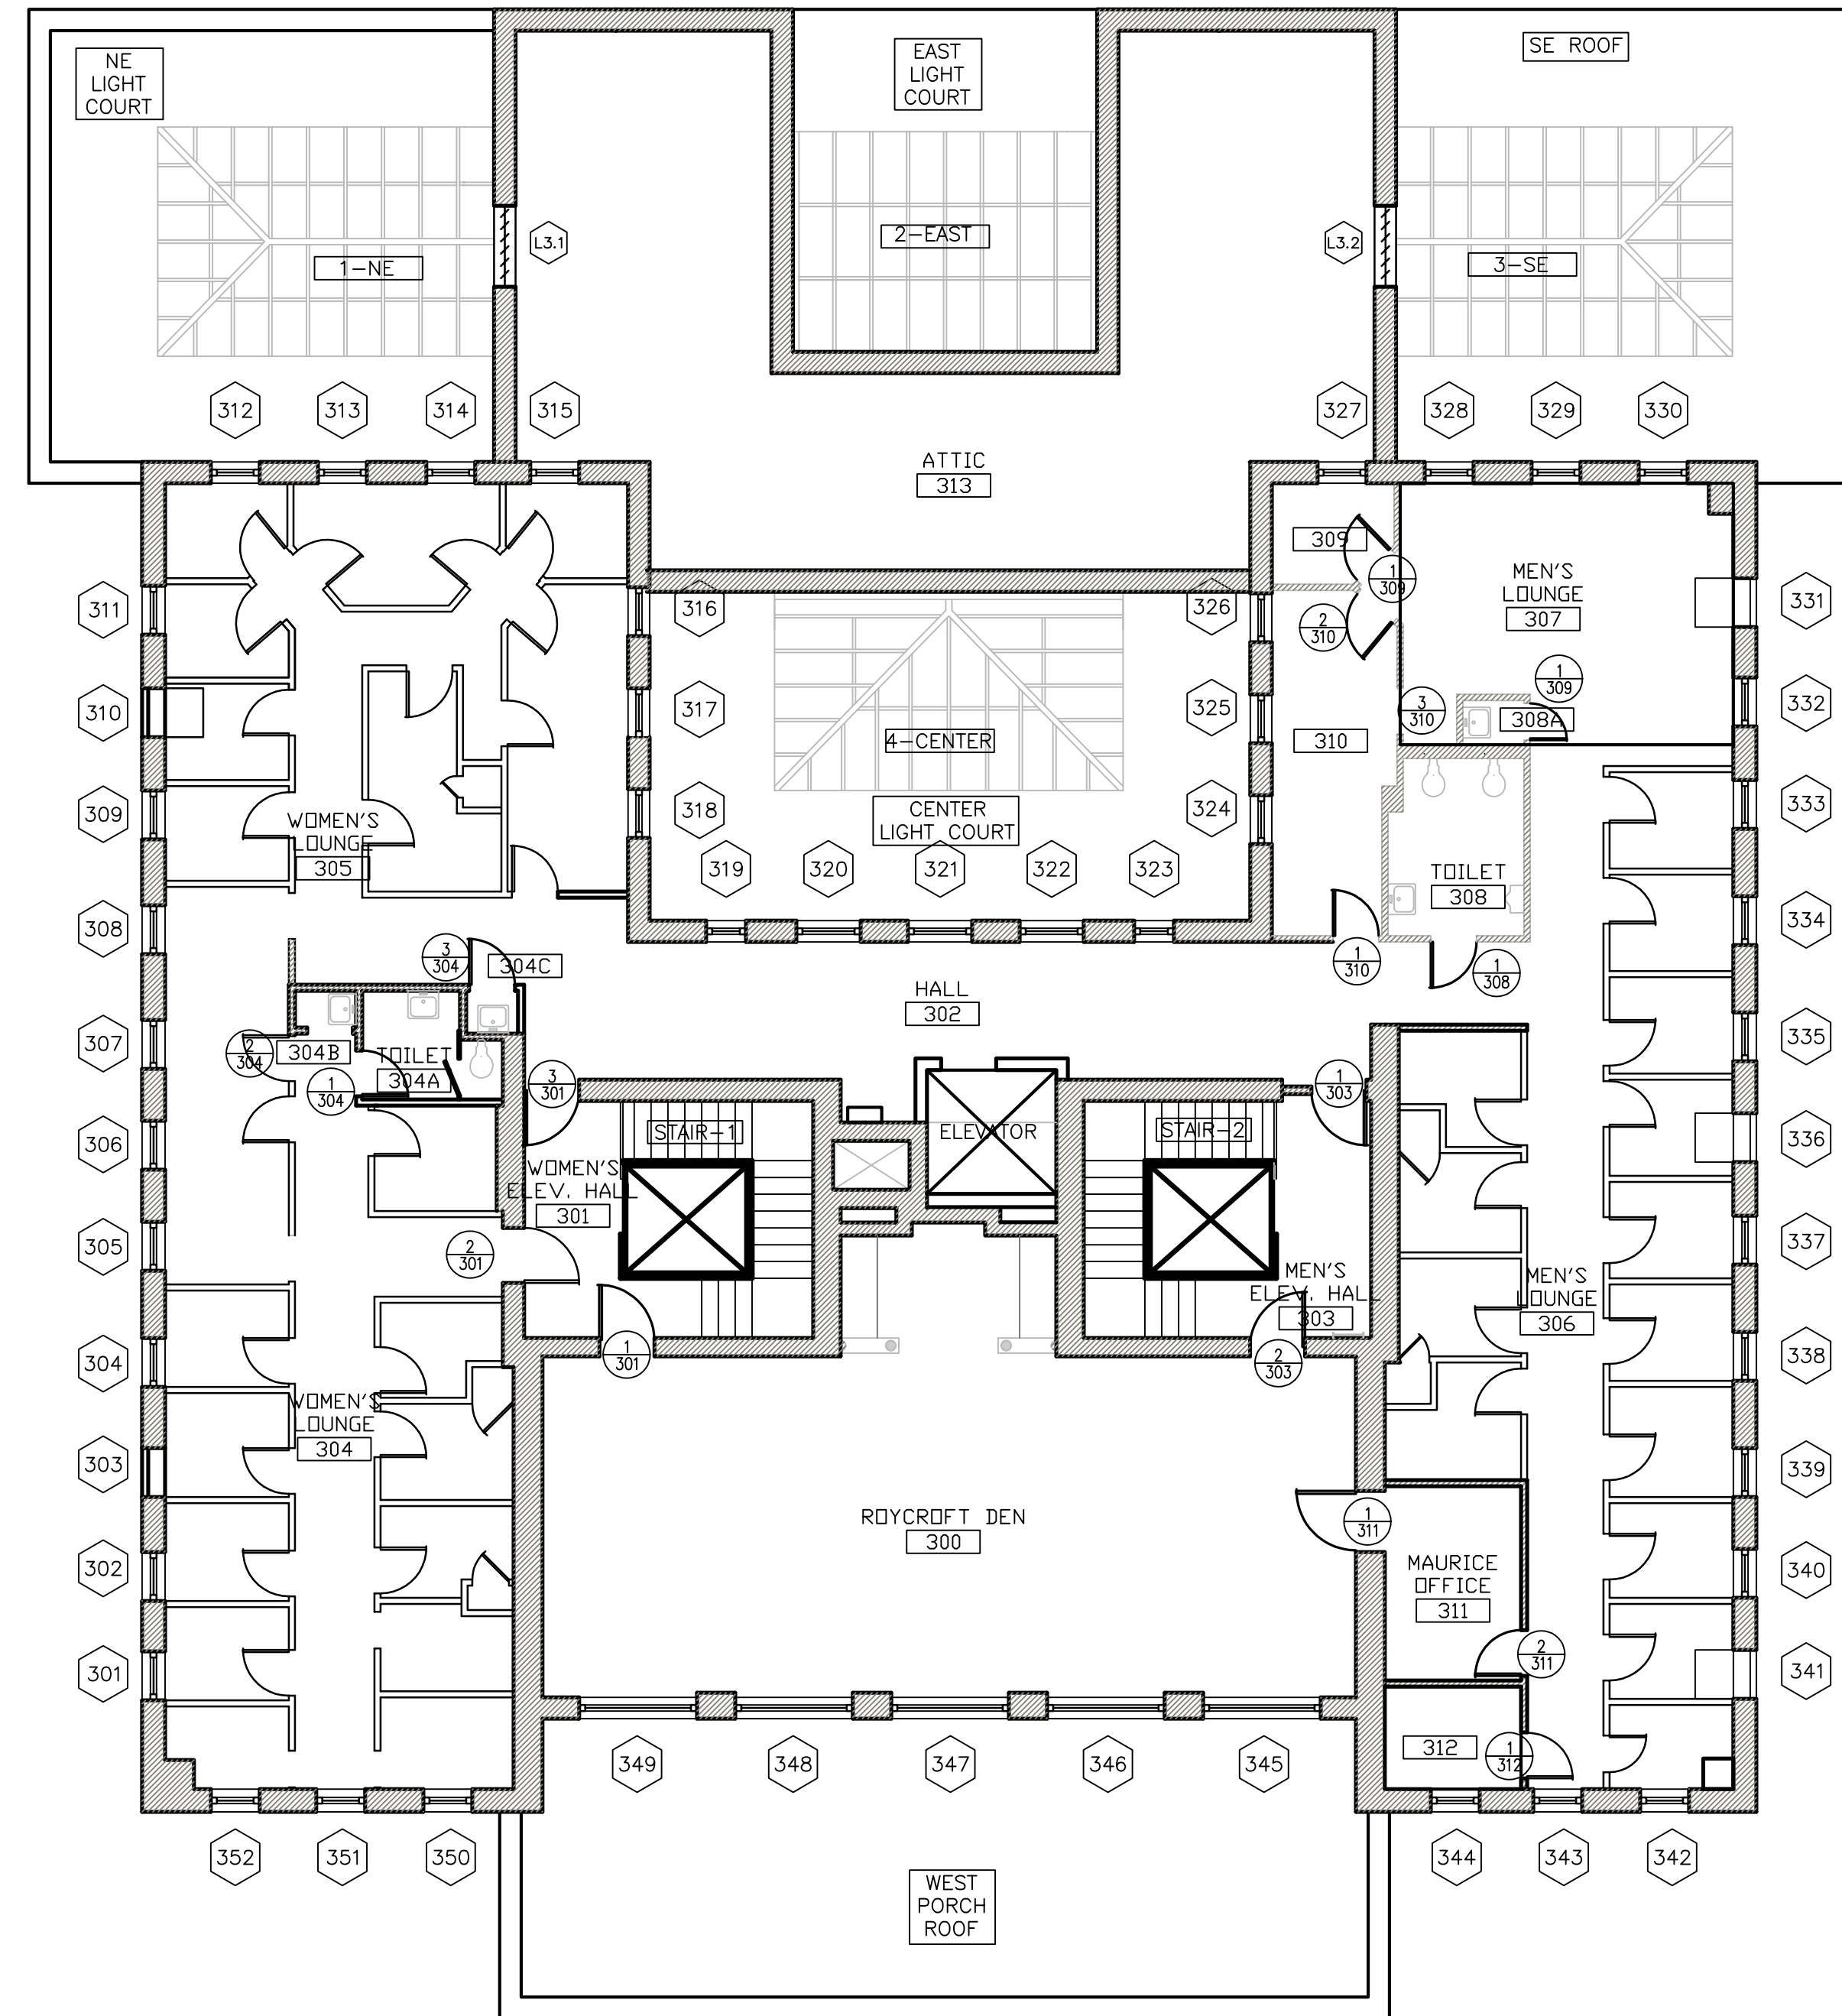
1 MAURICE_EXISTING THIRD FLOOR PLAN
 A3 1/8" = 1'-0"

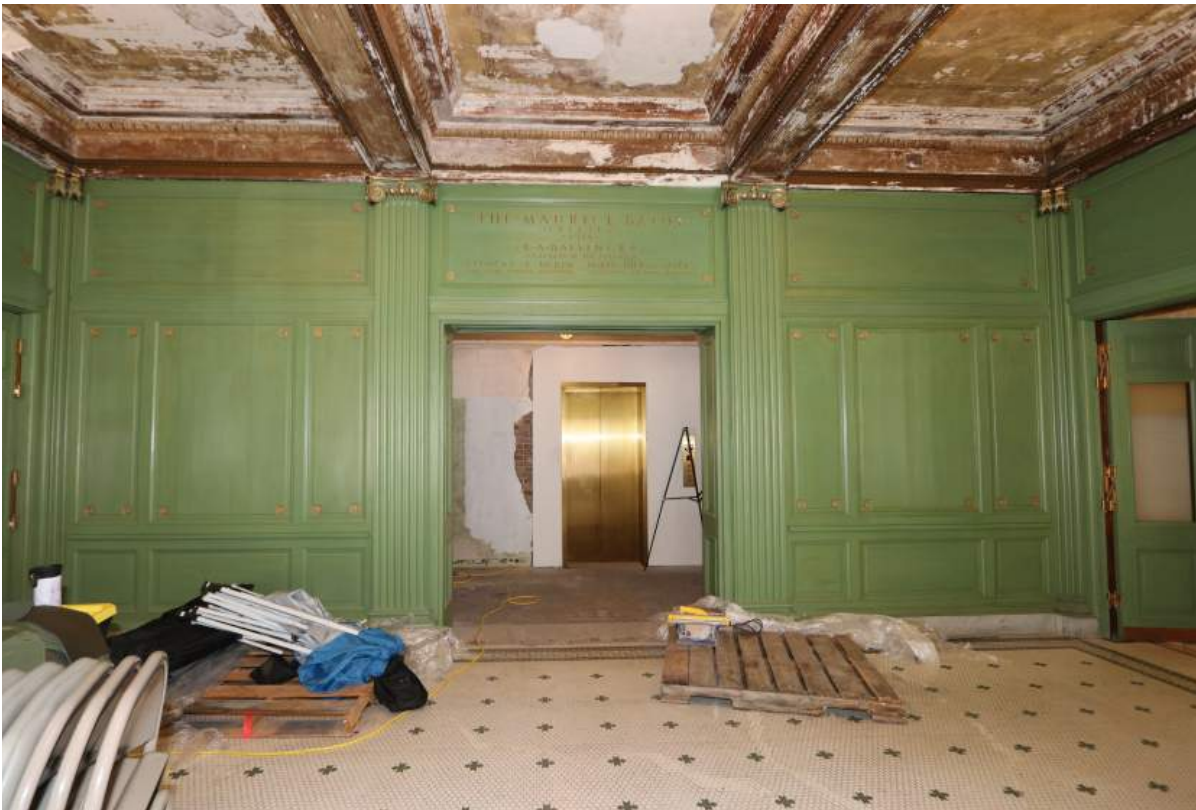
Maurice Bathhouse, Sun Porch Tile Detail (STRATA, 2022)

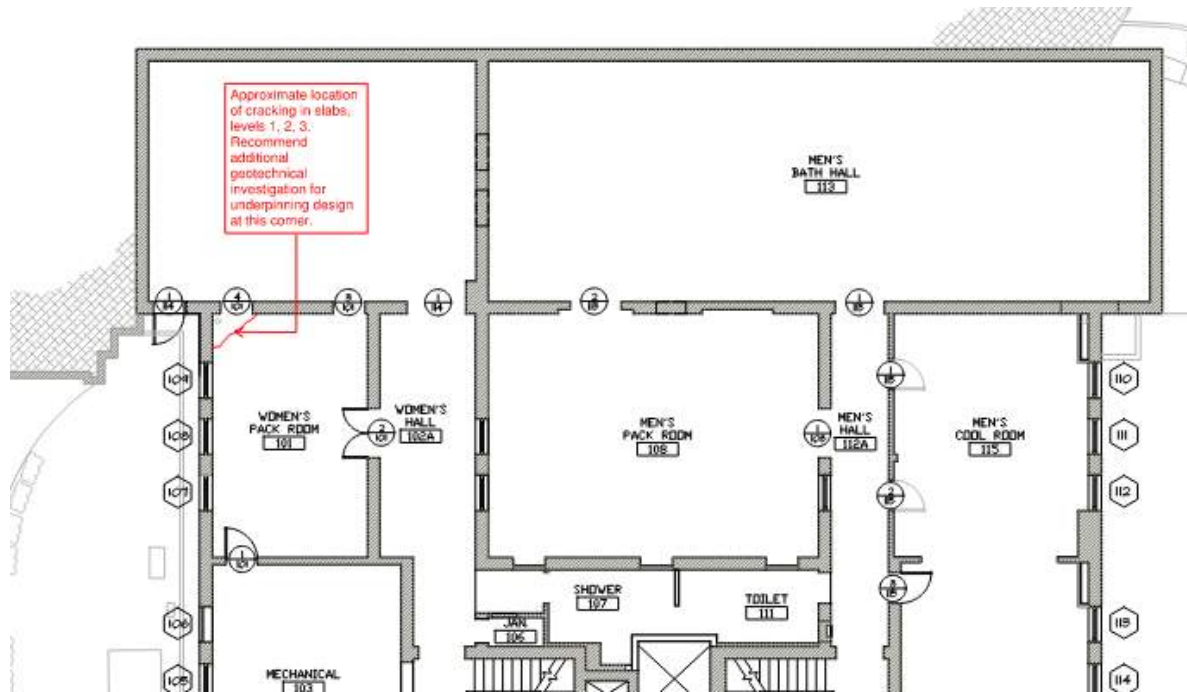
Figure 3.1. Structural crack in northeast corner of Maurice.

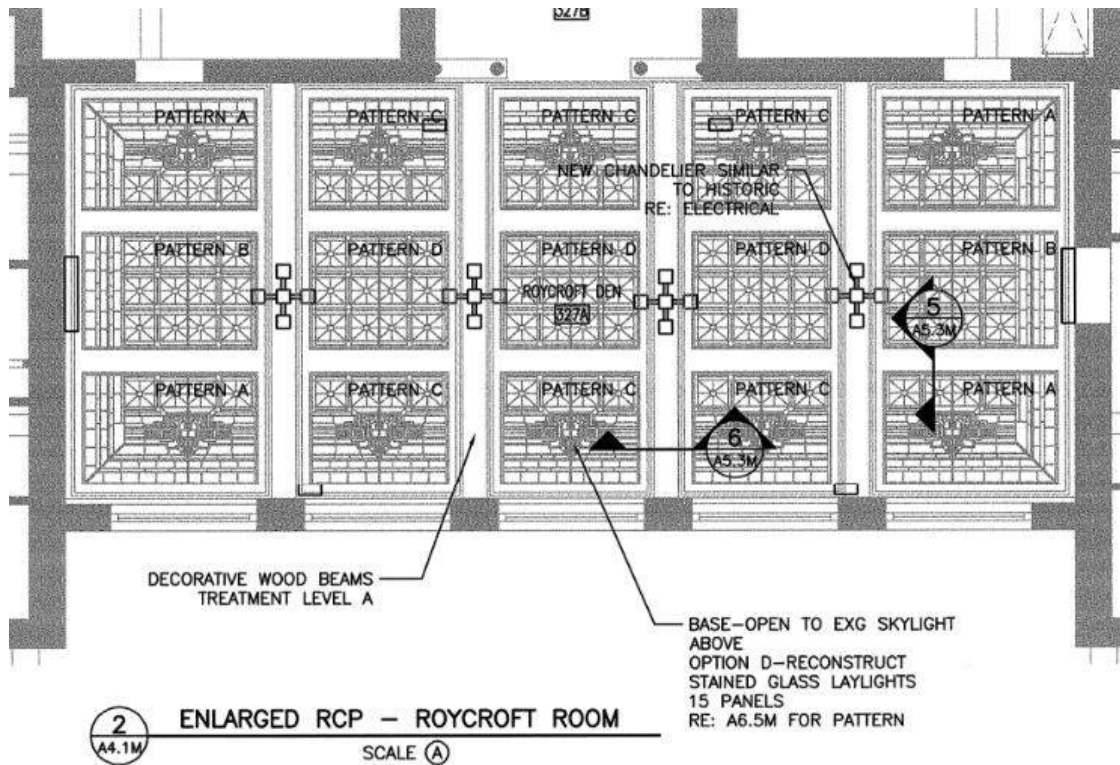
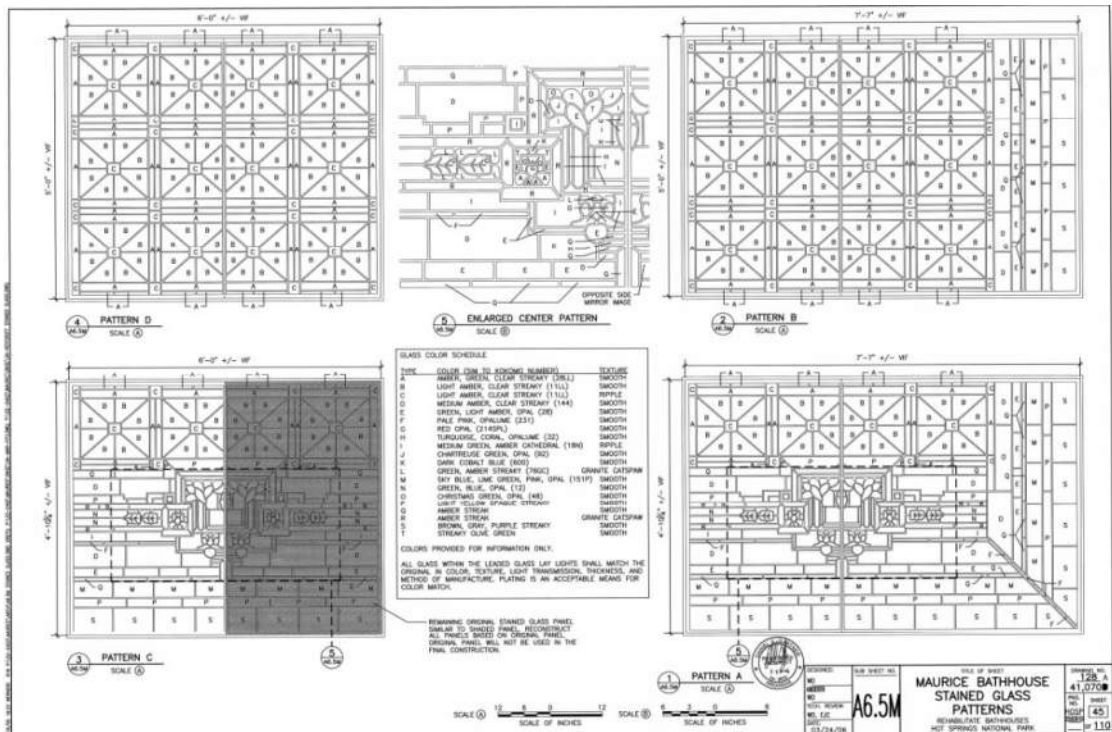
Figure 3.2. Drawings from National Park Service Project 128-41070_A, 2004.

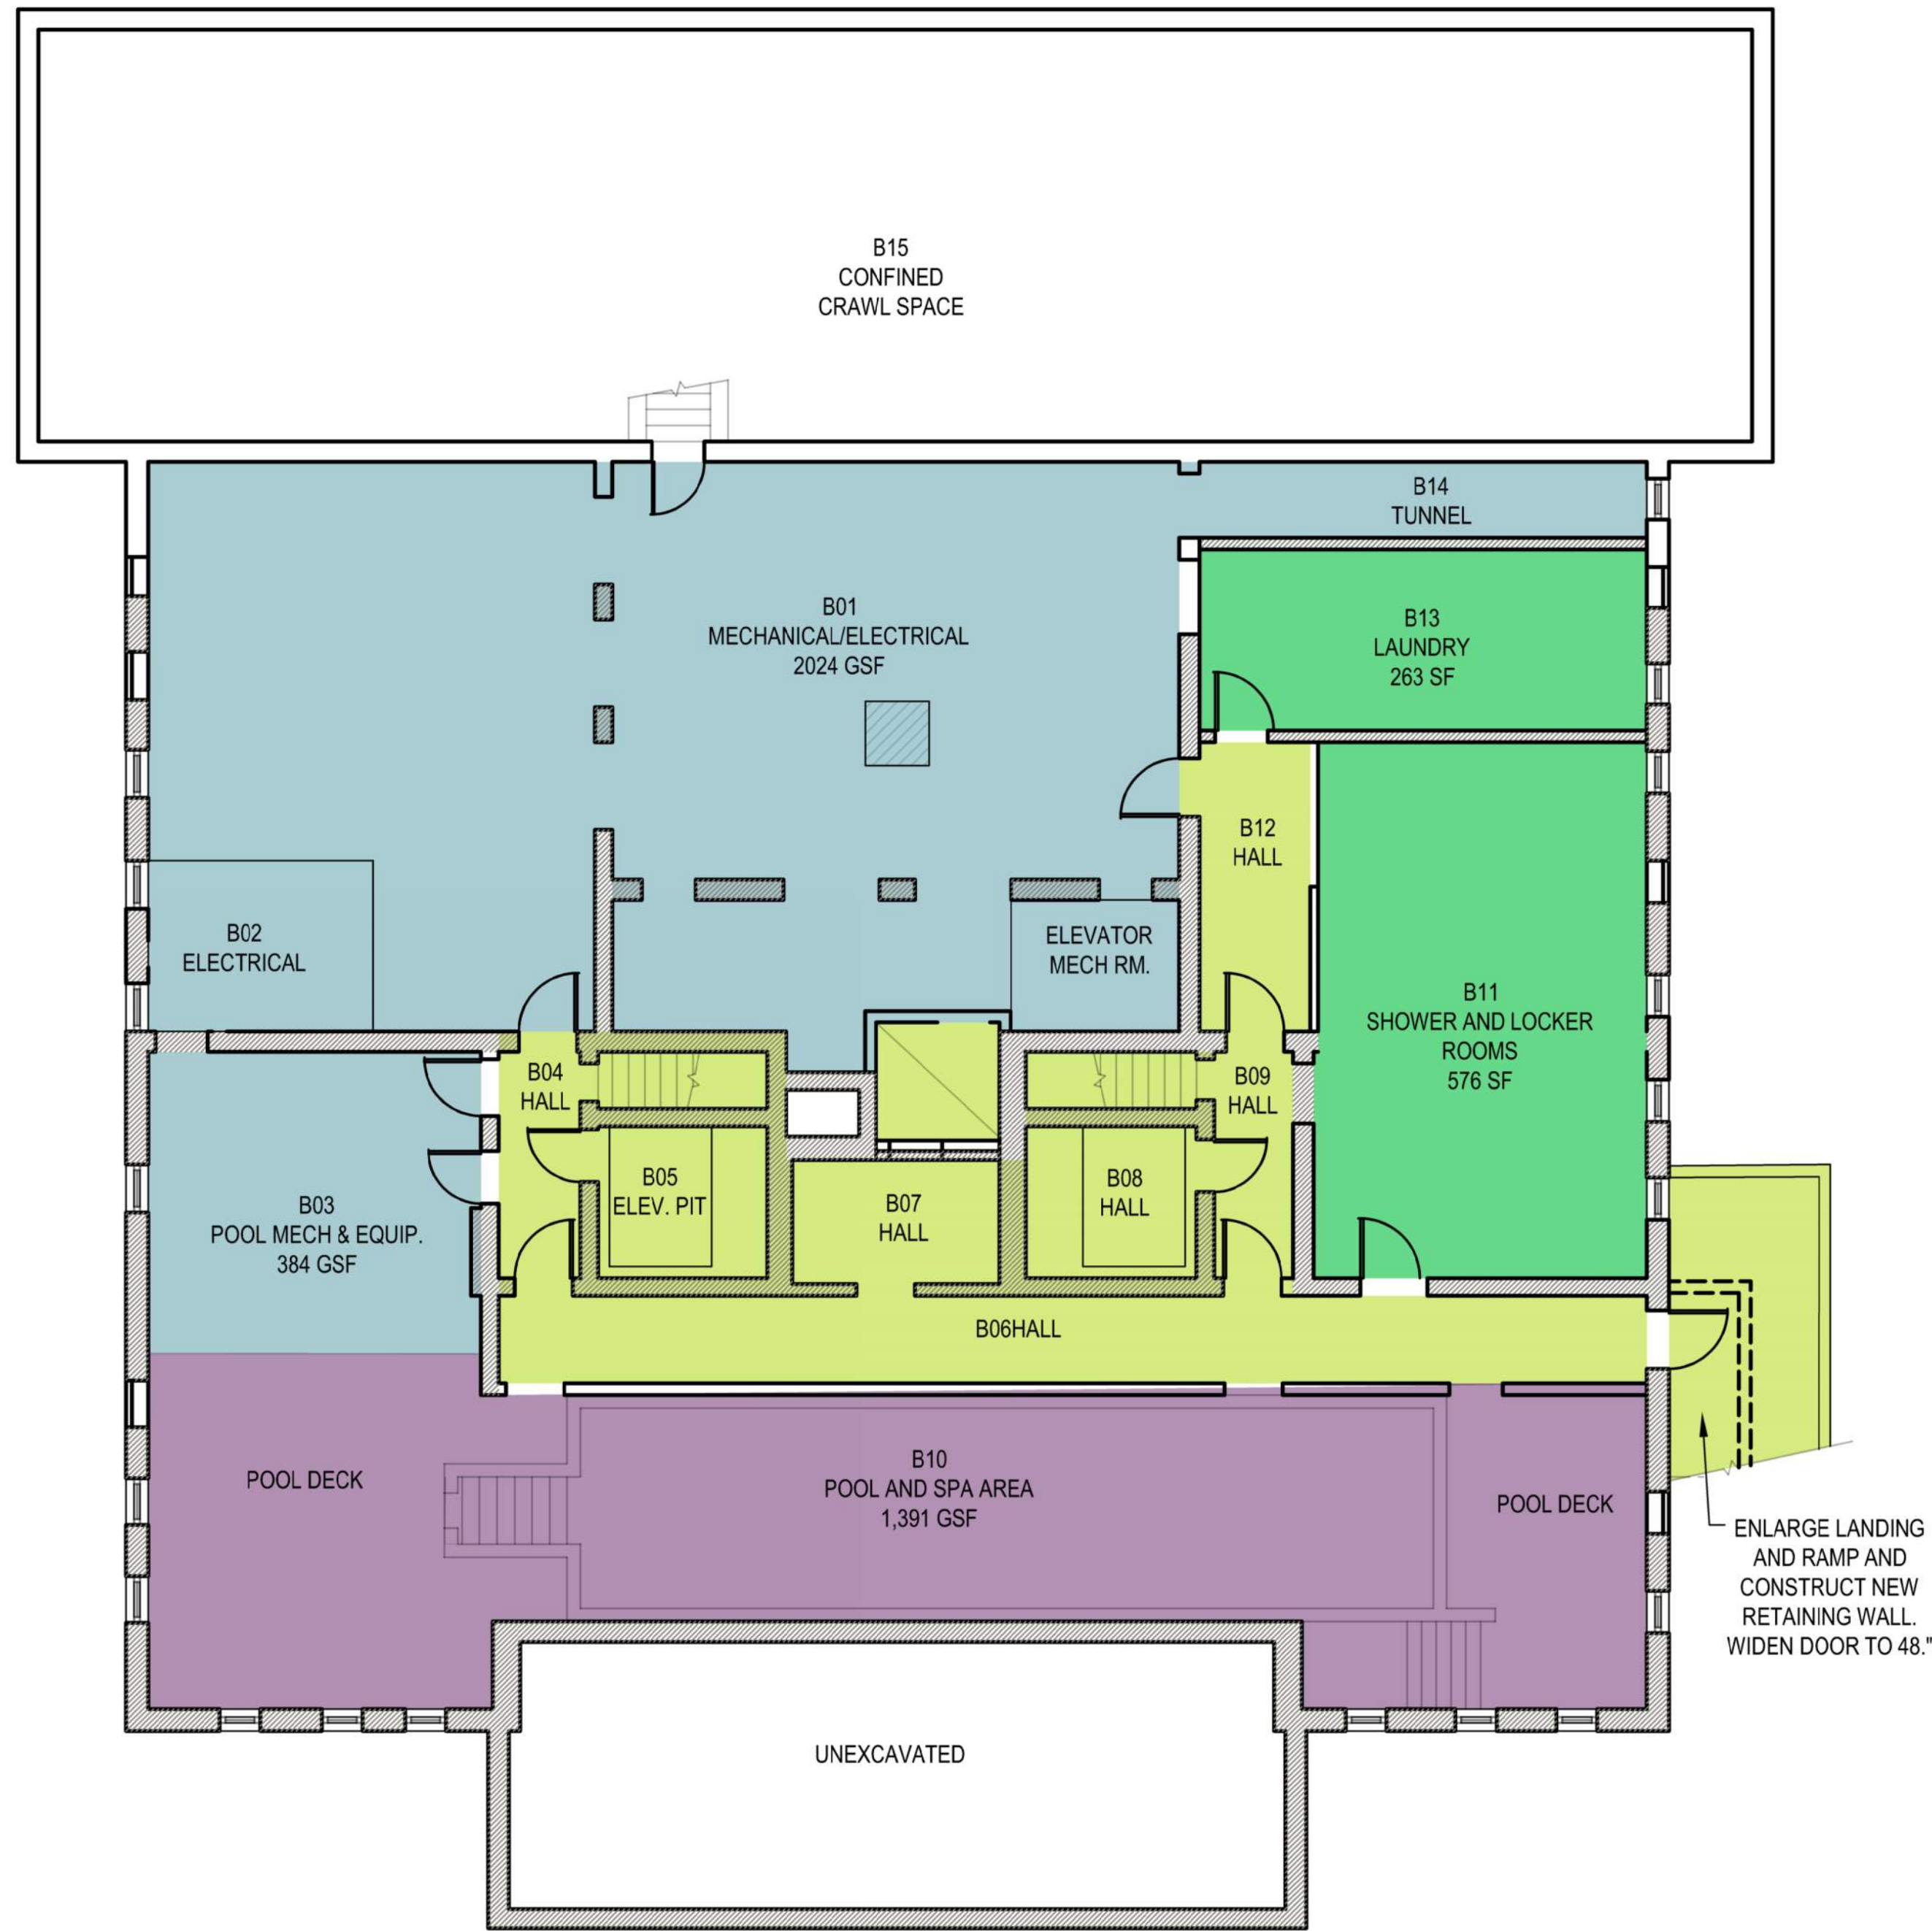
1 SPA AND CAFE -- BASEMENT FLOOR PLAN
A5 1/8" = 1'-0"
