Condition Assessment and Treatment Plan for Maurice Bathhouse

PRE-DESIGN SERVICES

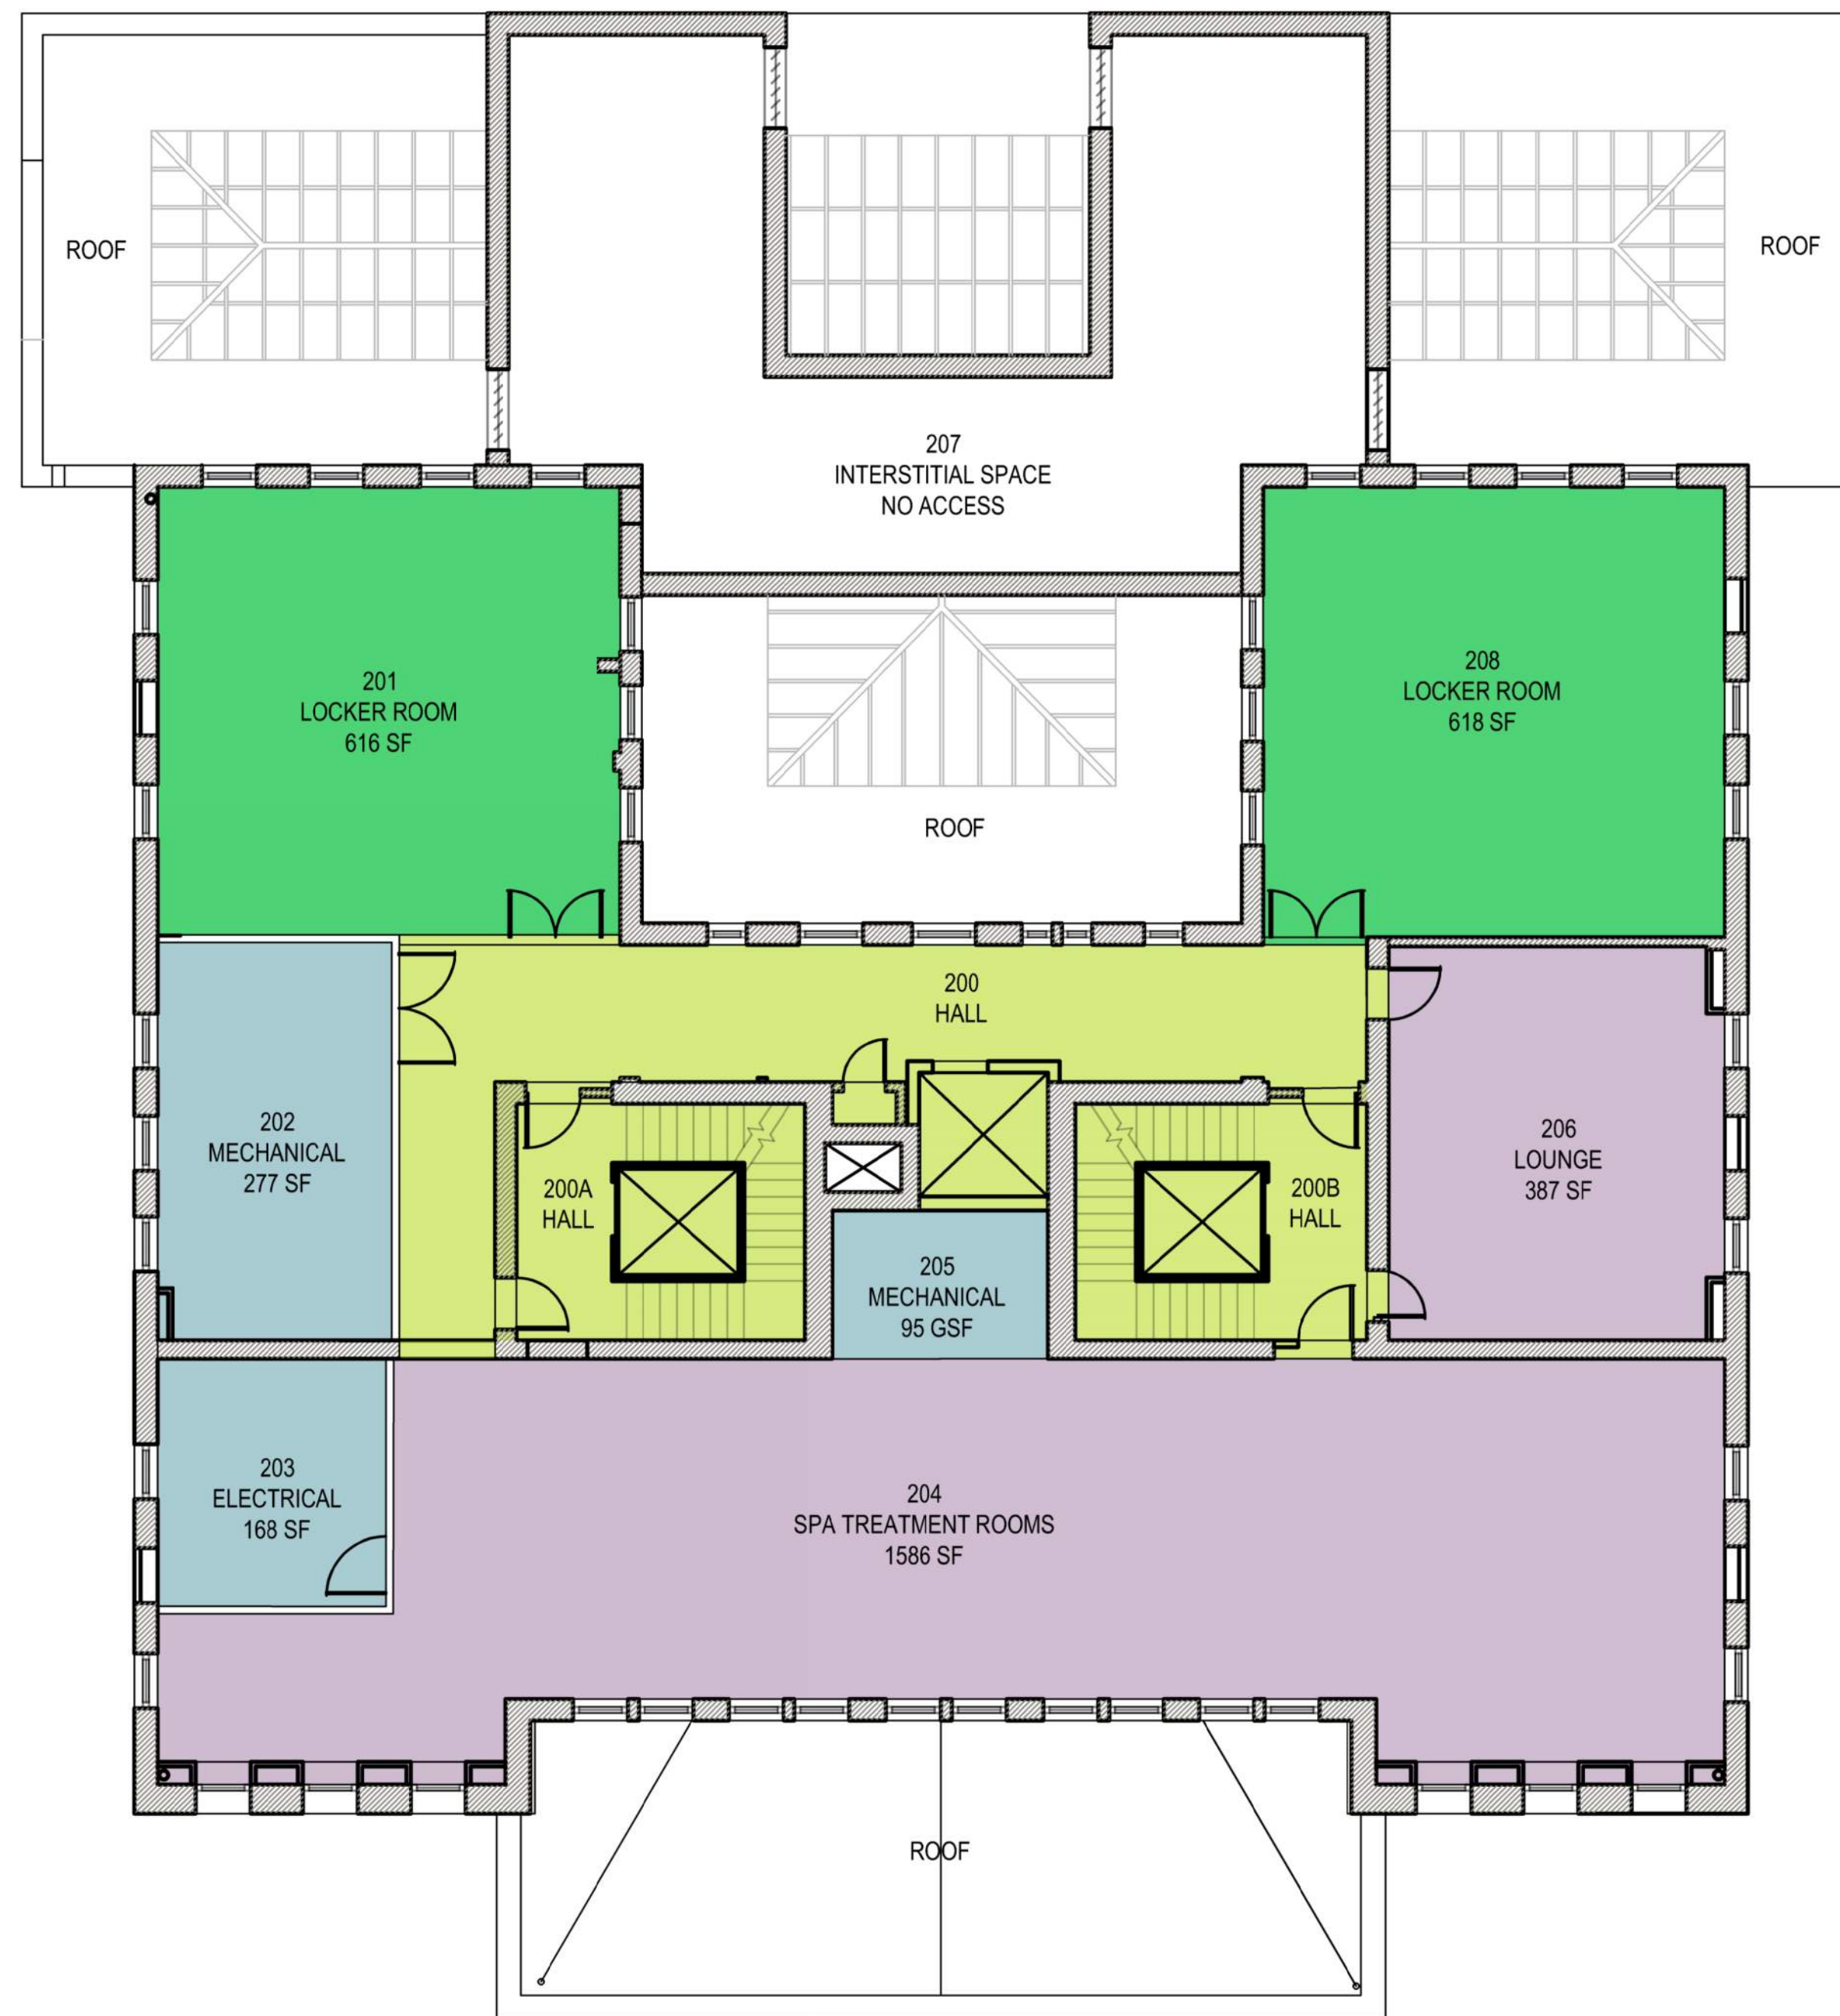
1 SPA AND CAFE - SECOND FLOOR PLAN
 A6 1/8" = 1'-0"

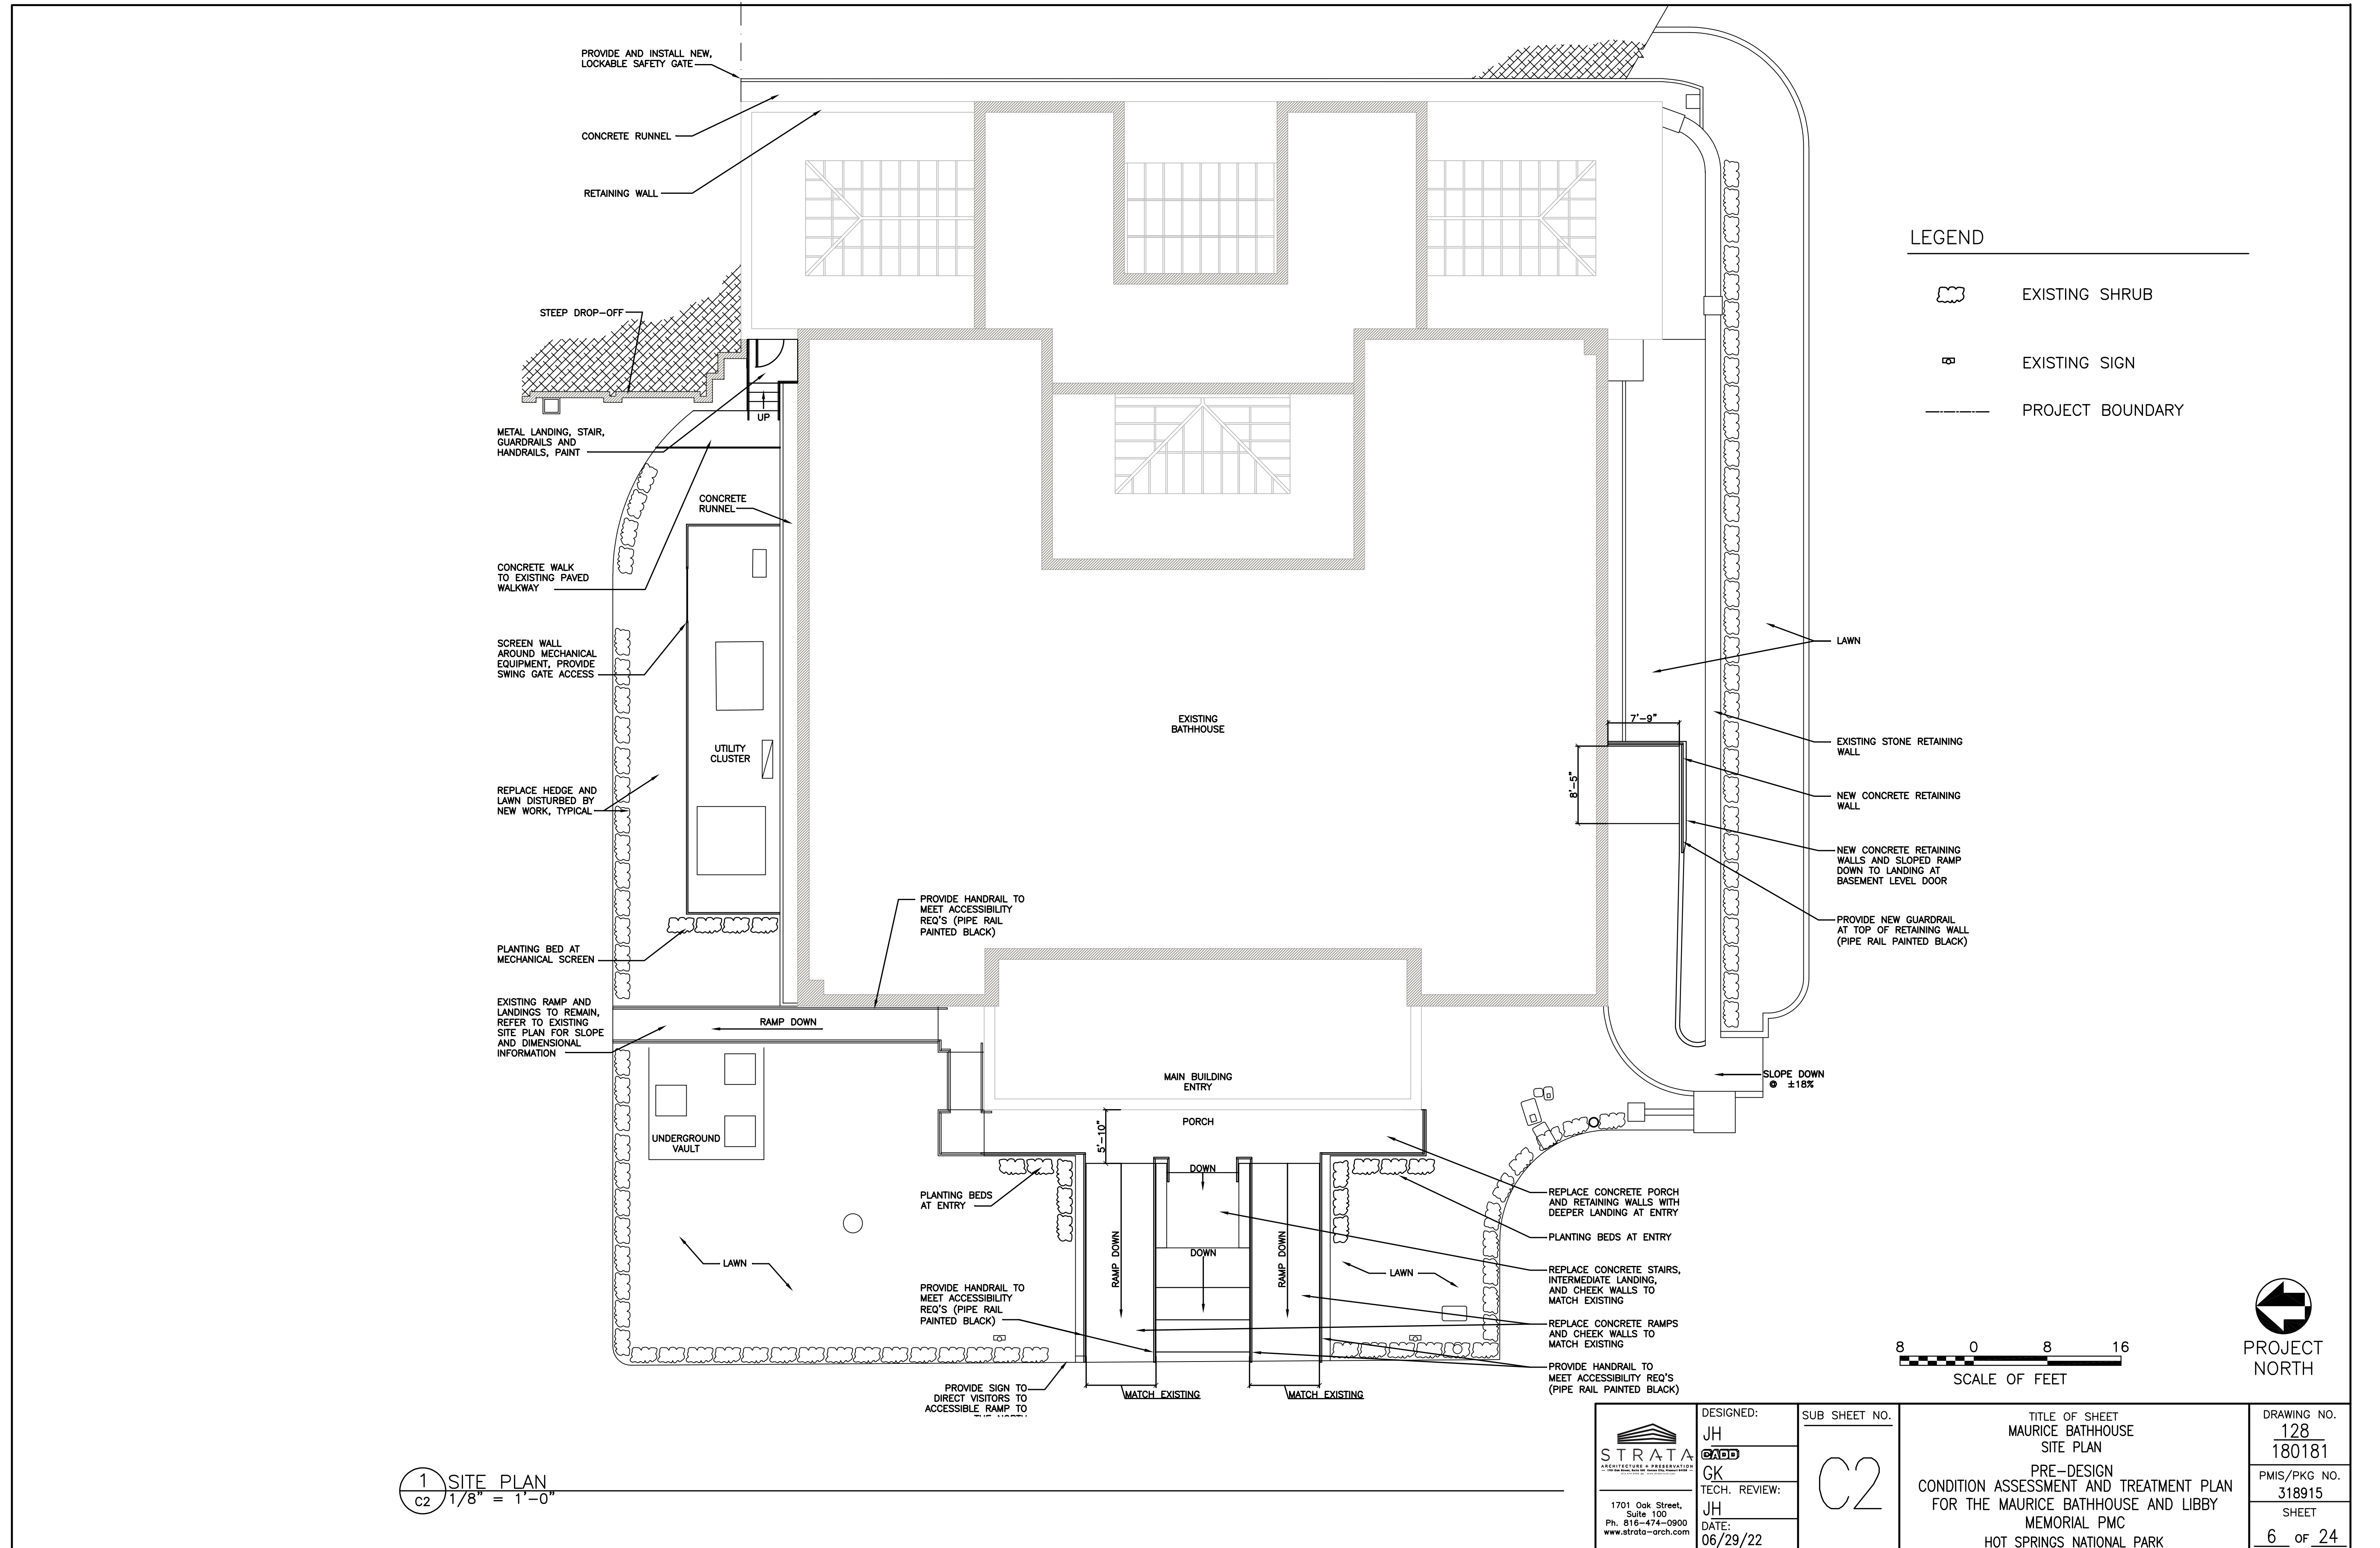
1701 Oak Street, Suite 100 Ph. 816-474-0900 www.strata-arch.com	DESIGNED: CA	SUB SHEET NO. A6	TITLE OF SHEET SPA AND CAFE- MAURICE BATHHOUSE THIRD FLOOR PLAN PRE-DESIGN CONDITION ASSESSMENT AND TREATMENT PLAN FOR THE MAURICE BATHHOUSE AND LIBBEY MEMORIAL PMC HOT SPRINGS NATIONAL PARK	DRAWING NO. 128 180181
	TECH. REVIEW: AG			DATE: 06/29/22

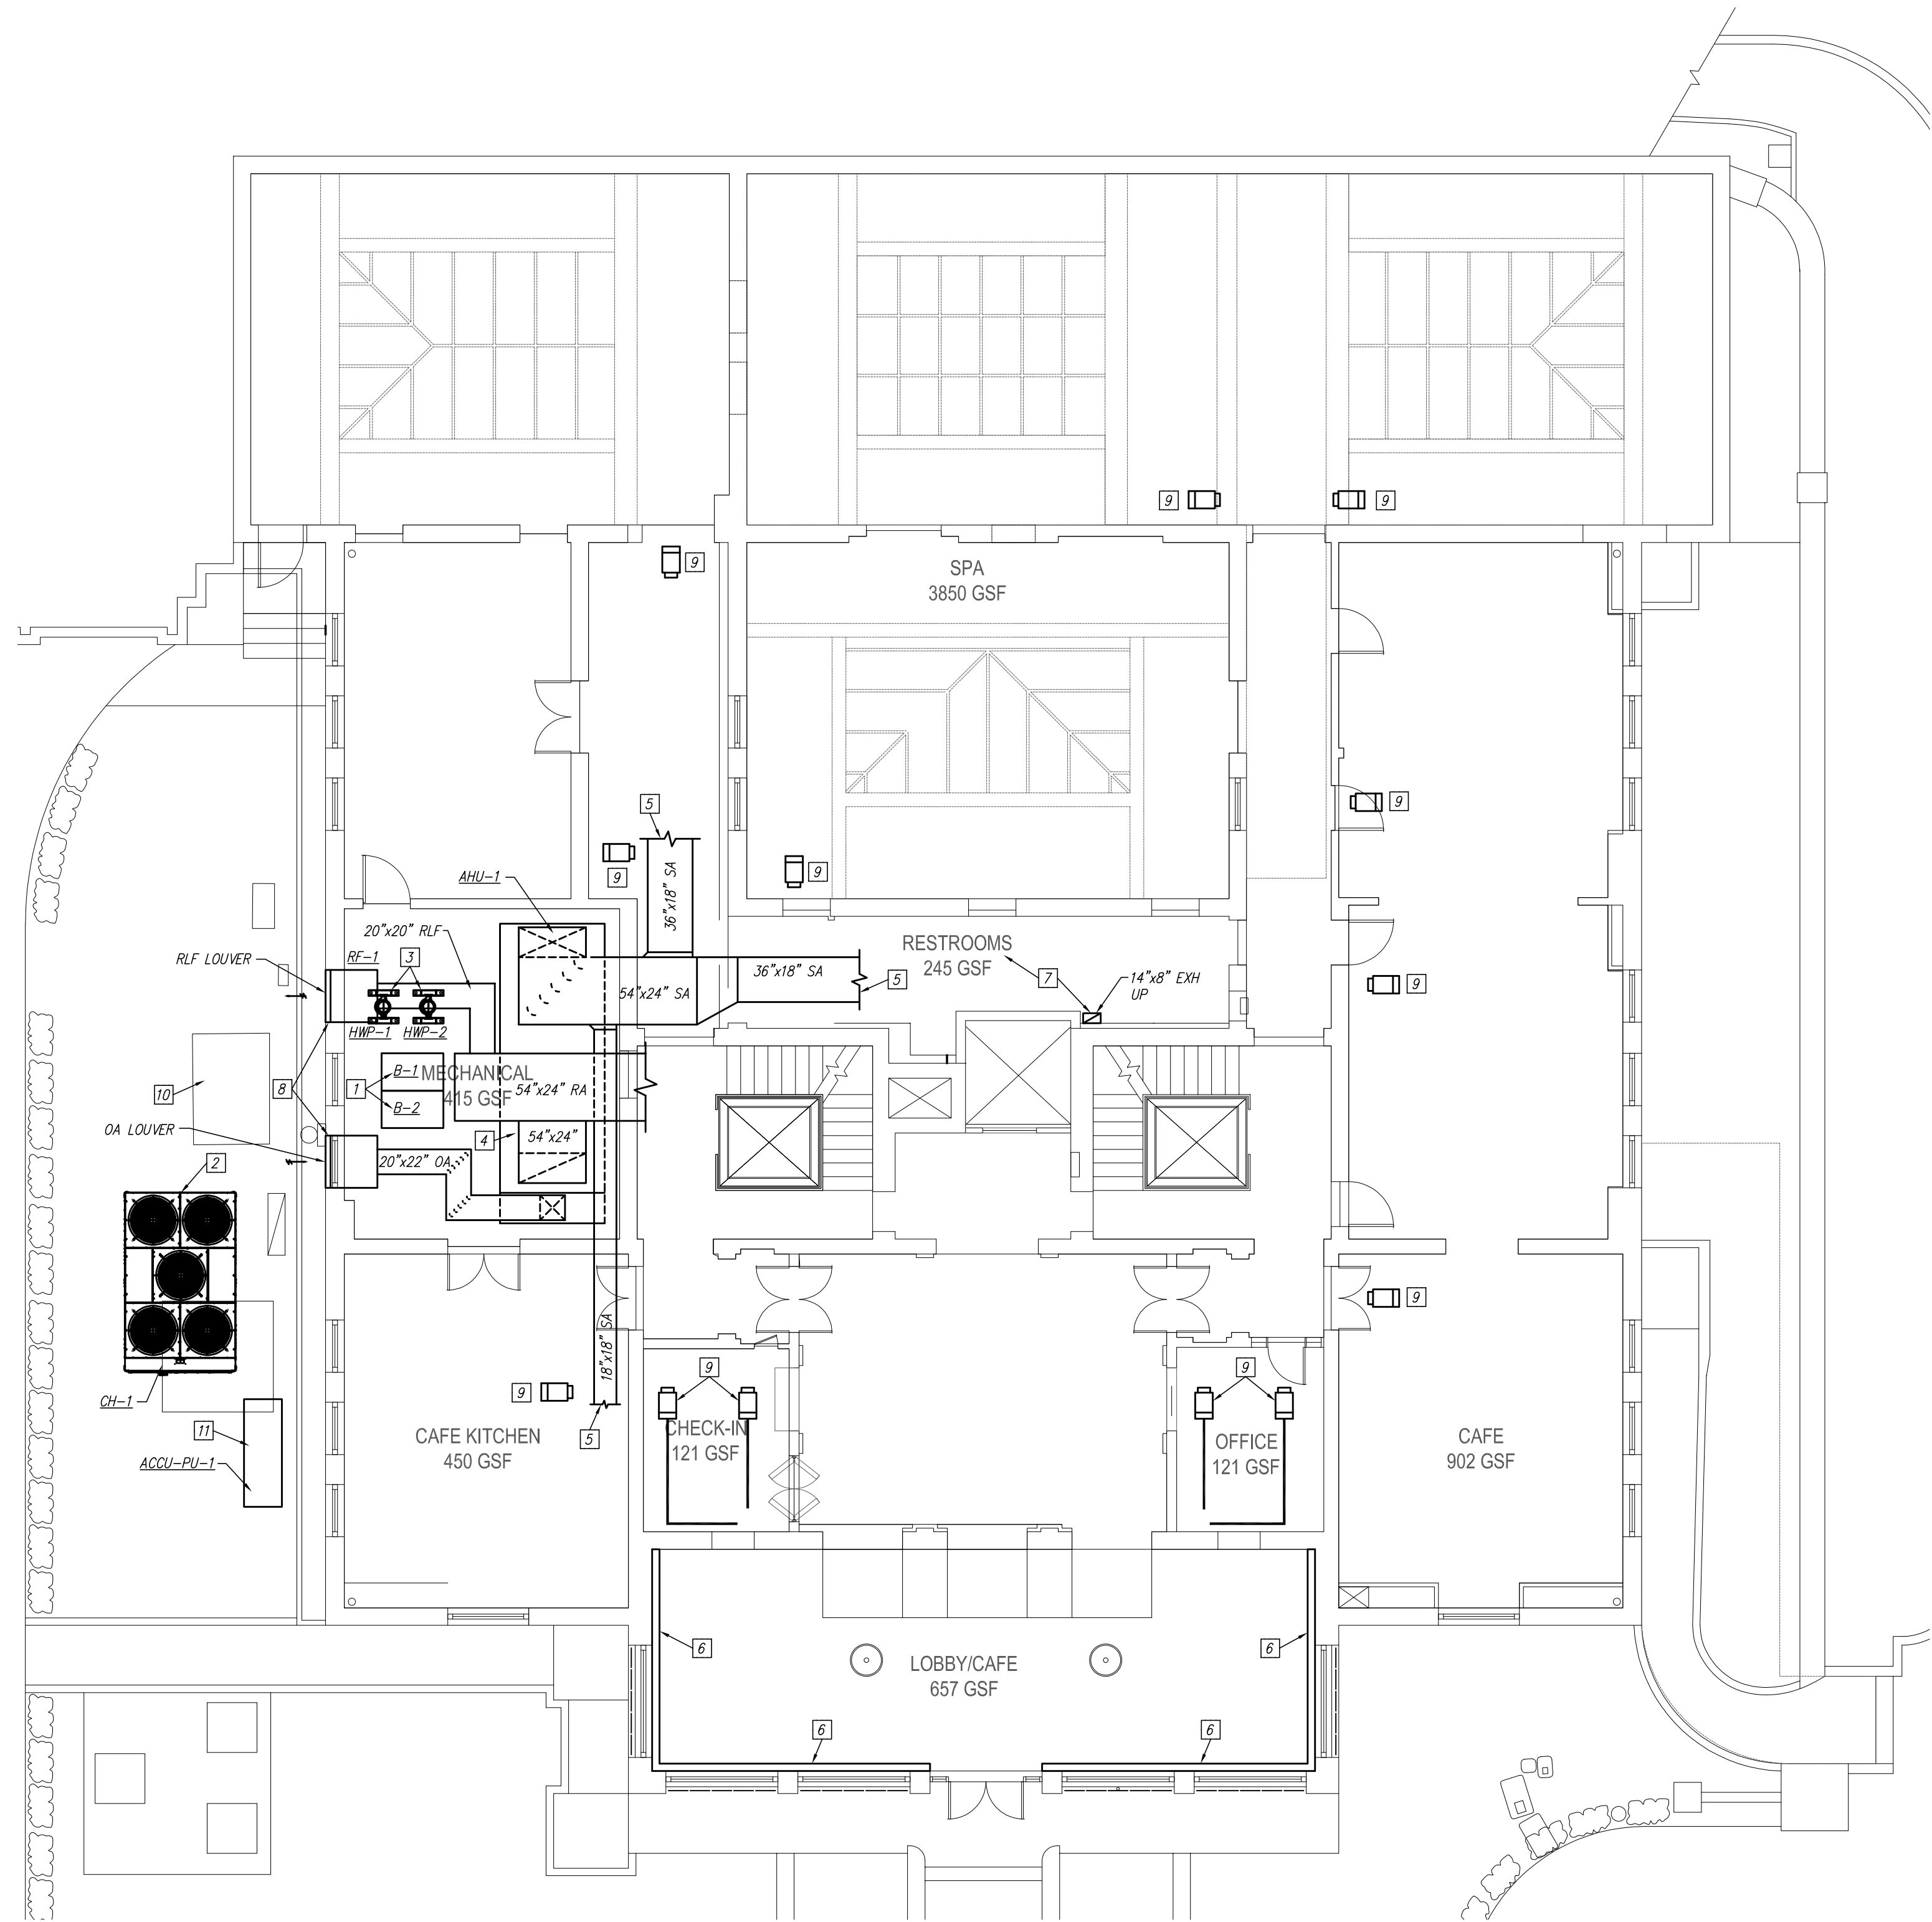
<p>1600 Baltimore, Suite 300 Kansas City, MO 64108 Ph. 816-842-9437 WWW.IMECCORP.COM</p>	DESIGNED: SGB	SUB SHEET NO. M1	TITLE OF SHEET BASEMENT MECHANICAL PLAN - MAURICE	DRAWING NO. 128 180181
	MWM/BWC TECH. REVIEW: SGB		PRE-DESIGN CONDITION ASSESSMENT AND TREATMENT PLAN FOR THE MAURICE BATHHOUSE AND LIBBEY MEMORIAL PMC HOT SPRINGS NATIONAL PARK	PMS/PKG NO. 318915 SHEET 15 OF 24
DATE: 6/29/22

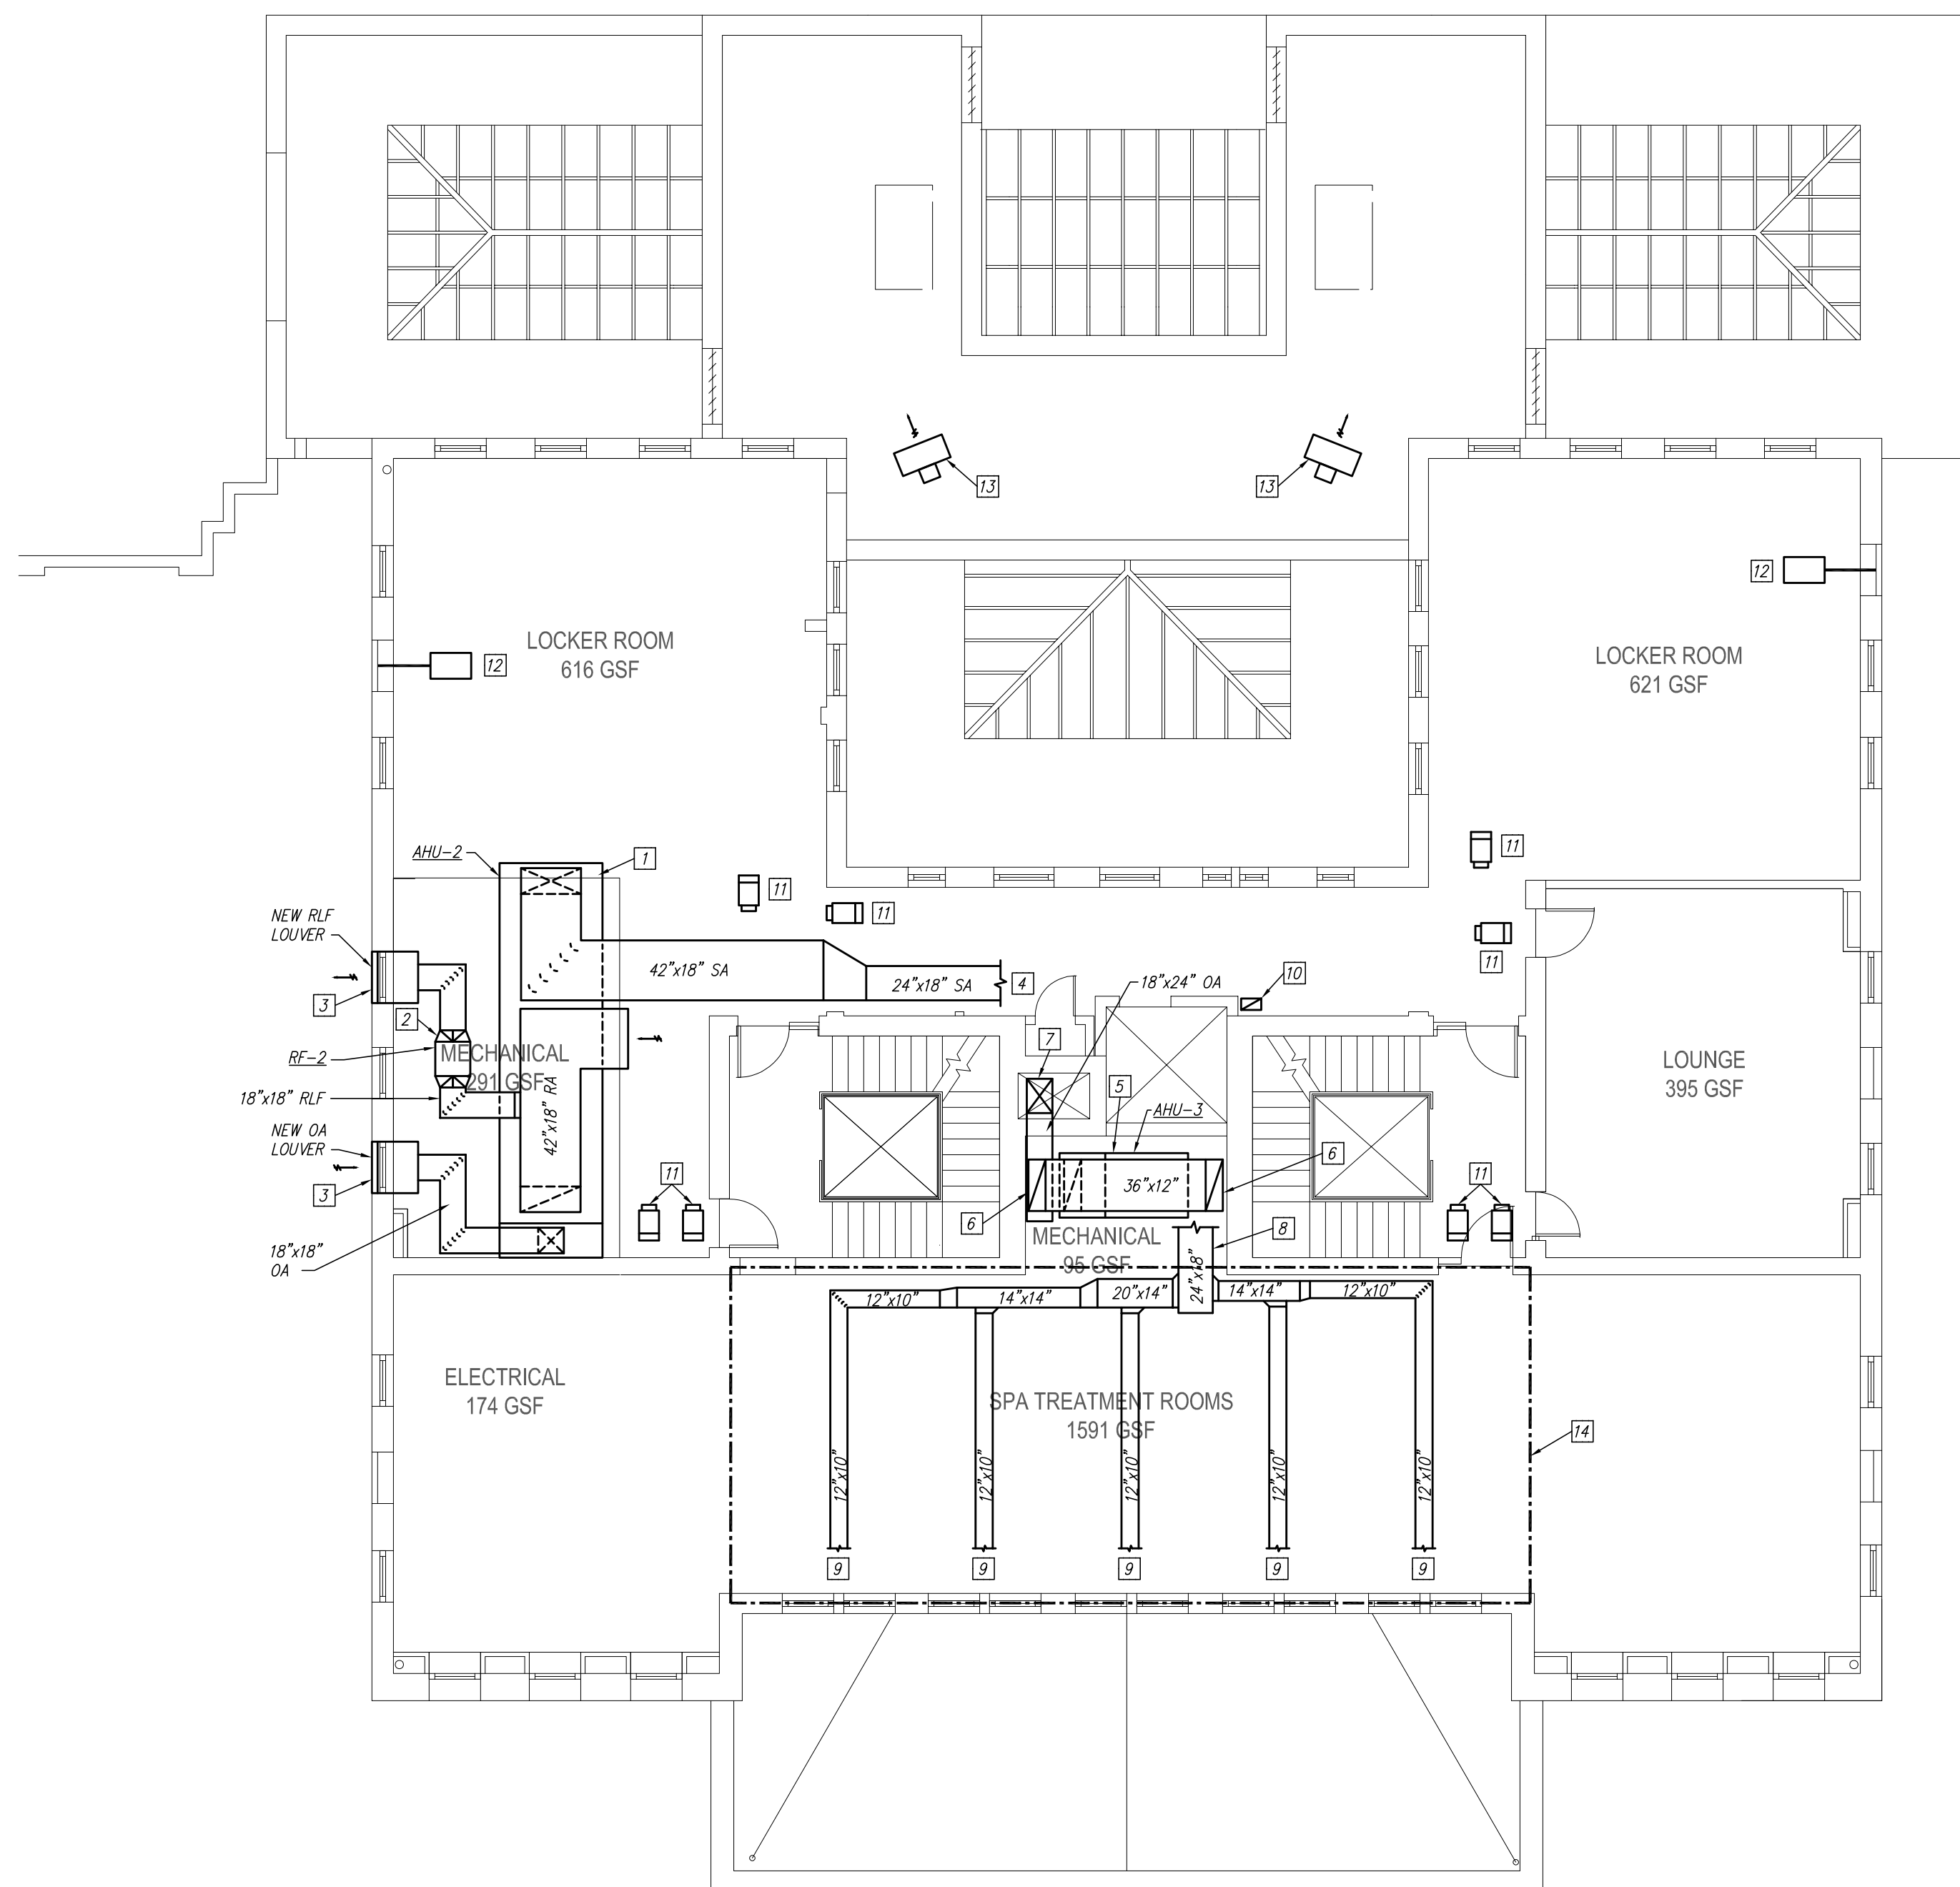
<p>1600 Baltimore, Suite 300 Kansas City, MO 64108 Ph. 816-842-8437 WWW.IMEG-CORP.COM</p>	<p>DESIGNED: SGB</p>	<p>SUB SHEET NO. M2</p>	<p>TITLE OF SHEET FIRST FLOOR MECHANICAL PLAN - MAURICE</p>	<p>DRAWING NO. 128 180181</p>
	<p>TECH. REVIEW: SGB</p>		<p>DATE: 6/29/22</p>	<p>PRE-DESIGN CONDITION ASSESSMENT AND TREATMENT PLAN FOR THE MAURICE BATHHOUSE AND LIBBEY MEMORIAL PMC HOT SPRINGS NATIONAL PARK</p>

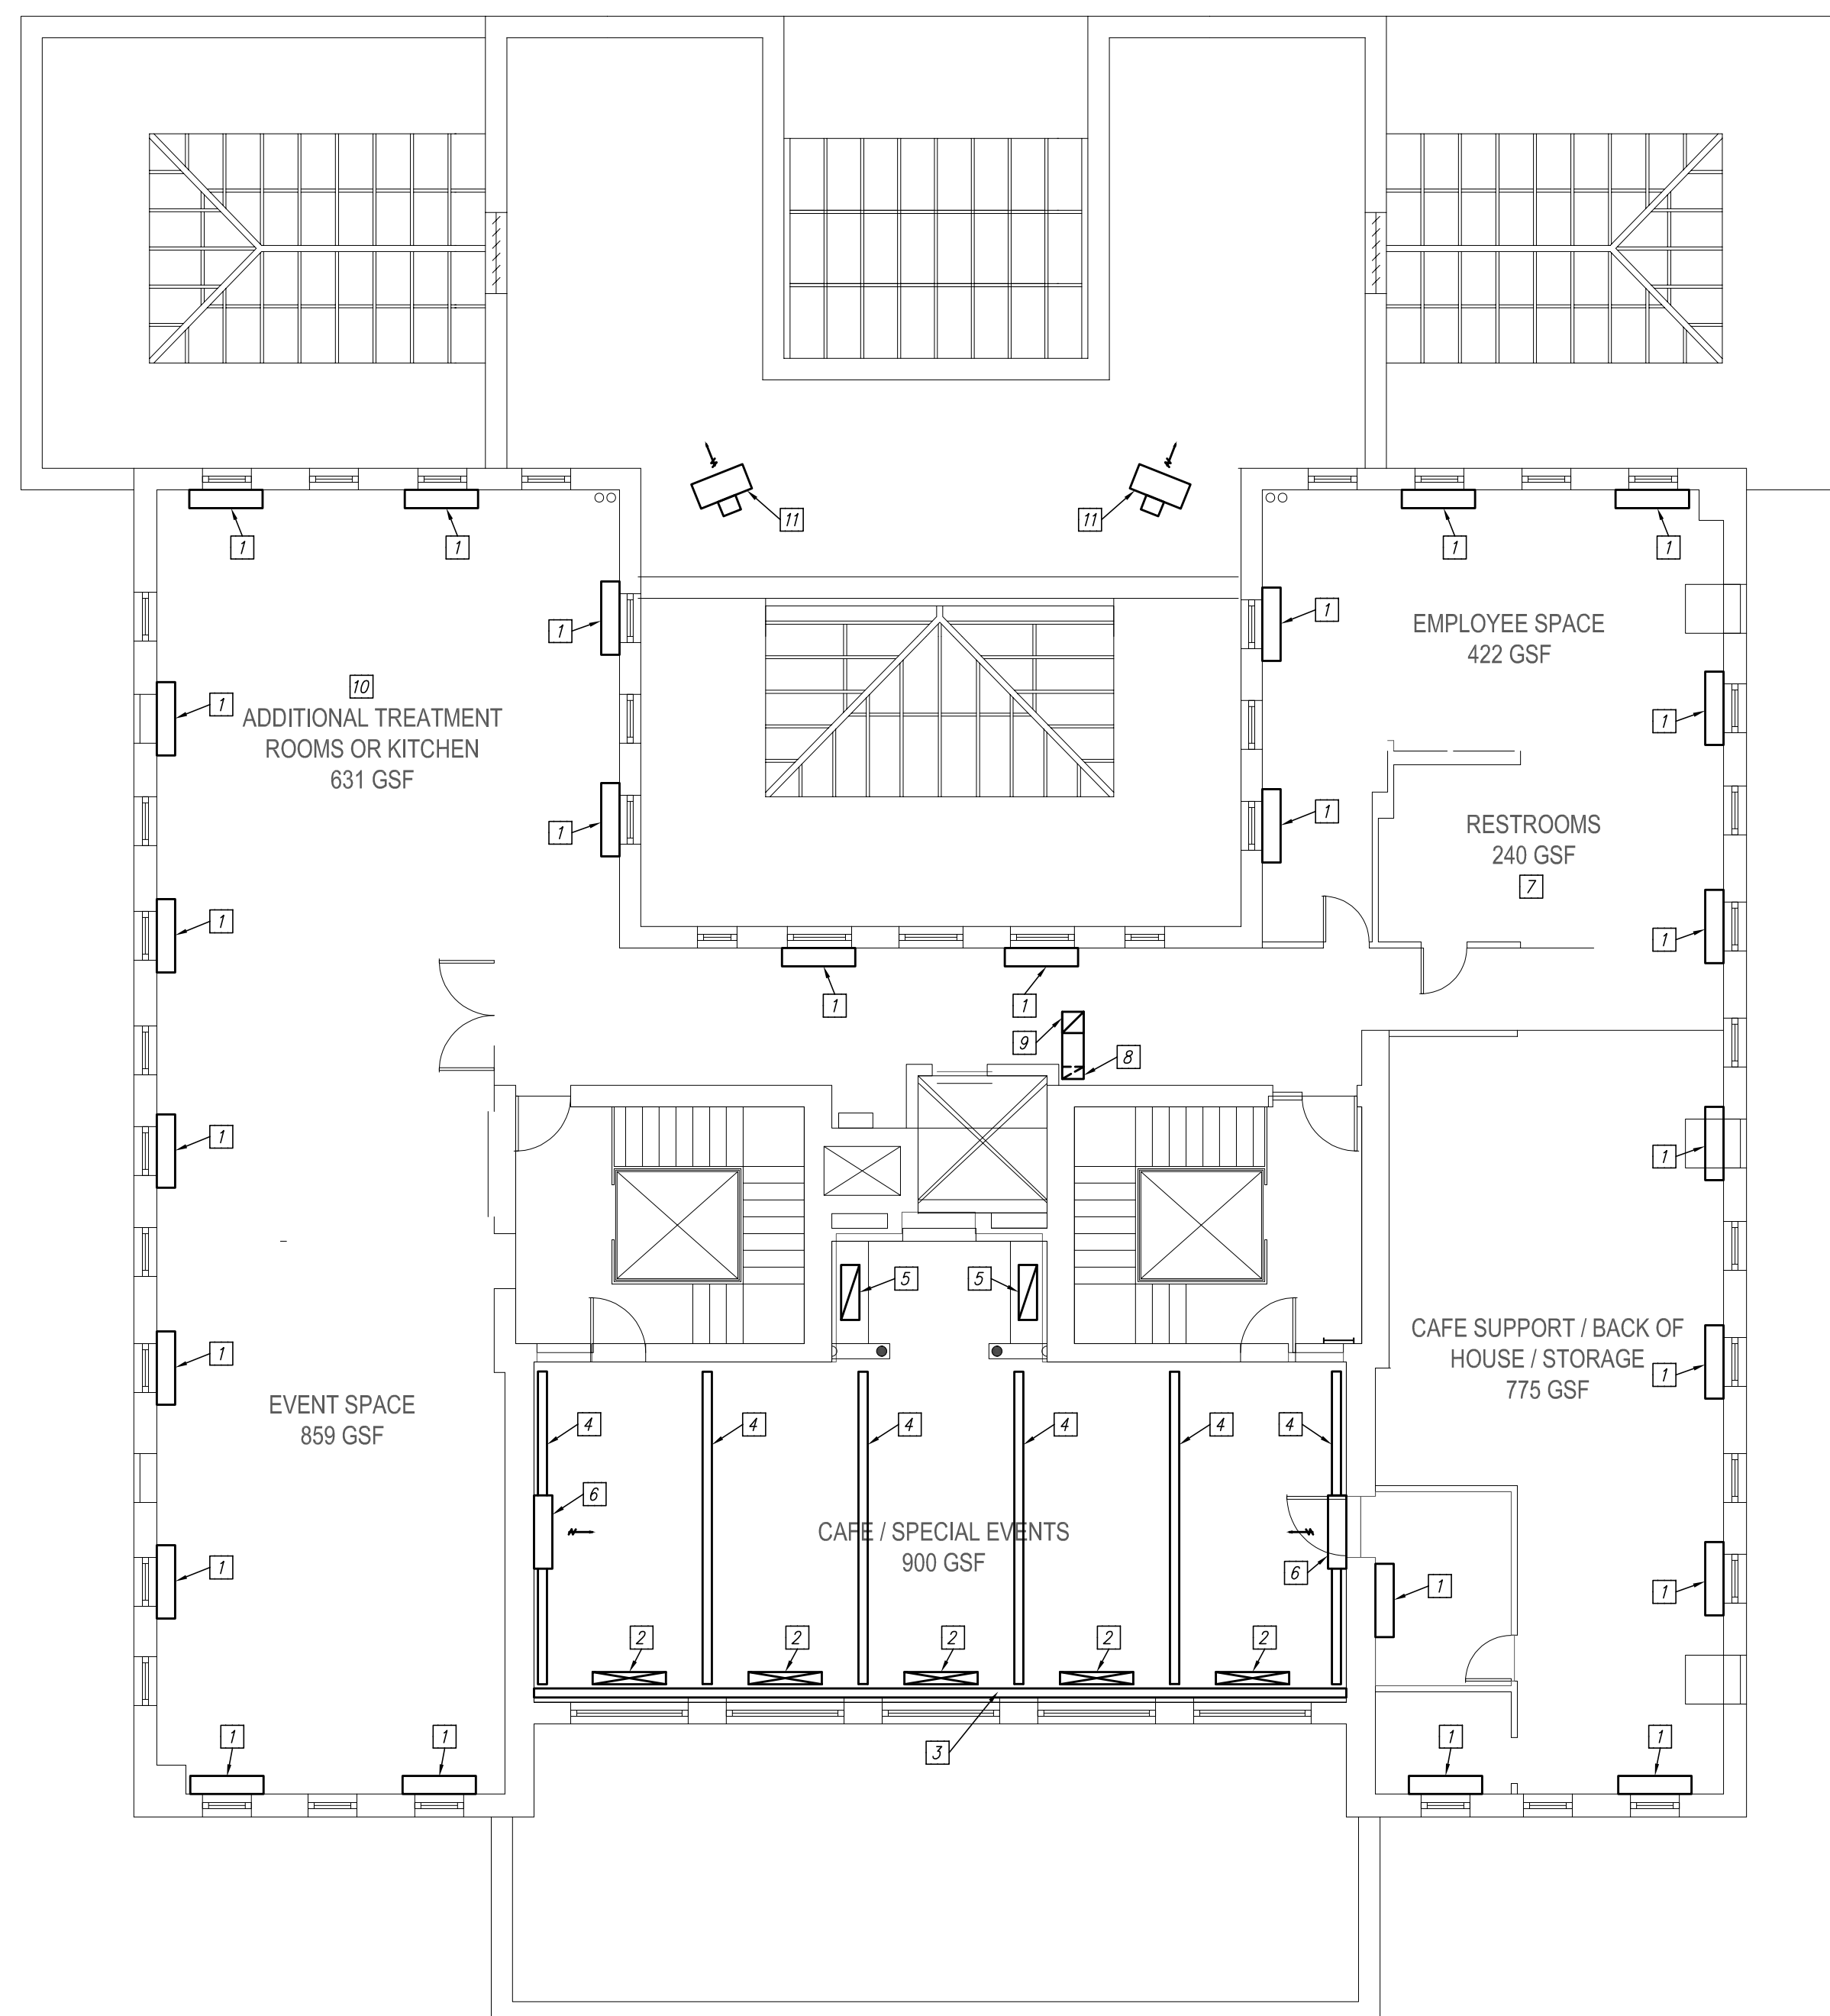
<p>1600 Baltimore, Suite 300 Kansas City, MO 64108 Ph. 816-842-8437 WWW.IMEG.CORP.COM</p>	DESIGNED: SGB	SUB SHEET NO. M3	TITLE OF SHEET SECOND FLOOR MECHANICAL PLAN – MAURICE		DRAWING NO. 128 180181
	MWM/BWC TECH. REVIEW: SGB		PRE-DESIGN CONDITION ASSESSMENT AND TREATMENT PLAN FOR THE MAURICE BATHHOUSE AND LIBBEY MEMORIAL PMC HOT SPRINGS NATIONAL PARK		PMS/PKG NO. 318915 SHEET 17 OF 24
DATE: 6/29/22

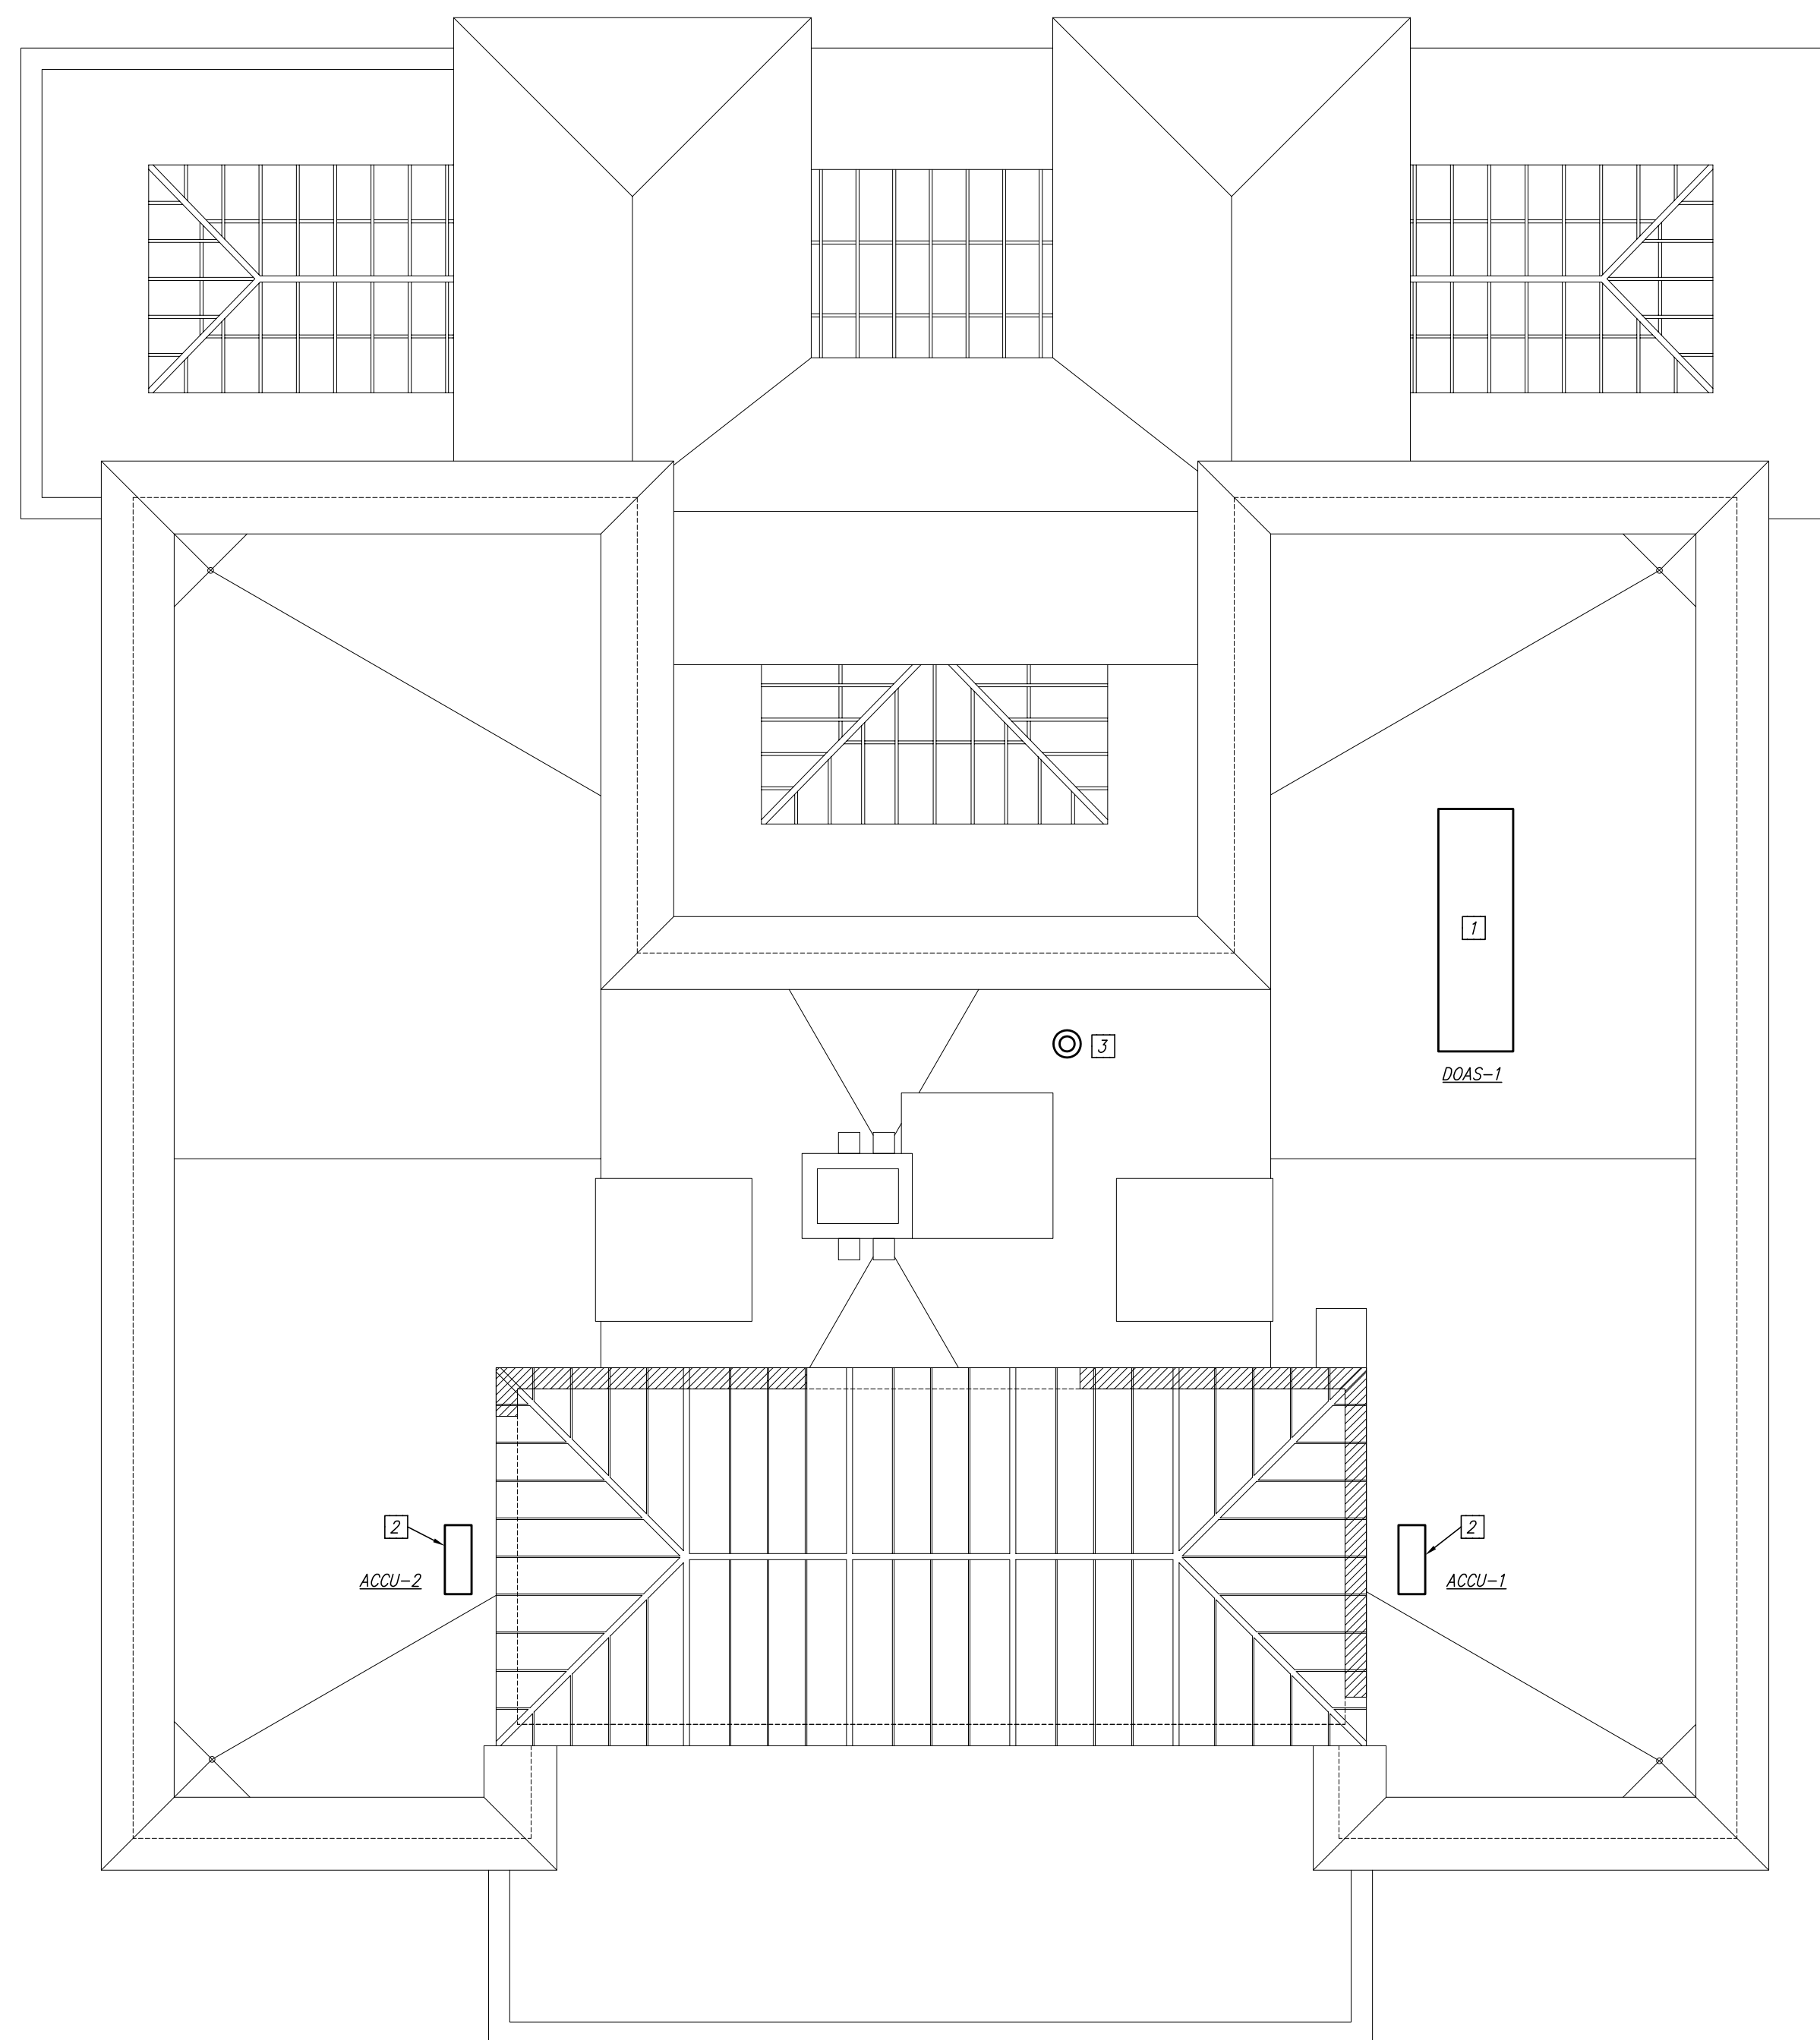
1600 Baltimore, Suite 300 Kansas City, MO 64108 Ph. 816-842-8437 WWW.IMEG.CORP.COM	DESIGNED: SGB MWM/BWC TECH. REVIEW: SGB	SUB SHEET NO. M4	TITLE OF SHEET THIRD FLOOR MECHANICAL PLAN – MAURICE PRE-DESIGN CONDITION ASSESSMENT AND TREATMENT PLAN FOR THE MAURICE BATHHOUSE AND LIBBEY MEMORIAL PMC HOT SPRINGS NATIONAL PARK	DRAWING NO. 128 180181 PMS/PKG NO. 318915 SHEET 18 OF 24
	DATE: 6/29/22
