Condition Assessment and Treatment Plan for Maurice Bathhouse

PRE-DESIGN SERVICES

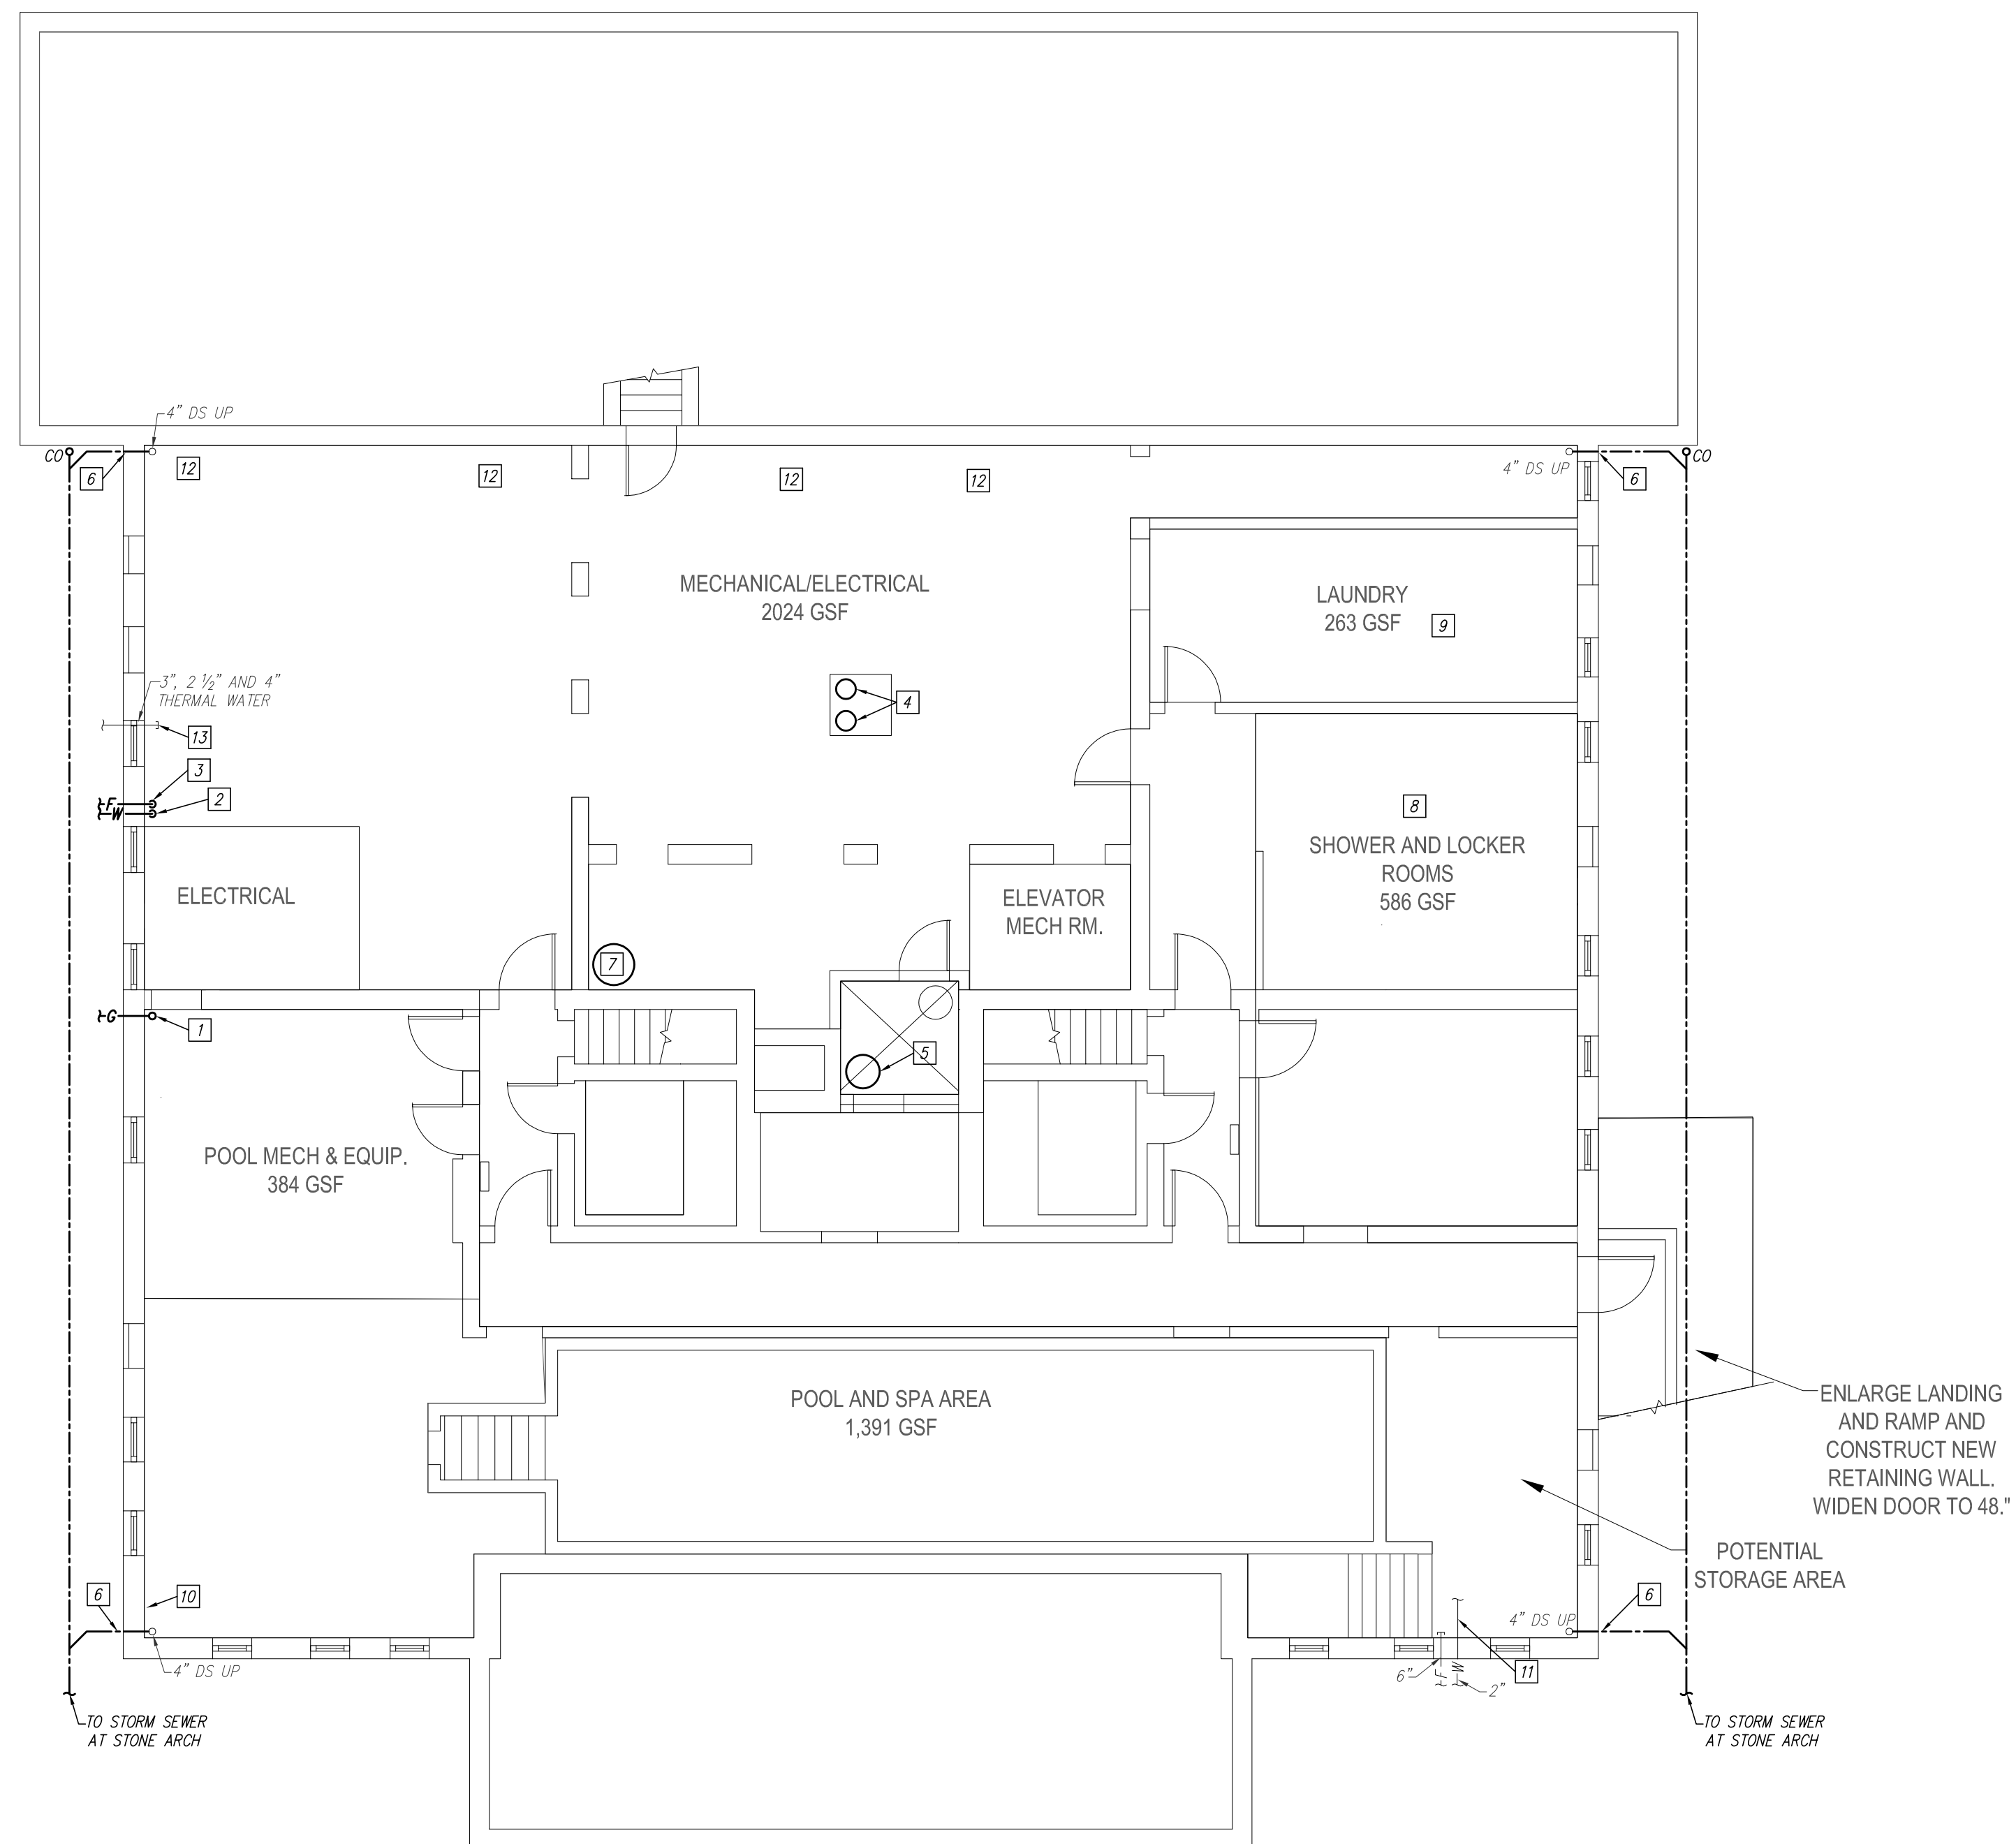
1600 Baltimore, Suite 300 Kansas City, MO 64108 Ph. 816-842-9437 WWW.IMEG.CORP.COM	DESIGNED: SGB CAD: MWM/BWC TECH. REVIEW: SGB	SUB SHEET NO. M5	TITLE OF SHEET ROOF MECHANICAL PLAN - MAURICE PRE-DESIGN CONDITION ASSESSMENT AND TREATMENT PLAN FOR THE MAURICE BATHHOUSE AND LIBBEY MEMORIAL PMC HOT SPRINGS NATIONAL PARK	DRAWING NO. 128 180181 PMS/PKG NO. 318915 SHEET 19 OF 24
	DATE: 6/29/22

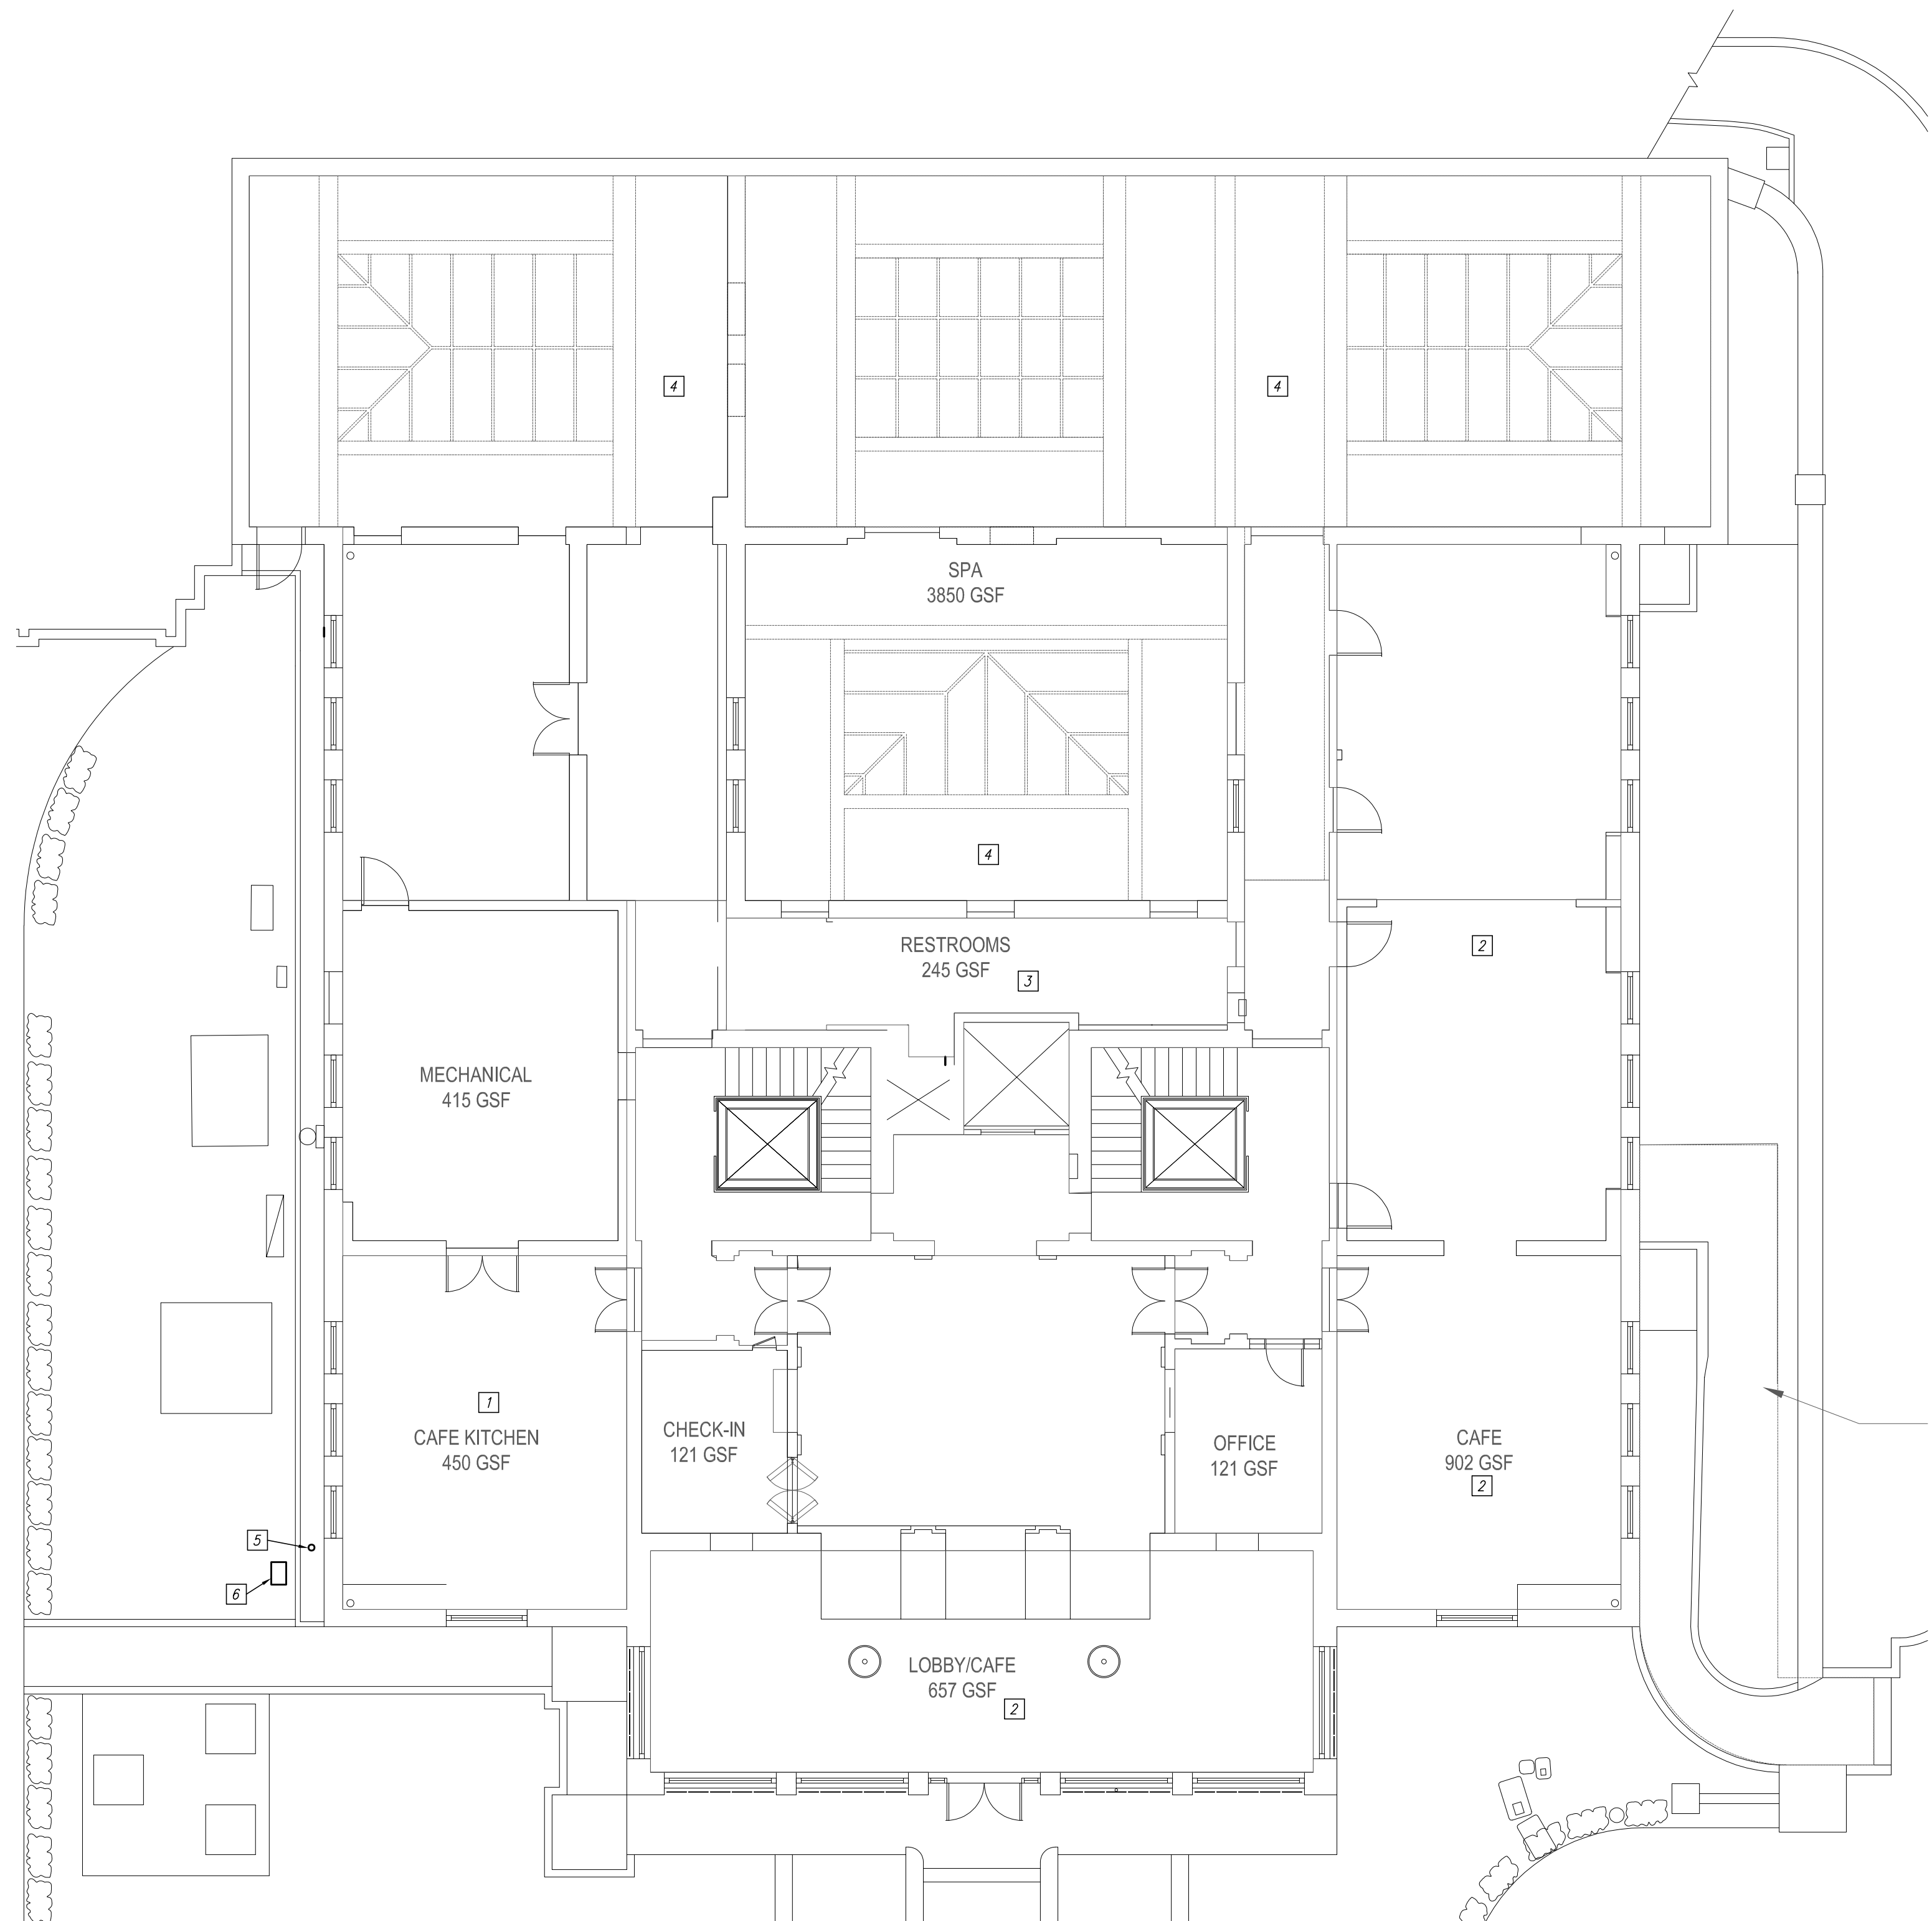
<p>1600 Baltimore, Suite 300 Kansas City, MO 64108 Ph. 816-842-8437 WWW.IMEG-CORP.COM</p>	<p>DESIGNED: SGB</p>	<p>SUB SHEET NO. P1</p>	<p>TITLE OF SHEET BASEMENT PLUMBING PLAN – MAURICE</p>	<p>DRAWING NO. 128 180181</p>
	<p>TECH. REVIEW: SGB</p>		<p>DATE: 6/29/22</p>	<p>PRE-DESIGN CONDITION ASSESSMENT AND TREATMENT PLAN FOR THE MAURICE BATHHOUSE AND LIBBEY MEMORIAL PMC HOT SPRINGS NATIONAL PARK</p>

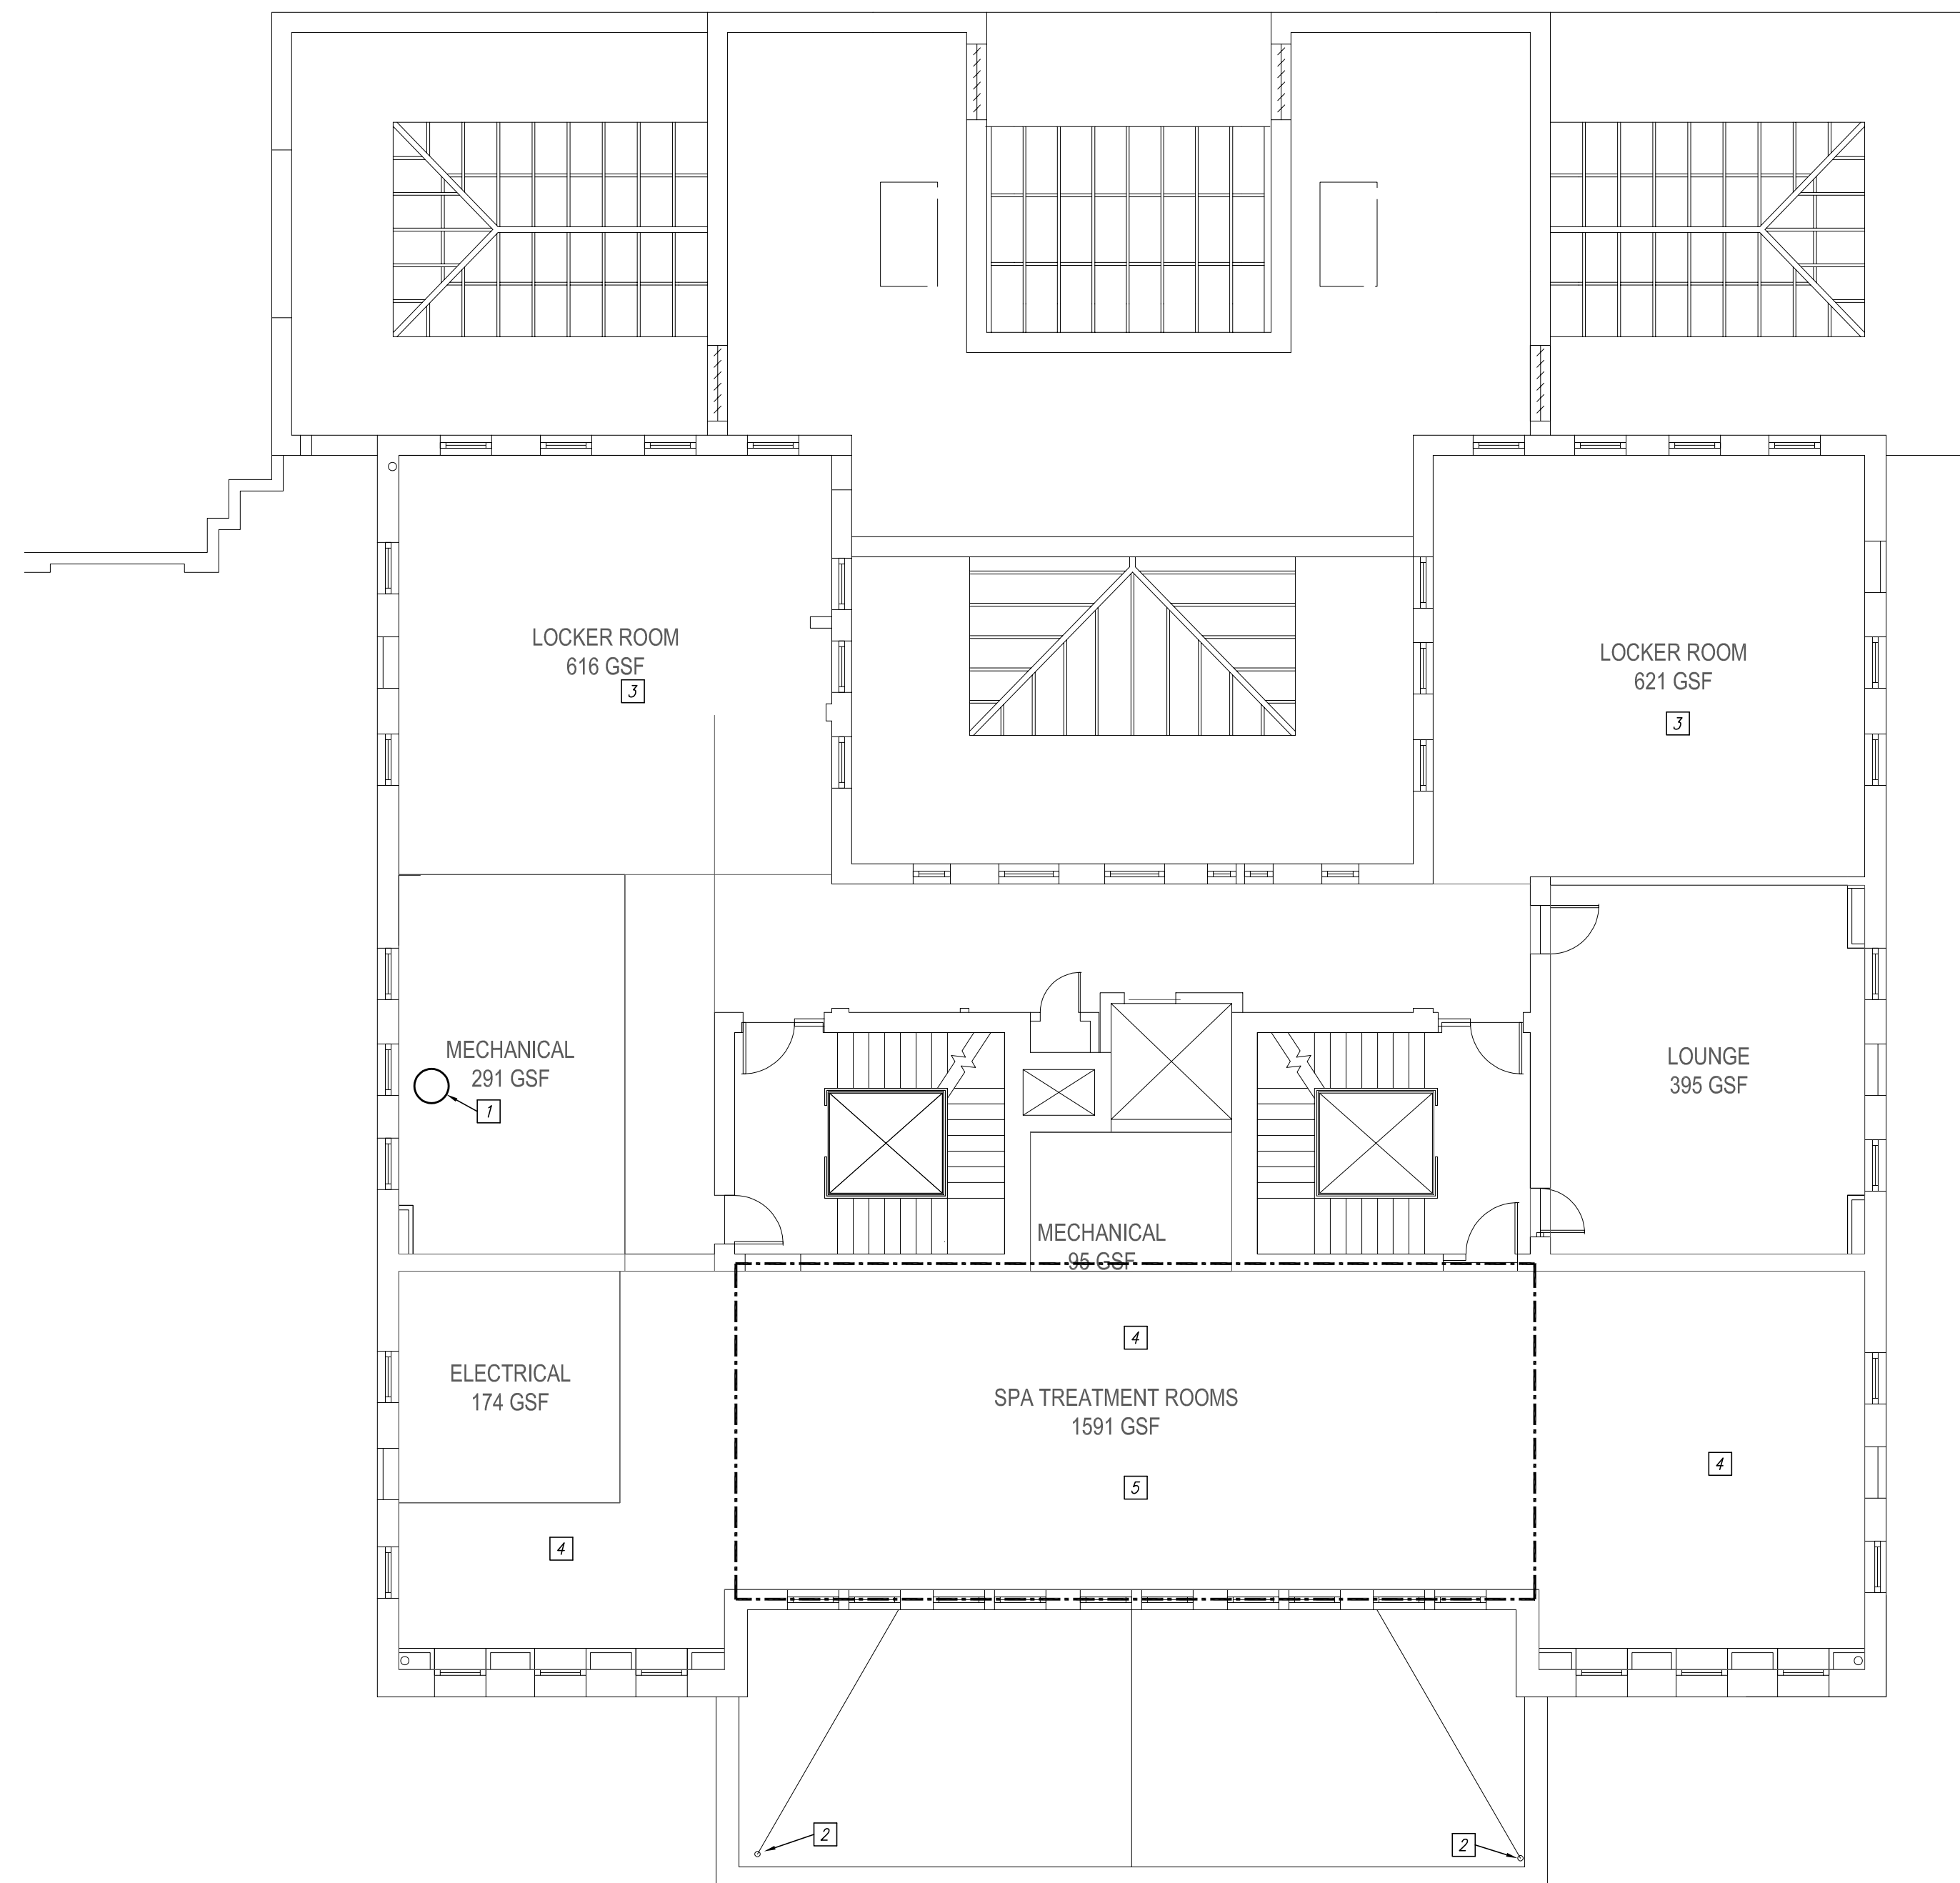
DRAWING NO.
128
180181
PMS/PKG NO.
318915
SHEET
21 OF 24

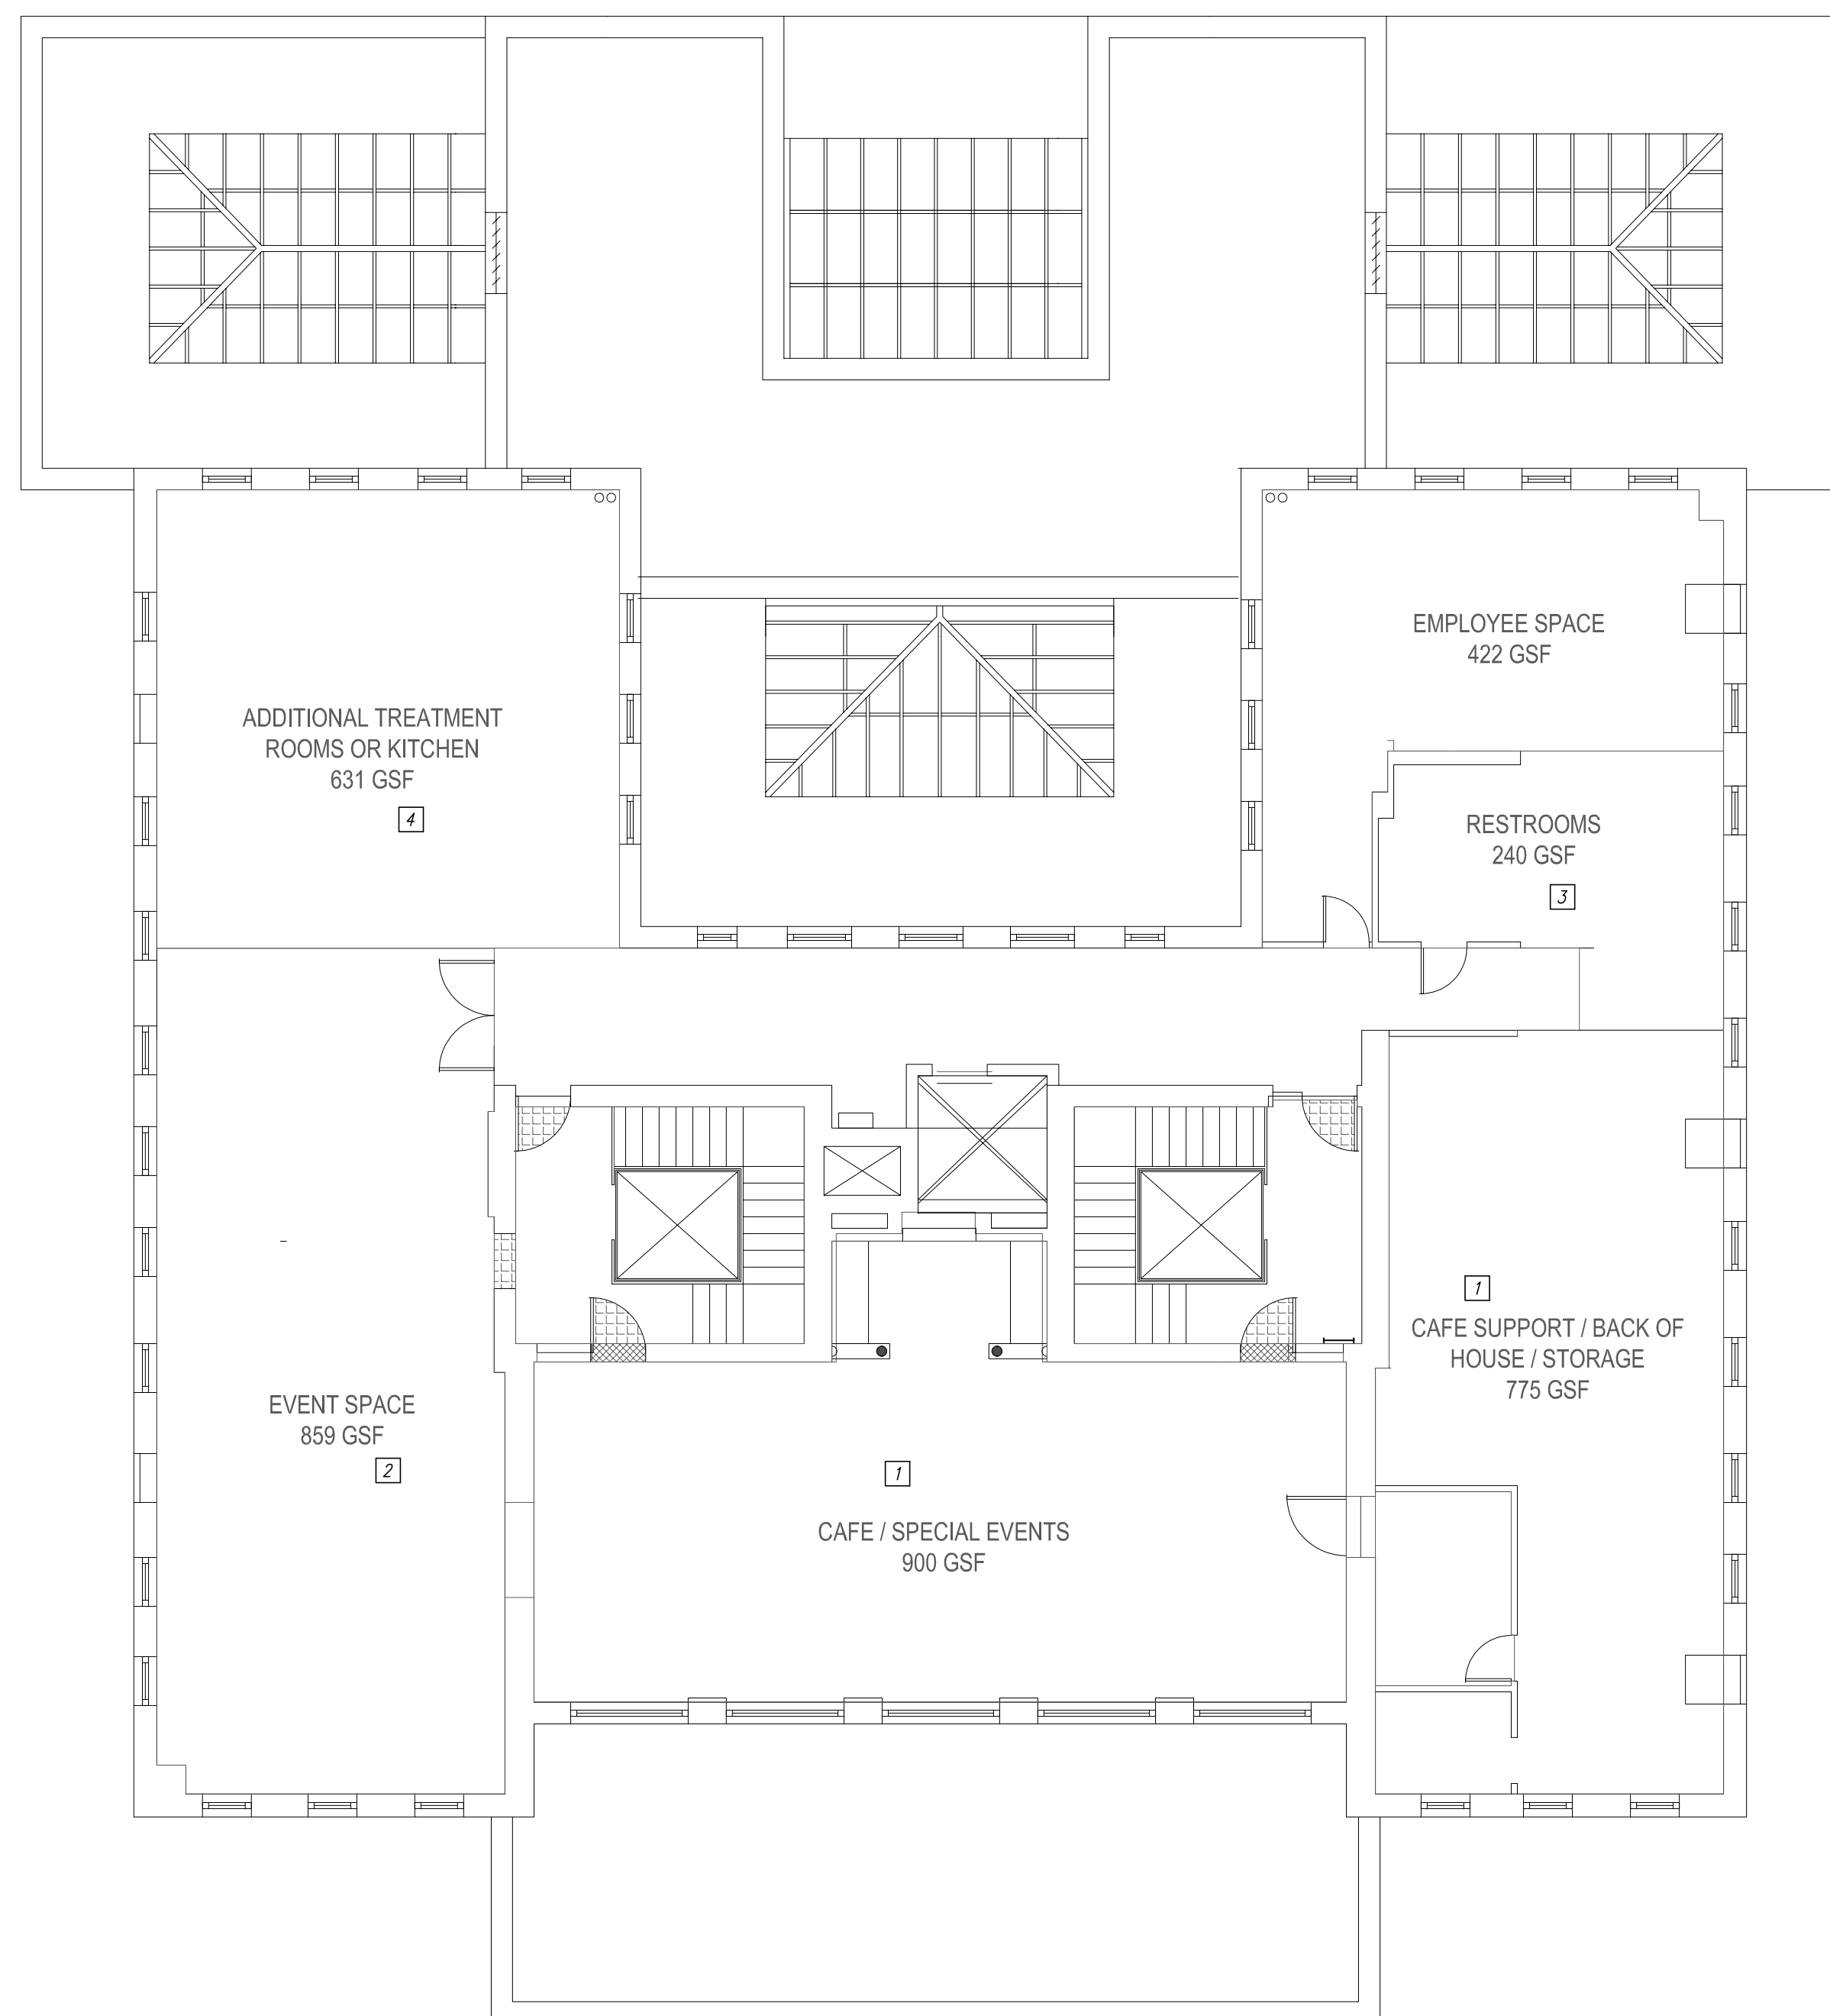
<p>1600 Baltimore, Suite 300 Kansas City, MO 64108 Ph. 816-842-9437 WWW.IMEG-CORP.COM</p>	DESIGNED: SGB	SUB SHEET NO. P3	TITLE OF SHEET SECOND FLOOR PLUMBING PLAN - MAURICE PRE-DESIGN CONDITION ASSESSMENT AND TREATMENT PLAN FOR THE MAURICE BATHHOUSE AND LIBBEY MEMORIAL PMC HOT SPRINGS NATIONAL PARK	DRAWING NO. 128 180181
	MWM/BWC TECH. REVIEW: SGB			PMS/PKG NO. 318915
DATE: 6/29/22			SHEET 22 OF 24

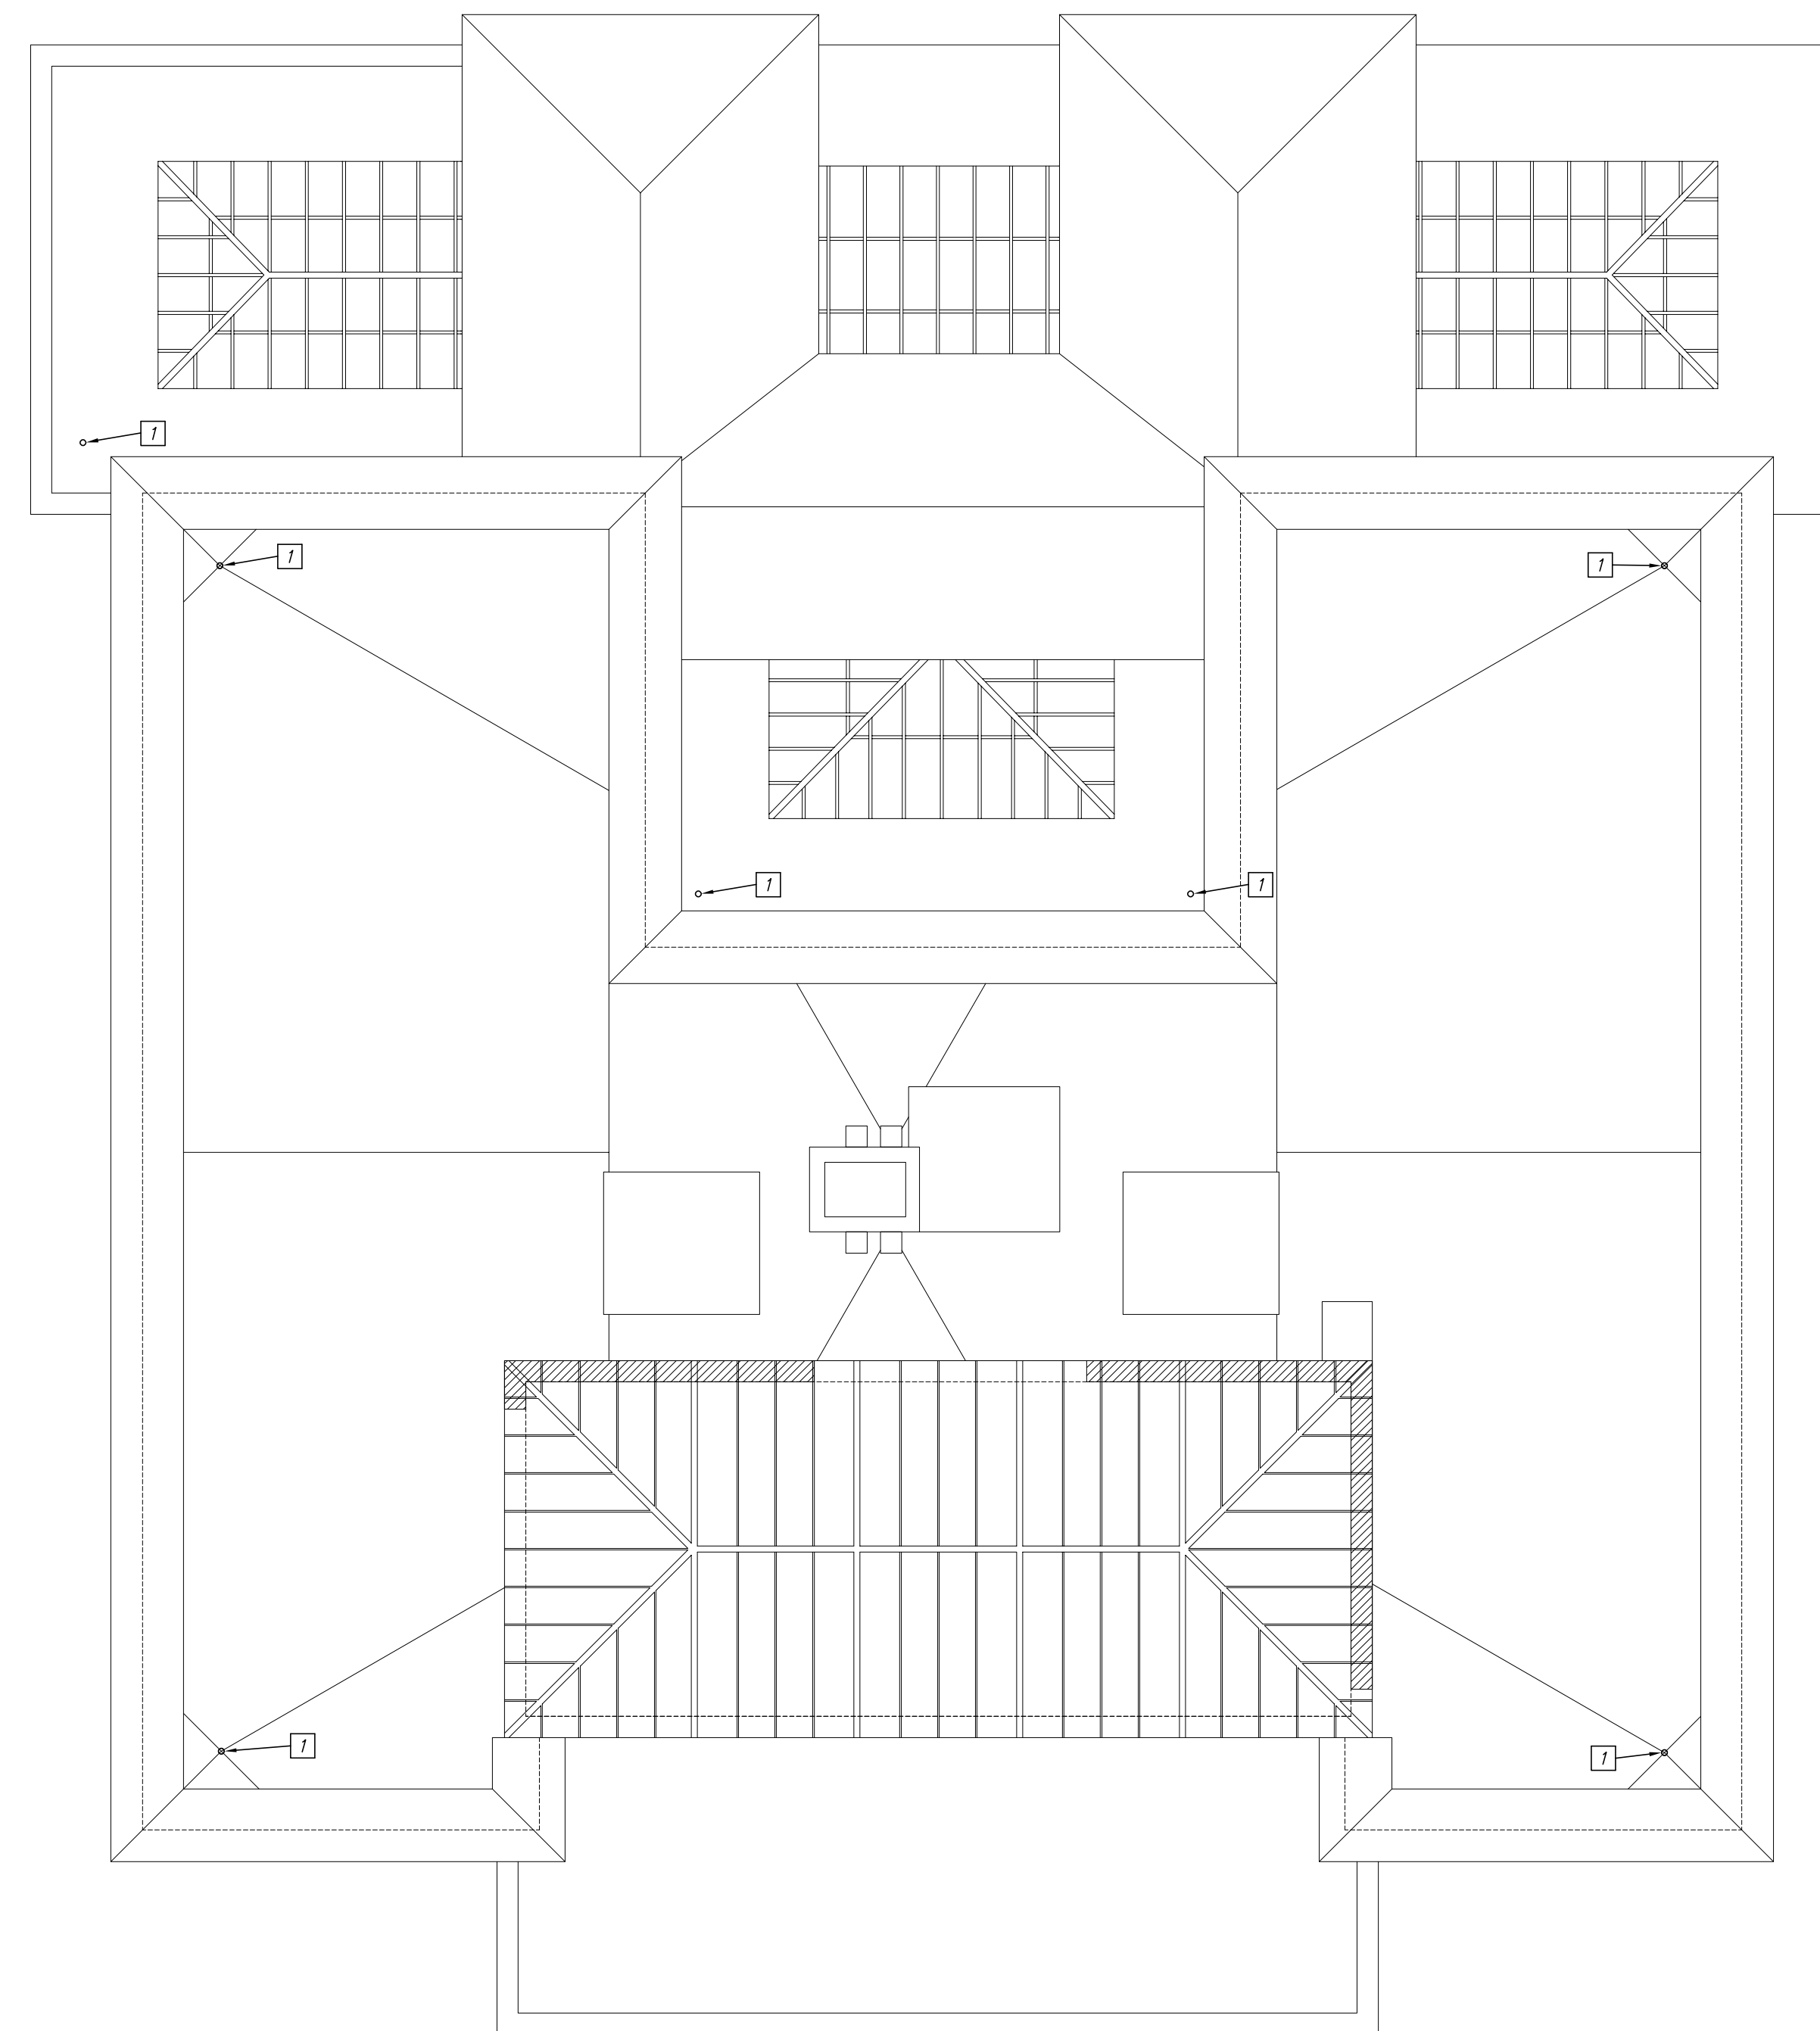
1 ROOF PLUMBING PLAN - MAURICE
P5 1/8" = 1'-0"

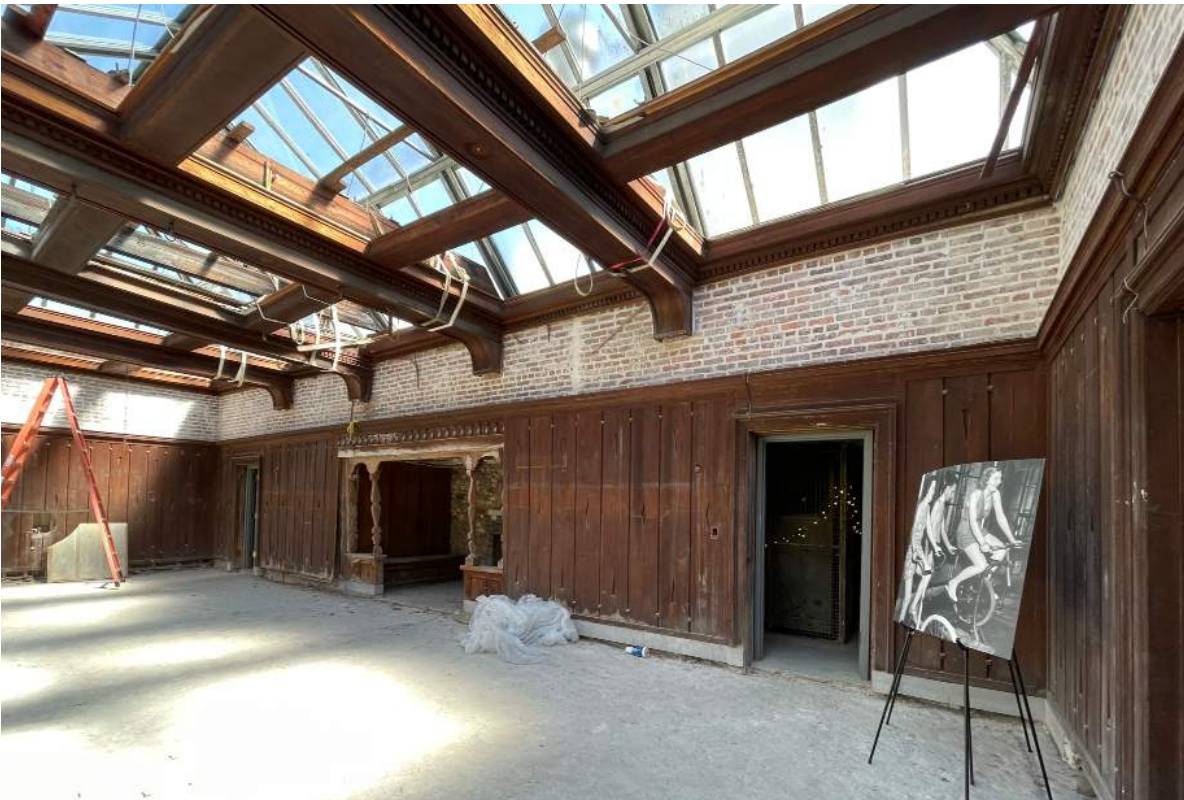
Maurice Bathhouse, Roycroft Den (STRATA, 2022)

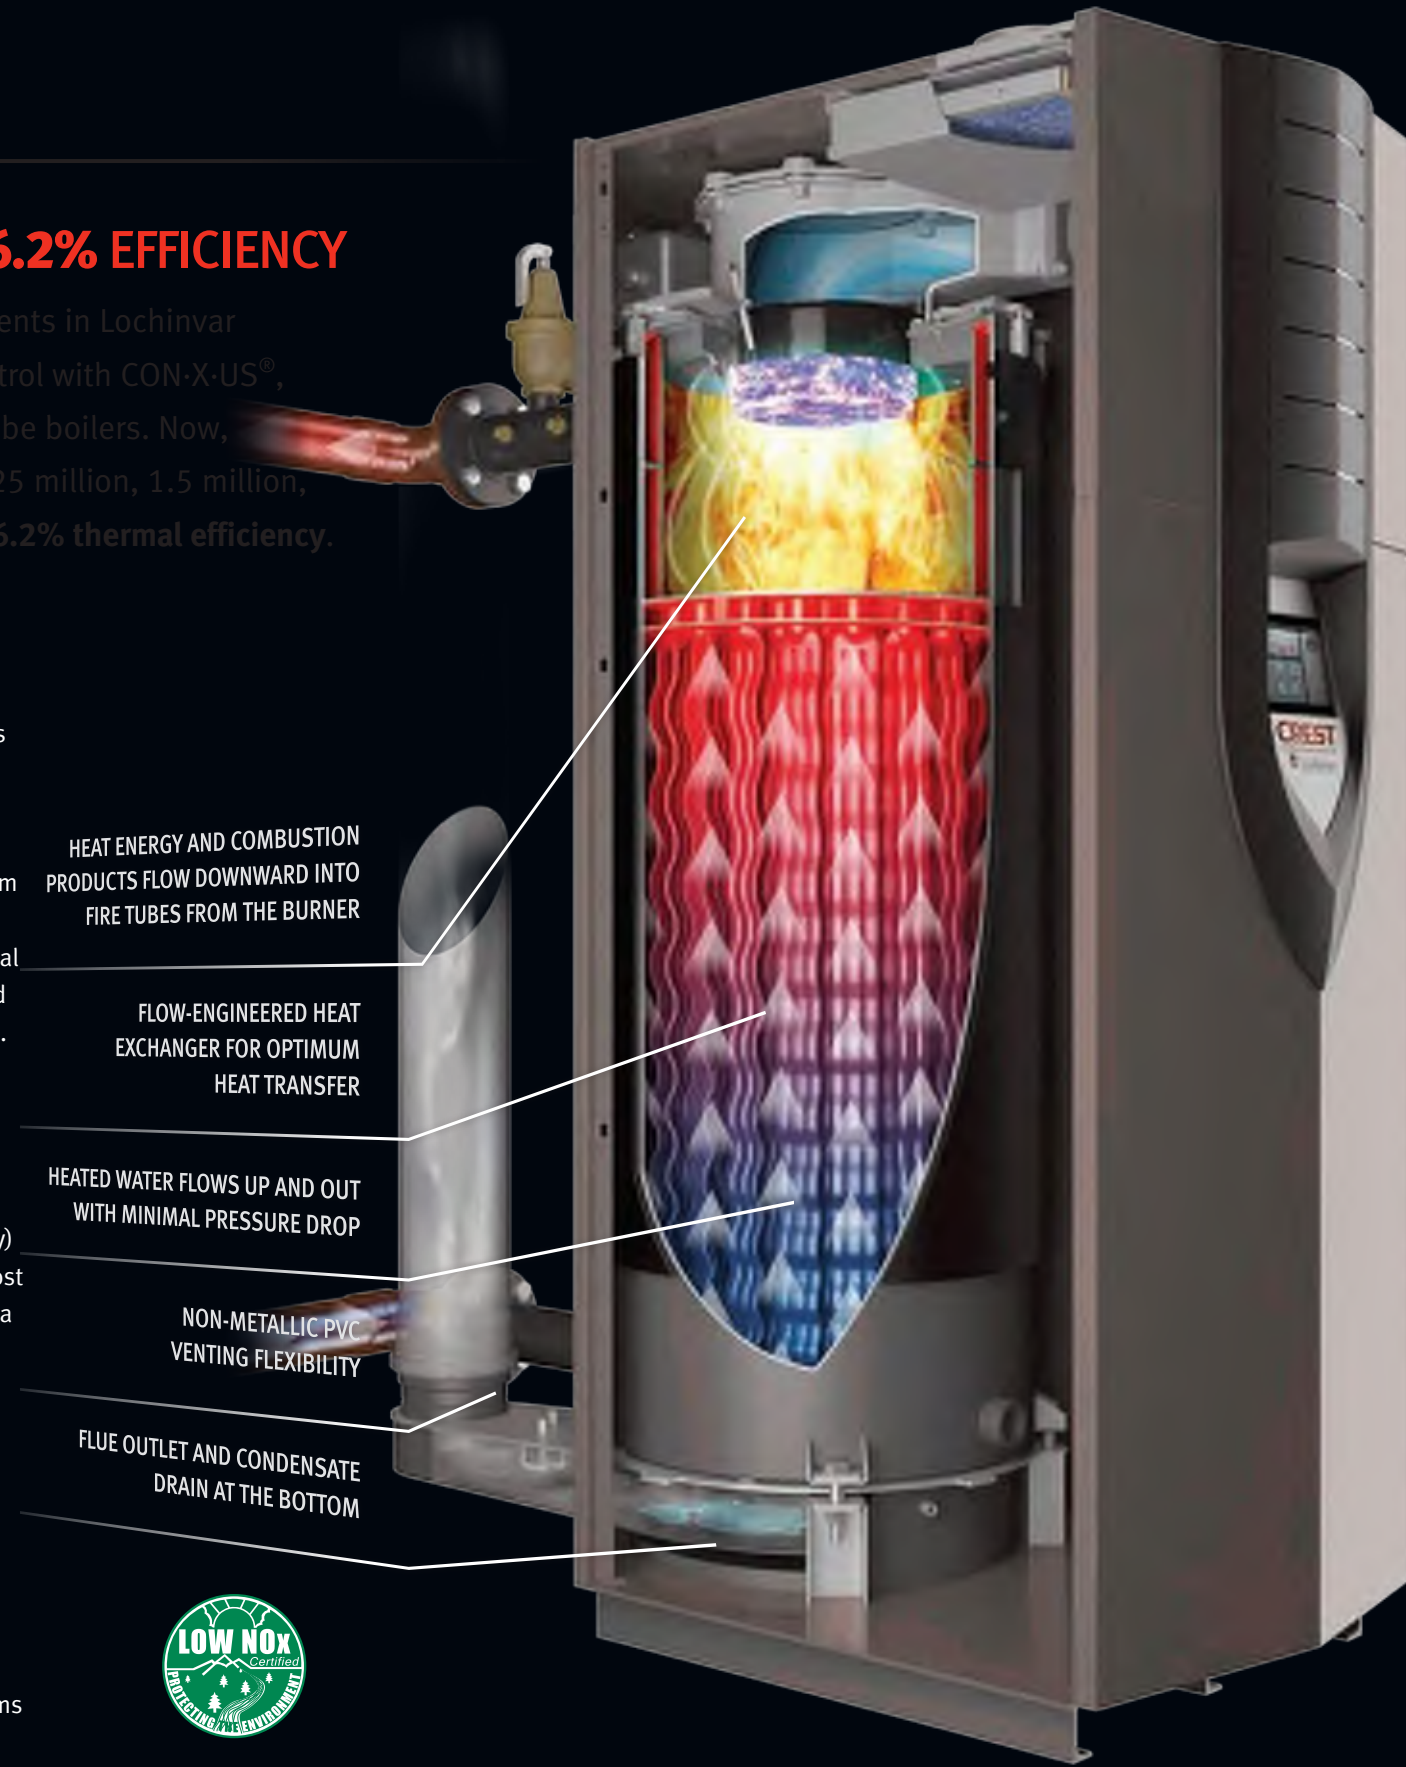
CREST operates reliably with supply gas pressure as low as 4 inches water column. Negative Regulation technology draws gas into a pre-mix combustion system, instead of relying on utility pressure through the gas valve. Operation is steady in low gas pressure systems or when peak gas supply demand occurs. Plus, Neg/Reg fan control fine-tunes the fuel/air ratio entering the burner, providing an even, cleaner-burning flame, achieving high combustion efficiency.

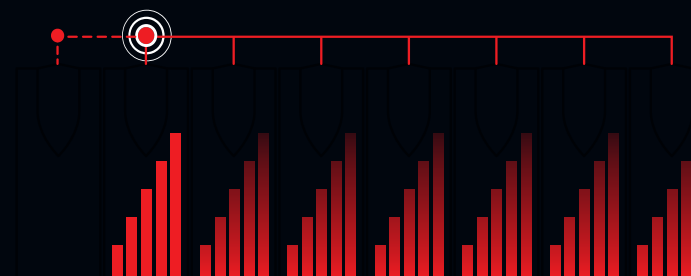
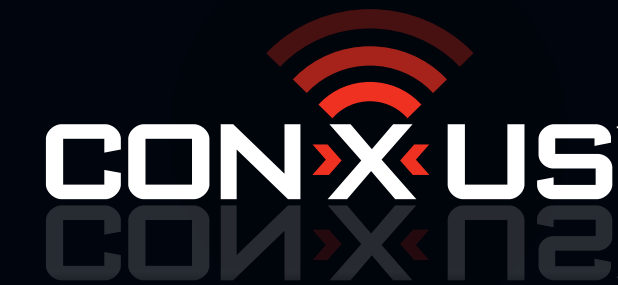
FLEXIBLE VENTING OPTIONS
