Condition Assessment and Treatment Plan for Maurice Bathhouse

PRE-DESIGN SERVICES

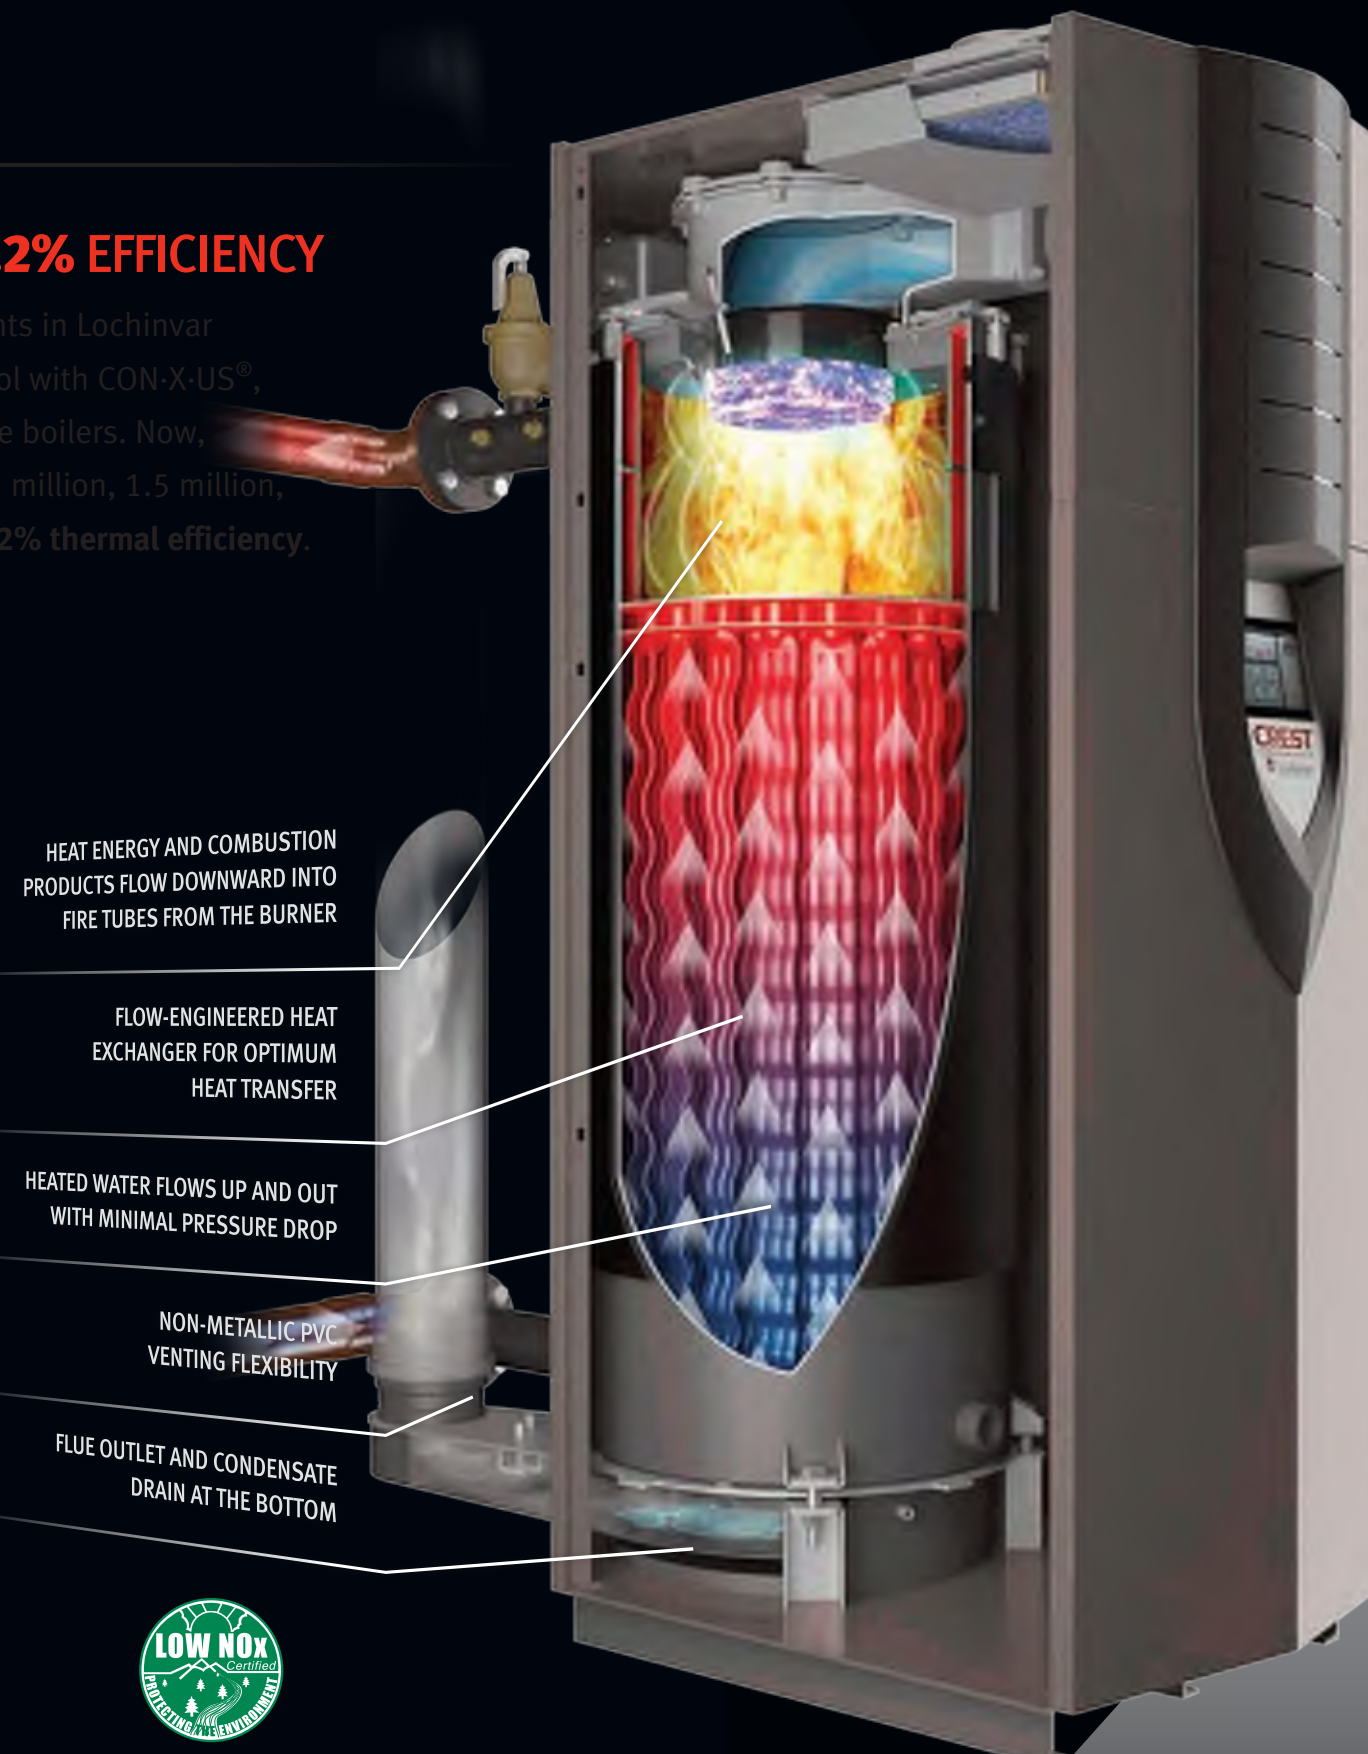
SUPERIOR FIRE-TUBE HEAT EXCHANGER DESIGN BOOSTS THERMAL EFFICIENCY

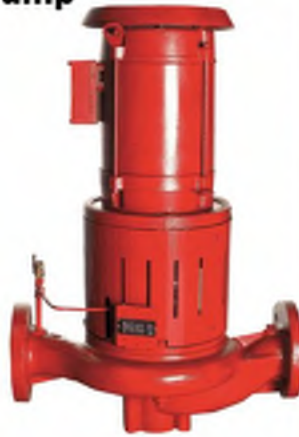
*The Bell & Gossett Series e-80SC is available in stainless steel fitted construction, with flows to 8500 GPM, heads to 202 ft.

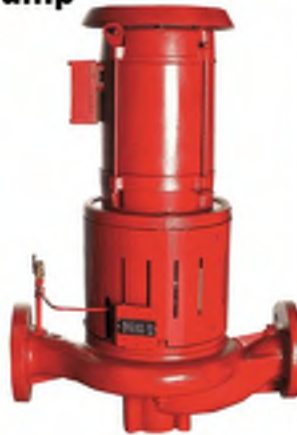
*The Bell & Gossett Series e-80SC is available in stainless steel fitted construction, with flows to 8500 GPM, heads to 202 ft.

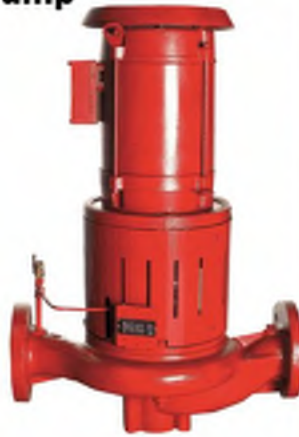
*The Bell & Gossett Series e-80SC is available in stainless steel fitted construction, with flows to 8500 GPM, heads to 202 ft.

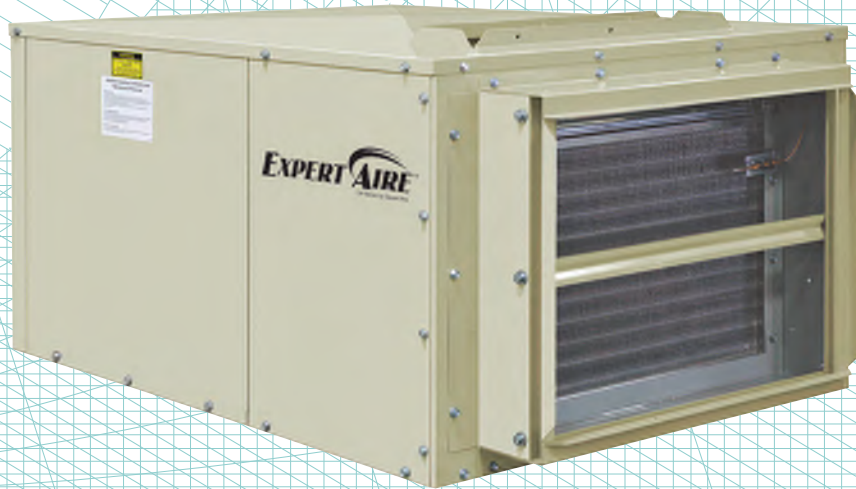
Desert Aire's ExpertAire has product lines that are designed to operate in two different temperature ranges. The LW Series covers the widest range operating from 45 to 80°F (7 to 26°C). The LC and LV Series are for higher temperature applications such as special manufacturing facilities and pools. Please refer to the LC/LV brochure for details on these systems.

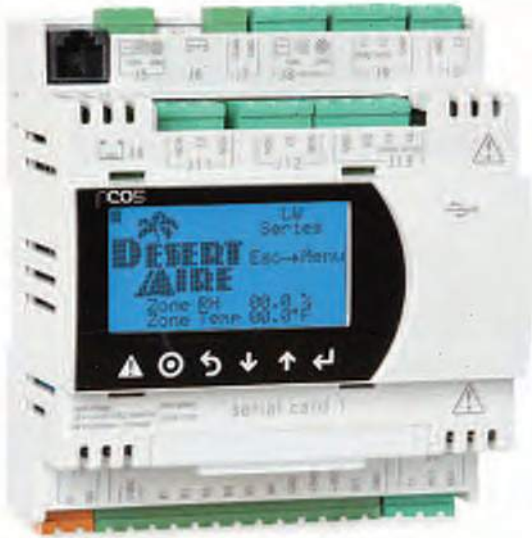
CM3540 Controller
Used on LW Dehumidifier

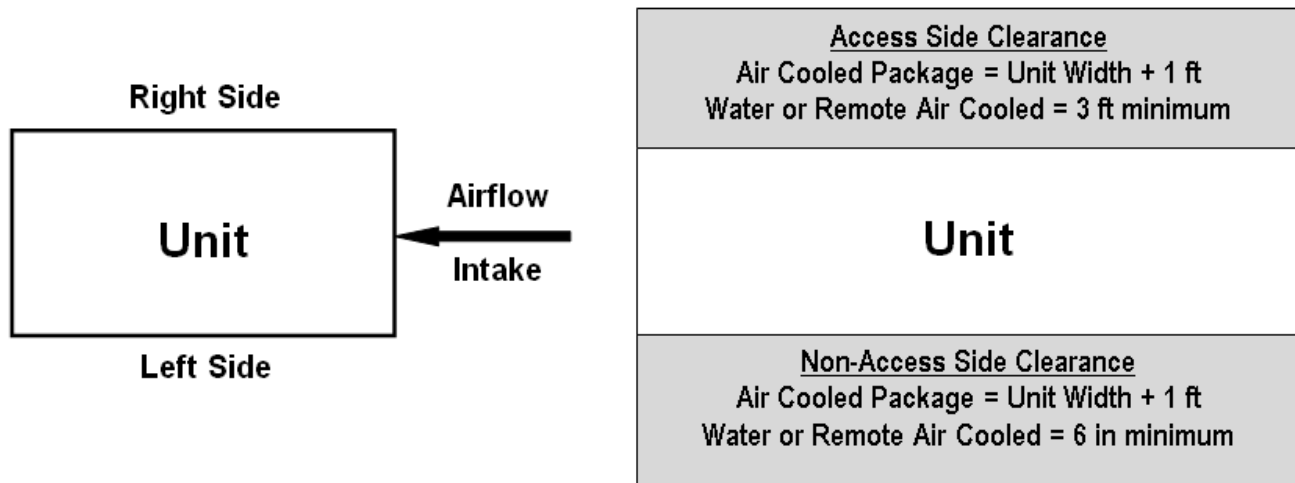
Utility	Location
Electrical, Filter and Service Access	Left Side
Remote Condenser Refrigerant Lines	Not Applicable
Water Cooled Piping Connection(s)	Not Applicable
Aux Heat Connection	Left Side
Condensate Drain	Left Side
Outdoor Intake	Horizontal
Supply Air Discharge	Down
Return Air Intake	Down
Exhaust Air Discharge	Horizontal

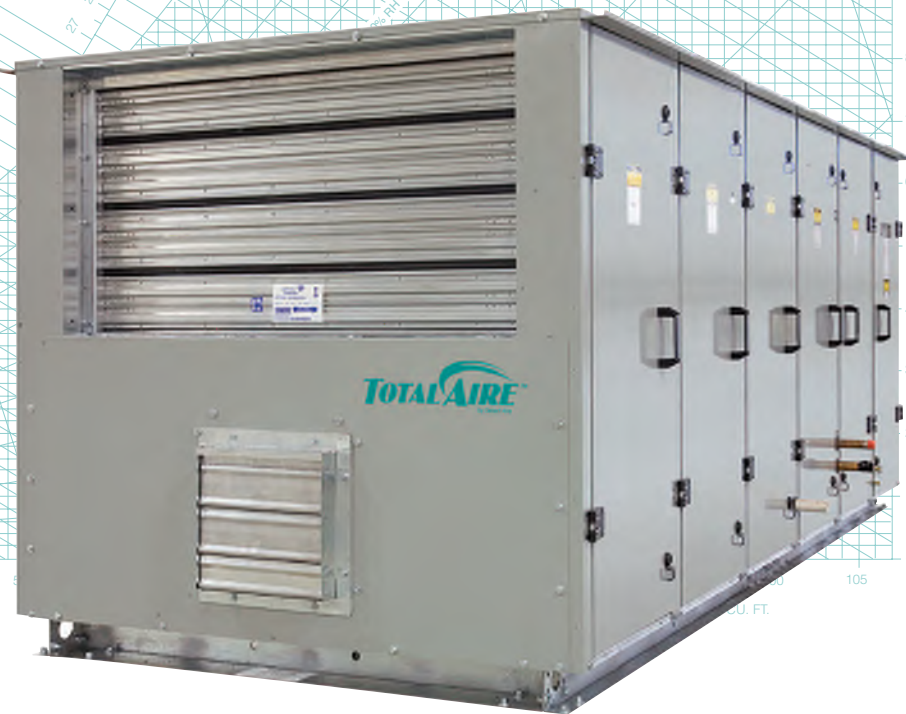
Desert Aire's TotalAire™ Series dehumidifiers provide you the most complete solution for your dedicated outdoor air system (DOAS) and high outside air system (HOAS) applications. Our many options allow you to design the highest energy saving solution for your compliance to ASHRAE 62.1 code ventilation requirements for new construction and renovation projects. This system allows the engineer to separate the latent load of the building and deliver conditioned air to the space which will optimize the performance of the buildings convention heating and cooling systems. Rely on Desert Aire for a solution for your complete outside air needs.

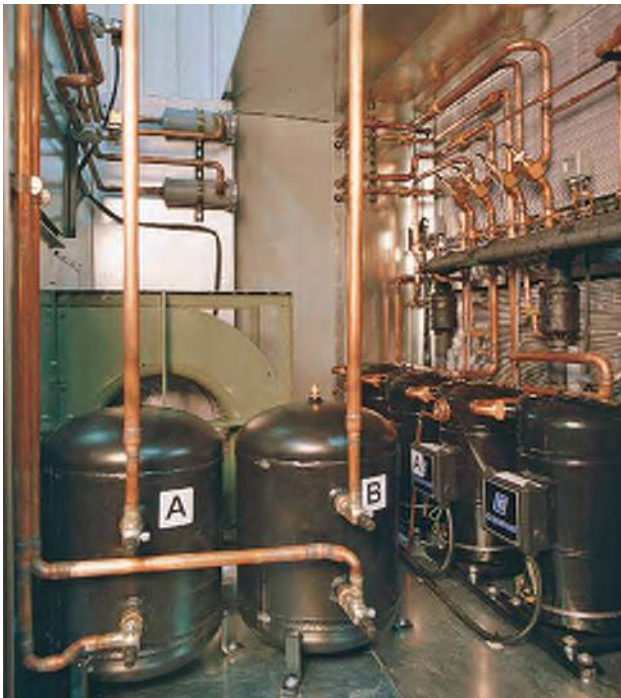
Figure 1 - Basic Refrigeration Circuit Diagram

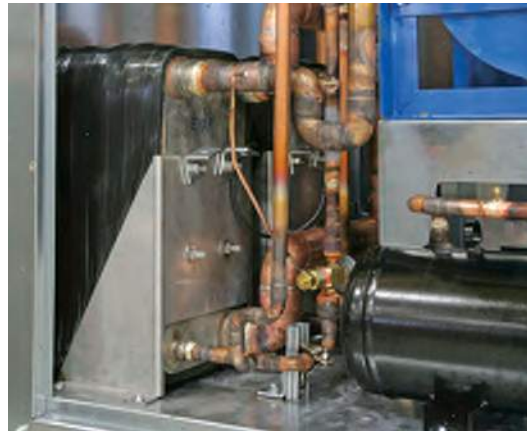
Figure 2 - Water Condenser

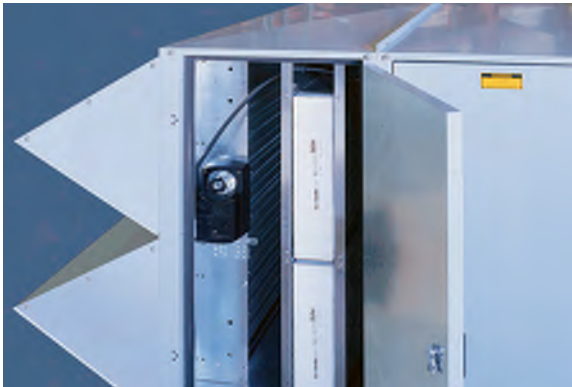
Figure 4 - TotalAire™ Filter Rack With MERV 13 Filters Installed.

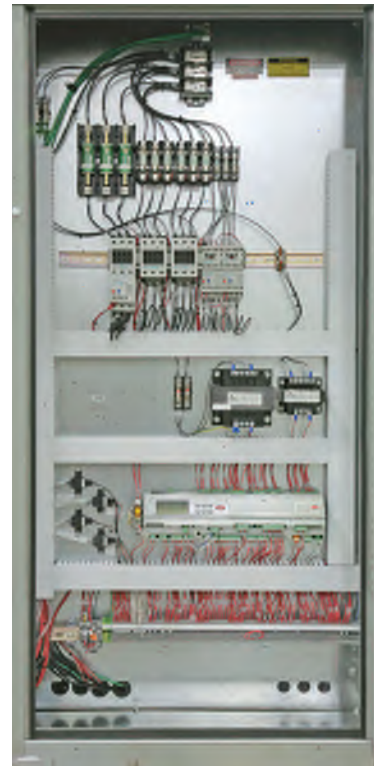
Figure 5 - TotalAire™ Electrical Panel Detail

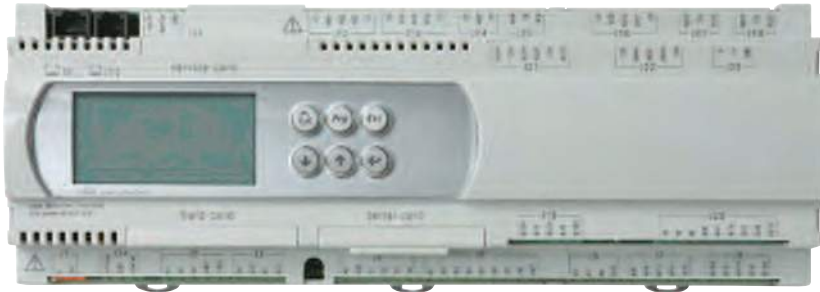
CM3500 Controller Used on QS/QV (20-30 ton) Dehumidifier

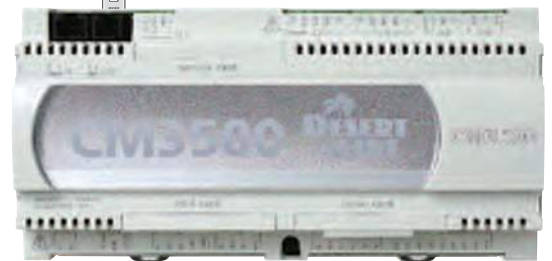
CM3500 Controller Used on QV (4-15 ton) Dehumidifier

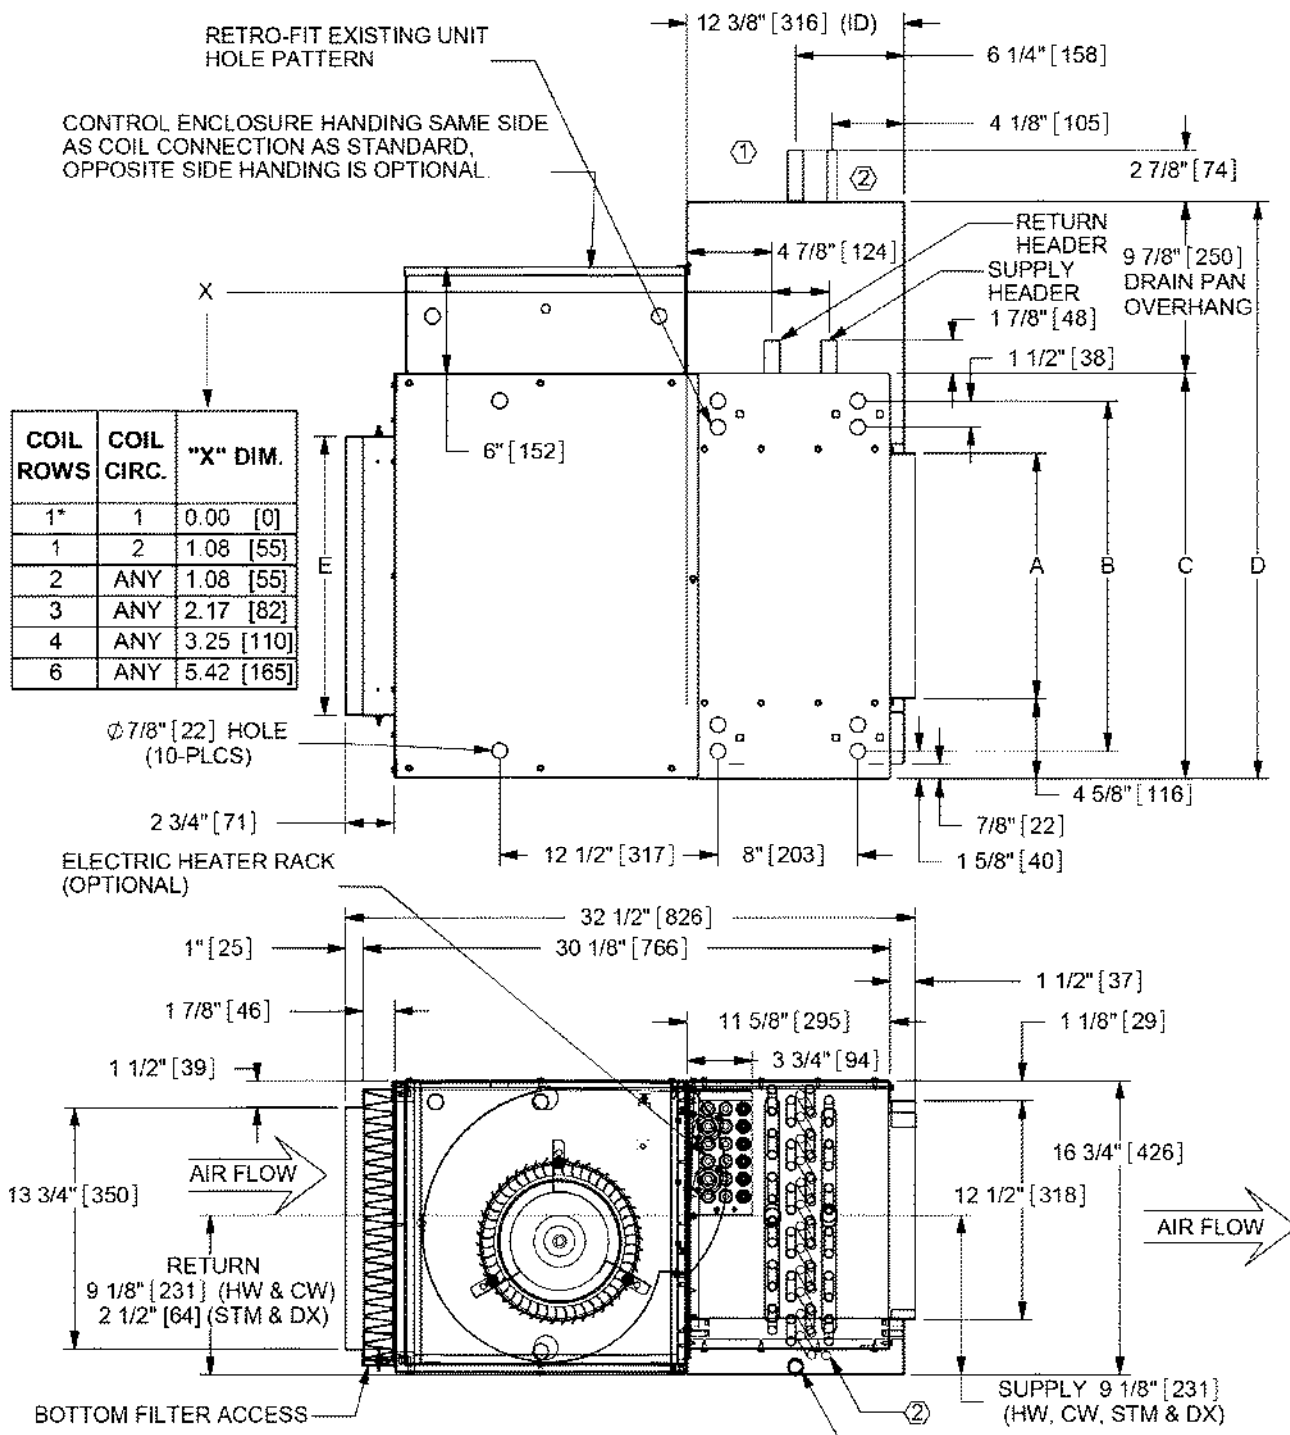
DRAIN PAN MATERIAL	SINGLE CONNECTION (STD) ①	SECONDARY CONNECTION (OPT) ②
GALVANIZED (STD)	7/8" OD COPPER	5/8" OD COPPER
STAINLESS (OPT)	3/4" MPT GALV.	1/2" MPT GALV.

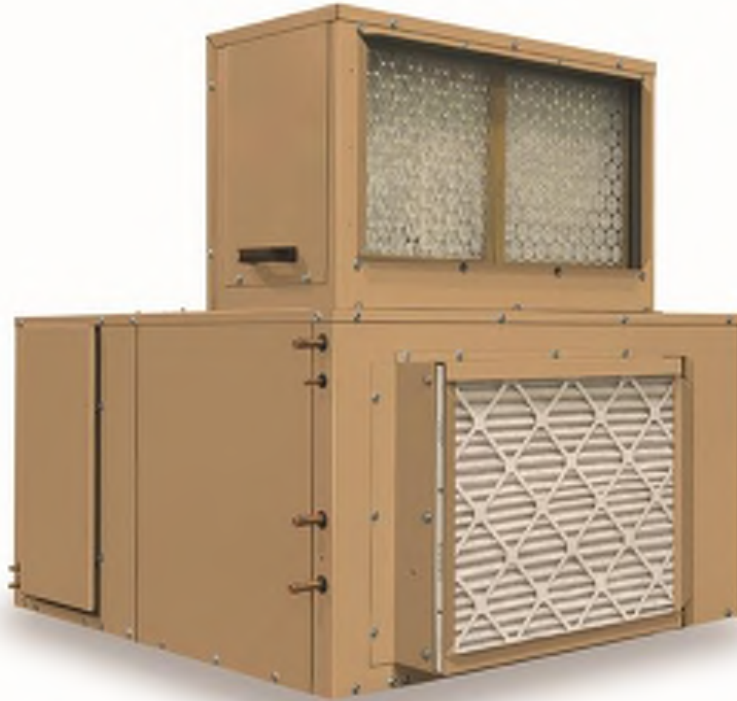
DESERT AIRE REPRESENTATIVE

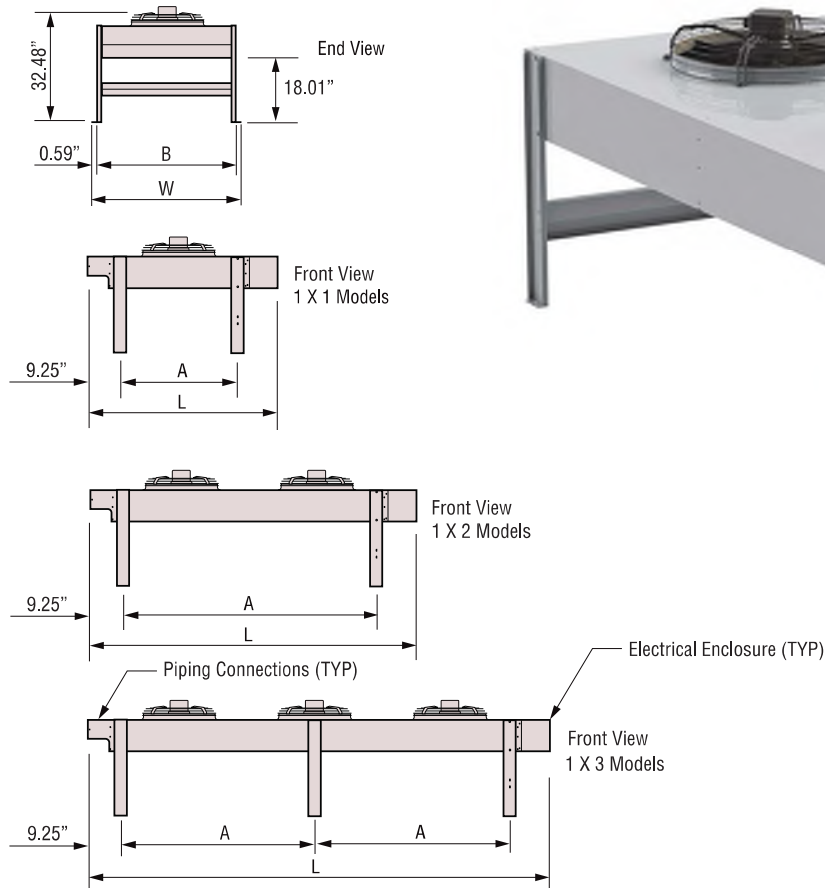
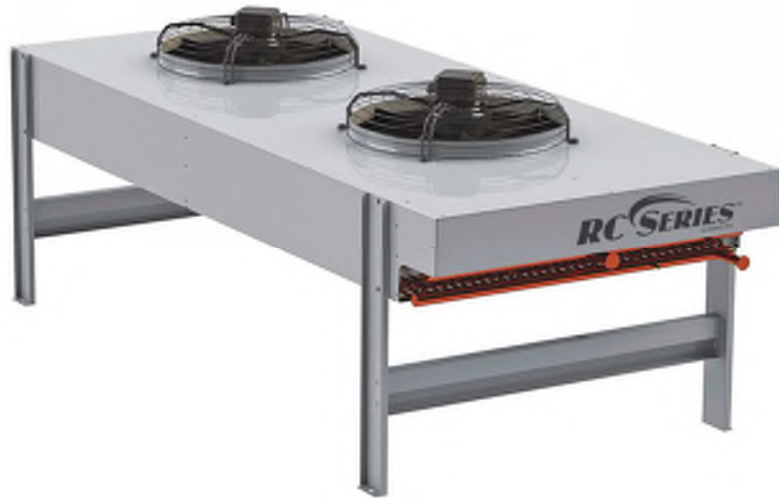
OPTIMIZING SOLUTIONS THROUGH SUPERIOR DEHUMIDIFICATION TECHNOLOGY

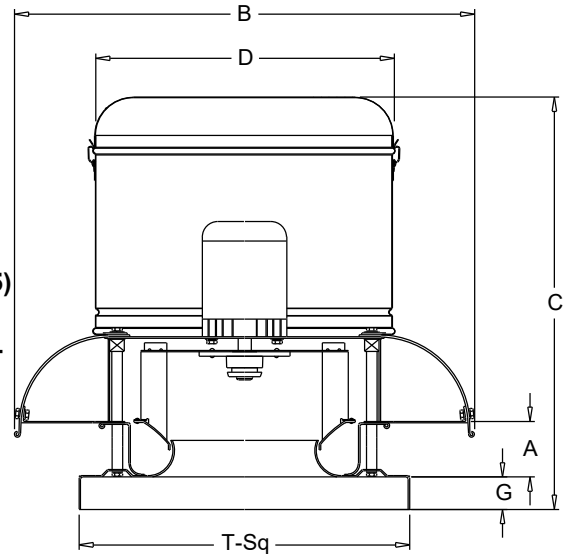
STANDARD CONSTRUCTION FEATURES:
 All aluminum housing - Backward inclined all aluminum wheel - Two piece top cap with stainless steel quick release latches (sizes 101 - 135)
 - Welded curb cap corners - Birdscreen - Permanently lubricated ball bearing electronically commutated motor - Power rated in Input Watts - Corrosion resistant fasteners - Transit tested packaging.

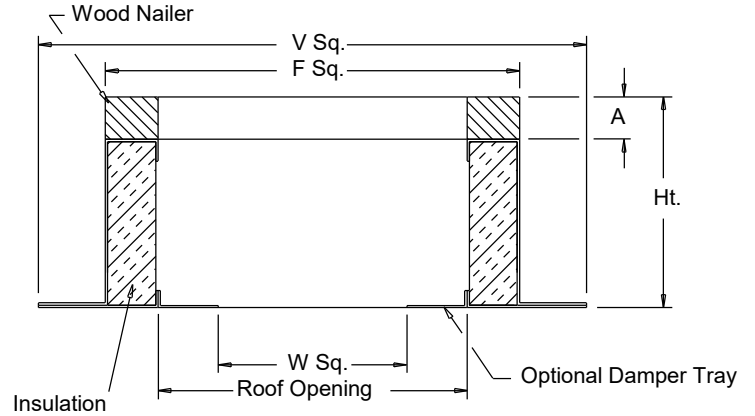
- 1) No wood nailer (deduct 1-1/2" for actual height).
- 2) Damper tray.
