Superior Bathhouse

Historic Structure Report

National Park • Arkansas

prepared by
Chamberlin Architects
Grand Junction Colorado

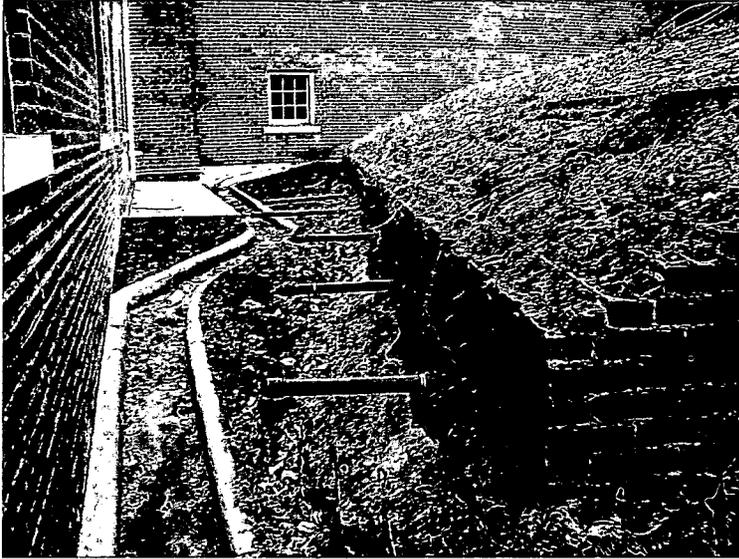
Figure CLA-6: Superior's project area along its back side is comprised mostly of a runoff drainage channel, which is in excellent condition. (Shapins Associates, 2003)

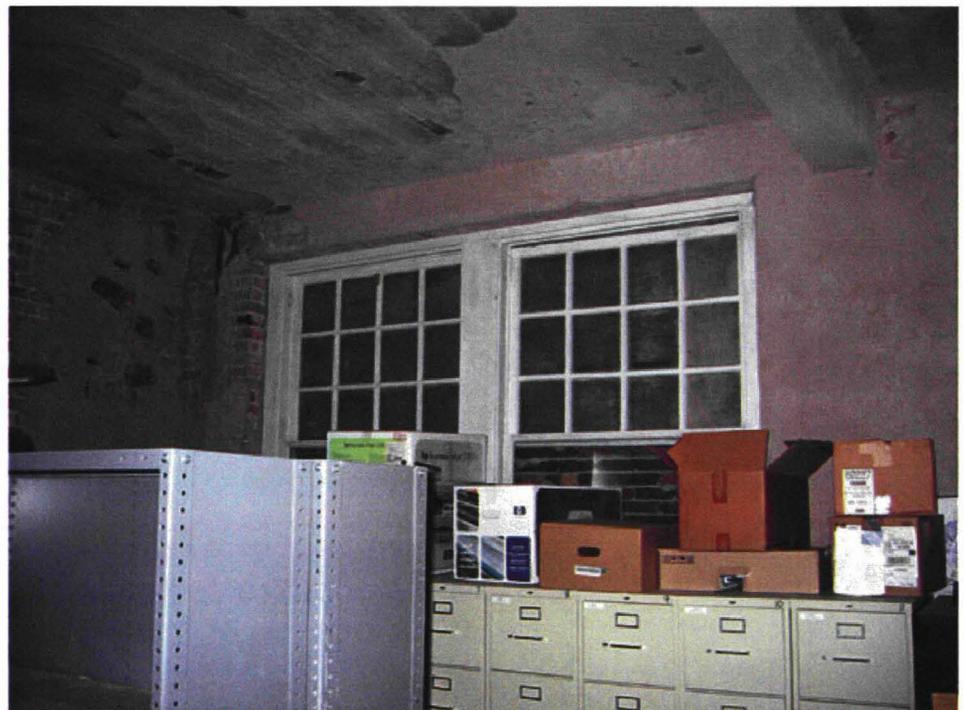
1C-112: Room 111, Women's Dressing. Note ceiling deterioration. Window: 136 (blocked).
Chamberlin. 11/03

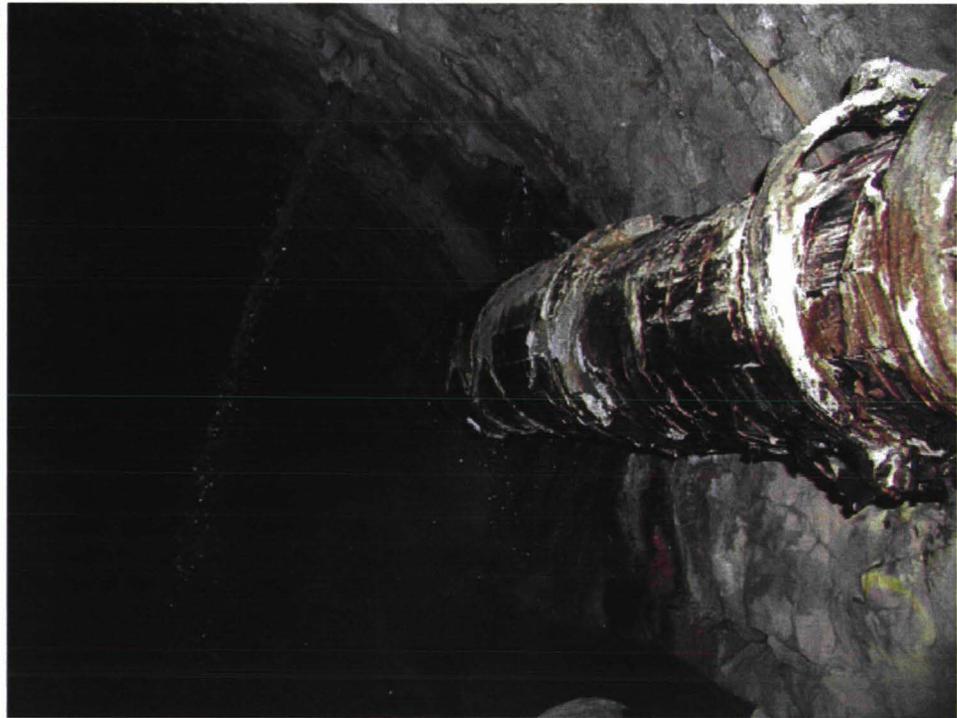
CA-7: The Creek Arch. The droplets glisten on the surface, indicating the passage of water through the masonry.

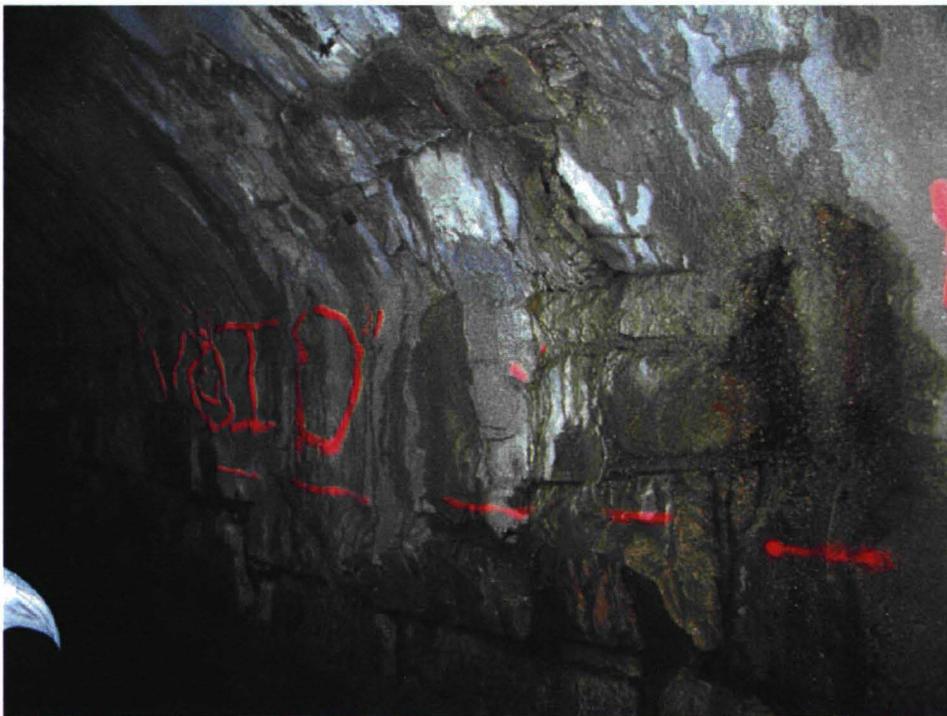
CA-9: The Creek Arch. The "void" designation was the only one found, but it did coincide with areas of mortar loss deep within the joints.

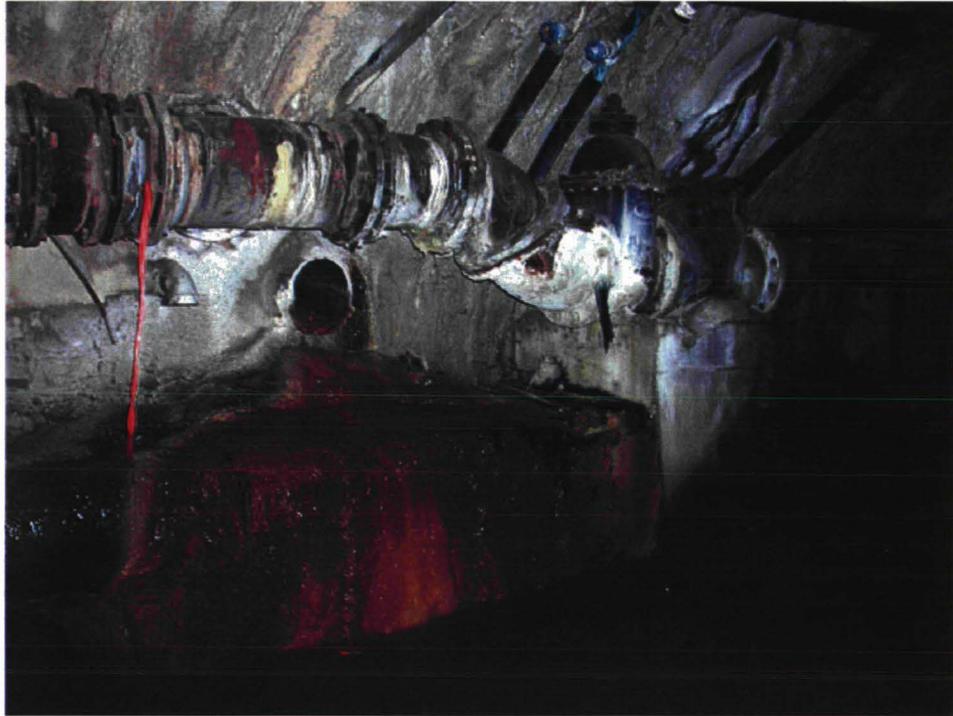
CA-11: The
Creek Arch. Note
the abundance of
faded and overlaid
markings on the
wall beside this
part manhole.
These markings
make location of
problems difficult.

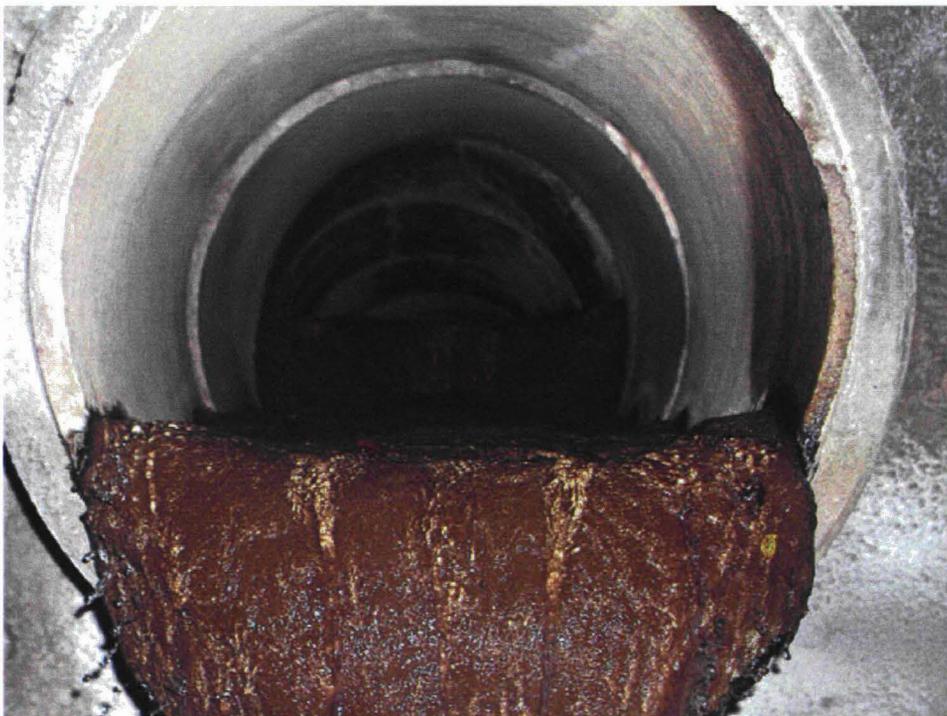
CA-13: The
Creek Arch. The
lower one-third to
two-thirds of the
pipe's diameter
has been blocked
by hot springs
mineral deposits
which can build
up quite rapidly.
