SEED REPORT
ON
RICKS ESTATE DAM
NATIONAL PARK SERVICE
HOT SPRINGS NATIONAL PARK, ARKANSAS
SOUTHWEST REGION

AUG 1984

Prepared by
United States Department of the Interior
Bureau of Reclamation
Division of Dam Safety
Assistant Commissioner - Engineering and Research
Denver, Colorado

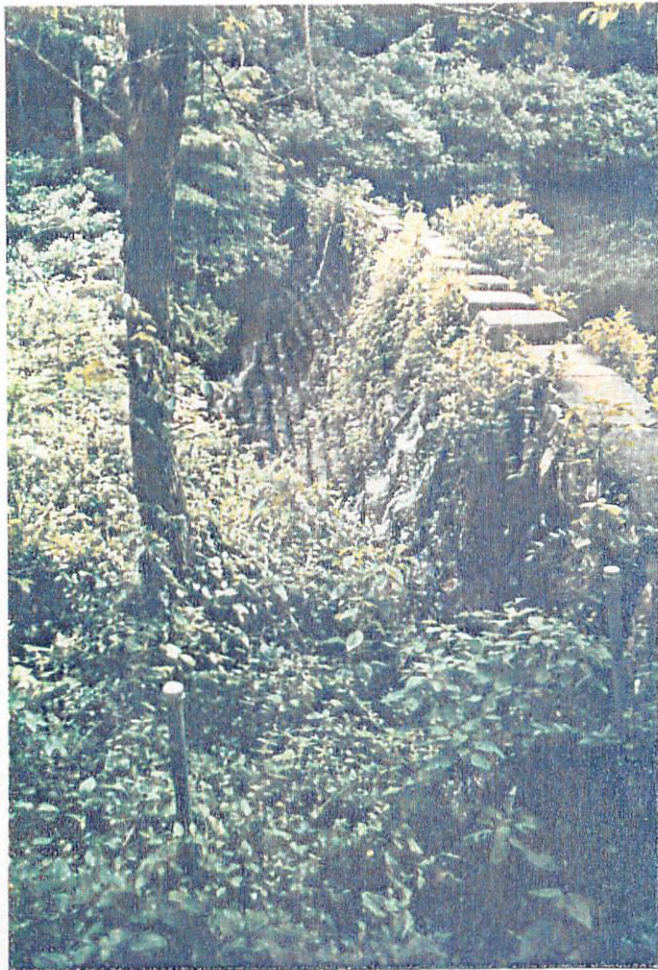
During the June 10, 1982 onsite examination, the reservoir water surface was at the top of the overflow section of the dam (photo CE-2). Seepage was appearing along the downstream face of the dam (photo CE-2).

Photo CE-2. Ricks Estate Dam - Weir
along downstream face showing seepage
near right and left abutments. 6-10-82

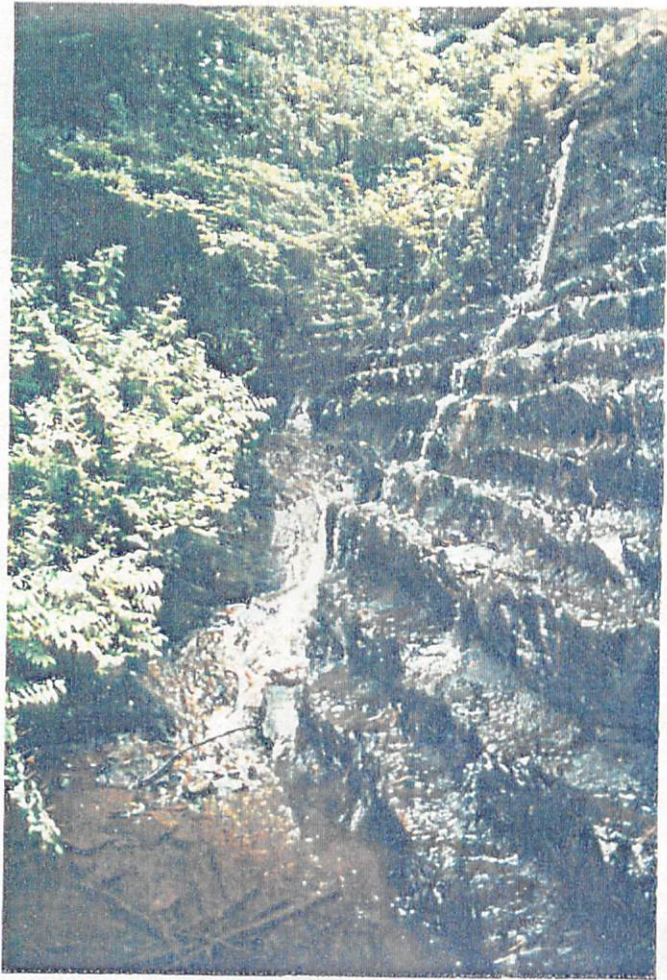
Seepage was primarily present in a 20-foot-wide area beginning approximately 30 feet from the left end of the crest and a 30-foot-wide area at the right end of the dam (photos CE-3 and -4).

Photo CE-3. Ricks Estate Dam - View of right portion of downstream face and groin from toe of dam. 6-10-82

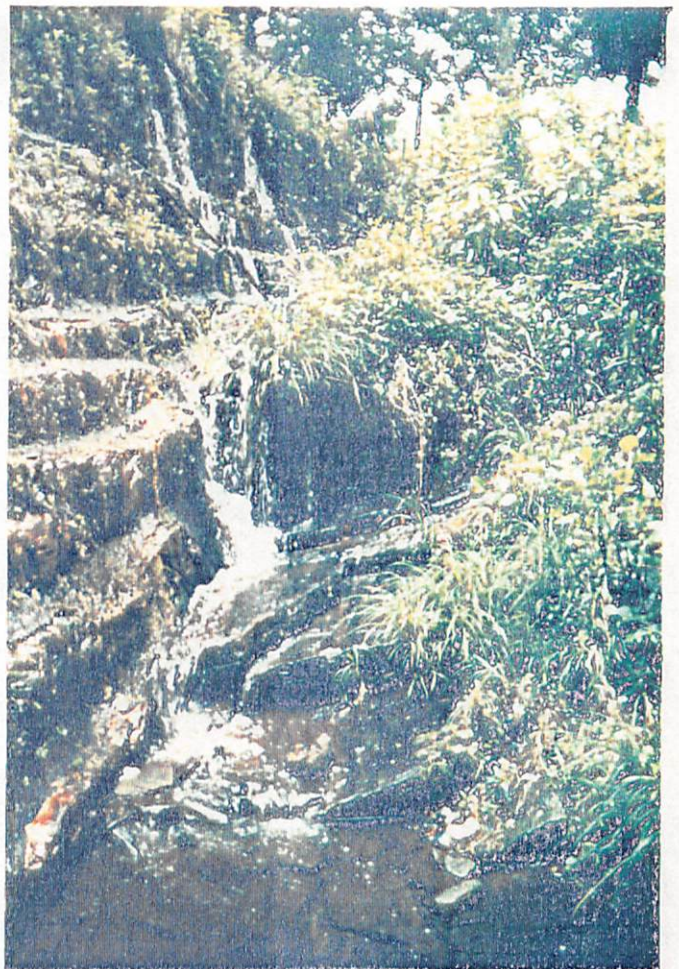
Photo CE-4. Ricks Estate Dam - View of left portion of downstream face and groin. 6-10-82

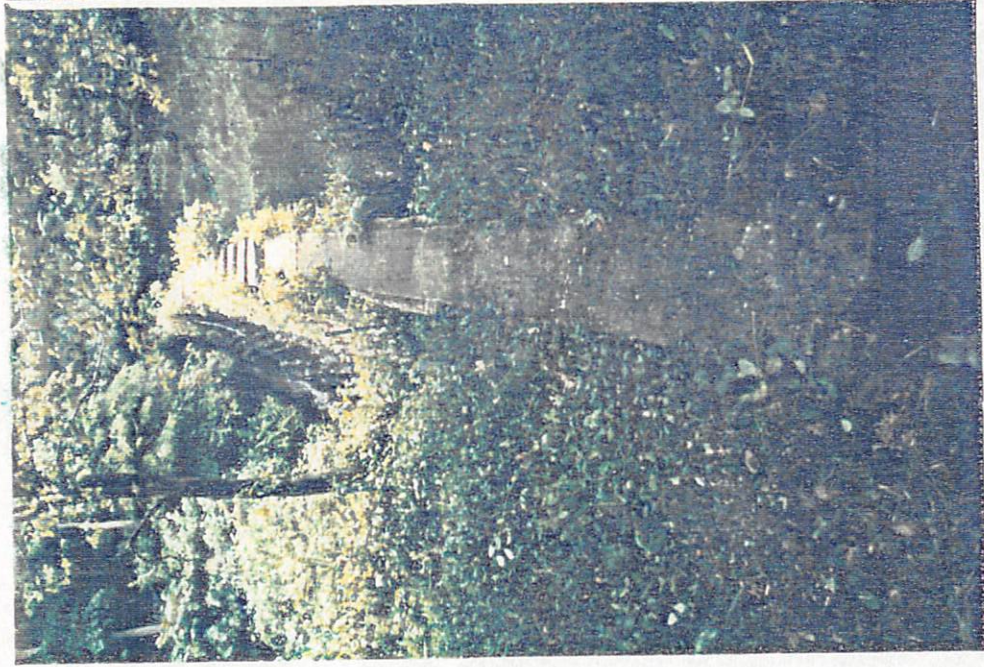
a. Description. - The dam is an ashlar stone gravity structure with a slight curvature. Crest length of the dam is approximately 122 feet at approximate elevation 613.2 near the maximum section. Crest elevation varies being 2 feet higher at the left abutment than at the center of the dam. Crest width varies from approximately 2 feet at the abutments to approximately 2.5 feet at the maximum section. The crest is a castellated overflow section and contains 16 depressed sections which are approximately 1.25 feet deep (photos CE-5 and -6). Width of the depressed areas totals approximately 31.5 feet.

Photo CE-5. Ricks Estate Dam - View along crest of dam from left abutment. 6-10-82

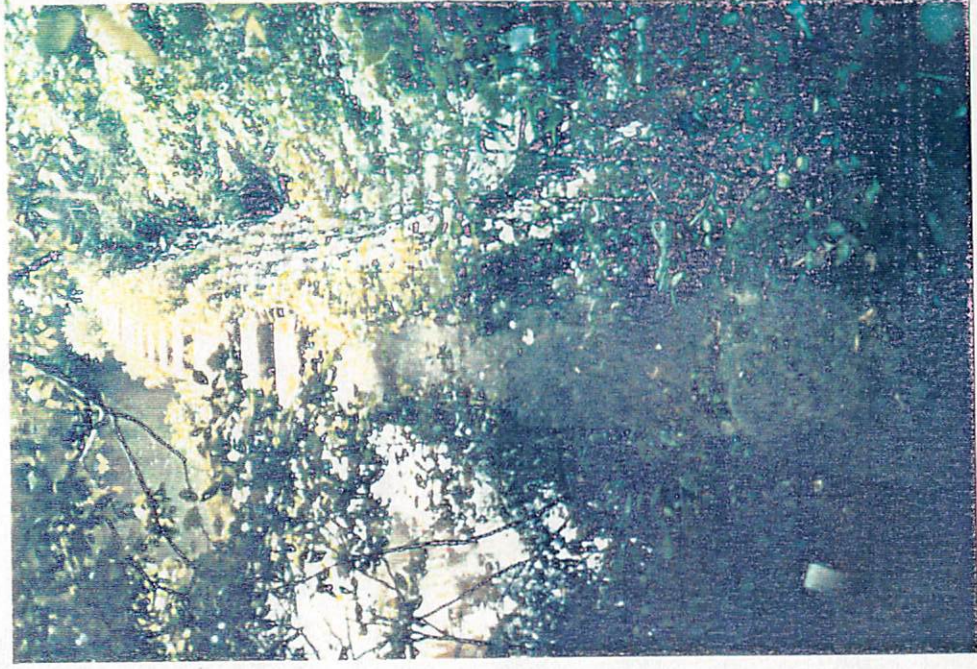
Photo CE-6. Ricks Estate Dam - View along crest of dam from right abutment. 6-10-82

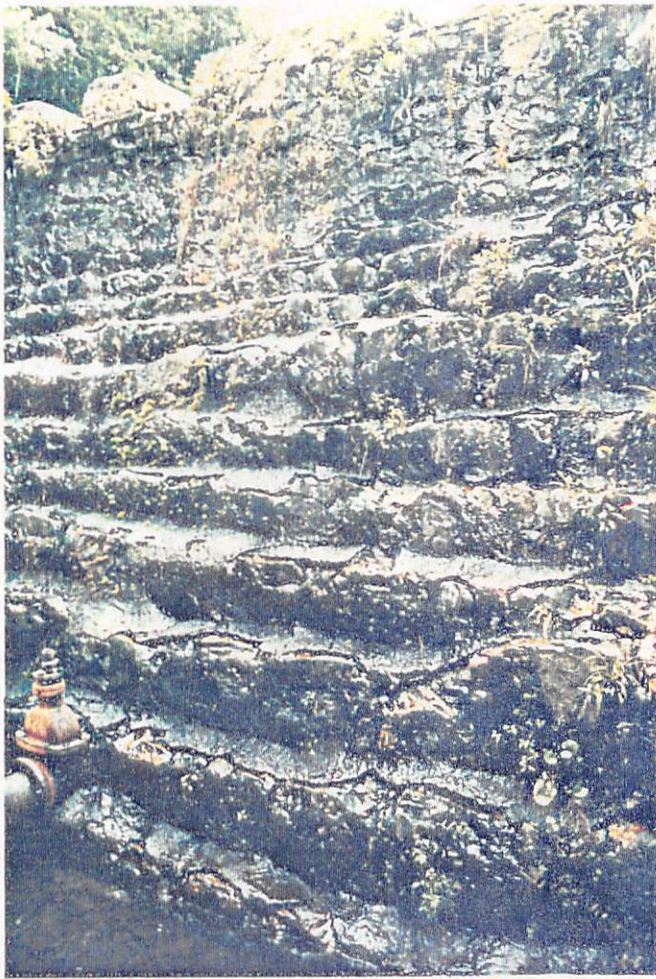
The dam is about 16 feet in height above the streambed. The downstream face at the maximum section is vertical for 6.5 feet below the crest, with about a 1:1 slope below this elevation to the foundation (photo CE-7).

The upstream face is reported by NPS personnel to be vertical to the depth which can be seen above reservoir silt (approximately 9 feet). The dam is constructed of varying size blocks, with the larger units at the base, and the size decreasing to the crest (photo CE-7). The maximum size blocks noted in the lower courses were approximately 2.5 by 2.0 feet. Rock exposed in the downstream face appears to be of local origin, probably composed of cherty novaculite.

Photo CE-7. Ricks Estate Dam - View of maximum section of dam from downstream toe.
6-10-82

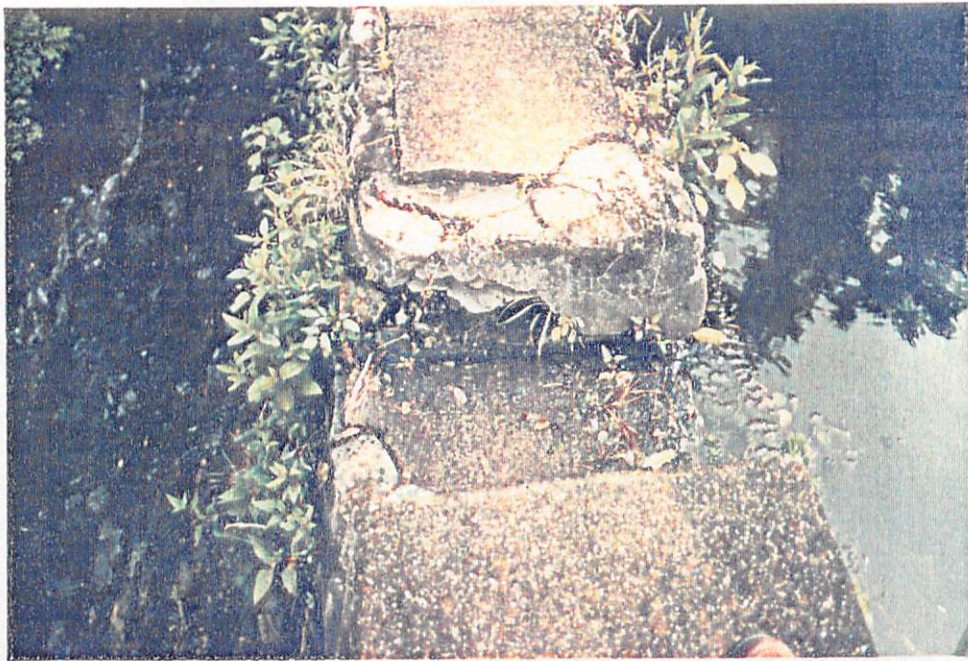
The spillway cap blocks are constructed of rubble masonry, with approximately 8-inch maximum size stones. The crest, including depressed sections, is surfaced and the cap blocks are faced with a thin concrete paving (photo CE-8).

Photo CE-8. Ricks Estate Dam - Closeup view of section of crest.
6-10-82

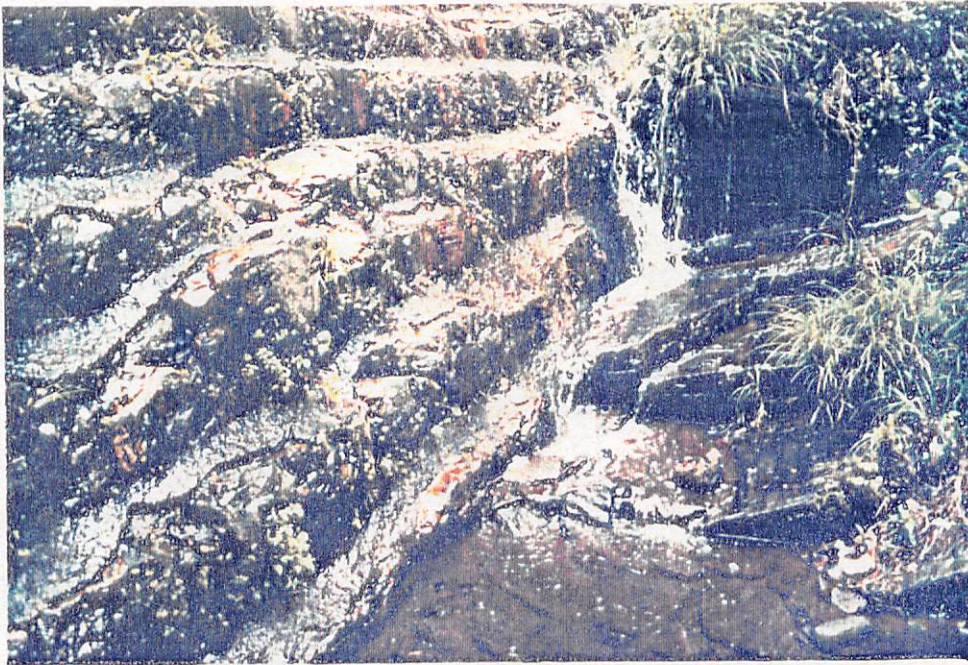
Photo CE-9. Ricks Estate Dam - Closeup of downstream face near left abutment. 6-10-82

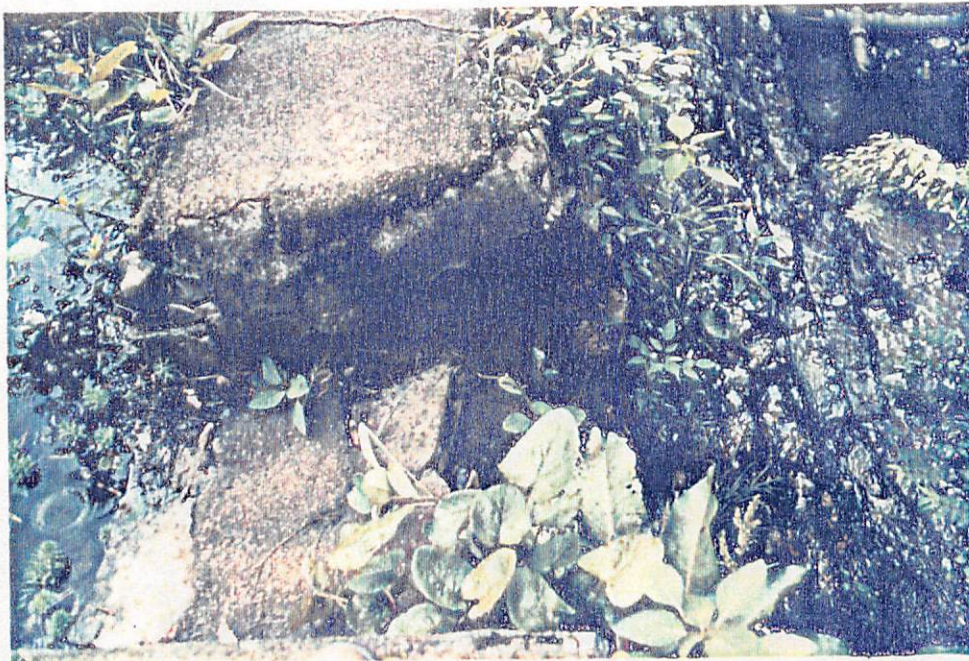
Photo CE-10. Ricks Estate Dam - Closeup of area on crest where stone has been lost from rubble masonry matrix. 6-10-82
