Harry S Truman National Historic Site

Truman Home HS-01
Truman Carriage House HS-02

Historic Structures Report

Architectural Data Section
Existing Condition Drawings

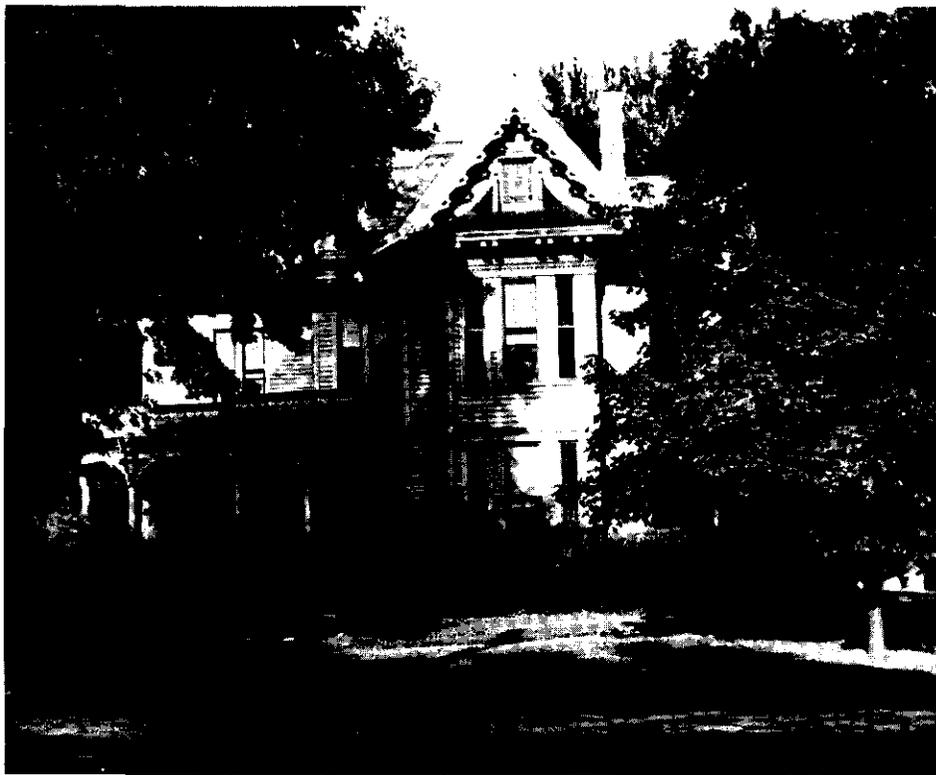
Fig. 1.8 Truman Home, July 11, 1944. West elevation (looking east). Before 1945 renovation. Credit: HSTL

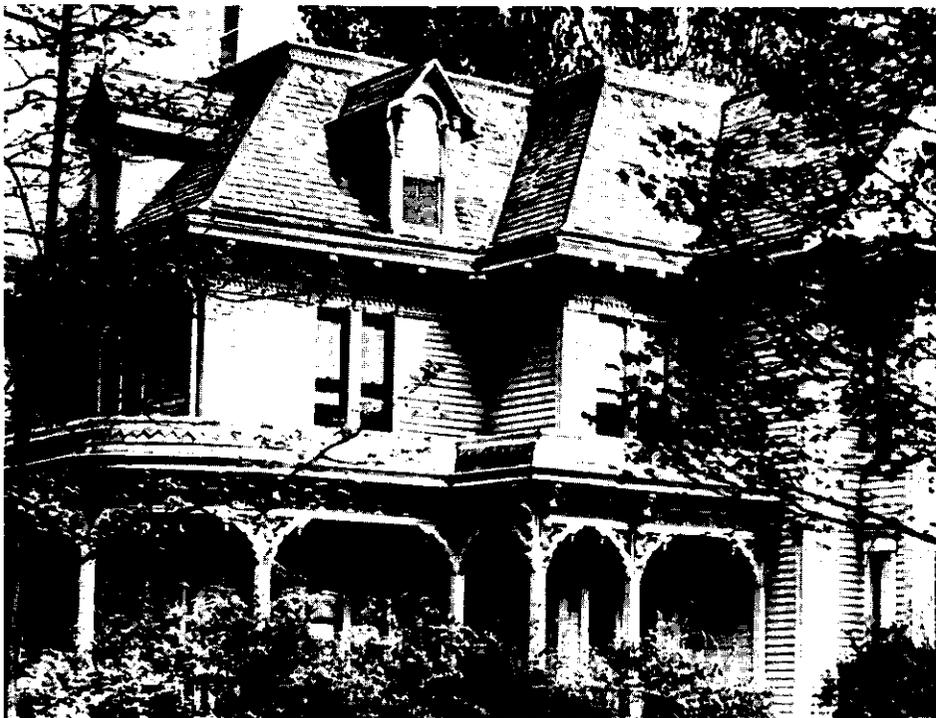
Fig. 1.9 Truman Home, July 22, 1944. West elevation (looking southeast). Detail showing condition of home prior to 1945 renovation. Credit: HSTL

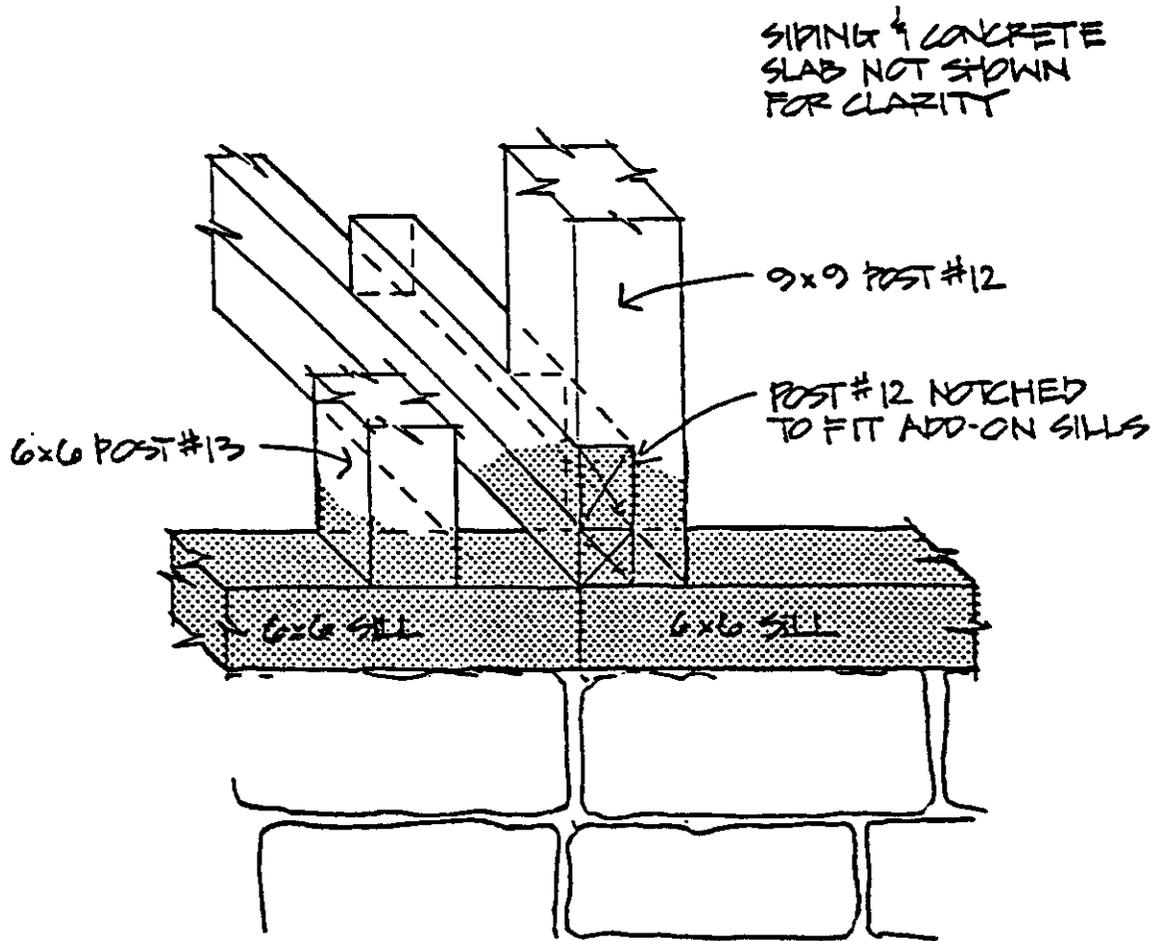
③ POST #12 DETAIL
SCALE ————— 1" = 1'-0"

DETERIORATION
