GATEWAY ARCH Corrosion Investigation Part III

St. Louis, Missouri

Final Report

April 3, 2015

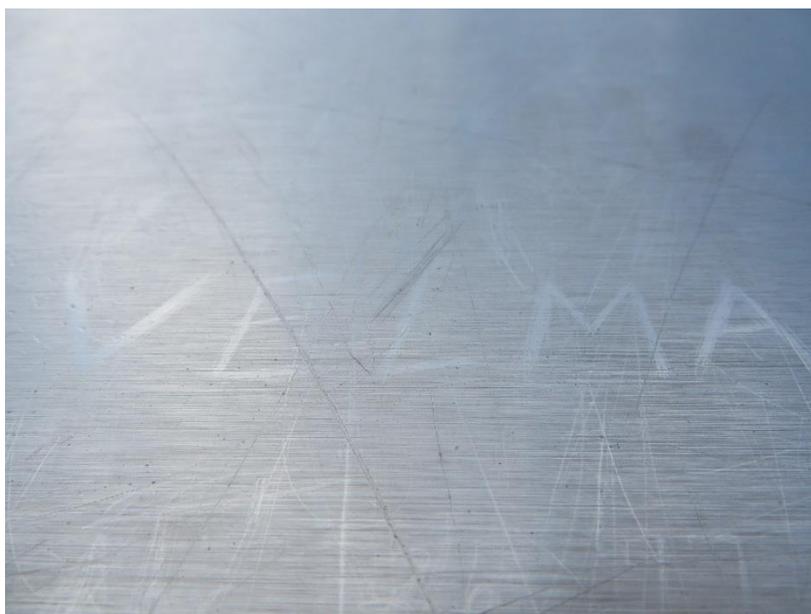
Figure 59. Incised graffiti at the base. (Photo by authors, 2014)

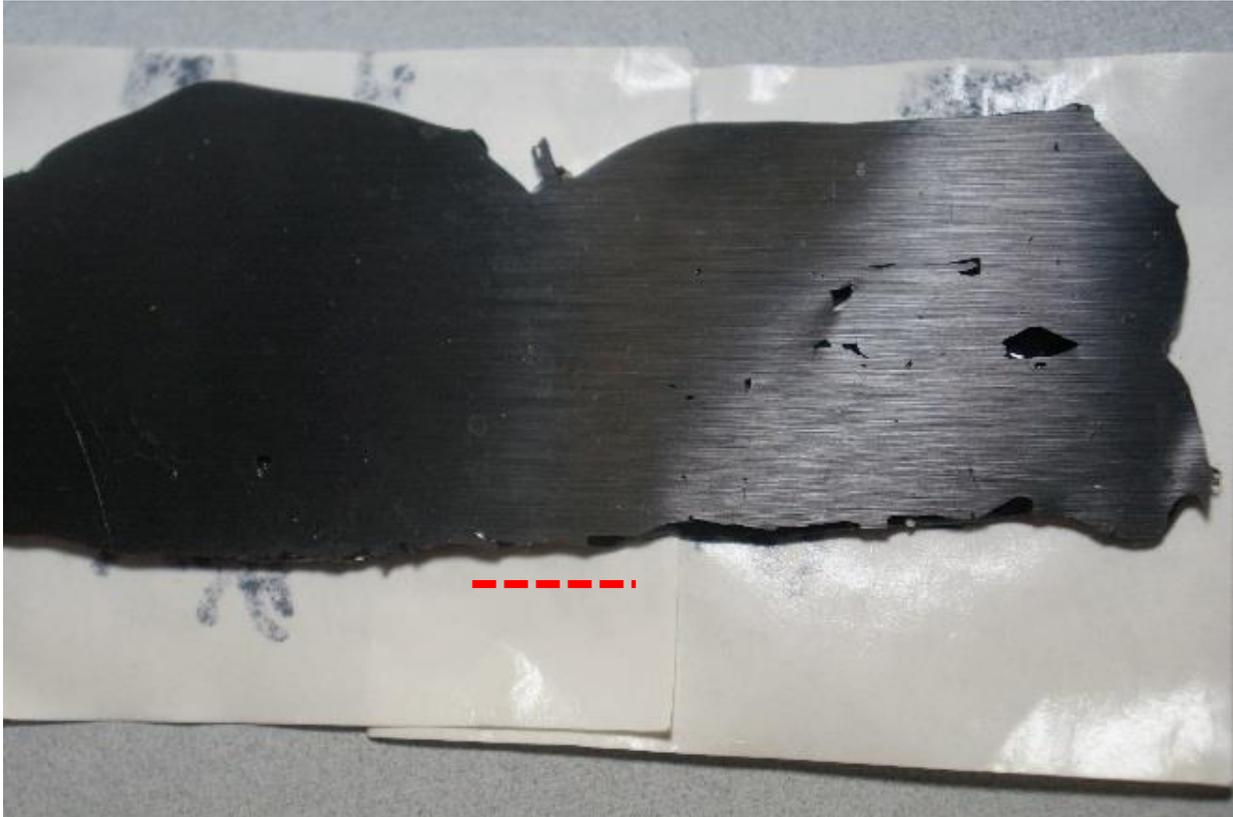
Figure 107. Silicone mold at stainless steel panel. Area above red line shows overlapping finish lines. (Photo by authors, 2014)

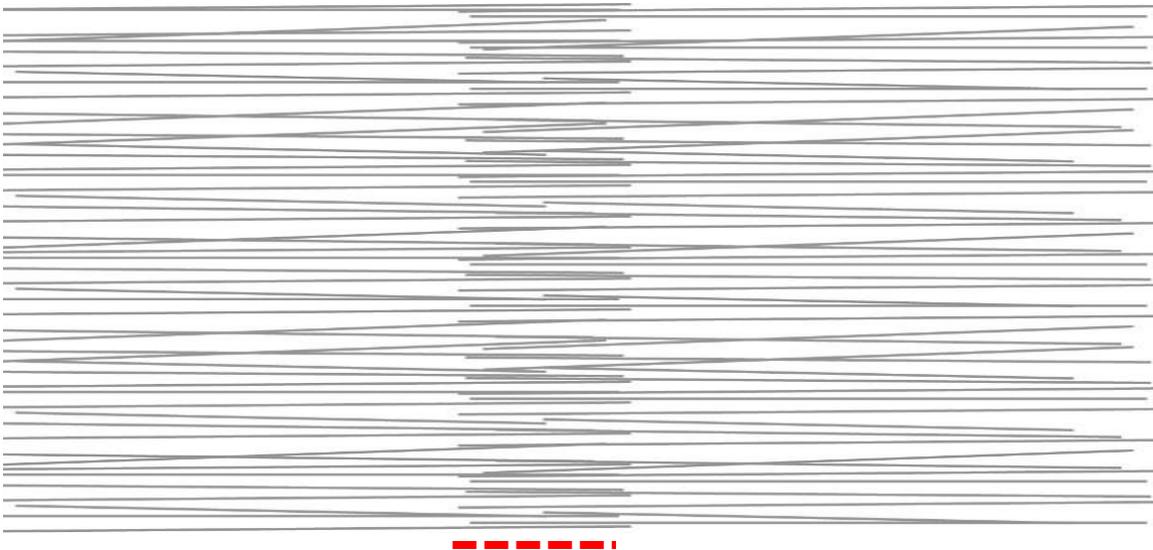
Figure 108. Schematic sketch of overlapping finishing lines in the stainless steel. Area above red line shows overlapping finish lines. (Sketch by authors, 2015).

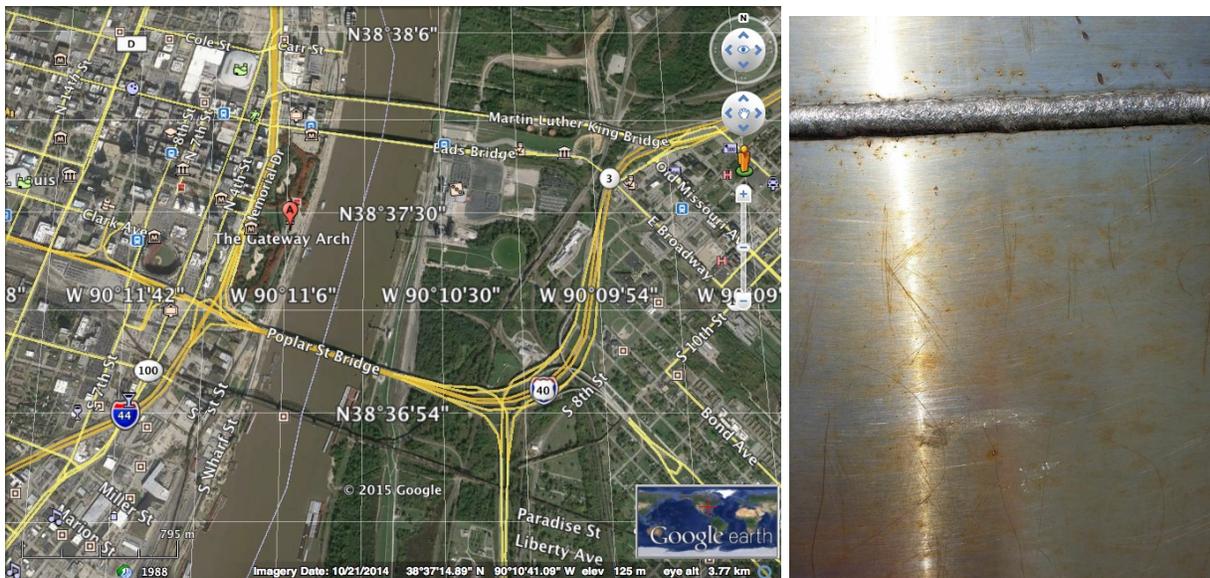
Other than very small, localized areas, such as the elevated areas where iron and ferrochrome particles were found, the only corrosion observed on the surface was at the base. This area would not be as effectively washed by rain as elevated areas with higher wind levels. Light staining caused by microscopic deicing salt related pitting was observed at the base. Very little residue was found on the surface when a Chlor-Test was done, but that would not be unusual in the fall. This corrosion is superficial and could easily be removed.

Figures 2 and 3: Google Earth image (Left) showing the highways and bridges immediately around the site which are adding deicing salts (chlorides) to the environment and the superficial corrosion staining at the base caused by deicing salt exposure. (Right photo taken by authors in 2014)

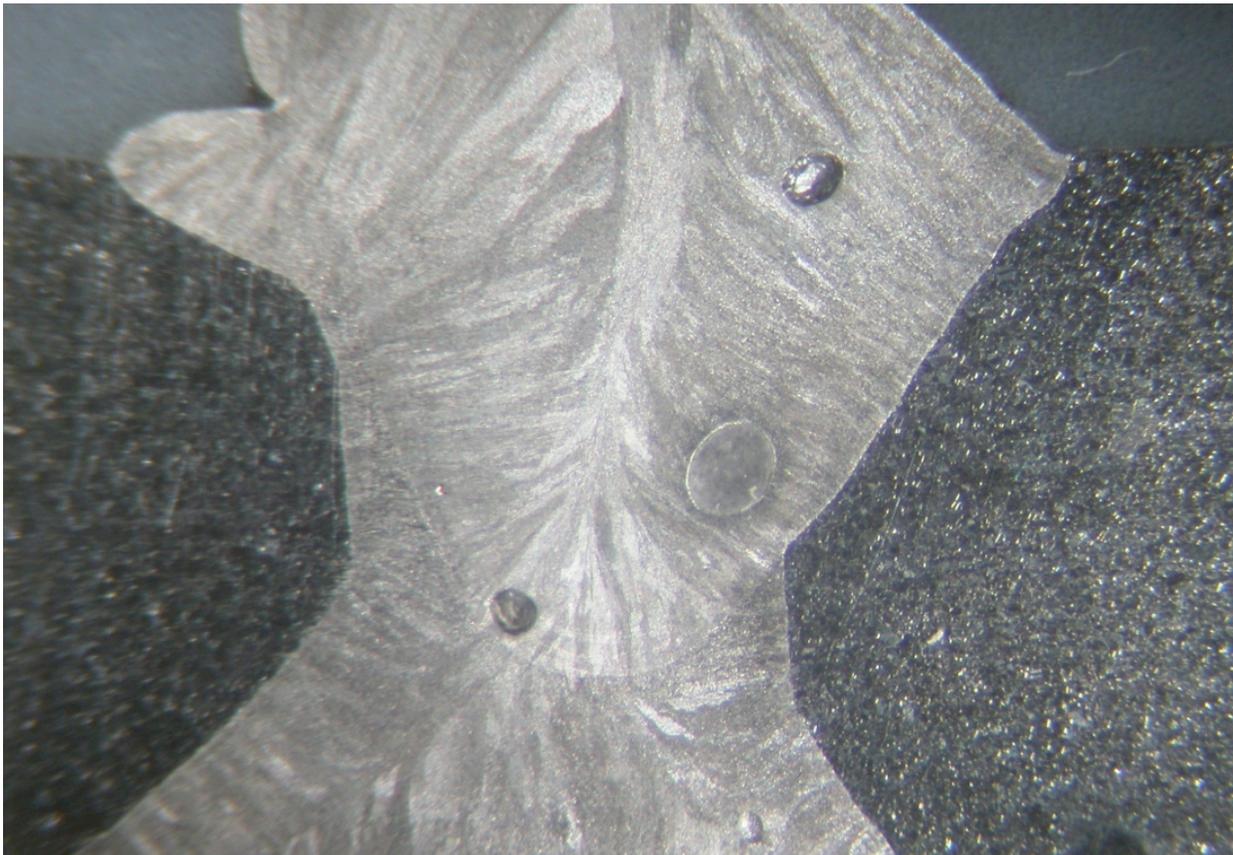
Figure A28: Macrograph, W4, etched condition, showing weld porosity. The largest void, which is located near mid thickness, has an approximate diameter of 0.04". (Photo taken by authors in 2014)

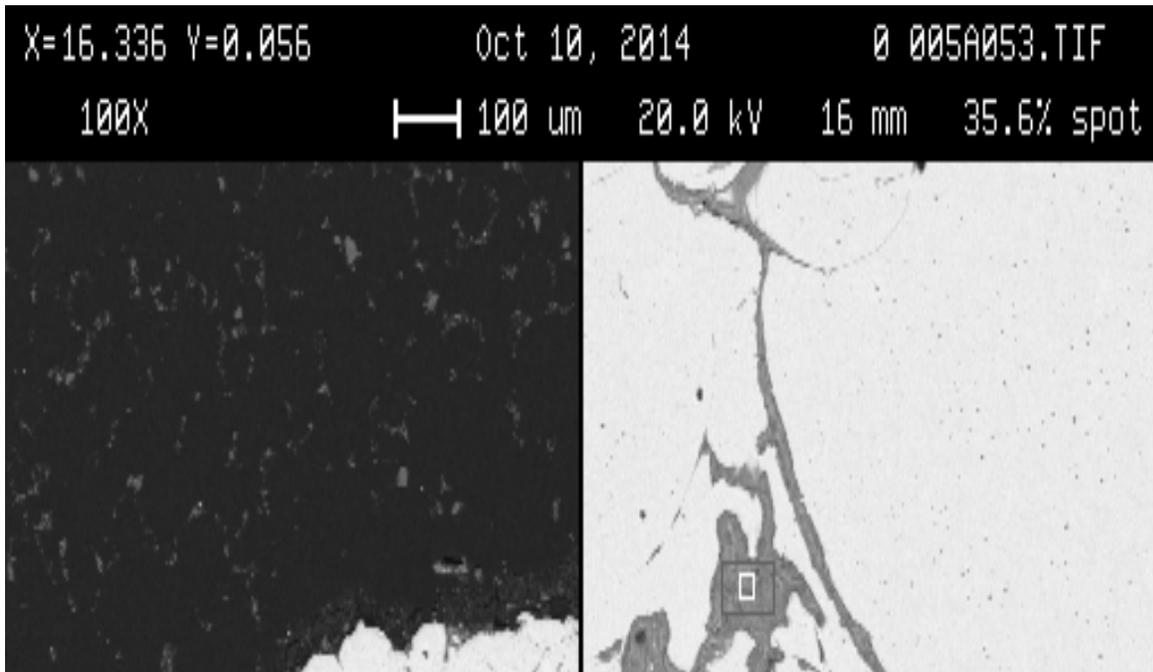
Figures A38: SEM, same weld slag inclusion area with different magnifications (RJ Lee SEM sample scans 2014)

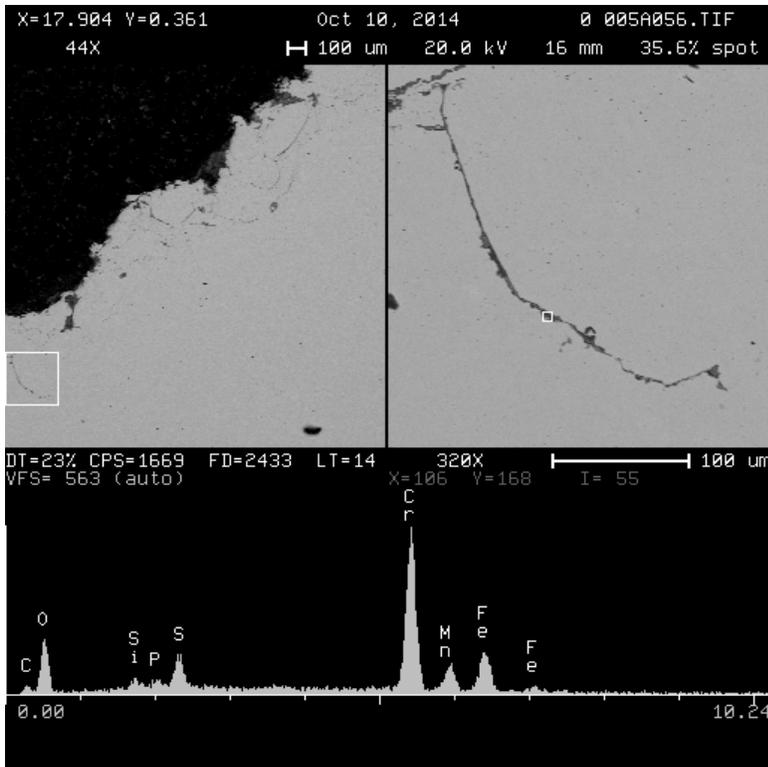
Figure A39: SEM micrograph, sample 5 same area, documenting that the observed linear areas are CrO and not cracks in all areas. No corrosion was observed. (RJ Lee SEM sample scan 2014)

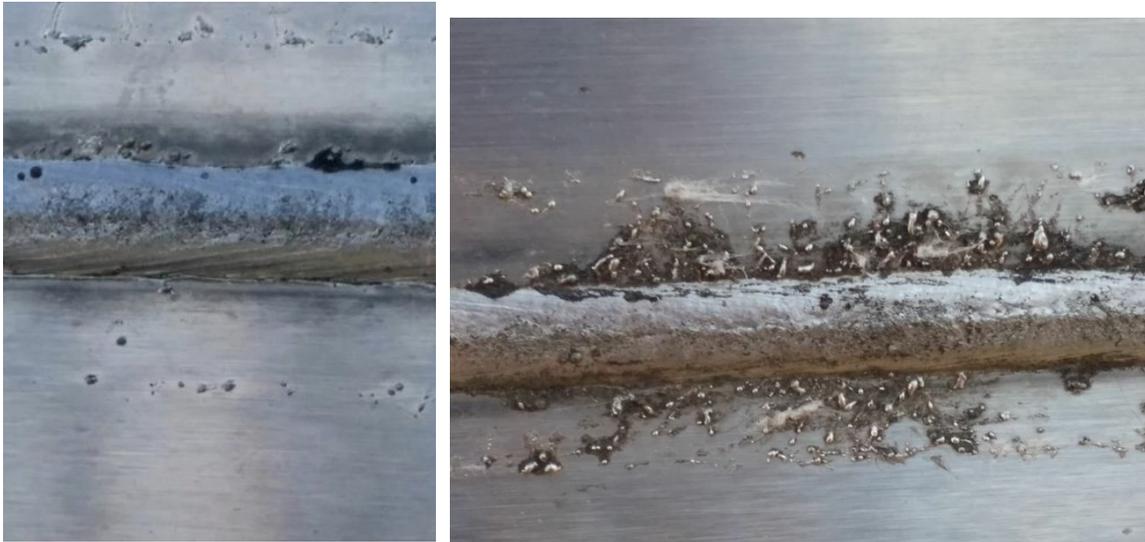
Figure C11 and C12: Weld spatter differences in areas with minimal versus significant surface deposits. (Photos taken by authors in 2014)

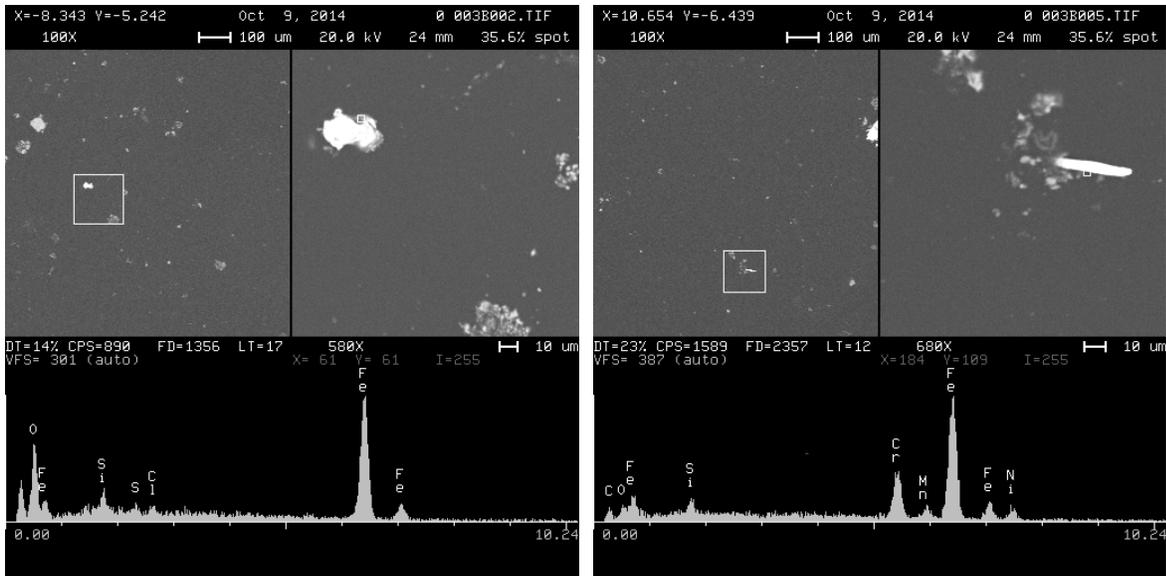
Figure C15 and C16: Iron with small amounts of soil (left, C15) and a stainless steel particle (no oxygen so it is not corrosion product) (right, C16). (RJ Lee SEM sample scans 2014)

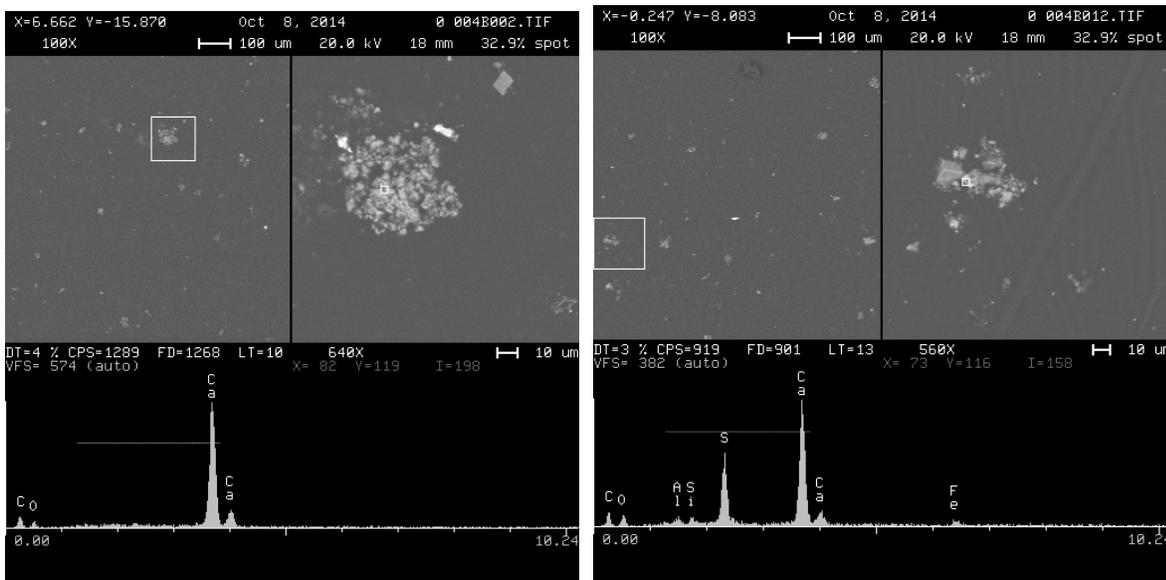
Figure C17 and C18: Calcium (left, C17) and fly ash (right, C18). (RJ Lee SEM sample scans 2014)

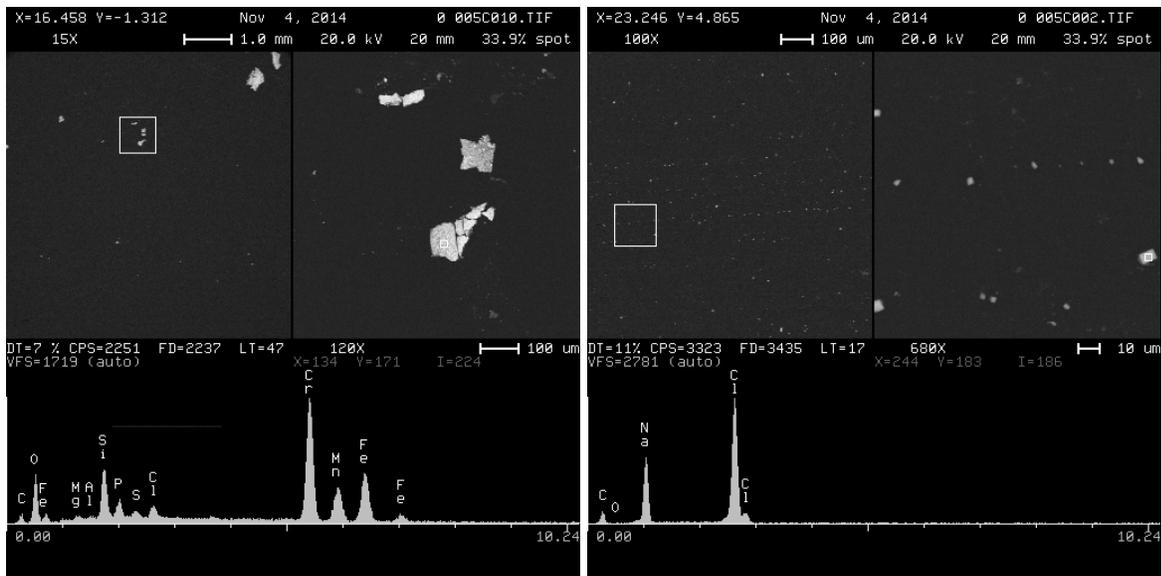
Figure C36 and C37: These were typical of the oxidized (corroded) steel or iron slag (left) and many small sodium chloride particles (deicing salt, right) on the lift. (RJ Lee SEM sample scans 2014)

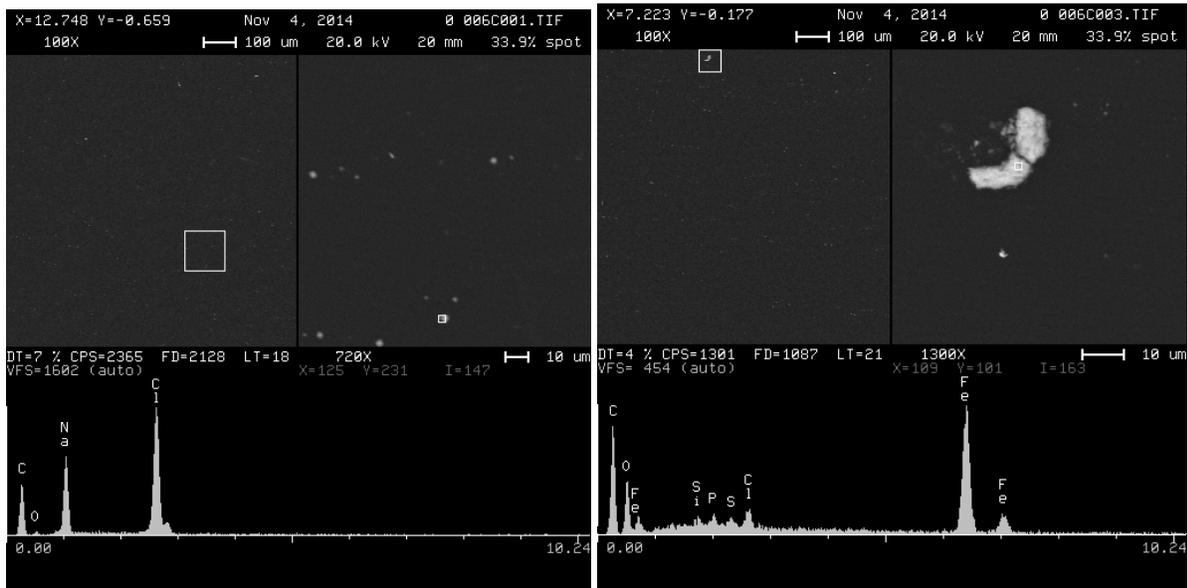
Figure C42: Sodium chloride (deicing salt) was found in combination with clay and iron/chloride/carbon organic particles were also found. (RJ Lee SEM sample scan 2014)

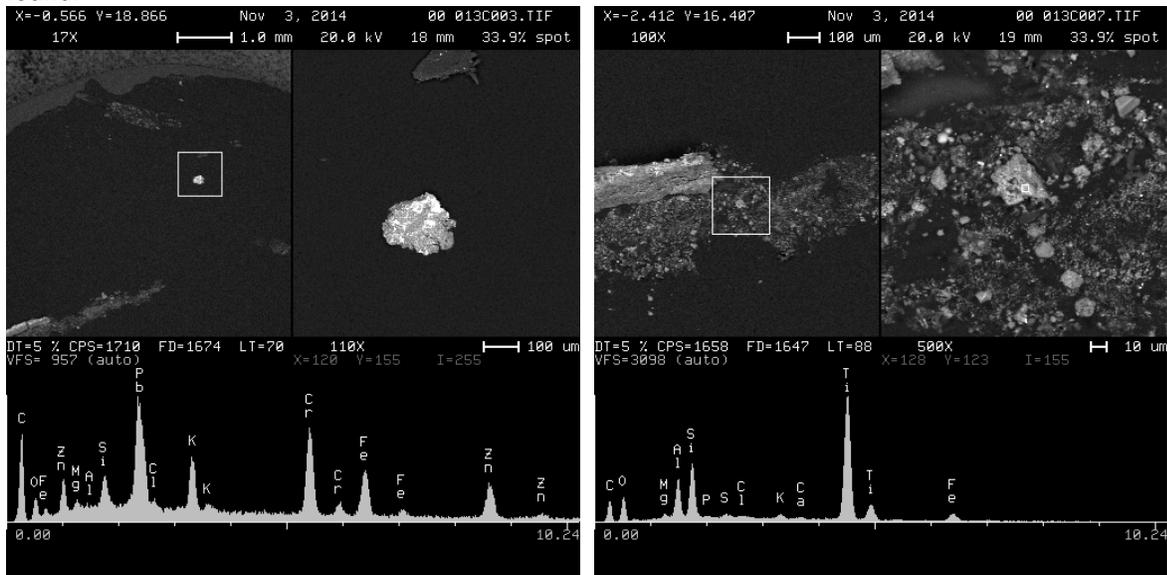
Figure C44 and C45: Iron or steel slag, zinc, lead, and potassium chloride (left) and titanium with soil and a small amount of iron and chlorides (right). (RJ Lee SEM sample scan 2014)
