**STABILIZATION OF THE SILVER BELL MINE:
JOSHUA TREE NATIONAL PARK, RIVERSIDE COUNTY, CALIFORNIA**

PREPARED FOR THE NATIONAL PARK SERVICE

THE SCHOOL OF ENGINEERING

October 2017

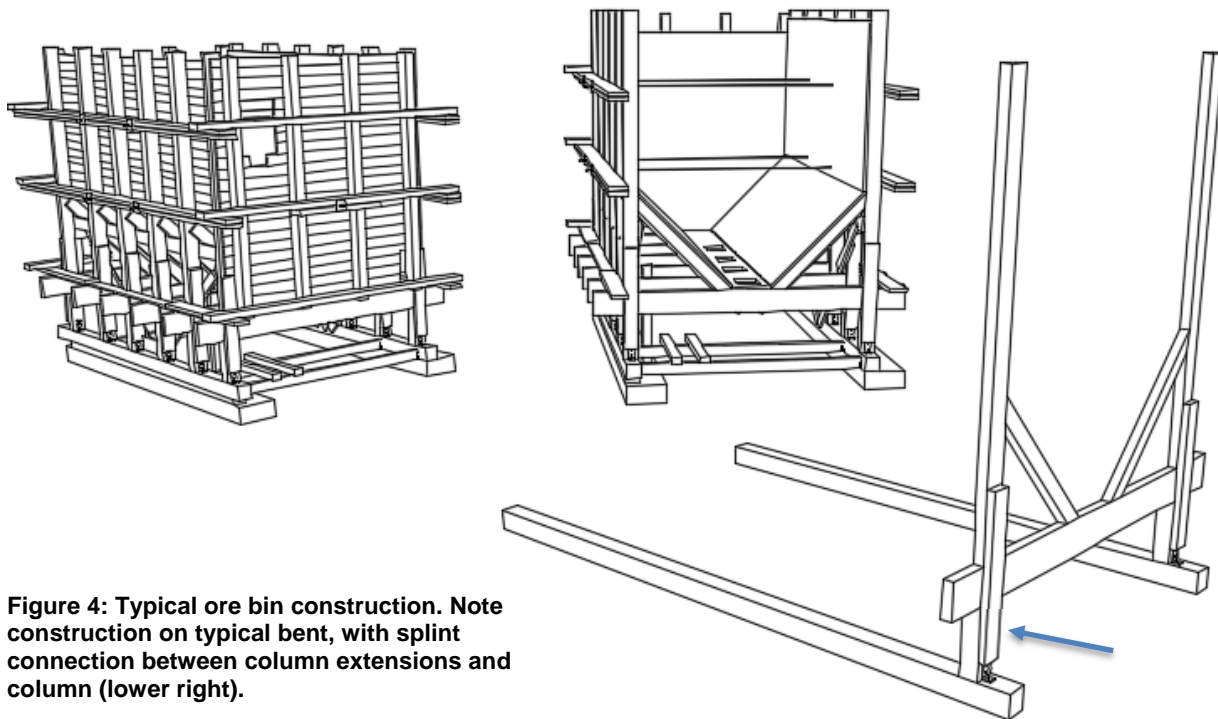
Figure 4: Typical ore bin construction. Note construction on typical bent, with splint connection between column extensions and column (lower right).

Differential settlement of the bins due to the deterioration of some, but not all, of the supporting elements resulted in rotations that placed stress on some of the bolted connections that exceeded capacity. An inspection of splint-column and brace-column connections discovered end splits and relish failures in splints and other small-dimension members that resulted in reductions in connection capacity. UV weathering of small dimension members contributes to this reduction in capacity insofar as weathering promotes the development of drying checks that can become end splits and relish failures.

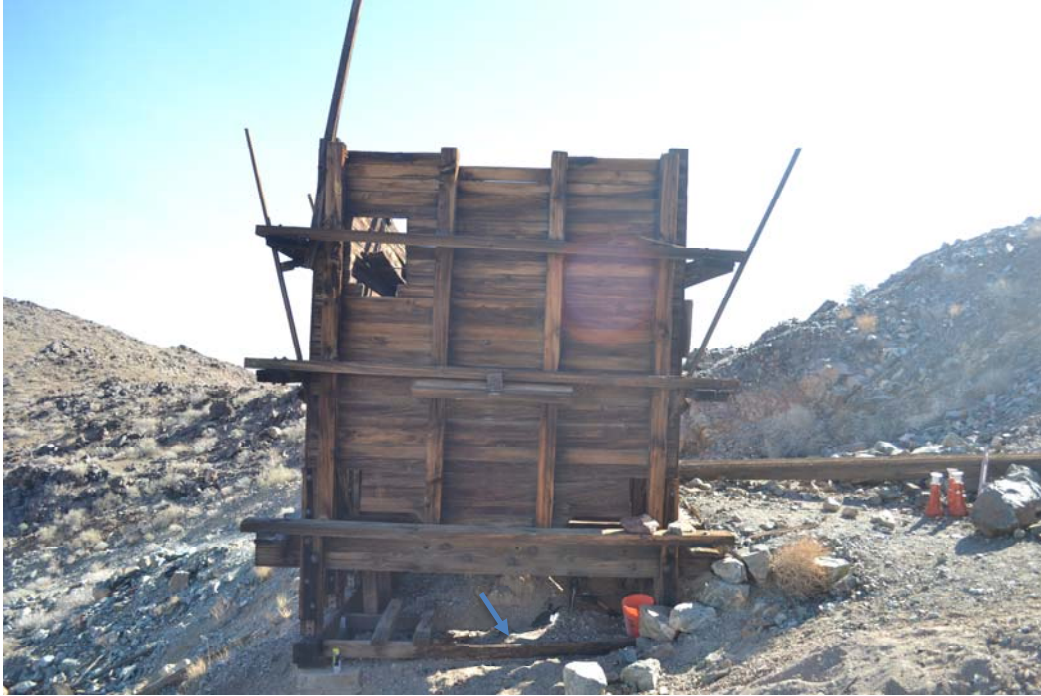
At the east bin (Bin #1), loss of support on the south side due to decay of the sill, column extensions, and diagonal bracing resulted in rotation of the bin around the north sill (out of plumb to the south). At the west bin (Bin #2), encroachment of the bank on the south side of the bin caused significant timber decay to the south end of both the east and west sills, along with the loss of several column extensions and dimension lumber braces on the east and west sides of the structure. This resulted in settlement and an out-of-plumb condition to the south.

Figure 5: Bin #1, looking east. Decay at the south sill (just out of view) has allowed the ore bin to rotate out of plumb to the south. Also, note the condition of the timber spreader between the north and south sill (bottom center).

- Jack and return the ore bin to a plumb position using screw jacks positioned on the south side of the structure;
- Excavate and replace the decayed south sill and four of six column extensions supporting the ore bin in order to fix the bin in a plumb position;
- For splints in salvageable condition, reattach with existing hardware, torqued to establish sufficient connection capacity. Replace unsalvageable splints in-kind, using original hardware;
- Replace deteriorated bracing to tie all column assemblies to new timber sill;
- Repair/replace boards on south retaining wall as necessary to reduce accumulation of soil on new sill;
- Replace wood spreaders between north and south sills;
- Re-attach all existing clip angles, TECO ties, and hardware;
- Apply borate preservative to mitigate future decay and insect infestation.

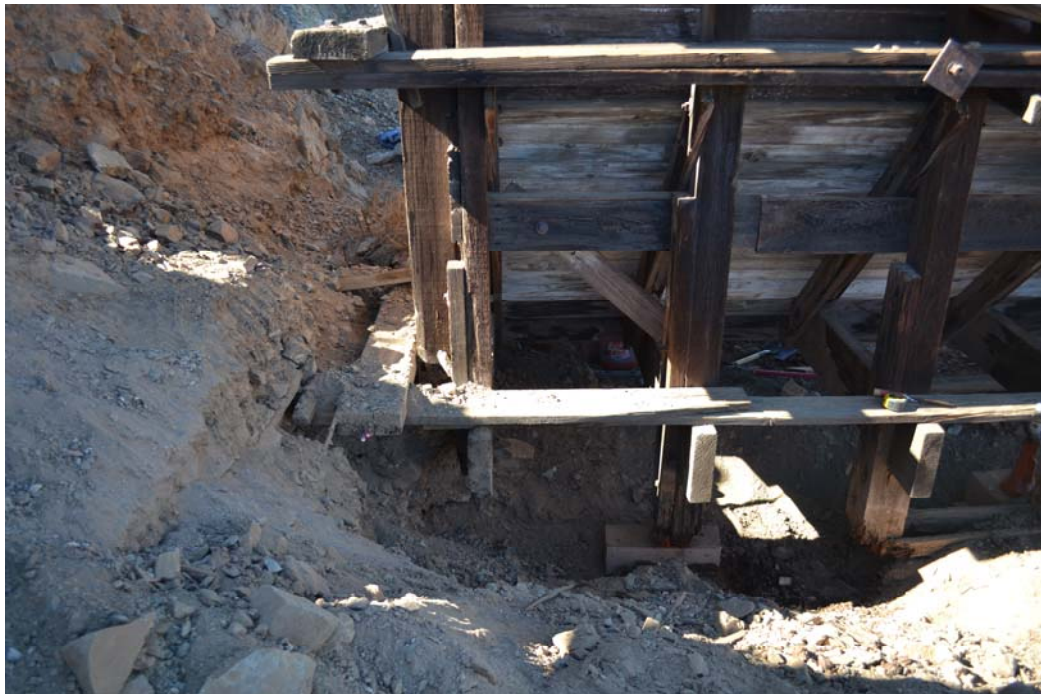
Figure 6: Bin #2, looking west. Note the condition of the east sill at its south end (bottom left, foreground). The sill and column extensions have completely decayed allowing the tipple to rotate out of plumb to the south.

- Jack and return the ore bin to a plumb position using screw jacks positioned at both the east and west side of the structure;
- Excavate and replace the decayed east and west sills and seven of twelve column extensions supporting the ore bin in order to fix the bin in a plumb position;
- For splints in salvageable condition, reattach with existing hardware, torqued to establish sufficient connection capacity. Replace unsalvageable splints in-kind, using original hardware;
- Replace deteriorated bracing to tie all column assemblies to new timber sills.
- Repair/replace boards on east and west of structure as necessary to reduce accumulation of soil on new sills;
- Re-attach all existing hardware;
- Apply borate preservative to mitigate future decay and insect infestation.

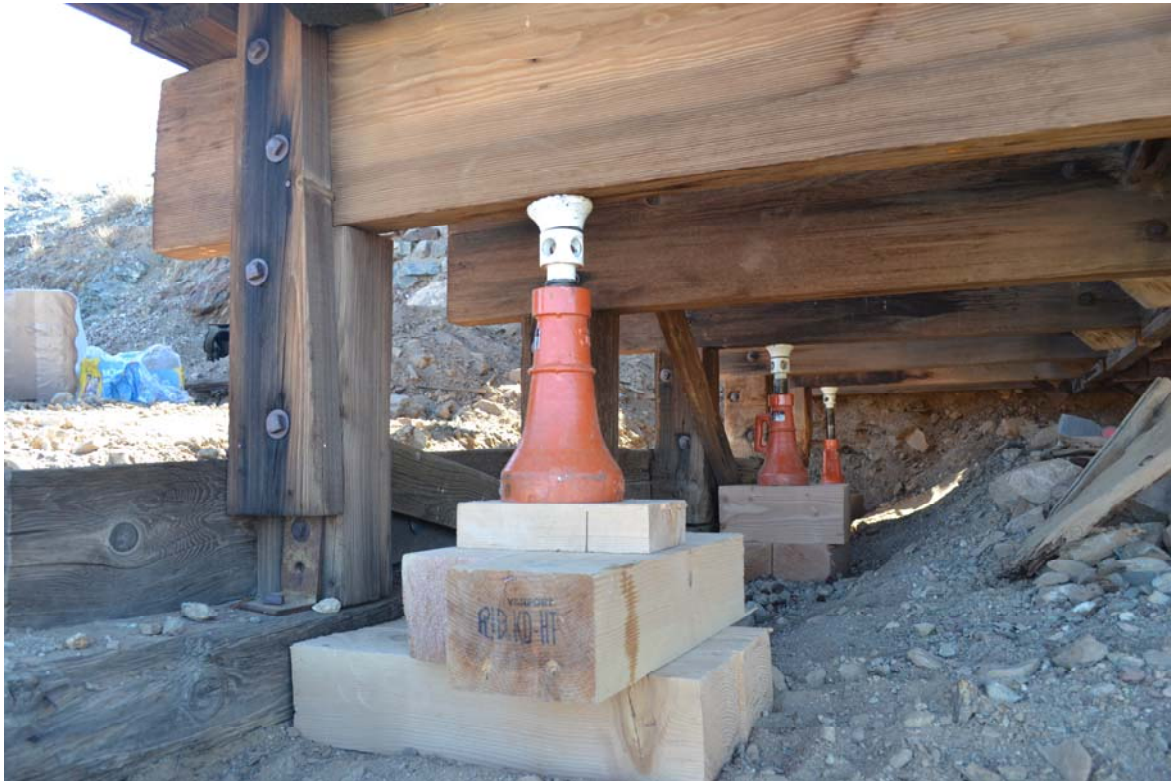
Figure 7: Cribbing and screw jacks were used to plumb Bin #2 (west) prior to removal of deteriorated sills and column extensions for repair or replacement.

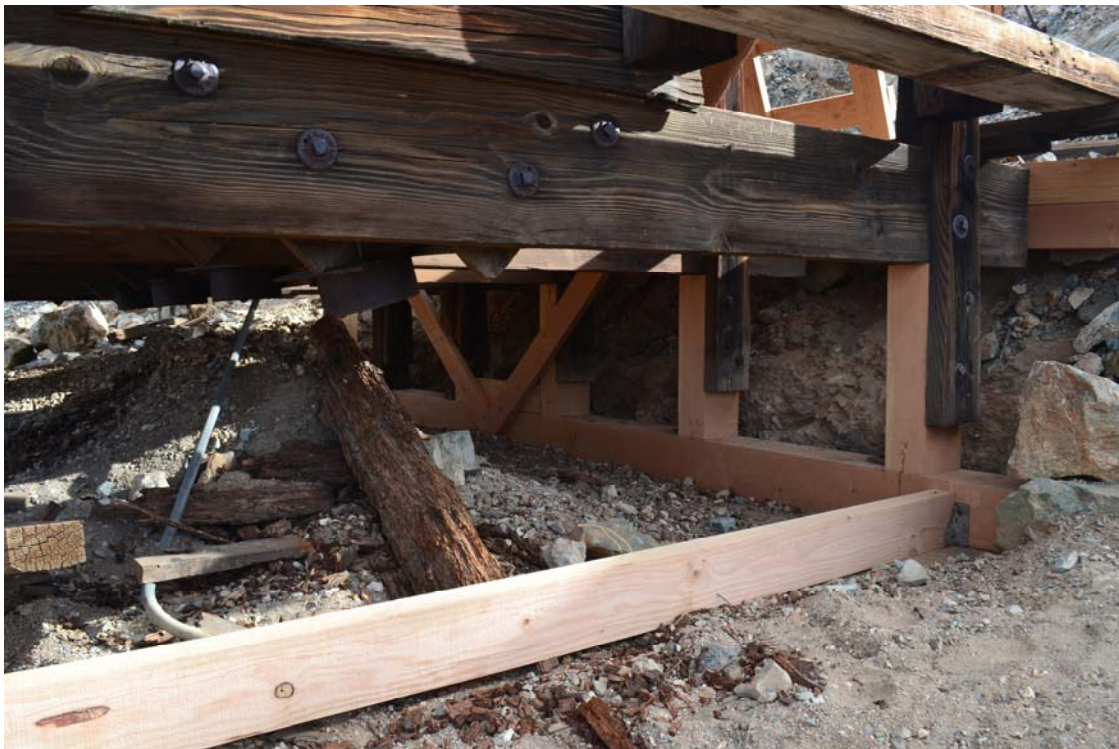
Ore bin #1 was several inches out of plumb to the south due to decay of the south sill and several of the column extensions on the south façade. Repair work on the ore bin included: in-kind replacement of the south sill, four column extensions, diagonal bracing of the substructure on the south façade, and one of two spreaders; installation of splints and re-torquing of all splint connections. Replacement members were secured using existing hardware where possible; where original hardware could not be salvaged, connections were made with bolts, nuts and washers custom-fabricated to match the originals.

Figure 8: Ore bin #1 after installation of replacement column extensions, south sill, diagonal bracing, and spreader (foreground). Original splints were salvaged for reinstallation. Holes bored for borate rod installation are visible at the base of each column extension.

were bolted in place, using original hardware where possible, and additional structural fasteners were installed (these are hidden from view) to stiffen the assembly.

The east ore bin included two horizontal braces (spreaders) between the north and south sills (spreaders do not appear to have been used in the construction of the west ore bin). The spreader on the south, buried in tailings, was unsalvageable and a replacement member was installed with the existing hardware.

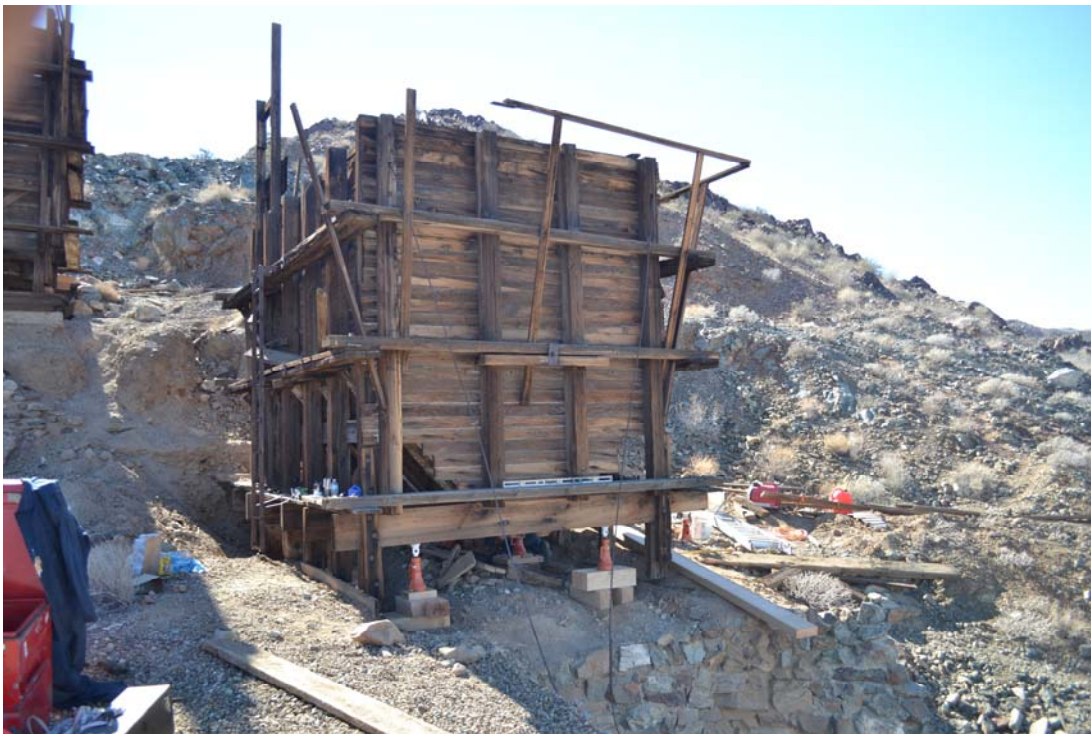
Figure 9: West ore bin supported on cribbing and screw jacks. New timber sill (right) is ready for installation on the west elevation.

For lifting ore bin #2, cribbing and screw jacks were placed underneath the structure (as opposed to outside the structure, as for one bin #1), to lift and support floor girts while allowing room for removal of both sills. Once the ore bin had been lifted, sills were removed, providing access to deteriorated column extensions. Deteriorated column extensions (specific locations

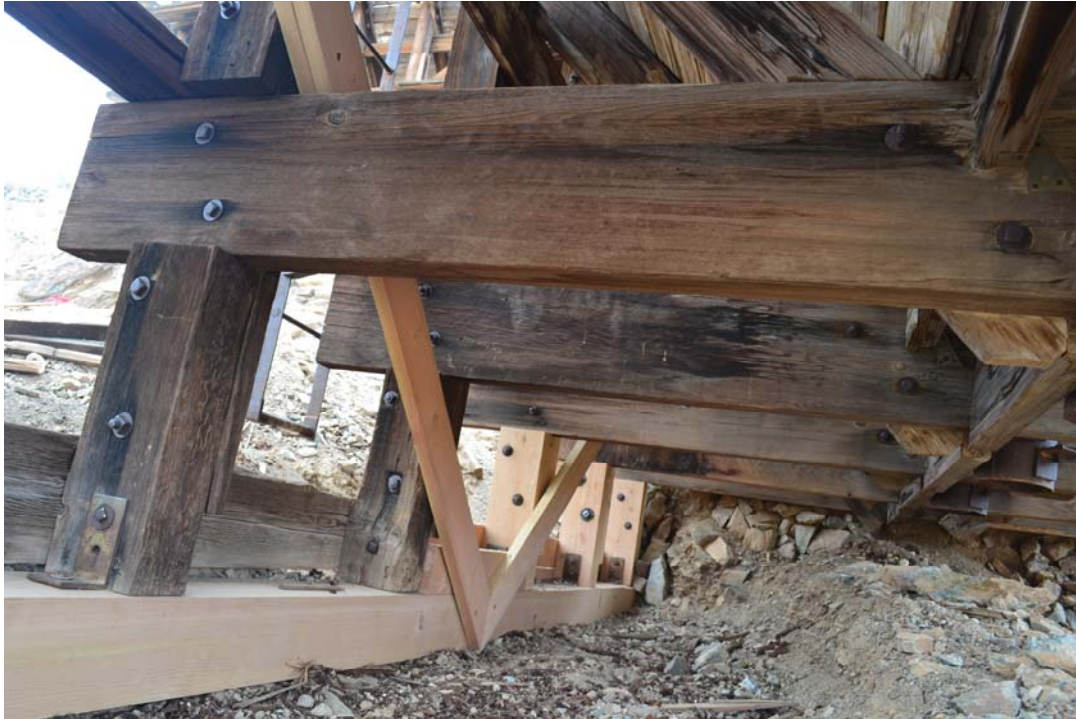
Figure 10: Ore bin #2, following replacement of east sill, column extensions, and diagonal bracing (left).

Diagonal bracing connects sills to column assemblies, providing shear capacity. On east and west elevations, diagonal bracing was decayed below grade, and sufficiently weathered above grade that connection capacity at outer columns was substantially reduced. Replacement members were bolted in place, using original hardware where possible, and additional structural fasteners were installed (these are hidden from view) to increase the stiffness of the assembly.

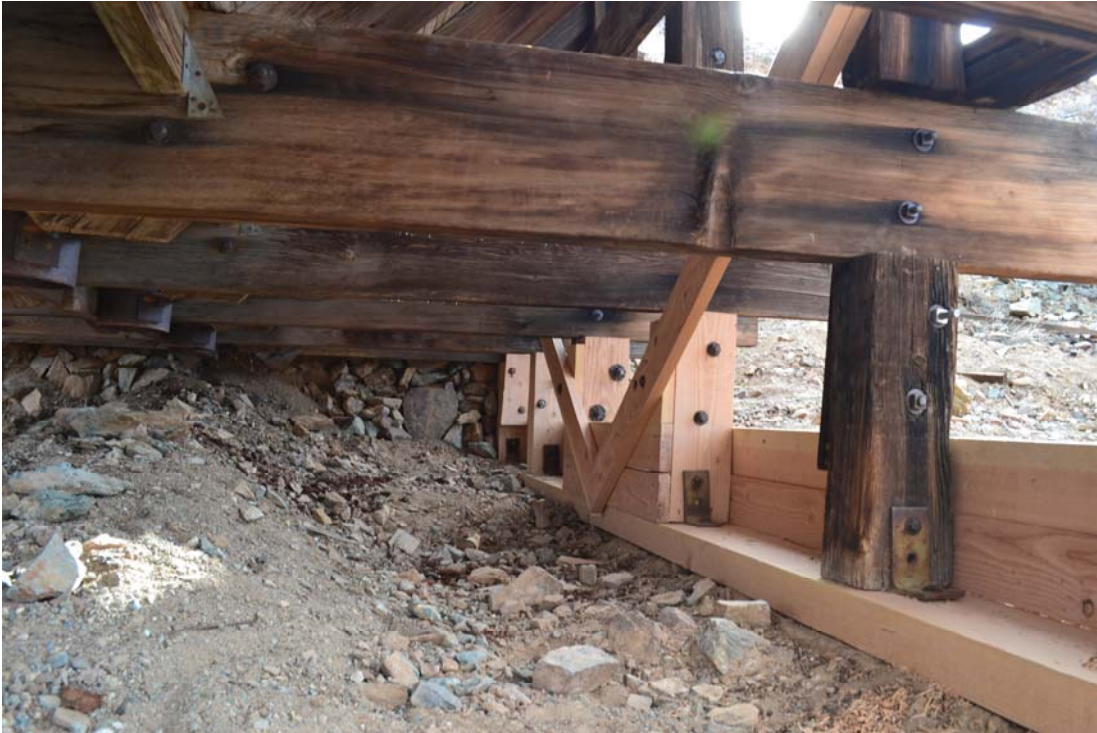
Figure 11: Ore bin #2, following replacement of west sill, column extensions, splints, and diagonal bracing. Note boarding installed to isolate the sill and column bases from soil (right).

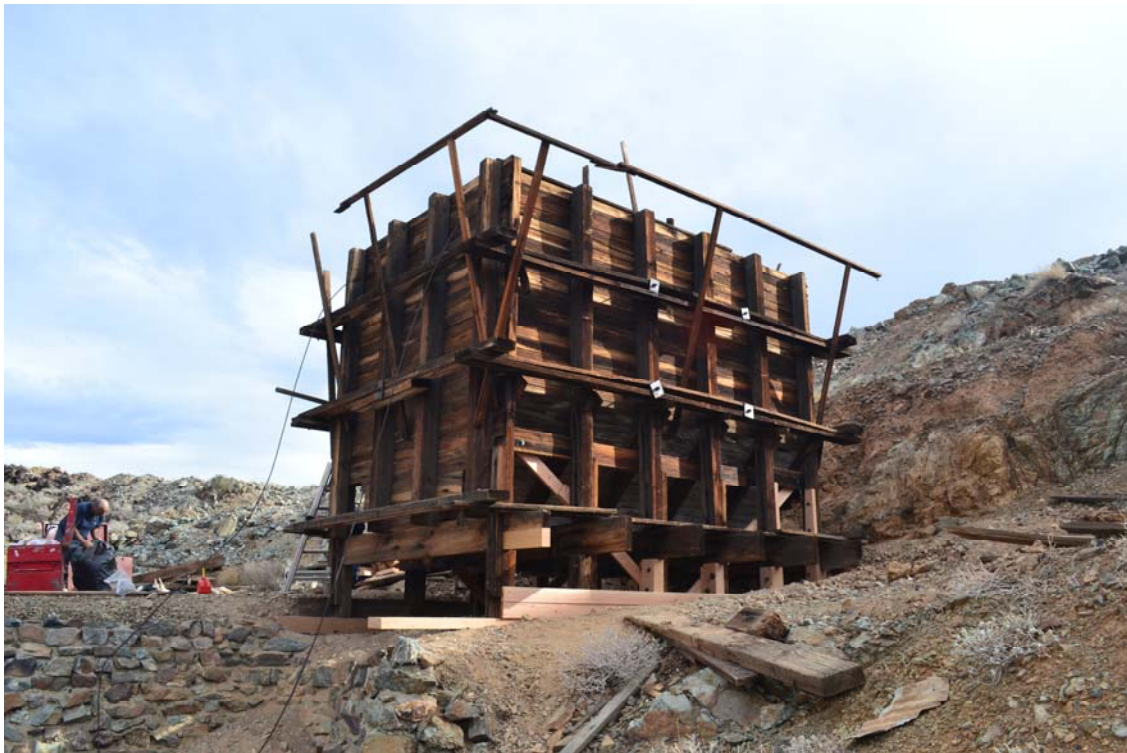
Figure 12: West ore bin with repairs completed, looking southeast. Note replacement boards attached to column extensions and intended to isolate substructure from soil (foreground).

Remnants of boards originally installed to isolate substructure elements from the soil were found at both structures. These can be considered sacrificial elements and periodic replacement of them is required to avoid substructure decay. The original boarding had exceeded its effective service life, allowing soil to accumulate against sills and column extensions. These were repaired or replaced in kind to provide protection against further soil infiltration. Borate preservative rods were installed in sills and column extensions as an additional preventative measure.

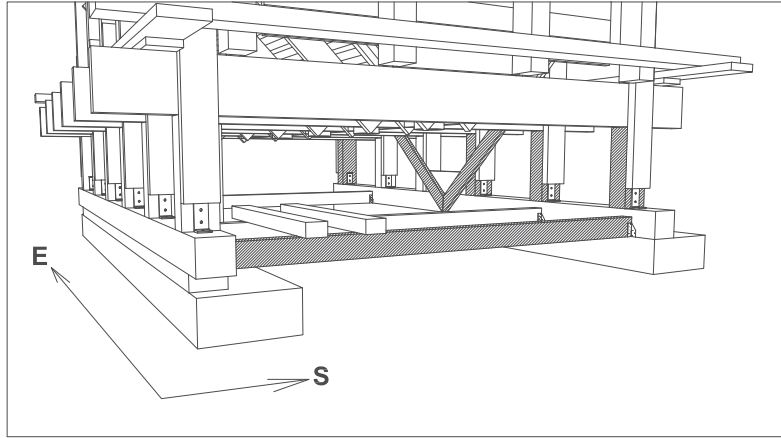
1
4 SILVER BELL: BIN #1 ISOMETRIC
SCALE: NTS

DETERIORATED MEMBER REPLACED IN-KIND
