HISTORIC STRUCTURE REPORT

FURE'S CABIN

BAY OF ISLANDS, NAKNEK LAKE

KATMAI NATIONAL PARK & PRESERVE

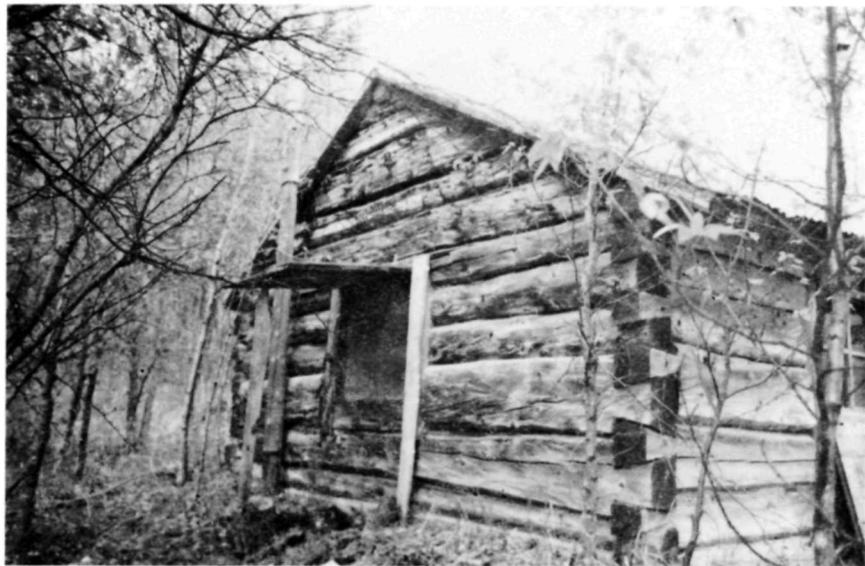
The roof planks are sheathed with corrugated metal at the exterior. There are signs of rot at the butts of many of the planks because the corrugated metal does not uniformly cover the last inch of the plank. Water running off the roof is being soaked up into the end-grain and causing damage. It should be noted that the end-grain of the roof planks and the corrugated metal have all been treated historically with what appears to be red paint, similar to that found on wall corners.

Photograph 3
West Elevation: Note Deteriorated Condition of
Roof Planks
6/82 D. Snow

- 9) Once corrugated roofing is removed, inspect roof planks for extent of deterioration.
- Roof Repair 10) Replace with new ones any roof planks that have lost structural integrity (loss of more than 30% of thickness). Hand hew new planks on the exposed underside. Retain roof planks judged in acceptable condition and remove dry rot with hand tools.

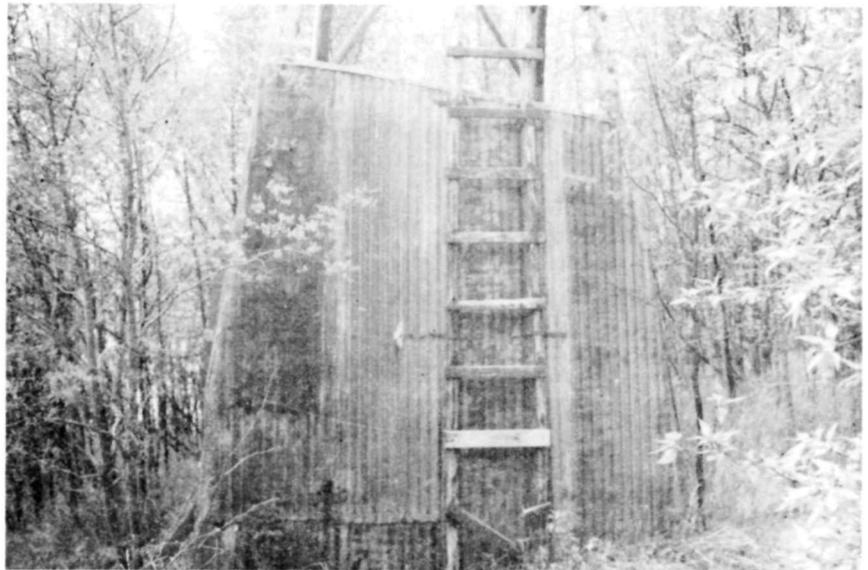
Photograph 48
North Elevation of Cabin Above Window:
Note isolated Dry Rot
6/82 D. Snow

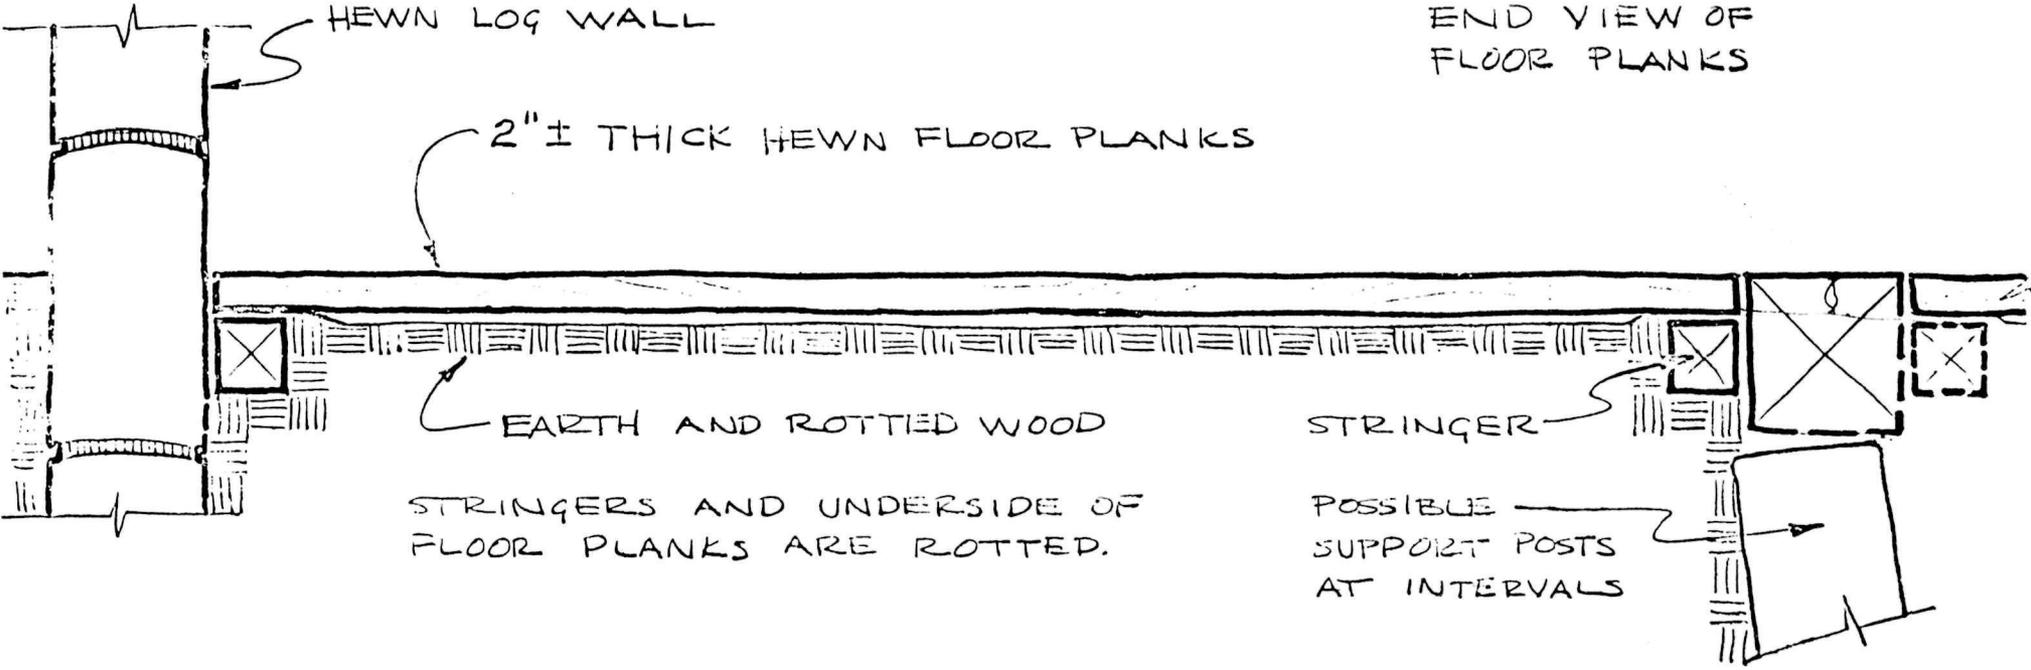
FLOOR SECTION

The southeasterly or front half of the wood plank floor of the cabin has settled and become uneven, probably caused by both rotting and settling of the plank supports. The floor is pitched and uneven and at one location there is perhaps a 4 inch difference from the surface of one plank to the adjacent one. A brief investigation at this location gave some clues as to the construction of the supporting members of the flooring. The attached sketches show possible constructions, but these remain in part, conjecture, as only a small area beneath the planks could be felt.

SHOWING APPARENT CONSTRUCTION AND EXISTING CONDITION

Initially, dismantling and inspection of this section of the floor will permit the maintenance staff to determine the construction and replacement materials needed. Much of the material preparation can then be done in the shop at Brooks Camp to minimize transporting of equipment to the site in the boat.
