Historic Fire Station No. 6 Martin Luther King, Jr. National Historical Park

Historic Structure Report

August 2019
Cultural Resources, Partnerships and Science Division
Southeast Region

Prepared by:
Panamerican Consultants, Inc.
2390 Clinton Street
Buffalo, New York 14227-1735

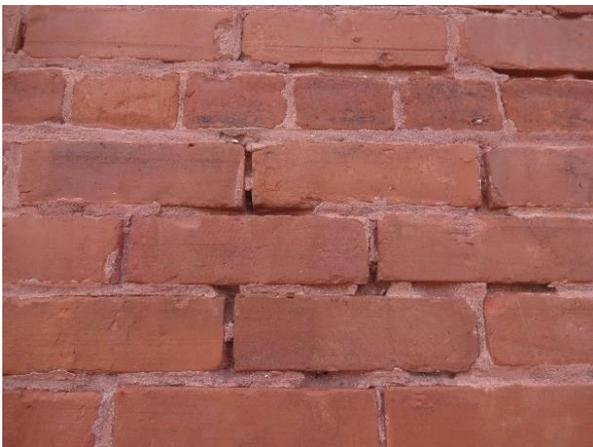
FIGURE 52. Detail of open and deteriorated mortar joints.

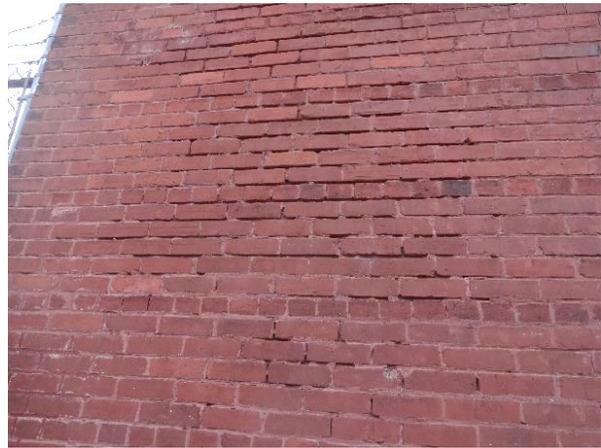
FIGURE 53. Large area with open mortar joints.

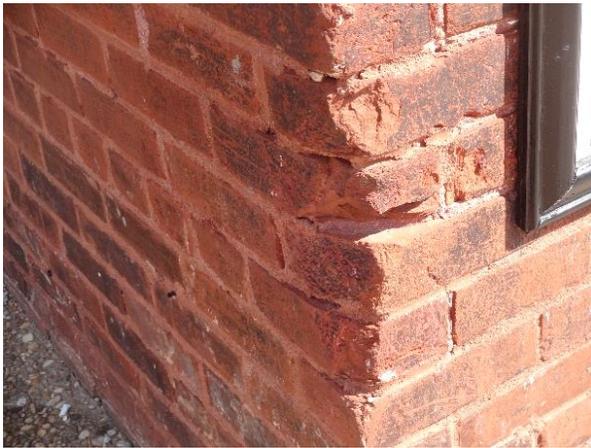
FIGURE 56. Spalled brick at corner of building.

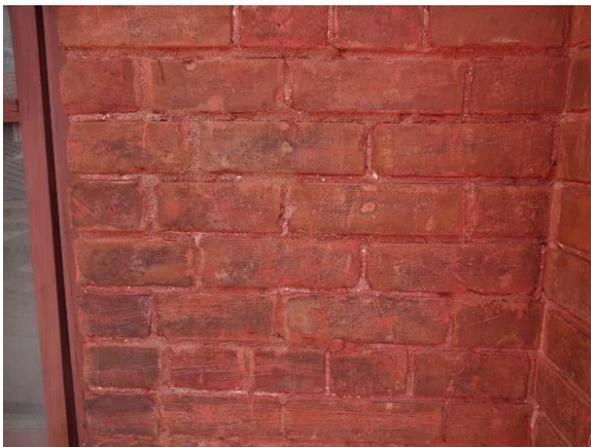
FIGURE 57. Residue of a previous coating application on the masonry.

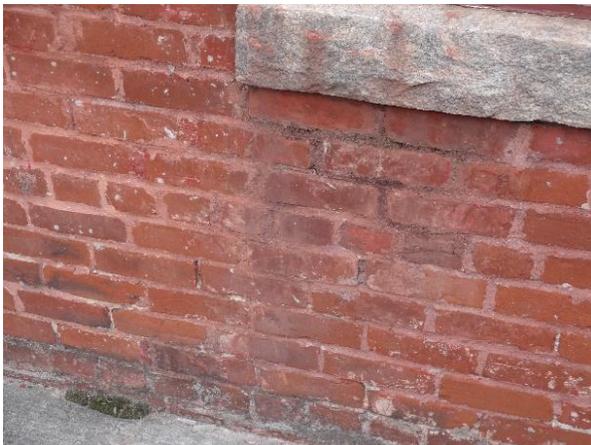
FIGURE 58. Moisture staining below window sill.

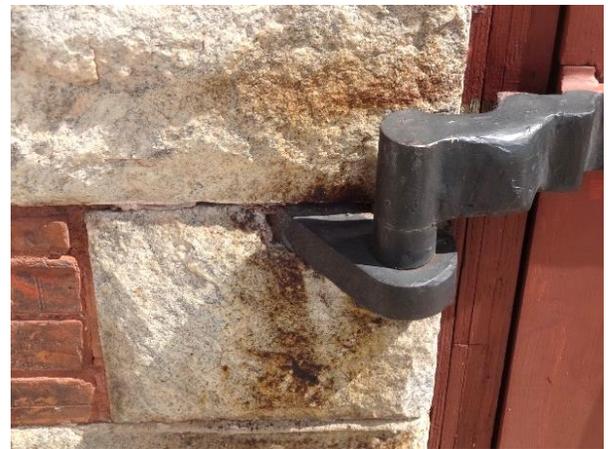
FIGURE 59. Corrosion staining at stone near metal door hinges.

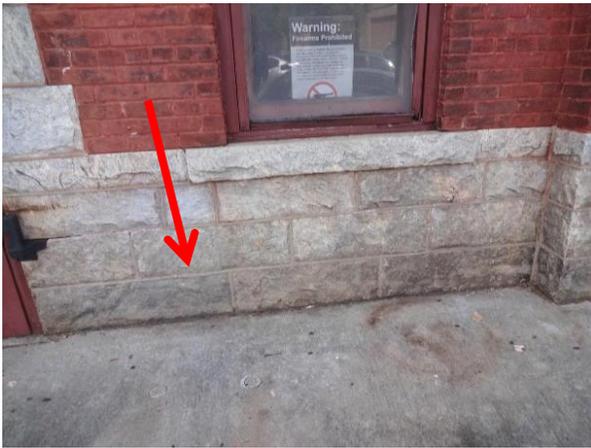
FIGURE 60. Soiling and discoloration of stone adjacent to grade.

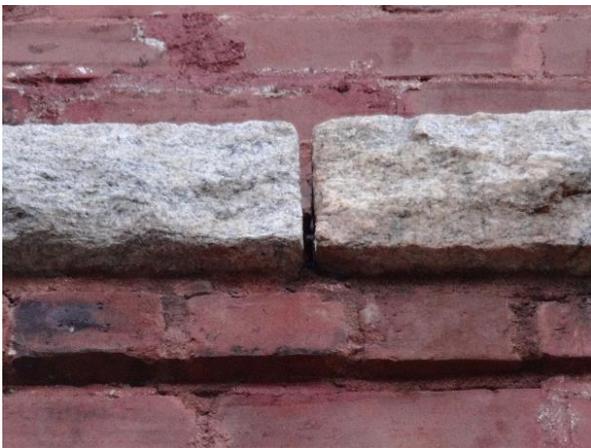
FIGURE 61. Deterioration of mortar joints between stone units.

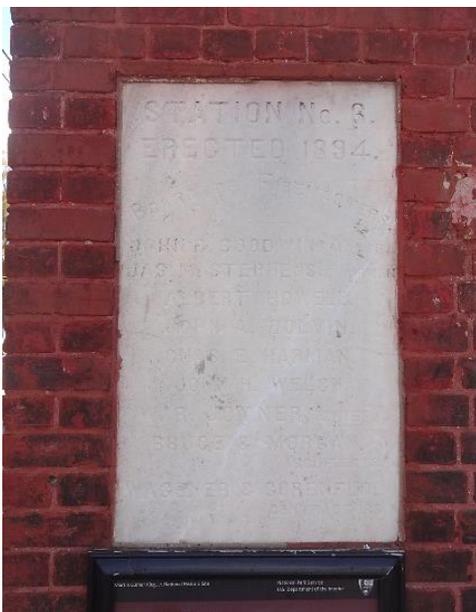
- Slight surface erosion was observed at the marble dedication plaque (Figure 62). While not difficult to read, the erosion resulted in an observed loss of definition in the engraving.

FIGURE 62. Slight surface erosion at marble dedication plaque.

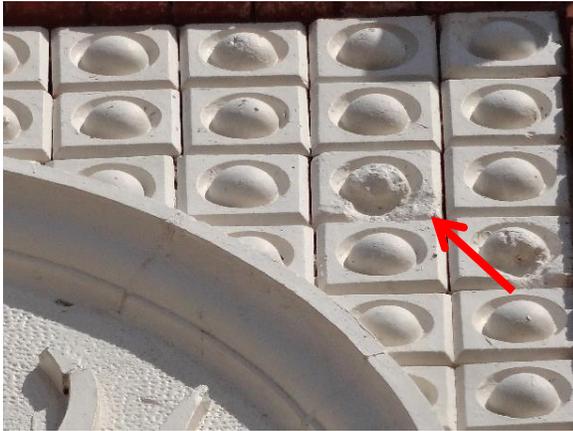
FIGURE 63. Missing grout between terra cotta units.

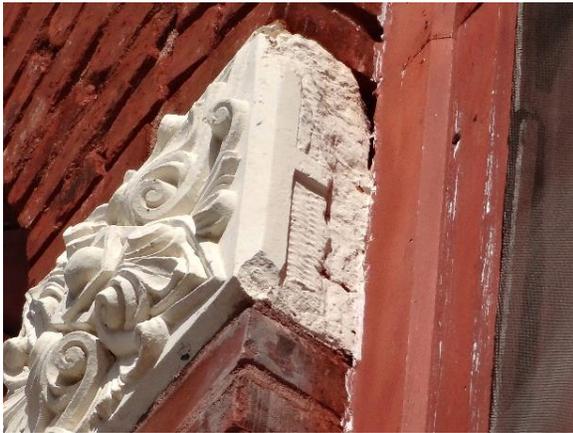
FIGURE 64. Exposed unglazed face of the terra cotta pilaster cap units.

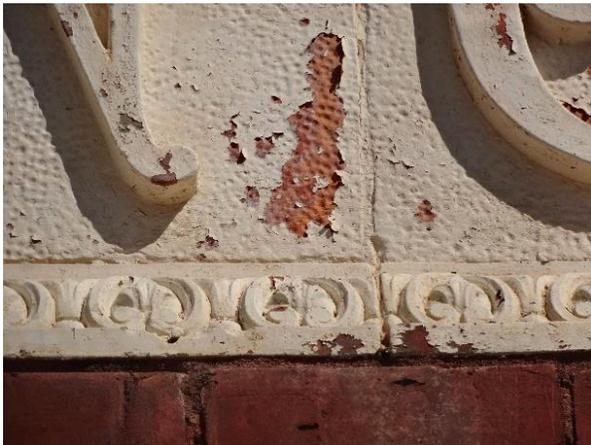
FIGURE 65. Glaze spalls at terra cotta units.

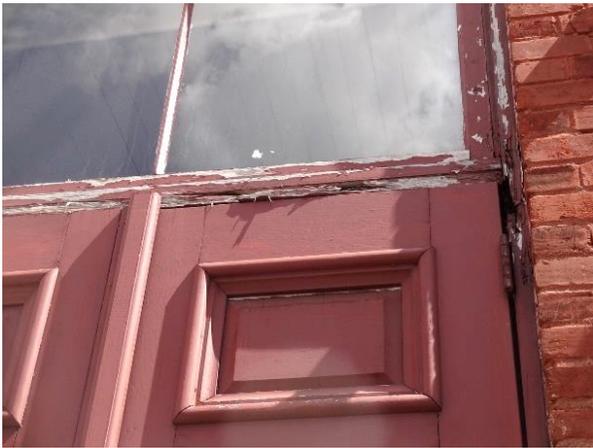
FIGURE 67. Deterioration of wood framing at hose door entrance.

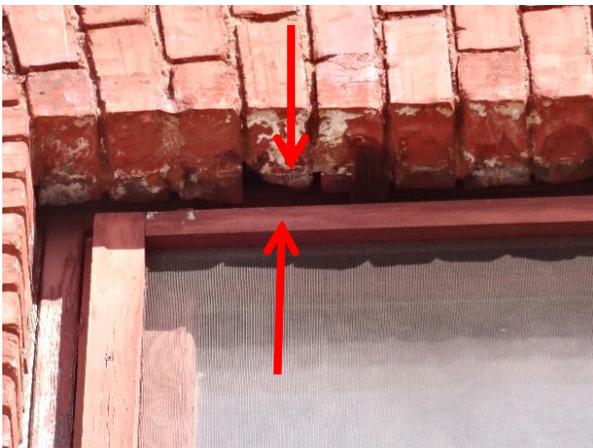
FIGURE 68. Large gap between wood window framing and brick masonry opening.

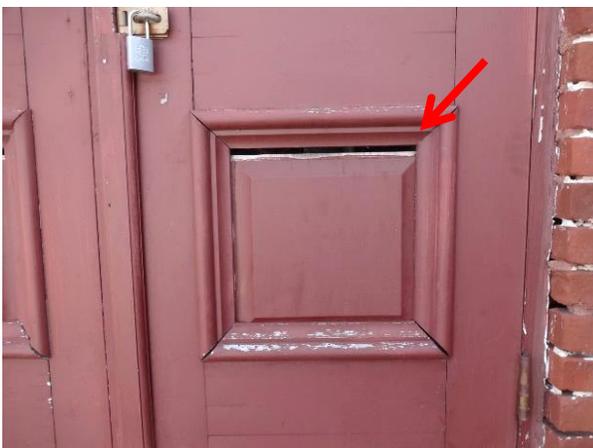
- Recessed panels at door leafs were loose and displaced (Figure 69). Approximately four recessed panels, two at the vehicular door and two at the hose door on the west elevation, were displaced approximately 3/8 inch. The panels were all located near the bottom of the door. The displacement consisted of a gap between the top of the panel and the opening. The unpainted edge of the wood panel was exposed to view.

FIGURE 69. Displaced wood panel at door. Note gap between panel and frame.

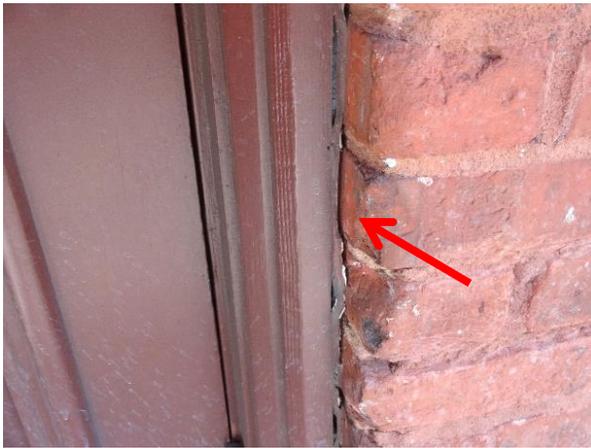
FIGURE 70. Failed sealant at perimeter of door opening.

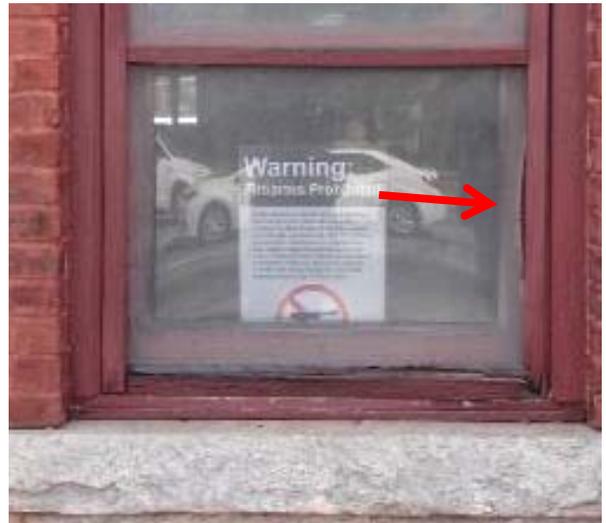
FIGURE 73. Damaged window screen.

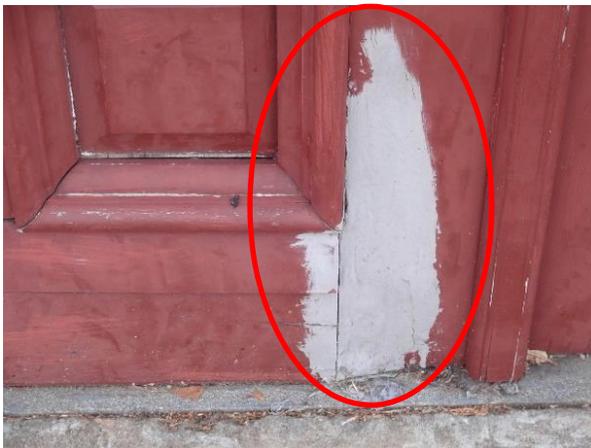
FIGURE 71. Previous repair at base of door.

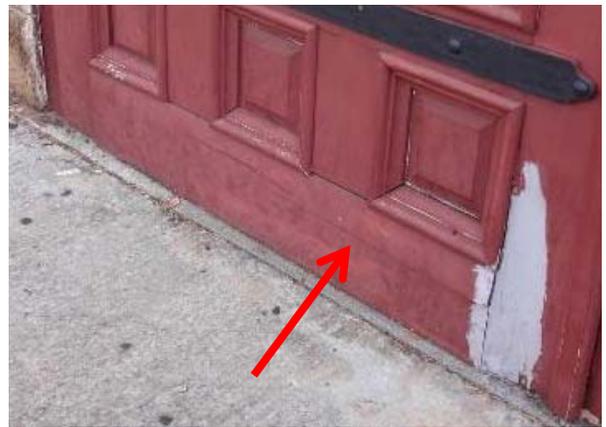
FIGURE 74. Checks and splits at base rail of door.

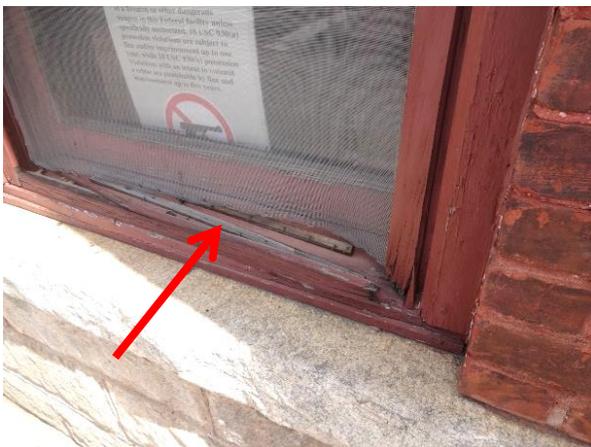
FIGURE 72. Damaged window screen and deteriorated wood framing.

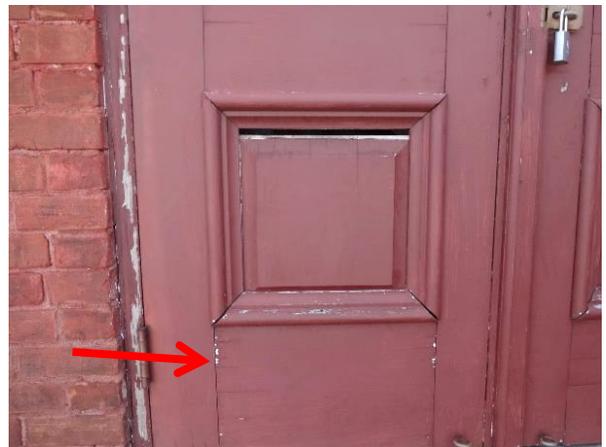
FIGURE 75. Open joints between door rails and stiles.

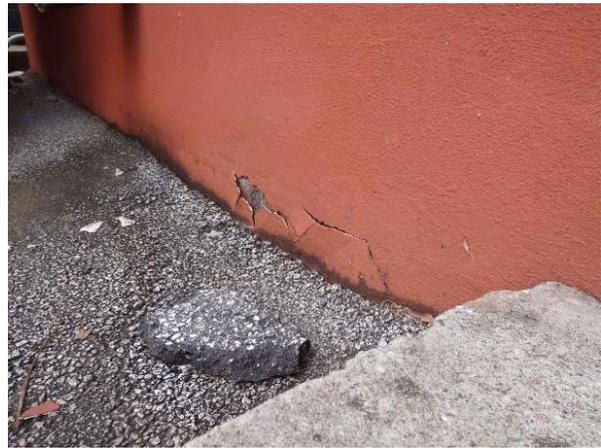
FIGURE 78. Cracked and delaminated EIFS laminae at the base of the stair tower, adjacent to grade.

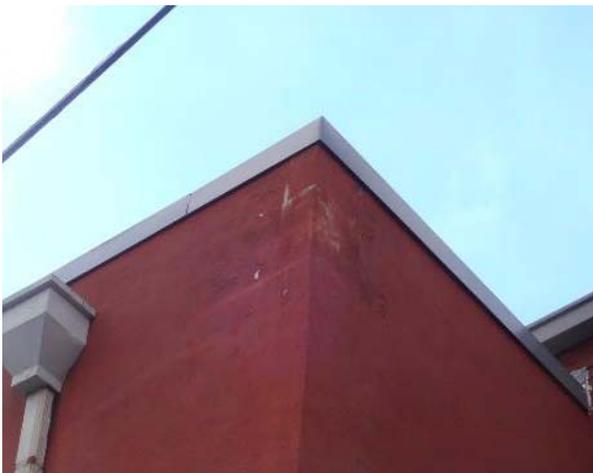
- Moisture staining was observed at the EIFS at the northeast parapet of the elevator tower addition (Figure 77). The staining included efflorescence and a general dark coloration of the EIFS. The outline of the underlying CMU wall was visually apparent.
- Cracking and delamination of the EIFS laminae was observed at a few locations on the base of the wall at the elevator tower addition (Figure 78). The distress was located at grade. At both locations, the distress area was approximately eight inches and portions of the laminae had spalled, exposing the underlying CMU to view.

FIGURE 77. Moisture staining at the EIFS at the corner of the east elevation stair tower.

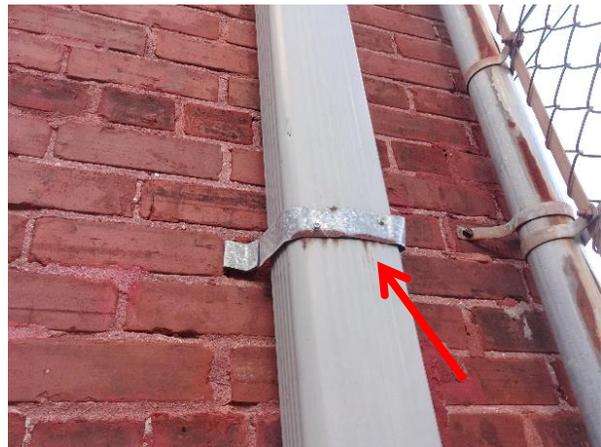
- Surface corrosion was observed at the interface between the sheet metal straps and downspouts (Figure 79). The corrosion was observed at the edge of the strap in contact with the downspout.

FIGURE 79. Surface corrosion along edge of downspout straps.

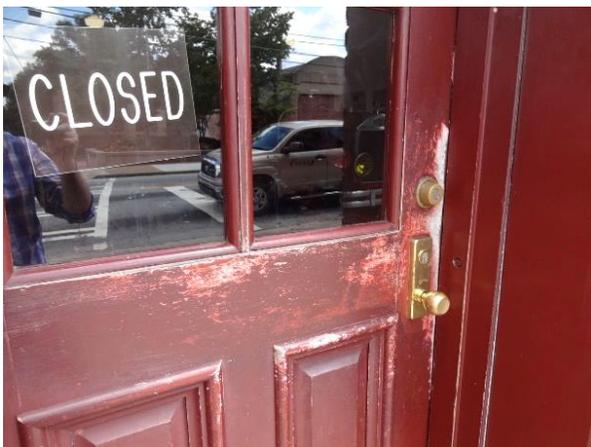
FIGURE 81. Deteriorated paint at fiberglass door.

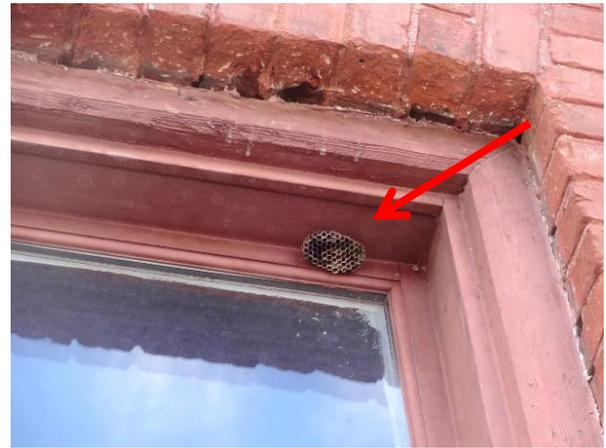
FIGURE 82. Possible yellow jacket nest at window frame.

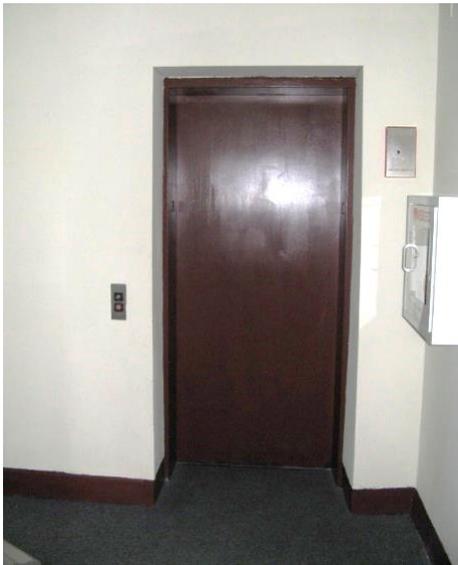
Elevator. The hydraulic elevator is installed in a shaft constructed outside of the footprint of the original fire station on the east exterior wall. The elevator shaft is constructed from load-bearing concrete masonry units (CMU), with the original exterior brick wall of the fire station remaining on the west of the shaft. Doors at each floor open from the left side of the elevator and have a single-leaf painted dark red to match the baseboards and trim (Figure 114). Call buttons are located to the left of each door and there are no hall lanterns for the elevator. A fire department key panel is located to the right of the door at the first floor. The elevator appears to be in serviceable condition; however, the mid-1990s Ascension 1000 model, manufactured by U.S. Elevator, is obsolete and may be difficult to service or maintain.

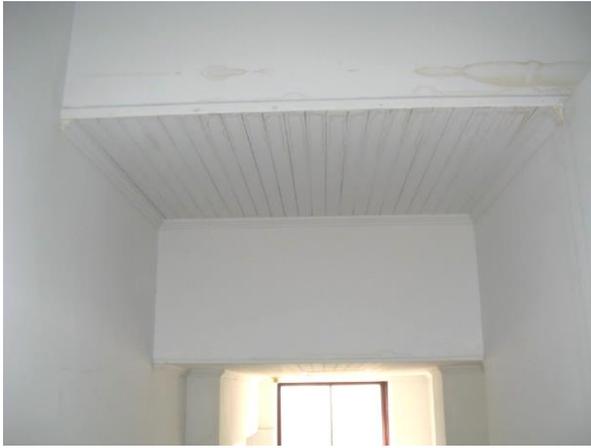
FIGURE 139. Water stains at hose room ceiling.

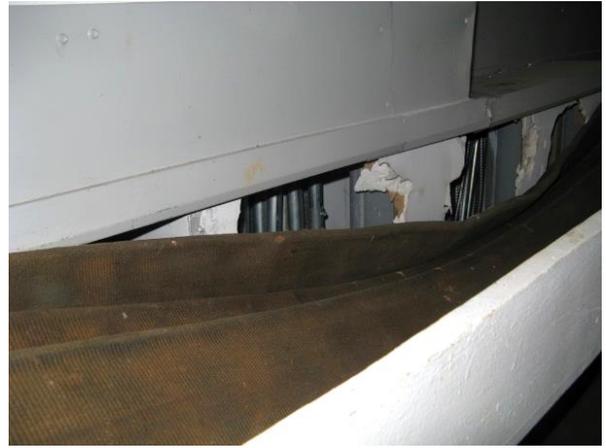
FIGURE 142. Openings in gypsum board at hose room.

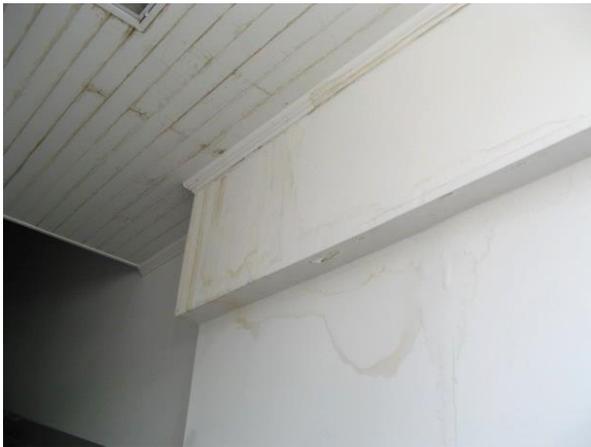
FIGURE 140. Water stains at hose room.

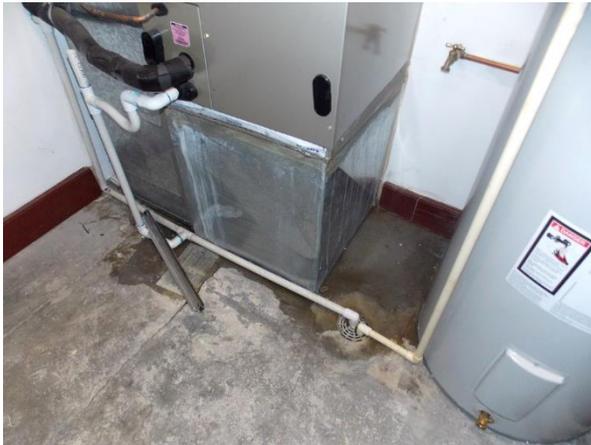
FIGURE 141. Standing water below hose bibb at second-floor mechanical room.

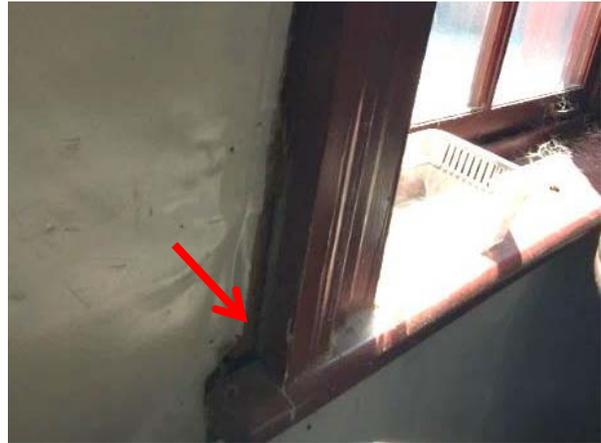
FIGURE 147. Moisture damage at the sill and jamb of this window caused separation of the casing, stool and apron from the wall.

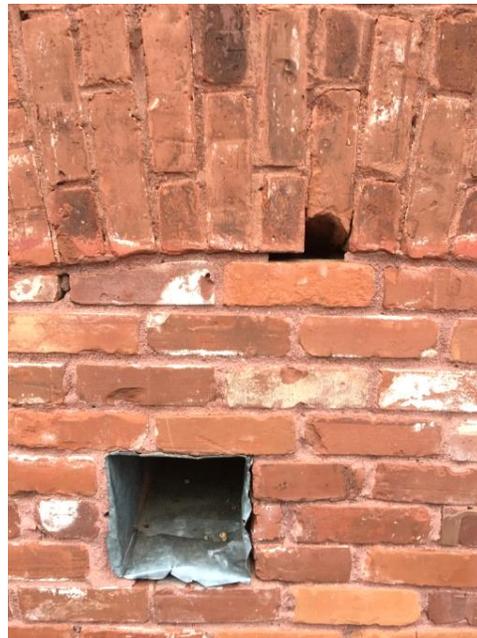
FIGURE 165. Exhaust penetration with no louver at the south elevation.
