# Reid-Zachary House 497 Auburn Avenue

Martin Luther King, Jr.  
National Historical Park

## Historic Structure Report

2018

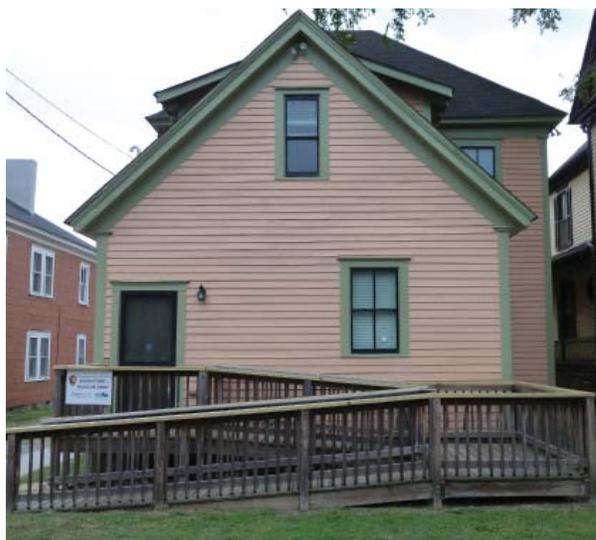
Figure M4. Rear elevation with wheelchair ramp and altered fenestration.

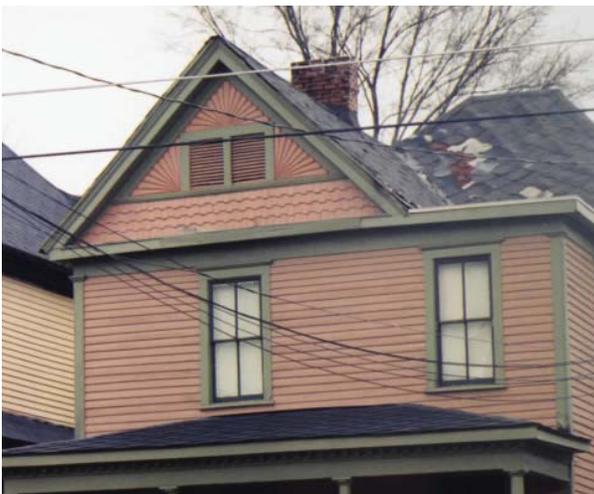
Figure B31. Roof was in poor condition and leaking when work stopped in 2000. In contrast, the porch roof was replaced early in the 1999 work. (MALU collection)

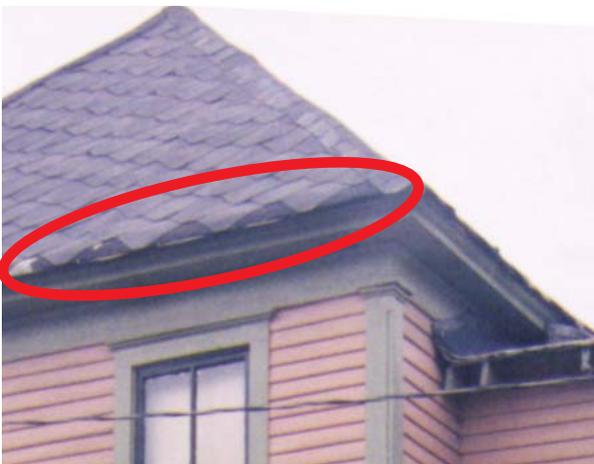
Figure B32. Roll roofing is exposed beneath shingles of main roof. (MALU collection)

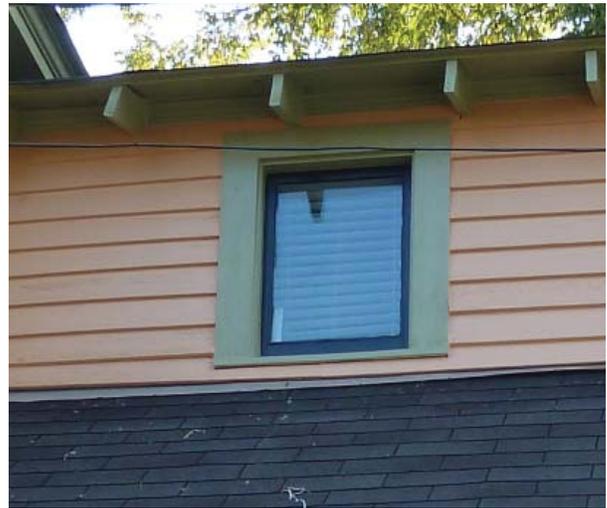
**Figure B41.** Four-light casement window was replaced with a single-light fixed-sash window. (MALU collection)

- Replace, according to physical evidence and photo-documentation, the dormer windows and two south windows with windows of historically appropriate size and design.

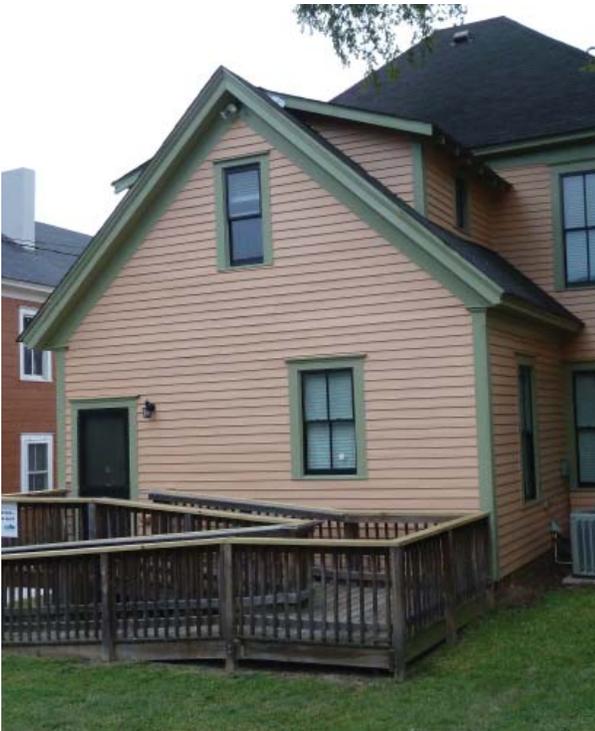
**Figure B45.** Back of the ell showing significant changes. The doorway was moved again, back to the approximate location of the opening removed in 1999. Siding was replaced, removing the vertical board seen in earlier images; the gable end window was replaced with one-over-one sash; the first-floor east casement window was removed; and a wood handicap ramp was constructed. (Photographed 2016)

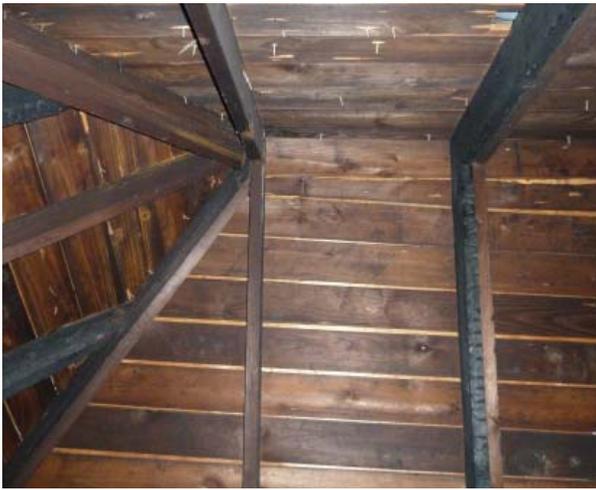
**Figure C13.** Rafters of the main hip roof. Note that rafters are toe-nailed at ridge. Also note the charring of original rafters to which modern rafters have been sistered for structural support.

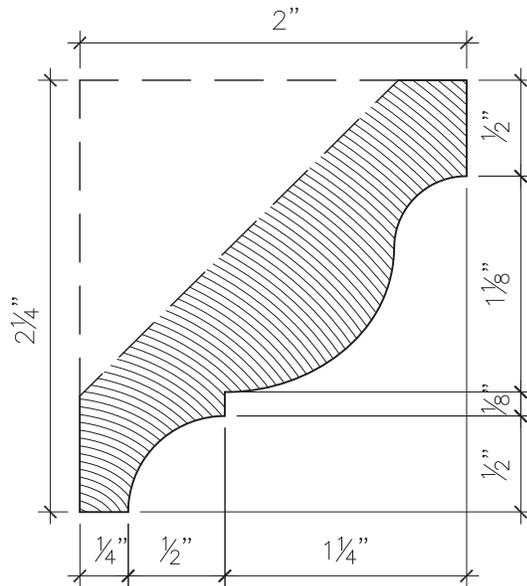
Figure C35. Non-matching replacement decorative molding below original drip edge.

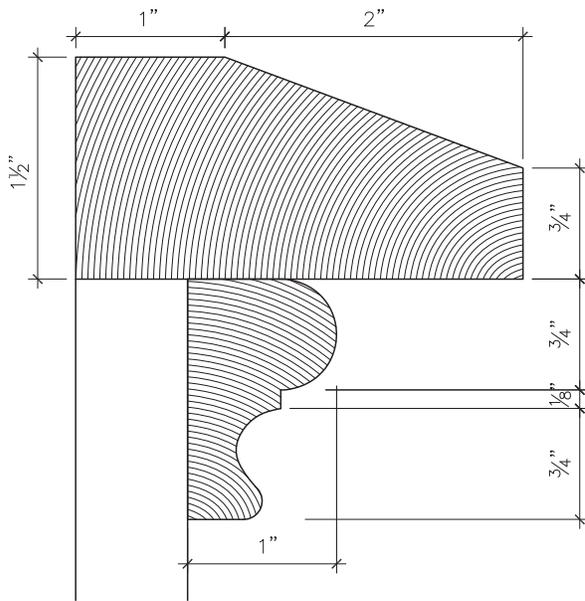
Figure C36. Non-matching modern replacement drip board and backband molding.

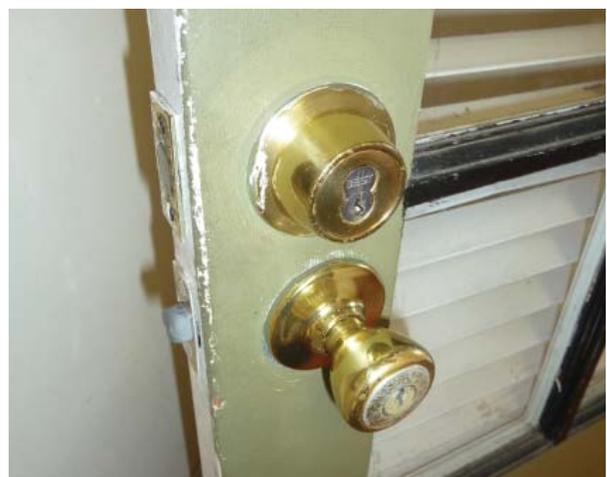
Figure C45. Modern replacement front door hardware.

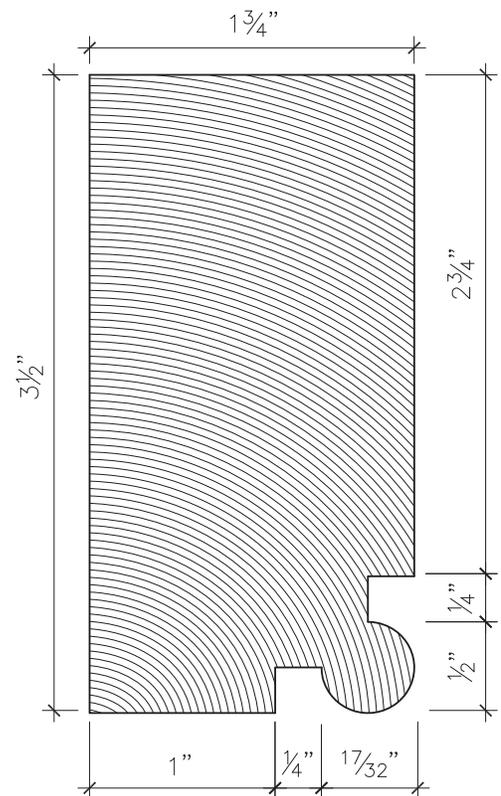
Figure C54. Non-matching replacement front porch dentil.

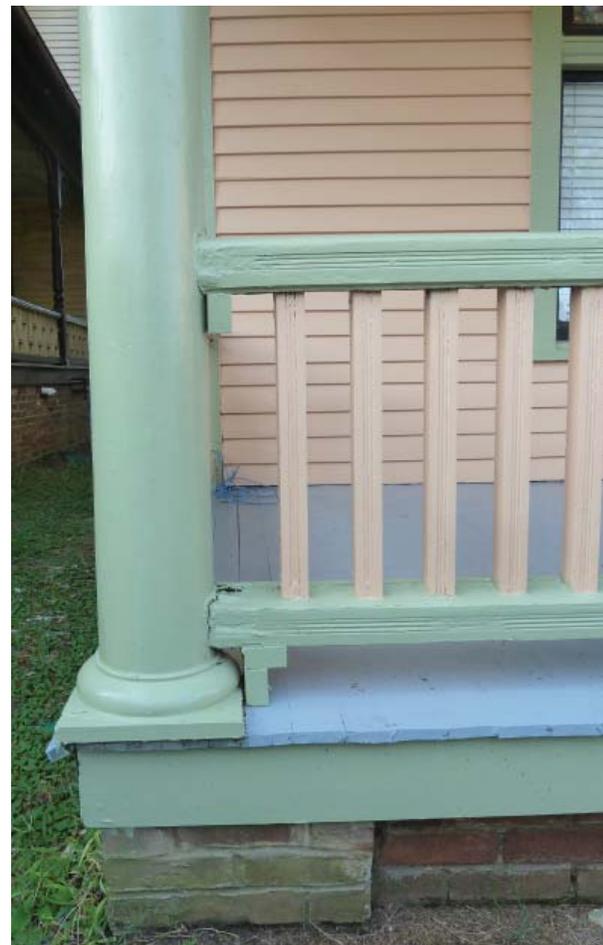
Figure C58. Porch balustrade. Note the added 2x4 blocking and the original balusters with an incised double-reed detail.

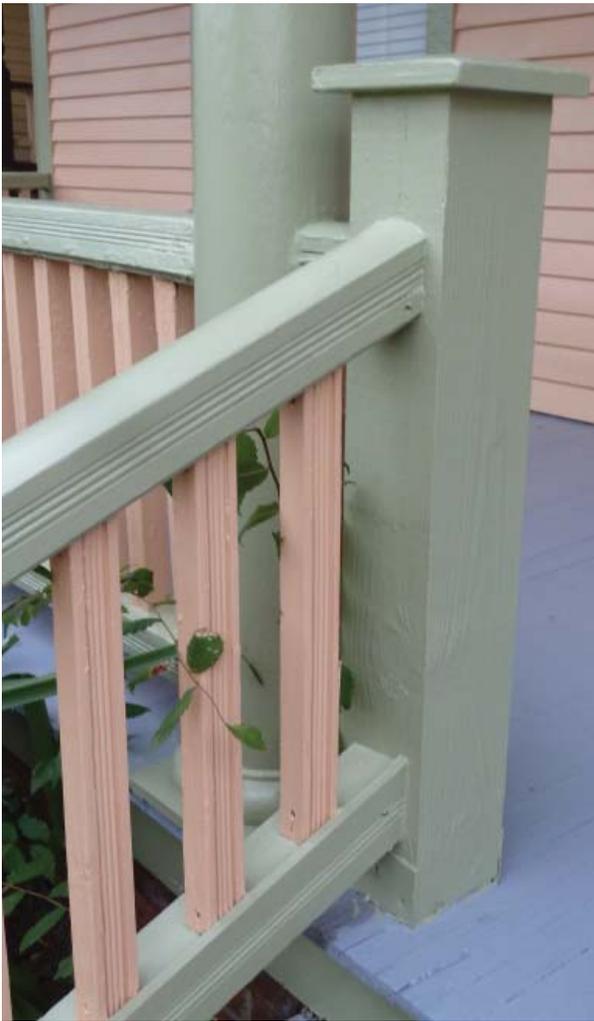
Figure C59. Balustrade at front steps. Note the replacement balusters with an incised triple-reed detail.

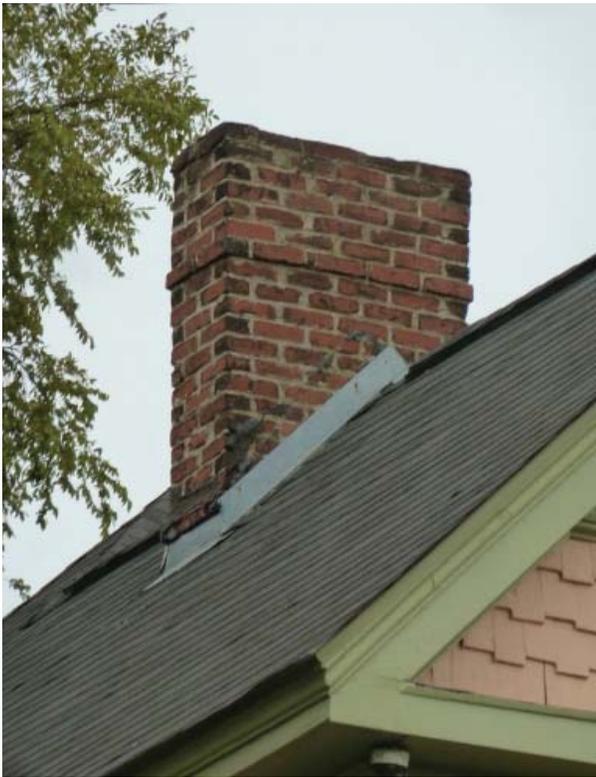
Figure C68. Front interior chimney and continuous flashing at roofline. Note that the visible porch of chimney above roofline is likely a truncated version of the original design.

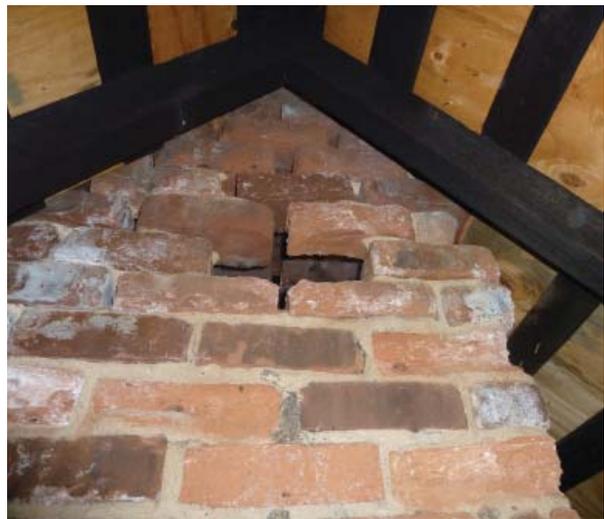
Figure C70. North face of front chimney visible inside attic. Note the water damage, eroded mortar, and missing brick near roofline.

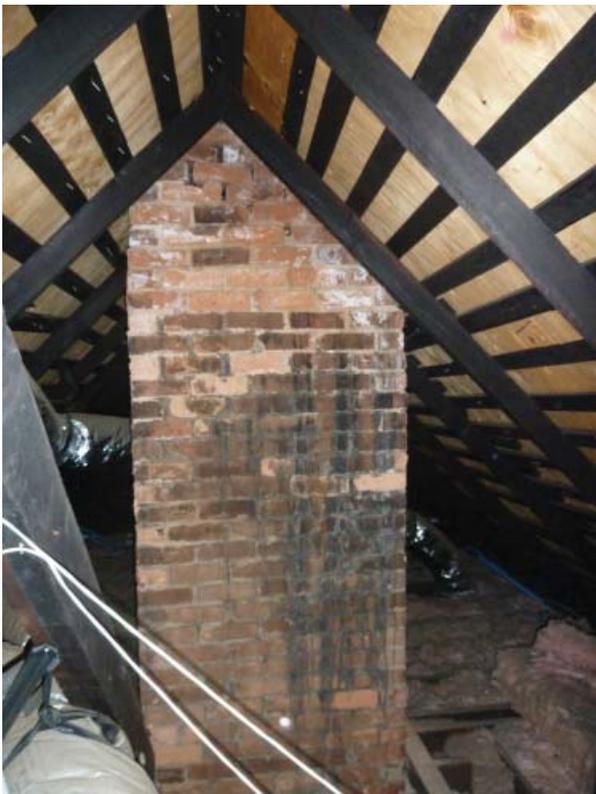
Figure C69. South face of front chimney visible inside attic. Note the water damage and eroded mortar near roofline.

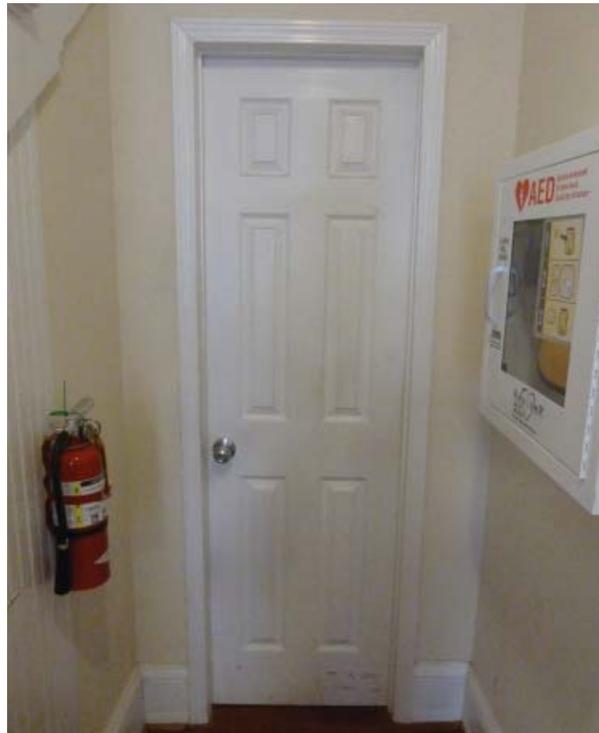
Figure C102. Typical modern replacement interior four-panel hollow-core door and modern replacement molded door casing.
