503 Auburn Avenue, NE Historic Structure Report

503 Auburn Avenue, NE
Martin Luther King, Jr. National Historical Park
Atlanta, Georgia

Historic Structure Report

September 2019

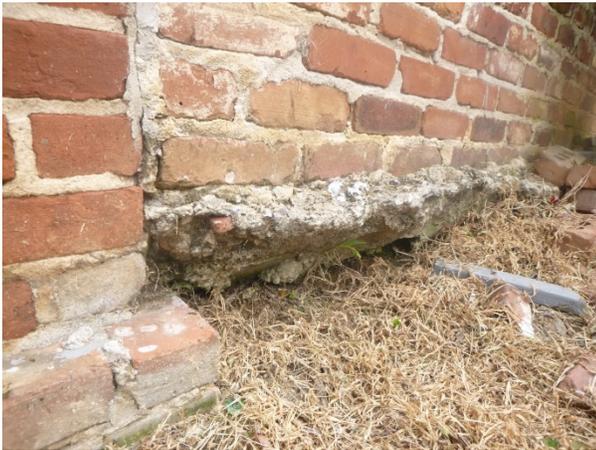
- Erosion was observed at the concrete foundation and brick infill below the south deck (Figure 78). The dirt fill under this portion of the wall was missing, and there was a void that provided direct access into the crawl space. The mortar joints at the masonry infill wall were cracked but there was no significant displacement of the masonry.
- Bowing was observed at the south chimney at the south end gable (Figure 79). The upper 3-foot portion of the chimney, above the roof peak, appears to be leaning toward the east.

FIGURE 78. Erosion at concrete foundation below south deck.

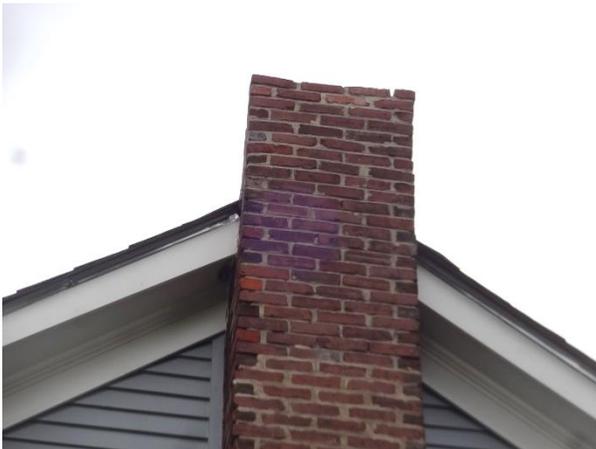
FIGURE 79. Bowing at south chimney at south end gable.

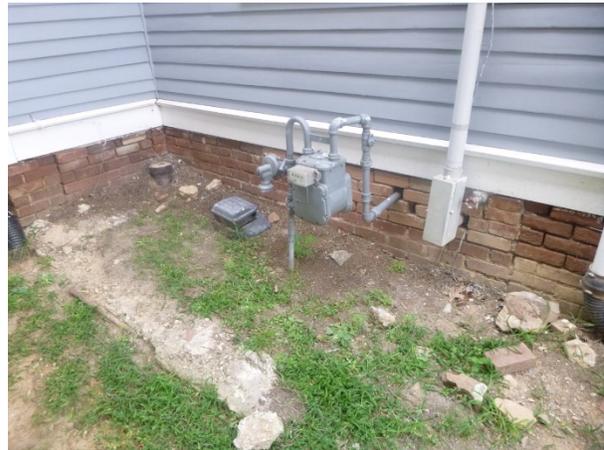
were as wide as 1 inch. At some locations, the brick units were displaced and out of plane.

FIGURE 80. Deteriorated joints at building corners.

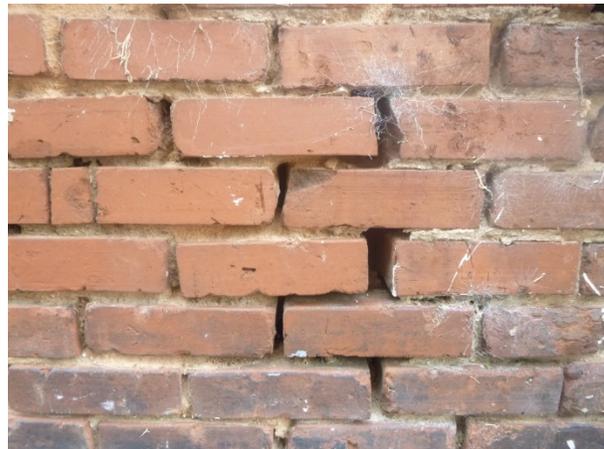
FIGURE 81. Loose brick units at infill walls.

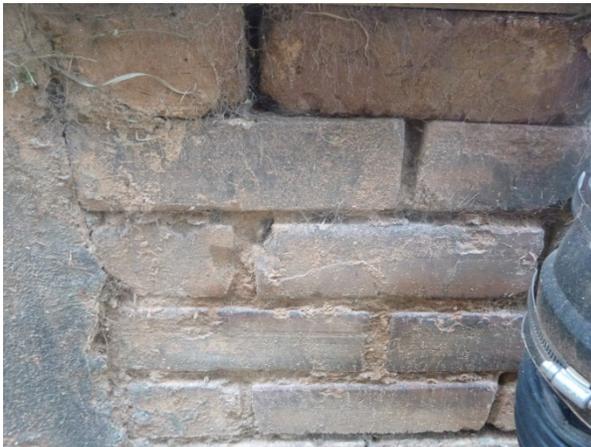
FIGURE 82. Eroded mortar joints at brick pier and infill wall.

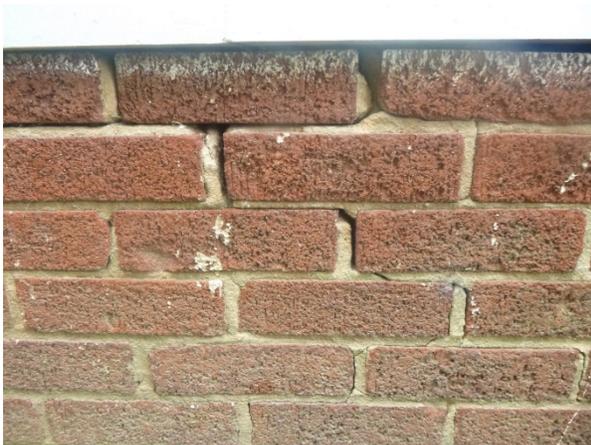
FIGURE 83. Cracked and open mortar joints at brick infill wall.

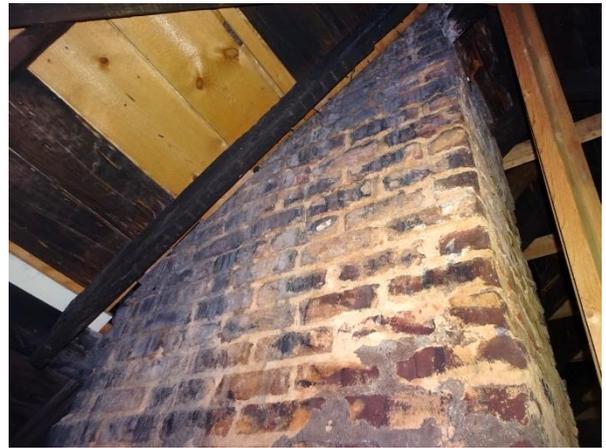
FIGURE 84. Evidence of water leakage in the attic at the masonry chimney.

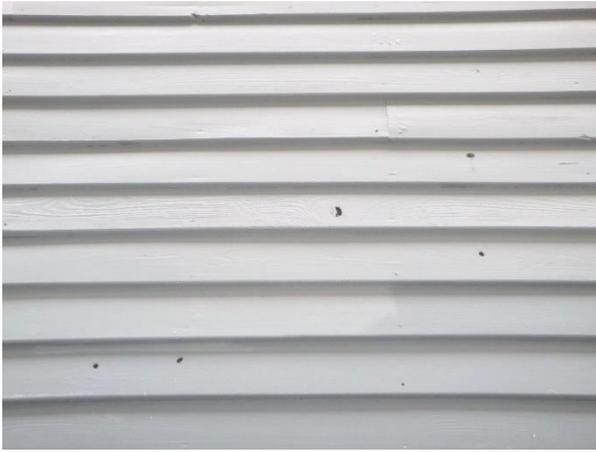
- In general, the wood elements are in good condition. Typical distress conditions include failure of surface coatings and mild to moderate deterioration of the wood. The most severe deterioration is located at the south deck and at areas where the end grain of the wood is exposed. Areas of previous siding replacement are evident due to the presence of more knots and defects on the newer boards, siding that stops short of perimeter trim at window and door openings, and differences in paint coatings and build-up (Figure 86, Figure 87, and Figure 88).

FIGURE 86. Defects in replacement siding.

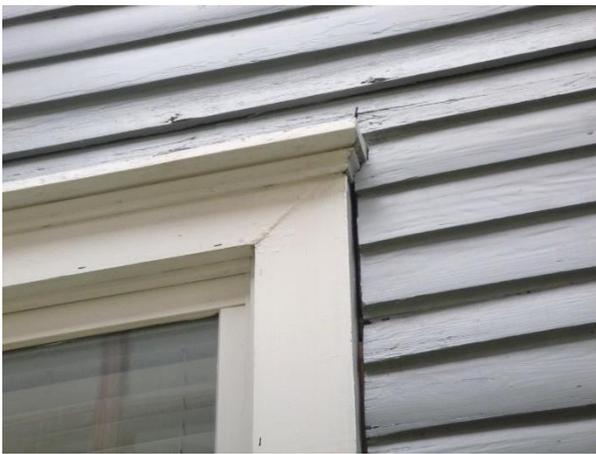
FIGURE 87. Siding stopping short of perimeter trim.

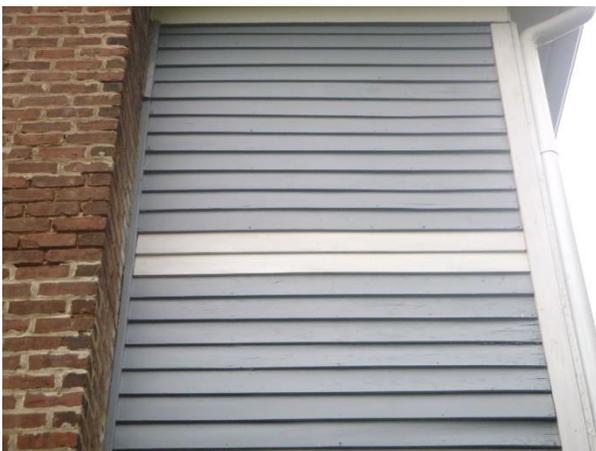
FIGURE 88. Difference in paint coatings and build-up.

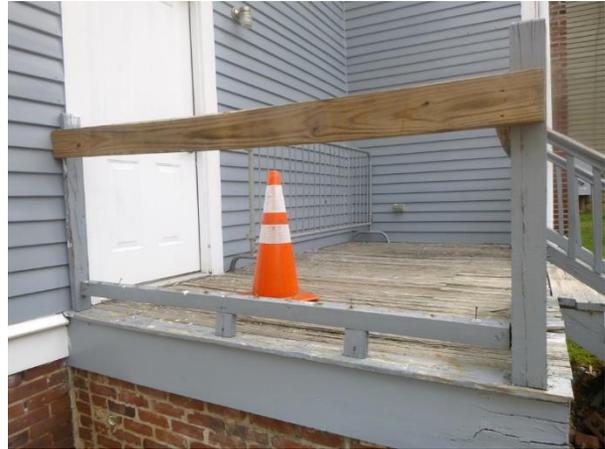
- Severe deterioration was observed at the wood guardrail of the south deck (Figure 89). The top rail and spindles were missing and the bottom rail did not appear to be well secured. The corner posts also appeared to have vertical splits that extended the full height of the post. The deck is approximately 3 feet above grade. The missing guardrail is a potential safety hazard.

FIGURE 89. Deterioration at wood guardrail of the south deck.

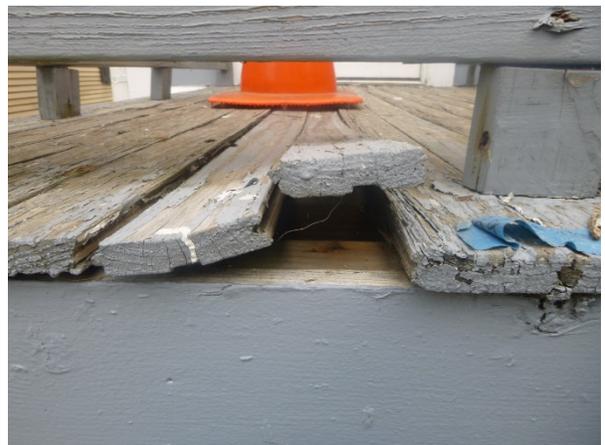
- Cupping was observed at approximately 50 percent of the decking boards at the south deck (Figure 90). Where cupping was present, the tongue-and-groove between the boards was disengaged, and the decking had buckled. The buckling was observed at a few locations and has the potential to be a tripping hazard. Mild cupping was also observed at the front porch decking but did not appear to be a tripping hazard (Figure 91).

FIGURE 90. Cupping observed at decking boards.

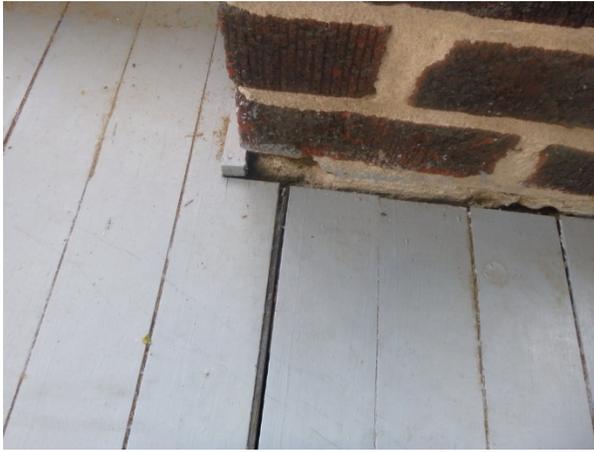
FIGURE 91. Mild cupping at front porch decking.

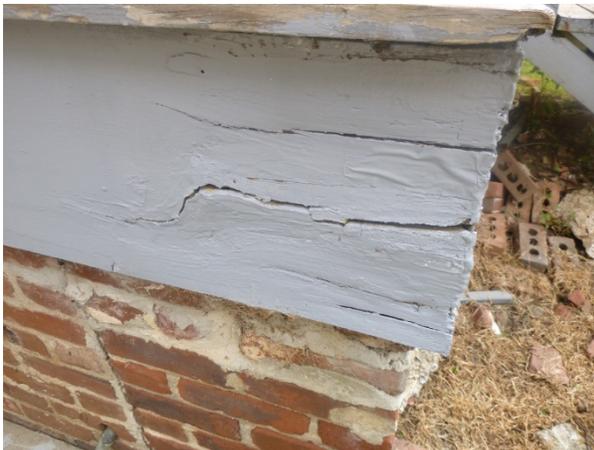
- Mild to moderate decay and deterioration was observed at some wood siding and trim (Figure 92). Typical distress included checking and splitting of wood near the end grain and along the bottom edge.
- Displacement was observed at localized siding and trim boards (Figure 93). The displacement was located at the ends of some wood siding members and at vertical trim members. Typically, the displacement was less than 1/2 inch.
- Splitting was observed at the wood shingle siding at the north end gable (Figure 94). There were approximately three shingles that had split and portions of the shingle were missing, exposing the underlying shingle. It appears that the distress occurred prior to the most recent exterior painting of the end gable.

FIGURE 92. Decay at wood siding and trim.

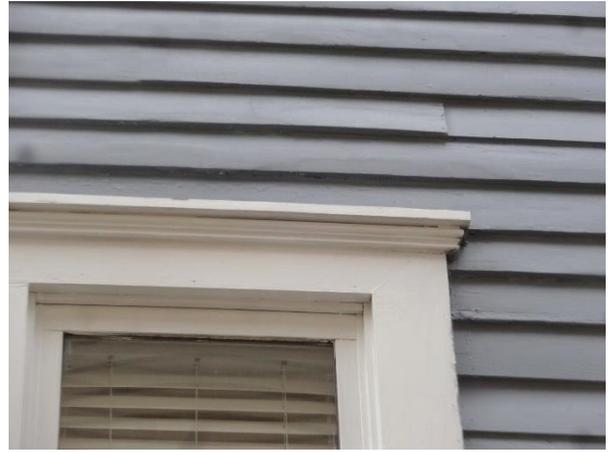
FIGURE 93. Displacement at siding and trim boards.

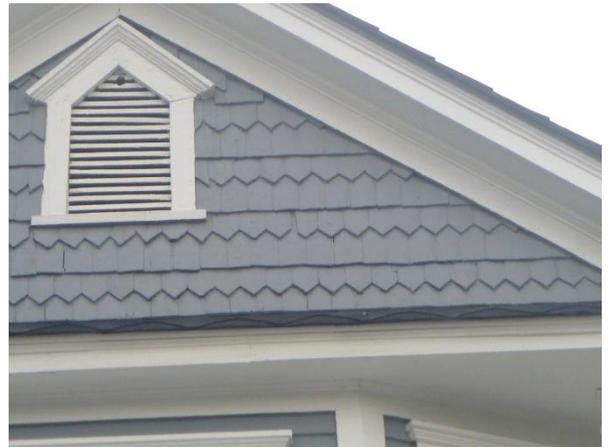
FIGURE 94. Splitting at wood shingle siding at north end gable.

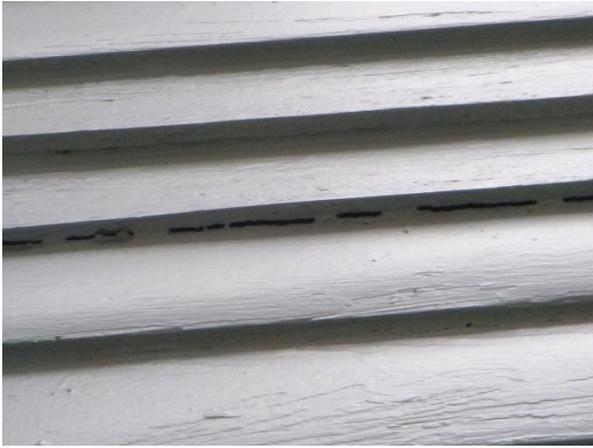
- Bowing was observed at the wood siding at localized areas. The area of bowing was typically located at the east elevation and consisted of gaps between fasteners where the lower portion of cladding boards separated from the adjacent cladding boards (Figure 95). The gap was approximately 1/4 inch to 3/8 inch wide. The gaps were not covered by the paint coating.
- Cracking, debonding, blistering, and peeling paint was observed at wood siding, trim, porch decking, and decorative elements (Figure 96, Figure 97). The distress was most pronounced at the south deck and at the wood siding near downspouts and at the foundation wall.

FIGURE 95. Bowing at wood siding at east elevation.

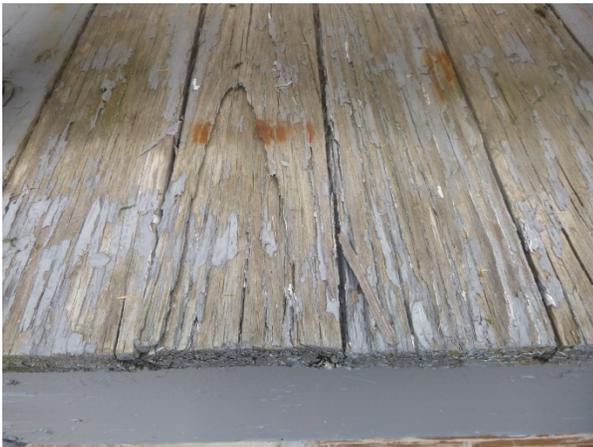
FIGURE 96. Cracking and peeling at south deck.

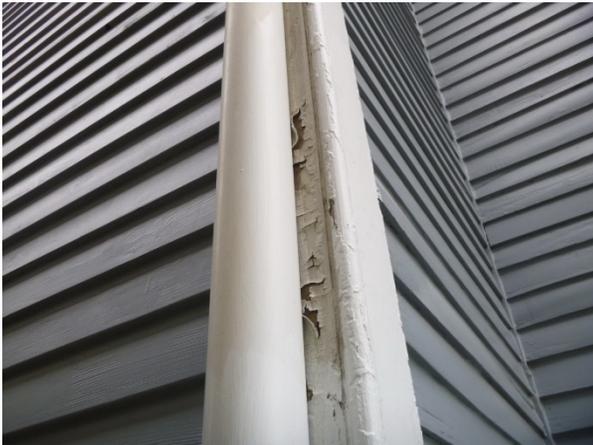
FIGURE 97. Distress at wood siding near downspouts.

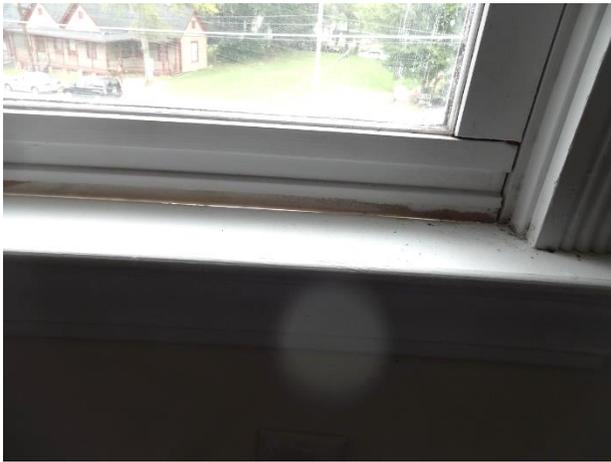
FIGURE 99. Gap between window sash and frame.

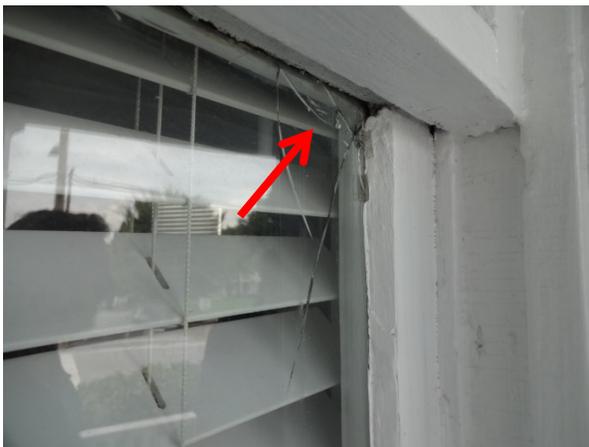
FIGURE 101. Broken glazing at north elevation.

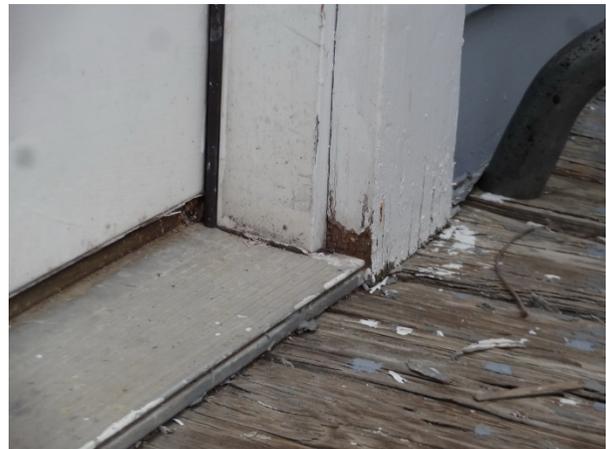
- The doors are in good condition.
- Mild to moderate decay and deterioration was observed at the wood door trim (Figure 103). Typical distress included splitting of wood and peeling paint near the end grain, and was located at the bottom of the trim, adjacent to floor level.

FIGURE 103. Decay and deterioration at door trim.

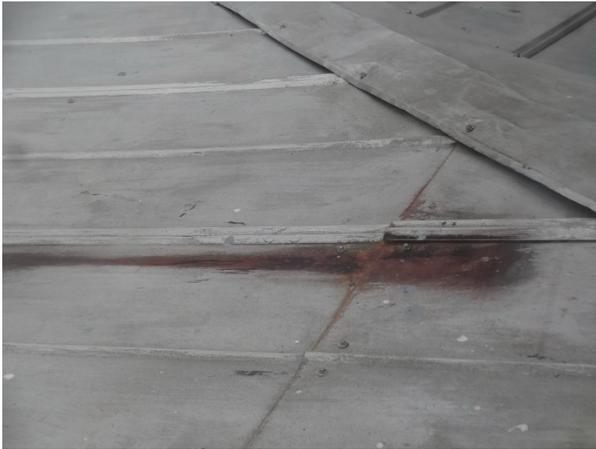
metal panels near the roof ridge. Corrosion staining extended down the slope of the roof to the gutter.

FIGURE 104. Staining and surface corrosion at porch roof.

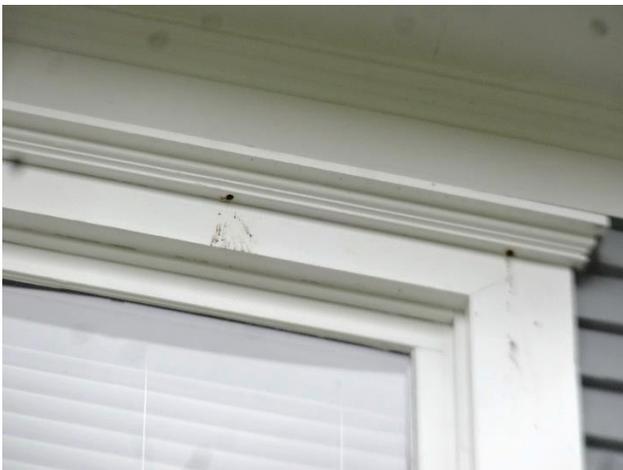
- Pest infestations were observed at one exterior projecting window molding and at the soffit of the porch (Figure 105 and Figure 106). The infestation included small circular insect holes, measuring approximately 3/8 inch in diameter, at the underside of the projecting window molding. At the porch, there was a bird's nest. No evidence of termite infestation was observed.

FIGURE 105. Insect holes at window molding.

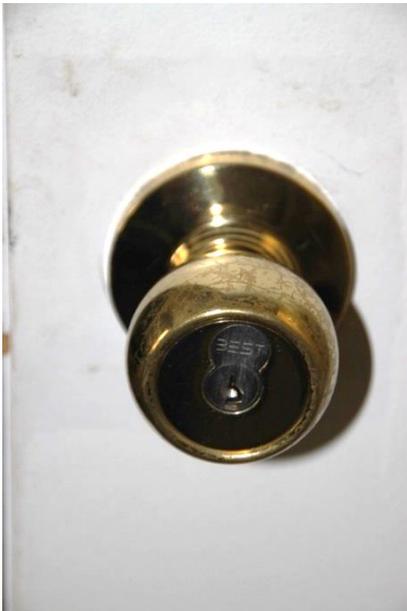
FIGURE 133. Latch set with round knob trim. This type is not ADA (Americans with Disabilities Act) compliant.

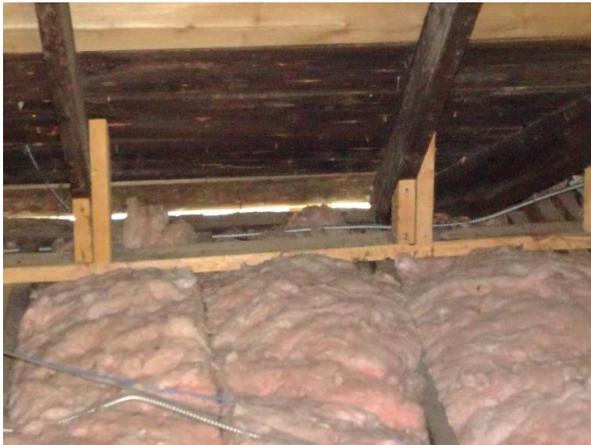
FIGURE 160. Gaps at interface between roof and wall framing.

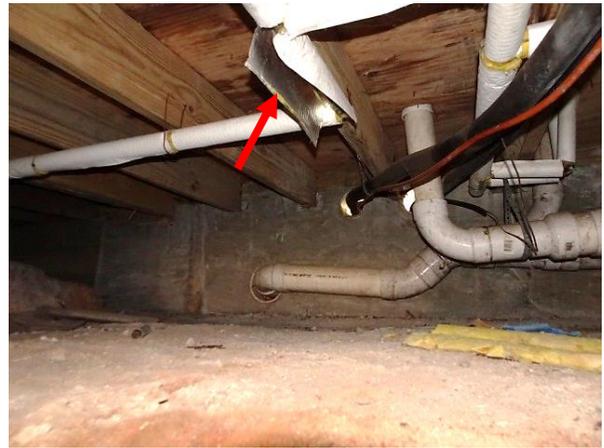
FIGURE 190. Delaminating insulation on copper water pipe in the crawl space.
