506 Auburn Avenue, NE Historic Structure Report

Martin Luther King, Jr. National Historical Park

Atlanta, Georgia

Historic Structure Report

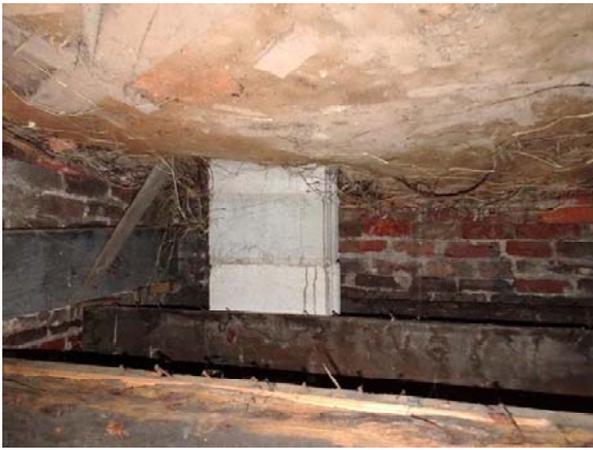
FIGURE 25. Supplemental CMU pier support at south end of foundation.

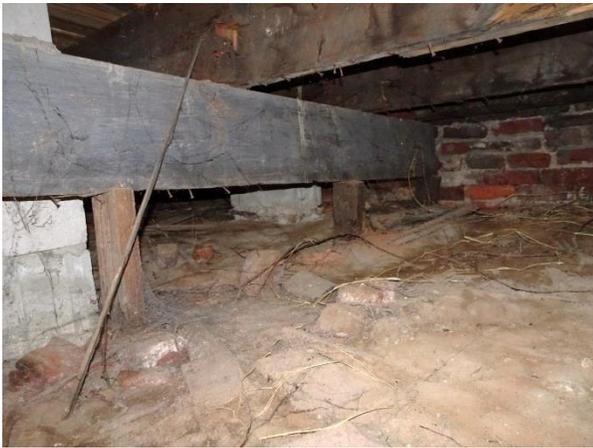
FIGURE 26. Supplemental beam support under floor joists at south end of foundation.

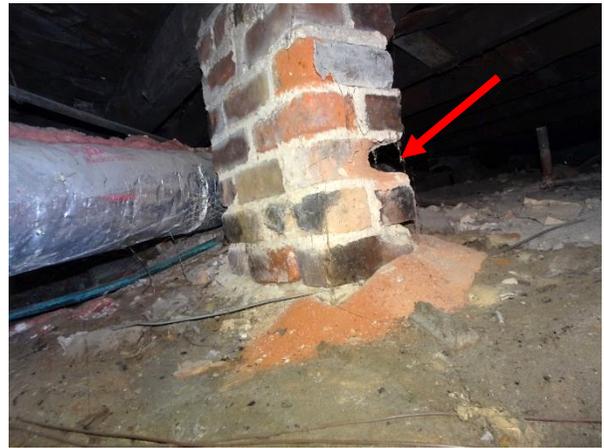
FIGURE 69. Severely deteriorated brick at foundation piers.

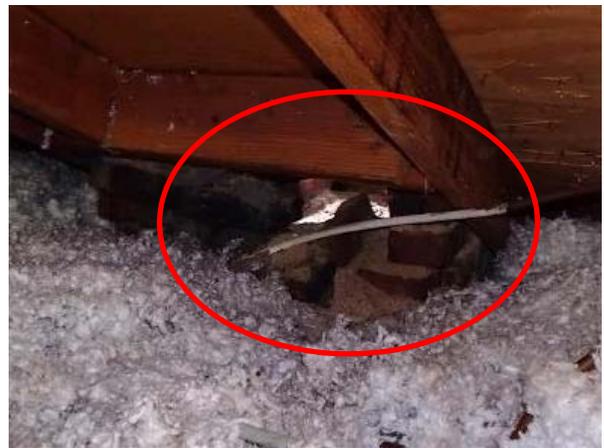
FIGURE 70. Portion of brick chimney where the brick is displaced, and daylight is visible.

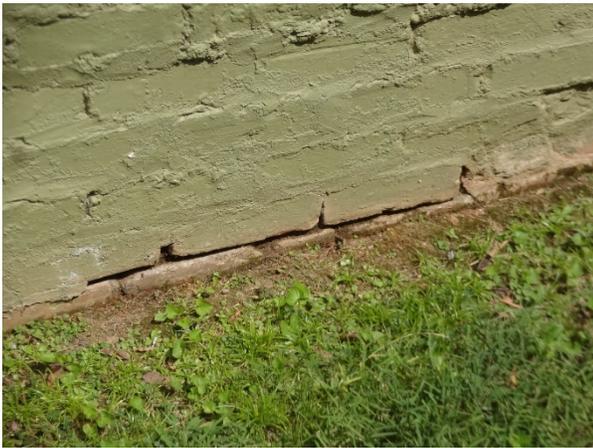
FIGURE 72. Deterioration of mortar at joints along base of foundation wall.

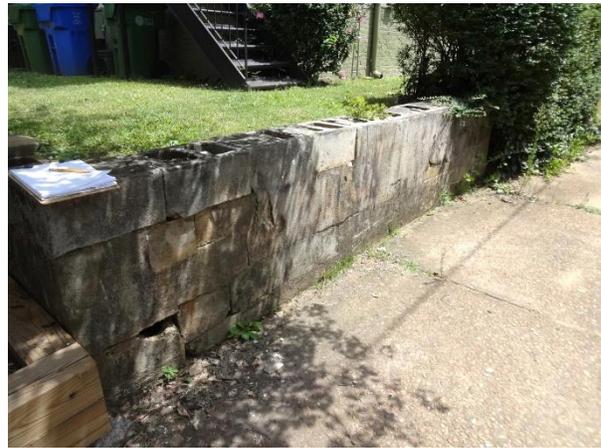
FIGURE 74. Open mortar joints and deteriorated parge coating at CMU retaining wall.

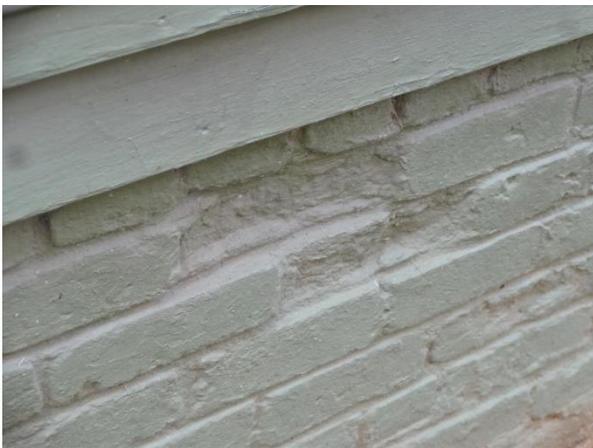
- Spalled and deteriorated brick were observed at the brick foundation wall (Figure 73). Where observed, the spalling included the loss of the finished face of brick to a depth of approximately 1-1/2 inches. The spalls had been painted green, along with the rest of the foundation wall, indicating that the spalls were present at the time of the most recent repainting.

FIGURE 73. Pre-existing spalls at brick foundation, prior to most recent painting of the brick.

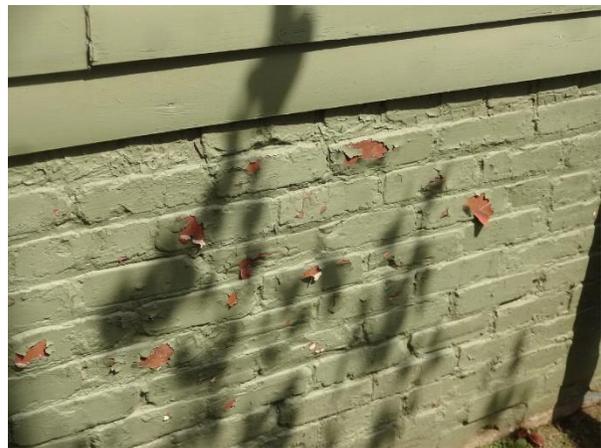
FIGURE 75. Peeling paint at brick foundation wall.

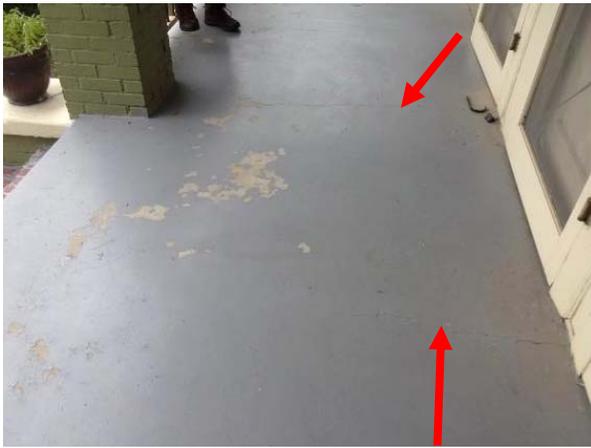
- In general, the existing concrete located at the front porch landing was in good condition.
- Hairline cracking was observed at the concrete deck slab at the front porch (Figure 76). The cracking extended perpendicular across the slab.
- Peeling and flaking of paint was observed at the concrete slab at the front porch.

FIGURE 76. Hairline cracking at concrete porch slab extends perpendicular to direction of slab.

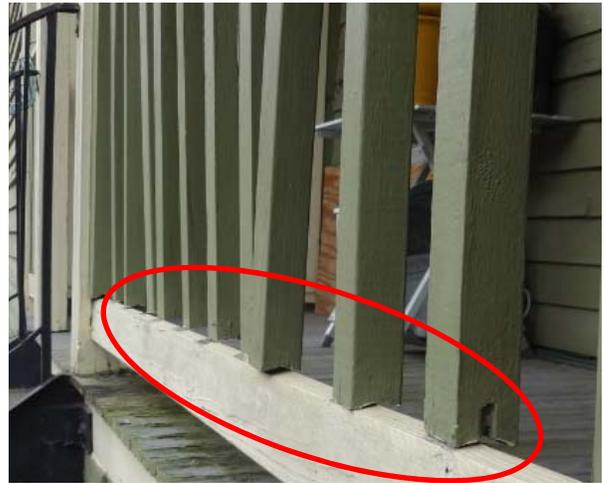
FIGURE 77. Displaced spindles at north porch balustrade.

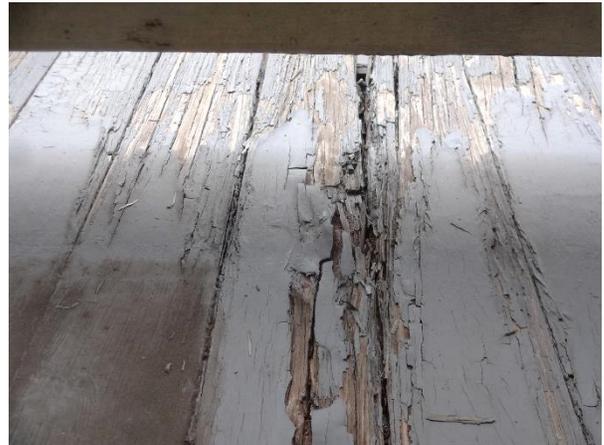
FIGURE 78. Deteriorated wood decking near ends of porch floor boards.

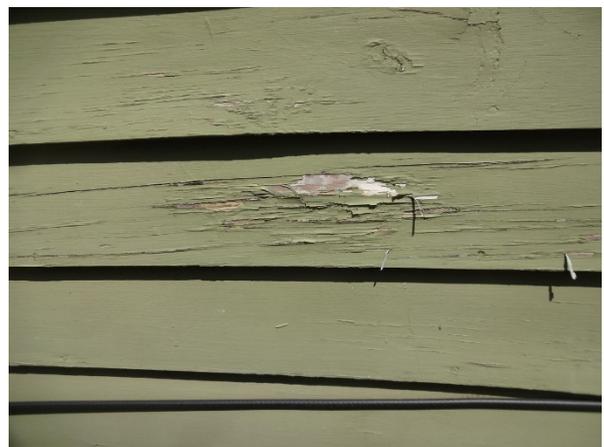
FIGURE 79. Peeling paint at wood siding.

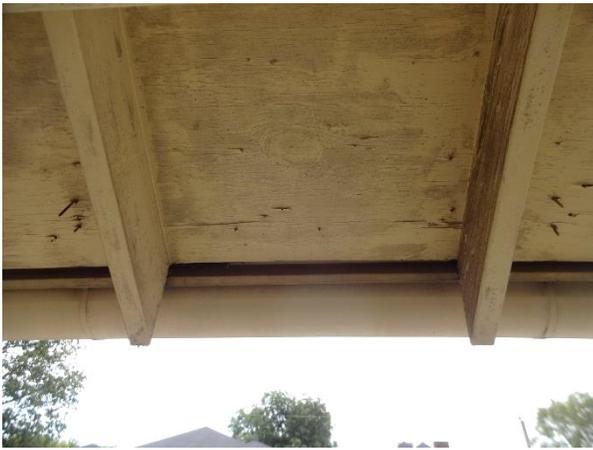
FIGURE 80. Deteriorated paint at underside of roof eaves.

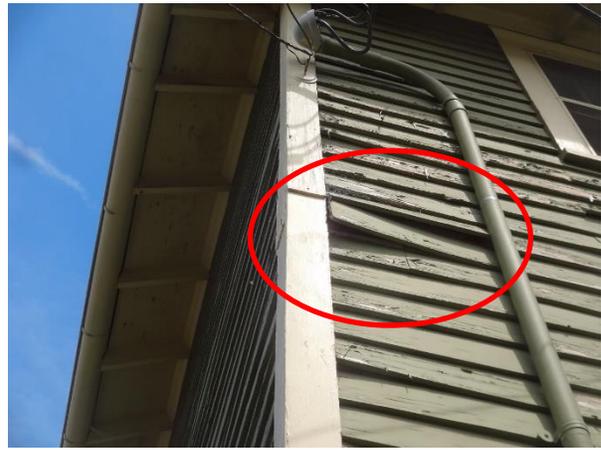
FIGURE 81. Displaced siding board.

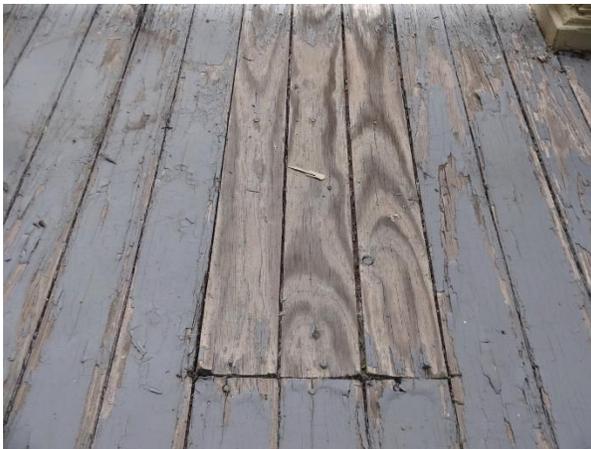
- Previous wood deck repairs were observed at one location at the second floor of the south porch (Figure 86). An 18-inch-by-12-inch section of the wood deck had been removed and replaced with new decking.

FIGURE 86. Replacement deck boards at south porch.

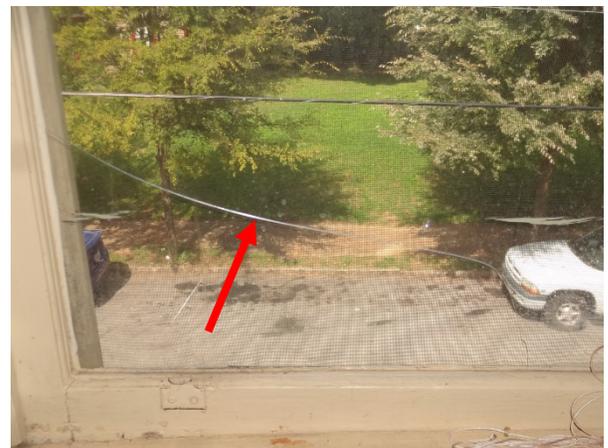
FIGURE 87. Cracked glazing unit at one window. This window is located at second floor unit B, in the bedroom.

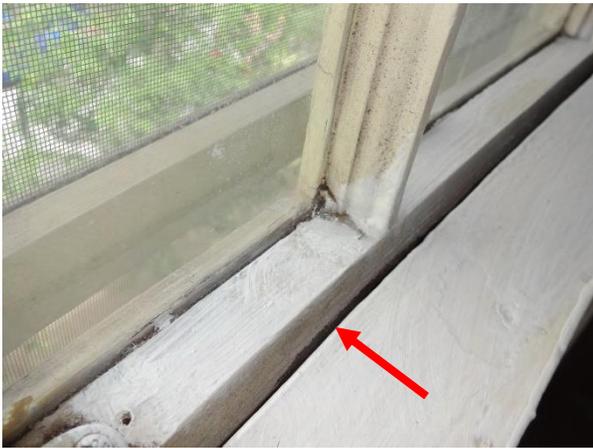
FIGURE 88. Gap between upper and lower sash meeting rails.

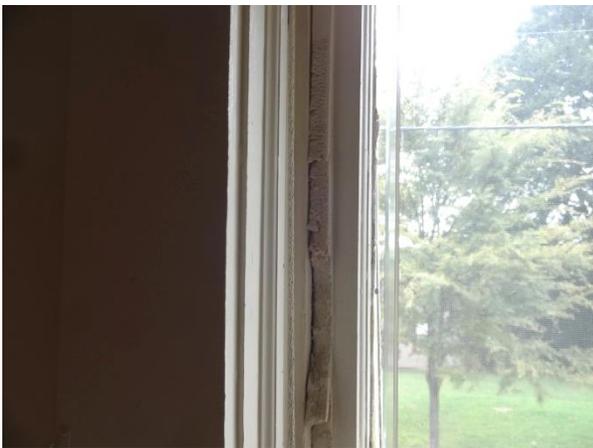
FIGURE 89. Weather stripping applied to interior face of window sash to address air infiltration.

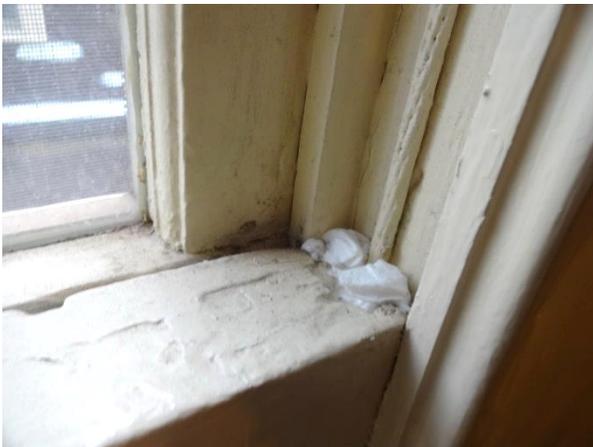
FIGURE 90. Void between rope sash cord and sash has been filled in with tissue.

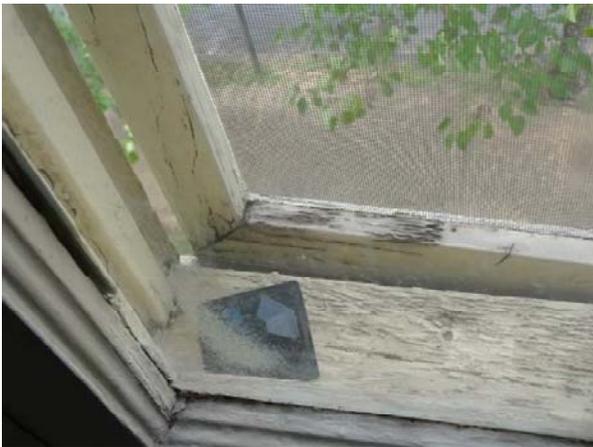
- Deterioration of the wood sill, and exterior window screen was observed. The distress included peeling paint and evidence of decay of the underlying wood (Figure 92).

FIGURE 92. Deterioration of wood at window sill and screen window sash.

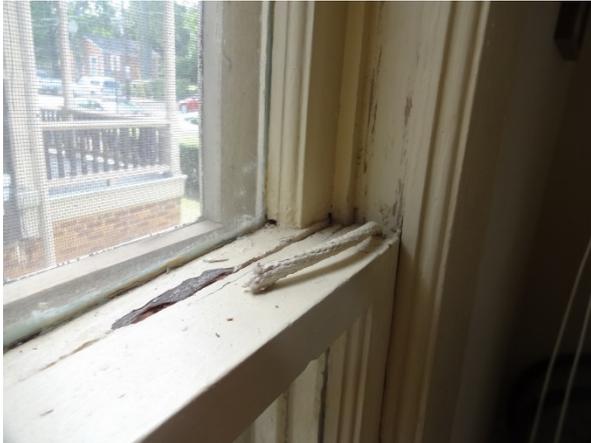
FIGURE 93. Rope sash cord at double-hung windows that has been cut.

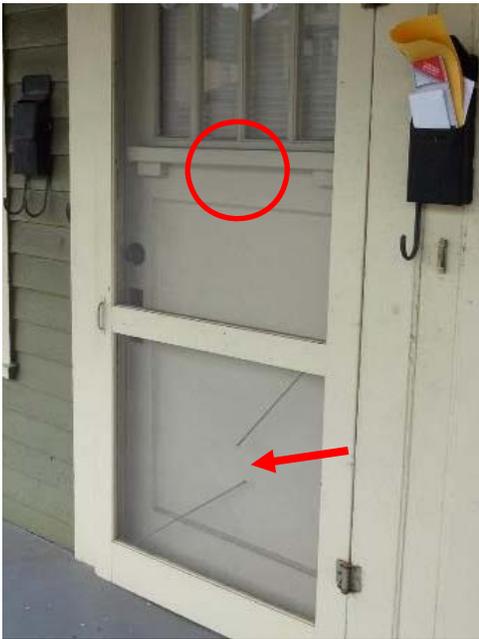
- The doors are in good condition.
- A decorative element was observed to be missing on the first-floor door at the west end of the south elevation. The center dentil block below the projecting trim applied to south elevation doors was missing (Figure 97).
- A broken turnbuckle was observed at one exterior screen door. The screen door was located at the west end of the first floor on the south elevation of the building. The turnbuckle between the diagonal tie rods was missing and the rods were loose (Refer to Figure 97).
- Torn screens were observed at two screen doors (Figure 98). At both locations, the metal screening was ripped in a linear pattern measuring approximately 4 inches long. The screens were located at the first floor at the east end of the south elevation and at the second floor at the west end of the north elevation.

FIGURE 97. South elevation door with missing decorative wood piece (circle) and missing turnbuckle at diagonal bracing of screen door (arrow).

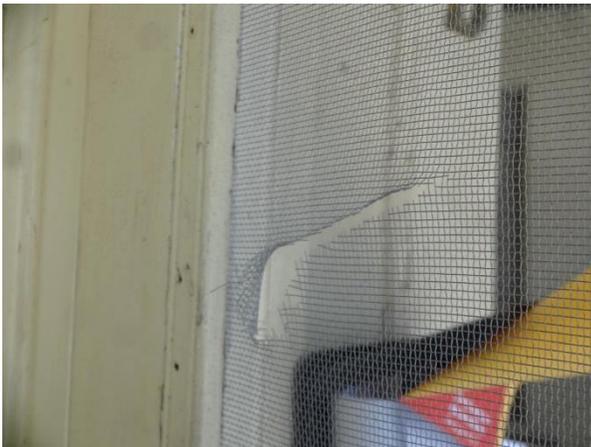
FIGURE 98. Ripped screen at south elevation screen door.

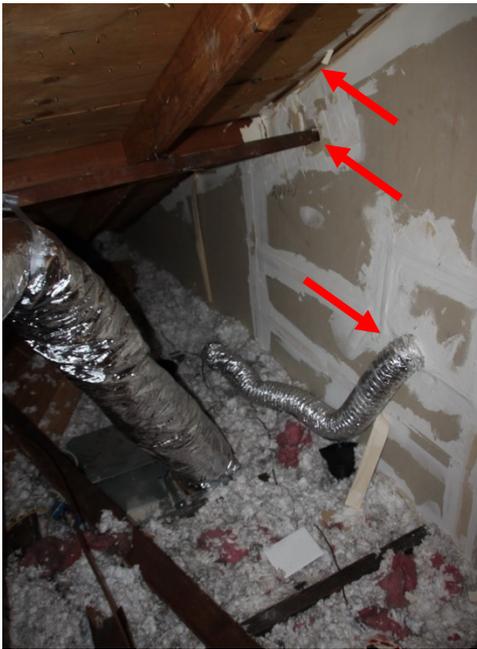
- Biological growth is evident in grout and sealant joints of the ceramic tile bathtub surrounds.
- The code-required integrity, continuity, and smoke and fire rating of the fire barrier separation (gypsum board partition) between the two units on the east side of the building and the two units on the west side are questionable because of unsealed penetrations, lack of fire-caulking, cut-outs and damage to the gypsum board and joints that are improperly taped and floated, particularly in the attic.

FIGURE 130. Lack of code-required integrity, continuity, and smoke and fire rating of the fire barrier separation (gypsum board partition) in the attic between the two units.

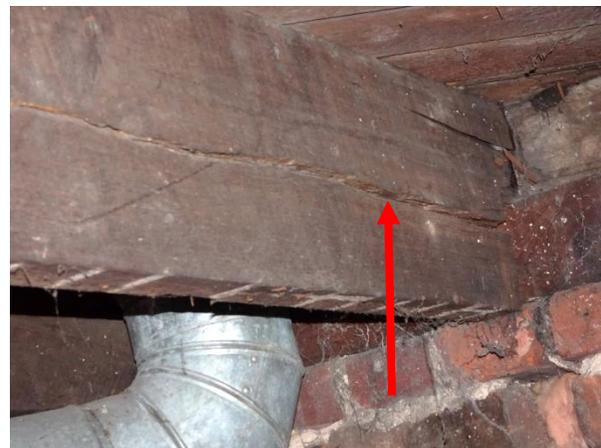
FIGURE 135. Severe cracking at end of floor joist.

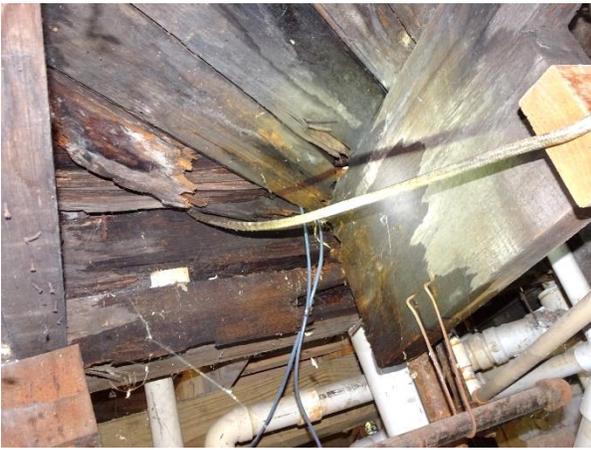
FIGURE 136. Moisture damage and wood deterioration at wood framing below kitchen.

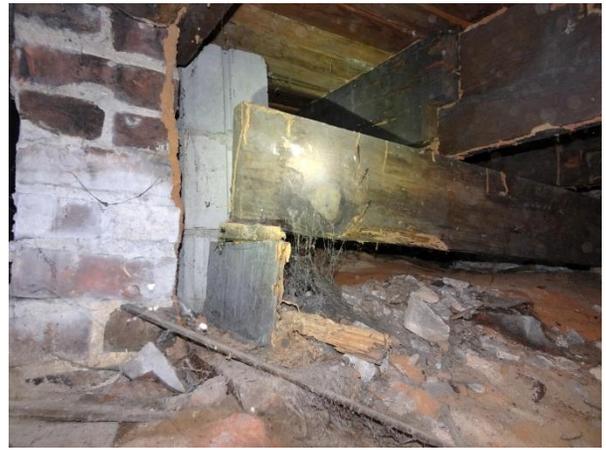
FIGURE 139. Deteriorated supplemental wood post at south end of building.

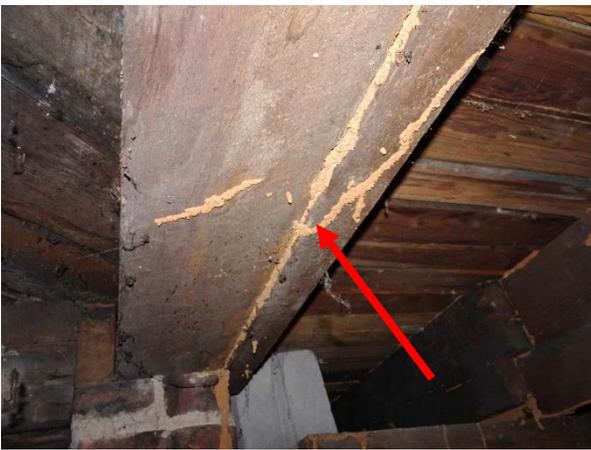
FIGURE 137. Termite damage at floor joists on south end of building.

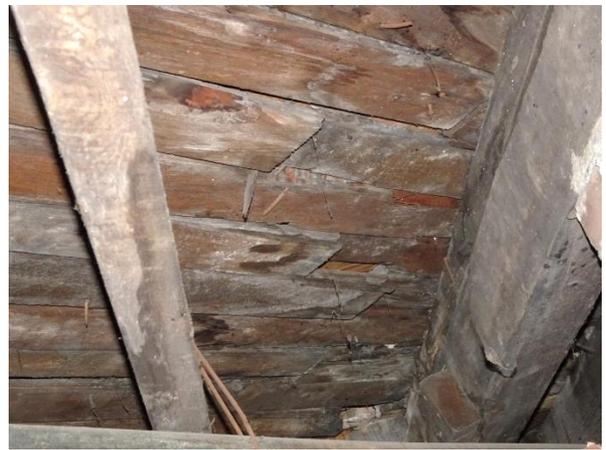
- Moisture staining was observed at numerous locations at the deck board and some beams (Figure 140). The staining typically had an irregular shape outlined with either a dark- or white-colored stain line. Where present, the moisture leakage did not appear to be active.

FIGURE 140. Moisture staining at underside of wood deck boards.

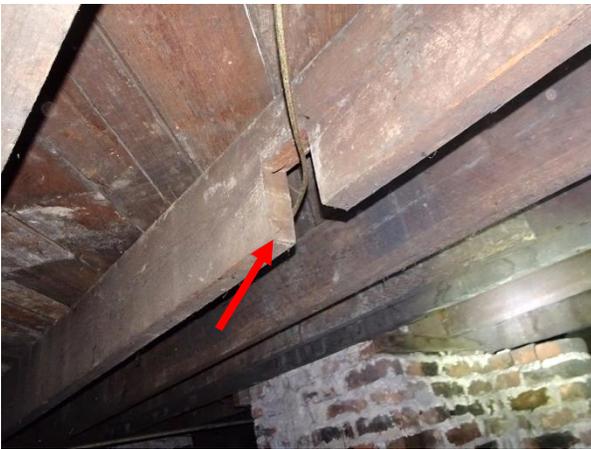
FIGURE 138. Notch cut into lower half of the floor joist.

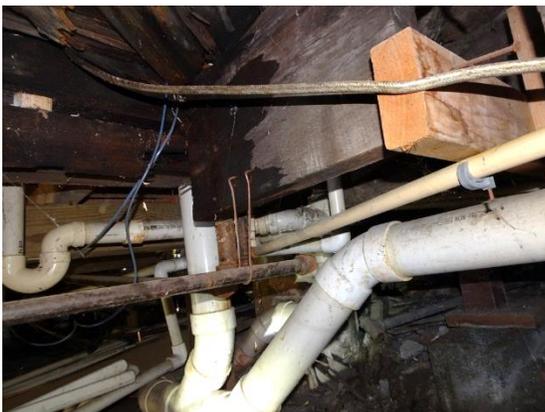
FIGURE 151. Tangle of pipes and wires in crawl space.

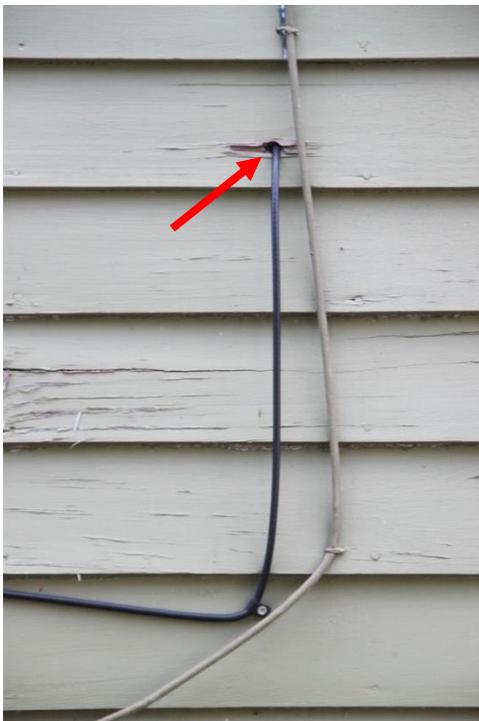
FIGURE 162. TV and internet cables stapled to the wood siding. Note the damage to the siding where the cable penetrates the exterior envelope, and the penetration is not sealed.

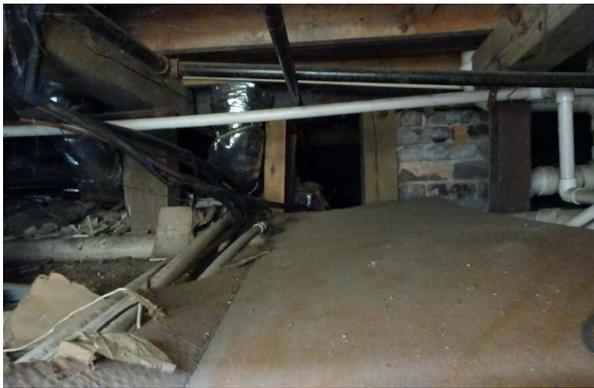
FIGURE 170. Web of new and abandoned PVC, black steel (gas), and copper piping in the crawl space.
