510 Auburn Avenue, NE Historic Structure Report

510 Auburn Avenue, NE
Martin Luther King, Jr. National Historical Park
Atlanta, Georgia

Historic Structure Report

September 2019

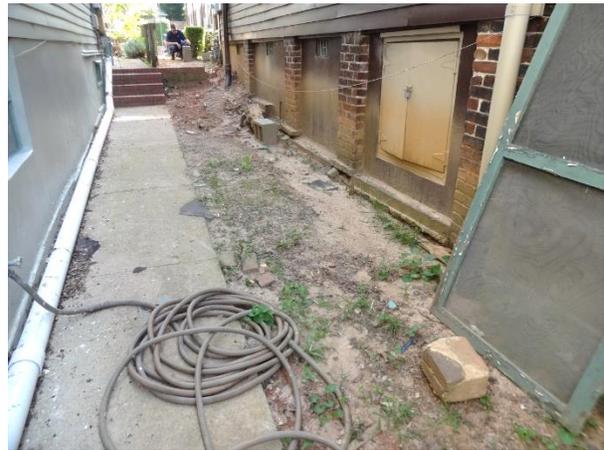
- Mild erosion was observed at the concrete footing, specifically near the crawl space entrance at the north end of the east elevation and at the west side of the porch foundation (Figure 95). At these locations, the soil appears to be undercutting the footing. The site at these locations is sloped slightly to the north.

FIGURE 90. The east yard of the site has evidence of soil erosion.

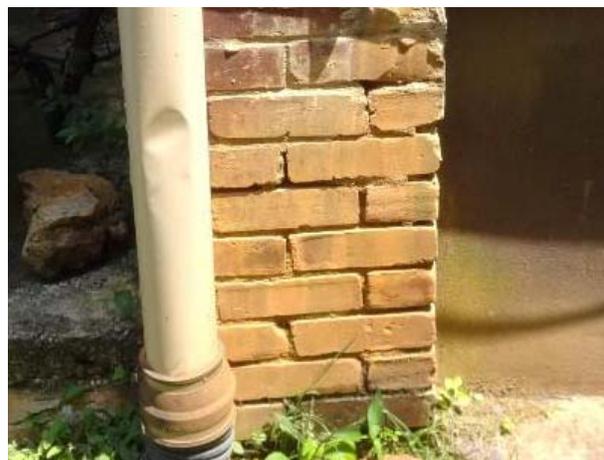
FIGURE 91. Open and deteriorated joints at foundation piers.

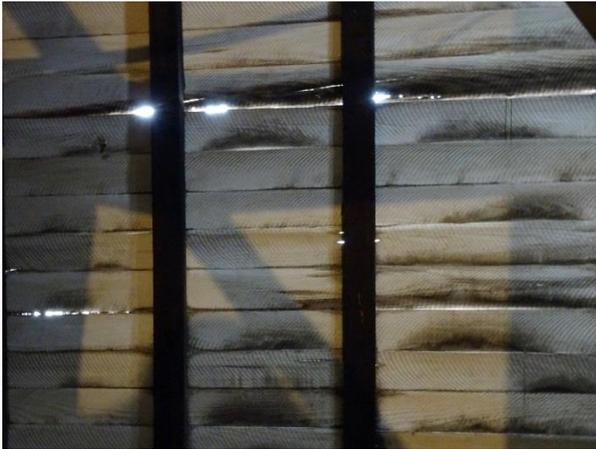
FIGURE 96. Gaps in the horizontal wood siding at the north elevation of the main building as evidenced by visible daylight.

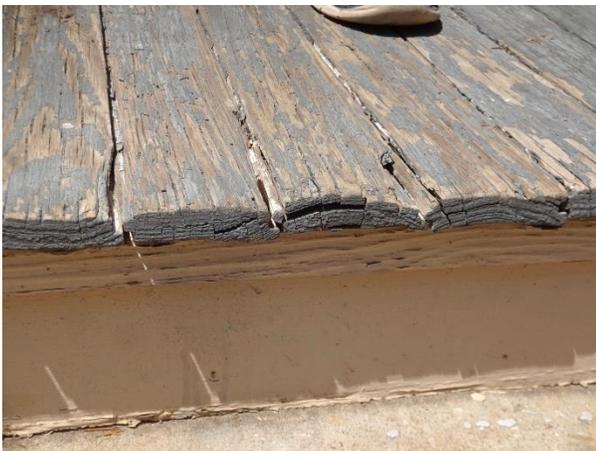
FIGURE 98. Cupping at south porch deck boards.

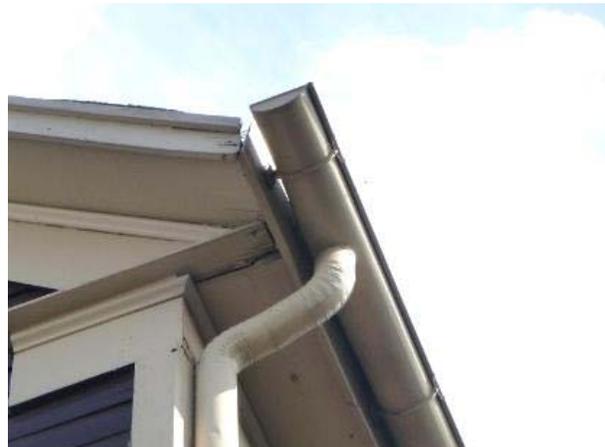
- Bowing and displacement was observed at the wood siding at localized areas. The area of bowing was typically located at the west elevation and consisted of gaps between fasteners where the lower portion of cladding boards separated from the adjacent cladding boards (Figure 100). The gap was approximately 1/4 inch to 3/8 inch wide. The gaps were not covered by the paint coating. Displacement was observed at the ends of siding boards, where boards had come loose, creating a gap between the wall and the siding (Figure 101). At the fascia, some of the boards had displaced downward approximately 1 inch and were no longer aligned with the adjacent fascia (Figure 102). The displaced fascia boards also show evidence of deterioration.

FIGURE 99. Displaced wood fascia.

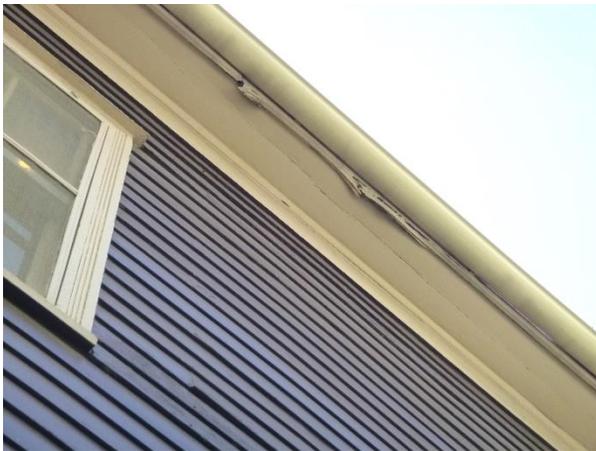
FIGURE 102. Displaced fascia board shows evidence of deterioration as well.

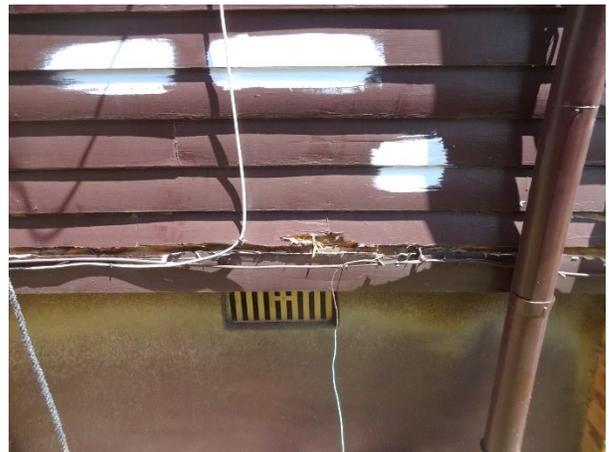
FIGURE 103. Deterioration along the bottom edge of the wood siding

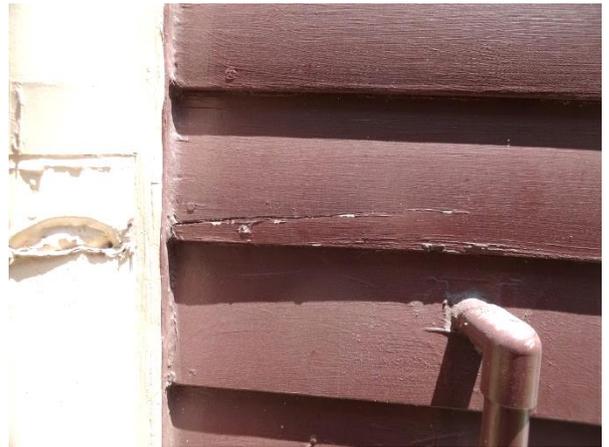
FIGURE 104. Checking at end of wood siding.

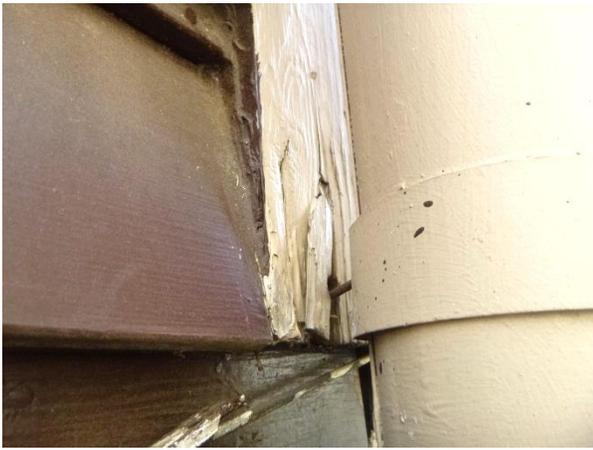
FIGURE 105. Decay of vertical wood trim piece.

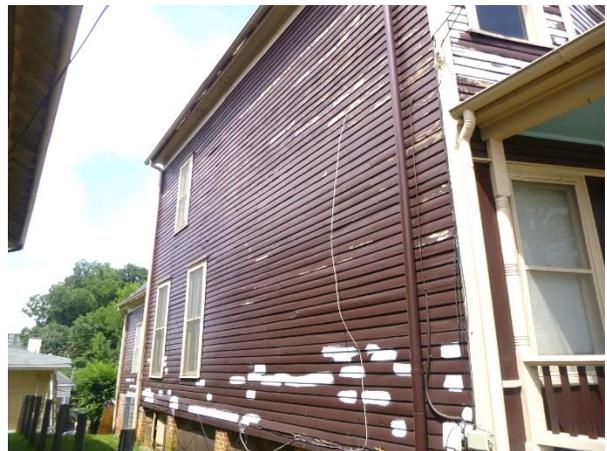
- Cracking, debonding, and peeling of paint were observed at the wood siding, trim, porch deck boards, porch railings, rafters, and at the underside of the overhanging eaves (Figure 109). The pattern of peeling paint typically followed the graining on the boards. At these locations, some of the wood was exposed to view. The paint failure may be related to poor surface preparation.

FIGURE 109. Peeling paint at west elevation. Note loose paint at some locations has been removed and primer applied.

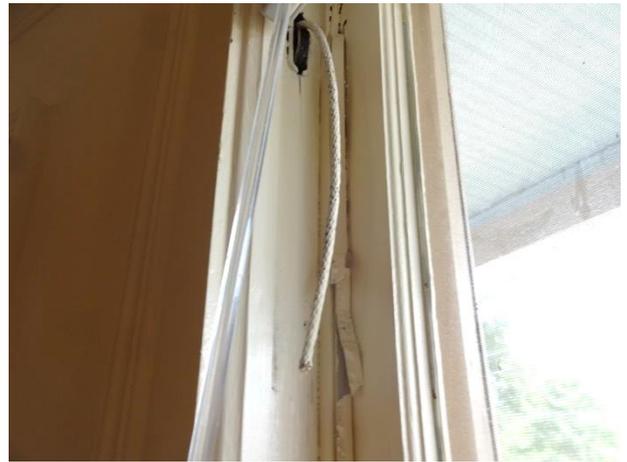
FIGURE 111. Broken rope sash cord.

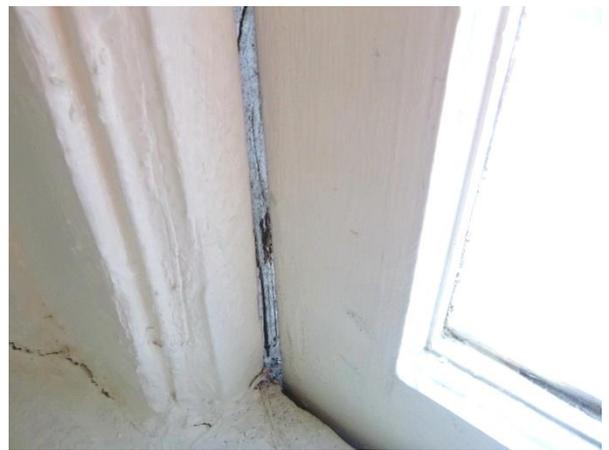
FIGURE 112. Lower window sash that is out of plumb.

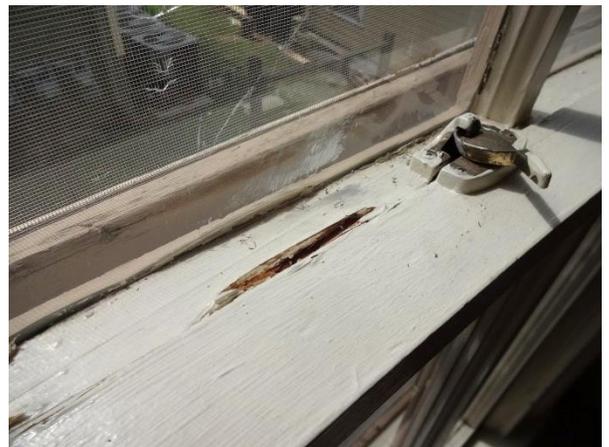
FIGURE 113. Damage to corner of upper sash meeting rail in bedroom 2, second floor.

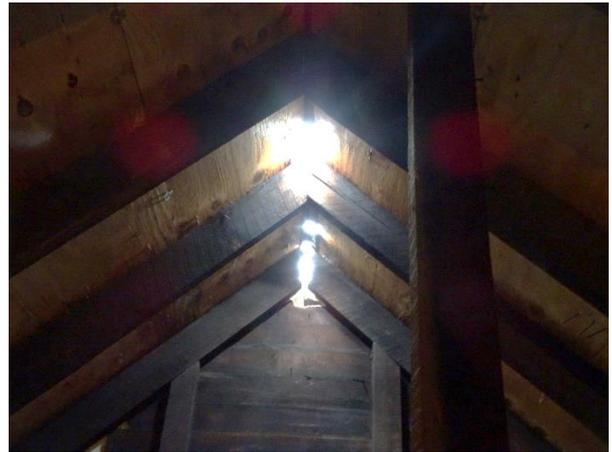
FIGURE 120. Gaps along the main building roof as evidenced by visible daylight.

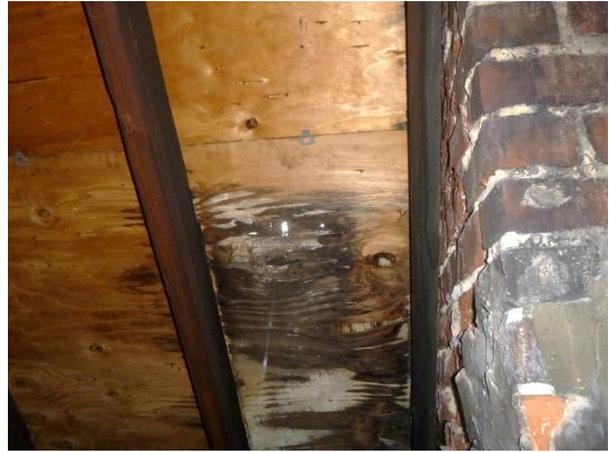
FIGURE 124. Moisture staining and deterioration of roof sheathing adjacent to chimney at the main building roof.

- Moisture staining was observed at some plywood sheathing (Figure 124). The staining was located at plywood sheathing adjacent to chimneys and along the eaves at the base of the roof slope. The staining typically had a black color which may be an indication of mold, mildew, or biological growth. The moisture staining is an indication of moisture infiltration; however, there was no report of active water infiltration.
- Asphalt shingles were observed to be in poor condition (Figure 125 and Figure 126). Distress conditions included curling along the edges of the shingles; erosion of the granulated surface coating; loose and debonded shingles, particularly along roof edges; and ripped and torn shingles.

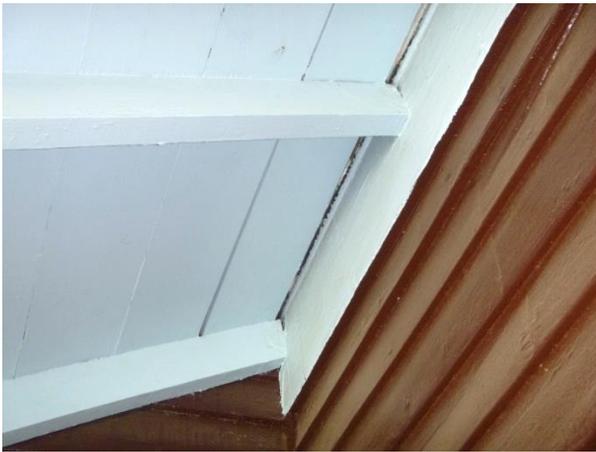
- A gap and separation were observed between the sheathing and wall at the northeast porch shed roof (Figure 123). As viewed from the underside of the roof, the sheathing was displaced approximately 1-1/2 inch, creating a gap between the roof and the wall. The wood roof rafters also appeared to have sagged, resulting in a 3/4 inch gap at the top of the rafters. It appeared that the roof assembly covered the gap in the roof framing.

FIGURE 123. Gap and displacement of shed roof at the northeast roof.

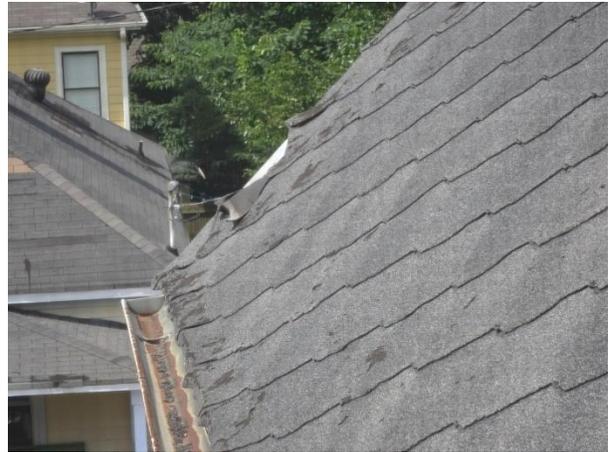
FIGURE 125. Deteriorated roof shingles as viewed on the north extension roof.

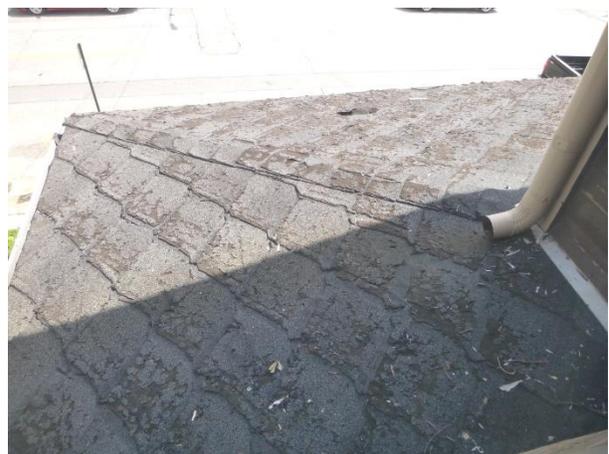
FIGURE 126. General deteriorated condition of roof shingles.

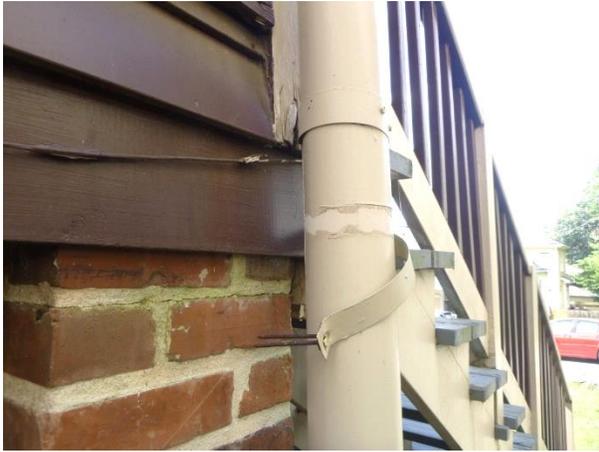
- Loose and displaced gutter straps were observed at a few locations on the building (Figure 127). Despite the straps being loose, the gutters appeared secure and were not displaced.
- Mild surface corrosion was observed at roof gutters (Figure 128). The corrosion was located at the trough of the gutters.

FIGURE 127. Loose downspout strap.

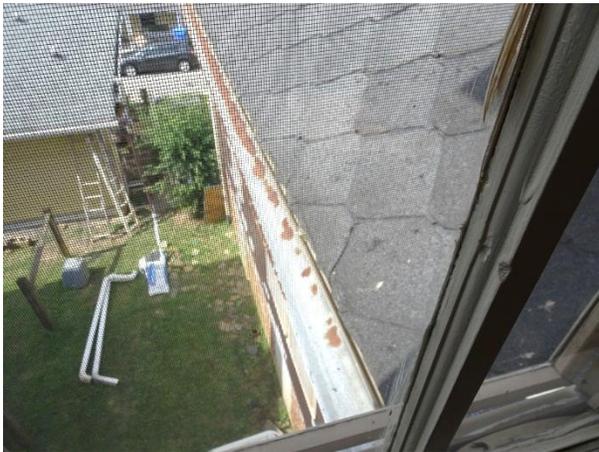
FIGURE 128. Corrosion at north extension gutter.

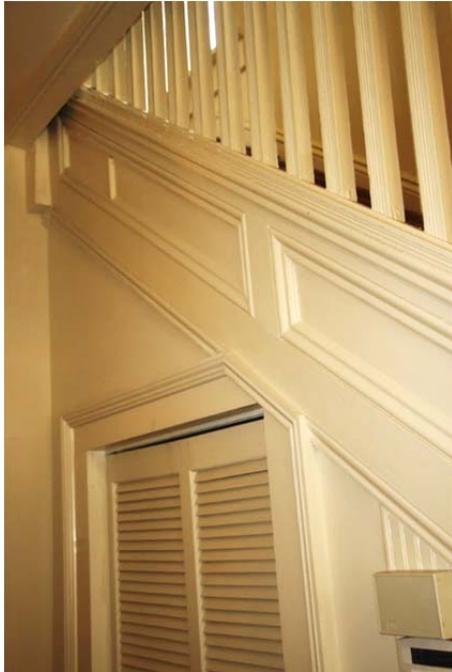
FIGURE 151. Louvered bi-fold door at the water-heater closet. Note the awkward clipped corner of the door trim under the paneled stair stringer.

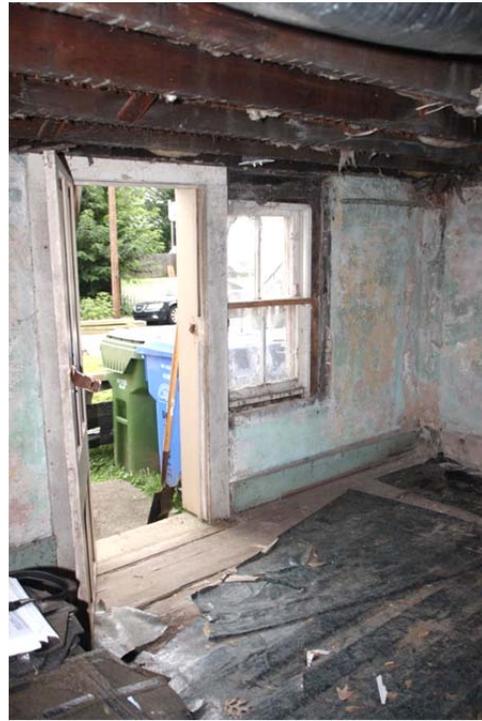
FIGURE 167. Basement entrance into north room. Note deteriorated plaster and exposed ceiling joists.

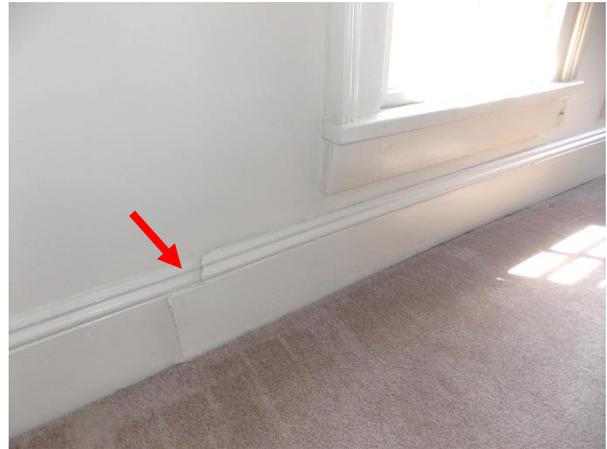
FIGURE 180. Misaligned baseboard joint. Perhaps an attempt to merge original baseboard with new baseboard.

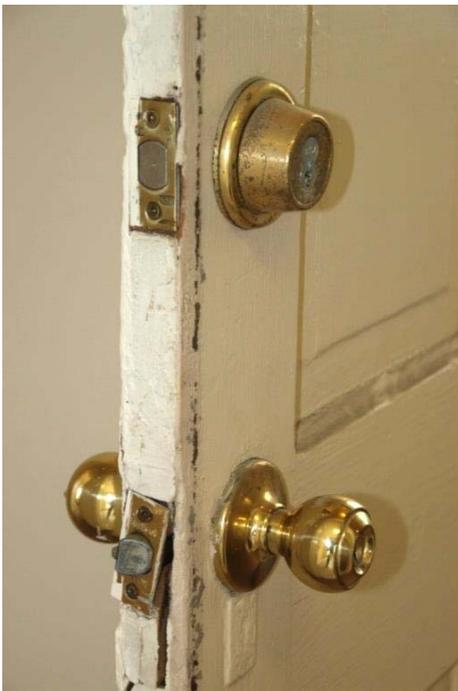
FIGURE 182. This rear hall exterior door edge is damaged to the extent that the stile is no longer solid enough to hold the screws for the lockset and deadbolt. The brass finish on the deadbolt and lockset is tarnished and scratched.

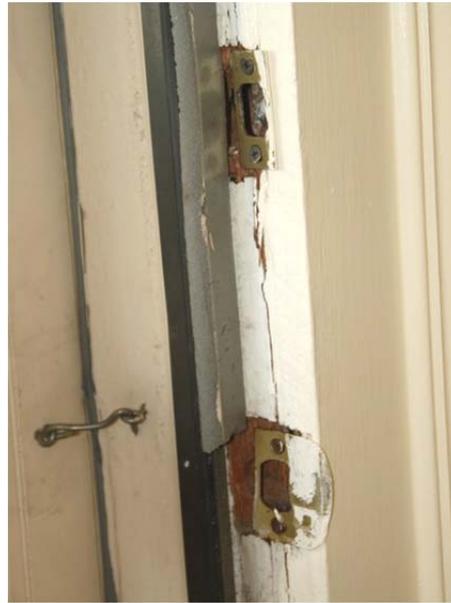
FIGURE 183. This door jamb at the rear hall exterior door is split to the extent that it is not sound enough to secure the strike plates for the lock and deadbolt.

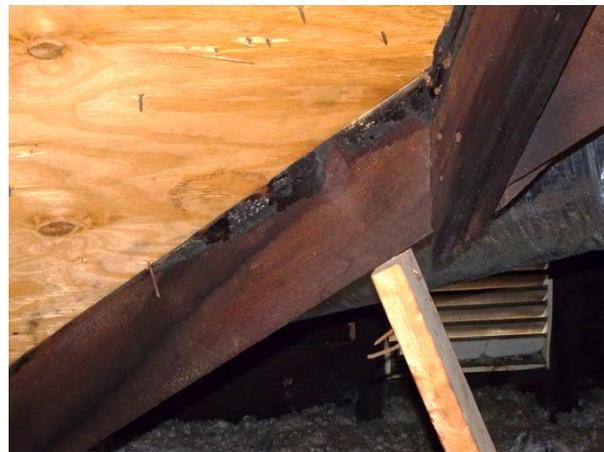
FIGURE 194. Wood roof rafter with evidence of previous fire damage.

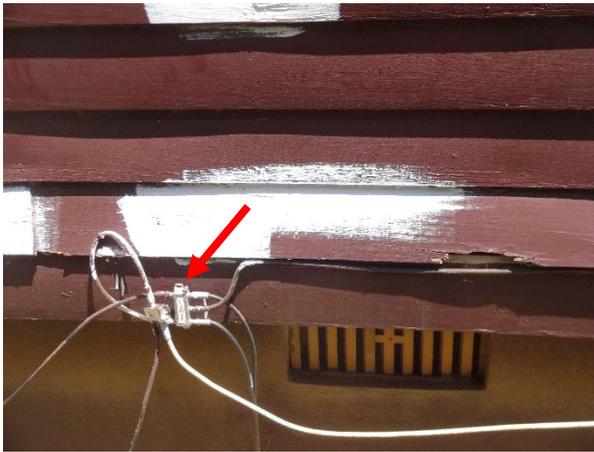
FIGURE 217. Exposed co-axial cable attached to wood siding.
