518 Auburn Avenue, NE Historic Structure Report

518 Auburn Avenue, NE
Martin Luther King, Jr. National Historical Park
Atlanta, Georgia

Historic Structure Report

August 2019

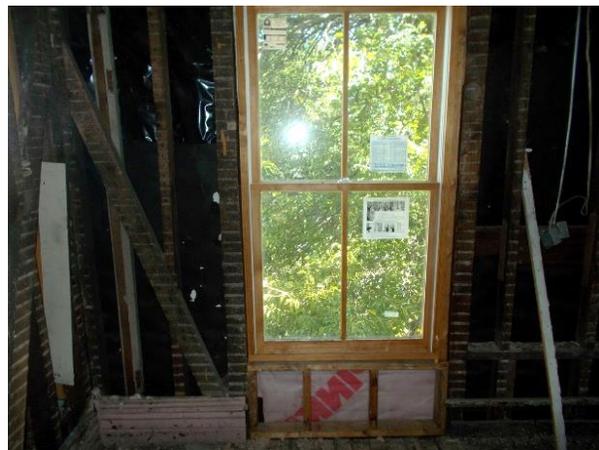
FIGURE 43. Interior conditions indicate significant alteration to the window configuration including addition of the north elevation window opening seen here.

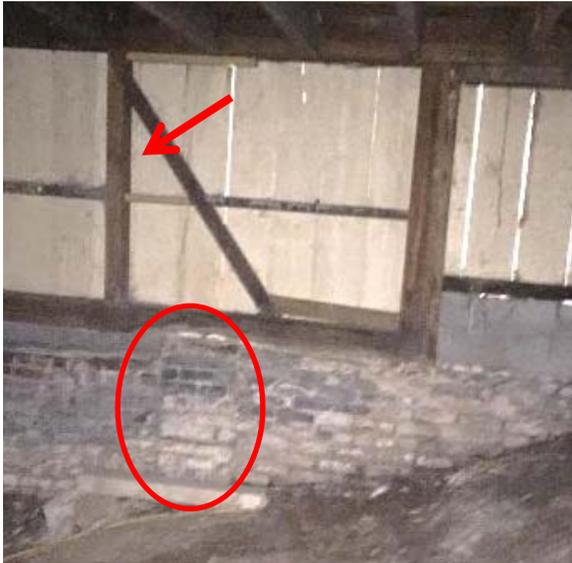
FIGURE 56. Foundation pier (circle) and structural post (arrow). Note that pier and post do not align.

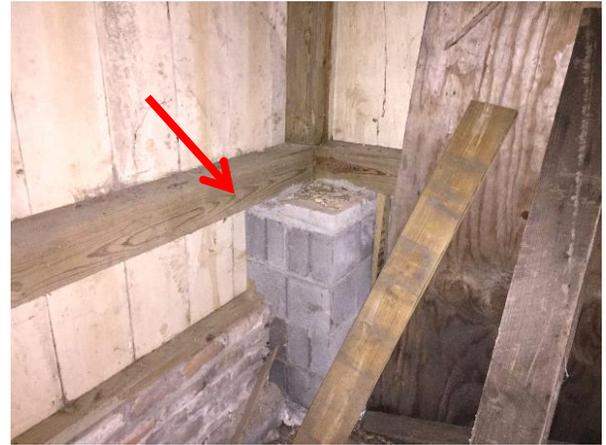
FIGURE 59. Foundation pier rebuilt with CMU.

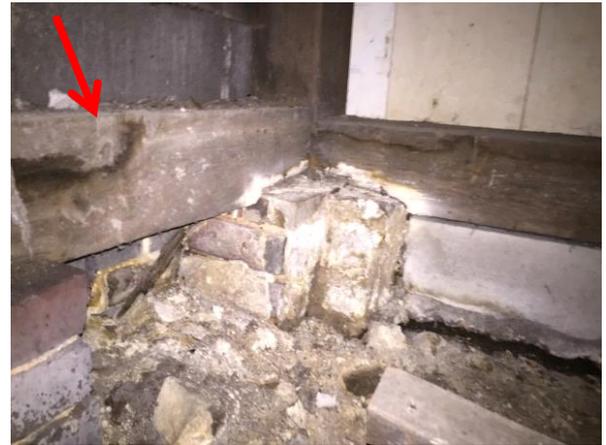
FIGURE 60. Staining and deterioration of wood at brick foundation piers. Note general deteriorated condition of brick.

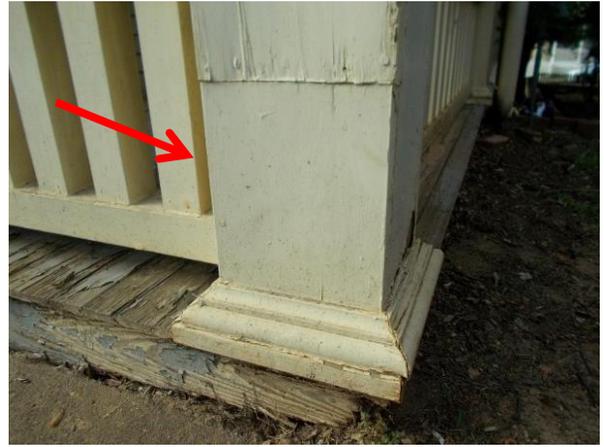
FIGURE 65. Dutchman repairs at base of balustrade columns.

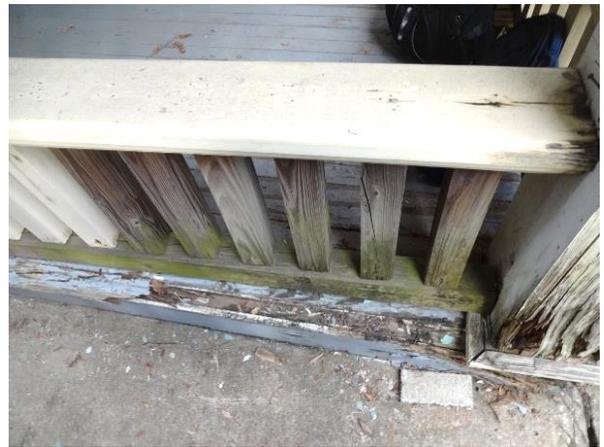
FIGURE 66. Unpainted replacement balusters at balustrade.

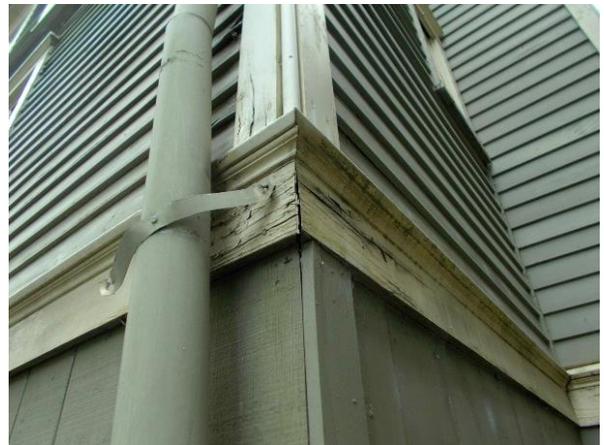
FIGURE 67. Deterioration of wood at trim board.

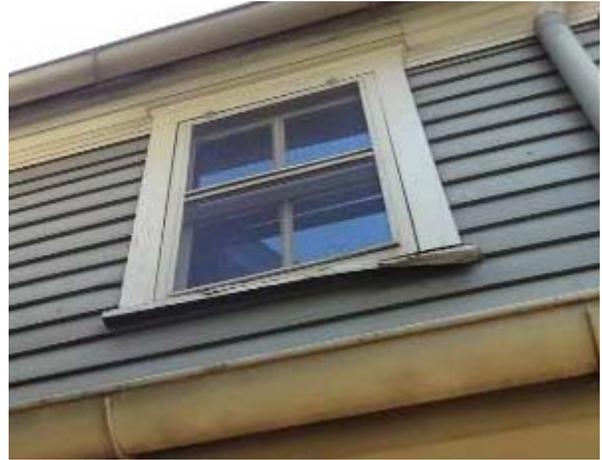
FIGURE 74. Deteriorated wood at window sill.

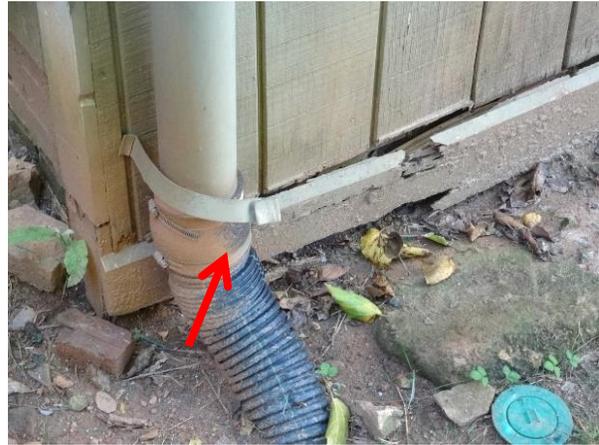
- In general, the roof is in good condition; gutters and downspouts were connected and secure at the time of the survey except for the downspout at the northwest corner of the house. It was not connected to the gutter (refer to Figure 55). During rainy weather, water flows out of the gutter at this location and runs down the side of the building. There was no other evidence or report of water leakage.
- Loose and displaced downspout straps were observed at a few locations on the north elevation (Figure 78). Despite the straps being loose, the downspout remained in place.
- Loose or missing gutter brackets were observed at a few locations (Figure 79). The condition was typically associated with areas of distress where the wood fascia and soffit had deteriorated to the point that it could no longer support the bracket.

FIGURE 78. Loose strap at base of downspout.

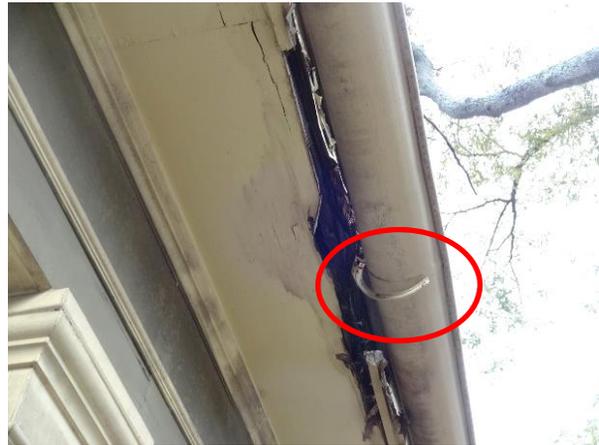
FIGURE 79. Loose bracket at gutter. Note adjacent area of wood deterioration.

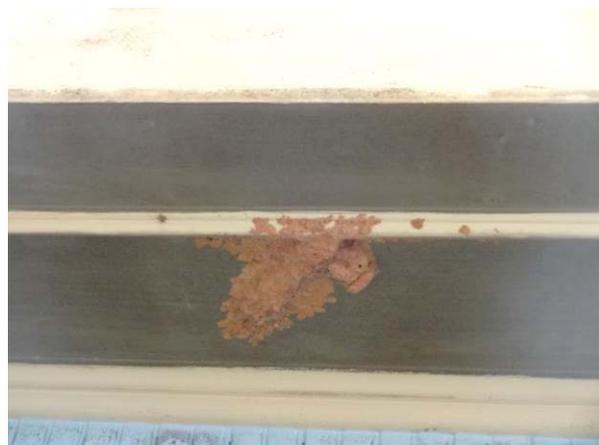
- Pest infestations were observed at one location at the soffit of the porch (Figure 80). The infestation included what appeared to be a mud dauber nest. No evidence of termite infestation was observed.

FIGURE 80. Mud dauber nest at porch soffit.

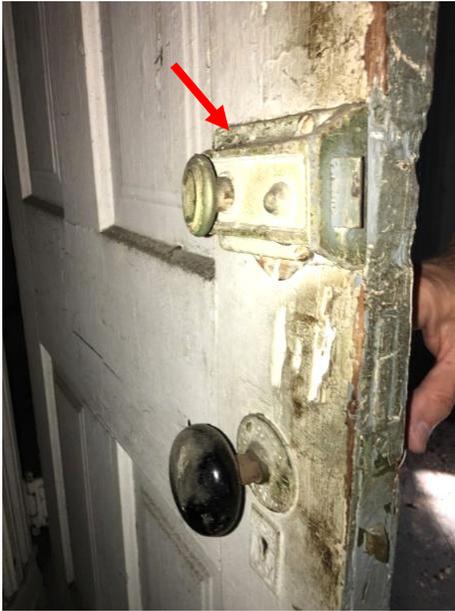
FIGURE 93. Typical condition of door hardware at second-floor room doors. Arrow indicates surface mounted deadbolt which dates from use as a rooming house.

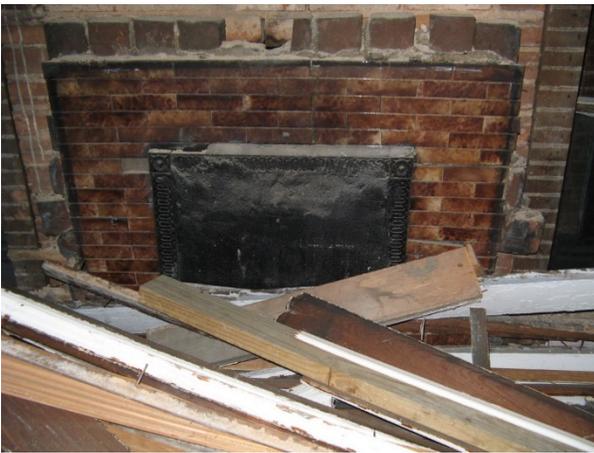
FIGURE 106. First-floor northeast bedroom and fireplace with missing mantelpiece. Note encaustic tile surround.

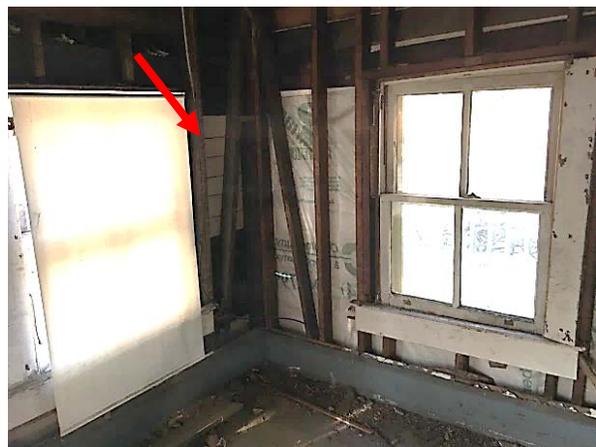
FIGURE 122. Southwest corner of bedroom addition with air and moisture barrier visible. The arrow indicates back-primed lap siding and no air and moisture barrier.

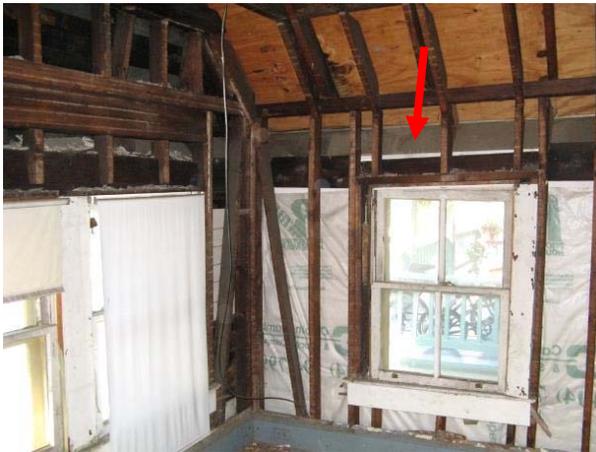
FIGURE 144. Air and moisture barrier material does not continue behind frieze board. Daylight gaps were noted between exterior trim members.

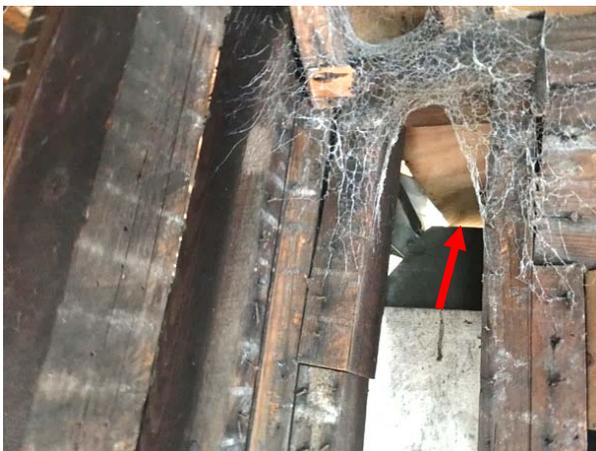
FIGURE 145. Daylight penetration at roof valley flashing, seen from interior.

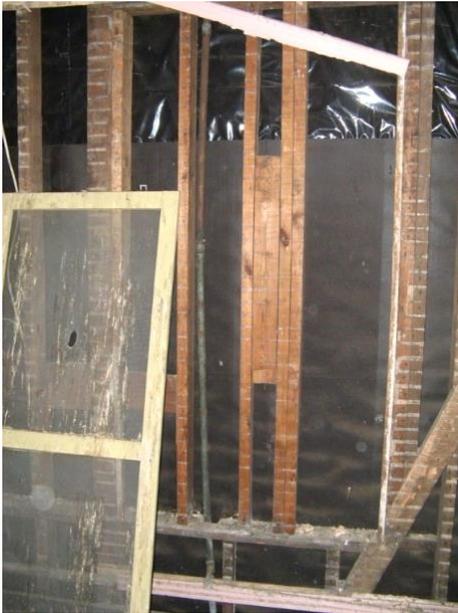
FIGURE 148. Two types of plastic air and moisture barrier membranes installed on the north elevation. If these membranes are not permeable and prevent moisture vapor from passing through them, condensation will occur on one or both sides and become trapped behind the siding or in the wall cavity.

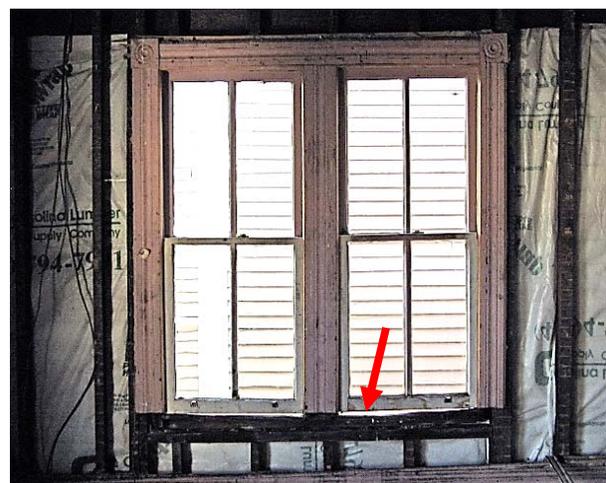
FIGURE 149. Refurbished lower sash do not fully seat against the sill. Weatherstripping, a stool, and an apron are also missing.

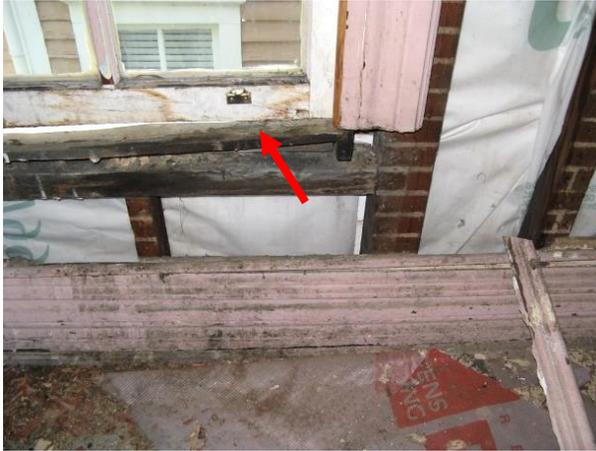
FIGURE 150. Deterioration of the window sill and interior of this replacement window sash.

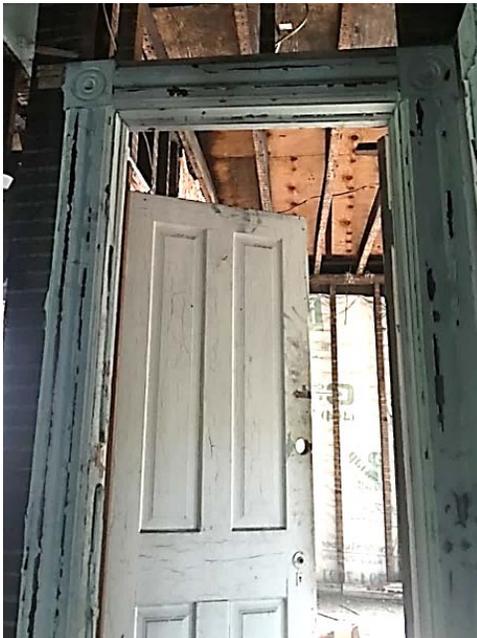
FIGURE 151. Typical interior door with missing hardware.

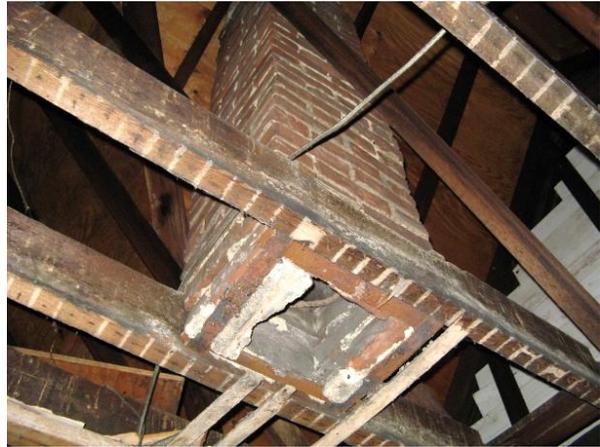
FIGURE 153. Steel straps supporting the bottom of an abandoned masonry chimney in the attic.

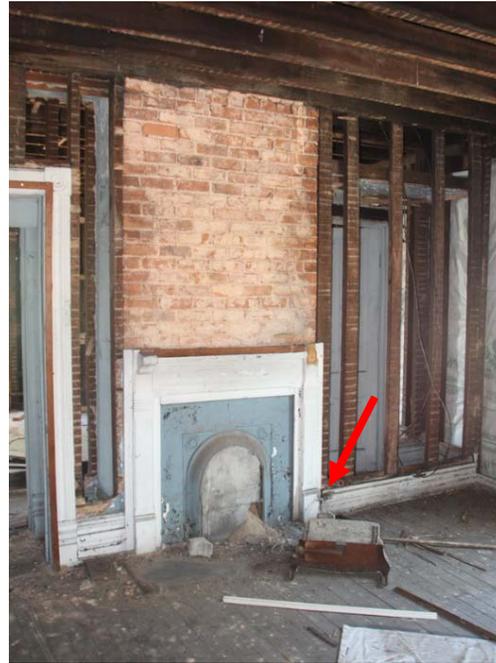
FIGURE 168. Infilled coal-burning fireplace with gas space heater turned over on the hearth.

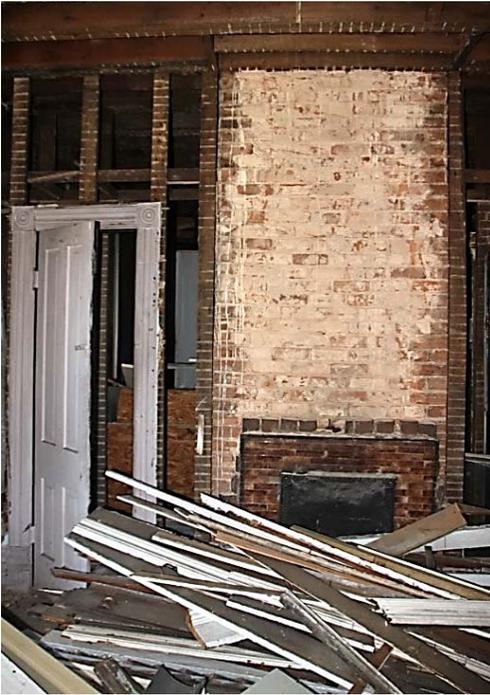
FIGURE 170. Salvaged construction materials strewn around the fireplace in the northeast bedroom.
