535 Auburn Avenue, NE Historic Structure Report

535 Auburn Avenue, NE
Martin Luther King, Jr. National Historical Park
Atlanta, Georgia

Historic Structure Report

August 2019

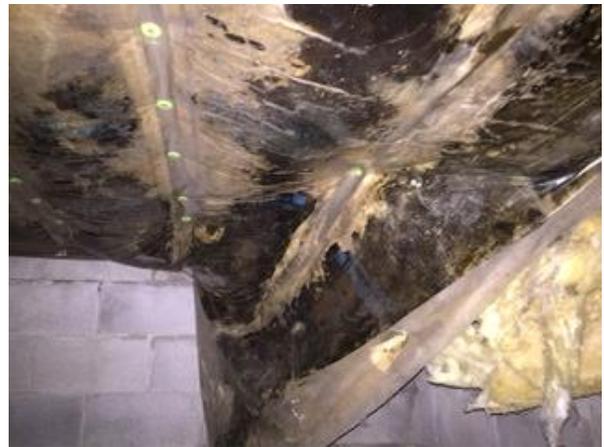
FIGURE 53. Vapor barrier at underside of porch deck is collecting water and is a location of biological growth.

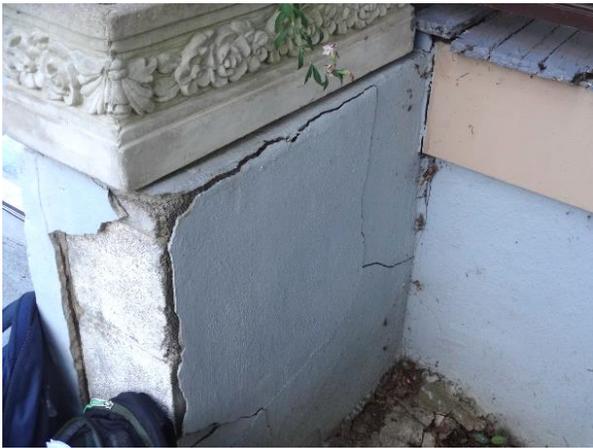
FIGURE 54. Debonding of the cementitious parge coating at the porch foundation wall.

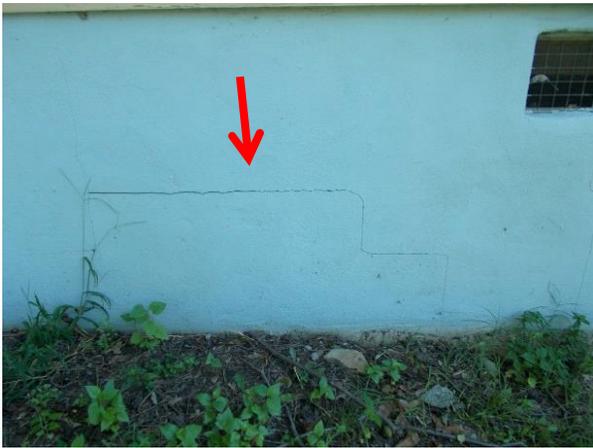
FIGURE 55. Step cracking observed through parge coating aligns with joints between CMU.

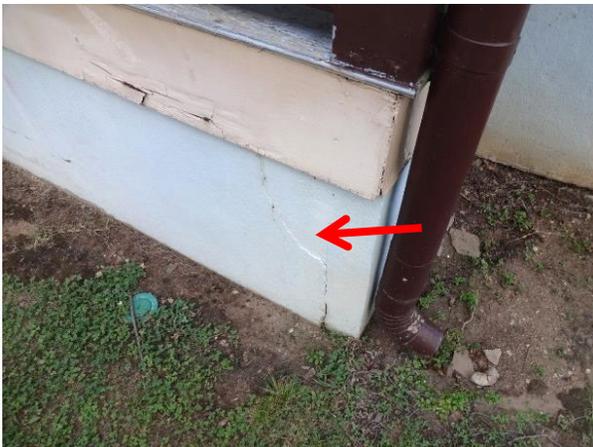
FIGURE 56. Vertical cracking at parge coating near corners of the foundation.

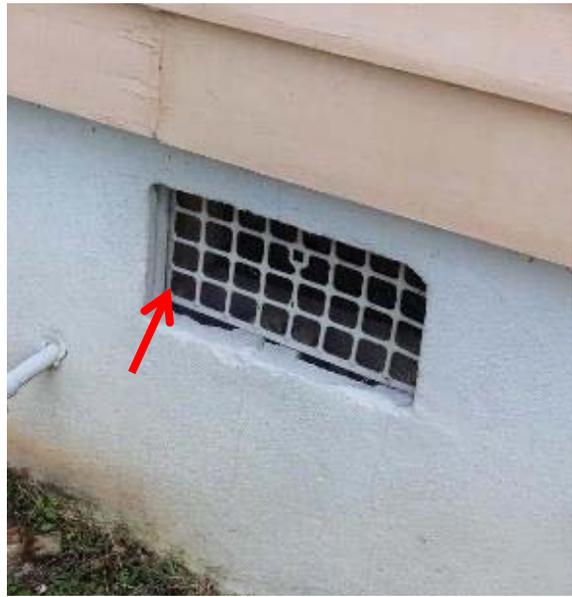
FIGURE 57. Open cells in CMU below vent openings.

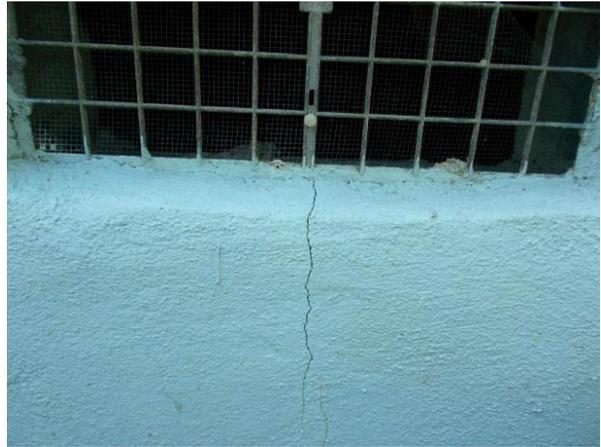
FIGURE 58. Vertical cracking in parge coating below vent openings.

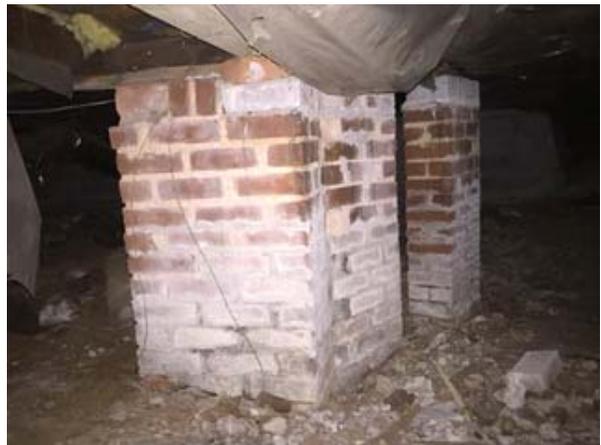
FIGURE 59. Efflorescence at brick foundation piers.

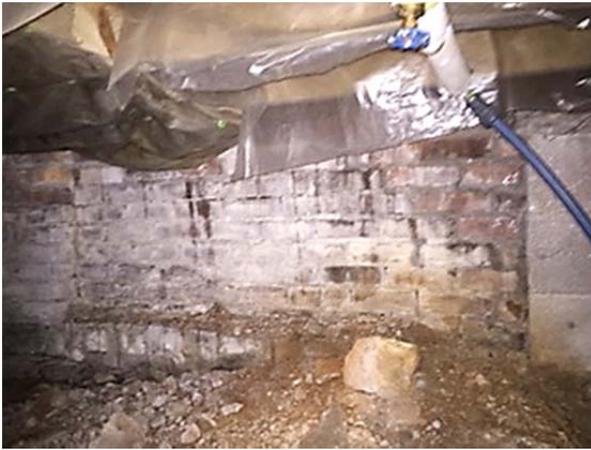
FIGURE 60. Efflorescence at brick foundation walls below porch.

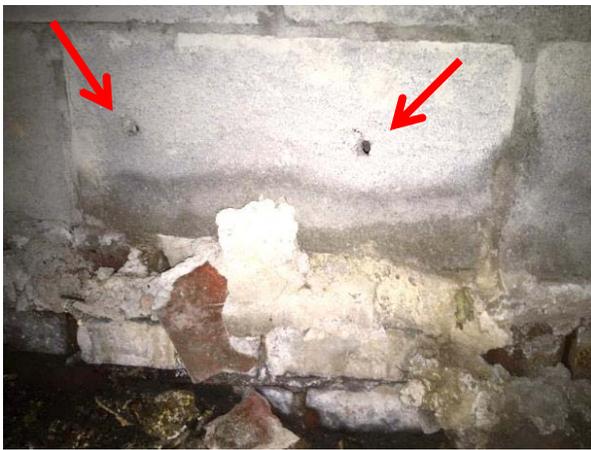
FIGURE 61. Holes drilled in bottom course of CMU foundation wall, one at each cell.

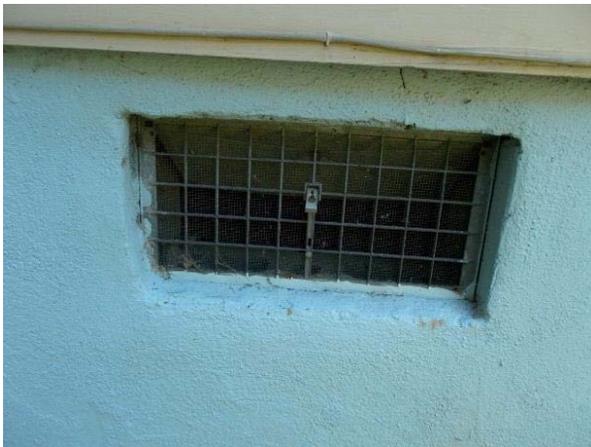
- Some of the cast-metal vent grates at the west elevation have been replaced with new wire mesh grates (Figure 62).

FIGURE 62. Non-original replacement vent grate.

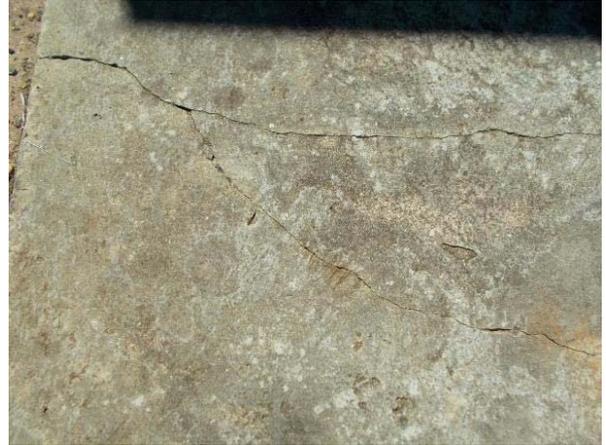
- Cracking was observed at the concrete walk that extends from the public sidewalk to the front porch (Figure 63). The crack is located at the center of the walk and extends perpendicular across the full width. The crack was approximately 1/16 inch wide.

FIGURE 63. Cracking at the concrete sidewalk.

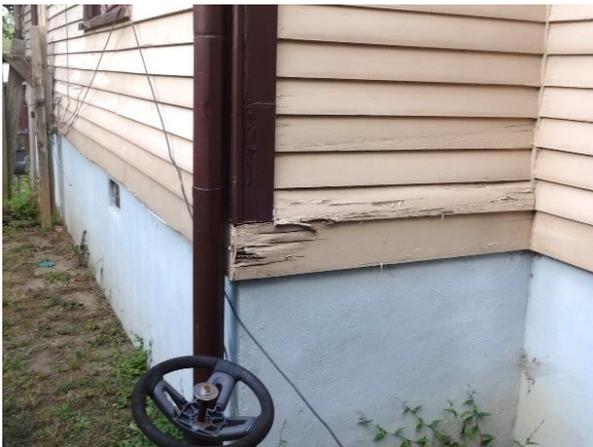
FIGURE 64. Decay and deterioration of wood at horizontal siding.

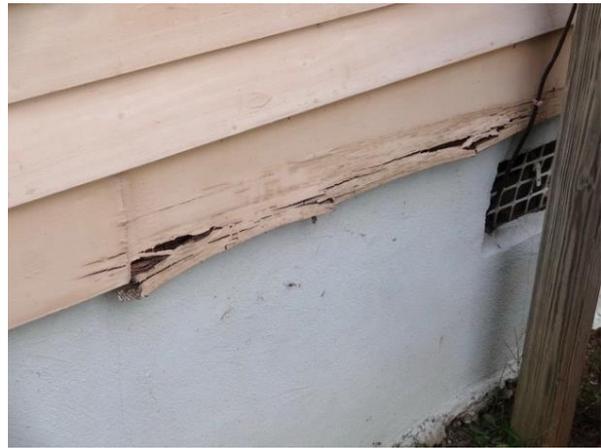
FIGURE 65. Decay and deterioration of wood at horizontal siding.

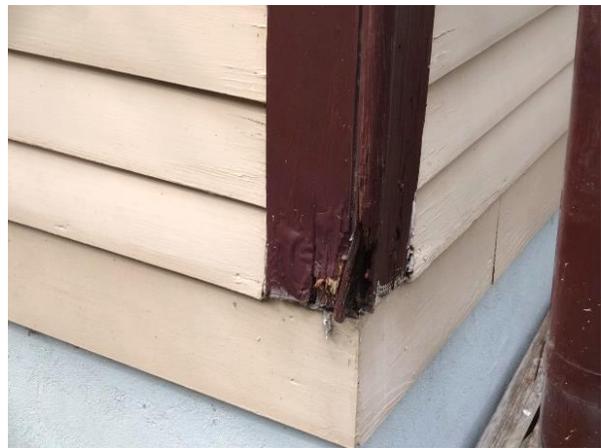
FIGURE 66. Decay and deterioration of wood at vertical trim boards.

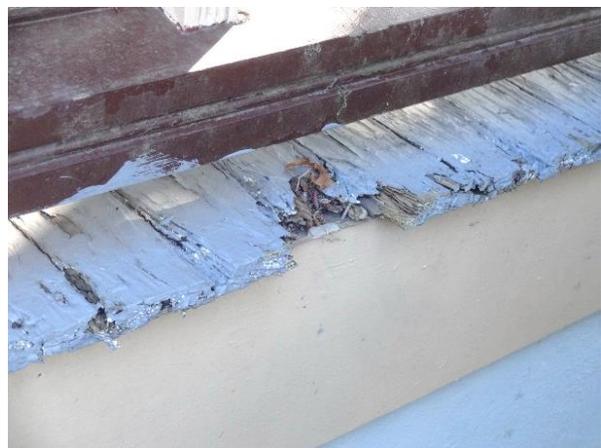
FIGURE 67. Decay of wood floorboards at the porch.

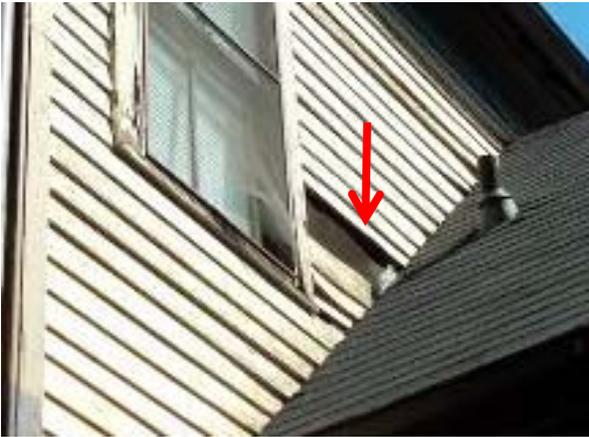
- An area of missing siding boards was observed at the west side of the south elevation, adjacent to the rear addition roof (Figure 68). Approximately four boards were missing.
- Deterioration was observed at approximately half of wood decking boards and balustrade rails and at some of the flute balustrade spindles (Figure 69). The deterioration was typically located at the ends of boards where fasteners are located, and the end grain was exposed.
- Cupping was observed at approximately 50 percent of the decking boards (Figure 70). The cupping was approximately 1/8 inch. At most locations, the tongue-and-groove between the boards were still engaged.
- Mild buckling was observed at the porch decking (Figure 71). The buckling was observed at a few locations and has the potential to be a tripping hazard.

FIGURE 68. Missing horizontal siding members.

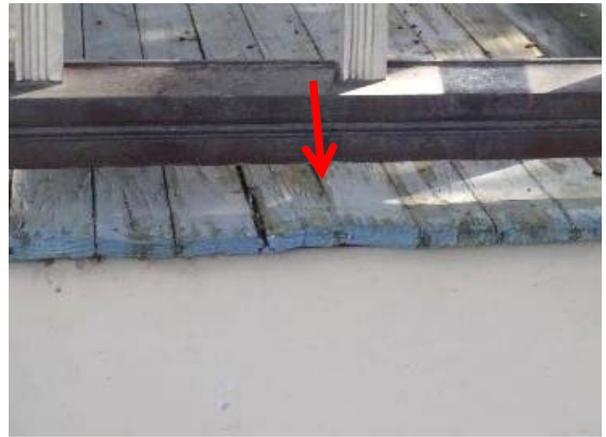
FIGURE 71. Buckling of floorboards.

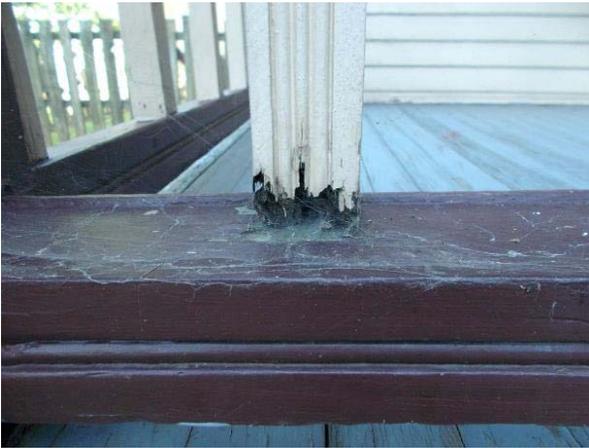
FIGURE 69. Decay and deterioration at bottom of wood balustrade spindles.

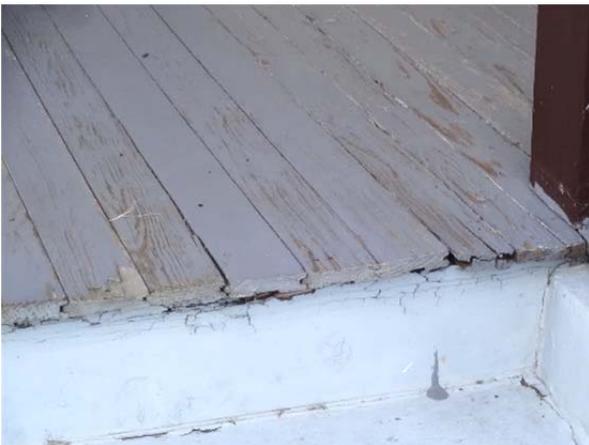
FIGURE 70. Cupping of porch floorboards.

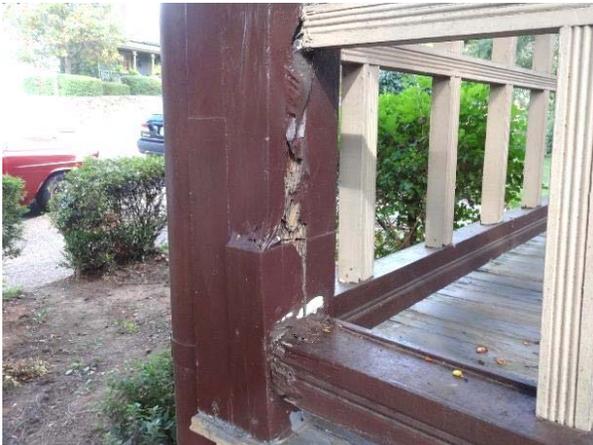
FIGURE 73. Divots in wood porch posts.

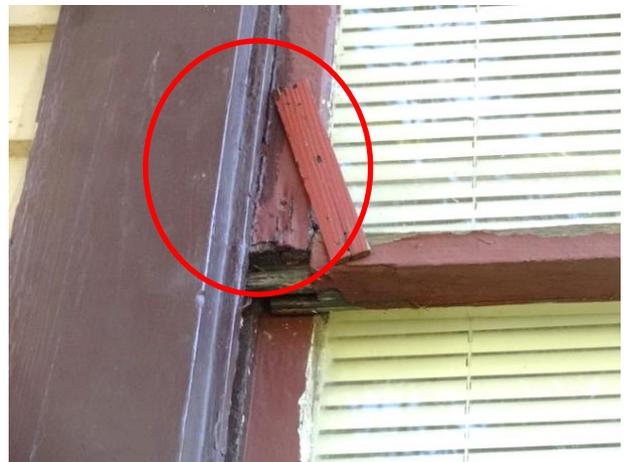
FIGURE 78. Deteriorated wood at sash. Note wood repair at corner.

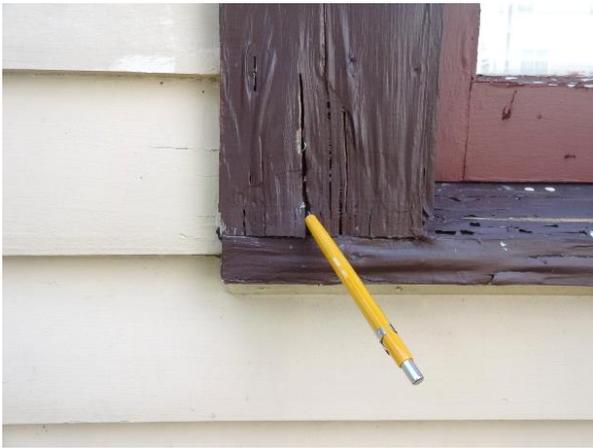
FIGURE 79. Deteriorated wood at bottom of trim.

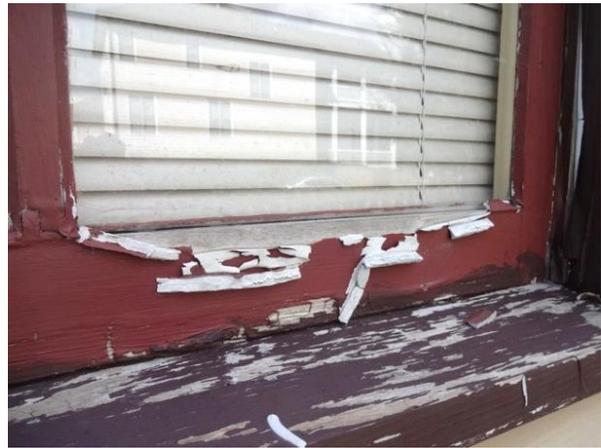
FIGURE 82. Peeling paint at window sash and sill.

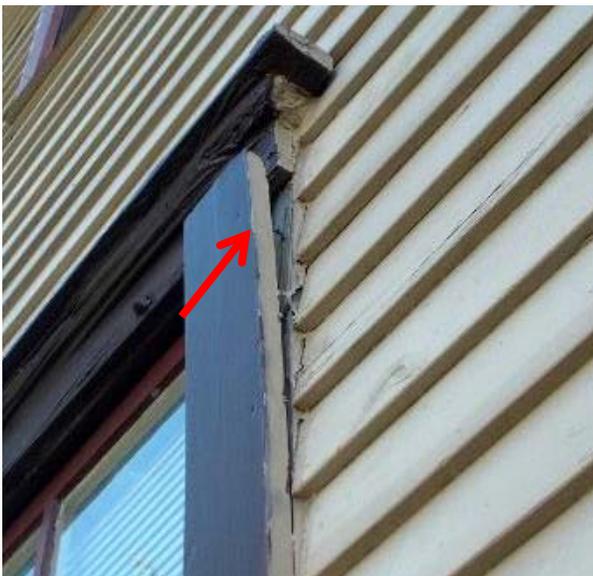
FIGURE 81. Loose trim boards at window.

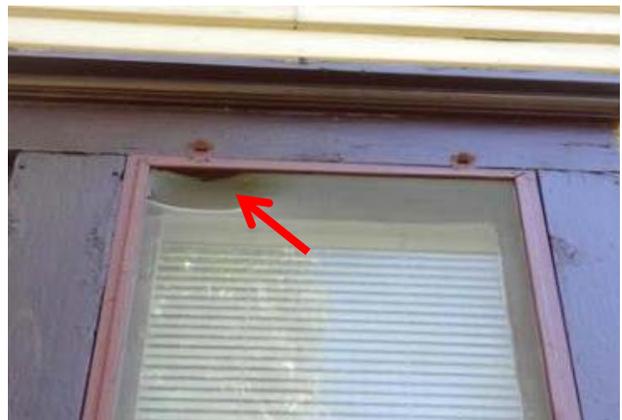
FIGURE 84. Damaged window screen.

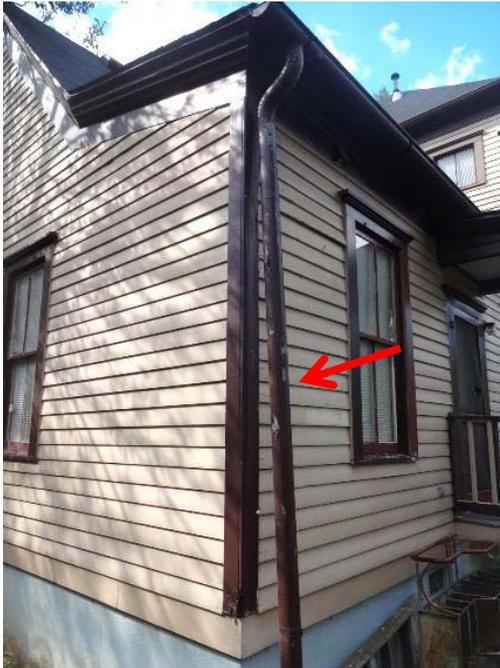
FIGURE 85. Downspout is no longer secured to the building.

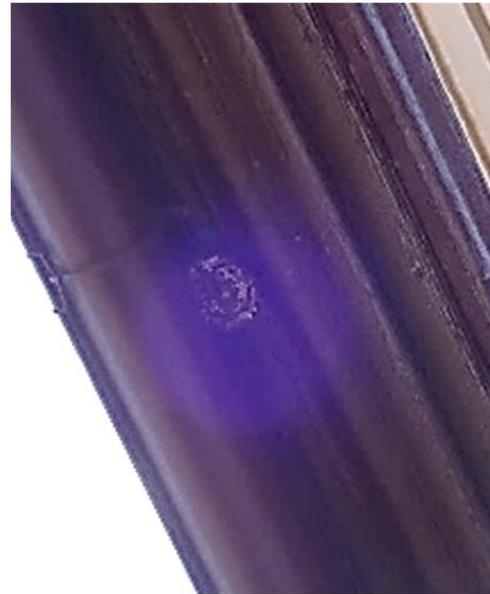
- Pest infestations were observed at the cornice on the north and east elevations (Figure 87). The infestation included what appeared to be a mud dauber nest. No evidence of termite infestation was observed.

FIGURE 87. Mud dauber nest at roof eave.

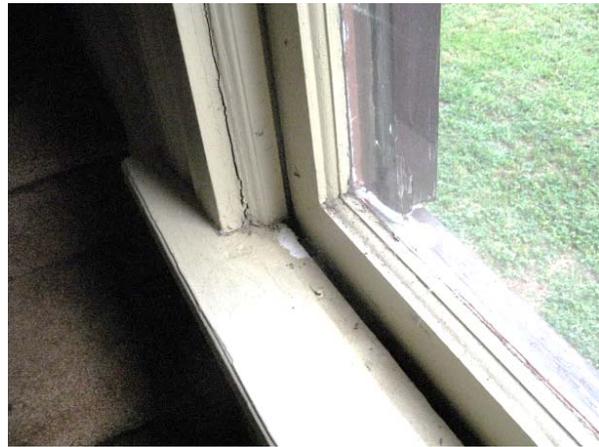
FIGURE 96. Gap between window sash and frame and lack of weather-stripping.

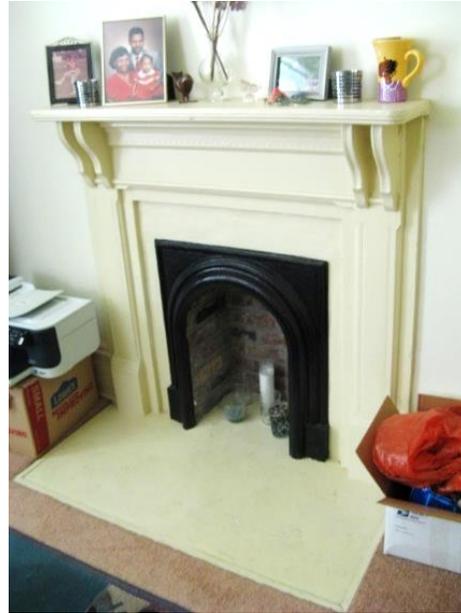
FIGURE 110. Fireplace at the southwest bedroom, second floor. Note missing arched-top front grille of cast-iron register.

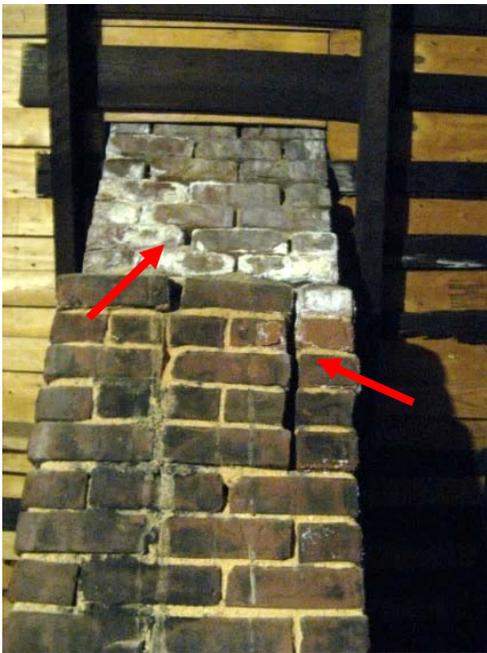
FIGURE 118. Masonry chimney in attic. Note open mortar joints.

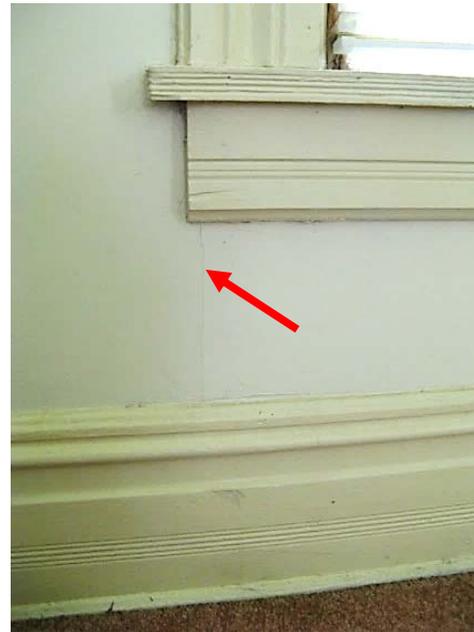
- Some linear and hairline cracks can be seen in plaster wall finishes. Most cracks occur at corners of some doors and windows, particularly windows that have experienced distress because of moisture intrusion and air infiltration (Figure 121). Except where these cracks are associated with delamination of the plaster, they are not considered significant.

FIGURE 121. Common hairline crack in plaster at lower corner of window.

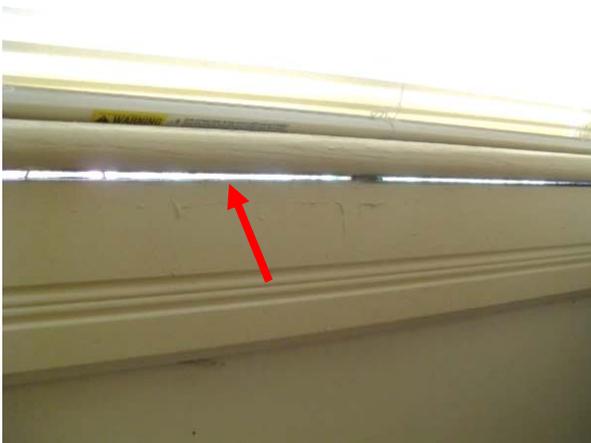
FIGURE 122. Air and moisture infiltrate through gap under the windowsill.

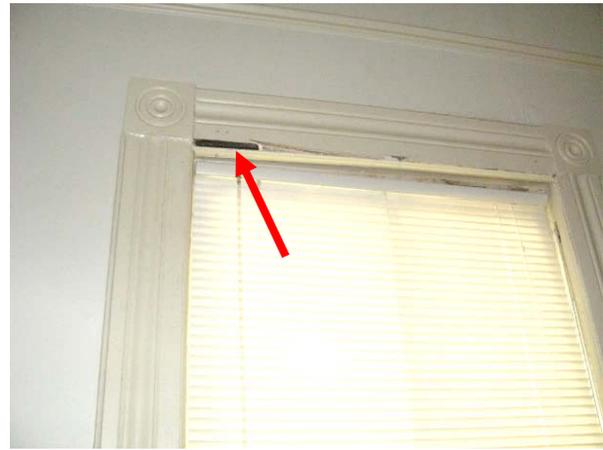
- Paint on some window sash and adjacent trim is peeling and delaminating as exterior deterioration progresses (Figure 123).

FIGURE 123. Deterioration of interior window frame and trim.
