Three Double-Shotgun Houses 493ABC Auburn Avenue

Martin Luther King, Jr. National Historic Site

Historic Structures Report

May 2017

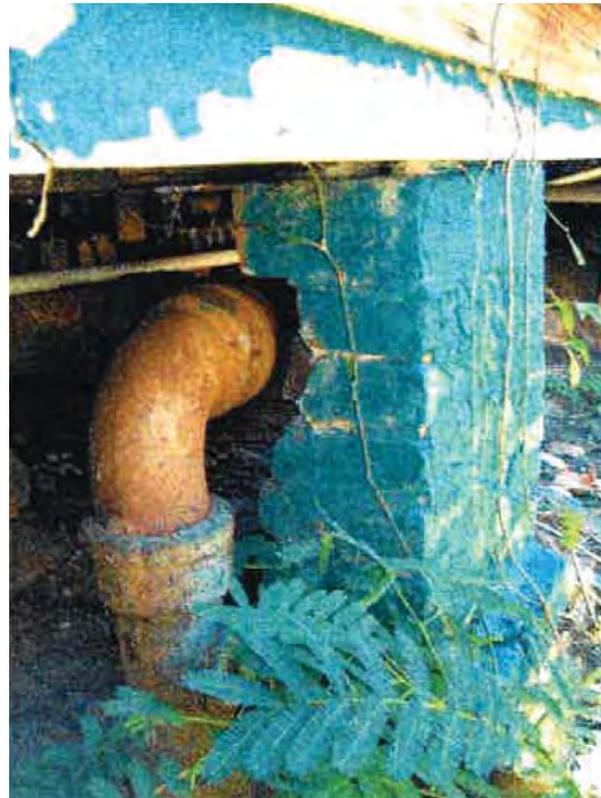
Figure B22. Placement of the toilet directly above the foundation pier caused it to be cut to accommodate the waste pipe. Photographed 2008 for Condition Assessment Report.

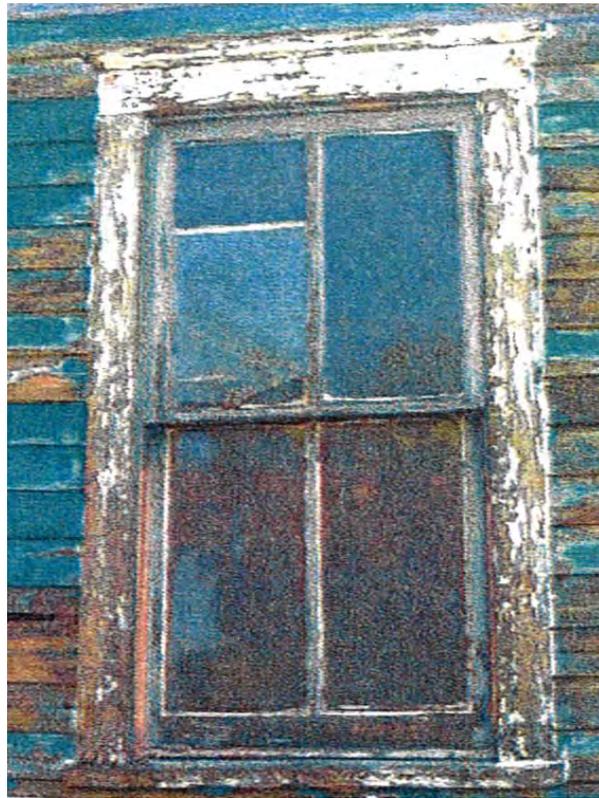
Figure B44. Condition of side window in 2008. (CAR, p. 53)

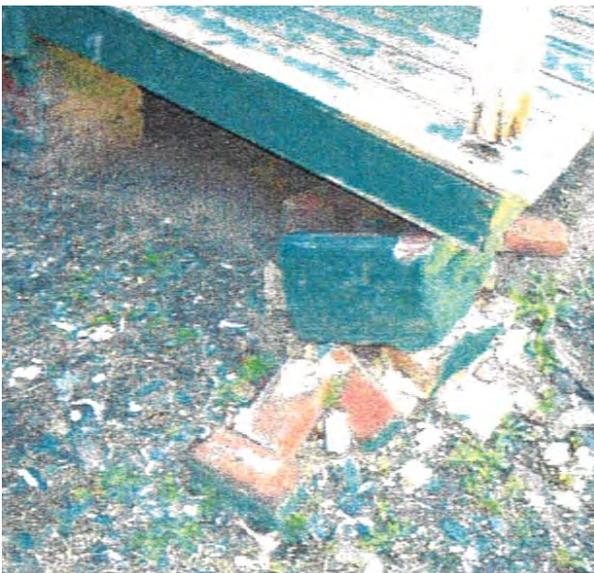
Figure B46. Failed porch pier. Photographed 2008. (CAR, p. 55)

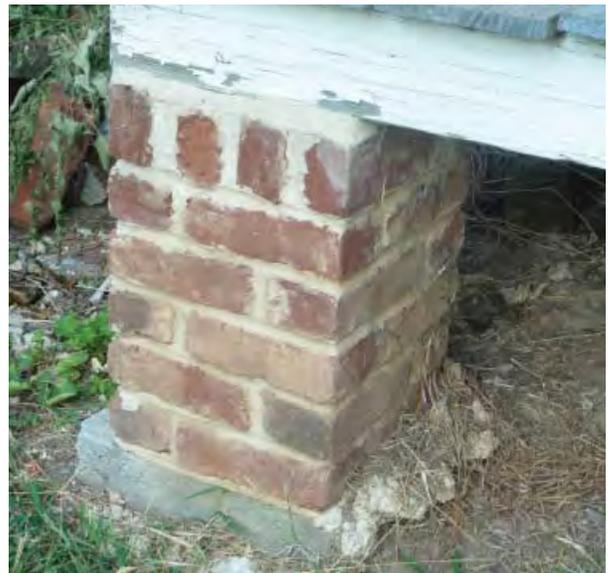
Figure B47. New porch pier. Photographed 2008. (CAR, p. 55)

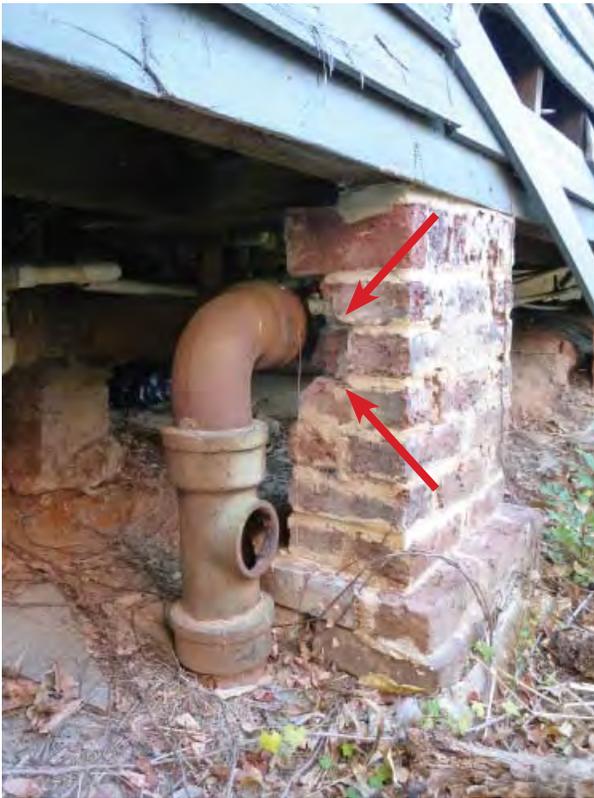
Figure C45. Battered foundation pier allowing for drain line to be installed.

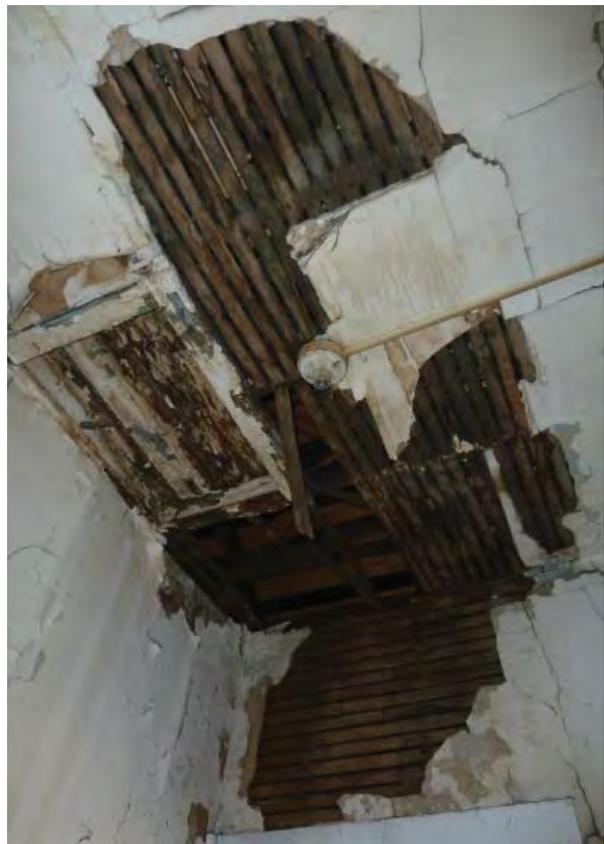
Original plaster appears to remain on parts of the original west walls and ceiling. Plaster loss, primarily from former roof leaks, is extensive at the ceiling above the window on the west wall (*Fig. C81*).

Figure C81. Failed plaster on walls and ceiling. Note ceiling hatch.

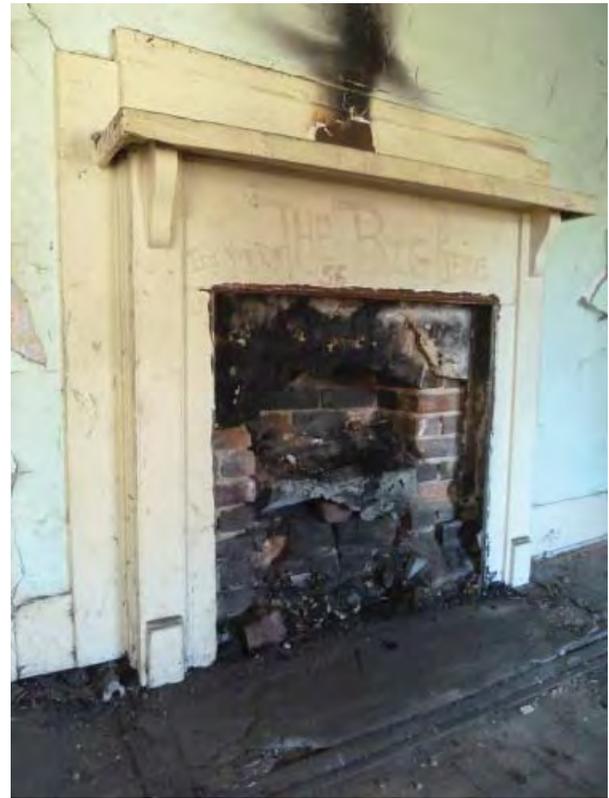
Figure C84. Fireplace mantel and hearth. Note fire damage.

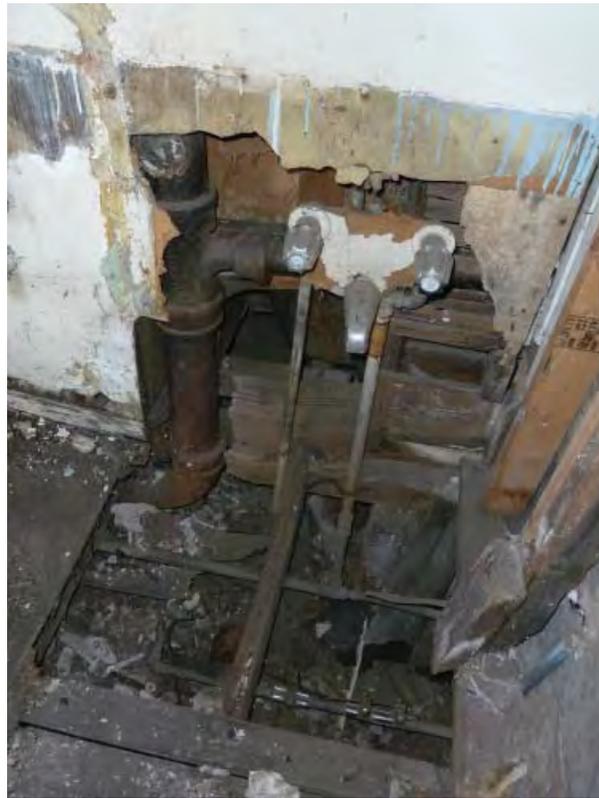
Figure C94. Faucet and handles for bathtub. Note severed girder.

- Lift girder segments back into position and make Dutchman repair where severed for the bathroom/kitchen installation.
- Lift slumping floor joists back into position and secure. Sister new framing onto old where strengthening is needed.

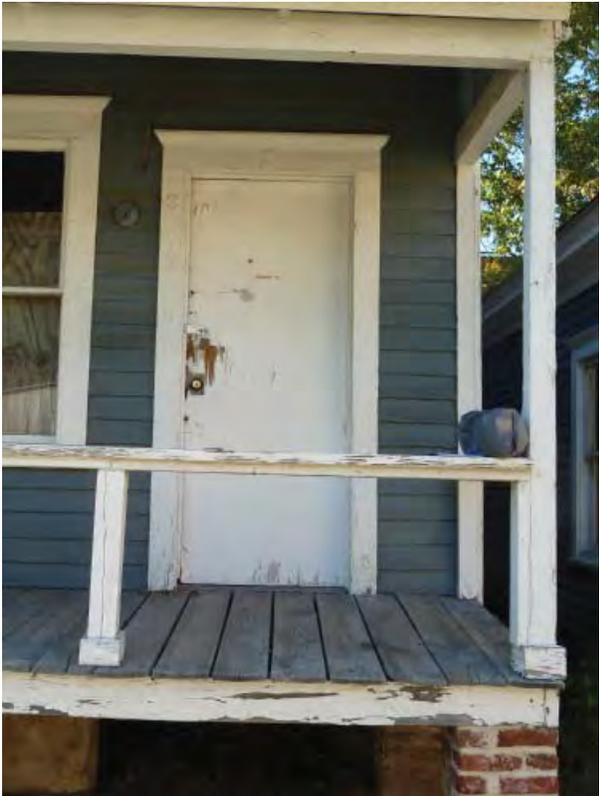
Figure C98. Porch of Unit 3. Note warped deck boards, loose trim, and repointed pier.

- Replace porch posts, deck boards, and railing with elements that are dimensionally correct for the period of interpretation.
- Renail loose elements.
- Replace in kind the missing elements.
- Replace exposed plywood roof deck with tongue-and-groove boards.
- Repaint porch elements according to the paint analysis.
- Address the concrete front entrance as appropriate based on the pre-restoration investigations and paint analysis.

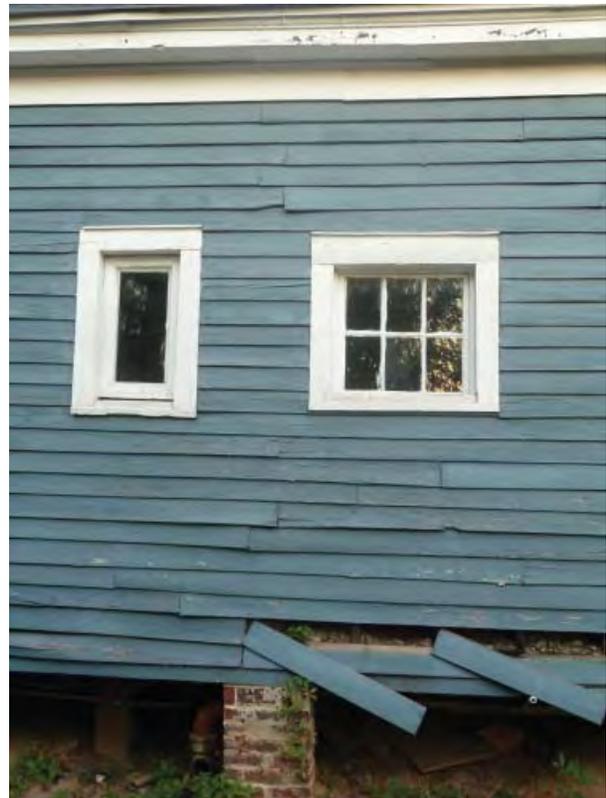
Figure C143. Large original windows of west elevation were replaced with small mismatched sash.

- Remove all sash on the west elevation (added in the 1960s), and reinstall a reproduction of the original double-hung sash window and window hardware. Return all other sash to working order.
- Retain, clean, repair, and make operable the early sash-cord roller and latch.
- Install reproduction screen sash and hardware.
- Repaint window sash, screen sash, and casing based on the paint analysis.

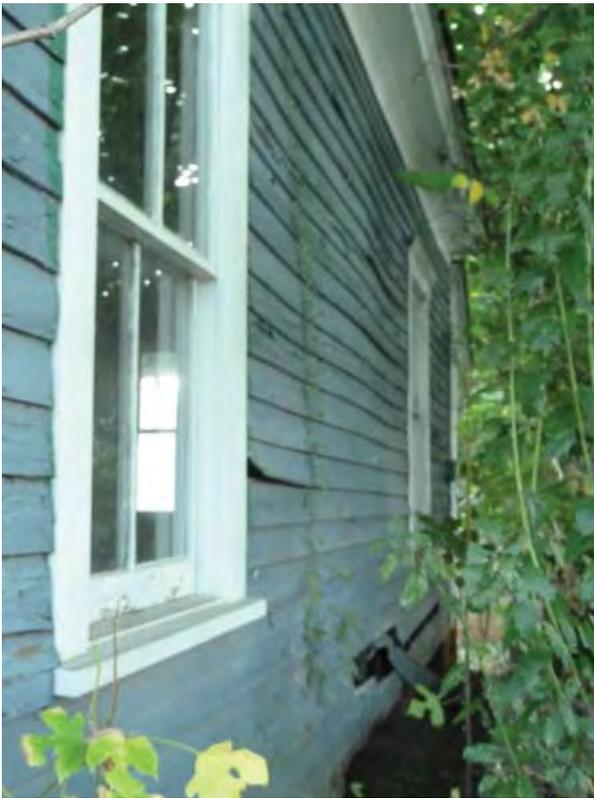
Figure C144. Failing weatherboards along south elevation.

- Renail loose siding and trim.
- Replace in-kind missing or severely compromised elements.
- Repaint based on the paint analysis.
