Historic Structures Report
PART III
ON
DOGAN HOUSE
Manassas National Battlefield Park
Architectural Data Section

Prepared by
Orville W. Carroll
June 1962

HISTORIC STRUCTURES REPORT

DOGAN HOUSE

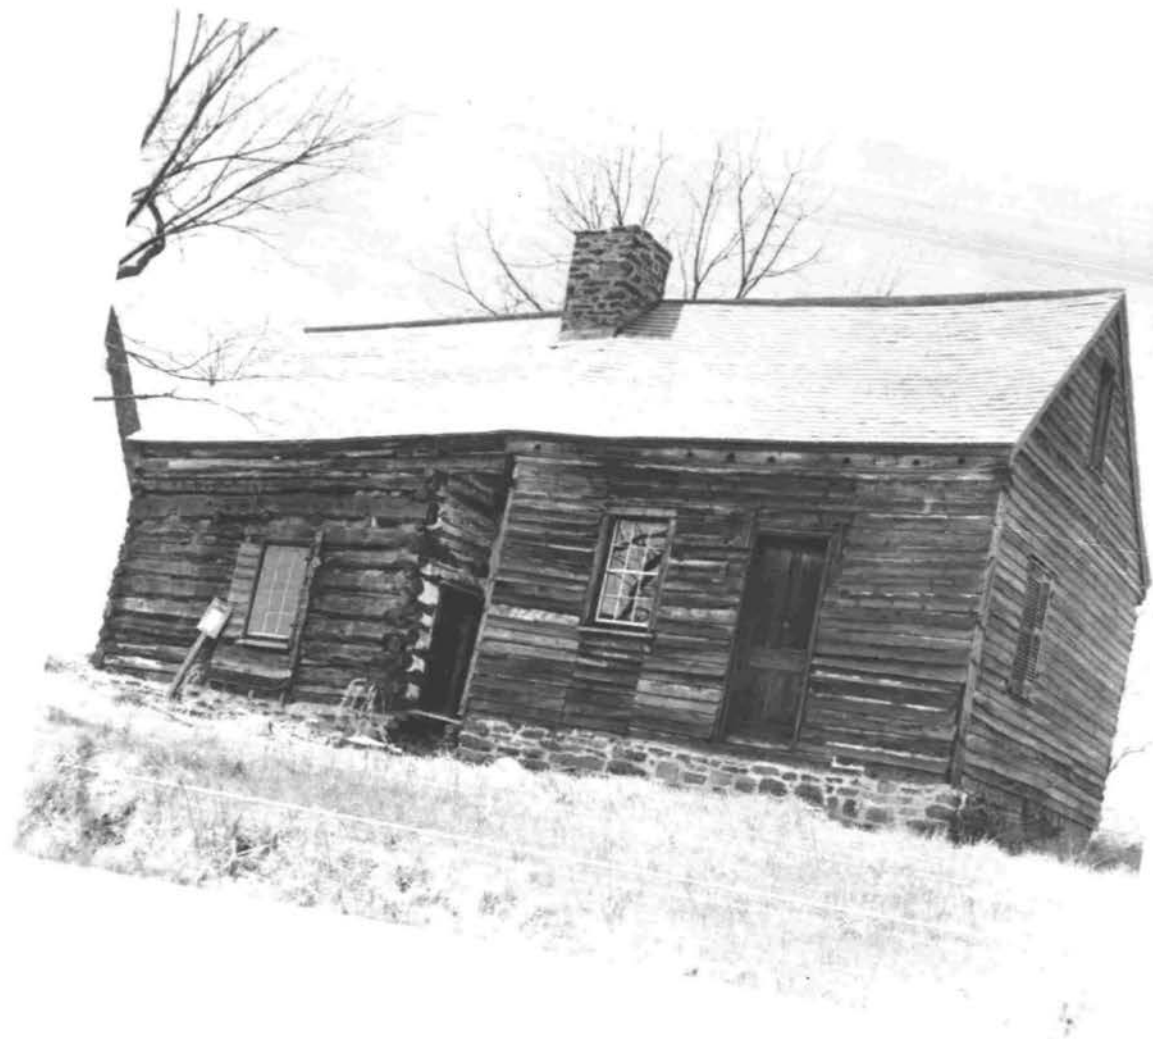
ILLUSTRATION NO. 6

A view of the west or rear side of the Dogan House prior to architectural investigations and exploratory excavations started in April 1960. Very little of the exterior fabric is original.

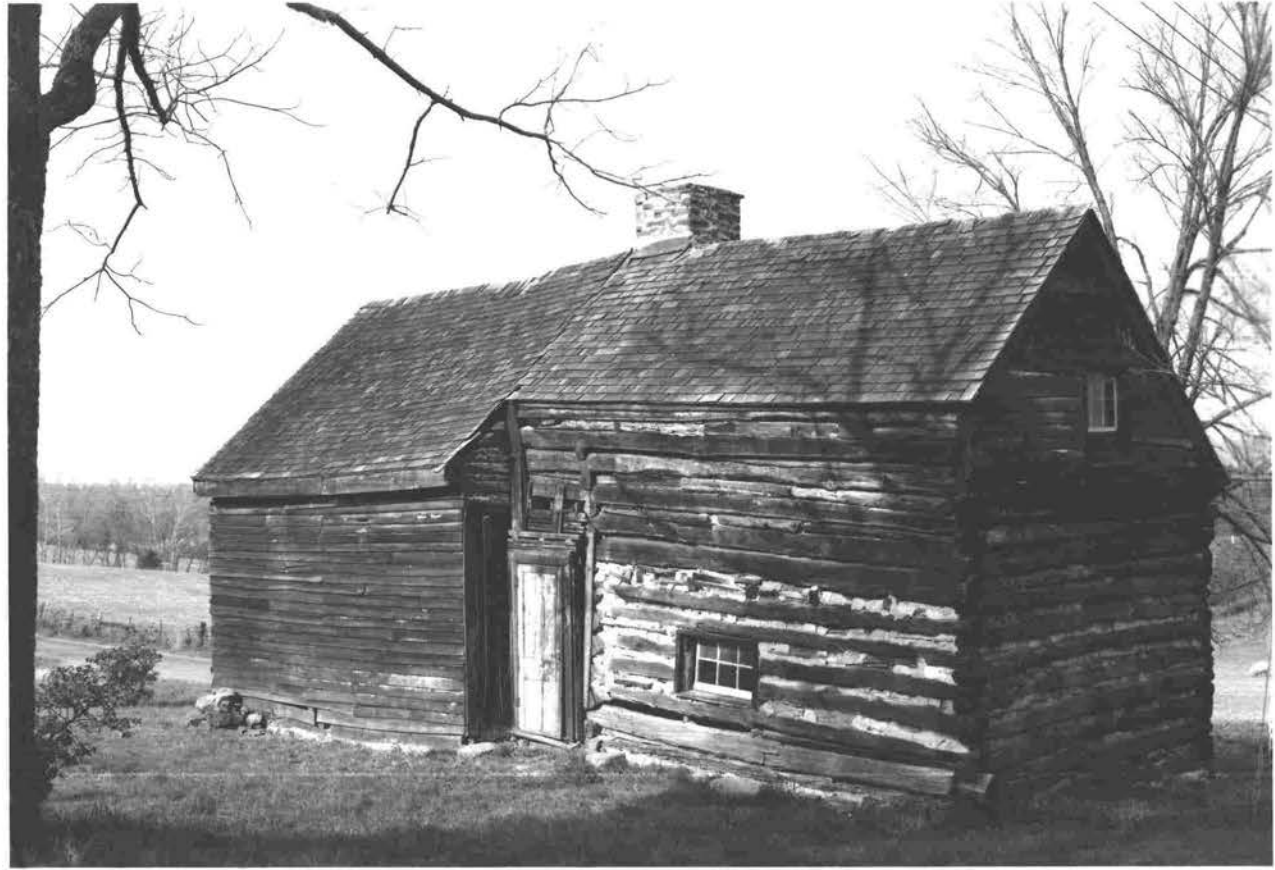
ILLUSTRATION NO. 7

Exploratory excavations on the west side of the Dogan House were carried out to determine if former porch footings could be found. If any existed, they were obliterated when the 1882 foundation which was built of granite rock rather than the red sandstone found in the foundation of the house. In the background is Raymond Smith.

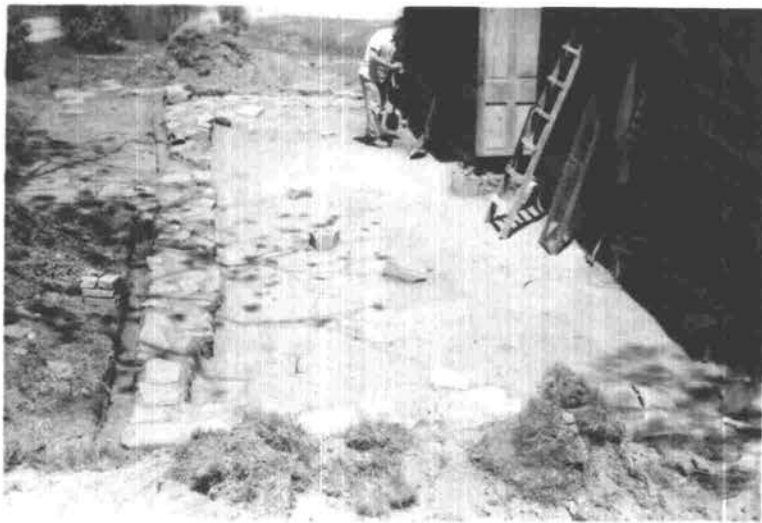
ILLUSTRATION NO. 8

An attempt was made to locate either porch or step footings across the east side of the Dogan House. No footings were found. Raymond Smith is shown screening soil for rifle balls. A bayonet and several rifle balls were found in this location.

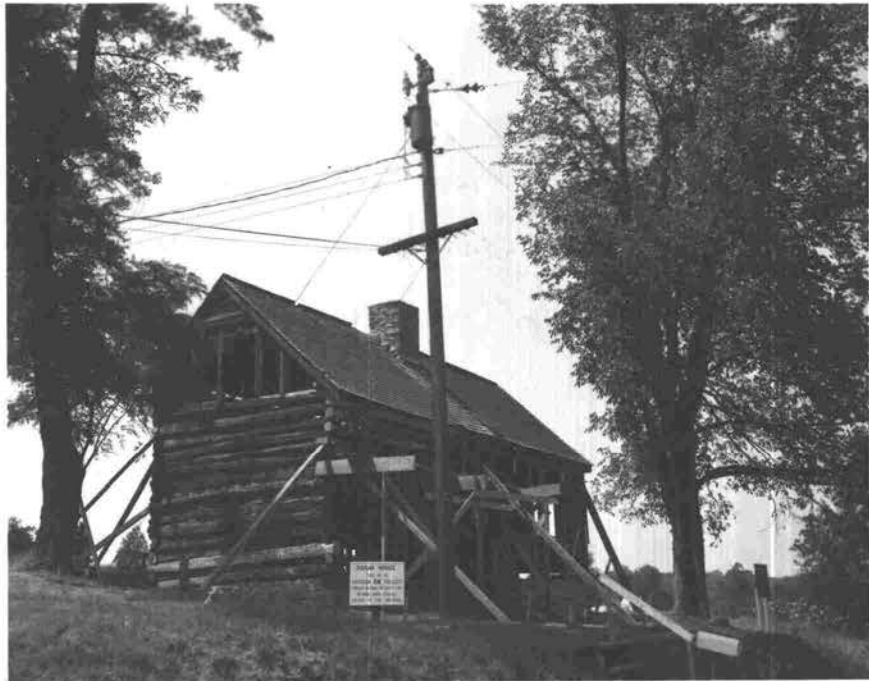
ILLUSTRATION NO. 10

This photograph shows the completed foundation walls as rebuilt by Ervin Sisler, mason from Falls Church, Virginia. Work was completed during July. The stone walk appearing in the foreground was uncovered during exploratory investigations of the surrounding grounds.

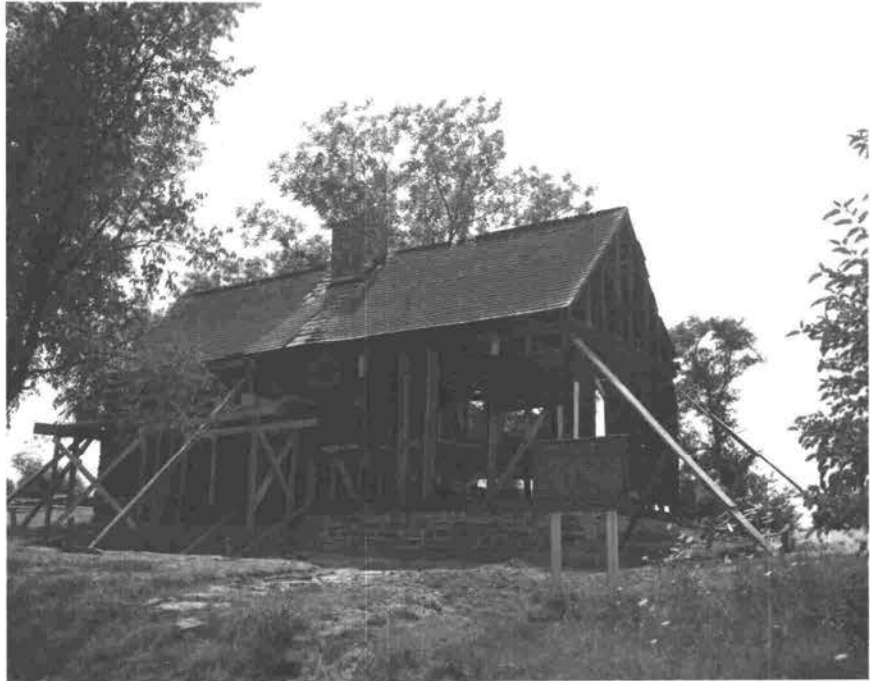
ILLUSTRATION NO. 11

Most of the original framework that was found to be in good condition was used. If a structural member was found to contain some rot, this was cut out and the remaining piece spliced with new material. In some places, such as the west and east sills of the frame addition, a completely new piece was required.

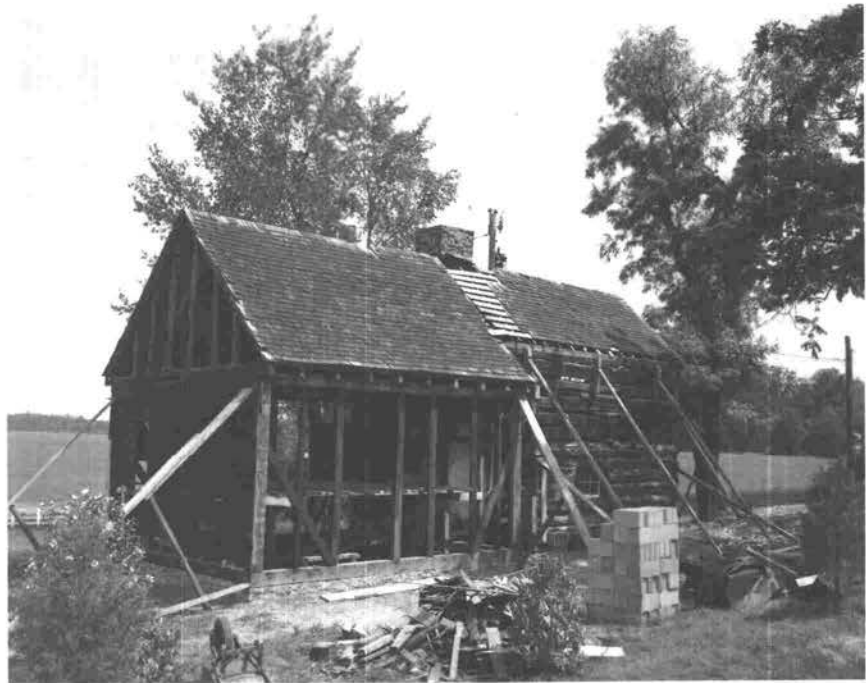
ILLUSTRATION NO. 12

Progress view of work accomplished up to August 1960. The 1950 shingled roof was left in place during the application of the exterior weatherboarding. The weatherboarding was hand-planed and primed with two coats of white lead paint prior to its final whitewash coat.

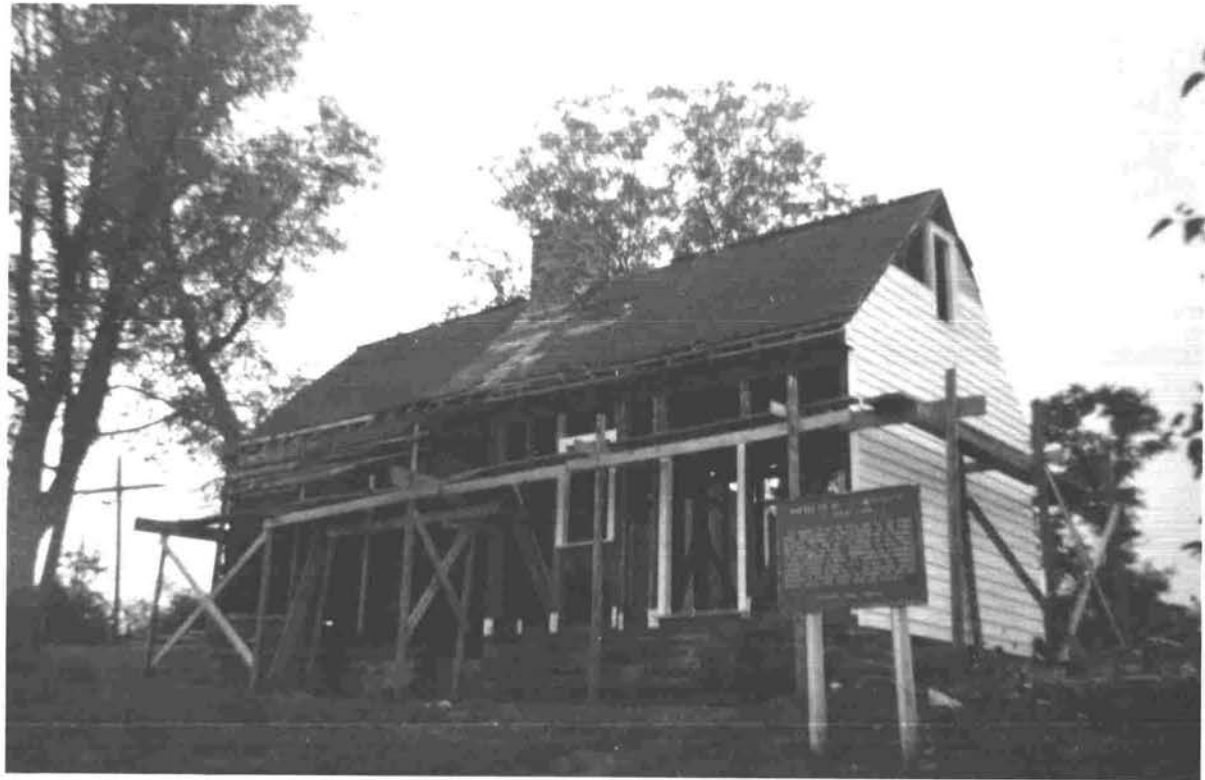
ILLUSTRATION NO. 13

It is thought that the log cabin was covered with weatherboarding in 1860 when the frame building was pulled over from the old "Peach Grove" site and added to it in an attempt to unify the exterior appearance. The upper portion of the log wall was built up to allow the roof ridge to join. Because of a difference in widths of the two buildings, the west side of the log cabin, being on the rear, was raised about two feet higher than the east and south walls. The weatherboarding was nailed into vertical nailing strips. The window in the south gable end wall was enlarged during the 1882 remodeling to accommodate a larger window frame.

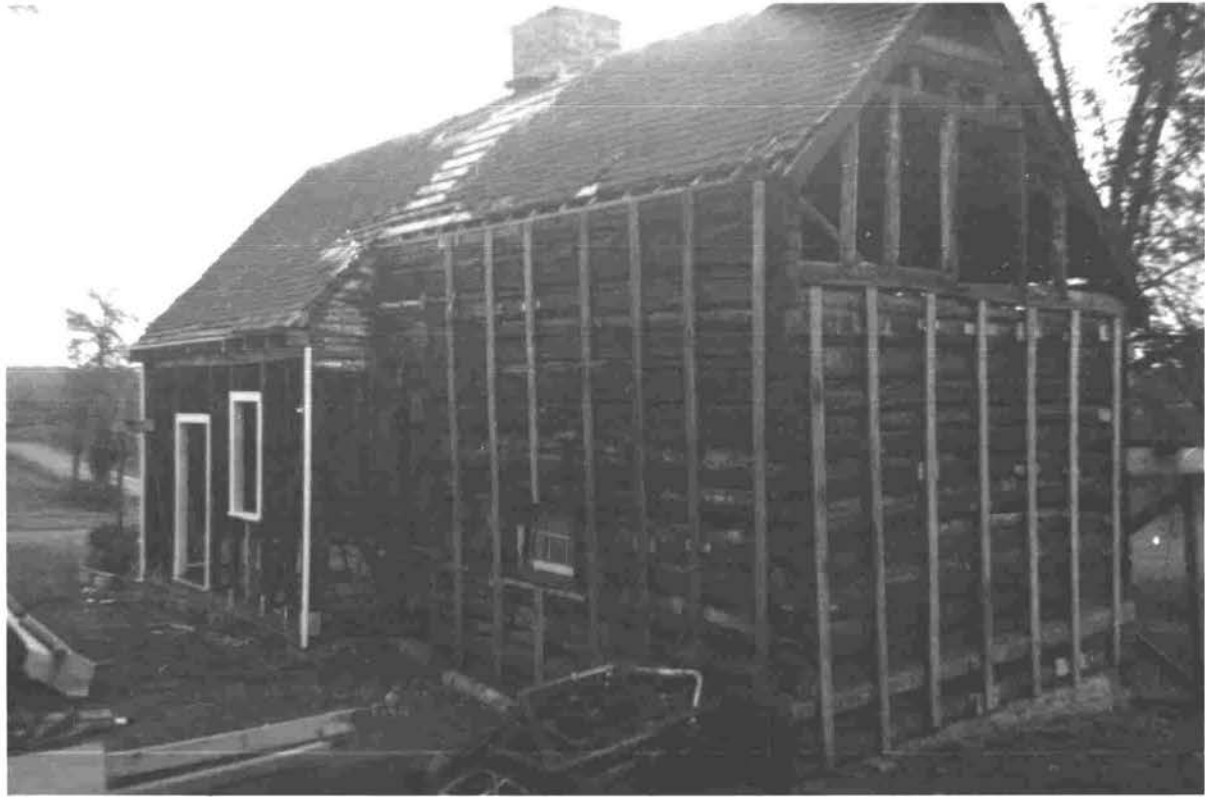
ILLUSTRATION NO. 14

View of work on August 27. Work was accomplished by two local carpenters from Haymarket and one local laborer. Much of the work to begin with was straightening and leveling of the two structures and replacing rotted members. The spacing of the weatherboarding was determined by measuring the spacing of the original nails still visible in the oak studding. The window and door frames were patterned after original pieces found in the walls of the building.

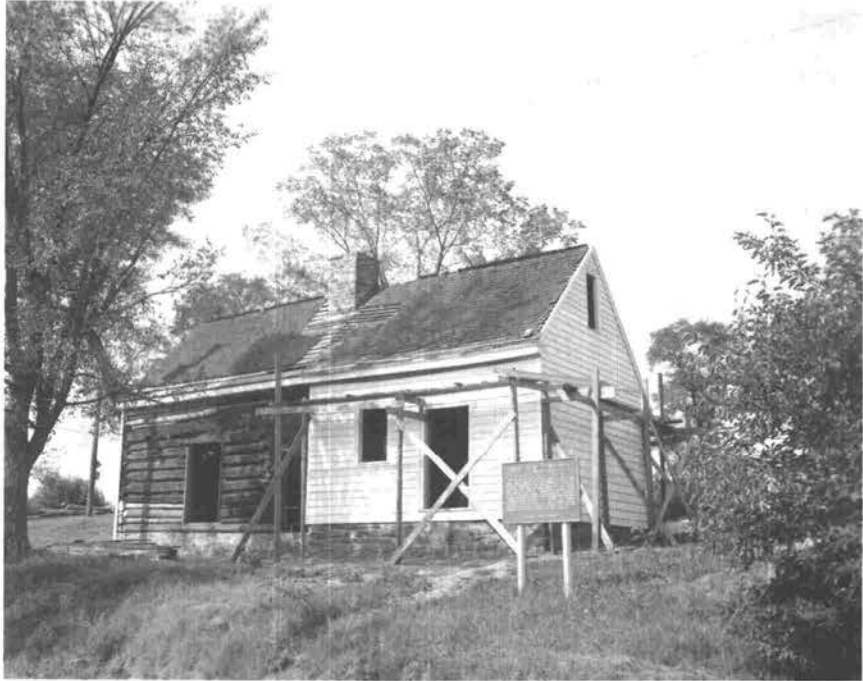
ILLUSTRATION NO. 17

Work accomplished during the start of restoration was primarily concentrated on the frame addition. In this view, the weatherboarding, cornice, verge boards and trim have been completed.

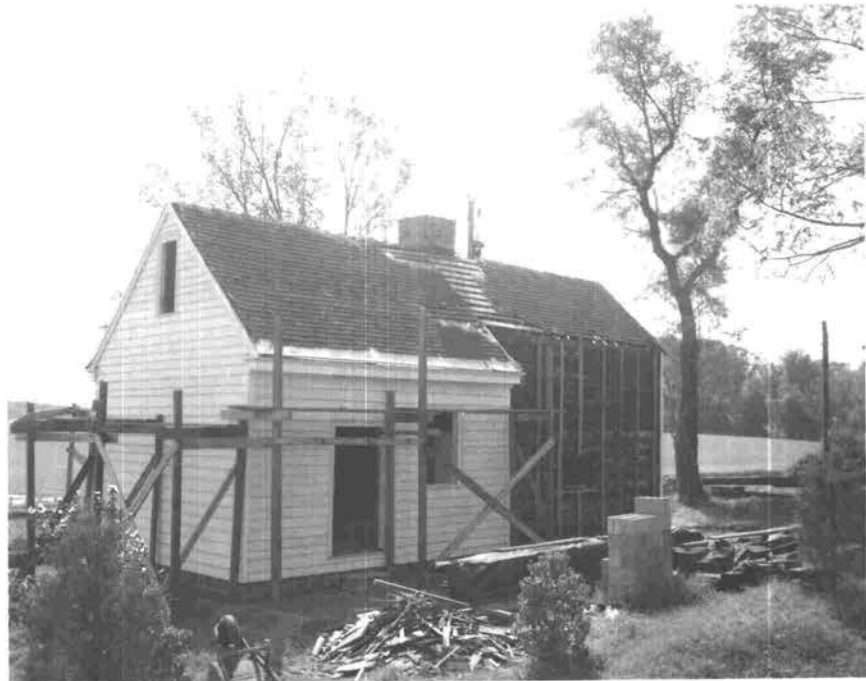
ILLUSTRATION NO. 18

Photograph taken October 1, shows the completed cornice and the wood shingled roof. The chimney has been repaired and whitewashed. Work has begun on the front stoop. The weatherboarding was given a second coat of white lead paint after it was nailed in place. No attempt was made to eliminate the sag in the roof of the frame addition as this was felt to be part of its historic appeal.

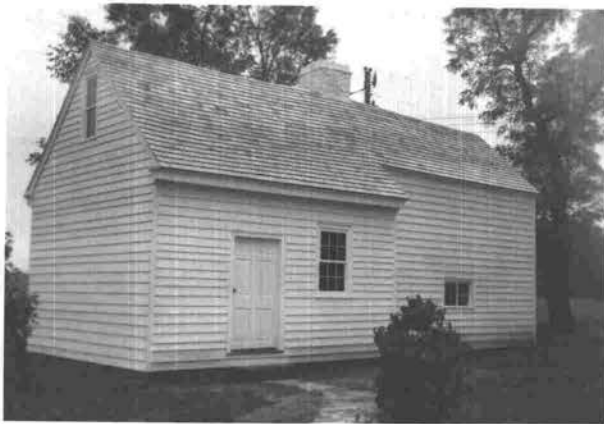
ILLUSTRATION NO. 23

An original door and window frame was found in the west wall of the frame addition covered over during the 1881-82 remodeling. The two openings are shown in this view, restored to their original positions. Both openings are identical to the door and window positions in the opposite wall.

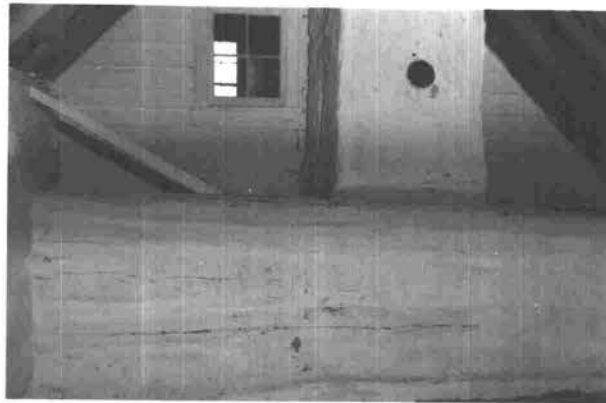
ILLUSTRATION NO. 30

The final finishing touches to the interior of the log cabin was completed during May 1961. Approximately one-half of the floor boards required replacement and the stair railing rebuilt according to what remaining evidence could be found. The roof structure seen is that installed in 1950 and was left undisturbed during restoration work.

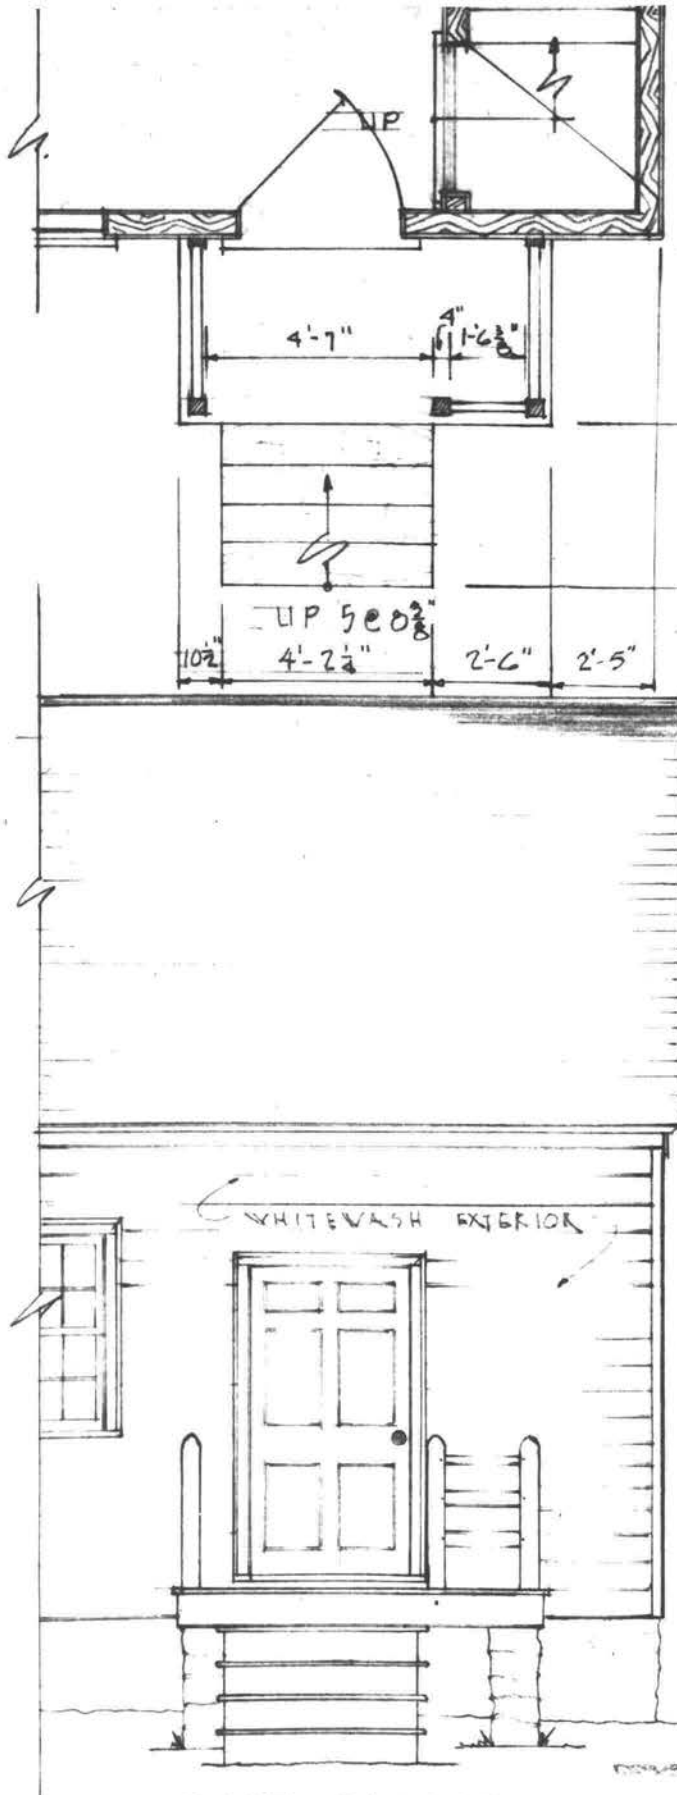
CHANGE OF PLANS TO EAST STOOP OF DOGAN HOUSE

NOTE: CHANGES TO STOOP
DIFFER FROM DRAWINGS
NO. NHS-ANBP 3051 3 SHIS.
