CONDITION ASSESSMENT and PRESERVATION PLAN
for
Various Structures

Manzanar National Historic Site

DECEMBER 31, 2000

Mark L. Mortier
Historical Architect

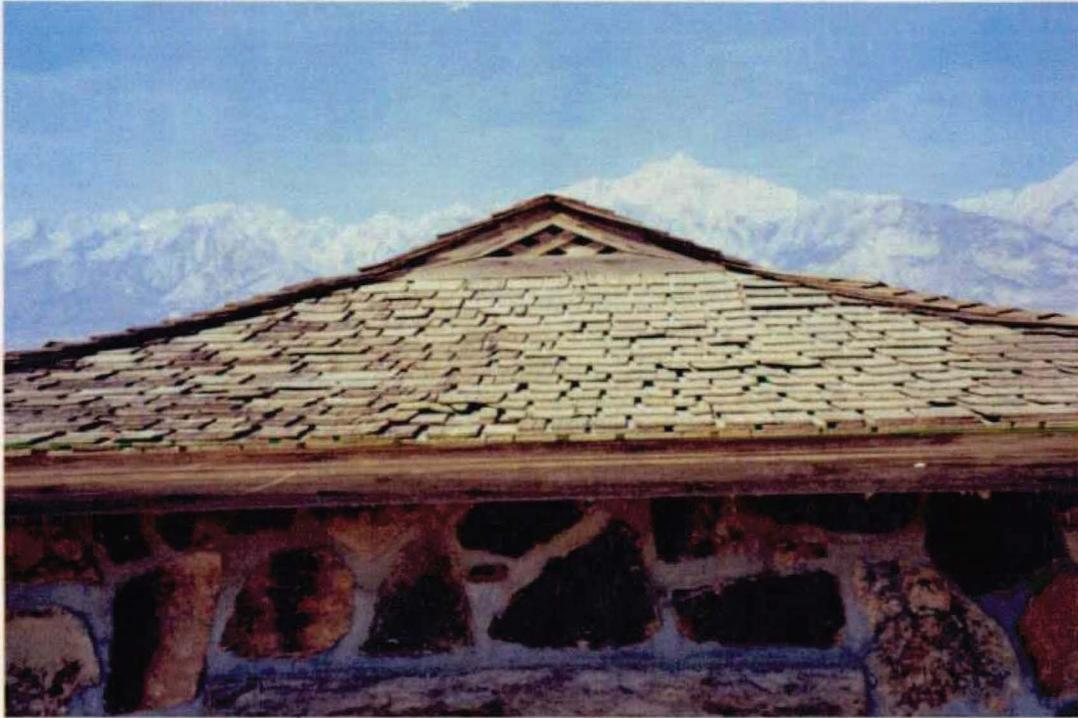
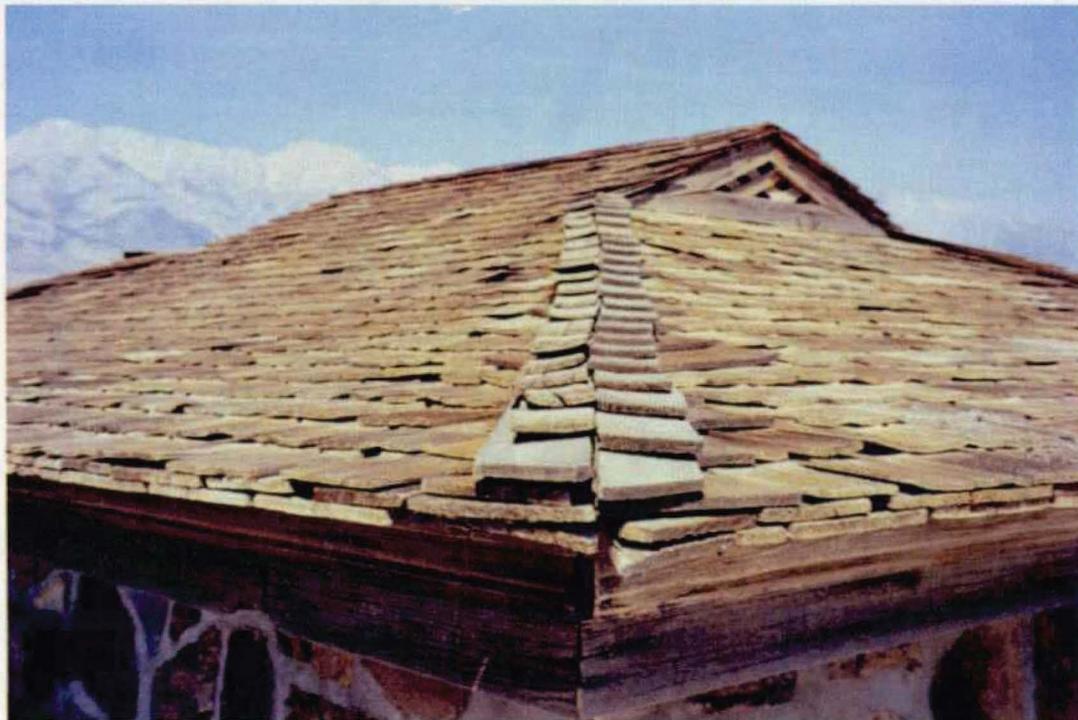
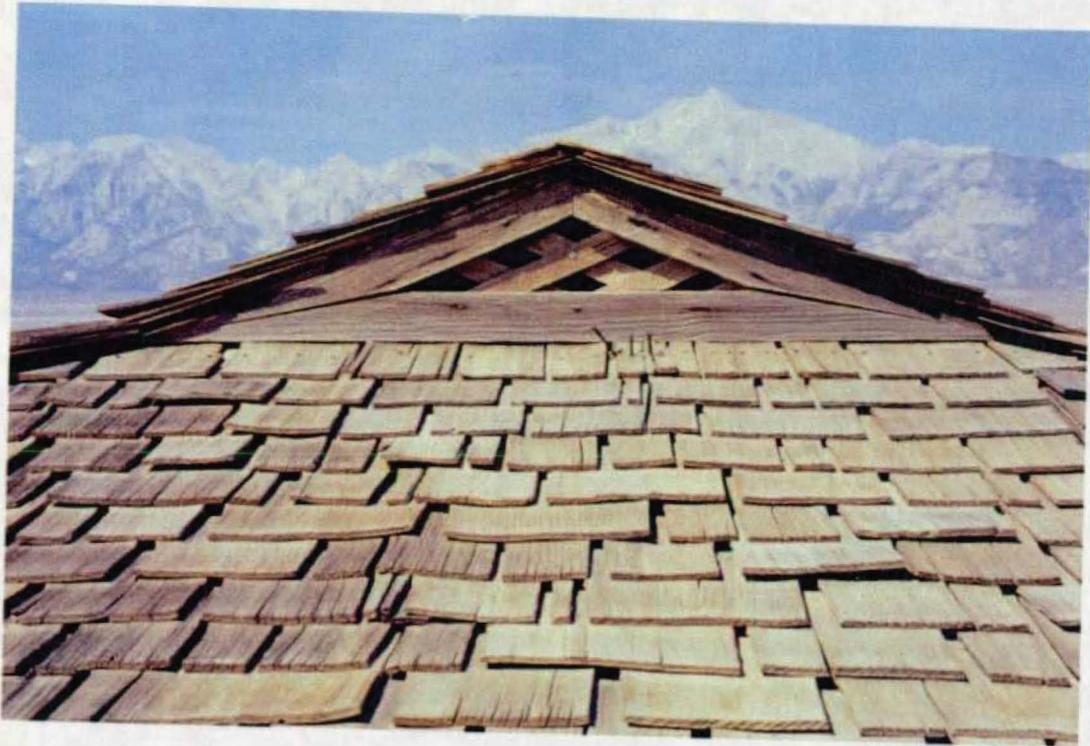
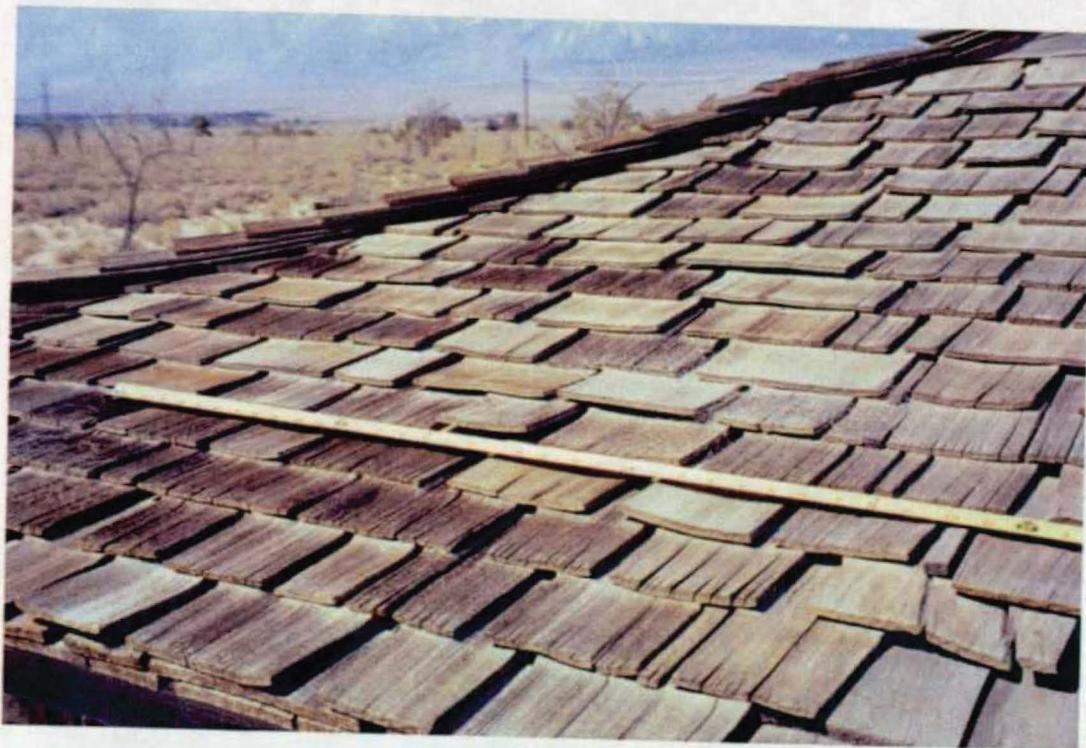
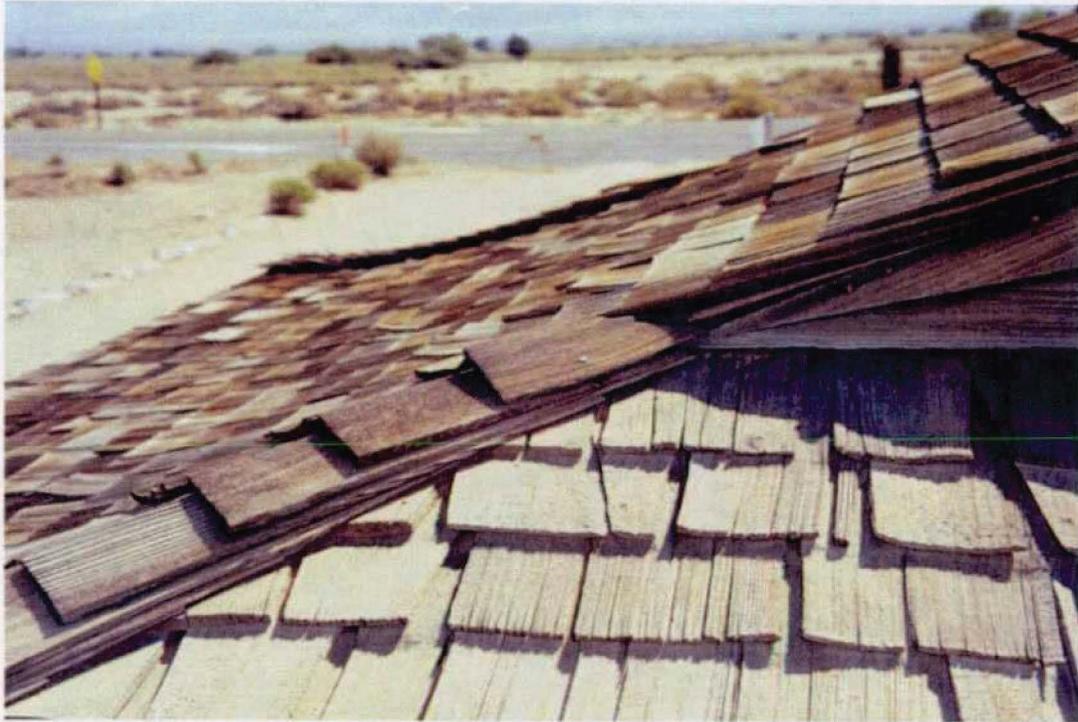
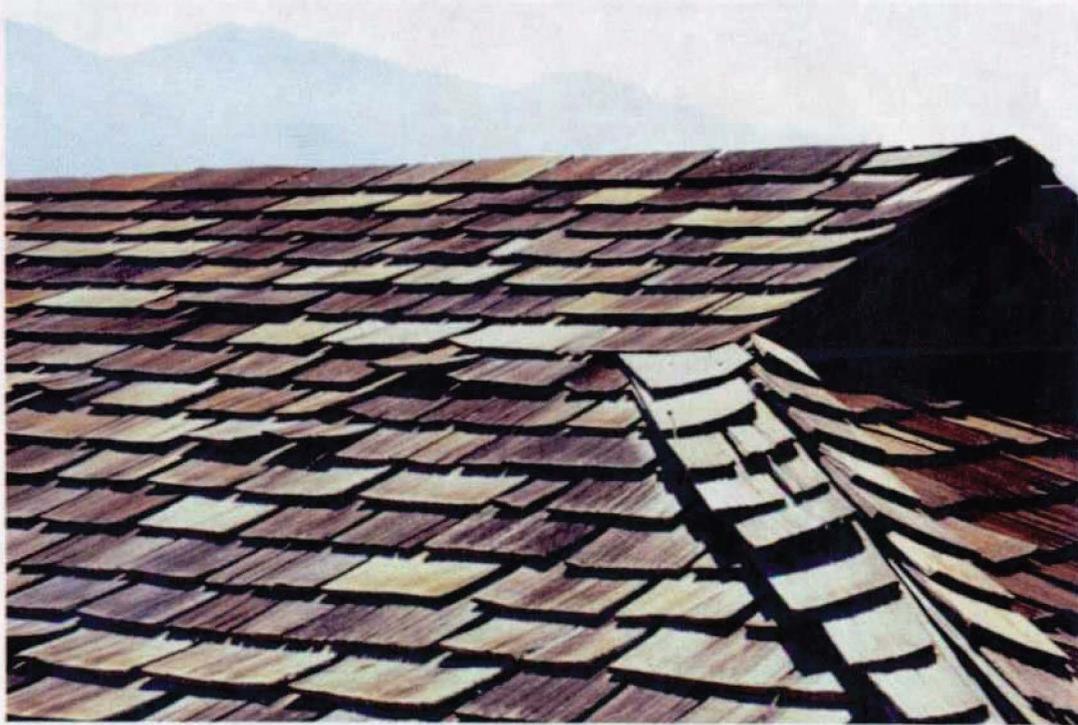
Roof: The roof is in fair to poor condition. The shingles are weathered, eroded, cupped, cracked, and dried out. A couple of the shingles are missing, and there are a couple of obvious holes in the roof.

Military Sentry Post Roof from East

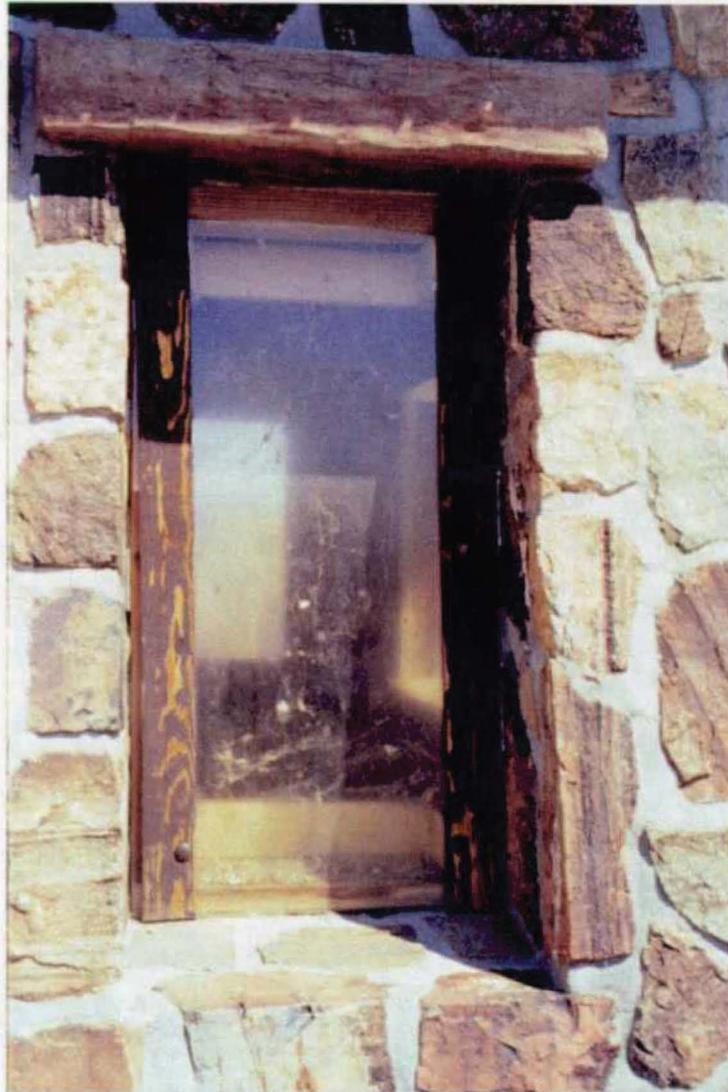
Doors and Windows: The original historic fabric of the doors and windows is missing, although the frames are still in place. The plywood and Plexiglas panels, which have been installed in the door and window openings, do keep the weather out, and restrict access, but they do not allow enough ventilation, nor do they keep bugs out.

Detail at Military Sentry Post Mothballed Window - Plexiglas

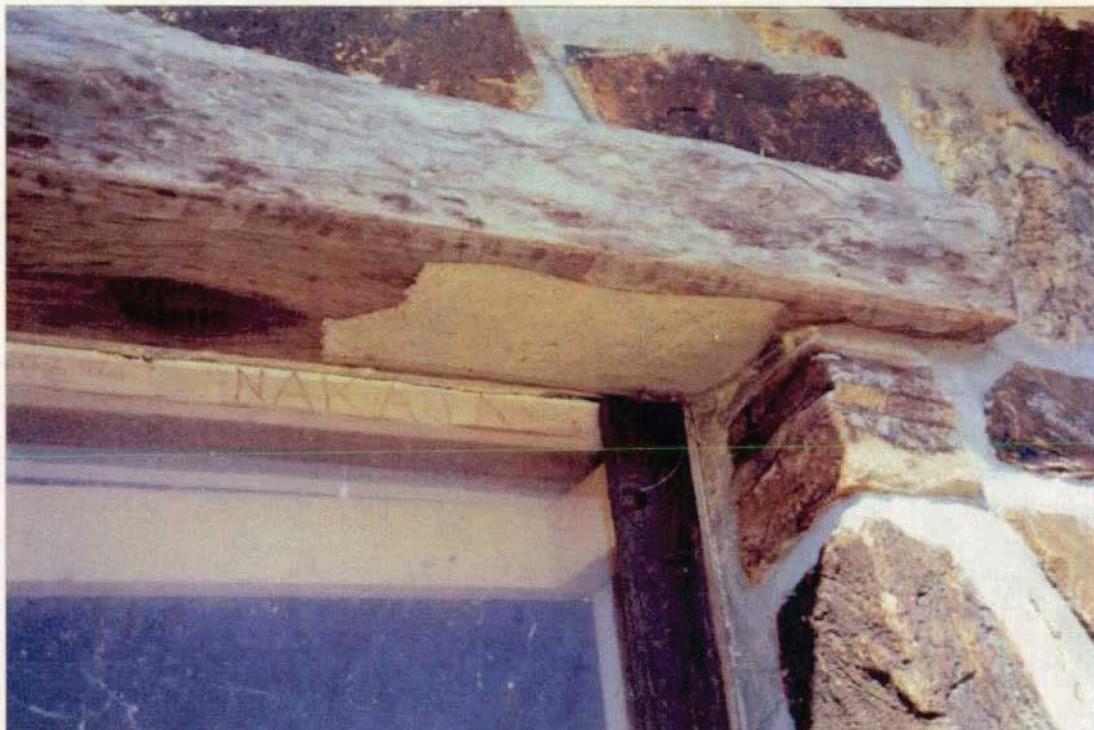
The stucco covered concrete lintels and sills are in fair to poor condition. They all show some evidence of weathering, erosion, cracking, and vandalism. In one or two places, the stucco has spalled off and the substrate is exposed.

Detail at Military Sentry Post Concrete Window Lintel with Stucco Finish

Next, the stucco covered concrete lintels and door sills need to be repaired and stabilized.

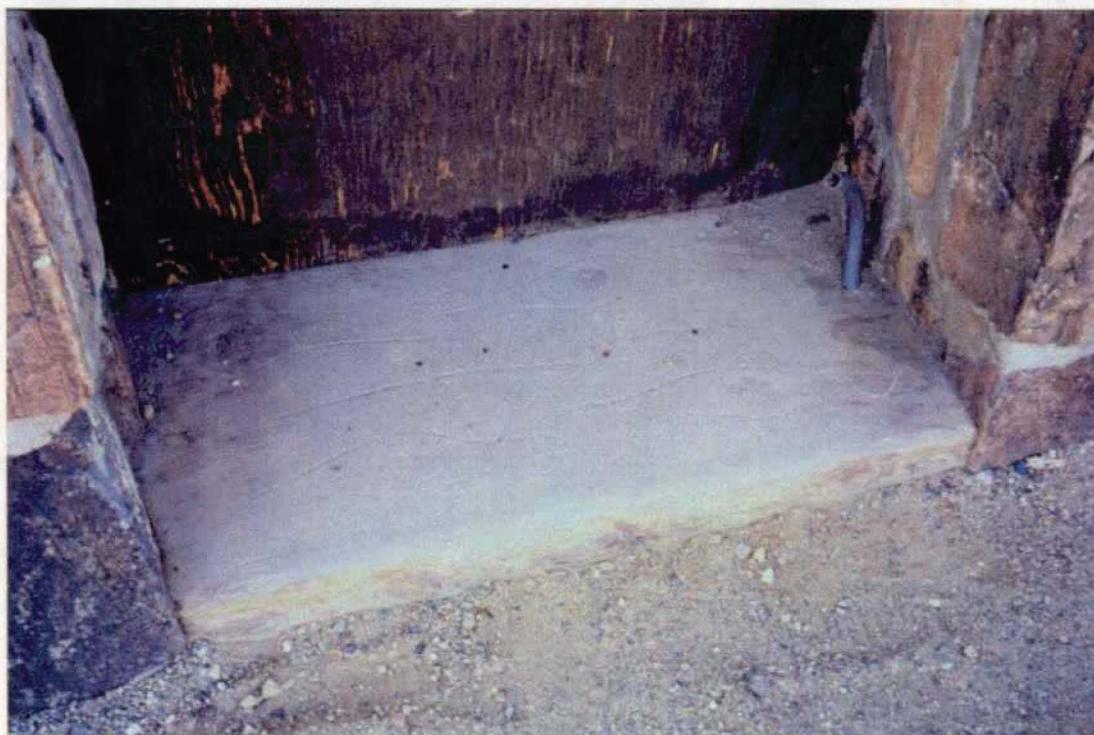
Detail at Military Sentry Post Concrete Door Sill with Stucco Finish

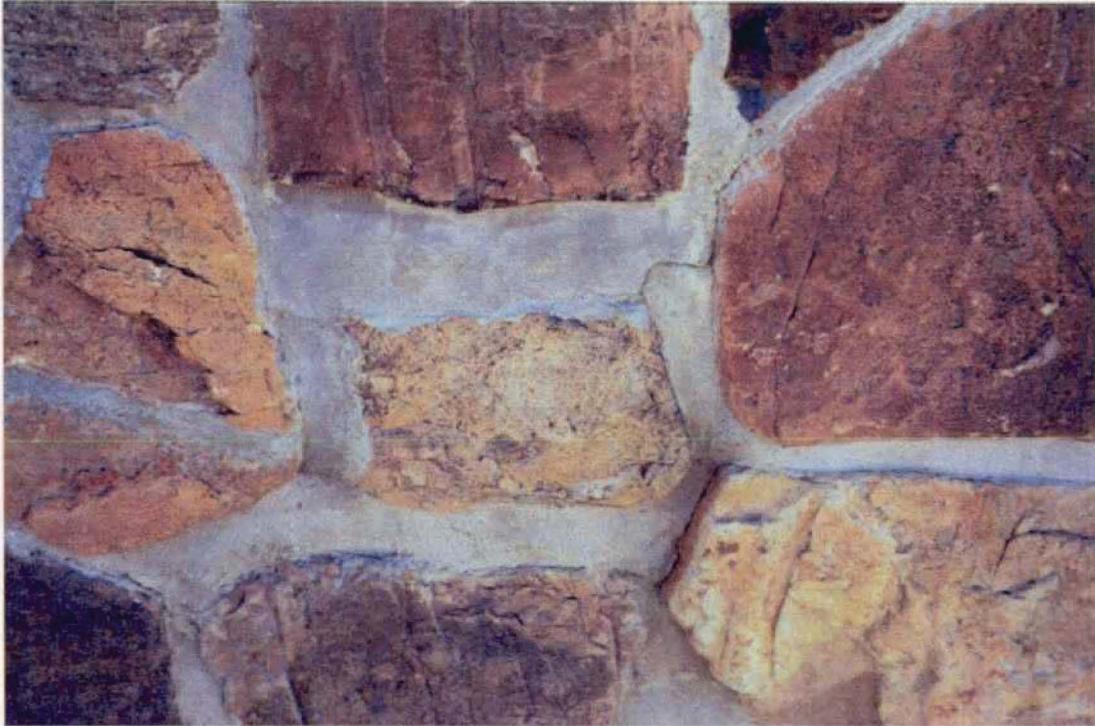
Walls: The walls are also in good condition. There is some minor cracking of the mortar joints, and some evidence of re-pointing which was done in the past, using mortar that doesn't match the original mortar (in color or texture). There are also some paint drips on the stone from painting the trim, but none of this merits any need for attention.

Detail at Military Sentry Post Stone Walls Showing Mortar Joints

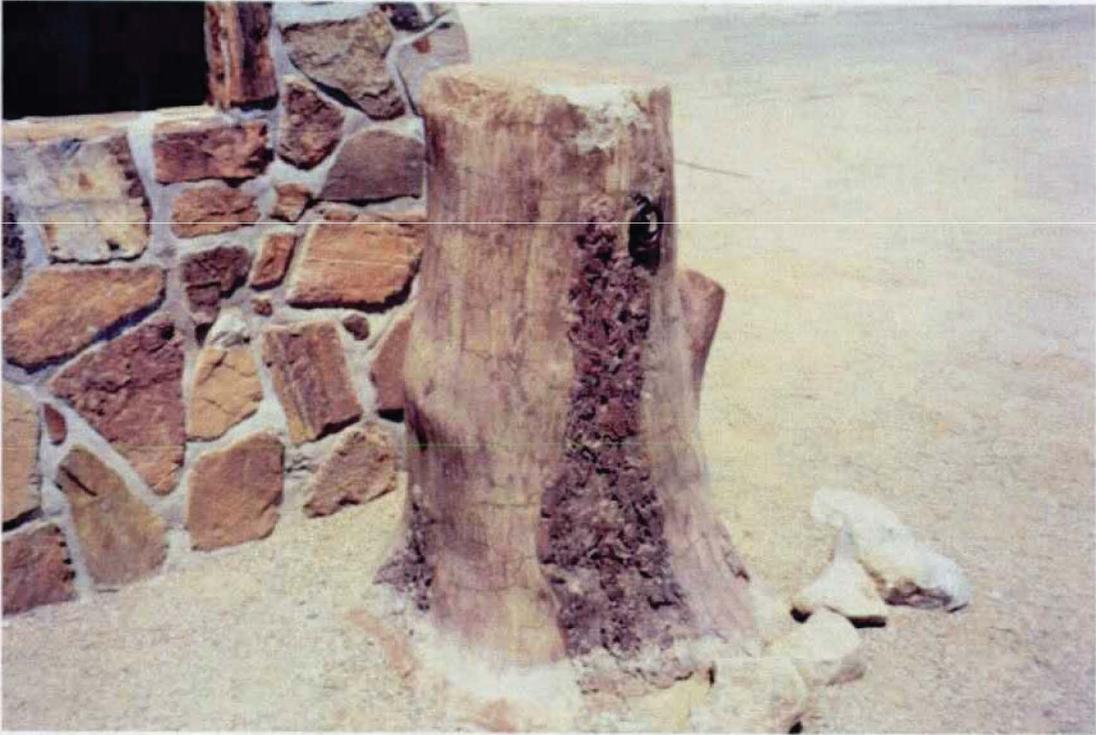
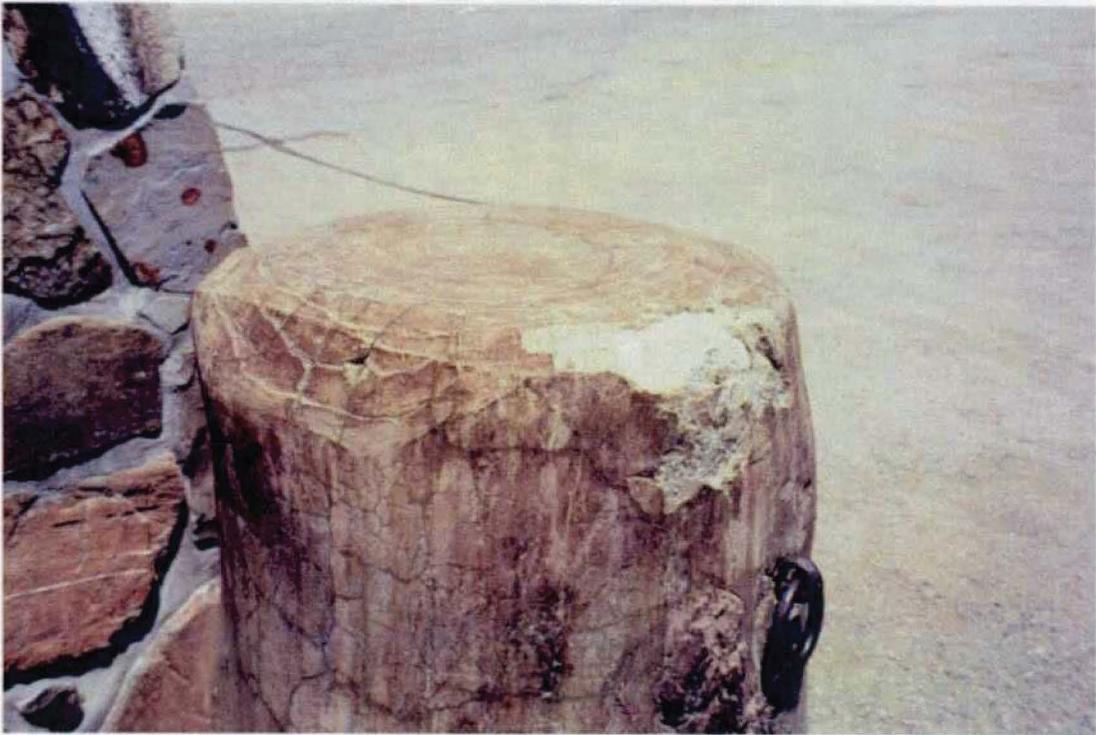
The concrete "tree stumps" built on either side of the building suffer from the same problems listed above for the concrete lintels and sills - they show some evidence of weathering, erosion, cracking, and vandalism, and in one or two places, the stucco has spalled off and the substrate is exposed.

Stucco Covered Concrete Tree Trunk at Military Sentry Post

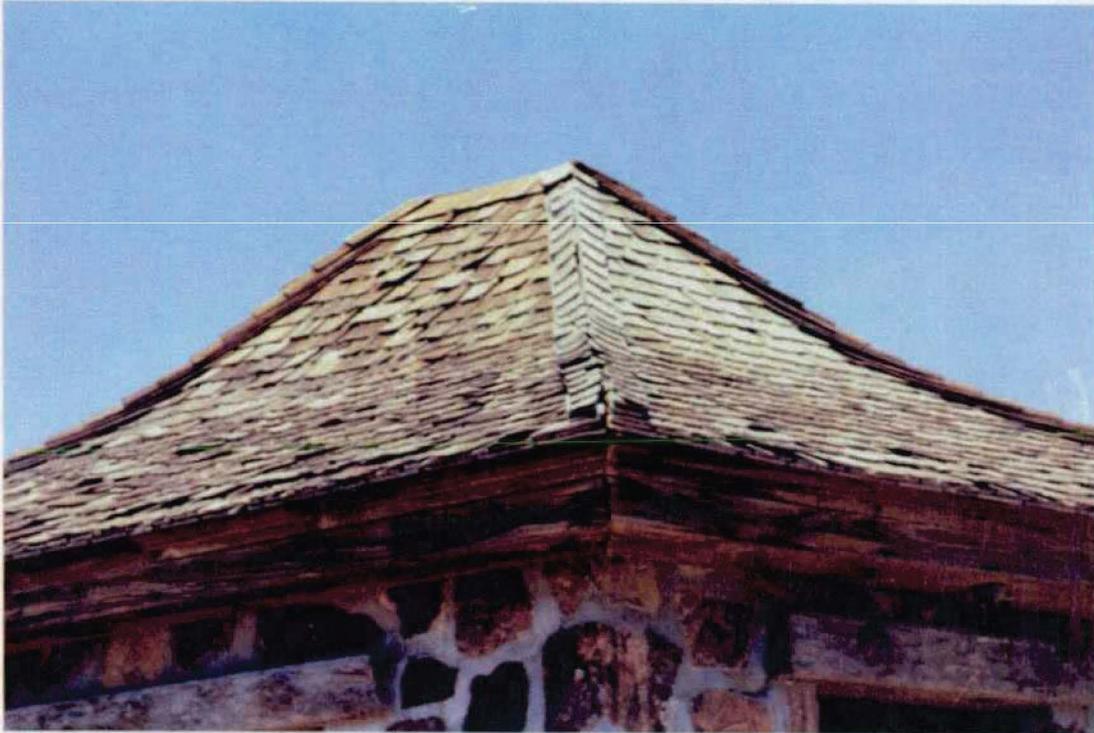
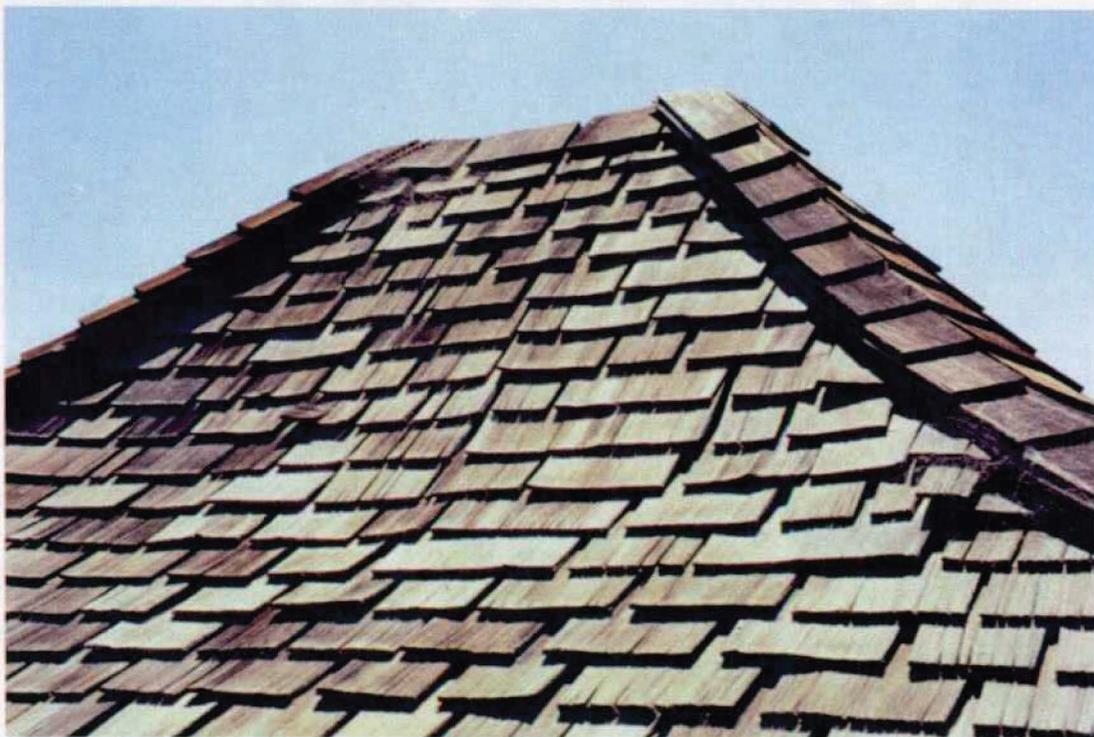
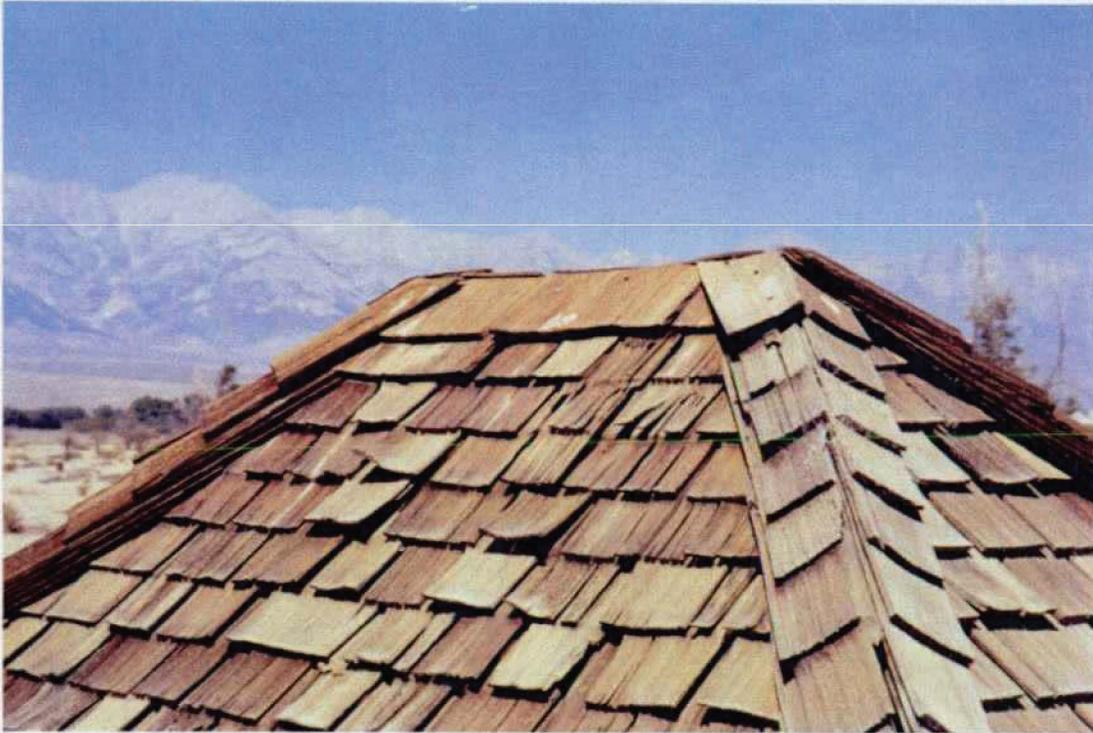
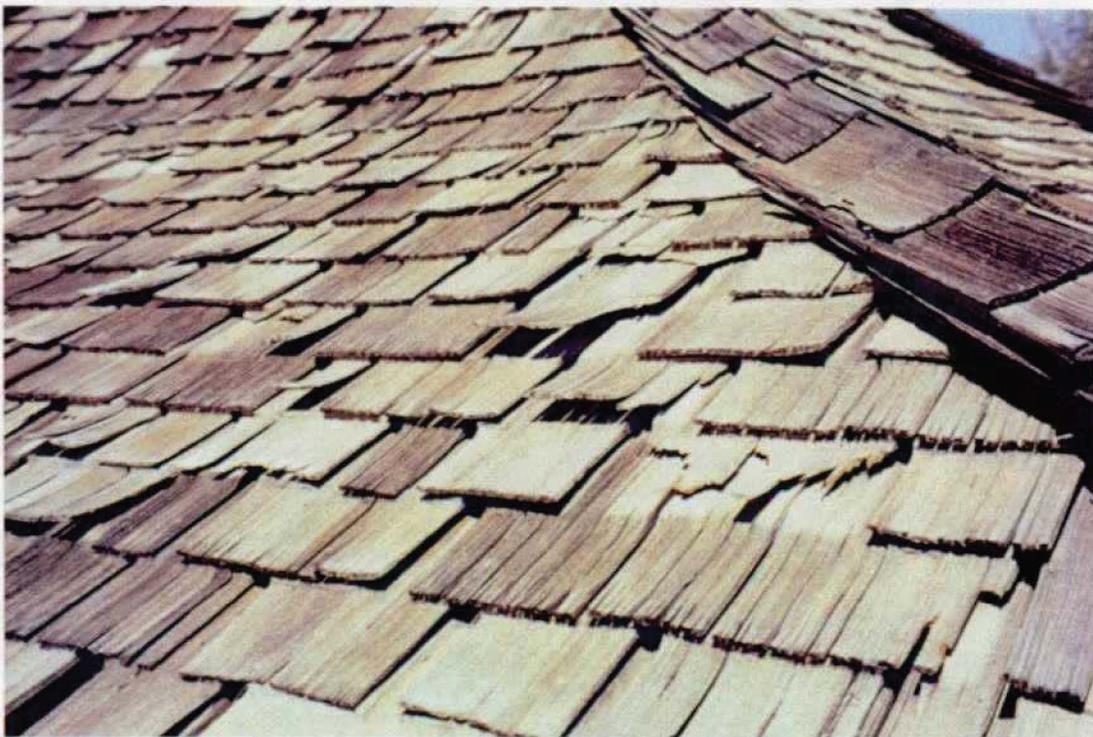
Roof: The roof is in fair to poor condition. The shingles are weathered, eroded, cupped, cracked, and dried out. A couple of the shingles are missing, and there are a couple of obvious holes in the roof.

Detail at Roof at Police Post

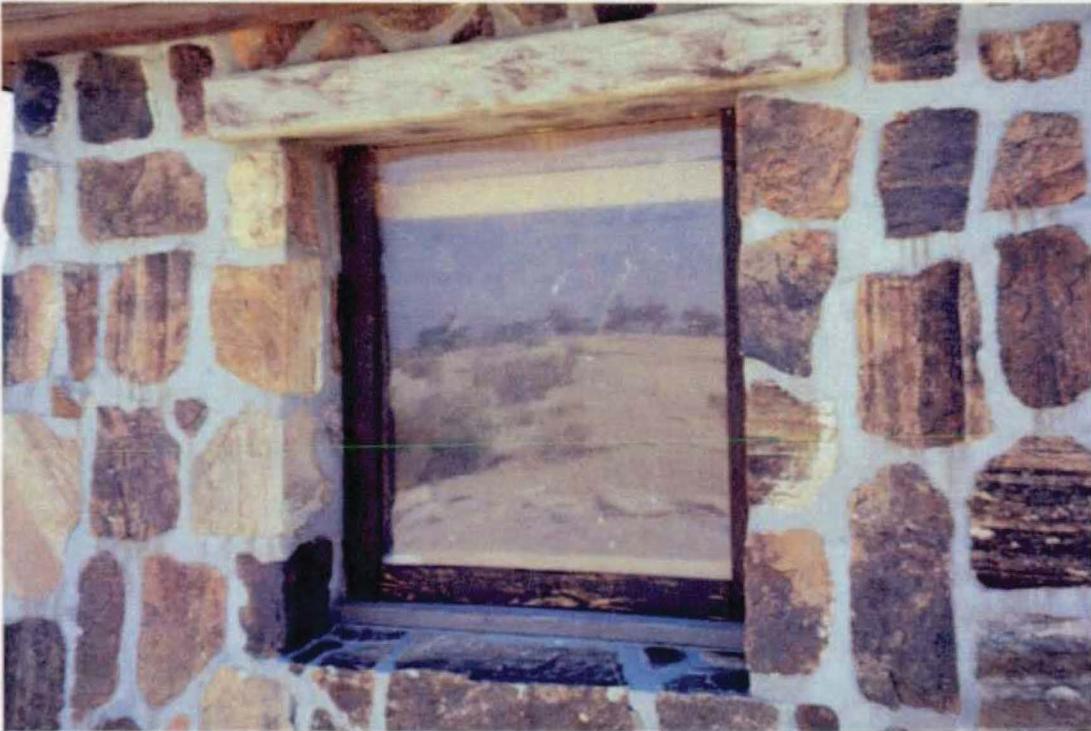
Doors and Windows: The original historic fabric of the doors and windows is missing, although the frames are still in place. The plywood/Plexiglas panels, which have been installed in the door and window openings, do keep the weather out, and restrict access, but they do not allow enough ventilation, nor do they keep bugs out. And, they are very difficult to remove to gain access into the building. In addition, they detract from the architecture and character of the building.

Detail at Mothballed Window at Police Post - Plexiglas

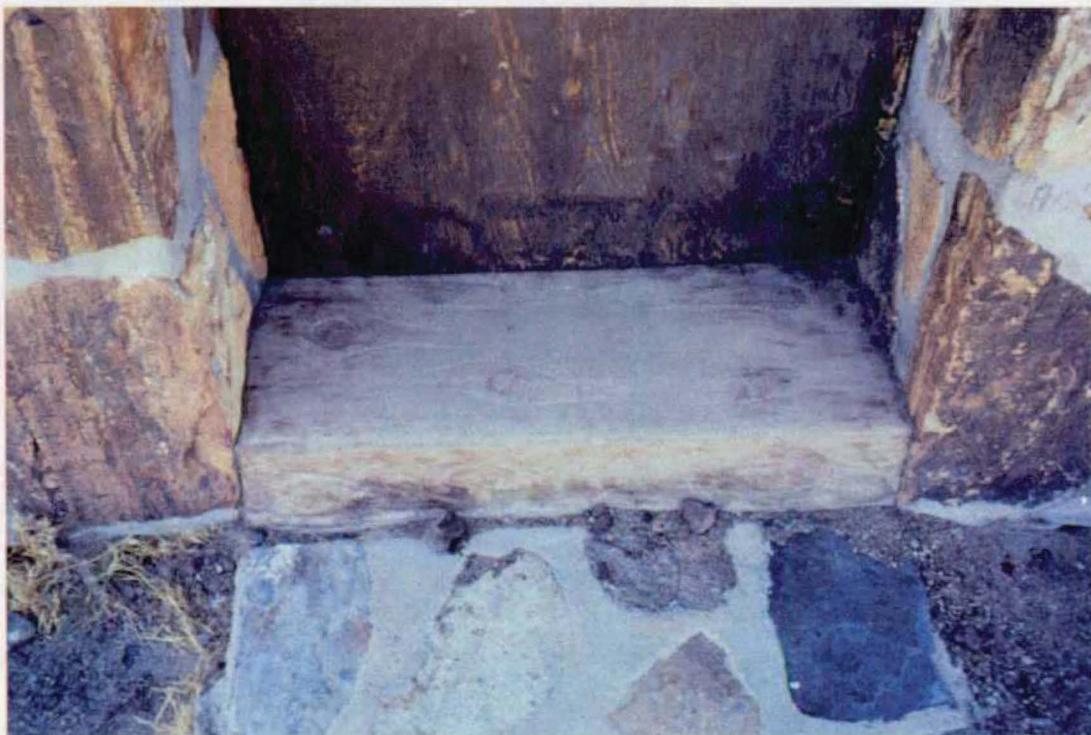
The stucco covered concrete lintels and sills are in fair to poor condition. They all show some evidence of weathering, erosion, cracking, and vandalism. In one or two places, the stucco has spalled off and the substrate is exposed.

Detail at Police Post Concrete Door Sill with Stucco Finish

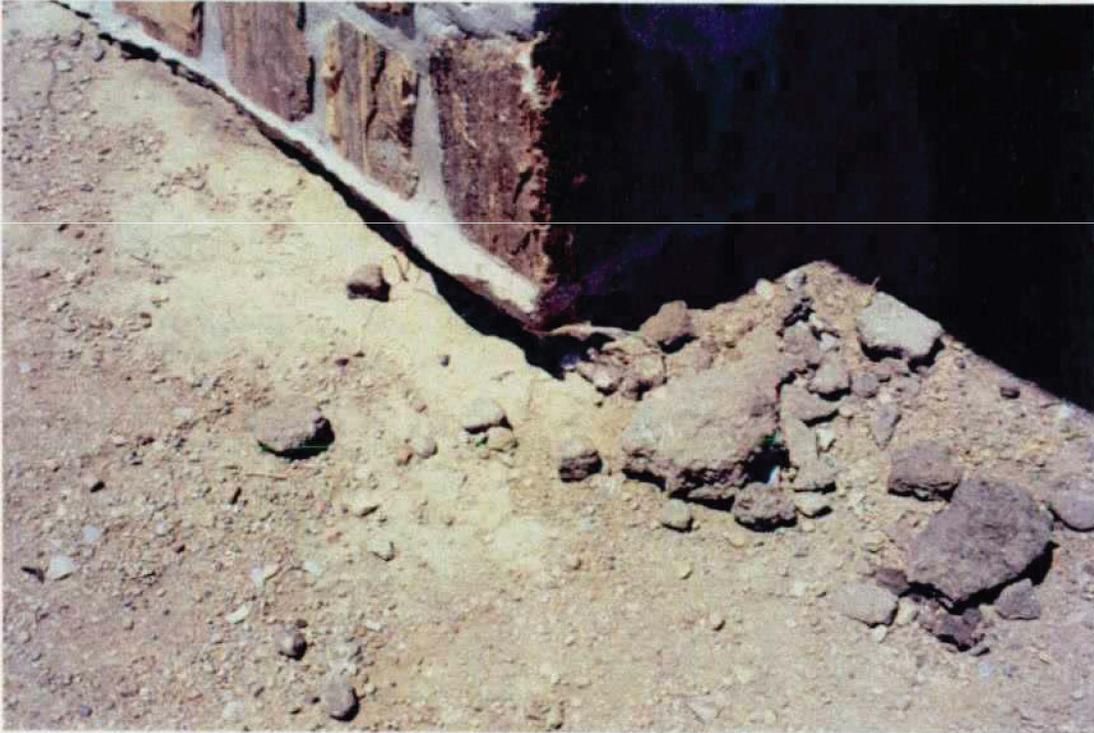
Foundation: The foundation is assumed to be in good condition. There is no evidence of settlement or failure, although the grading around the base of the building does have some low areas, which expose the foundation, and may allow water to pond against the foundation.

Detail at Police Post Foundation

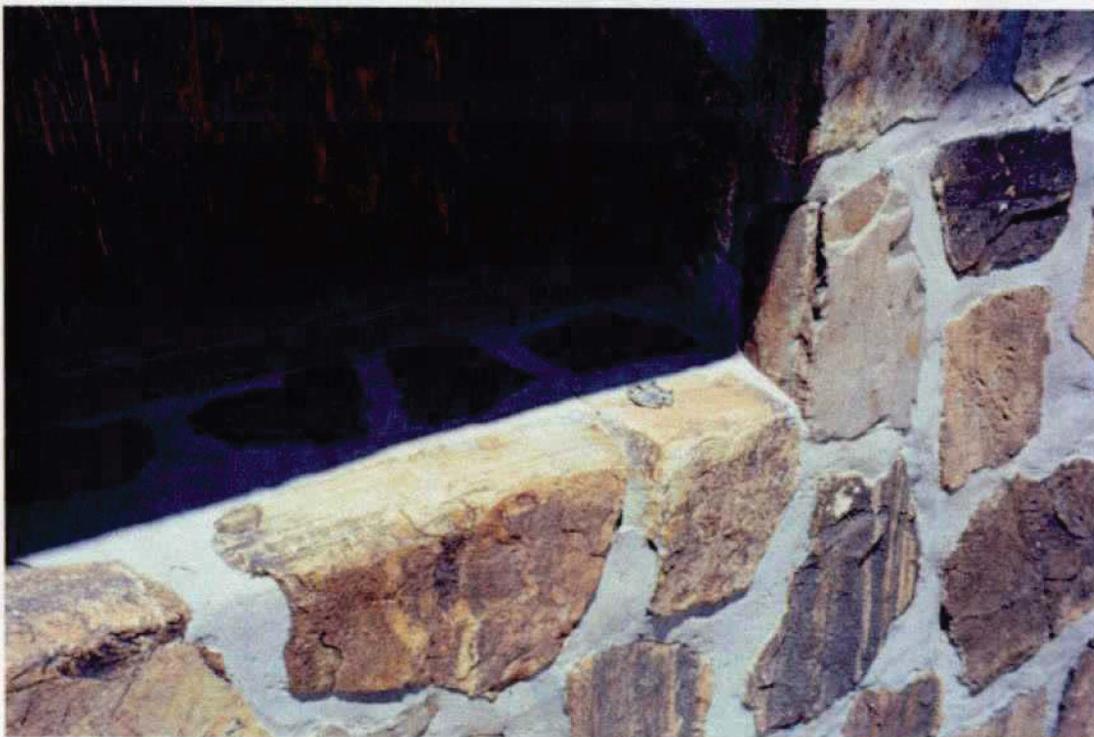
Walls: The walls are also in good condition. There is some minor cracking of the mortar joints, some evidence of re-pointing which was done in the past, using mortar that doesn't match the original mortar (in color or texture). There are also some paint drips on the stone from painting the trim, but none of this merits any need for attention; with the exception of one small area at the window sill on the south window, which does need to be re-pointed.

Detail of Damage to Mortar at South Window Sill at Police Post

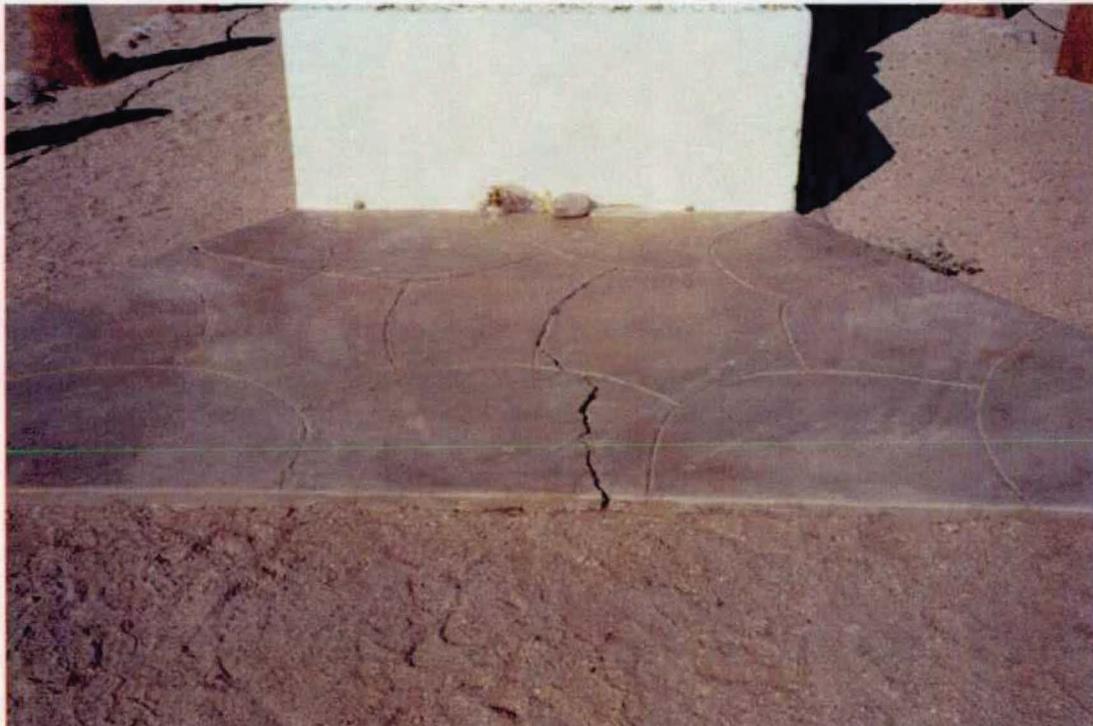
Finally, the concrete slab on the east has a large crack right in the middle.

Detail of Concrete Slab at Base of Cemetery Monument

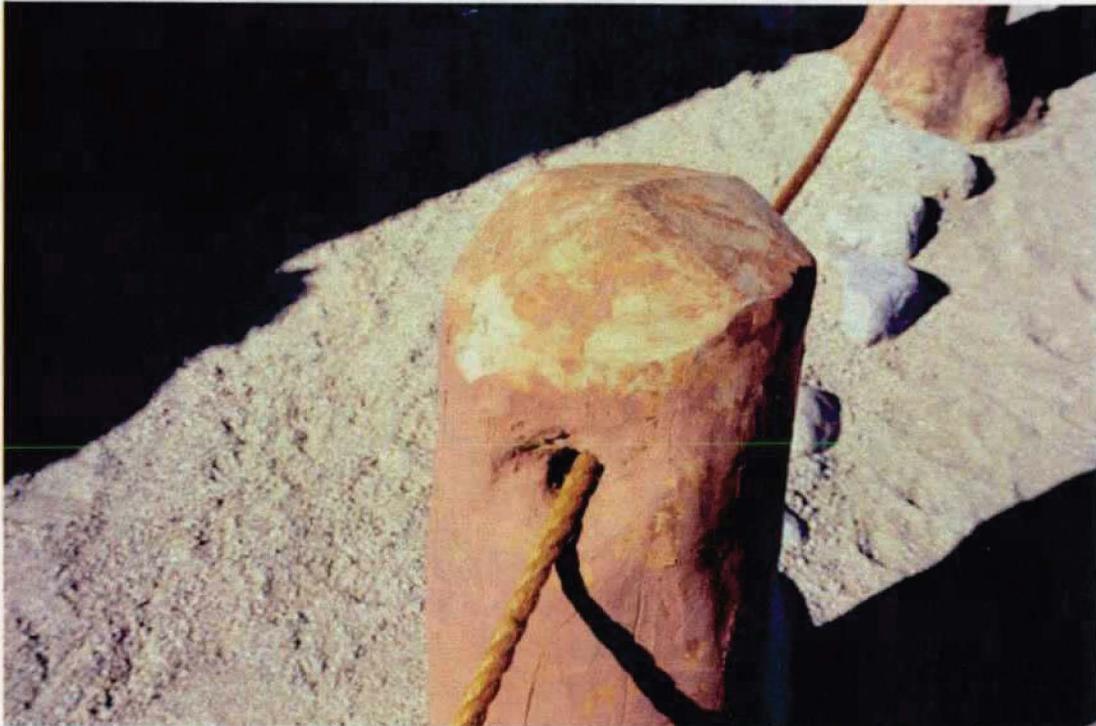
The concrete/stucco covered tree stumps are showing signs of weathering and improper maintenance. The weathering has led to deterioration of the stucco finish – most noticeably fading, erosion, and cracking. Some of the stucco is loose or has spalled off. Also, the structures have been painted at some time in the past, and the paint is very deteriorated.

Stucco Covered Concrete Tree Trunk at Cemetery Monument

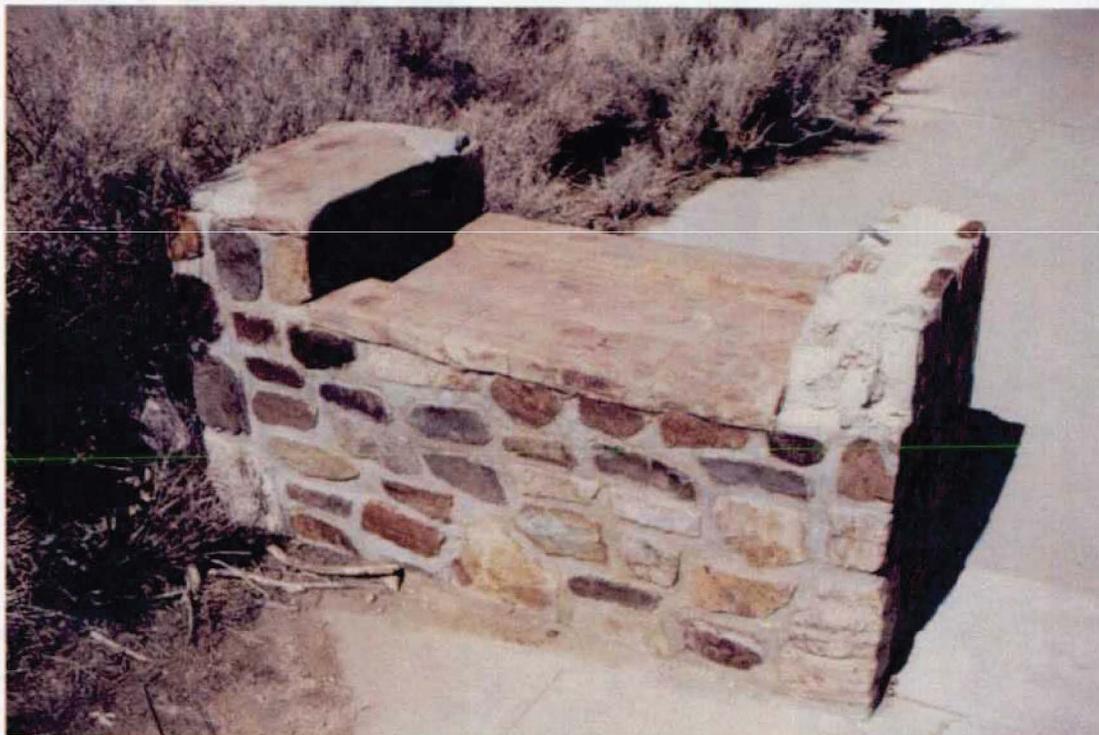
Stone Masonry Object: Generally, this structure is in good condition, although the condition of the stucco covered concrete is fair to poor, showing the effects of weathering, fading, erosion, cracking, and spalling.

Stone Masonry Object

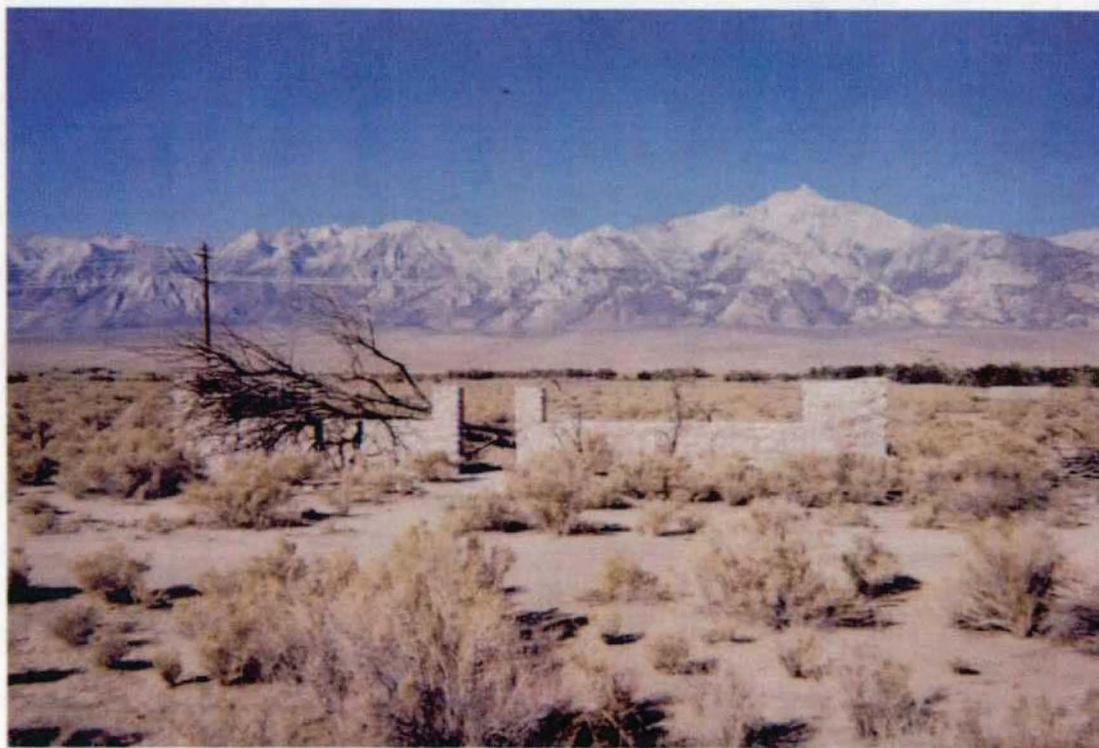
Camp Director's Residence Patio Walls: This structure is in good condition. However, there is a tree, which has died and fallen on top of the wall.

Camp Director's Residence Patio Walls

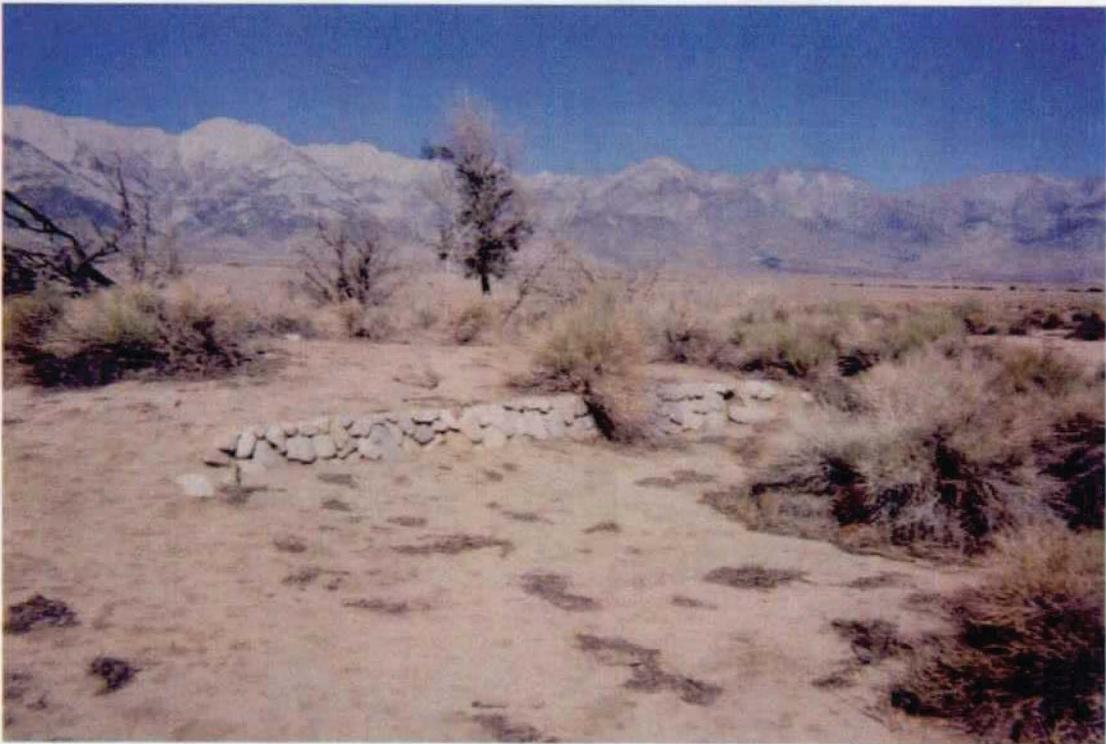
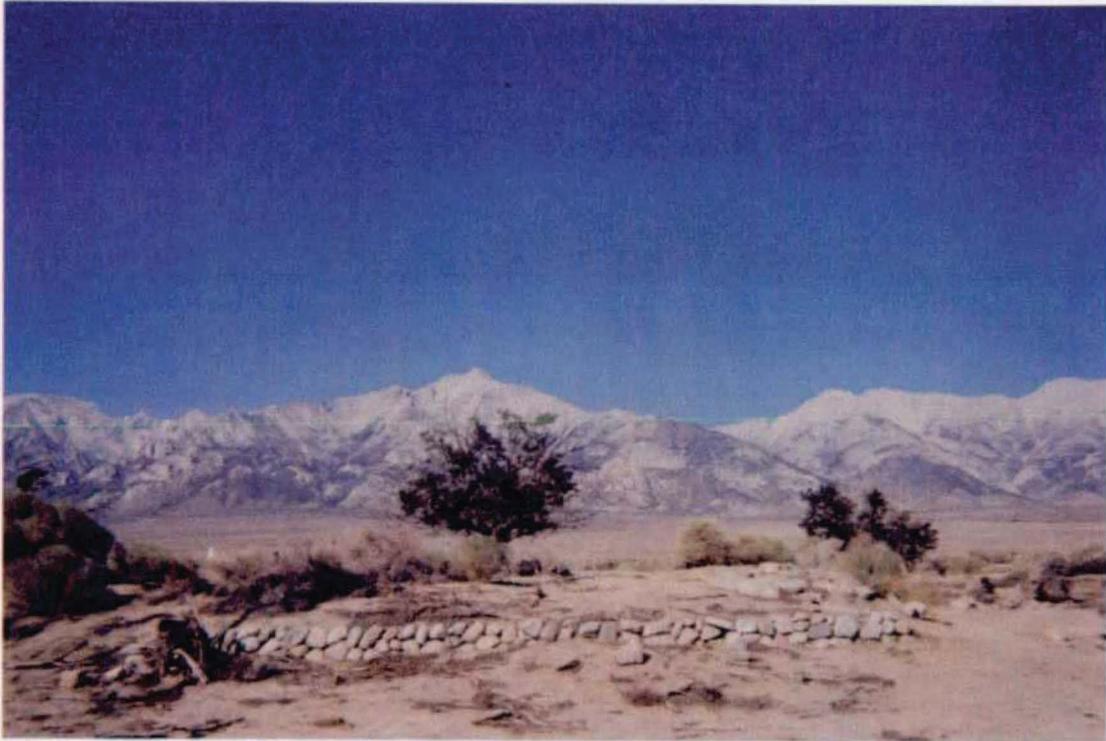
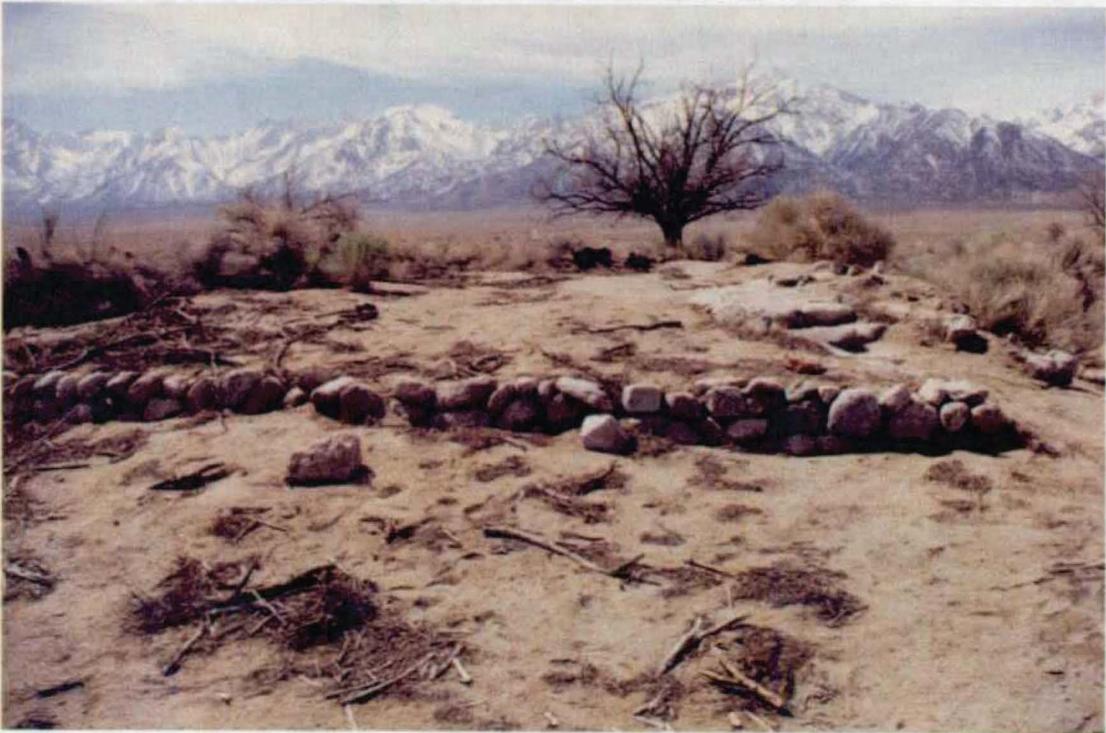
Hospital area Features: These structures are in fair to poor condition. They are scattered about and hard to identify.

Hospital Area Features
