CONDITION ASSESSMENT and PRESERVATION PLAN
for
Various Structures

Manzanar National Historic Site

DECEMBER 31, 2000

Mark L. Mortier
Historical Architect

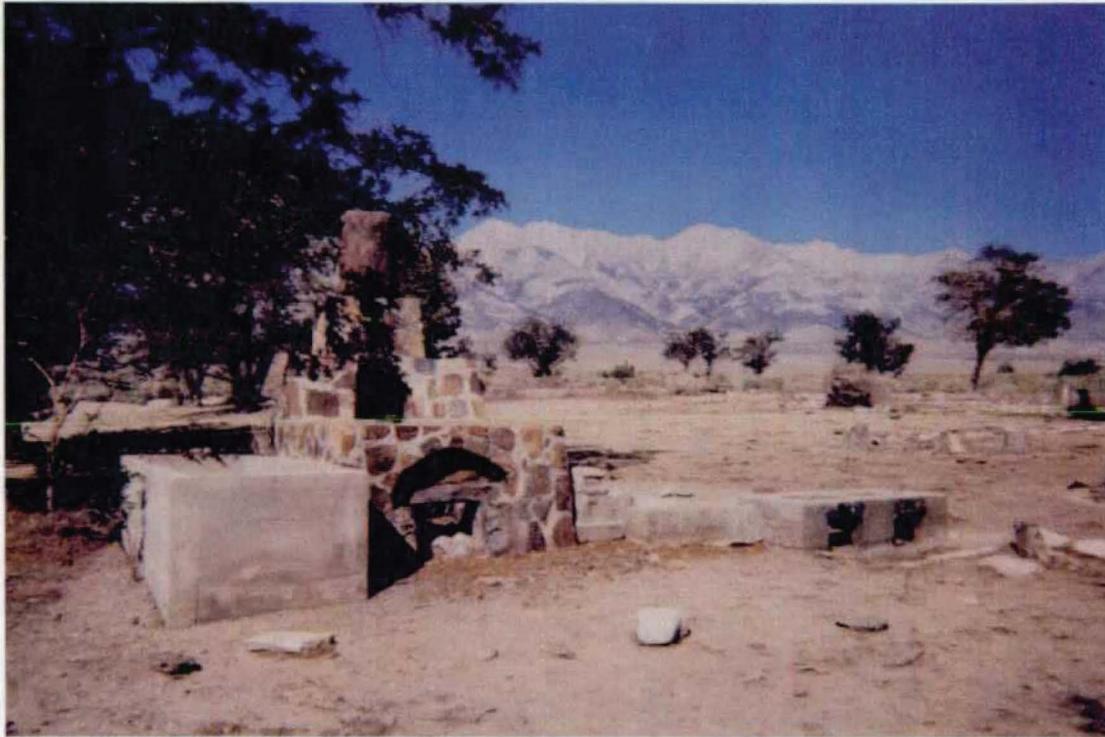
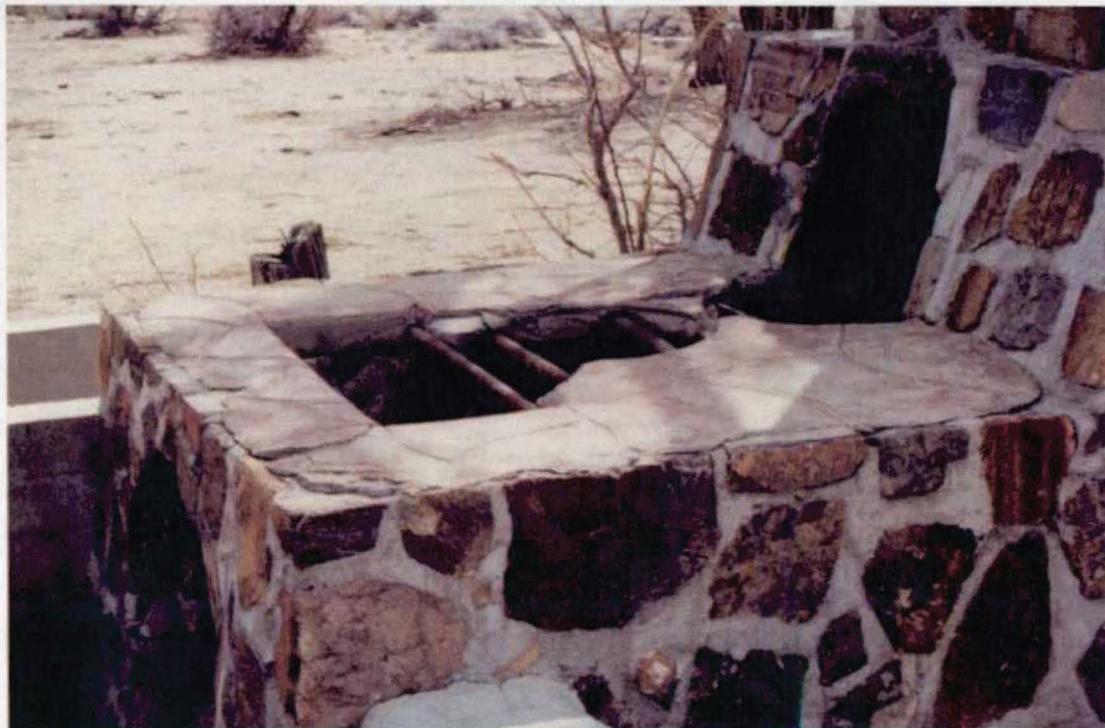
Chicken Farm Incinerator: These structures are in fair condition. The main structure itself is in fair to good condition, but the finishes (tinted stucco over concrete) are deteriorated.

Chicken Farm Incinerator

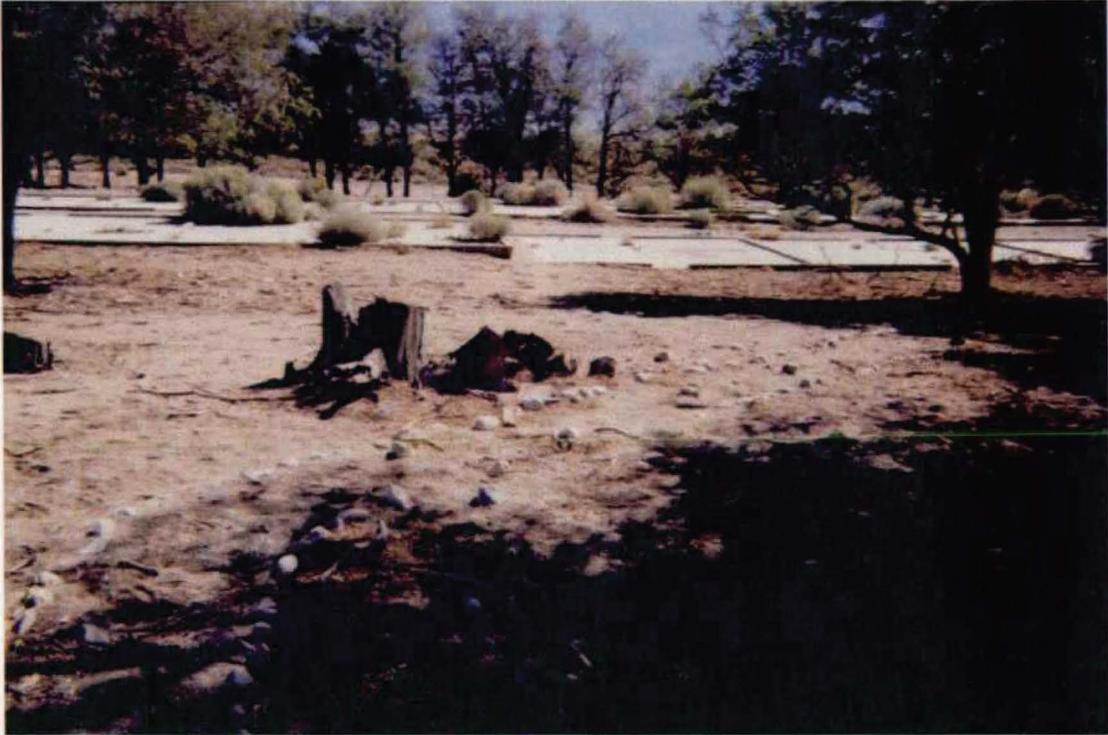
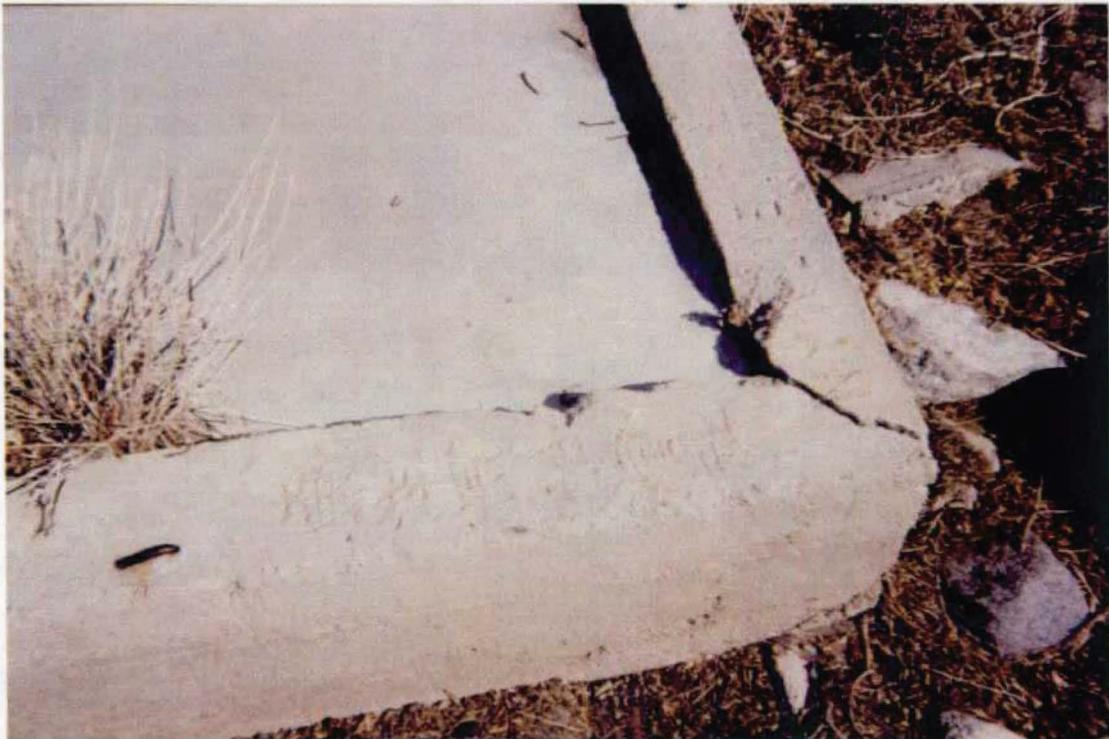
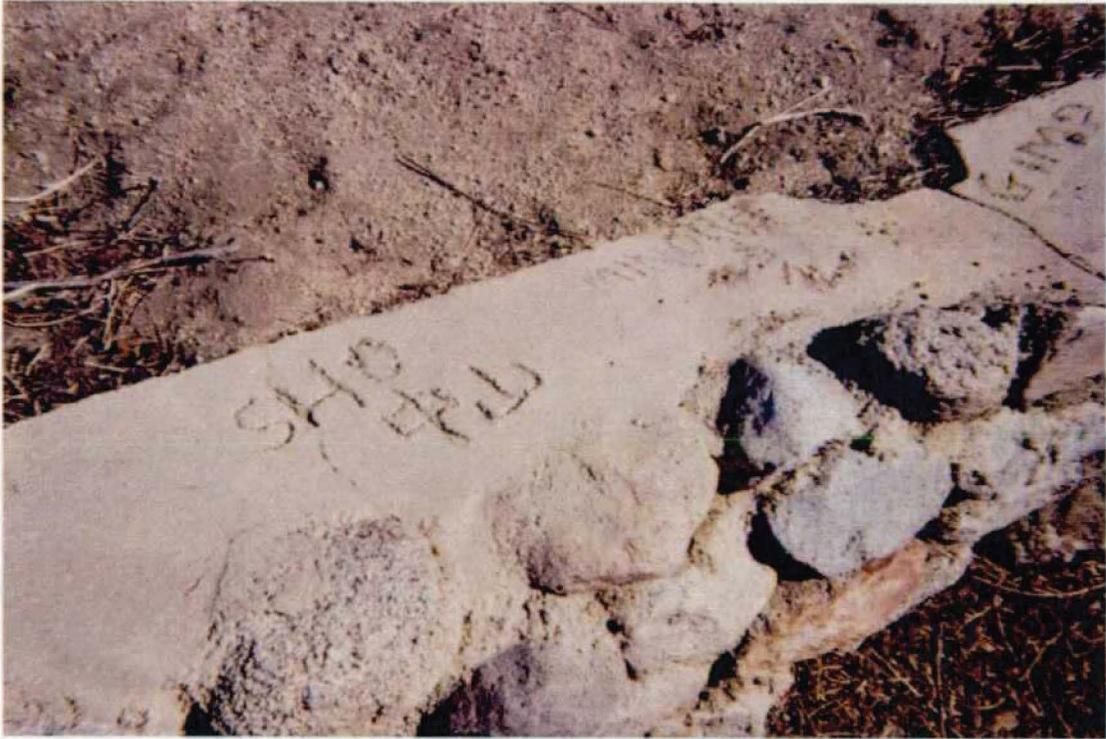
Chicken Coop Foundations: These structures are in fair to poor condition. Like the Hospital Area features, they are scattered about and hard to identify. The inscriptions carved into the concrete and mortar are in fair to good condition. Some of the parging is weathered, cracked, or spalling off

Chicken Coop Foundations

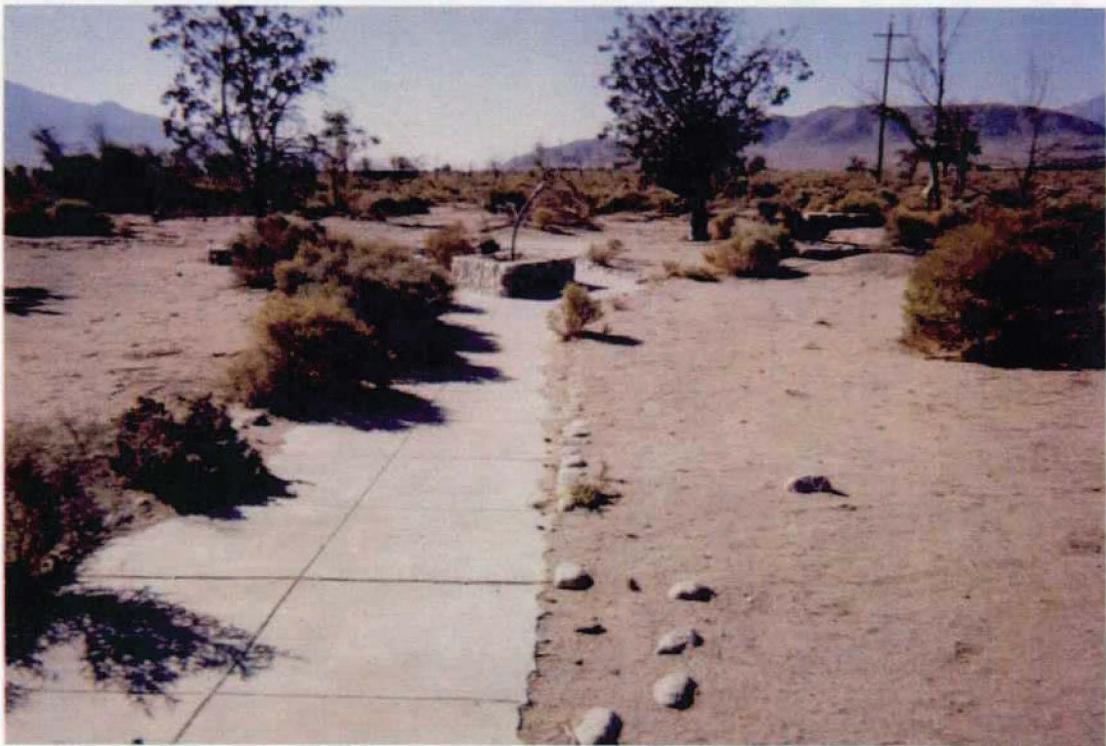
Stone Lined sidewalks: These are in fair to poor condition.

Stone-Lined Sidewalks
