Spruce Tree House Alcove

National Park Service
U.S. Department of the Interior
Mesa Verde National Park

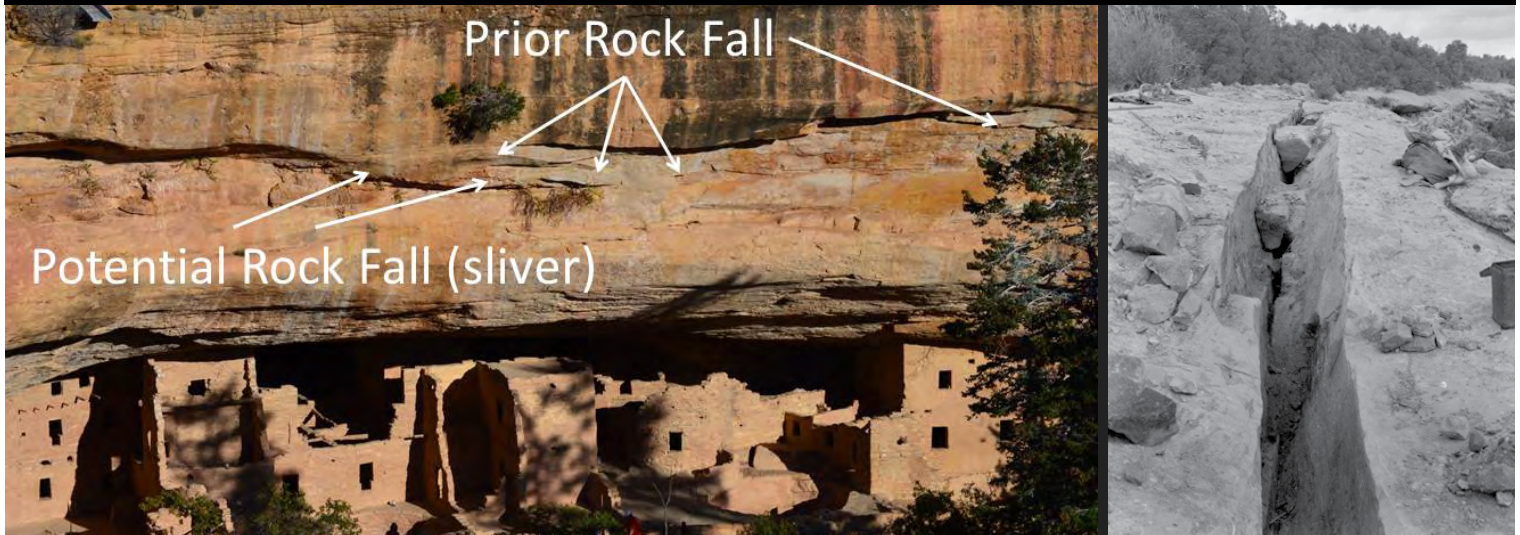
Left: Areas of previous and potential rockfalls. Right: 1940 photo of widest section of crack above Spruce Tree House.

The primary concern is a large, naturally forming arch located within one of several cracks that exist in the cliff above Spruce Tree House, nearly parallel to the outer edge (above right). In 1940, an attempt was made to slow the erosional processes by cleaning the crack of plants and rock debris which were acting like wedges, exerting force and widening the crack. Following cleaning, a protective covering was constructed over the crevice in an attempt to make it water proof. In 1960, a large, 10-ton rock fell from a ledge under the lip of the cliff overhanging the south end of Spruce Tree House, impacting the public trail as well as a small portion of the site. This resulted in the 1961-2 anchoring of the natural rock arches. The earlier covering was removed, the arches were pinned to the cliff face, and the crack was filled with aggregate and cement grout. Forty two rock anchor bolts, some 16 feet long, were drilled horizontally into the cliff face to secure the arches.

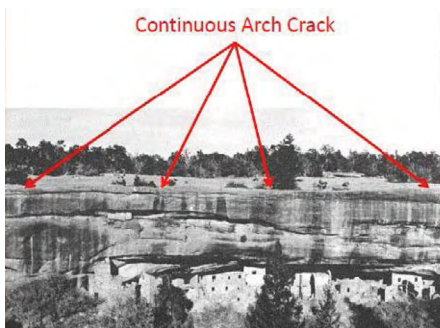
The arch crack spans Spruce Tree House.

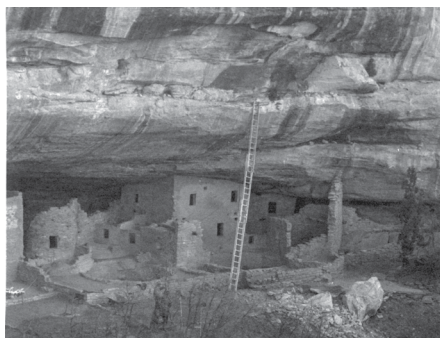
1960 rock fall. Note large debris field on lower right. One 10-ton rock fell, and a second, loose 5-ton slab was pulled down.

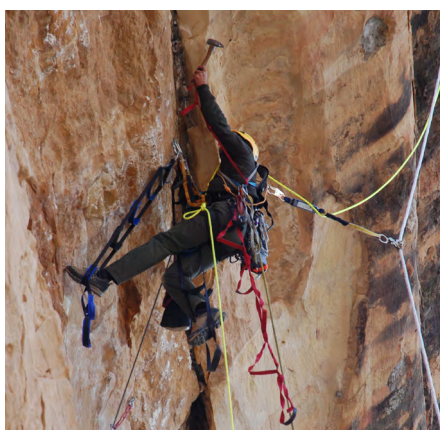
Scaling operation in the fall of 2015. Note the rock anchor (bolt) in the rock along the right side of photo, just above climber.

In the fall of 2015, the arches, specifically the large one in the south end of the site, were again the focus of concern. A number of smaller rock falls, some which fell on public trails, occurred within the alcove in the area of the large arch. The site was closed in order to conduct an assessment and remove loose rock material from the cliff face and ledges. The scaling operation brought down about 60 cubic feet (cf) of material from the alcove edge. Some of the rock removed had a harder, desiccated outer surface with a substantially softer interior, revealing that sections of the sandstone are weakening due to water leaching the calcium carbonate matrix that binds the sand particles within the sandstone.

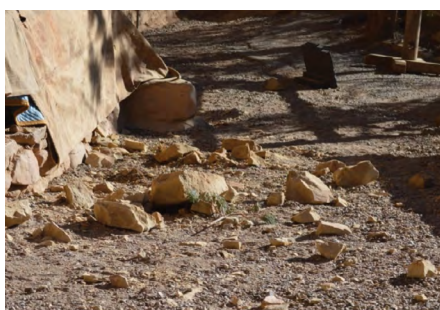
About 60 cubic feet (cf) of loose material fell along the public trail from the alcove edge above during the scaling operation.

The park service has contracted with a geotechnical firm to conduct a detailed assessment of the alcove through core drilling to determine composition and integrity of the rock. The process will involve Light Detection and Ranging (LiDAR), sophisticated laser imaging, and performing a 3-D computer analysis of the data to model alcove stability. The assessment will result in recommendations for treatment that, if necessary, will use modern engineering technology to ensure that the alcove is stable and safe for public visitation.
