CONDITION ASSESSMENT REPORT
SPRUCE TREE HOUSE ALCOVE
SANDSTONE ARCH
MESA VERDE NATIONAL PARK
MESA VERDE, CO

James A. Mason, Ph.D., P.E.
Structural, Geotechnical, and Preservation Engineer
Vanishing Treasures Program
National Park Service
Mesa Verde National Park, Colorado
January 19, 2016

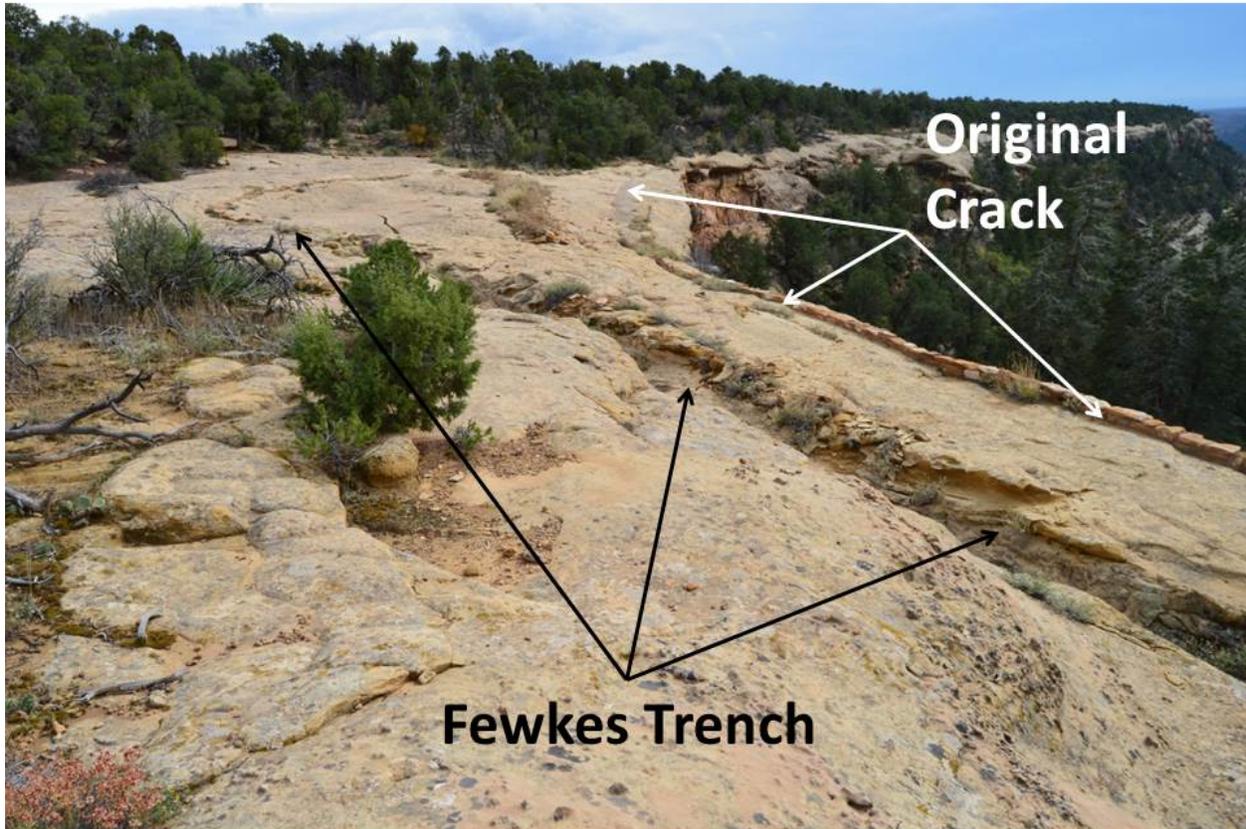
Water issues within the STH archeological site and associated alcove were originally documented in 1908 by Fewkes (NPS, 1908). Ground surface water run-off at the top of the mesa followed the natural slope and ultimately flowed through the arch crack and sheeted over the alcove roof edge and onto the ancient dwellings. In an effort to deflect the water, Fewkes “blasted” a trench into the rock back from the outer edge to create a channel that would capture and deflect water away from the alcove. See Figure 3. The trench was minimally effective. The effect of the blasting on the alcove arch was not documented, but in the opinion of this author, could have had detrimental effect on the performance of the arch.

Figure 3. Trench built by Fewkes (1908).
(photo: Mason 2015)

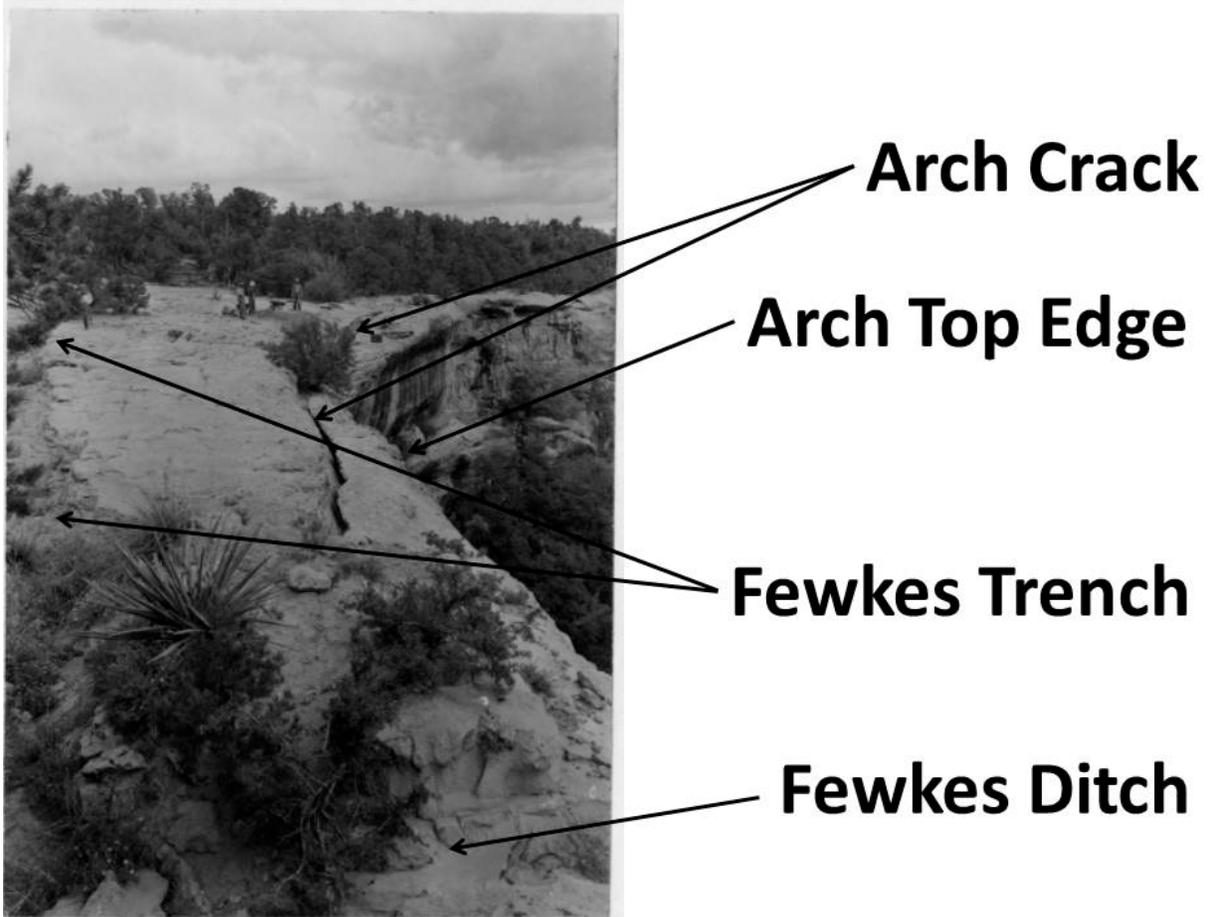
The condition of the arch in 1940 brought great concern to NPS officials and is shown in the next three figures. Figure 4 (Lancaster, Neg. No. 0828, 1940, (Richardson, 1940)) shows the view of the crack from the north and looking south. The drainage ditch / scupper is at the bottom of the photo (Sta. 0+10 +/-). The slippage and downward movement of the arch is clearly visible in the photo. Figure 5 (Lancaster, Neg. No. ? (negative missing from files), 1940, (Richardson, 1940)) shows the opening of the crack which allowed a direct path for surface

Figure 4. Overall view of crack in Spruce Tree House alcove arch. Looking south. Ditch at left and bottom of photo in near Sta. 0+10 +/-.

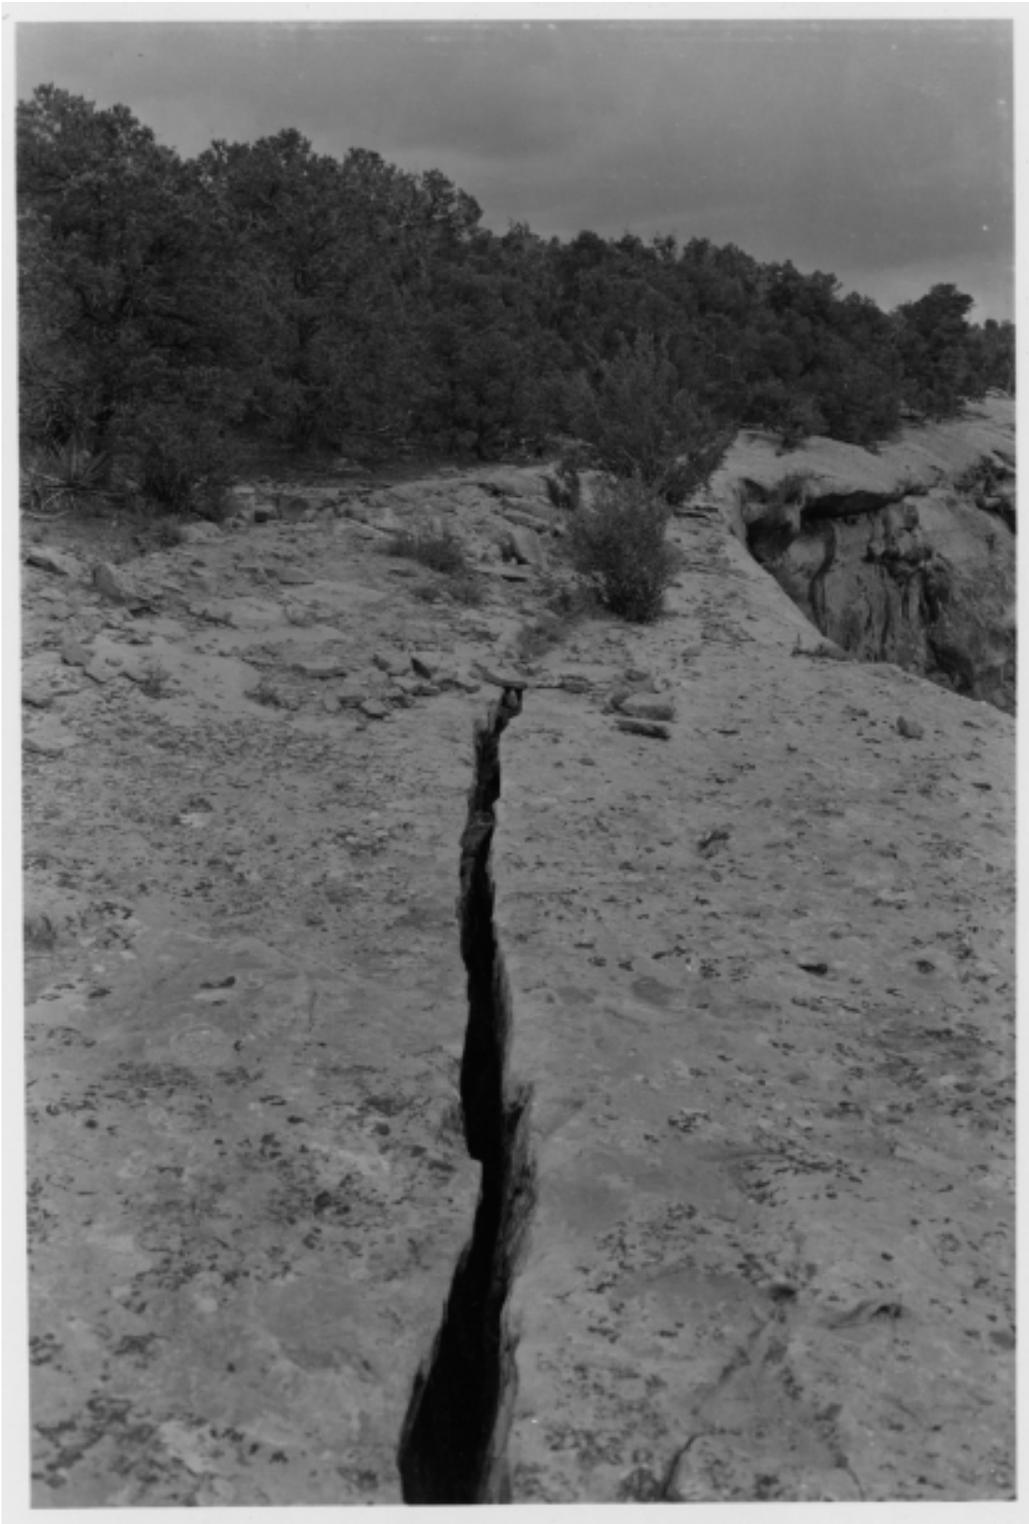
water runoff from the upper surface into the alcove. Also discussed with this photo was ice accumulation with associated ice jacking. Figure 6 (Lancaster, Neg. No. ? (negative missing from files), 1940, (Richardson, 1940)) shows the crack in the process of being cleaned. The back slope of the crack could have been caused by the ice jacking forces and subsequent shearing of the arch sandstone, which indirectly indicates the relatively weak strength of this sandstone.

Figure 5. View of crack at southern end. Looking south. Near Sta. 2+30 +/-.
(Lancaster, Neg. No. ? (Negative missing from files, Richardson Report, 1940)

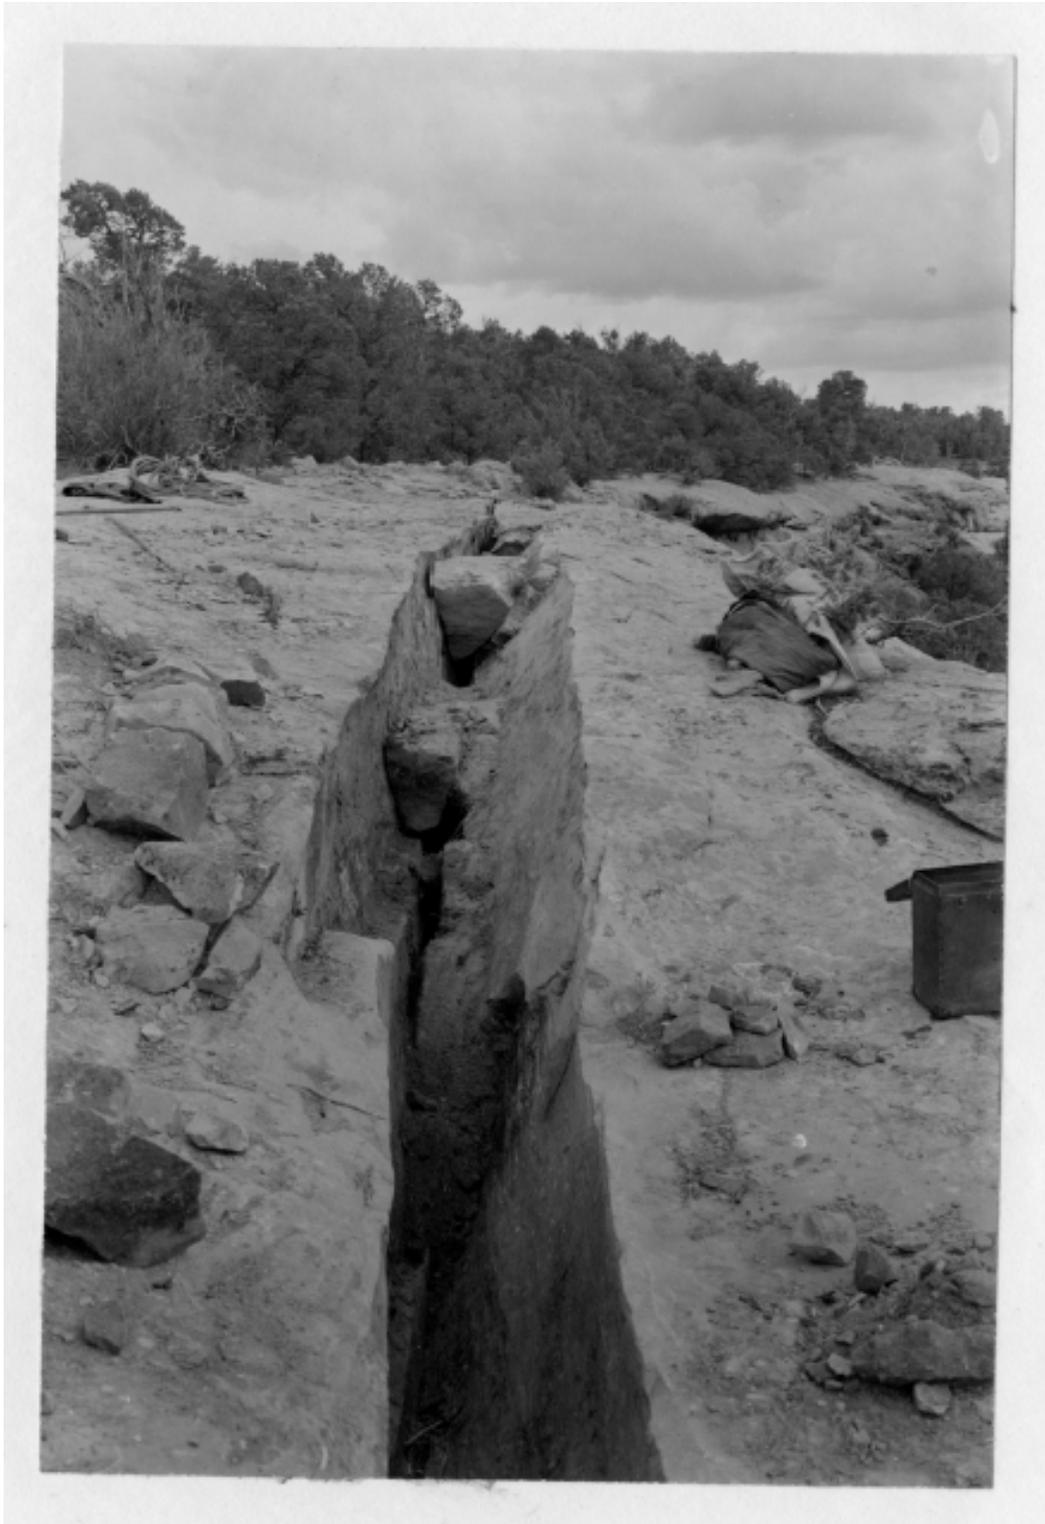
Figure 6. View of widest portion of crack. Looking south. Near Sta. 2+00 +/-.
(Lancaster, Neg. No. ? (Negative missing from files, Richardson Report, 1940)

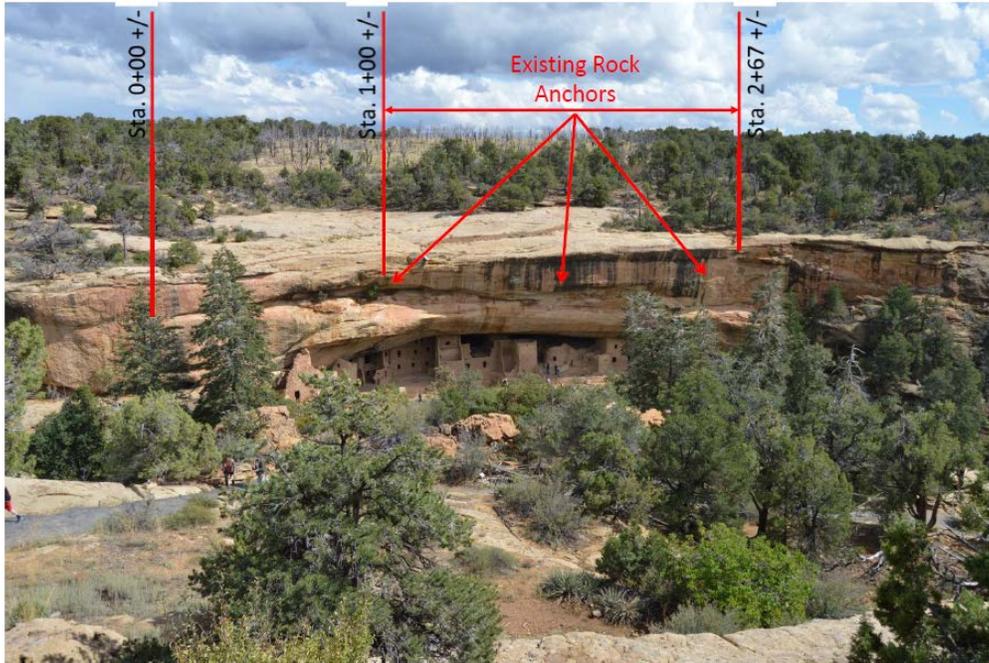
The problem with the swedge device in soft sandstone, such as at the STH alcove, is that the radial outward pressure of the swedge breaks the cementitious bond between sand grains in the immediate vicinity of the swedge. This problem has been documented by other engineers (Wyllie, 1992). Thus, the effectiveness of the clamping force that was applied in 1962 is questionable now, leaving the grout-to-sandstone bond as the resisting mechanism to anchor pull-out. Interestingly, the rock bolt system at STH was designed by A.C. Hawkins who also designed the rock bolt systems at Glen Canyon Dam (Letter from Regional Director T.J. Allen to Chief, Western Office, Division of Design and Construction. June 01, 1961). Glen Canyon Dam has also been experiencing problems with rock spalls in the last 30 years. This issue will be discussed further in Section 5. Figure 7 shows the general region where the rock bolts were installed.

Figure 7. Spruce Tree House. Rock Anchor (Bolt) General Location. (photo: Mason 2015)

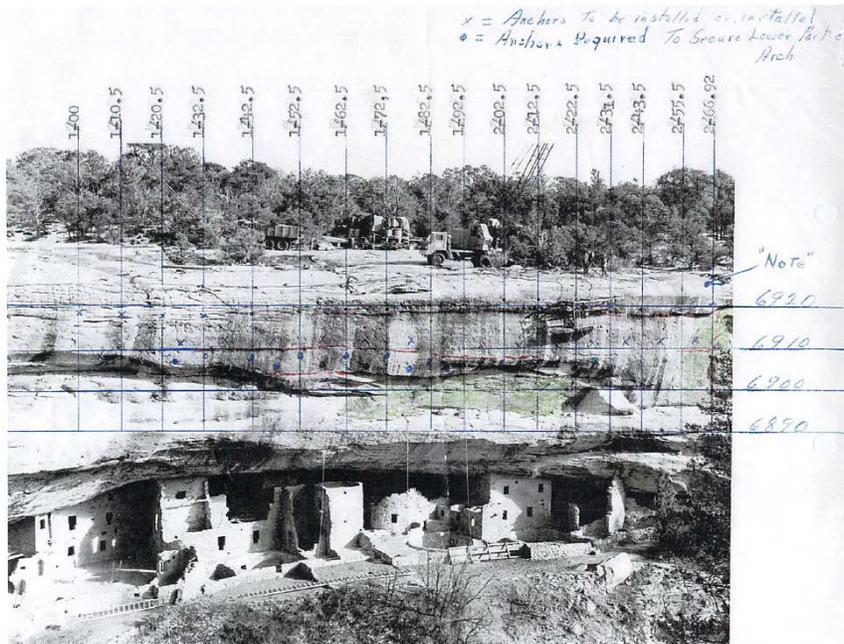
Figure 8 is a working drawing (1962) created to show the as-built locations of the rock anchors in the southern end of the STH alcove sandstone arch. The stationing shown at the top of the figure is correlated with the work by Richardson (1940). These anchor locations were confirmed by the author with high definition photography. It should be noted that the sliver of rock from Sta. 1+42 to 1+72, as shown in Figures 9 and 10, is under the line of rock anchors.

Figure 8. Rock Bolts Installed at Spruce Tree House. (NPS. 1962)

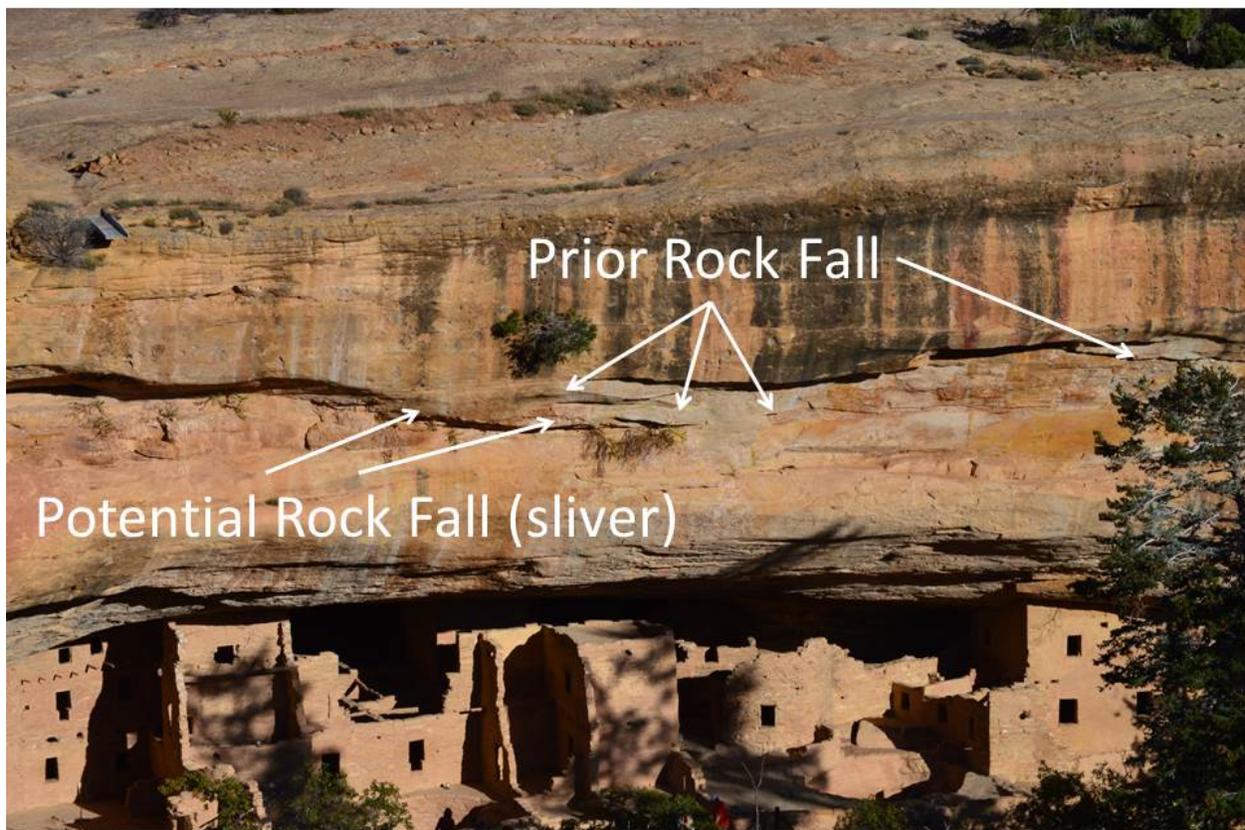
Figure 9 shows a portion of the STH alcove arch from about Sta. 1+00 to 2+10. Prior rock fall and potential rock fall are shown in this photo. It must be noted that the installed rock bolts were aligned horizontally directly above the region of prior and potential rock fall structures. Thus, the potential rock fall structure (sliver) has no added restraining components, i.e. rock bolts, leaving only natural mechanics for resistance.

Figure 9. Site Investigation of STH Alcove Structure for Potential Rock Fall.
View from across canyon. (photo: Mason, 2015)

The confirmation of rock anchor locations was completed in the office with high definition photographs. The rest of the objectives were completed in the field. Potential small rock spall hazards that could be reached by the climbers were removed. The large sliver will require pinning with rock bolts to prevent it from falling. The abutments were photographed and will

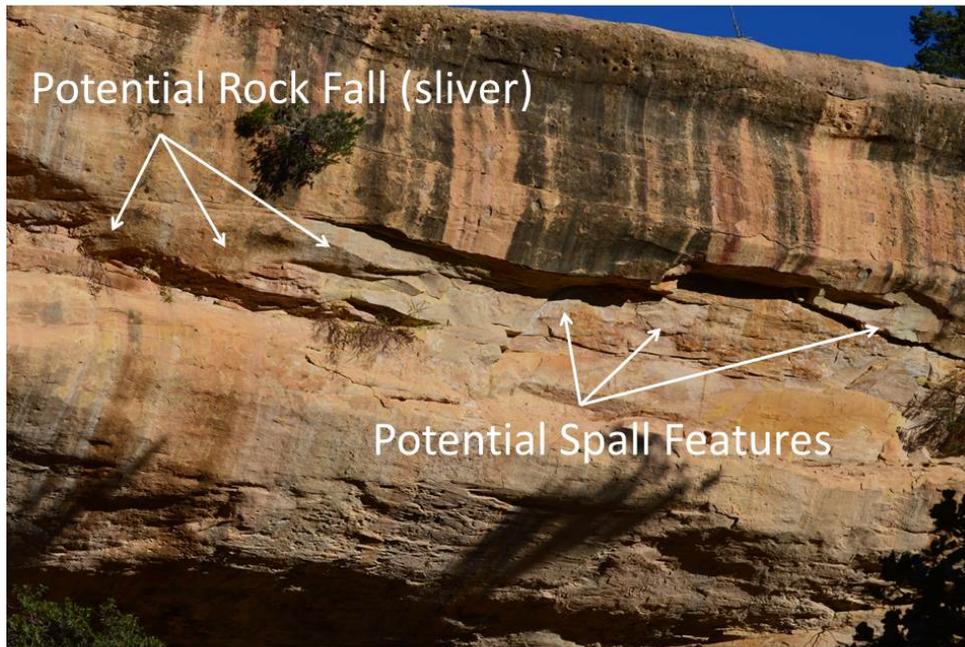
Figure 10. Site Investigation of STH Alcove Structure for Potential Rock Fall. View from below alcove arch. (photo: Mason, 2015)

Figure 10 shows the same potential rock fall feature (sliver) from the visitor path prior to closure of this area. Also shown in this photo are other smaller potential rock fall features.

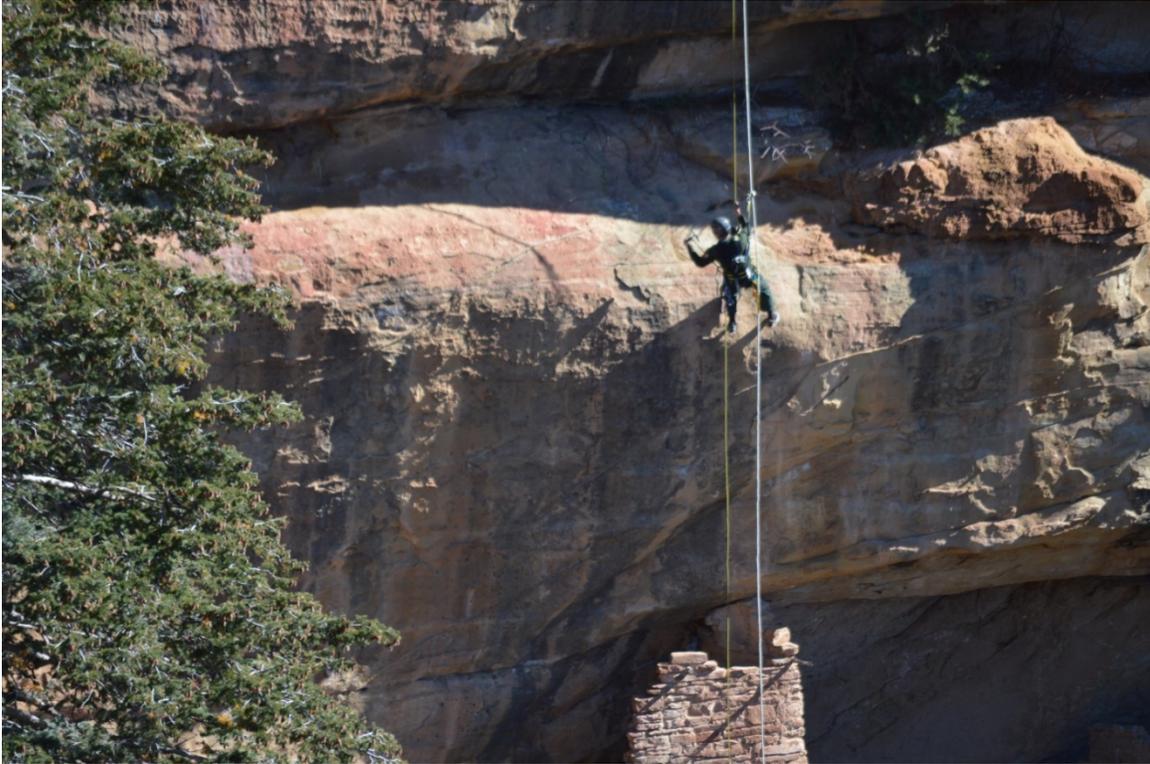
Figure 12. NPS climber using a rock hammer to dislodge loose material at the outer alcove edge. (photo: Mason, 2015)

Figure 12 shows one of the climbers using a rock hammer to dislodge loose material. This material was detected in the field by first looking for obvious loose material then sounding the rock surface with the hammer. A “hollow” sound was a positive identifier that material was loose. There was one instance when a climber was suspended from a roof structure (ceiling) and a very large piece of hanging rock was dislodged with only the touch of his hand. He was smartly and safely at arm’s reach and out of the way of the large piece. It fell directly onto the visitors’ path. The material that was removed was found to have a harder, desiccated outer surface with a substantially softer interior. This confirms that the weakening of the sandstone is due to water leaching the calcium carbonate matrix that binds the sand particles in the sandstone.

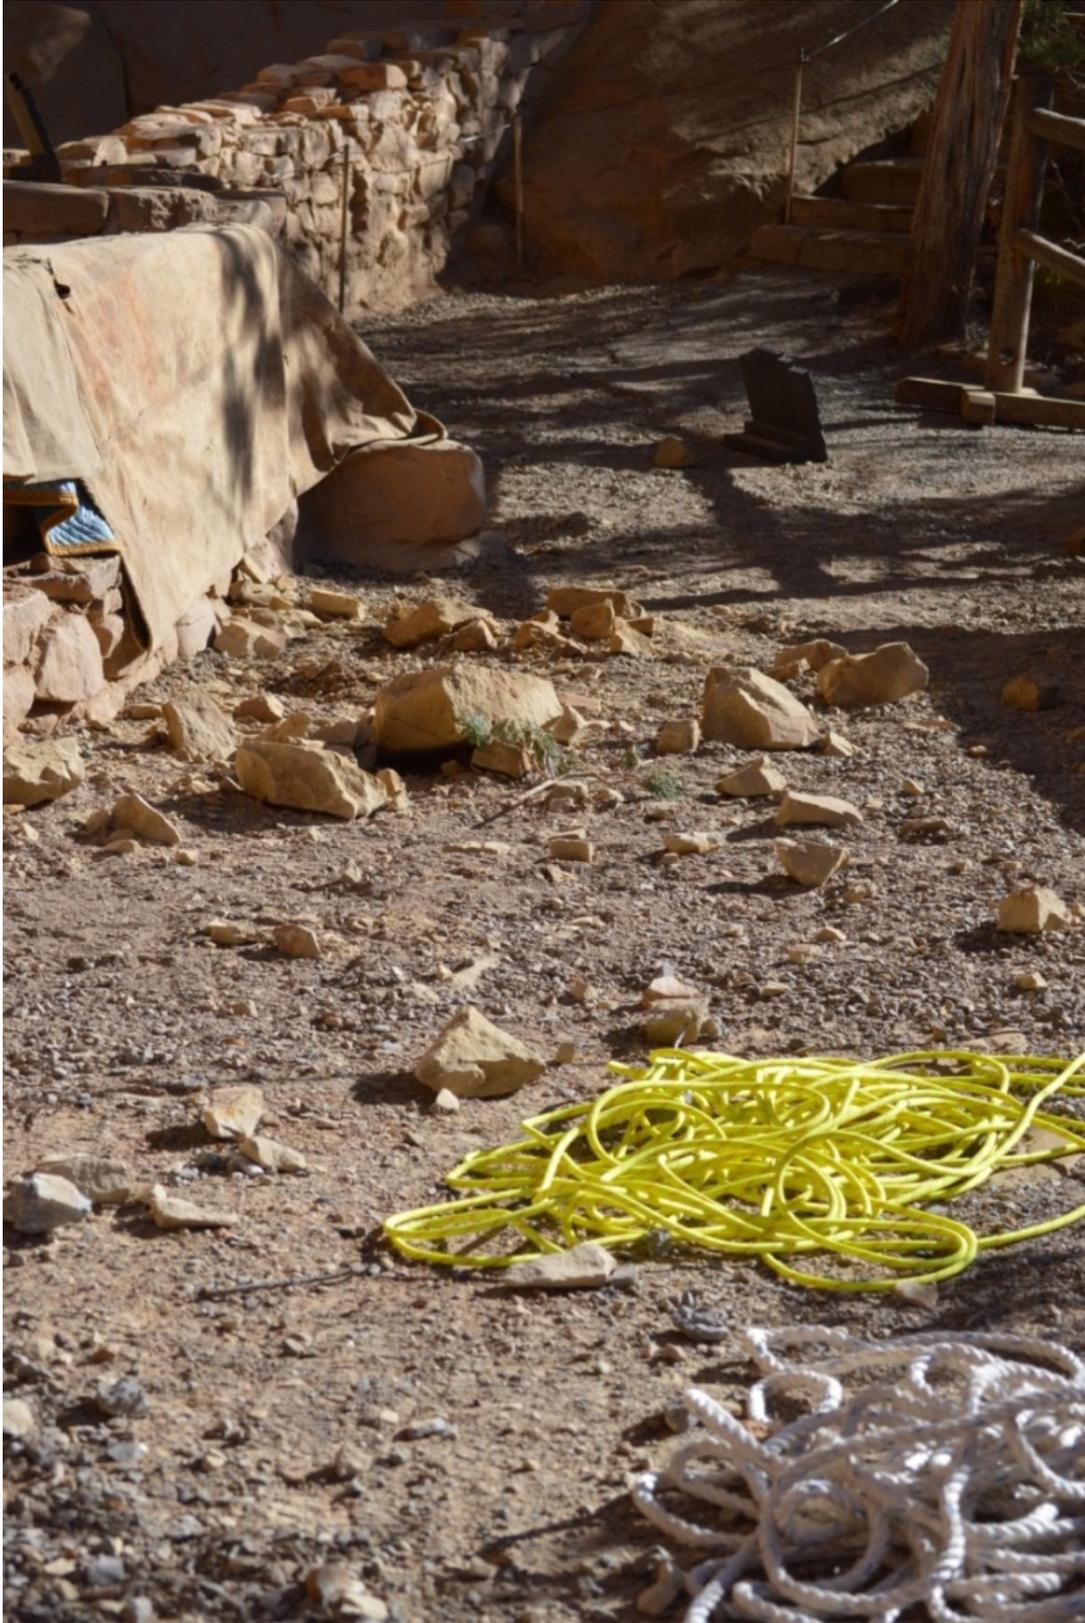
Figure 13 shows the debris which fell onto the path at the southern end of the site during the scaling operation. A similar amount fell over the edge of the path into the brush downslope of the path. It took about 6 wheel barrow loads to clean the visitors’ paths along the complete length. Thus, at least 60 cubic feet (cf) of material was removed from the alcove edge (at 5 cf per wheel barrow load). Every one of these rocks was a major potential hazard to both staff and visitor.

Figure 13. STH alcove spall material at southern end.

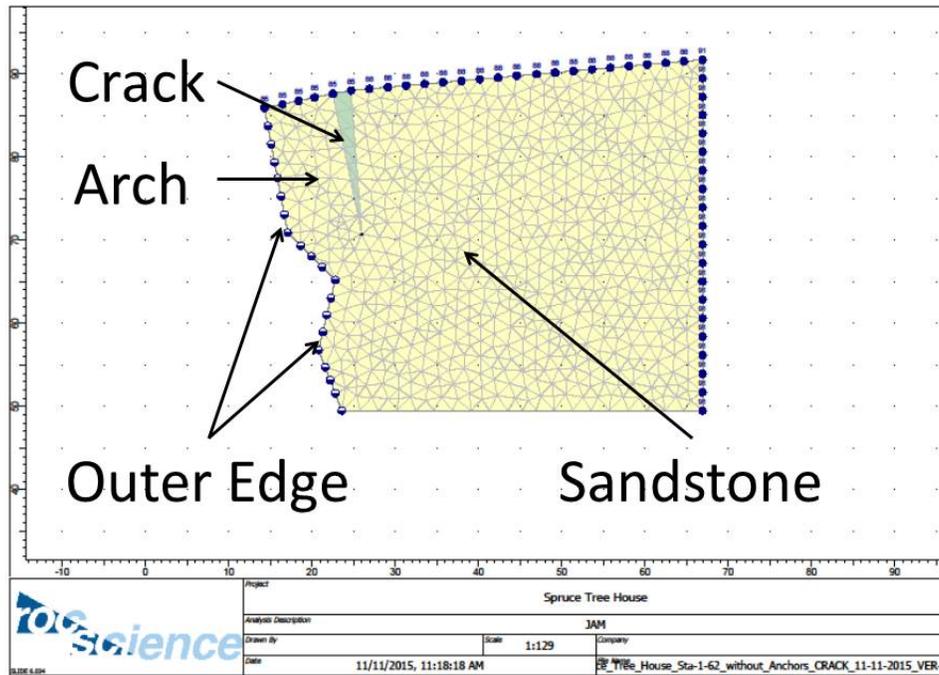
Third, the very composition of the sandstone could be changed due to the change of water drainage caused by the installed concrete plug. Sandstone is inherently a very porous material in which groundwater could move relatively easily in comparison to hard rock or concrete. Before the concrete plug was installed, groundwater that seeped into the alcove roof could freely drain both vertically and horizontally with the crack providing drainage release. This condition was modeled in an advanced computer program: *SLIDE* (RocScience, 2012). The basic model was constructed from the geometry from Sta. 1+62. See Figure 14. These are partial models investigating the crack and the effect of the concrete dam on ground water movement around the crack. The X and Y axes for Figures 14, 15, and 16 are shown to scale in feet. Full models of the complete alcove cross-section were constructed and showed similar results to the partial models. The sandstone was colored light yellow. The unfilled crack was modeled as a material with no strength, and permeability a thousand times greater than the sandstone. The left hand side (LHS) of the model was assigned as a free draining surface. The top surface and right hand side (RHS) were modeled with a total head condition.

Figure 14. Spruce Tree House alcove. Basic model for cross-section at Sta. 1+62. (Sandstone: Light yellow. Crack: Light green).

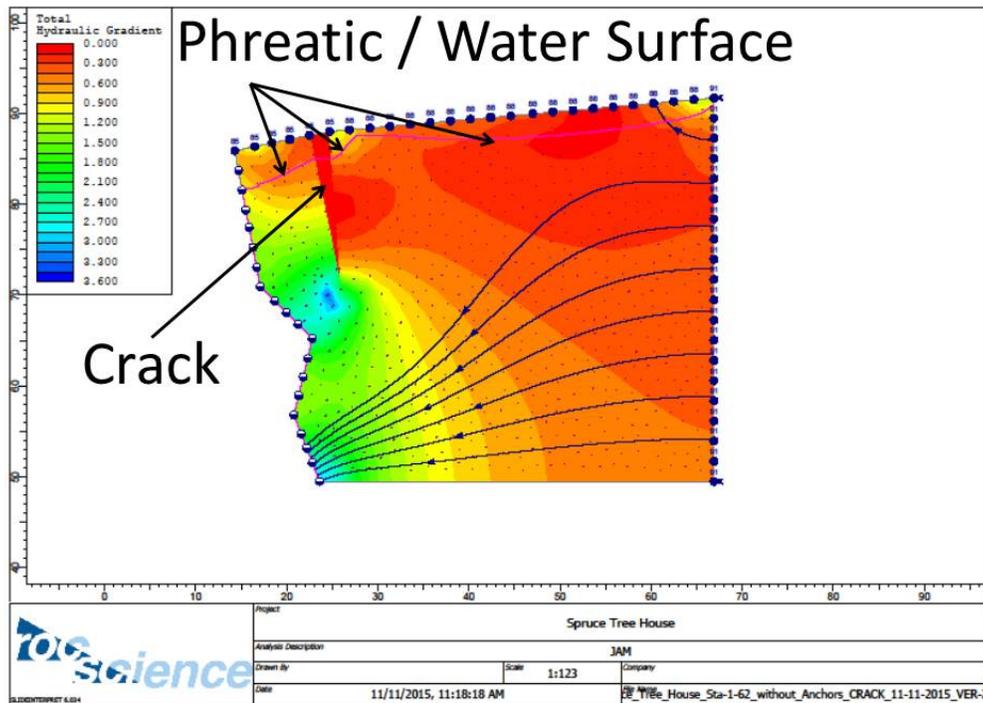
Figure 15 shows the hydraulic gradient, water flow path, and phreatic (water) surface. It can be seen that there is no gradient in the crack (free drainage). The water surface is approximately parallel to the top surface, indicating that the crack filled with water. The arch drainage is roughly planar downward. The overall groundwater movement is towards the lower outer edge of the alcove arch and roof surface. This drainage pattern has been noted in the field.

Figure 15. Spruce Tree House alcove. Basic model for groundwater flow at Sta. 1+62. (Crack: Red wedge)

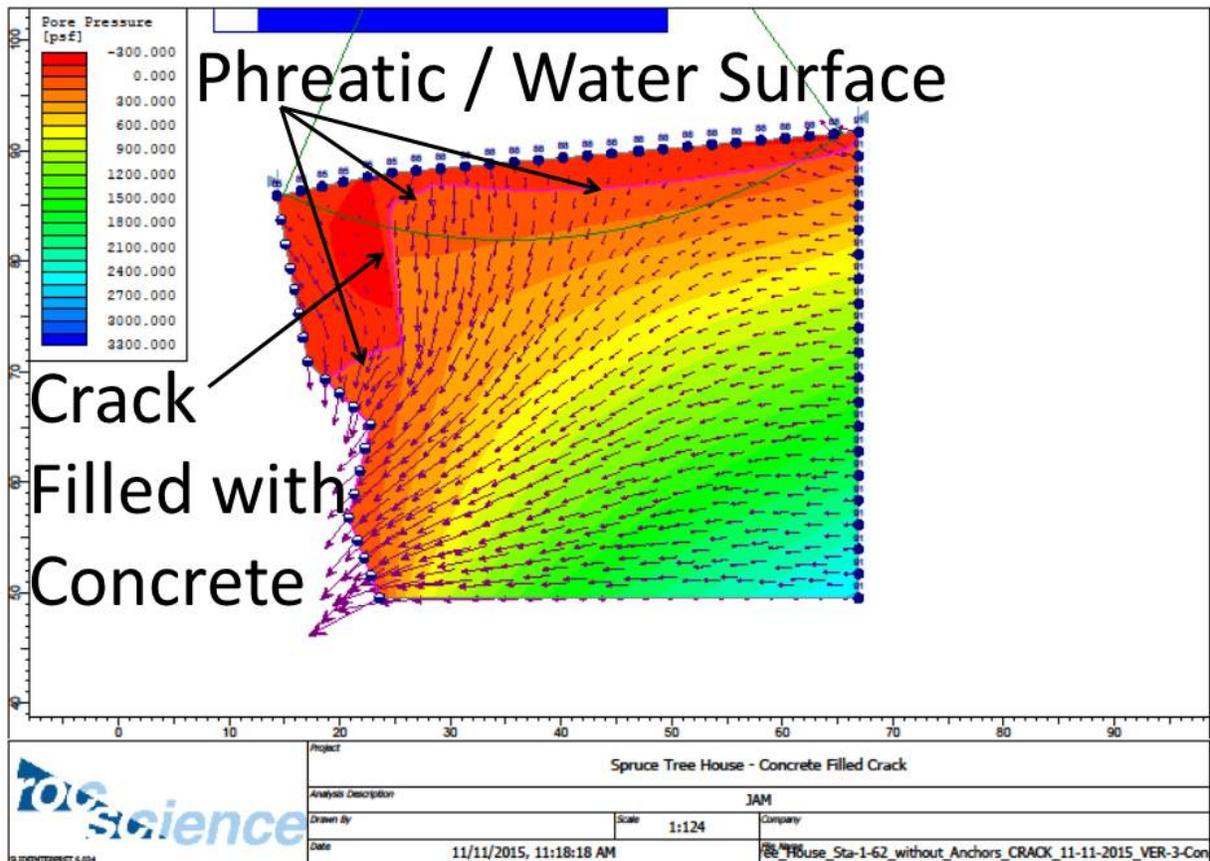
Figure 16 shows the results of groundwater movement and pore pressure in the sandstone for the case of the crack filled with concrete. For this case, the permeability of the concrete in the crack is roughly 10,000 times less than the porous sandstone. The vectors (arrows) show the ground water flow path. Figure 16 shows that the concrete plug acts as a dam within the alcove roof structure, where the flow vectors point downward alongside the plug. The phreatic surface is approximately parallel to the ground surface upslope and dips down alongside the concrete filled crack. The concrete filled crack is acting as a dam and forcing the ground water flow downward. This phenomenon creates a problem of increased groundwater velocity around the plug, a process which could easily increase the leaching of the calcium carbonate binder in the sandstone, thus leaving sand. This was seen during the scaling operations where piles of sand were found at the base crack of the arch at the north-central part of the alcove.

Figure 16. Spruce Tree Alcove. Basic model for pore pressure and groundwater flow at Sta. 1+62. Crack filled with concrete.
