HISTORY OF RUINS STABILIZATION AT  
CLIFF PALACE AND SPRUCE TREE HOUSE  
MESA VERDE NATIONAL PARK, COLORADO

Jonathon C. Horn  
Co-Project Director

Alpine Archaeological Consultants, Inc.  
P.O. Box 521  
Montrose, Colorado 81402  
(303) 249-6761

National Park Service  
Mesa Verde National Park

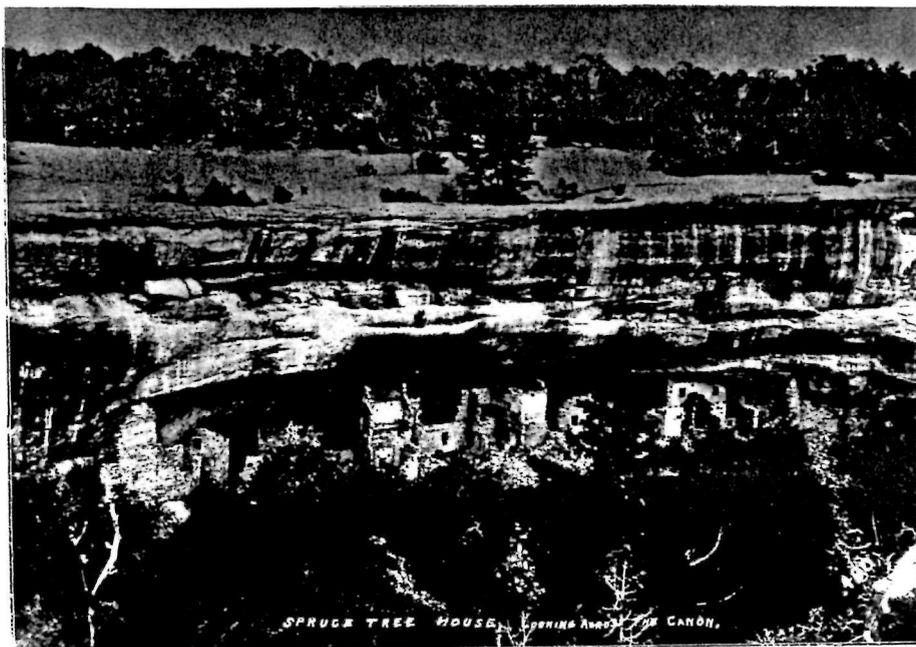
Figure 2. Copy of historic photograph of Spruce Tree House looking east across the canyon prior to 1908. (Neg. #4693, Mesa Verde Museum)

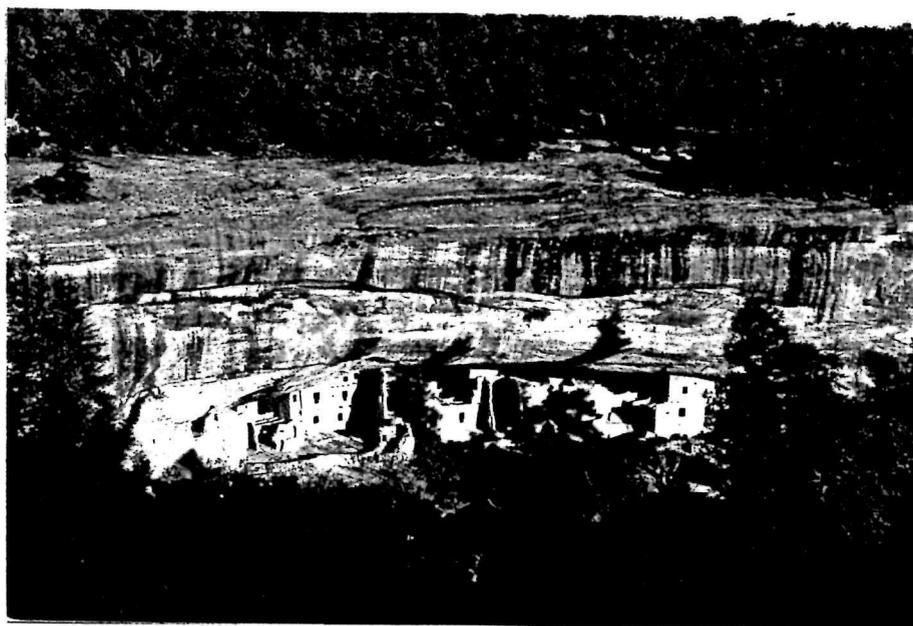
Figure 3. Present view of Spruce Tree House looking east across the canyon.

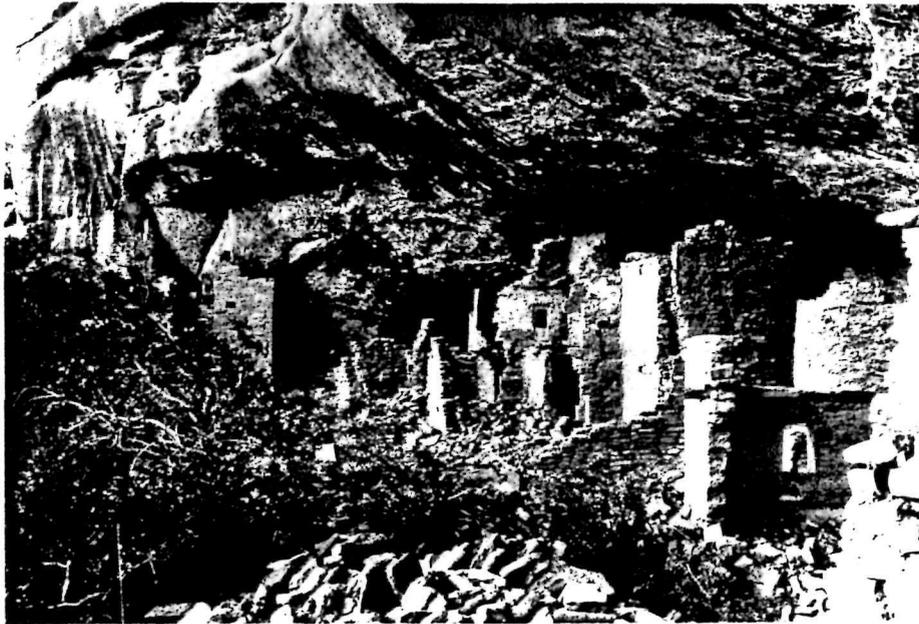
Figure 4. Copy of historic photograph entitled, "Spruce Tree House Before Excavation" looking north across front of the ruin. (Neg. #4915, Mesa Verde Museum).

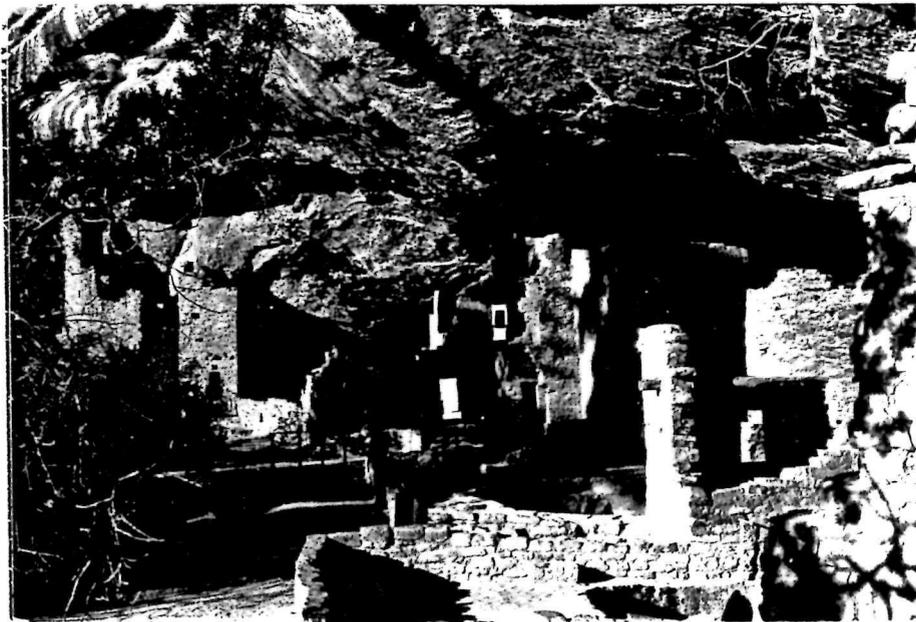
Figure 5. Present view north across the front of Spruce Tree House from the same vantage point as the historic photo.

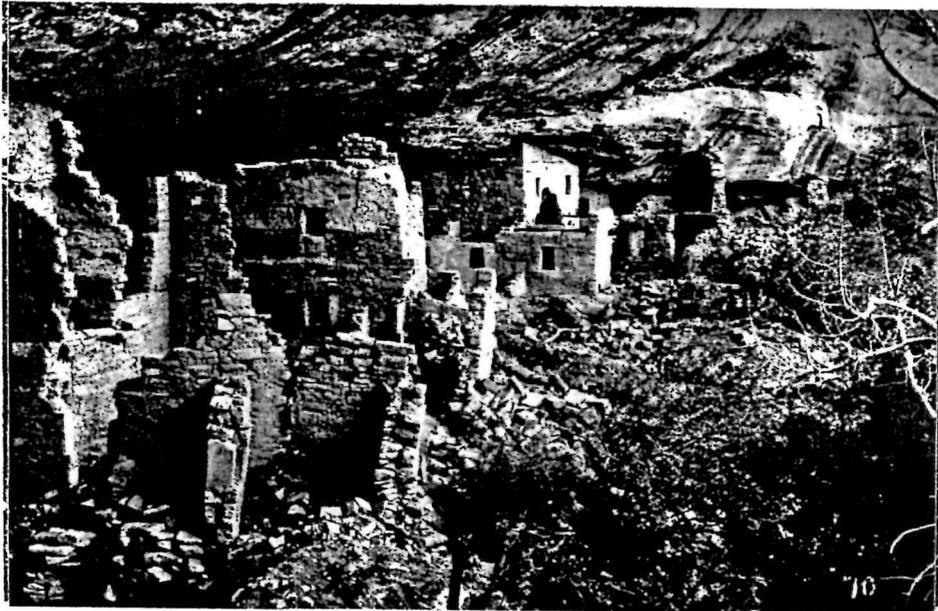
Figure 6. Copy of historic photograph entitled, "Spruce Tree Before Excavation" looking south across front of the ruin. (Neg. #4916, Mesa Verde Museum).

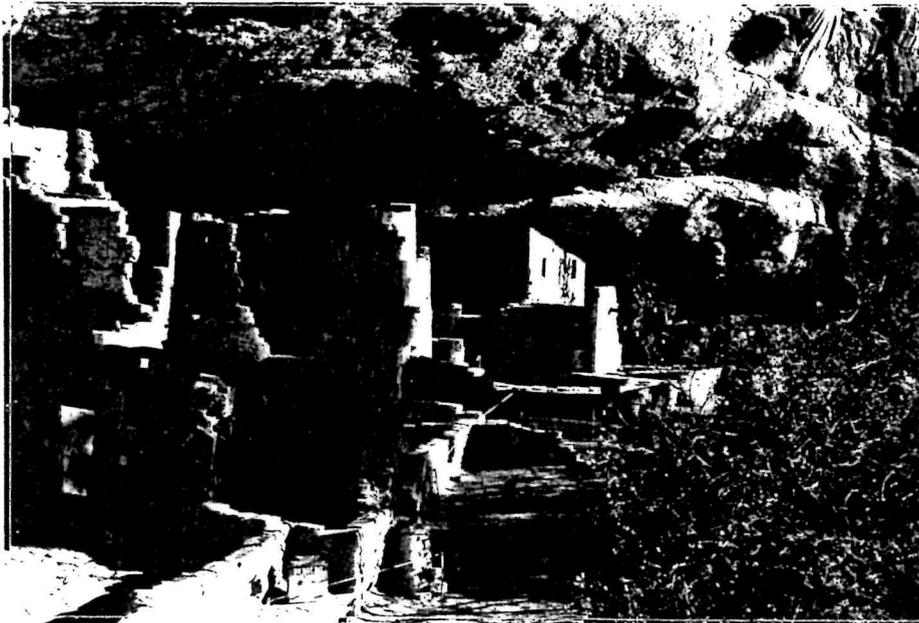
Figure 7. Present view south across the front of Spruce Tree House from the same vantage point as the historic photo.

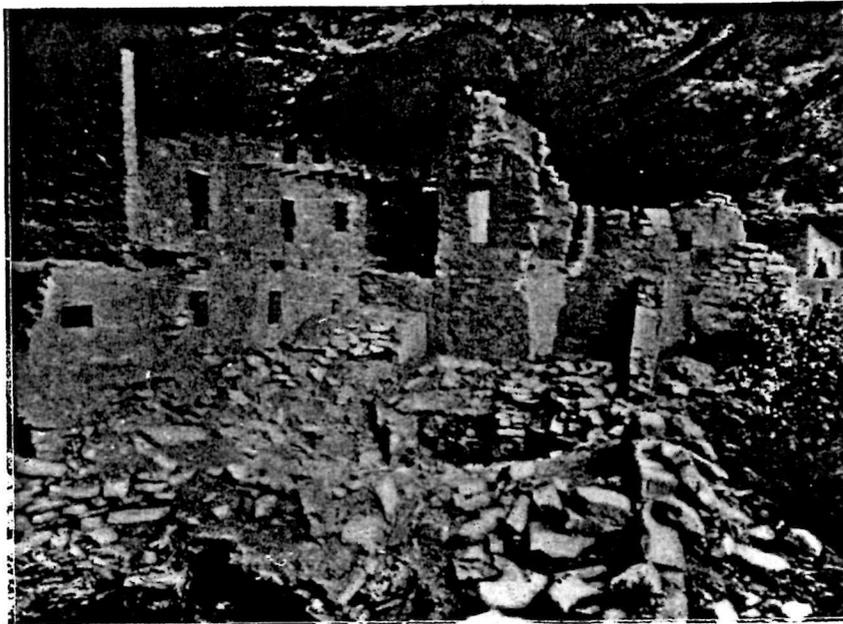
Figure 8. Copy of an historic photograph attributed to Fewkes, ca. 1908, entitled, "Spruce Tree House Before Repair" looking south into the courtyard of Kivas C and D. (Neg. #4153, Mesa Verde Museum).

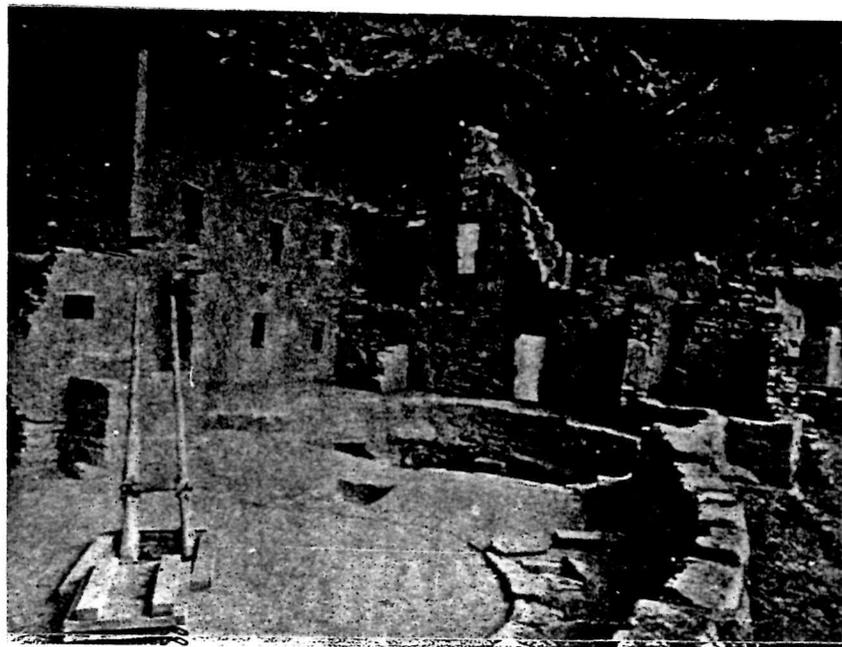
Figure 9. Copy of a photograph attributed to Fewkes, ca. 1908, entitled, "Spruce Tree House After Excavation" looking south into the courtyard of Kivas C and D. (Neg. #4154, Mesa Verde Museum).

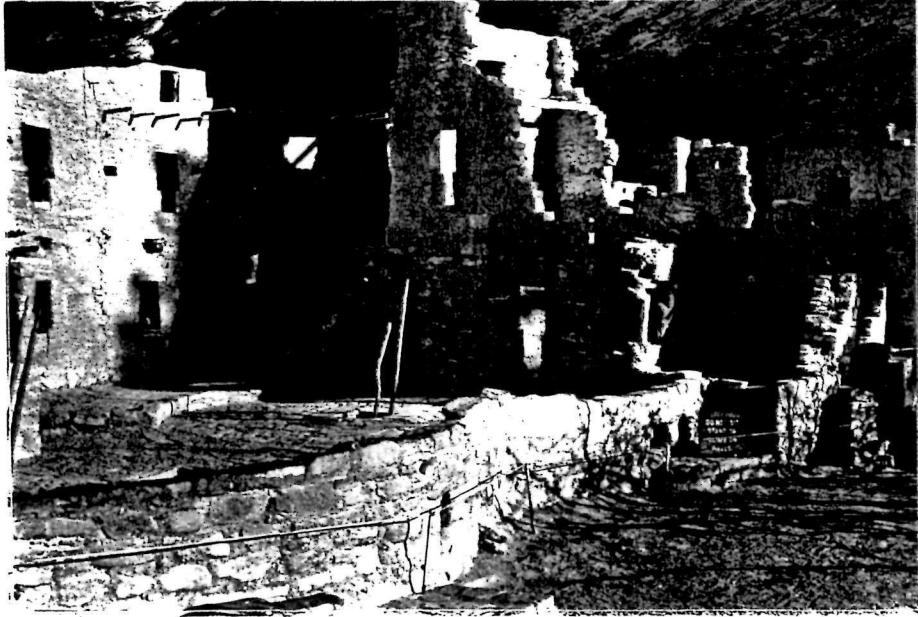
Figure 10. Present view south into the courtyard of Kivas C and D and Spruce Tree House from a similar vantage point as the two previous photographs.

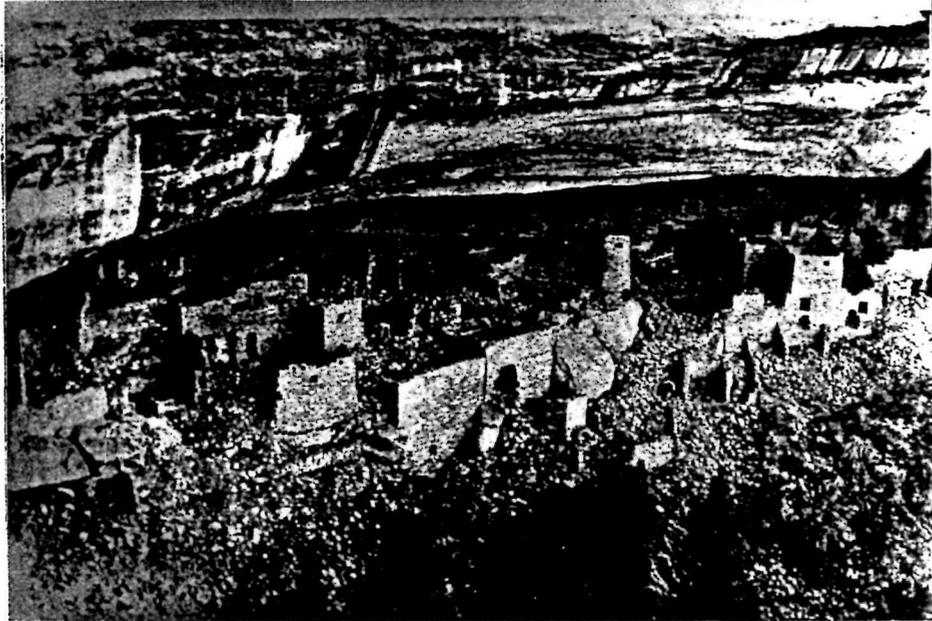
Figure 12. View of Cliff Palace before excavation and repair by Fewkes, looking southeast. Photograph taken by an unnamed park visitor, ca. 1908. (Neg. #18558, Mesa Verde Museum).

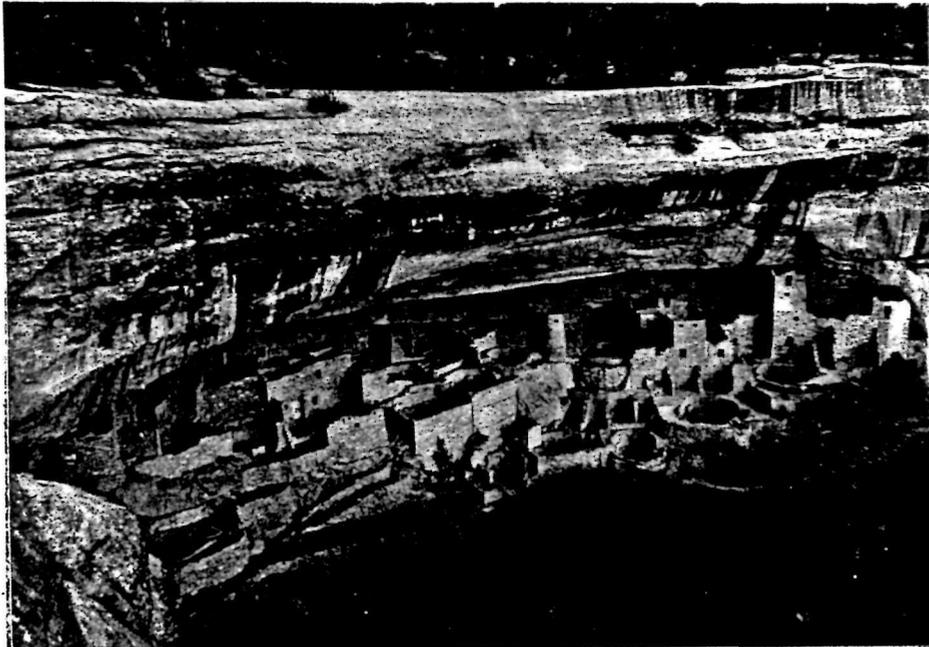
Figure 13. Present view of Cliff Palace looking southeast from the same vantage point as the historic photo.

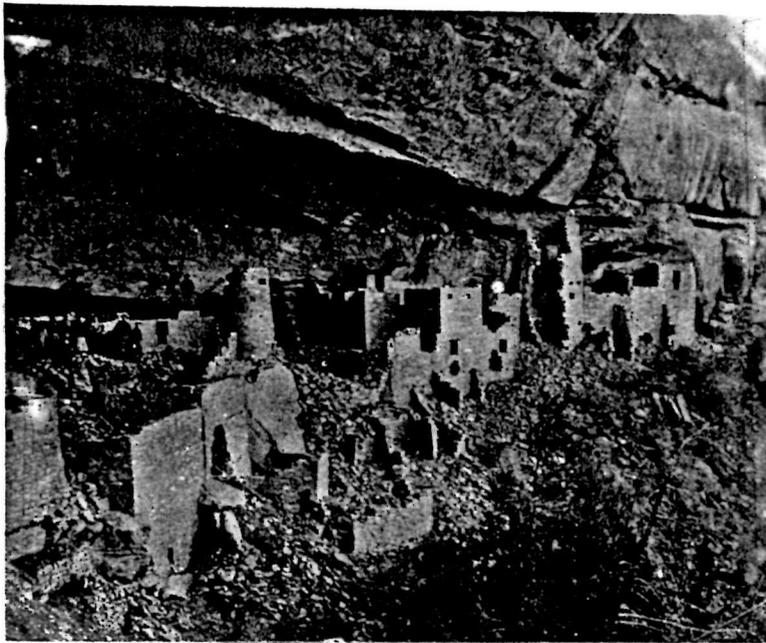
Figure 14. Copy of photograph of southern portion of Cliff Palace taken in 1896 by Rev. F. F. Peterson. (Neg. #3081, Mesa Verde Museum).

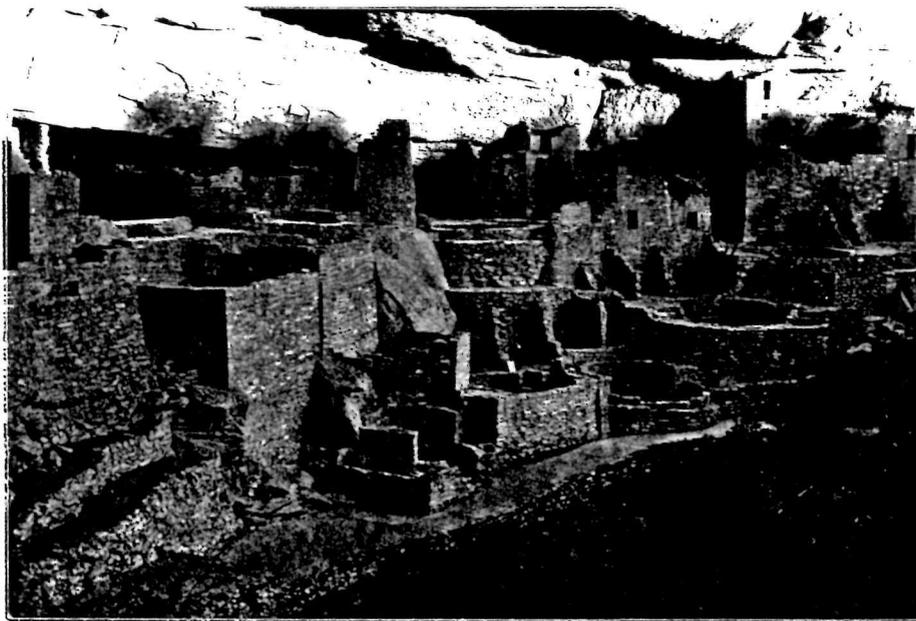
Figure 15. Present view of the southern portion of Cliff Palace from the same perspective as the historic photograph.

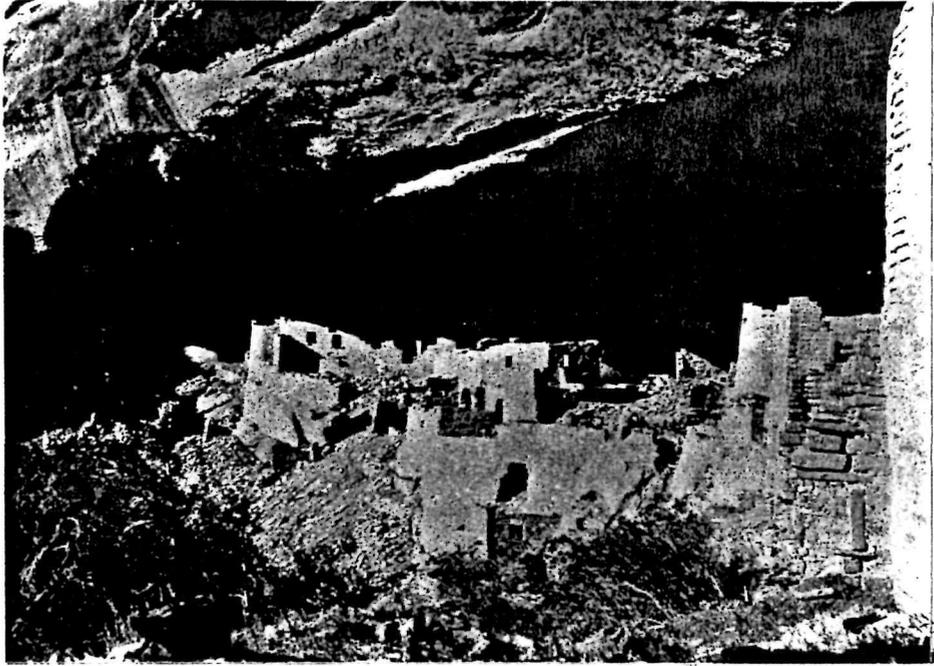
Figure 16. Copy of an historic photograph looking north across the front of the central portion of Cliff Palace prior to excavation and repair by Fewkes. (Neg. #4914, Mesa Verde Museum).

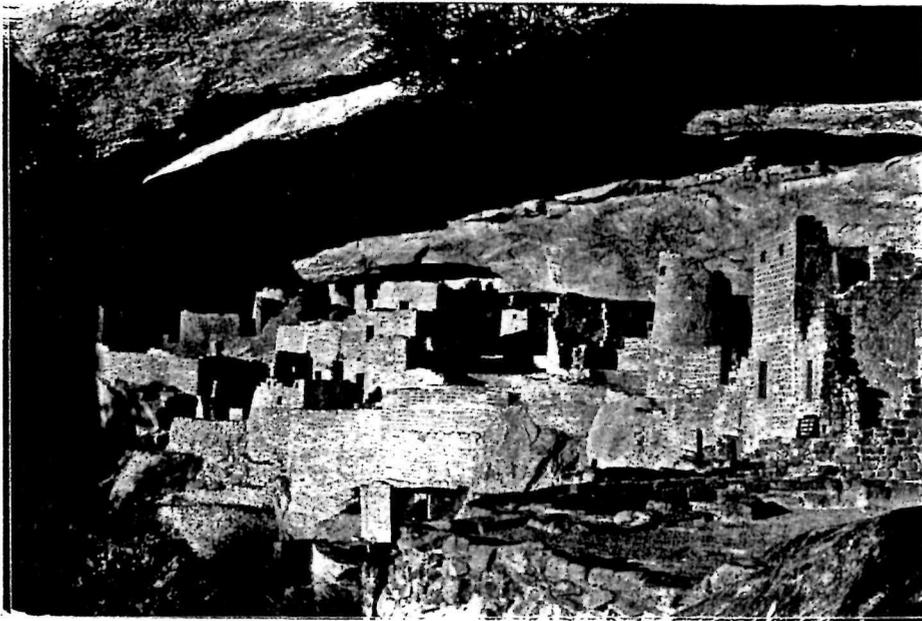
Figure 17. Present view looking north across the front of the central portion of Cliff Palace from the same vantage point as the historic photo.
